# Cultural Heritage Report

## *Proposed Caledon Pit/Quarry*

**CBM Aggregates, a division of St. Marys Cement Inc. (Canada)**

19129150-5700

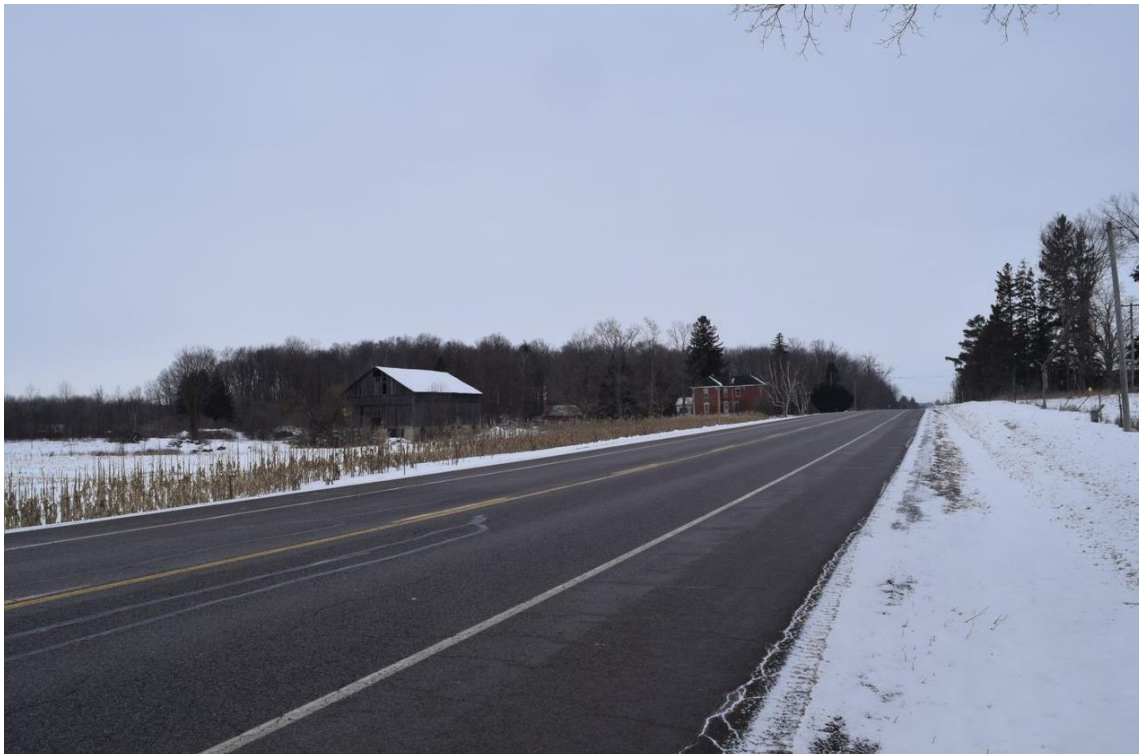
**Figure 5: Main Street north of Charleston Sideroad, exhibiting paved asphalt, two-lane roadway with partially paved and partially gravelled shoulder (latter under snow) accompanied by ditch, facing northwest.**

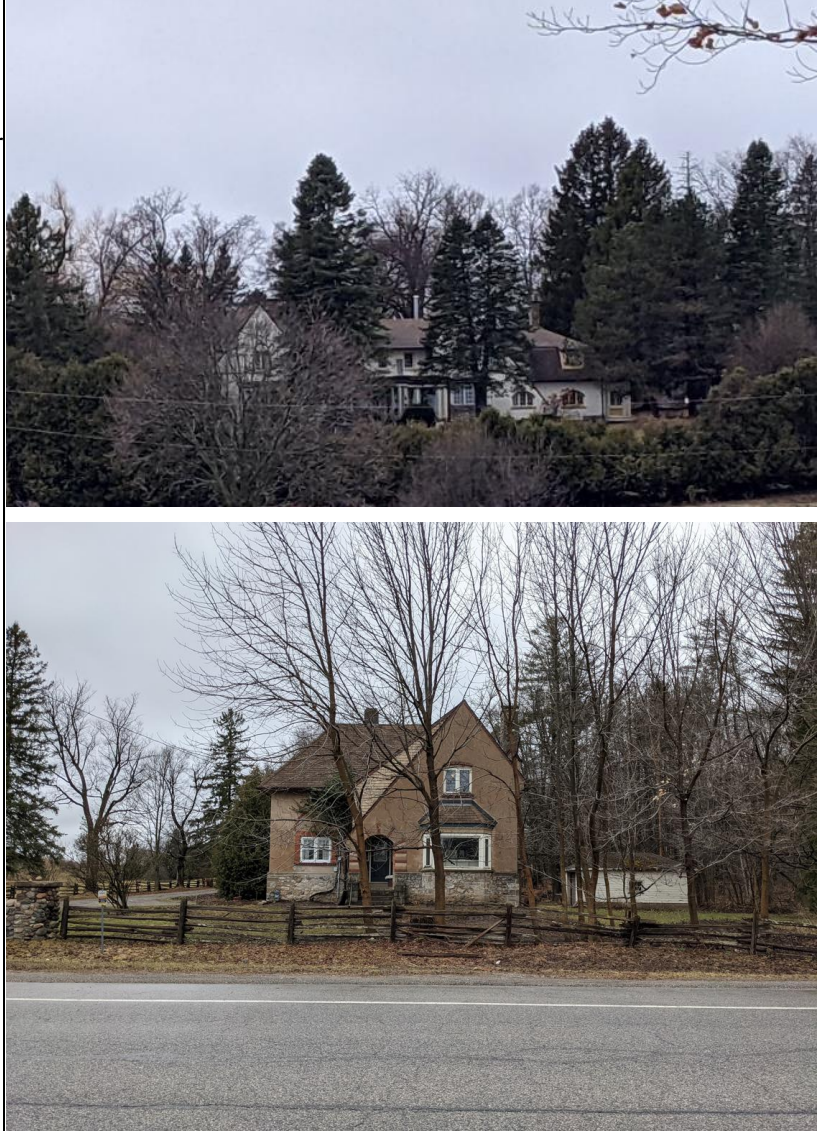
Address or Location	Cultural Heritage Status	Photograph	Description	Potential CHVI	Potential Heritage Attributes
18906 Main Street	Listed (not designated) on the Town of Caledon's <i>Heritage Register</i>

<p>Described on the Town of Caledon's <i>Heritage Register</i> as an arts and crafts style farmhouse with a plaster exterior commenced between 1850-1875 and 1900-1924.</p> <p>Historical research conducted for this Cultural Heritage Report determined that a farmhouse was located on the property as early as 1859 and appears to be situated in the same location as the present-day house with a large set-back at 18906 Main Street (top image). At that time the property was listed under James Dodds of Lot 18, Concession 4 WCR. By 1877, a second structure was constructed on the property fronting the concession road and appears to be situated in the same location as the present-day plaster façade house fronting Main Street (bottom image).</p> <p>The first house is a single-detached, two-storey structure with a T-shaped main block (with extensions to the northwest) and medium pitch gable and hip roof. The house is set back approximately 285 m from Main Street and is accessed by a partially paved, partially gravelled driveway to the northwest of the house.</p> <p>The second house is a single-detached, storey-and-a-half structure with a rectangular shaped main block, stone foundation and high pitch gable and hip roof. The house is set back approximately 10 m from Main Street and is accessed by the same driveway to the first house which runs south of this second house.</p> <p>To the south of the first house is a large barn with a metal gambrel roof as well as a smaller outbuilding with a metal gable roof (construction materials for both are indiscernible from ROW; details observed from satellite imagery). The barn and outbuilding are set-back approximately 335 m from Main Street and are accessed via a second partially paved/ gravelled driveway located to the south of the first driveway.</p> <p>The large property parcel extends to the northwest and southwest and consists of large, ploughed fields delineated by hedgerows/ treelines, interspersed with woodlots and traversed by a branch of the Credit River.</p>	<p><b>Design or physical value:</b></p> <ul style="list-style-type: none"> <li>■ Arts and crafts style farmhouse</li> </ul> <p><b>Historical or associative value:</b></p> <ul style="list-style-type: none"> <li>■ N/A</li> </ul> <p><b>Contextual value:</b></p> <ul style="list-style-type: none"> <li>■ Physical connection between the farmhouses and outbuildings</li> <li>■ Maintenance and support of the rural and natural landscape of area (large fields lined by hedge rows/ trees; Credit Valley River)</li> </ul>	<ul style="list-style-type: none"> <li>■ First house main block with:             <ul style="list-style-type: none"> <li>■ Gable roof</li> <li>■ T-shaped plan</li> </ul> </li> <li>■ Second house main block with             <ul style="list-style-type: none"> <li>■ Gable roof</li> <li>■ Rectangular plan</li> <li>■ Stone foundation</li> </ul> </li> <li>■ Large agricultural fields delineated by hedgerows/ treelines</li> </ul>

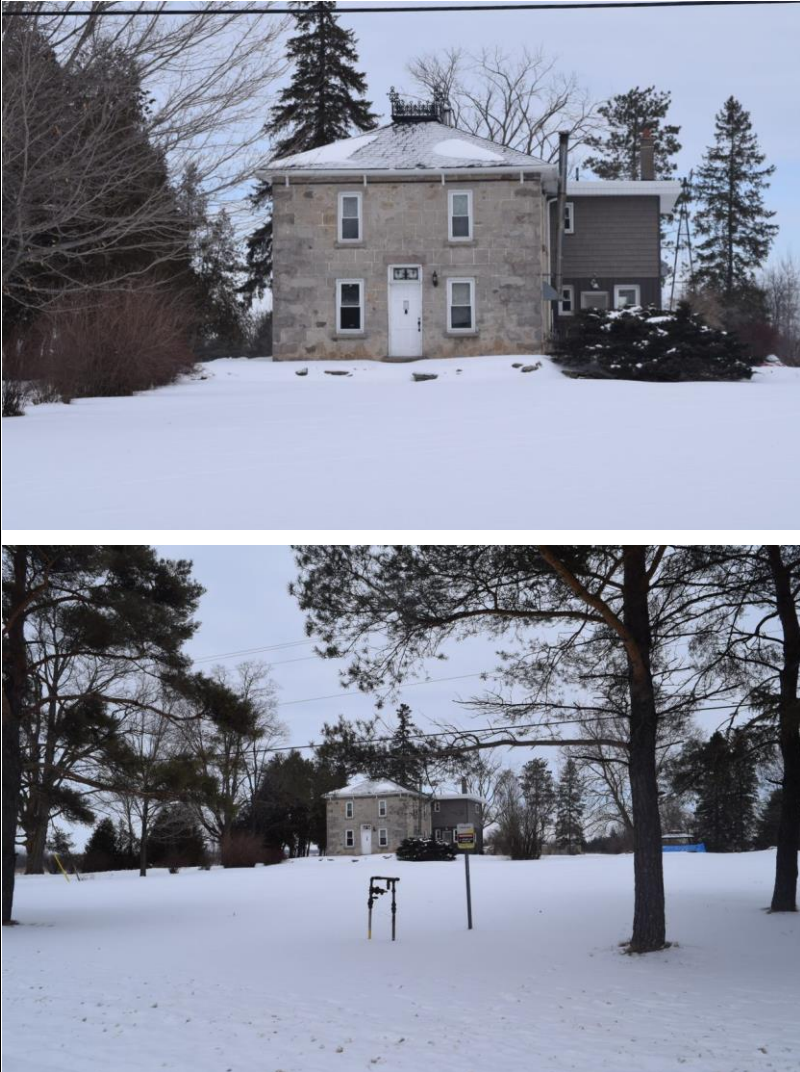
Address or Location	Cultural Heritage Status	Photograph	Description	Potential CHVI	Potential Heritage Attributes
18719 Main Street	Listed (not designated) on the Town of Caledon's <i>Heritage Register</i>

<p>Described on the Town of Caledon's <i>Heritage Register</i> as an Italianate style farmhouse with a cut stone exterior dating 1875-1899.</p> <p>Historical research conducted for this Cultural Heritage Report determined that a farmhouse was located on the property as early as 1859 and appears to be situated near the location of the present-day house at 18719 Main Street. At that time, the property was listed under Samuel Wallace of the northwest half of Lot 17, Concession 3 WCR.</p> <p>The house is a single-detached, two-storey structure with a rectangular shaped main block (with an extension to the southeast) and low pitch hip roof. The house is set back approximately 50 m from Main Street and is accessed by a gravelled driveway to the northwest of the house.</p> <p>To the northeast of the house is a barn with a metal gable roof (construction material indiscernible from ROW) set-back approximately 93 m from Main Street and accessed via the same driveway to the house. To the northeast of the barn are the remnants of a foundation for an earlier outbuilding.</p> <p>The property parcel consists of ploughed fields delineated by hedgerows/ treelines and a woodlot to the northeast which backs on to the Brampton-Orangeville Railway corridor identified on the Town of Caledon's <i>Cultural Heritage Landscapes Inventory</i> as the Former CVR CHL.</p>	<p><b>Design or physical value:</b></p> <ul style="list-style-type: none"> <li>■ Italianate style farmhouse</li> </ul> <p><b>Historical or associative value:</b></p> <ul style="list-style-type: none"> <li>■ N/A</li> </ul> <p><b>Contextual value:</b></p> <ul style="list-style-type: none"> <li>■ Physical connection between the farmhouse and outbuilding(s)</li> <li>■ Maintenance and support of the rural landscape of area (fields lined by hedge rows/ trees)</li> <li>■ Maintenance and support of the Former CVR CHL</li> </ul>	<ul style="list-style-type: none"> <li>■ House main block with:             <ul style="list-style-type: none"> <li>■ Hip roof</li> <li>■ Rectangular shaped plan</li> <li>■ Stone construction</li> </ul> </li> <li>■ Agricultural field delineated by hedgerows/ treelines</li> <li>■ Views of the Former CVR CHL</li> </ul>

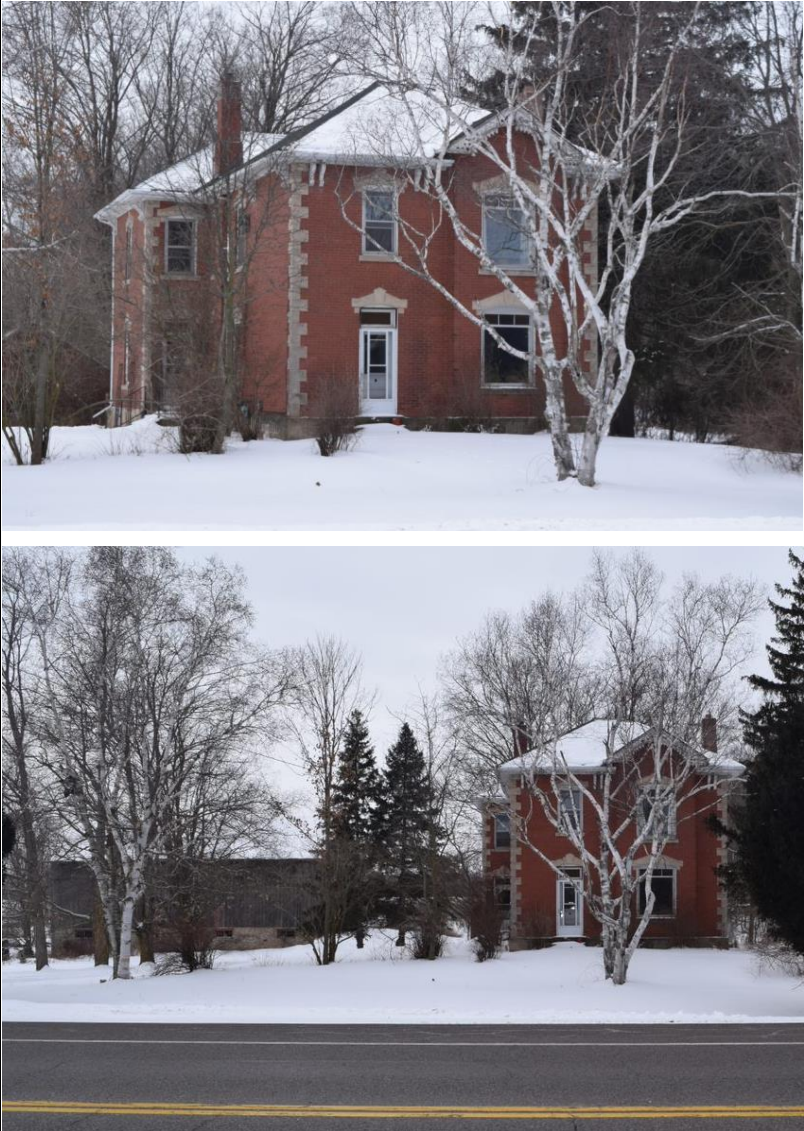
Address or Location	Cultural Heritage Status	Photograph	Description	Potential CHVI	Potential Heritage Attributes
18722 Main Street	Listed (not designated) on the Town of Caledon's <i>Heritage Register</i>

<p>Described on the Town of Caledon's <i>Heritage Register</i> as an Italianate style farmhouse with a red brick exterior dating 1875-1899.</p> <p>Historical research conducted for this Cultural Heritage Report determined that a farmhouse and barn were located on the property as early as 1937 and appear to be situated in the same location as the present-day house and barn at 18722 Main Street.</p> <p>The house is a single-detached, two-storey structure with a slight L-shaped main block and medium pitch hip roof. The house is set back approximately 20 m from Main Street and is accessed by a gravelled driveway to the southeast of the house.</p> <p>To the southwest of the house is a timber framed barn with a metal gable roof and stone foundation set-back approximately 75 m from Main Street and accessed via the same driveway to the house. The barn appears to be of the Central Ontario Barn style popular during the latter half of the 19th century.</p> <p>The large property parcel extends to the northwest and consists of large, ploughed fields delineated by hedgerows/ treelines, interspersed with woodlots and traversed by a branch of the Credit River.</p> <p><b>NOTE: A preliminary heritage evaluation for this property is presented in APPENDIX C.</b></p>	<p><b>Design or physical value:</b></p> <ul style="list-style-type: none"> <li>■ Italianate style farmhouse</li> <li>■ Central or Southern Ontario Barn style</li> <li>■ Board and Batten outbuilding</li> </ul> <p><b>Historical or associative value:</b></p> <ul style="list-style-type: none"> <li>■ N/A</li> </ul> <p><b>Contextual value:</b></p> <ul style="list-style-type: none"> <li>■ Spatial organization and range of forms in building complex maintains and supports local character</li> <li>■ Historical connection to 18667 Mississauga Road</li> </ul>	<ul style="list-style-type: none"> <li>■ Italianate style farmhouse:             <ul style="list-style-type: none"> <li>■ Two storey residence with L shaped floorplan.</li> <li>■ Projecting bay feature on northeast elevation with decorative bargeboard on gable.</li> <li>■ Medium pitch hip roof featuring a wide overhang, decorative paired brackets.</li> <li>■ Red brick construction with dichromatic stone accents.                     <ul style="list-style-type: none"> <li>– Stone quoins carved in a Drafted Margins pattern, decorative stone window heads, stone lug sills also carved in Drafted Margins pattern.</li> </ul> </li> <li>■ Segmental arched windows with original wooden frames.</li> <li>■ Parged stone foundation.</li> </ul> </li> <li>■ Central or Southern Ontario Style Barn.             <ul style="list-style-type: none"> <li>■ Timber framed barn.</li> <li>■ Gable roof.</li> <li>■ Field stone foundation.</li> <li>■ Ramp on the northwest elevation.</li> </ul> </li> <li>■ Board and batten outbuilding.</li> <li>■ Mature vegetation.             <ul style="list-style-type: none"> <li>■ Group of four deciduous trees lining the southeast side of the driveway.</li> <li>■ Cluster of coniferous trees on the northwest side of the house.</li> </ul> </li> </ul>

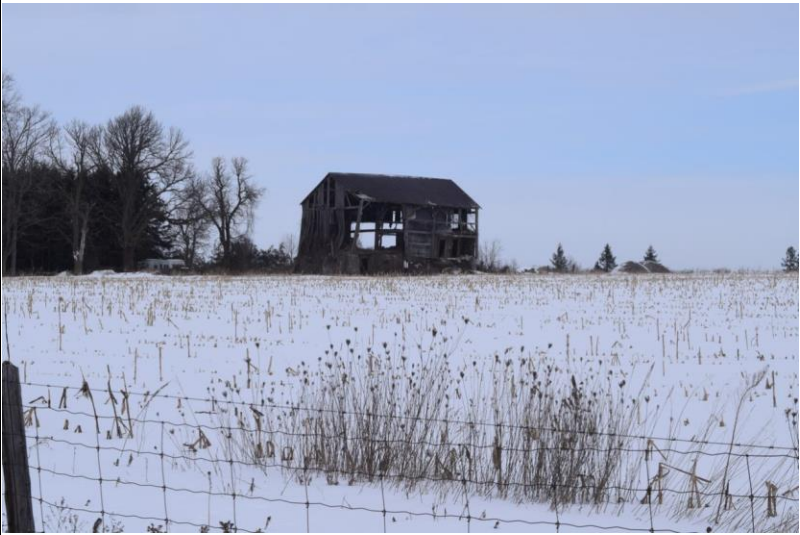
Address or Location	Cultural Heritage Status	Photograph	Description	Potential CHVI	Potential Heritage Attributes
18659 Main Street	Identified on the Town of Caledon's <i>BHRI of Pre-1946 Structures</i>

<p>The property is identified on the Town of Caledon's <i>BHRI of Pre-1946 Structures</i> for its treelined laneway and barn.</p> <p>Historical research conducted for this Cultural Heritage Report determined that a barn was located on the property as early as 1937 and appears to be situated in the same location as the present-day barn at 18659 Main Street. Though the present-day bungalow on the property is of later construction, it is possible the barn is associated with the earlier farmhouse on the property visible on the 1877 historical mapping. At that time the property was listed under Samuel Wallace of the southeast half of Lot 17, Concession 3 WCR and was the second structure constructed on Wallace's property (first was built by 1859).</p> <p>The barn is a timber framed structure with a metal gable roof and stone foundation. The barn appears to be of the Central Ontario Barn style popular during the latter half of the 19th century. The barn is set back approximately 130 m from Main Street and is accessed by a treelined gravelled driveway to the northwest of the barn.</p> <p>To the southwest of the barn is a one-storey (bungalow) red brick house set-back approximately 95 m from Main Street and accessed via the same driveway to the barn.</p> <p>The property parcel consists of ploughed fields delineated by hedgerows/ treelines which back on to the Brampton-Orangeville Railway corridor identified on the Town of Caledon's <i>Cultural Heritage Landscapes Inventory</i> as the Former CVR CHL.</p>	<p><b>Design or physical value:</b></p> <ul style="list-style-type: none"> <li>■ Central Ontario Barn style</li> </ul> <p><b>Historical or associative value:</b></p> <ul style="list-style-type: none"> <li>■ N/A</li> </ul> <p><b>Contextual value:</b></p> <ul style="list-style-type: none"> <li>■ Physical connection between the outbuilding and surrounding farm</li> <li>■ Maintenance and support of the rural landscape of area (fields lined by hedge rows/ trees)</li> <li>■ Maintenance and support of the Former CVR CHL</li> </ul>	<ul style="list-style-type: none"> <li>■ Barn with:             <ul style="list-style-type: none"> <li>■ Timber frame</li> <li>■ Rectangular plan</li> <li>■ Stone foundation</li> </ul> </li> <li>■ Treelined laneway</li> <li>■ Agricultural field delineated by hedgerows/ treelines</li> <li>■ Views of the Former CVR CHL</li> </ul>

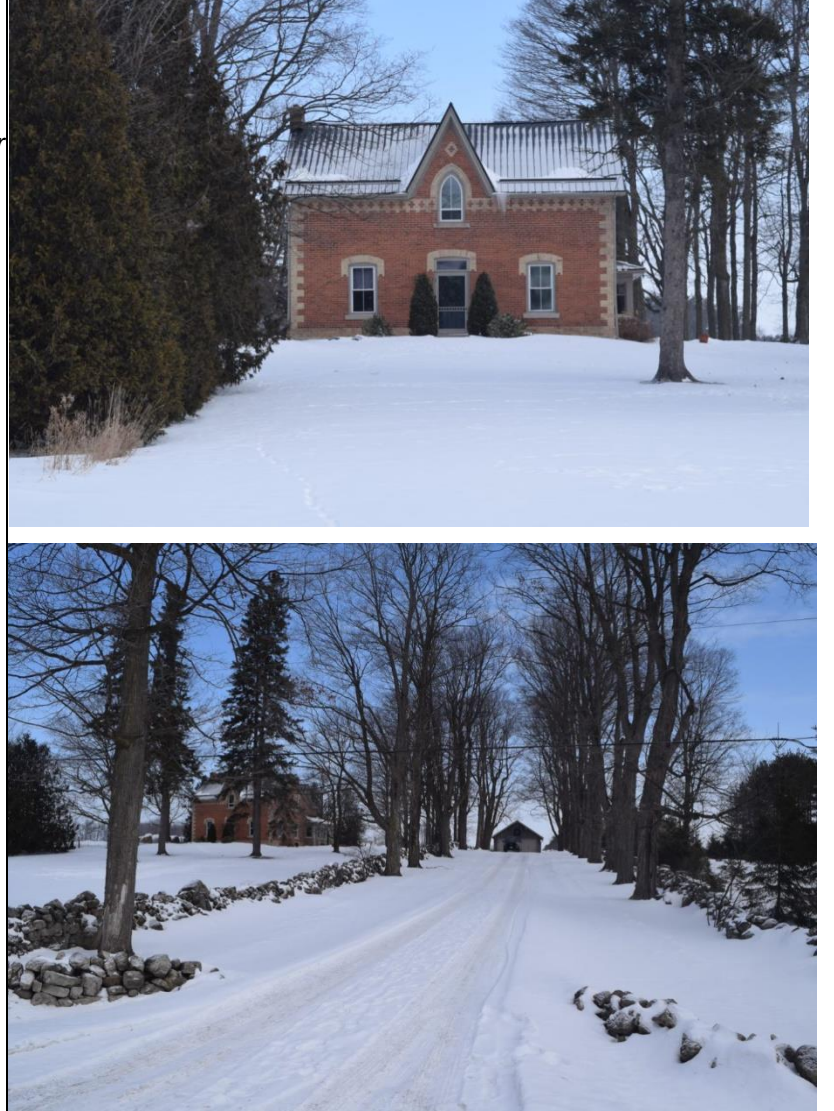
Address or Location	Cultural Heritage Status	Photograph	Description	Potential CHVI	Potential Heritage Attributes
18473 Main Street	Listed (not designated) on the Town of Caledon's <i>Heritage Register</i>

<p>Described on the Town of Caledon's <i>Heritage Register</i> as a Gothic Revival style farmhouse with a red brick exterior dating 1875-1899.</p> <p>Historical research conducted for this Cultural Heritage Report determined that a farmhouse and barn were located on the property as early as 1937 and the former appears to be situated in the same location as the present-day house at 18473 Main Street. The barn is no longer extant.</p> <p>The house is a single-detached, storey-and-a-half structure with a T-shaped main block (with an extension to the east) and medium pitch gable roof. The house is set back approximately 57 m from Main Street and is accessed by a treelined gravelled driveway with stone boundary walls to the southeast of the house which lead to a two-door wooden driveshed.</p> <p>Though now a small parcel, the property was originally part of the larger Coulter Estate depicted on historical mapping as early as 1859.</p>	<p><b>Design or physical value:</b></p> <ul style="list-style-type: none"> <li>■ Gothic Revival style farmhouse/ cottage</li> </ul> <p><b>Historical or associative value:</b></p> <ul style="list-style-type: none"> <li>■ Association with former Coulter Estate for which Coulterville is named</li> </ul> <p><b>Contextual value:</b></p> <ul style="list-style-type: none"> <li>■ Maintenance and support of the rural landscape of area</li> </ul>	<ul style="list-style-type: none"> <li>■ House main block with:             <ul style="list-style-type: none"> <li>■ Gable roof</li> <li>■ T-shaped plan</li> </ul> </li> <li>■ Treelined laneway</li> <li>■ Stone boundary walls</li> </ul>

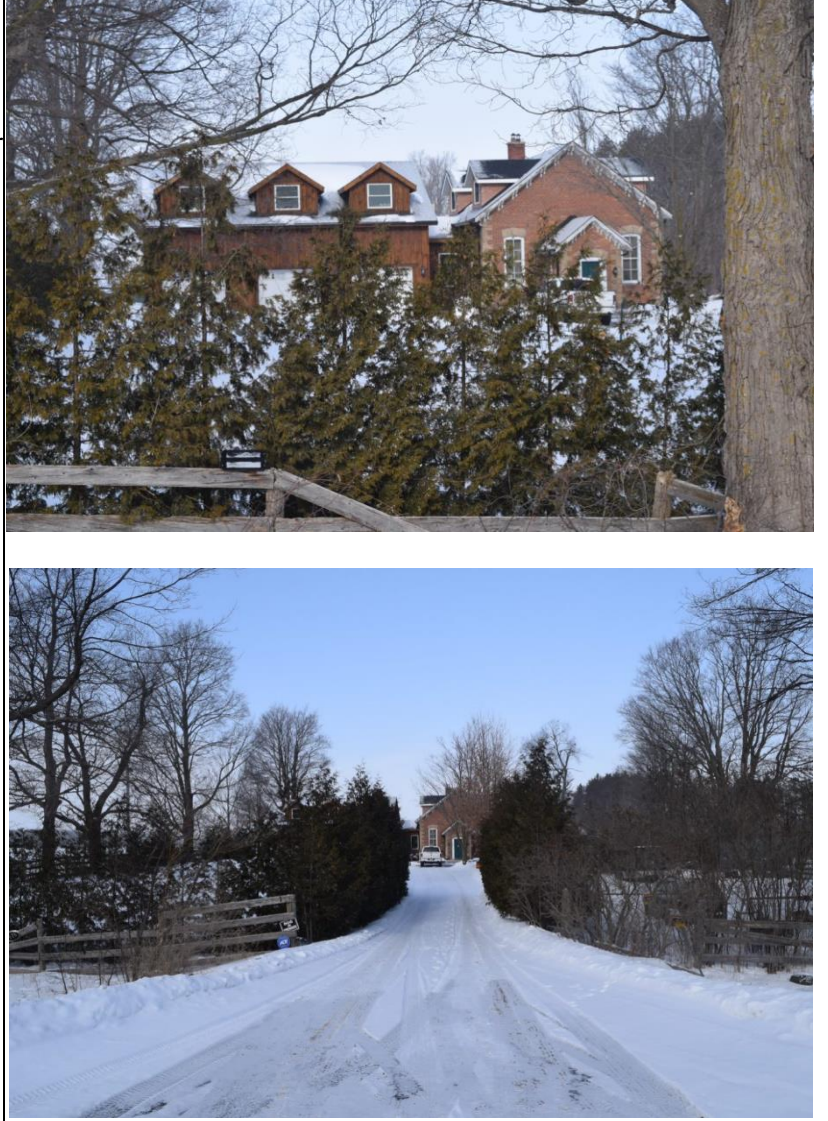
Address or Location	Cultural Heritage Status	Photograph	Description	Potential CHVI	Potential Heritage Attributes
1626 Charleston Sideroad	Listed (not designated) on the Town of Caledon's <i>Heritage Register</i>

<p>Described on the Town of Caledon's <i>Heritage Register</i> as a 19th century schoolhouse dating to 1879.</p> <p>Historical research conducted for this Cultural Heritage Report determined that a school was located on the property as early as 1877 and appears to be situated in the same location as the present-day house conversion at 1626 Charleston Sideroad.</p> <p>The house is a single-detached, storey-and-a-half, red brick structure with a rectangular shaped main block (with a large garage extension to the southwest) and medium pitch gable roof. The house is set back approximately 60 m from Charleston Sideroad and is accessed by a gravelled driveway to the southeast of the house.</p> <p>Though now a small parcel, the property was originally part of the larger Coulter Estate visible on historical mapping as early as 1859.</p>	<p><b>Design or physical value:</b></p> <ul style="list-style-type: none"> <li>■ 19th century schoolhouse design</li> </ul> <p><b>Historical or associative value:</b></p> <ul style="list-style-type: none"> <li>■ Association with former Coulter Estate for which Coulterville is named</li> </ul> <p><b>Contextual value:</b></p> <ul style="list-style-type: none"> <li>■ Maintenance and support of the rural landscape of area within the context of public institutions in a rural setting</li> </ul>	<ul style="list-style-type: none"> <li>■ House (converted) main block with:             <ul style="list-style-type: none"> <li>■ Gable roof</li> <li>■ Rectangular plan</li> </ul> </li> </ul>

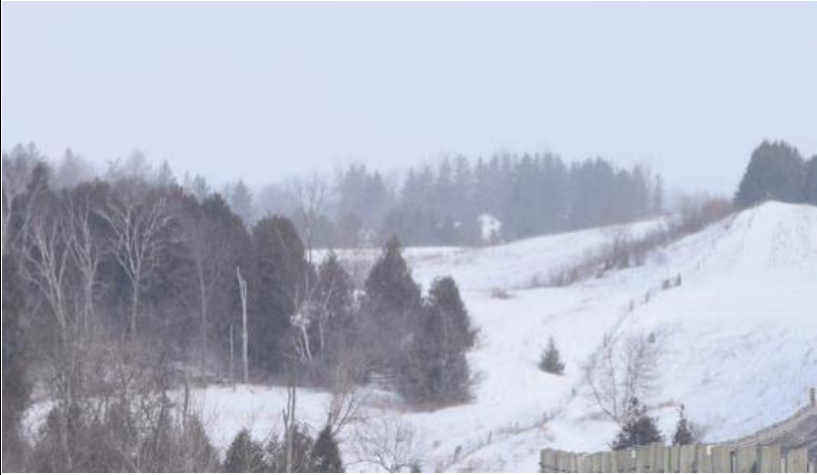
Address or Location	Cultural Heritage Status	Photograph	Description	Potential CHVI	Potential Heritage Attributes
0 Charleston Sideroad	Identified on the Town of Caledon's <i>BHRI of Pre-1946 Structures</i>

<p>The property is identified on the Town of Caledon's <i>BHRI of Pre-1946 Structures</i> as a former farmstead east of 1626 Charleston Sideroad.</p> <p>Historical research conducted for this Cultural Heritage Report determined that two structures, likely a farmhouse and outbuilding, were located on the property as early as 1937 and appear to be situated near the same location as the present-day silo (only visible remnant of the former farm) at 0 Charleston Sideroad.</p> <p>Characteristics of the silo include that it appears to be a dilapidated, unroofed, concrete structure. It is set back approximately 117 m from Charleston Sideroad and is accessed by an overgrown dirt and grass driveway to the north of the silo.</p> <p>The large property parcel consists of large unploughed fields now dominated by woodlots, shrubs and tall grasses which back on to the Brampton-Orangeville Railway corridor identified on the Town of Caledon's <i>Cultural Heritage Landscapes Inventory</i> as the Former CVR CHL.</p>	<p><b>Design or physical value:</b></p> <ul style="list-style-type: none"> <li>■ Remnants of silo structure</li> </ul> <p><b>Historical or associative value:</b></p> <ul style="list-style-type: none"> <li>■ N/A</li> </ul> <p><b>Contextual value:</b></p> <ul style="list-style-type: none"> <li>■ Physical connection between the silo remnants and former surrounding farm.</li> <li>■ Maintenance and support of the Former CVR CHL</li> </ul>	<ul style="list-style-type: none"> <li>■ Silo remnants with: <ul style="list-style-type: none"> <li>■ Concrete construction</li> </ul> </li> <li>■ Views of the Former CVR CHL</li> </ul>

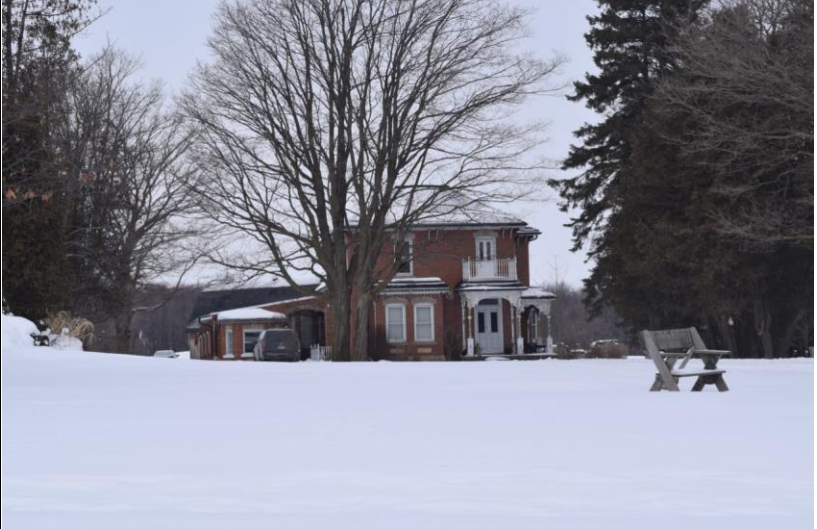
1420 Charleston Sideroad	Listed (not designated) on the Town of Caledon's <i>Heritage Register</i>

<p>Described on the Town of Caledon's <i>Heritage Register</i> as an Italianate style farmhouse with a red brick exterior and paired windows dating 1875-1899.</p> <p>Historical research conducted for this Cultural Heritage Report determined that a farmhouse was constructed on the property between 1877 and 1937. In 1877, the property was listed under James Cameron of the southeast half of Lot 16, Concession 4 WCR and was the third structure constructed on Cameron's property (first was built by 1859, the second was located at the eastmost corner of the property by 1877).</p> <p>The house is a single-detached, two-storey structure with a T-shaped main block (with a large extension to the northwest and southwest) and medium pitch hip roof. The house is set back approximately 95 m from Charleston Sideroad and is accessed by a paved driveway to the southeast of the house.</p> <p>To the northwest of the house is a small outbuilding with a metal gambrel roof (construction material indiscernible from ROW) set-back approximately 120 m from Charleston Sideroad and accessed via the same driveway to the house (which wraps around the southwest side of the house). To the north of the barn</p>	<p><b>Design or physical value:</b></p> <ul style="list-style-type: none"> <li>■ Main block of the Italianate style farmhouse</li> <li>■ Barn foundation ruins</li> </ul> <p><b>Historical or associative value:</b></p> <ul style="list-style-type: none"> <li>■ N/A</li> </ul> <p><b>Contextual value:</b></p> <ul style="list-style-type: none"> <li>■ Physical connection between the farmhouse and outbuilding.</li> <li>■ Maintenance and support of the rural landscape of area.</li> </ul>	<ul style="list-style-type: none"> <li>■ Residence main block: <ul style="list-style-type: none"> <li>■ Two storey Italianate style farmhouse with red brick exterior.</li> <li>■ Cut stone foundations with carved top course.</li> <li>■ Hip roof with wide eaves and paired brackets.</li> <li>■ Decorative elements of the main block: <ul style="list-style-type: none"> <li>– Decorative stone and brick accents (keystone eyebrow arches and drafted margin carved lug sills).</li> <li>– Accents carved into the wooden window frame heads.</li> </ul> </li> <li>■ Porches along the southeast and northeast elevations, creating a wrap around effect for the east corner of the house:</li> </ul> </li> </ul>

<p><b>1420 Charleston Sideroad</b> Listed (not designated) on the Town of Caledon's <i>Heritage Register</i></p>	<p>The proposed extraction area will encompass the majority of the property parcel, and is anticipated to directly impact the property, potentially adversely affecting the property's potential CHVI and heritage attributes which are linked to its BHR (i.e., the Italianate style farmhouse, barn foundation ruins, mature vegetation, and fieldstone wall).</p> <p>The proposed extraction area encompasses the entire property, on which the proposed construction activities will include extraction (blasting) as well as the possible use of temporary workspaces/ laydown areas, vegetation removal, and heavy machinery/ traffic.</p> <p>The location of the proposed construction activities suggests the possible demolition/ destruction of the farmhouse, barn foundation ruins, mature vegetation, and fieldstone wall, which will result in a change in land use and permanent removal of all potential CHVI and heritage attributes identified for the property (major direct impact).</p> <p>Given the possible demolition/ destruction of the property's heritage attributes, indirect impacts from vibration, fugitive dust emissions and shadows have not been assessed.</p> <p>While the isolation of the property's potential heritage attributes from the surrounding neighbourhood is not expected (as no known connection between the property and nearby structures or features were identified), the isolation of the potential heritage attributes within the property is expected as the possible demolition/ destruction will remove the connection between the BHRs and landscape features identified as heritage attributes.</p> <p>Direct or indirect obstruction of significant views or vistas is not expected as no significant views or vista were identified.</p>	<ul style="list-style-type: none"> <li>A major direct impact is anticipated for this property. To inform the impact assessment and offer focused mitigation recommendations, a preliminary heritage evaluation was completed to identify the property's potential CHVI and heritage attributes (see APPENDIX C).</li> </ul>	<ul style="list-style-type: none"> <li>Based on the results of the preliminary heritage evaluation the portion of the property mapped on Figure 10 contains cultural heritage value. As a result: <ul style="list-style-type: none"> <li>Prior to any site alteration or extraction within these areas, a Heritage Impact Assessment (HIA) shall be required. The HIA should include a full evaluation of the property using the criteria prescribed in O. Reg. 9/06, provide a Statement of CHVI with list of heritage attributes, identify all direct and indirect impacts, and recommend site-specific mitigation measures to ensure the CHVI and heritage attributes of the property are conserved in accordance with provincial requirements;</li> <li>Until the site-specific mitigation measures of the HIA are implemented a construction buffer shall be established to reduce the risk of accidental damage from vehicles, heavy equipment operation, or other activities of the mineral aggregate operation. The area of cultural heritage potential includes a 50 m construction buffer. This construction buffer shall be demarcated with temporary fencing and clearly marked as a "no-go-zone";</li> <li>Until the site-specific mitigation measures of the HIA are implemented the licensee shall implement the recommendations of the blast impact</li> </ul> </li> </ul>

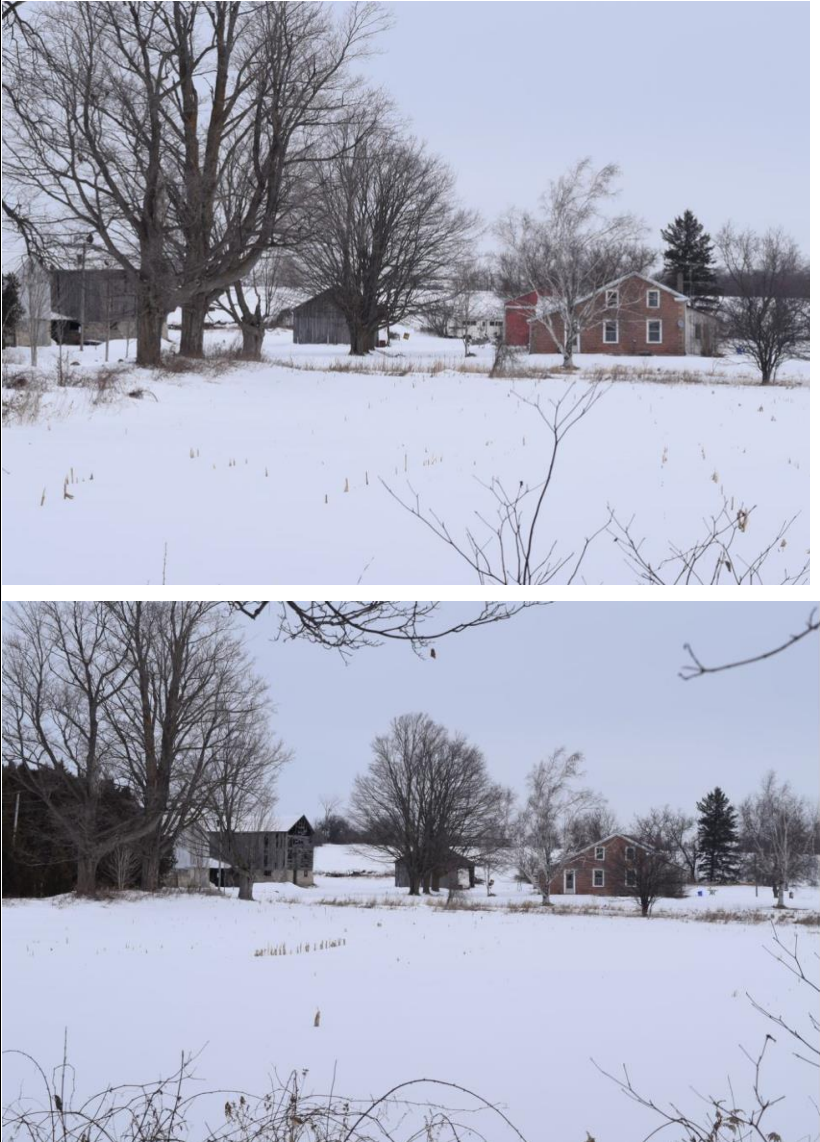
Address or Location	Cultural Heritage Status	Photograph	Description	Potential CHVI	Potential Heritage Attributes
18667 Mississauga Road	Listed (not designated) on the Town of Caledon's <i>Heritage Register</i>

<p>Described on the Town of Caledon's <i>Heritage Register</i> as a mid-19th century farmstead dating c. 1850-1874.</p> <p>Historical research conducted for this Cultural Heritage Report determined that a farmhouse was located on the property as early as 1859 and appears to be situated in the same location as the present-day house at 18667 Main Street. At that time, the property was listed under Duncan Cameron of Lot 17, Concession 4 WCR.</p> <p>The house is a single-detached, storey-and-a-half, red brick structure with a rectangular shaped main block and saltbox roof. The house appears to be of the gable front, side hall type, is set back approximately 182 m from Mississauga Road and is accessed by a treelined gravelled driveway to the northwest of the house.</p> <p>To the north of the house are two outbuildings (one wooden and one metal) and a large T-shaped timber framed barn (with a southwest extension) with a metal gable roof and stone foundation set-back approximately 190 m from Mississauga Road and accessed via the same driveway to the house. The barn appears to be of the Central Ontario Barn style popular during the latter half of the 19th century.</p> <p>The large property parcel consists of large, ploughed fields delineated by hedgerows/ treelines, interspersed with woodlots and traversed by a branch of the Credit River.</p> <p><b>NOTE: A preliminary heritage evaluation for this property is presented in APPENDIX C.</b></p>	<p><b>Design or physical value:</b></p> <ul style="list-style-type: none"> <li>■ Gable front, side hall type main block of the residence</li> <li>■ Central or Southern Ontario Barn style of the barn complex</li> <li>■ Outbuilding No. 1</li> </ul> <p><b>Historical or associative value:</b></p> <ul style="list-style-type: none"> <li>■ N/A</li> </ul> <p><b>Contextual value:</b></p> <ul style="list-style-type: none"> <li>■ Spatial organization and range of forms in building complex maintains and supports local character</li> <li>■ Physical connection between the farmhouse and outbuildings</li> <li>■ Historical connection to 18722 Main Street</li> </ul>	<ul style="list-style-type: none"> <li>■ Residence main block:             <ul style="list-style-type: none"> <li>■ Rectangular footprint with side hall floorplan</li> <li>■ Parged stone foundations.</li> <li>■ Gable roof.</li> <li>■ Red brick (stretcher bond) with contrasting buff coloured brick detailing including:                 <ul style="list-style-type: none"> <li>– Quoins.</li> <li>– Decorative diamond pattern on gable of southeast elevation.</li> <li>– Stretcher and solder brick flat arches above openings.</li> </ul> </li> <li>■ Original interior and storm windows on the northeast elevation.</li> <li>■ Decorative wooden trim around original entrance on southeast elevation.</li> </ul> </li> <li>■ Barn complex (Central or Southern Ontario style)             <ul style="list-style-type: none"> <li>■ Fieldstone foundations with cut stone cornerstones.</li> <li>■ Timber frame construction.</li> </ul> </li> <li>■ Outbuilding No. 1 (driveshed)             <ul style="list-style-type: none"> <li>■ Timber frame construction</li> <li>■ Diamond shaped gable window on southwest elevation</li> <li>■ Maltese/diamond cross shaped cut out on gable of northeast elevation</li> </ul> </li> <li>■ Mature tree lines             <ul style="list-style-type: none"> <li>■ Along driveway and ROW</li> </ul> </li> <li>■ Fieldstone walls at the foot of the driveway</li> </ul>

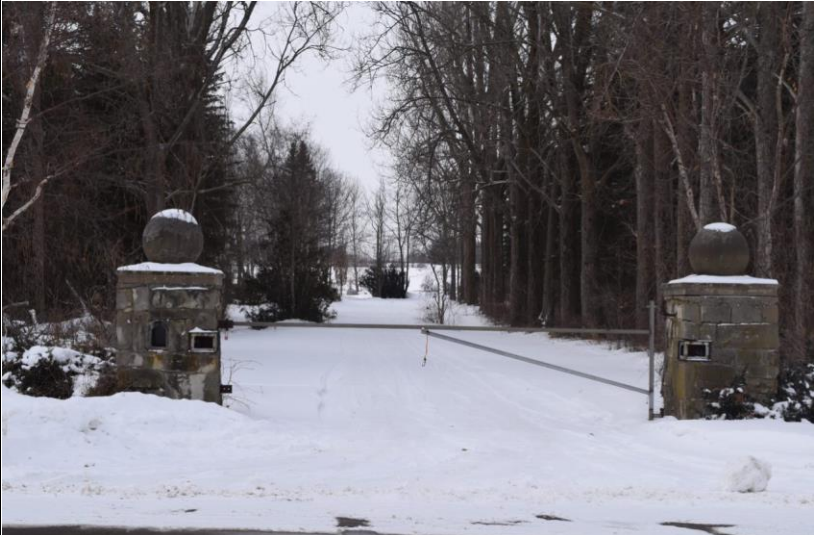
Address or Location	Cultural Heritage Status	Photograph	Description	Potential CHVI	Potential Heritage Attributes
18682 Mississauga Road	Property of potential CHVI

<p>Historical research conducted for this Cultural Heritage Report determined that a farmhouse was located on the property as early as 1877 and appears to be situated in the same location as the present-day house at 18682 Mississauga Road. At that time, the property was listed under Joseph Morris of Lot 17, Concession 5 WCR.</p> <p>Based on satellite imagery, the house is a single-detached structure (construction material indiscernible from ROW) with a T-shaped main block (with extension to the northwest), set back approximately 120 m from Mississauga Road and accessed by a treelined paved driveway to the northwest of the house.</p> <p>To the west of the house is a metal outbuilding set-back approximately 190 m from Mississauga Road and accessed via the same driveway to the house (which turns west after approaching the house).</p> <p>The large property parcel consists of large, ploughed fields delineated by hedgerows/ treelines, interspersed with woodlots and traversed by a branch of the Credit River.</p>	<p><b>Design or physical value:</b></p> <ul style="list-style-type: none"> <li>■ N/A</li> </ul> <p><b>Historical or associative value:</b></p> <ul style="list-style-type: none"> <li>■ N/A</li> </ul> <p><b>Contextual value:</b></p> <ul style="list-style-type: none"> <li>■ Physical connection between the farmhouse and outbuildings</li> <li>■ Maintenance and support of the rural and natural landscape of area (large fields lined by hedge rows/ trees; Credit Valley River)</li> </ul>	<ul style="list-style-type: none"> <li>■ House main block with:             <ul style="list-style-type: none"> <li>■ T-shaped plan</li> </ul> </li> <li>■ Treelined laneway</li> <li>■ Large agricultural fields delineated by hedgerows/ treelines</li> </ul>

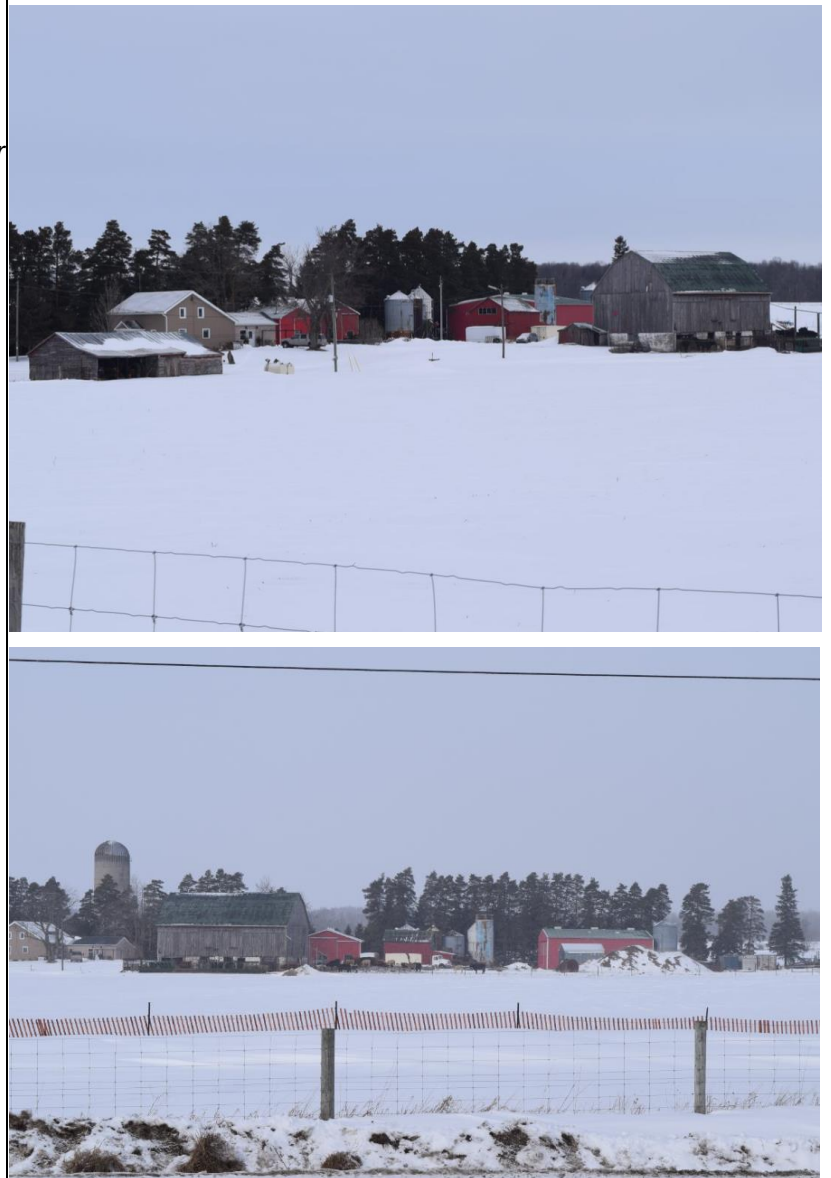
Address or Location	Cultural Heritage Status	Photograph	Description	Potential CHVI	Potential Heritage Attributes
18501 Mississauga Road	Listed (not designated) on the Town of Caledon's <i>Heritage Register</i>

<p>Described on the Town of Caledon's <i>Heritage Register</i> as a Neoclassical style farmhouse with vertical board exterior and an addition at the rear, dating c. 1850-1874.</p> <p>Historical research conducted for this Cultural Heritage Report determined that a farmhouse was located on the property as early as 1859 and appears to be situated in the same location as the present-day house at 18501 Mississauga Road. At that time, the property was listed under James Cameron of Lot 16, Concession 4 WCR.</p> <p>The house is a single-detached, storey-and-a-half, buff brick structure with a rectangular shaped main block (with a large one-storey extension to the northeast) and saltbox roof. The house is set back approximately 181 m from Mississauga Road and is accessed by a gravelled driveway to the southeast of the house.</p> <p>To the east of the house is a large timber framed barn with a metal gambrel roof and possible concrete faced stone foundation set-back approximately 219 m from Mississauga Road and accessed via the same driveway to the house. The barn appears to be of the Central Ontario Barn style popular during the latter half of the 19th century. Additional outbuildings on the property include a wooden shed with metal gable roof to the south of the house, two large concrete silos with an indeterminate outbuilding to the northwest of the house and a complex of four metal outbuildings and three metal silos to the northeast of the house.</p> <p>The property parcel consists of ploughed fields delineated by hedgerows/ treelines.</p> <p><b>NOTE: A preliminary heritage evaluation for this property is presented in APPENDIX C.</b></p>	<p><b>Design or physical value:</b></p> <ul style="list-style-type: none"> <li>■ One-and-a-half storey main block of the farmhouse</li> <li>■ Barn No. 1</li> <li>■ Barn No. 1</li> </ul> <p><b>Historical or associative value:</b></p> <ul style="list-style-type: none"> <li>■ N/A</li> </ul> <p><b>Contextual value:</b></p> <ul style="list-style-type: none"> <li>■ Spatial organization and range of forms in building complex maintains and supports local character</li> <li>■ Physical connection between the farmhouse and outbuildings</li> </ul>	<ul style="list-style-type: none"> <li>■ Main residence             <ul style="list-style-type: none"> <li>■ Original one-and-a-half storey main block with rectangular floor plan and gable roof</li> </ul> </li> <li>■ Barn No. 1             <ul style="list-style-type: none"> <li>■ Timber frame construction</li> <li>■ Fieldstone foundation</li> <li>■ Gable roof</li> </ul> </li> <li>■ Barn No. 2             <ul style="list-style-type: none"> <li>■ Concrete block foundations</li> <li>■ Timber frame construction</li> <li>■ Metal gambrel roof.</li> </ul> </li> <li>■ Mature vegetation             <ul style="list-style-type: none"> <li>■ Coniferous windbreaks around the house                 <ul style="list-style-type: none"> <li>– Perpendicular to Mississauga Road, in a northeast to southwest orientation, to the northwest of the main building complex.</li> </ul> </li> </ul> </li> </ul>

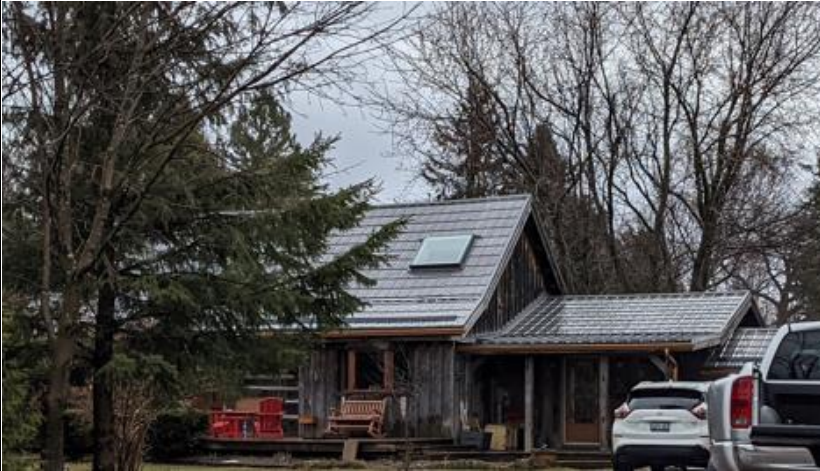
Address or Location	Cultural Heritage Status	Photograph	Description	Potential CHVI	Potential Heritage Attributes
77 William Street East	Identified on the Town of Caledon's <i>BHRI of Pre-1946 Structures</i>

<p>The property is identified on the Town of Caledon's <i>BHRI of Pre-1946 Structures</i> as a frame building with log façade, however, historical research conducted for this Cultural Heritage Report could not identify the structure on pre-1973 mapping.</p> <p>The house is a single-detached, one-storey structure with a rectangular shaped main block (with garage extension to southwest) and medium pitch gable roof with synthetic shingles. The house is set back approximately 25 m from William Street East and is accessed by a paved asphalt driveway to the southwest of the house.</p> <p>The property is located within the village of Cataract. Historical research determined that Cataract was established c. 1858 and was formerly known as the village of Church's Falls which is visible on historical mapping (as "Church's Falls") as early as 1859. By 1877, the village was renamed "Cataract".</p>	<p><b>Design or physical value:</b></p> <ul style="list-style-type: none"> <li>■ Frame building with log façade</li> </ul> <p><b>Historical or associative value:</b></p> <ul style="list-style-type: none"> <li>■ N/A</li> </ul> <p><b>Contextual value:</b></p> <ul style="list-style-type: none"> <li>■ Physical connection between the early village lots and lanes</li> <li>■ Maintenance and support of the historic village plan</li> </ul>	<ul style="list-style-type: none"> <li>■ House main block with: <ul style="list-style-type: none"> <li>■ Log façade</li> <li>■ Rectangular plan</li> </ul> </li> <li>■ Original lots and lanes from 19th century village plan</li> </ul>

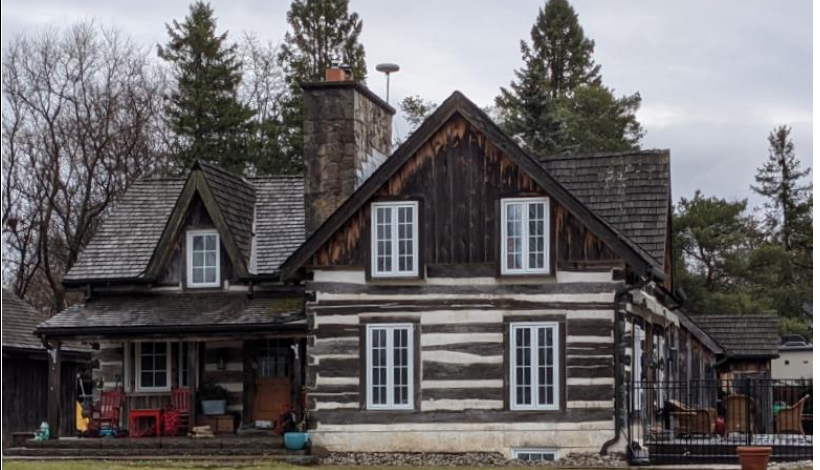
89 William Street East	Identified on the Town of Caledon's <i>BHRI of Pre-1946 Structures</i>

<p>The property is identified on the Town of Caledon's <i>BHRI of Pre-1946 Structures</i> as built in 1977, however, historical research conducted for this CHR determined that a structure was located on the property as early as 1937 and appears to be situated near the same location as the present-day house at 89 William Street East.</p> <p>The house is a single-detached, storey-and-a-half, wood frame structure with a log façade, L-shaped main block and medium pitch cross-gable roof with stone chimney. The house is set back approximately 21 m from William Street East and is accessed by a paved asphalt driveway leading to a detached wood frame garage northeast of the house. There is a pool to the southwest of the house.</p> <p>The property is located within the village of Cataract. Historical research determined that Cataract was established c. 1858 and was formerly known as the village of Church's Falls which is visible on historical mapping (as "Church's Falls") as early as 1859. By 1877, the village was renamed "Cataract".</p>	<p><b>Design or physical value:</b></p> <ul style="list-style-type: none"> <li>■ Frame building with log façade</li> </ul> <p><b>Historical or associative value:</b></p> <ul style="list-style-type: none"> <li>■ Association with the village of Cataract, formerly Church's Falls</li> </ul> <p><b>Contextual value:</b></p> <ul style="list-style-type: none"> <li>■ Physical connection between the early village structures, lots and lanes</li> <li>■ Maintenance and support of the historic village plan</li> </ul>	<ul style="list-style-type: none"> <li>■ House main block with: <ul style="list-style-type: none"> <li>■ Log façade</li> <li>■ L-shaped plan</li> <li>■ Cross-gable roof</li> <li>■ Stone chimney</li> </ul> </li> <li>■ Original lots and lanes from 19th century village plan</li> </ul>

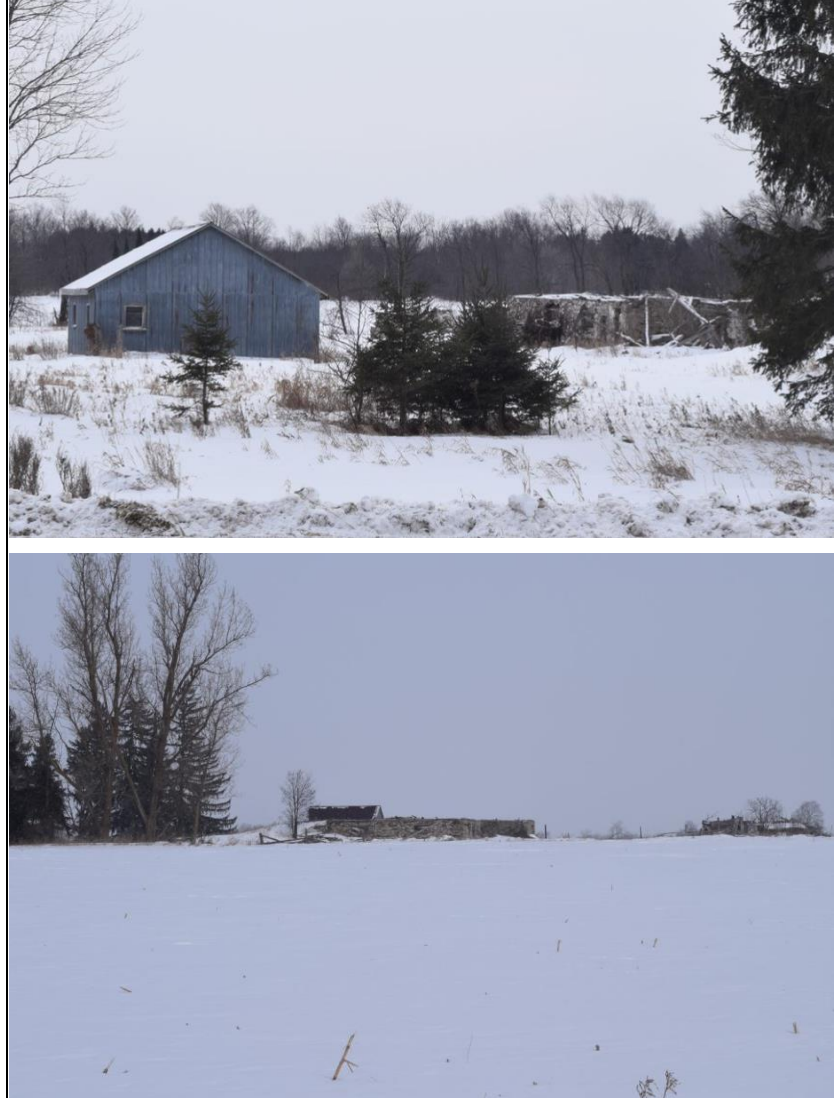
Address or Location	Cultural Heritage Status	Photograph	Description	Potential CHVI	Potential Heritage Attributes
1055 Charleston Sideroad	Identified on the Town of Caledon's <i>BHRI of Pre-1946 Structures</i>

<p>The property is identified on the Town of Caledon's <i>BHRI of Pre-1946 Structures</i> as the "property across the road at the southeast corner of Mississauga Road and Charleston Road".</p> <p>Historical research conducted for this Cultural Heritage Report determined that a farmhouse was located on the property as early as 1877 and appears to be situated in the same location as the present-day foundation remnants at 1055 Charleston Sideroad. At that time, the property was listed as part of the Morris Estate in the southwest half of Lot 15, Concession 4 WCR. The present-day outbuilding on the property appears to be of later construction.</p> <p>The foundation remnants appear to be rubble fieldstone. The foundation is set back approximately 73 m from Charleston Sideroad and is accessed by an overgrown dirt and grass driveway to the northeast of the foundation.</p> <p>To the southeast of the foundation are the remnants of a smaller structure's foundation and to the north of the foundation is a one-storey board and batten shed with metal roof set-back approximately 62 m from Charleston Sideroad and accessed via the same driveway to the foundation.</p> <p>The property parcel consists of ploughed fields delineated by hedgerows/ treelines.</p> <p><b>NOTE: A preliminary heritage evaluation for this property is presented in APPENDIX C.</b></p>	<p><b>Design or physical value:</b></p> <ul style="list-style-type: none"> <li>■ N/A</li> </ul> <p><b>Historical or associative value:</b></p> <ul style="list-style-type: none"> <li>■ N/A</li> </ul> <p><b>Contextual value:</b></p> <ul style="list-style-type: none"> <li>■ Spatial organization and range of forms in building complex maintains and supports local character</li> <li>■ Physical connection between the remnant outbuilding(s) and former surrounding farm</li> </ul>	<ul style="list-style-type: none"> <li>■ Rubble fieldstone foundations for both barn ruins.</li> <li>■ Treelines delineating the edge of the farm building complex.</li> </ul>

<p><b>1055 Charleston Sideroad</b> Identified on the Town of Caledon's <i>BHRI of Pre-1946 Structures</i></p>	<p>The proposed extraction area will encompass the majority of the property parcel, and is anticipated to directly impact the property's potential CHVI and heritage attributes which are linked to its BHR (i.e., the foundation remnants) and mature treelines.</p> <p>The proposed extraction area encompasses the area of the foundation remnants and mature treelines, Proposed construction activities include extraction (blasting) as well as the possible use of temporary workspaces/ laydown areas, vegetation removal, and heavy machinery/ traffic.</p> <p>The location of the proposed construction activities suggests the possible demolition/ destruction of the foundation remnants and mature treelines which will result in a change in land use and permanent removal of all potential CHVI and heritage attributes identified for the property (major direct impact).</p> <p>Given the possible demolition/ destruction of the BHR on the property, indirect impacts from vibration, fugitive dust emissions and shadows have not been assessed.</p>	<ul style="list-style-type: none"> <li>■ A major direct impact is anticipated for this property. To inform the impact assessment and offer focused mitigation recommendations, a preliminary heritage evaluation was completed to identify the property's potential CHVI and heritage attributes (see APPENDIX C).</li> </ul>	<ul style="list-style-type: none"> <li>■ Based on the results of the preliminary heritage evaluation the portion of the property mapped on Figure 10 contains cultural heritage value. As a result: <ul style="list-style-type: none"> <li>■ Prior to any site alteration or extraction within these areas, a Heritage Impact Assessment (HIA) shall be required. The HIA should include a full evaluation of the property using the criteria prescribed in O. Reg. 9/06, provide a Statement of CHVI with list of heritage attributes, identify all direct and indirect impacts, and recommend site-specific</li> </ul> </li> </ul>
