# Cultural Heritage Report

## *Proposed Caledon Pit/Quarry*

**CBM Aggregates, a division of St. Marys Cement Inc. (Canada)**

19129150-5700

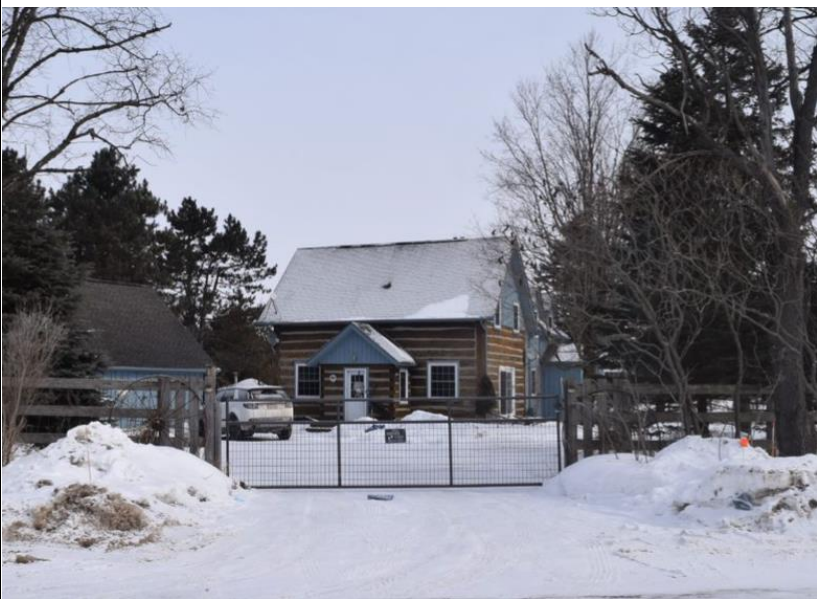
Address or Location	Cultural Heritage Status	Photograph	Description	Potential CHVI	Potential Heritage Attributes
18309 Mississauga Road	Property of potential CHVI

<p>While historical research conducted for this Cultural Heritage Report did not identify the presence of a farmhouse on the property before 1973, the hewn log construction suggests the structure may have been relocated or reassembled from repurposed materials (like 18205 Mississauga Road).</p> <p>Characteristics of the house include that it is a single-detached, storey-and-a-half structure with a rectangular shaped main block (with an extension to the northeast) and medium pitch gable roof. The house is set back approximately 30 m from Mississauga Road and is accessed by a paved asphalt driveway. To the west of the house is a detached garage of recent construction.</p>	<p><b>Design or physical value:</b></p> <ul style="list-style-type: none"> <li>■ Hewn log constructed house</li> </ul> <p><b>Historical or associative value:</b></p> <ul style="list-style-type: none"> <li>■ N/A</li> </ul> <p><b>Contextual value:</b></p> <ul style="list-style-type: none"> <li>■ N/A</li> </ul>	<ul style="list-style-type: none"> <li>■ House main block with:                             <ul style="list-style-type: none"> <li>■ Hewn log construction</li> <li>■ Rectangular shaped plan</li> </ul> </li> </ul>

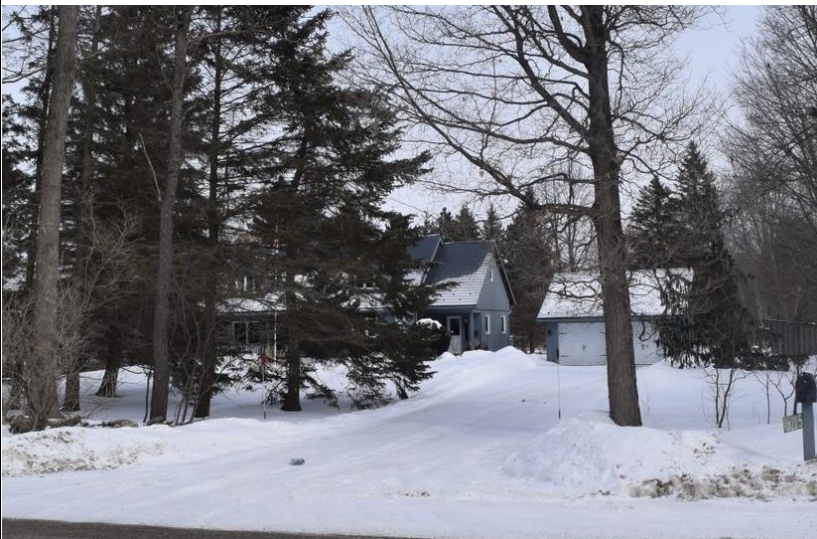
18205 Mississauga Road	Identified on the Town of Caledon's <i>BHRI of Pre-1946 Structures</i>

<p>The property is identified on the Town of Caledon's <i>BHRI of Pre-1946 Structures</i> as built with logs/ wood from the Ottawa Valley, however, historical research conducted for this Cultural Heritage Report could not identify the structure on pre-1973 mapping.</p> <p>The house is a single-detached, storey-and-a-half structure with a rectangular shaped main block (and small extension to the southeast), medium pitch gable roof, and two dormer windows on the front/ southwest façade. The house is set back approximately 32 m from Mississauga Road and is accessed by a paved asphalt driveway leading to a detached garage of recent construction (appears to be vertical siding) southeast of the house.</p>	<p><b>Design or physical value:</b></p> <ul style="list-style-type: none"> <li>■ Ottawa Valley wood/ log construction</li> </ul> <p><b>Historical or associative value:</b></p> <ul style="list-style-type: none"> <li>■ N/A</li> </ul> <p><b>Contextual value:</b></p> <ul style="list-style-type: none"> <li>■ N/A</li> </ul>	<ul style="list-style-type: none"> <li>■ House main block with:                             <ul style="list-style-type: none"> <li>■ Log façade</li> <li>■ Rectangular plan</li> </ul> </li> </ul>

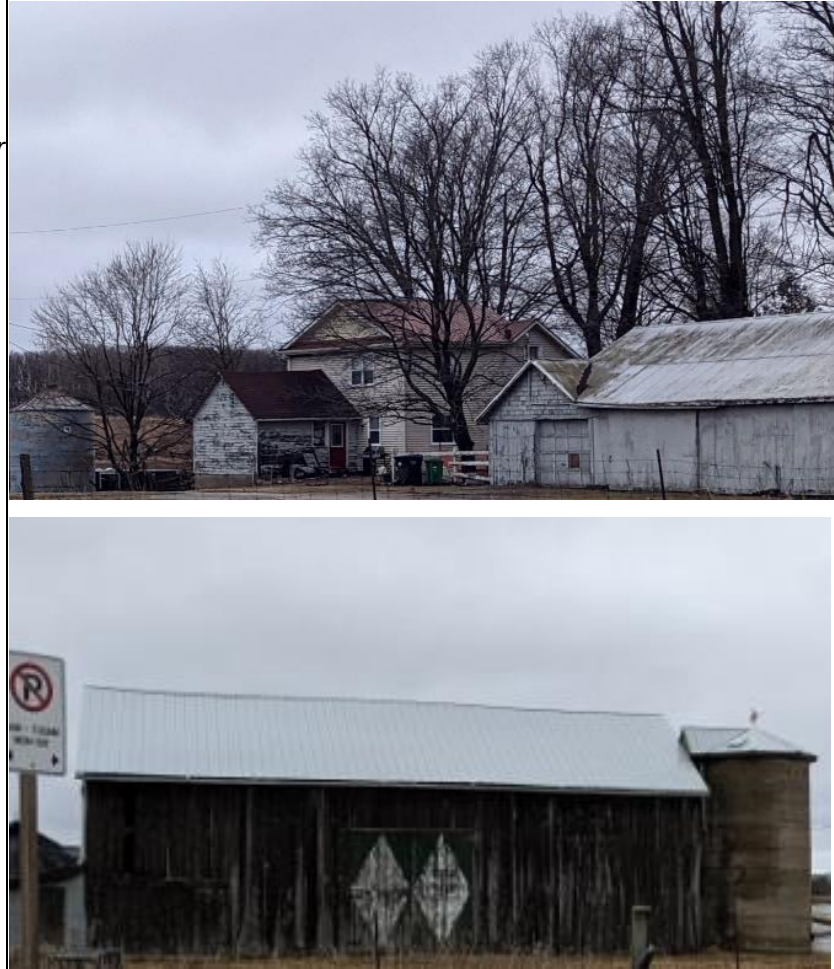
<p>Described on the Town of Caledon's <i>Heritage Register</i> as a late Neoclassical style farmhouse dating c. 1875-1899.</p> <p>Historical research determined that a farmhouse was located on the property as early as 1877 and appears to be situated in the same location as the present-day house at 833 Charleston Sideroad. At that time, the property was listed under William Richardson of the northeast half of Lot 15, Concession 4 WCR.</p> <p>The house is a single-detached, two-storey wood frame structure with a rectangular shaped main block (with a small one-storey wood frame extension to the northeast) and low-pitch gable roof. The house is set back approximately 50 m from Charleston Sideroad and is accessed by a gravelled driveway to the northeast of the house.</p> <p>To the north of the house is a large timber framed barn (including a large extension to the east) with a relatively new metal gable roof but indeterminate foundation. It is set-back approximately 35 m from Charleston Sideroad and accessed via the same driveway to the house. The barn appears to be of the Central Ontario Barn style popular during the latter half of the 19th century. Additional outbuildings on the property include a silo to the southwest of the barn, two wooden sheds to the southeast of the barn and one metal shed to the northwest of the house.</p> <p>The large property parcel consists of large, ploughed fields delineated by hedgerows/ treelines.</p>	<p><b>Design or physical value:</b></p> <ul style="list-style-type: none"> <li>■ Late Neoclassical style farmhouse</li> <li>■ Central Ontario Barn style</li> </ul> <p><b>Historical or associative value:</b></p> <ul style="list-style-type: none"> <li>■ N/A</li> </ul> <p><b>Contextual value:</b></p> <ul style="list-style-type: none"> <li>■ Physical connection between the farmhouse and outbuildings</li> <li>■ Spatial organization and range of forms in building complex maintains and supports local character</li> <li>■ Maintenance and support of the rural landscape of area (large fields lined by hedge rows/ trees)</li> </ul>	<ul style="list-style-type: none"> <li>■ House main block with:             <ul style="list-style-type: none"> <li>■ Wood frame</li> <li>■ Rectangular shaped plan</li> </ul> </li> <li>■ Barn with:             <ul style="list-style-type: none"> <li>■ Timber frame</li> </ul> </li> <li>■ Large agricultural fields delineated by hedgerows/ treelines</li> </ul>

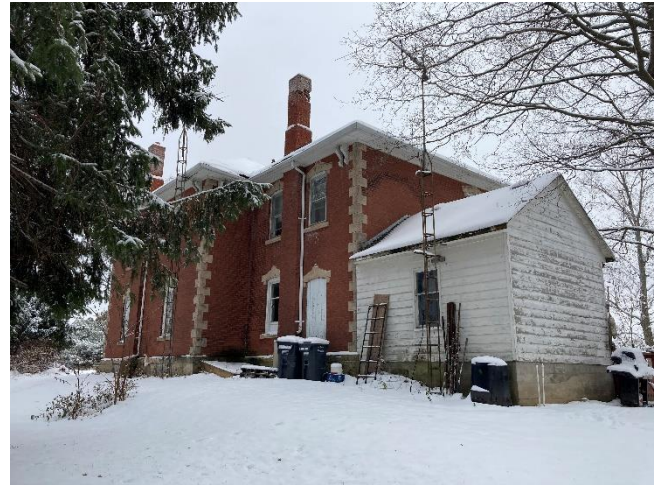
**Plate 3: Oblique view of west and south elevations, including rear addition**

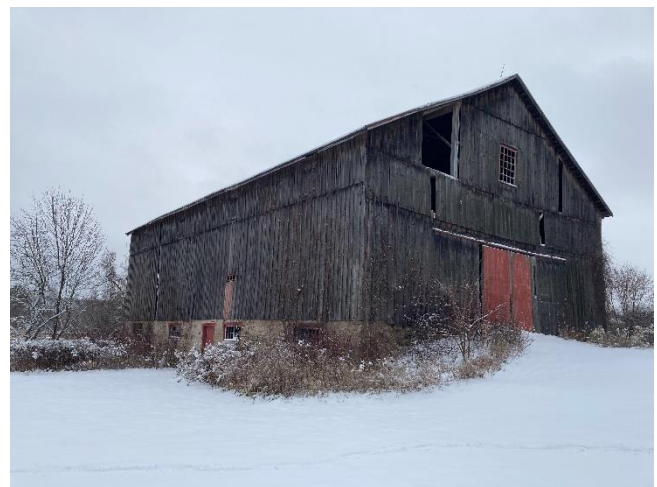
**Plate 5: North and west elevations of the barn**

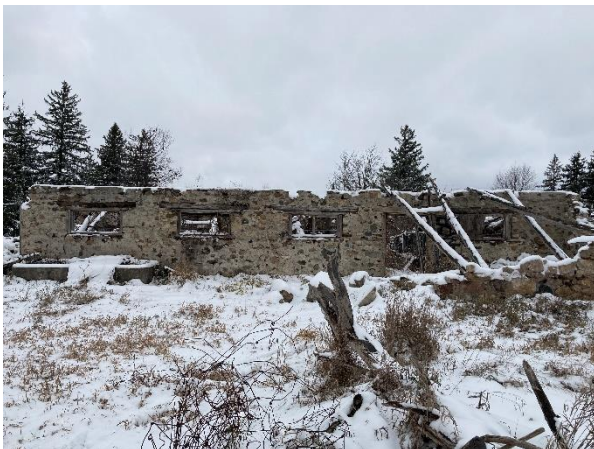
**Plate 8: Larger fieldstone foundation ruins**

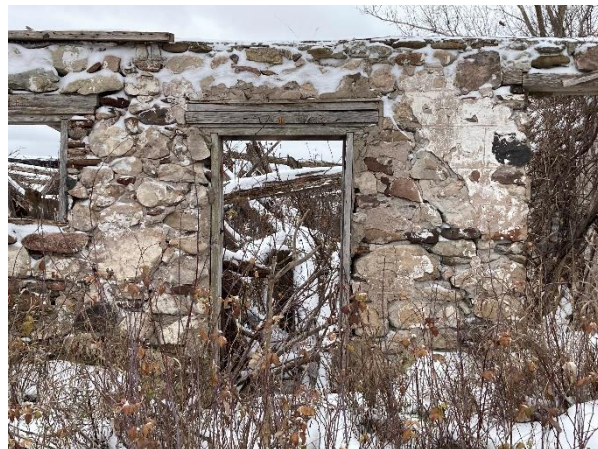
**Plate 9: Detail showing wood doorframe and window frames and parged fieldstone foundations**

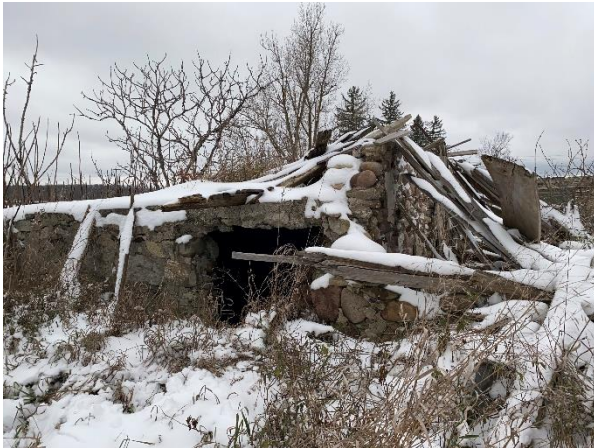
**Plate 10: Smaller fieldstone foundation ruins**

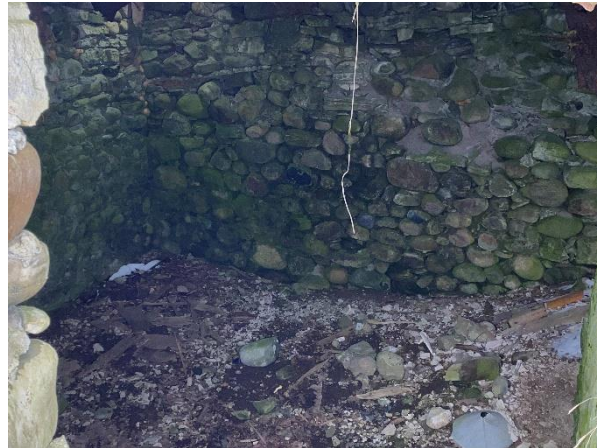
**Plate 11: Interior of smaller fieldstone foundation ruins**

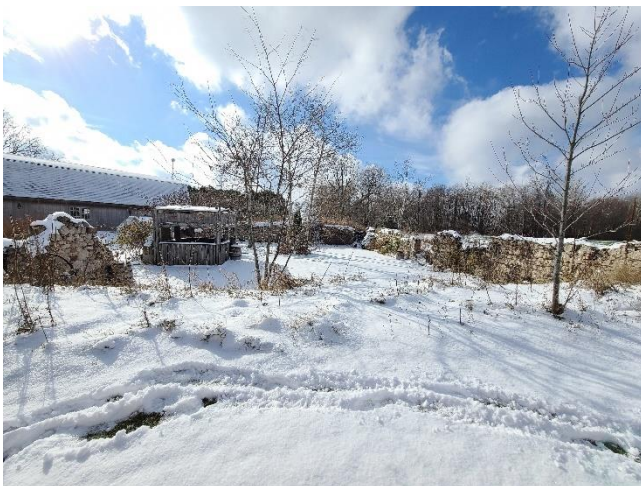
**Plate 17: Barn foundation ruins, looking southwest**

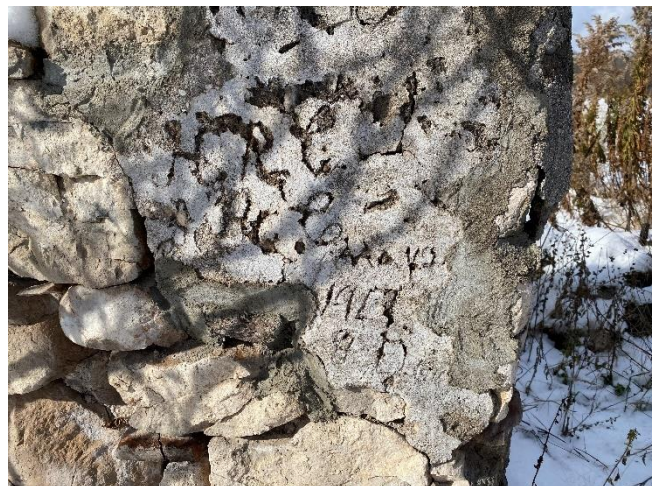
**Plate 18: Closeup of inscription on barn ruins**
