REPORT

Phase One ESA - PIN 14273-0089, Caledon, Ontario

Proposed Caledon Pit / Quarry

June 30, 2021

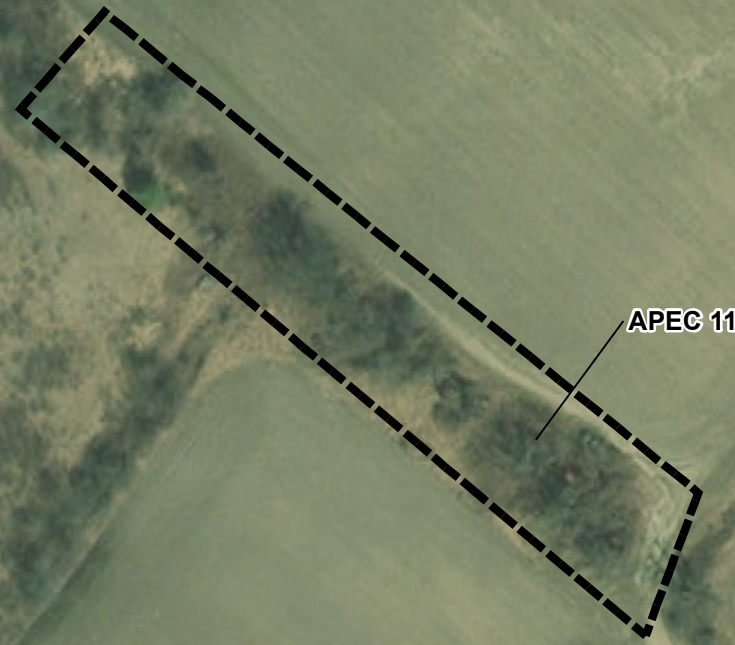
APEC	AREA OF POTENTIAL ENVIRONMENTAL CONCERN
1	A 910 L FUEL OIL AST IS PRESENT IN THE BASEMENT OF BUILDING #1
2	A 1360 L DIESEL AST IS PRESENT NORTH OF BUILDING #3.
3	FORMER DIESEL AST IN BUILDING #4 (REMOVED 20-25 YEARS AGO).
4	FORMER GASOLINE UST WAS LOCATED EAST OF BUILDING #4 (REMOVED 40 YEARS AGO).
5	FORMER GASOLINE AST IN BUILDING #4 (REMOVED 20-25 YEARS AGO).
6	FORMER FUEL OIL TANK IN BUILDING #3 (REMOVED 20 YEARS AGO).
7	A POLE-MOUNTED TRANSFORMER WAS OBSERVED SOUTH OF BUILDING #5.
8	THE PRESENCE OF SCRAP/DISCARDED METAL DEBRIS OBSERVED IMMEDIATELY ADJACENT TO BUILDING #3, WHICH INCLUDED AN OLD BUS AND
9	THE PRESENCE OF SCRAP/DISCARDED METAL DEBRIS OBSERVED IMMEDIATELY EAST OF BUILDING #4.
10	THE PRESENCE OF SCRAP/DISCARDED METAL DEBRIS, INCLUDING AN OLD AST, OBSERVED 20 M EAST OF BUILDING #5.
11	THE PRESENCE OF SCRAP/DISCARDED METAL DEBRIS OBSERVED ALONG THE TREE LINE AREA 75 M NORTH OF THE BUILDINGS.

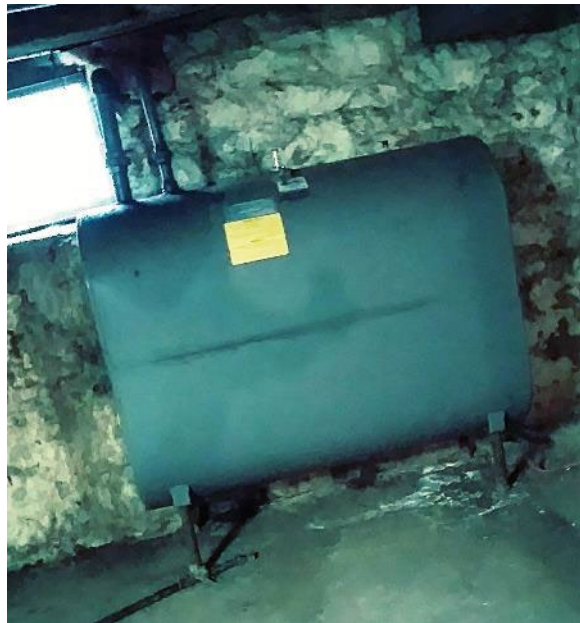
Location	Potentially Contaminating Activity	Information Source	Rationale for Potential Contribution of the PCA to an APEC
	is present in the basement of Building #1. Fill and vent pipes were observed along the southwest exterior wall of the building.

Photo 2 – View of the fuel oil AST located in the basement of Building #1.

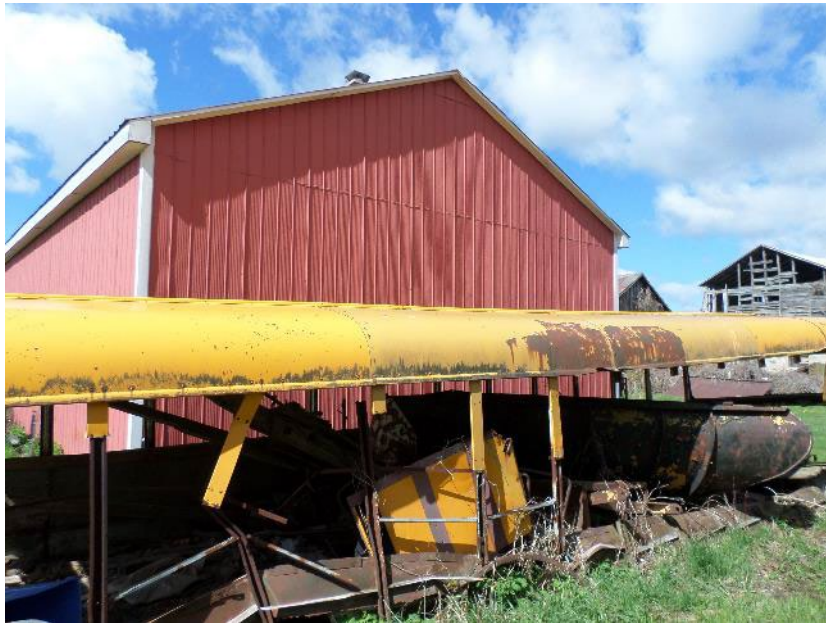
Location	Potentially Contaminating Activity	Information Source	Rationale for Potential Contribution of the PCA to an APEC
	conditioners – The presence of scrap/discarded metal debris observed immediately adjacent to Building #3, which included an old bus and snowplough.

Photo 7 – View of scrap metal (including former bus) located east of Building #3, facing west.

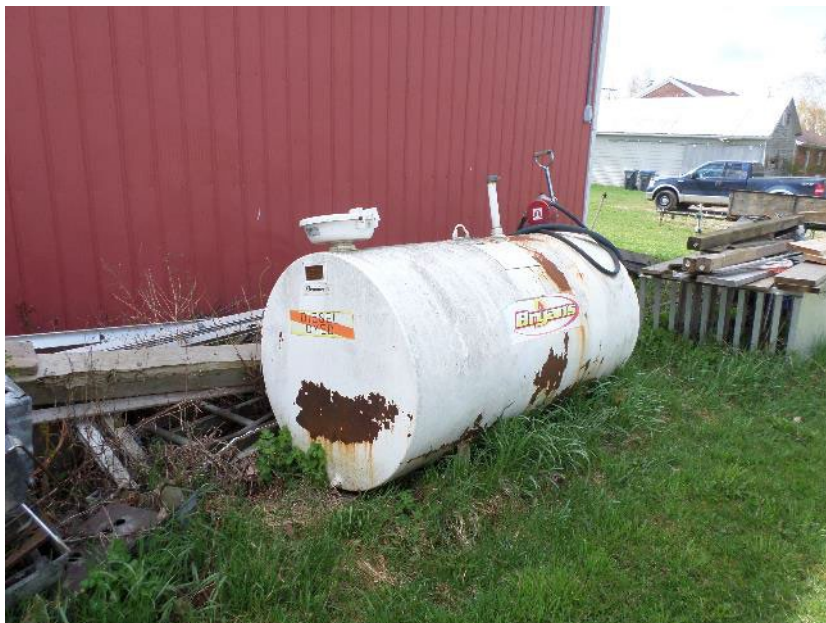
Photo 8 – View of diesel AST located north of Building #3, facing southwest.

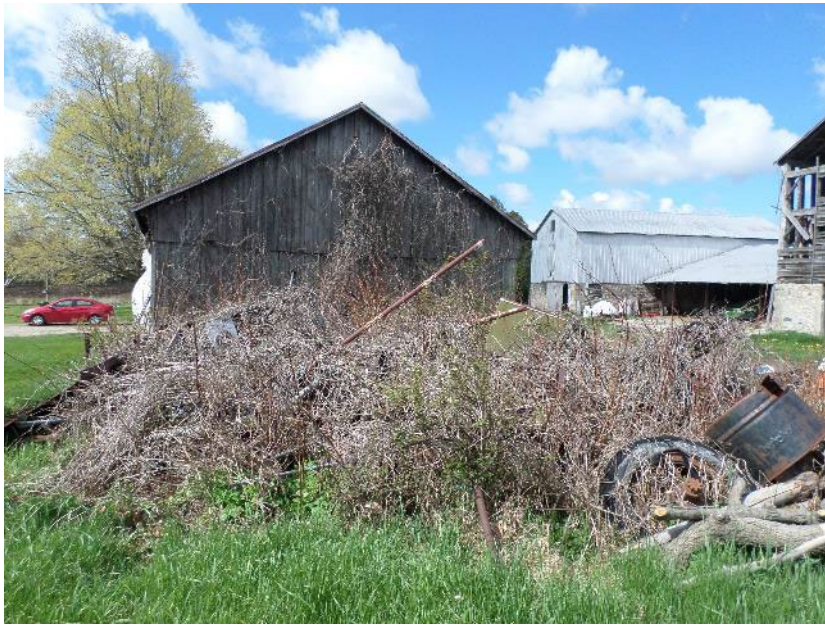
#58 Waste Disposal and Waste Management, including thermal treatment, landfilling and transfer of waste, other than use of biosoils as soil conditioners – The presence of scrap/discarded metal debris observed immediately east of Building #4.	Site observations	The PCA is located on the Phase One Property and must be identified as an APEC.

APEC 9 – The presence of scrap/discarded metal debris observed immediately east of Building #4.	East of Building #4.	#58 Waste Disposal and Waste Management, including thermal treatment, landfilling and transfer of waste, other than use of biosoils as soil conditioners.	On-Site	Metals, Petroleum Hydrocarbons ("PHCs")	Soil

Photo 11 – View of the east side of Building #4, and scrap metal area located immediately east of Building #4, facing west.

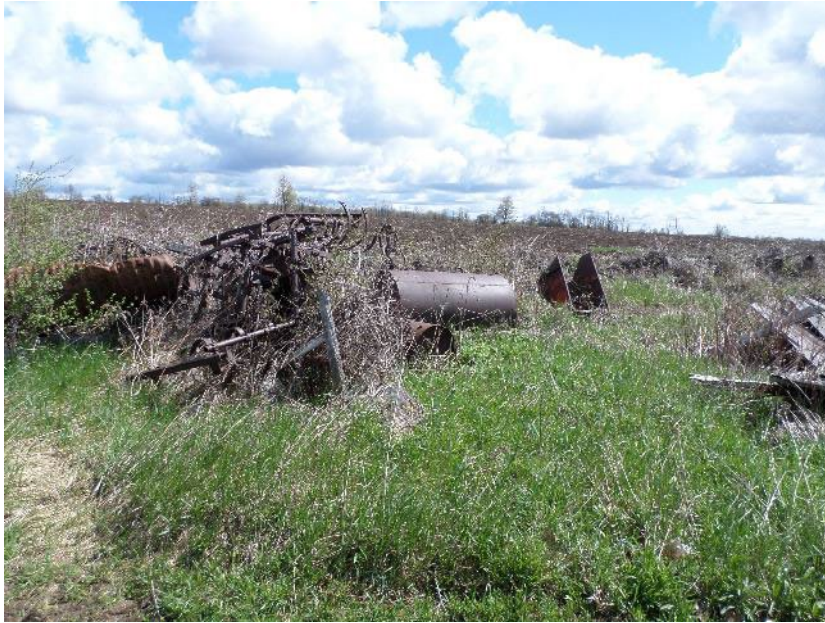
#58 Waste Disposal and Waste Management, including thermal treatment, landfilling and transfer of waste, other than use of biosoils as soil conditioners – The presence of scrap/discarded metal debris, including an old AST, observed 20 m east of Building #5.	Site observations	The PCA is located on the Phase One Property and must be identified as an APEC.

APEC 10 – The presence of scrap/discarded metal debris, including an old AST, observed 20 m east of Building #5.	20 m east of Building #5	#58 Waste Disposal and Waste Management, including thermal treatment, landfilling and transfer of waste, other than use of biosoils as soil conditioners.	On-Site	Metals, Petroleum Hydrocarbons (“PHCs”),	Soil

Photo 15 – View of the scrap metal area (including old AST) located east of Building #5, facing east.

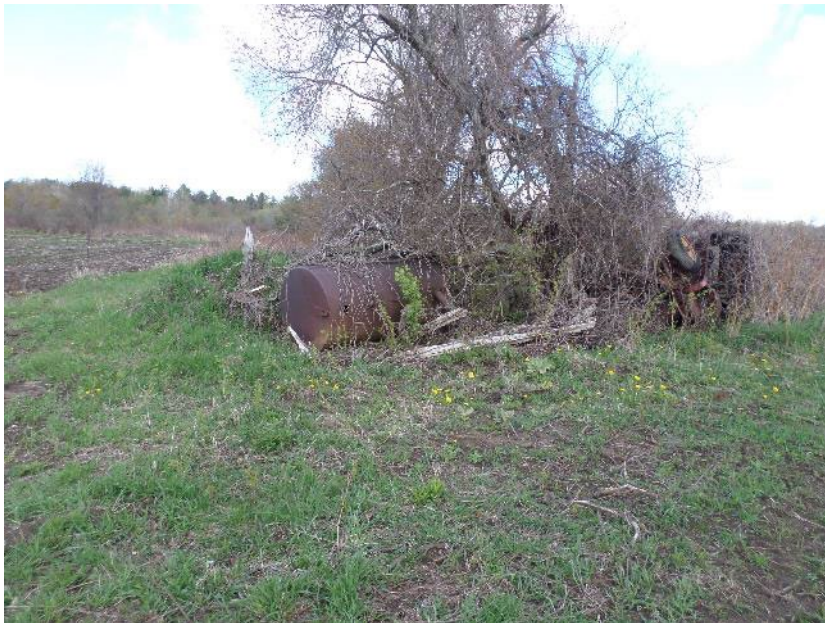
An empty, out-of-use UST was present northwest of the building area.	An out-of-use UST, reportedly to be the one previously installed east of Building #4, was observed to the northwest of the building area. No further details were provided.
	An empty out-of-use AST was present east of Building #5.	An empty out-of-use AST was located east of Building #5; no further details were provided.
Environmental monitoring data, including data created in response to an order or request of the Ministry	There are a total of seven monitoring wells located on the Phase One Property. Stick up monument casings of five monitoring wells were observed on Site, four to the northeast and one to the south along Mississauga Road. Two additional wells were reported to have been installed in the spring of 2021 by Golder on behalf of Votorantim Cimentos for hydrogeological evaluation.	It is understood that the overburden at these well locations consisted of sandy and silty clay till, and that the depth to dolostone bedrock ranged between 2.7 to 19.5 m bgs. .

#58 Waste Disposal and Waste Management, including thermal treatment, landfilling and transfer of waste, other than use of biosoils as soil conditioners – The presence of scrap/discarded metal debris observed along the tree line area 75 m north of the buildings.	Site observations	The PCA is located on the Phase One Property and must be identified as an APEC.

Photo 16 – View of the scrap metal (including old UST) located north of the building areas, facing north.

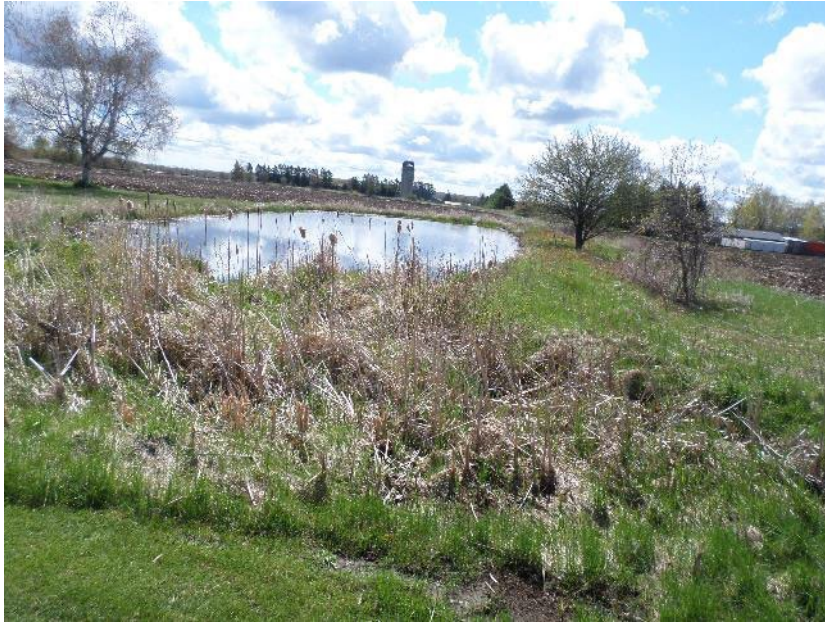
Topic	Conditions	Comment/Source
Nearest Open Water Body	<p>There is a small creek on the western portion of the Phase One Property that connects to a small pond on the Site. The pond is present south of the building area.</p> <p>An unnamed tributary of the Credit River (Erin Branch) is present 575 m southwest of the Site.</p> <p>The Credit River is present 1.6 km southeast of the Site.</p>	Site observations, Google Earth Pro

Photo 19 – View of the pond area located west of Building #1, facing south.
