# **Chickadee Lane Rounding Out Area B Comprehensive Environmental Impact Study and Management Plan**

**Part A: Existing Conditions and  
Characterization**

**Part B: Impact Assessment**

**Part C: Detailed Analysis and Implementation  
Environmental Impact Study (EIS)**

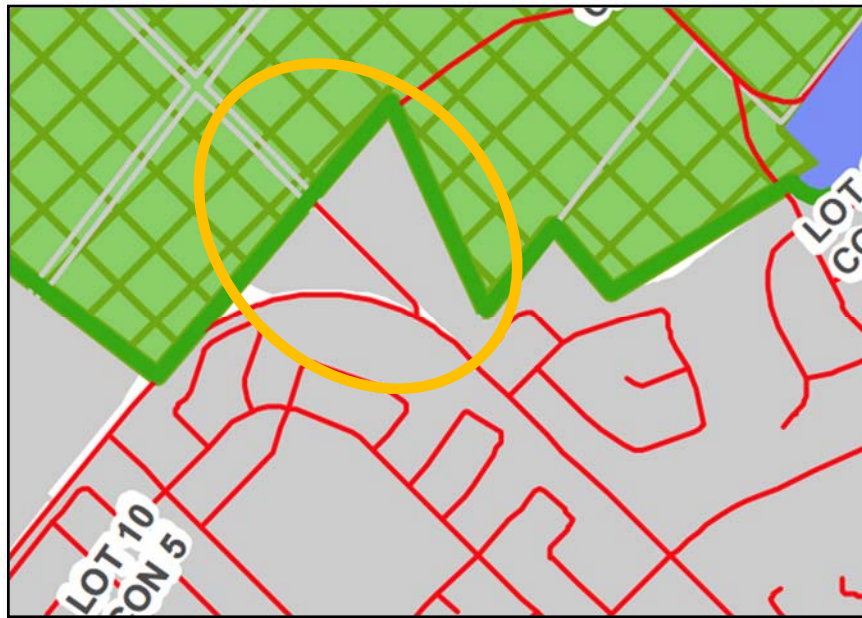
*Map A. Detailed Mapping of the Greenbelt Plan [Greenbelt shown in green]*

The Site contains lands designated as part of the Greenbelt (**Map A**). Under the Greenbelt Plan, lands through the western and eastern corners of the property are designated as part of the Natural Heritage System of the Protected Countryside. Proposed development must demonstrate that there will be no negative impacts to key natural heritage features and key hydrologic features or their function as well as no negative impact on biodiversity or connectivity of the Natural Heritage System.

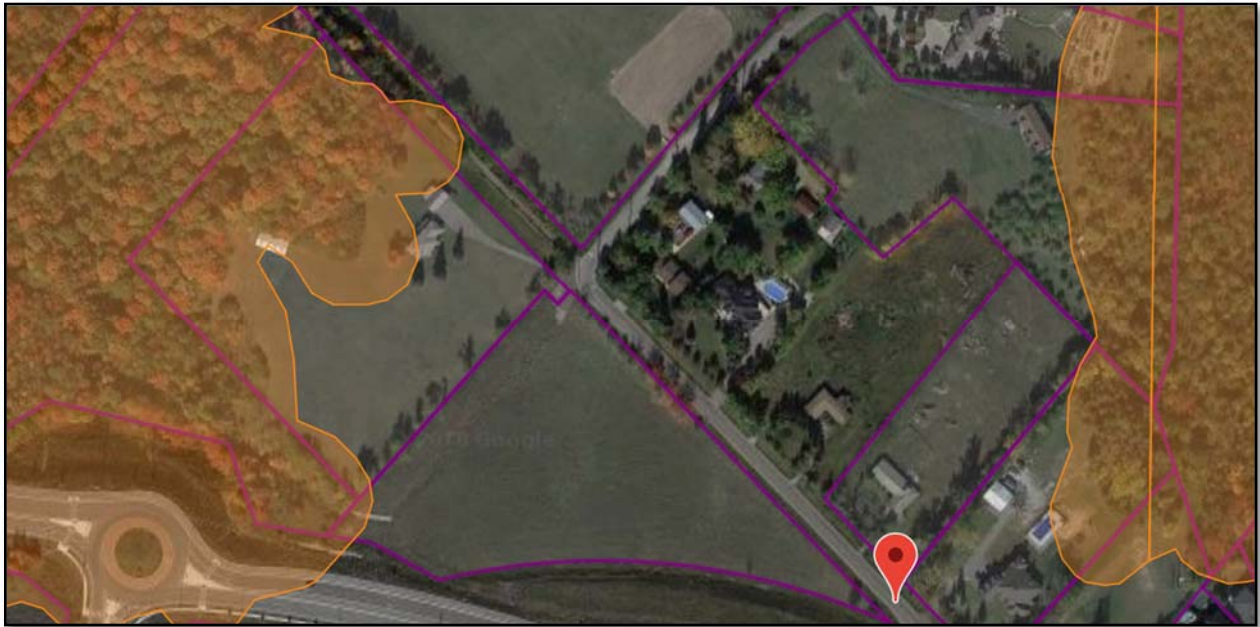
*Map D. TRCA Regulated Areas (orange)*

Regulated Area lands exist within the limits of the Site, at the northwestern and southeastern corners, in association with a series of small watercourse features (**Map D**). The hydrological and ecological functions and importance of lands within the Regulated Areas will have to be identified and development within these areas will be subject to approvals and permitting from the TRCA.

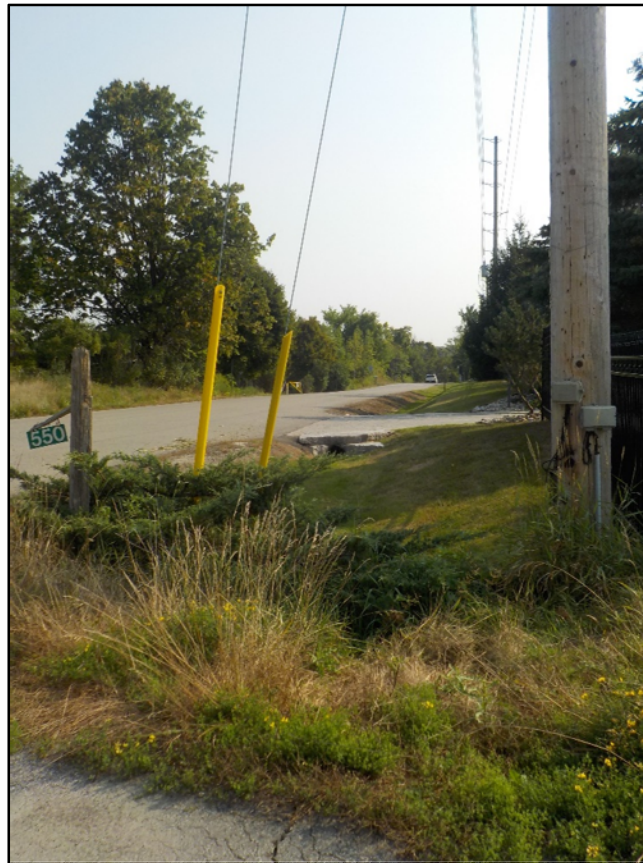
**Photo 1. Downstream view of HDF along Glasgow Road**

The HDF on the Site is located south of Glasgow Road and flows northeast in the ditch on the southern side of the road (**Photo 1, Figure 2**). The upstream and downstream sections of this feature are defined by the point where the feature becomes the Glasgow Road ditch. The upstream end of the feature is defined by cultural meadow with obligate species and the downstream end is a manicured lawn contained by a ditch and culverts for driveways along Glasgow Road. The upstream and downstream flow was dry during the assessment. There was no evidence of sediment transport or deposition observed. For the upstream feature, the feature and bankfull widths are approximately 4.8 m. For the downstream feature, the feature and bankfull widths are 3.1 m. The riparian vegetation upstream consists of meadow, and manicured lawns are found downstream. This feature is not entrenched into the floodplain and there is no channel connectivity present. The culvert observed downstream is buried under a driveway and conveys flows in the ditch adjacent to the road. The HDF is screened below in accordance with the TRCA protocol (**Table 2**). Based on the desktop screening, field assessment and application of the TRCA protocol, there is no management required for this HDF.

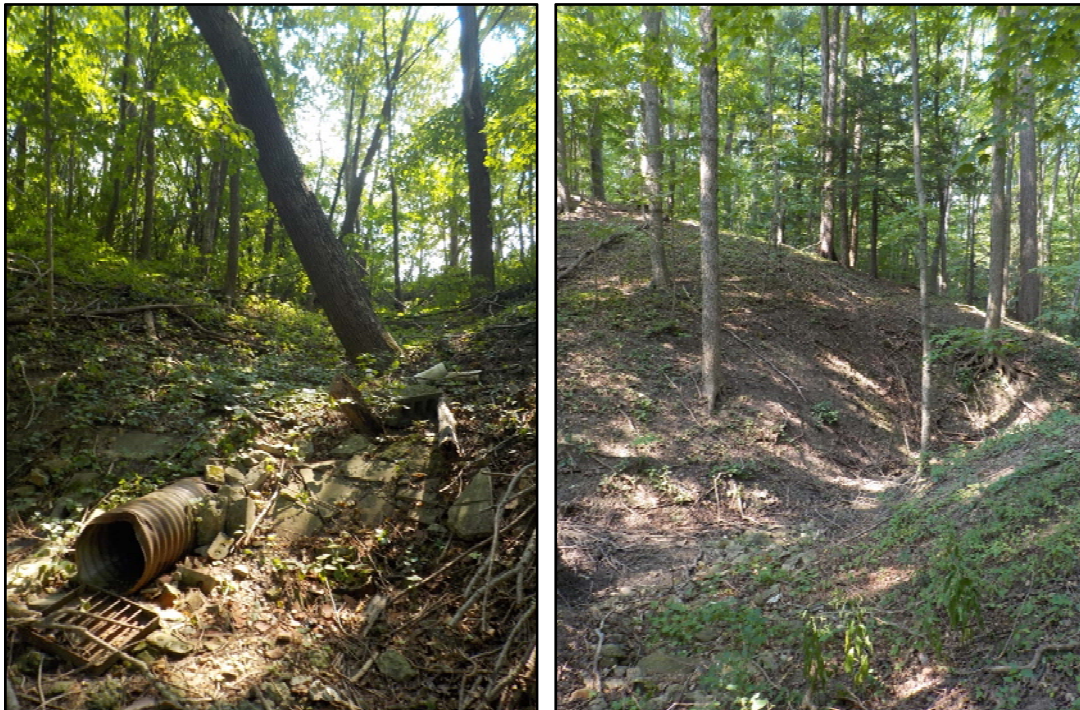
**Photo 2 and 3. Aquatic Survey Point 1**

This feature is an ephemeral tributary of the Humber River located in a forested area at the northwest portion of the Site. This intermittent stream was dry during the time of the assessment and exhibits a sinuous pattern throughout the forest floor. There is a potential fish barrier at the upper reach consisting of a culvert and it has been casually hardened with stones, brick and broken tiles. There is a culvert that exits above the location of the assessment (**Photo 2**). Two merging channels were observed at this location. The channel widths range from 2.2 to 3 m in the primary channel. The average width in the secondary channel is 1.3 m. The substrate on the banks and channel consist of fines and cobbles. The left and right bank shape are vertical and the riparian vegetation is mature deciduous forest. The instream cover consists of abundant large woody debris and canopy cover (**Photo 3**). The habitat quality for fish ranges from poor to none, due to the lack of permanent water that restricts spawning, rearing and overwintering opportunities. Groundwater/ surface water assessment completed at this location (MP1 on **Figure 5**) show a strong downwards hydraulic gradient indicating that this channel loses water to the water table and is not supported by groundwater discharge. Monitoring data is presented on **Table 6**.

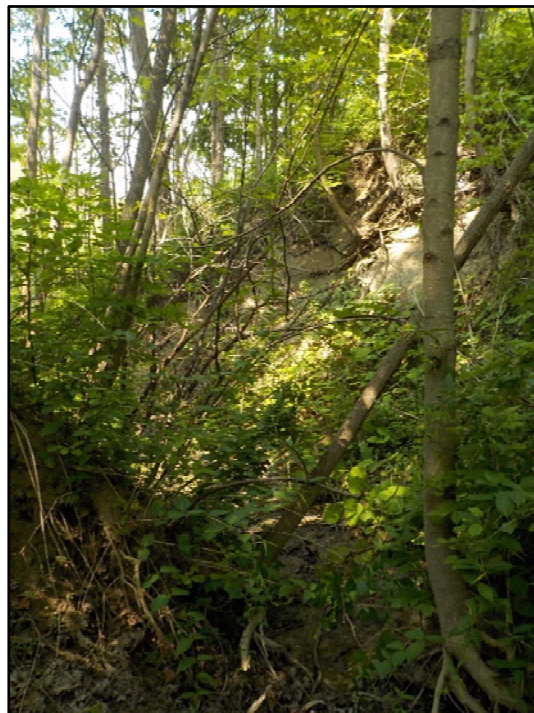
**Photo 4. Aquatic Survey Point 2**

This section of the Humber River is located in a forested area southwest of the Site. This intermittent stream was dry in some areas at the time of assessment and exhibits an irregular wandering to sinuous pattern throughout the forest floor (**Photo 4**). There were no fish barriers observed during the assessment. The average width in the channel is 5.2 m. The wetted width ranges from 15 to 30 cm. The bankfull depth ranges from 0.5 to 5 cm. The substrate on the banks and channel is dominated by clay with scattered boulders. The left and right bank shape are vertical and the riparian vegetation consists of a young forest with shrubs and deciduous trees. The instream cover consists of trace amounts of woody debris, vascular plants, overhanging vegetation and boulders. There was garbage and debris observed in the channel during the aquatic assessment. The habitat quality for fish ranges from poor to none, due to the lack of permanent water that restricts spawning, rearing and overwintering opportunities.

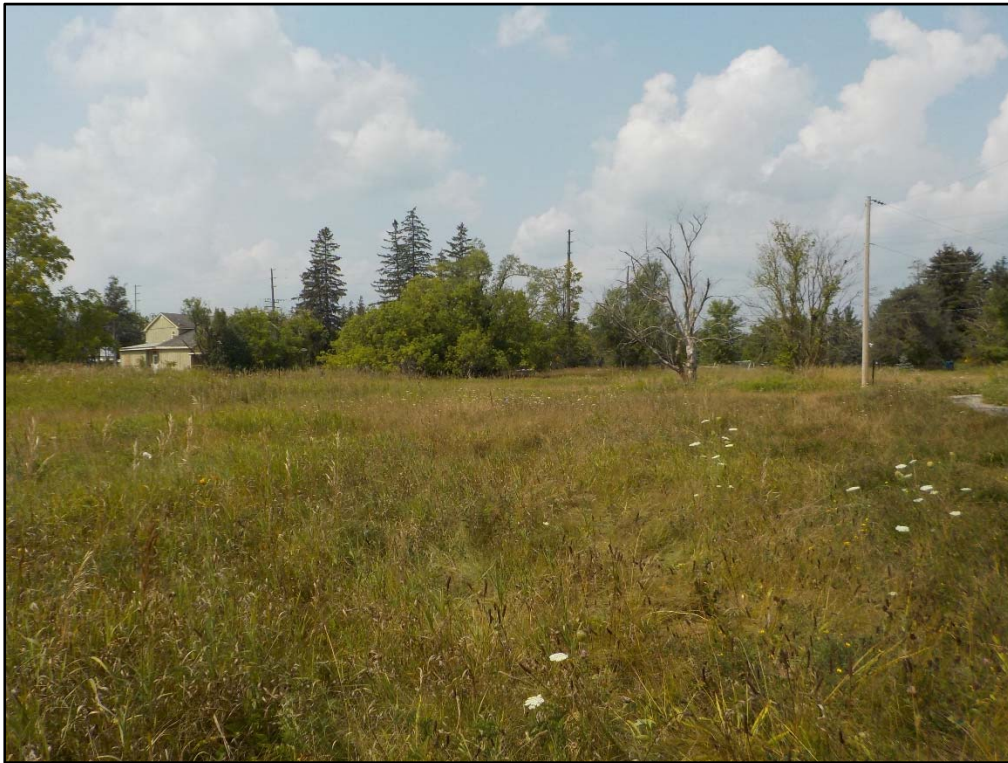
**Photo 5. Dry – Moist Old Field Meadow (CUM1-1a)**

This cultural meadow has a canopy consisting of scattered Manitoba Maple (*Acer negundo*), providing 0 to 10% cover at a height of 10 to 25 m (**Photo 5**). There is no subcanopy or understorey present in this community. The ground layer is dominated by non-native Smooth Brome (*Bromus inermis*). This area is

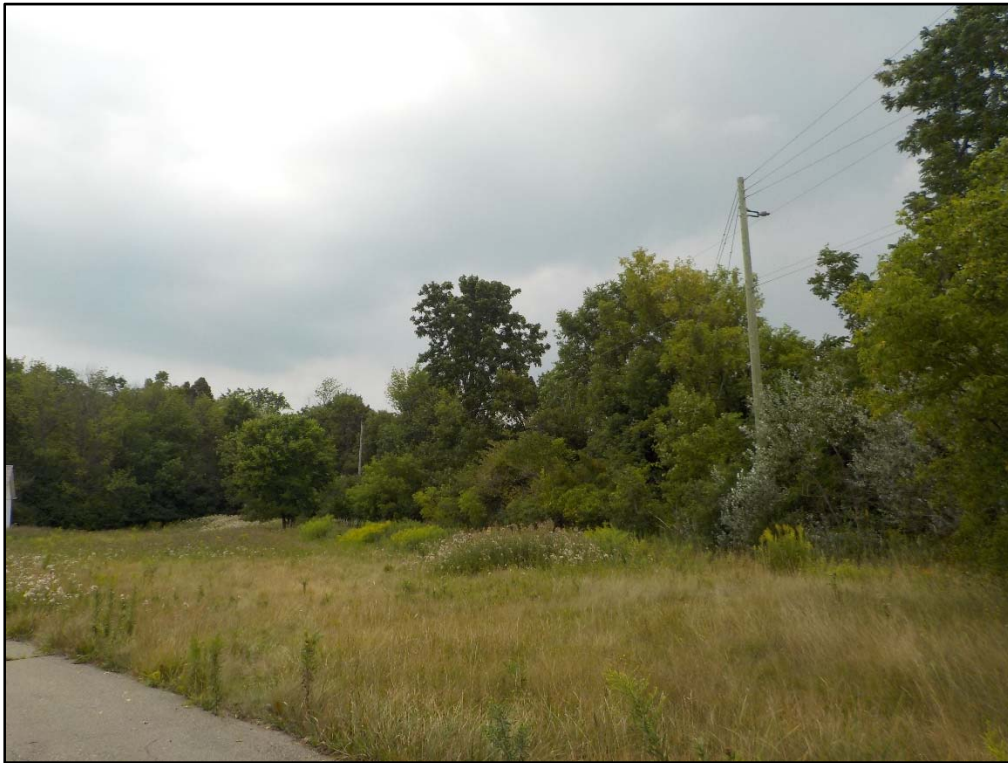
**Photo 13. Fencerow (TAGM5d)**

This fencerow is located along the northeastern boundary of the former rural residence and is adjacent to the Jack Garratt Soccer Park. The canopy is composed of Ash (*Fraxinus* sp.) and Manitoba Maple (**Photo 13**). There is a large White Willow (*Salix alba*) at the northern end of the fencerow.

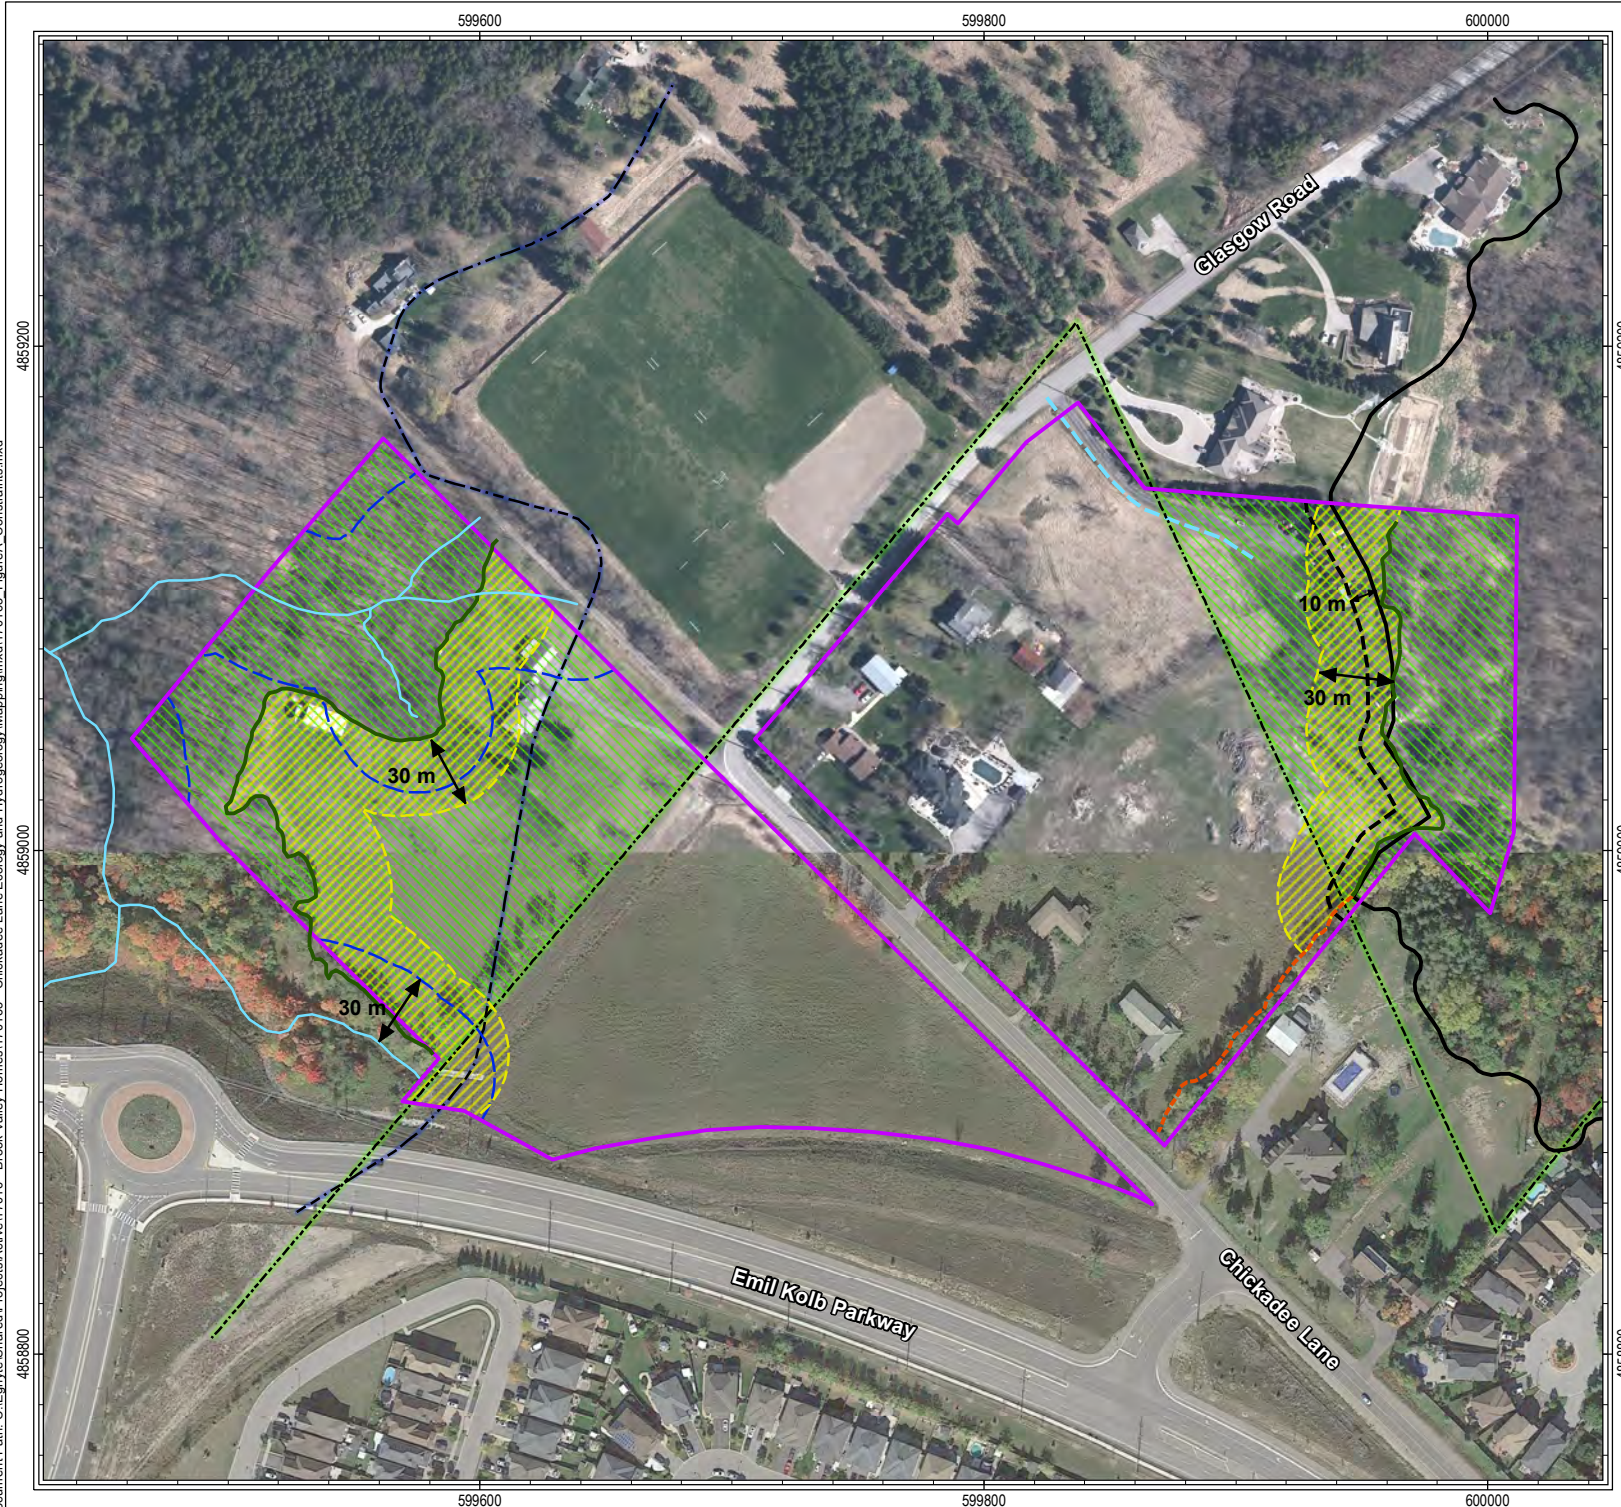
- Approximate TRCA Generic Regulation Line
- TRCA Top of Bank and Natural Features Staked Line (23/02/16)
- TRCA O. Reg. 166/06 Setback Line
- ▨ Significant Woodland Boundary (PECG staked dripline - August 2018)
- Drainage Feature
- Tree Protection Zone as per Standard No. 707
- Watercourse
- Watercourse Buffer (30 m)
- ▨ Greenbelt VPZ
- ▨ Greenbelt Protected Countryside
- Study Area

- Note that the combination of the 30 m minimum vegetation protection zone and the 10 m TRCA setback would define the limits of the natural features, and in combination with the Erosion Hazard Limit would define the development limit, whichever is the greater of the three.

- A small drainage feature occurs through the northern corner of the Site, just south of Glasgow Road. According to the results from the 2018 PECG survey and assessment following TRCA HDF guidelines (TRCA, 2014), this feature can be removed with no management recommendations required.

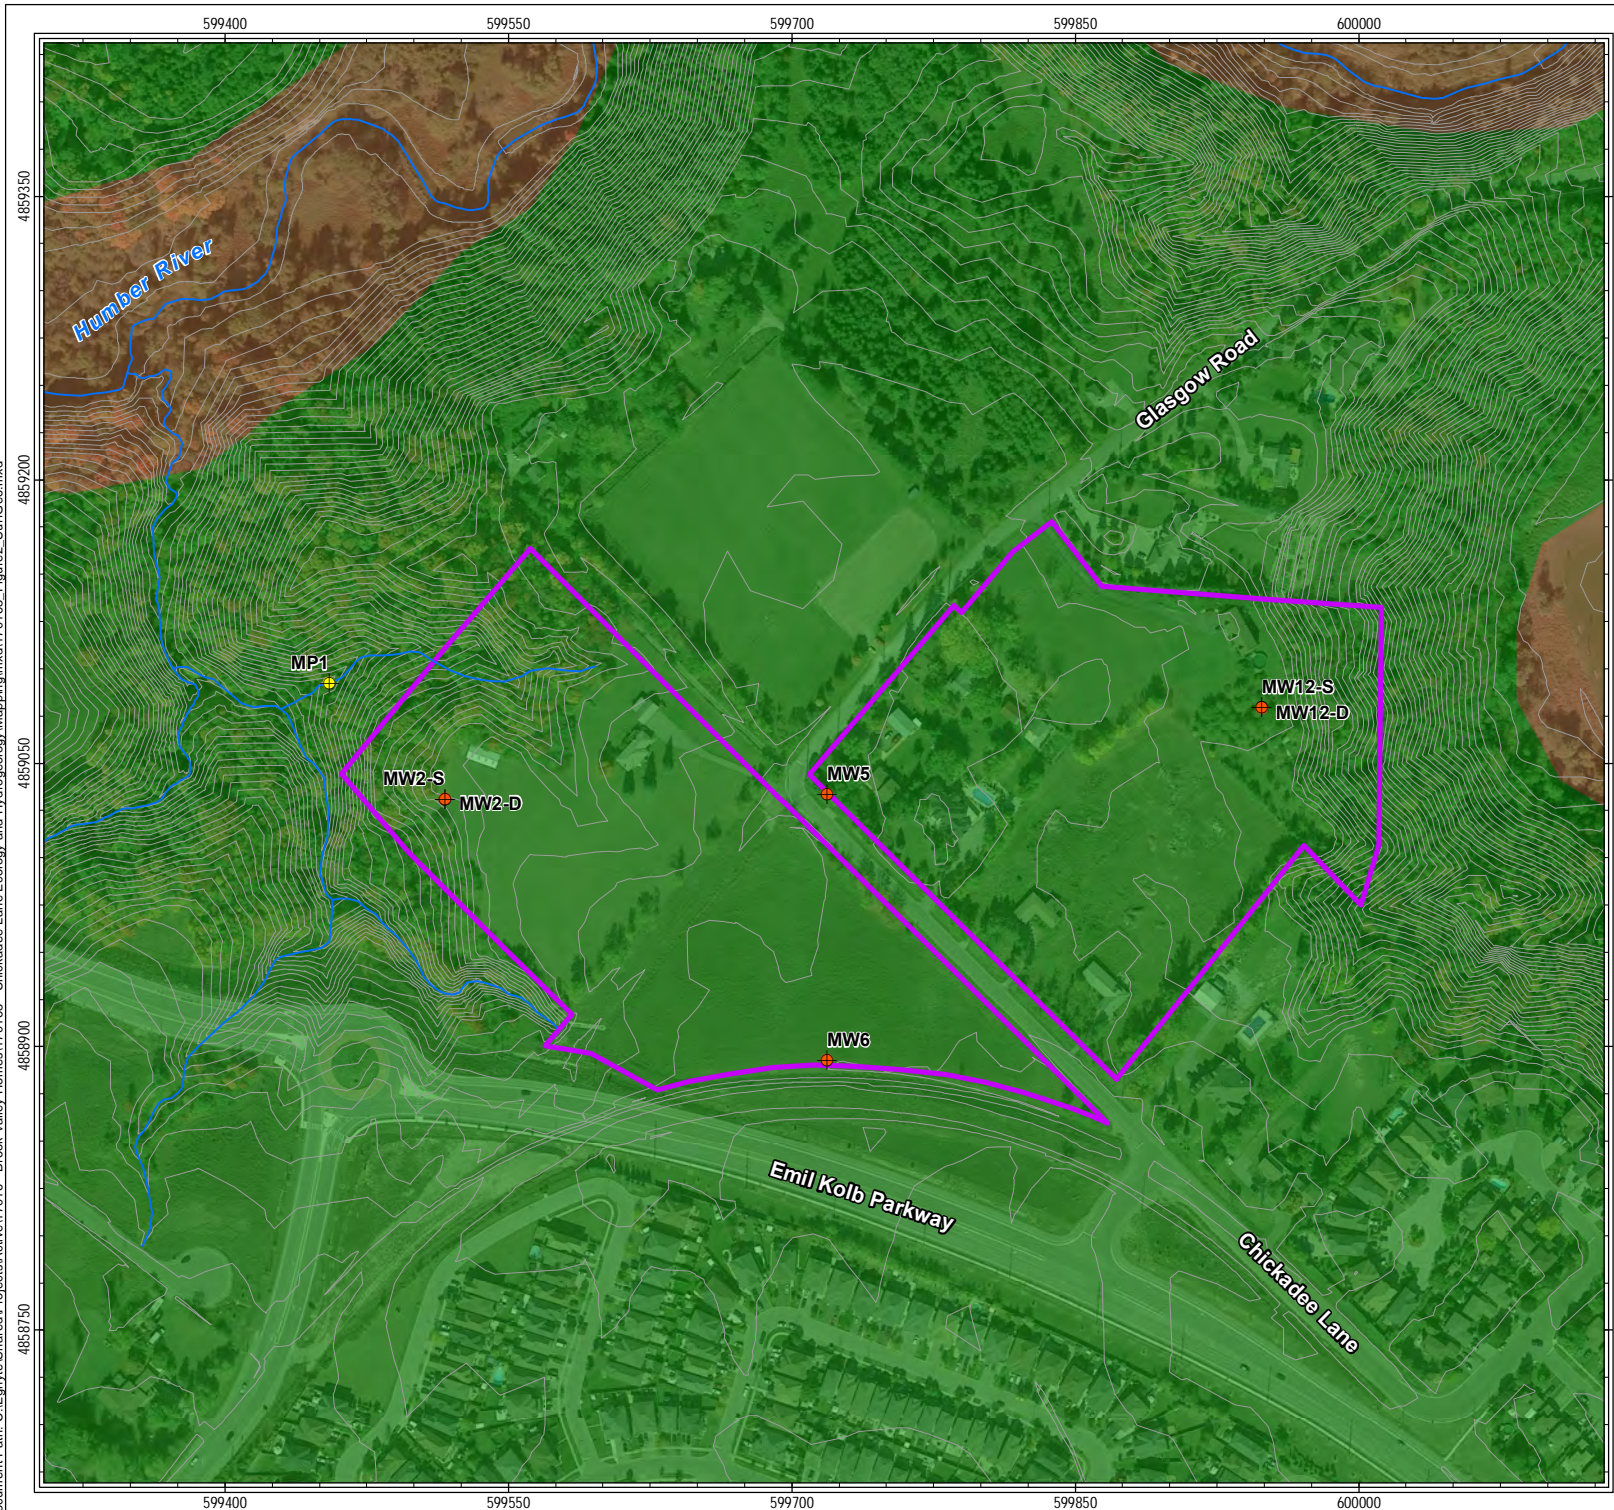
- Mini Piezometer
- Monitoring Well
- Watercourse
- Contour (1 m)
- Study Area

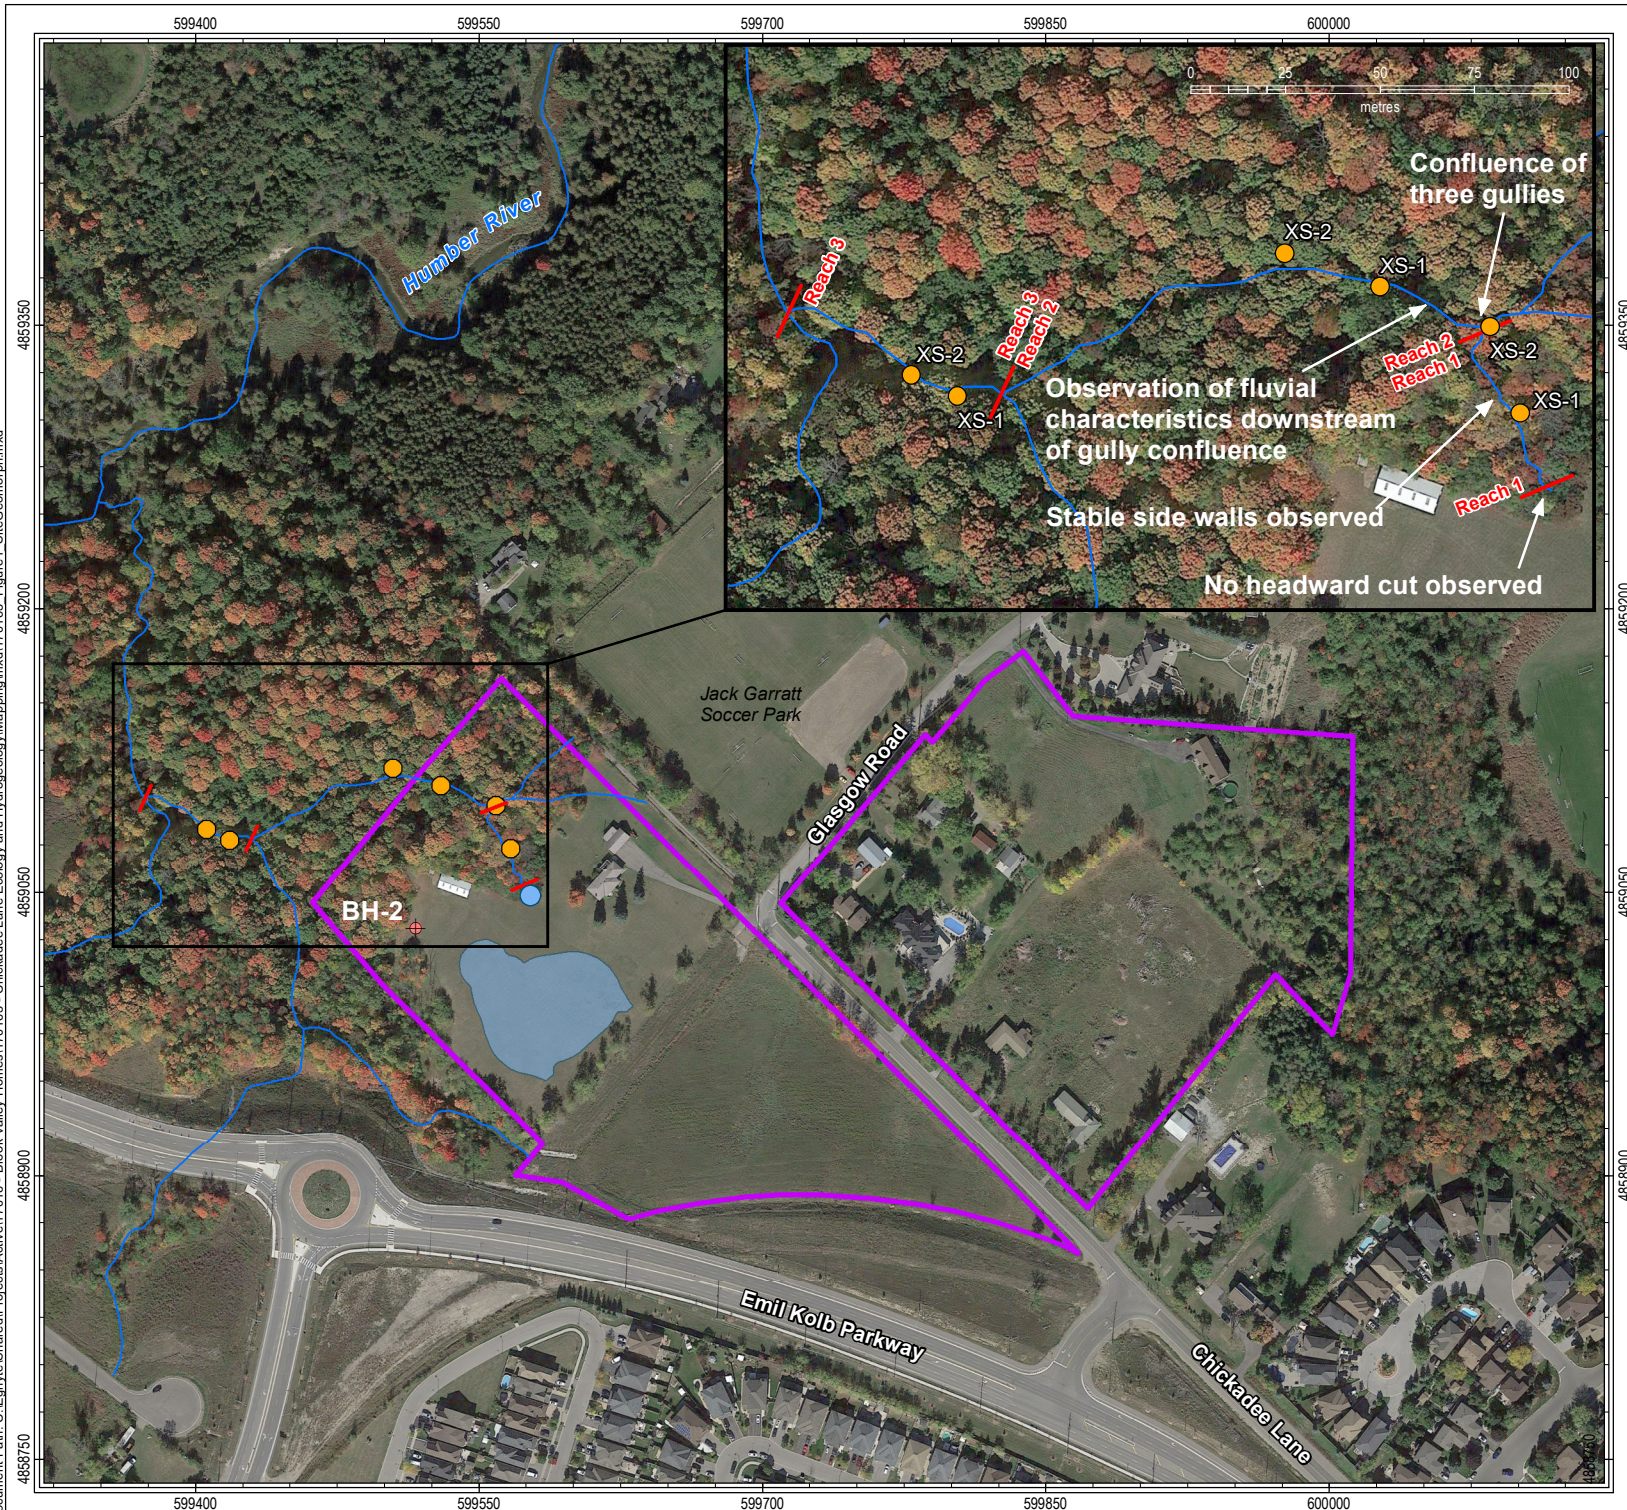
**FIGURE 12**

- Reach Break
- Cross Section Location
- Watercourse
- Study Area
- Contours (1 m)
- Proposed Location of Stormwater Management Pond
- Proposed Pond Outlet

An erosion hazard assessment was completed by PEGC to support the proposed SWM Pond outlet into the tributary to the Humber River (**Appendix H**). The purpose of the visit was to examine channel stability and scour processes, determine channel dimensions, and observe bed and bank materials along the three reaches identified during prior desktop review (**Figure 12**).

A geomorphic survey was completed along Reach 1 of representative bankfull<sup>1</sup> cross-sections (locations are shown on **Figure 12**) and a local longitudinal bed and water surface profile (to approximate the local energy gradient). Substrates were characterized by visual examination and hand texturing of fine-grained materials, with confirmatory reference to nearby borehole logs and associated grain size analysis records. A modified Wolman (1954) pebble count aided establishment of the grain size distribution of gravelly materials. Bank structure and composition were examined, where not obscured by snow or ice.

The planned SWM pond (**Appendix H**) is proposed to discharge into a well-defined network of gullies and channels that descends into the Humber River Valley (**Figure 12**). The pond is proposed to discharge directly into a deep, V-shaped gully (Reach 1) that drains into a defined headwater tributary approximately 50 m from the outfall (Reach 2). A better-defined watercourse (Reach 3) is located approximately 150 m downstream of the confluence which drains a residential subdivision south of Glasgow Road and overland flow from the roadway drainage ditching.

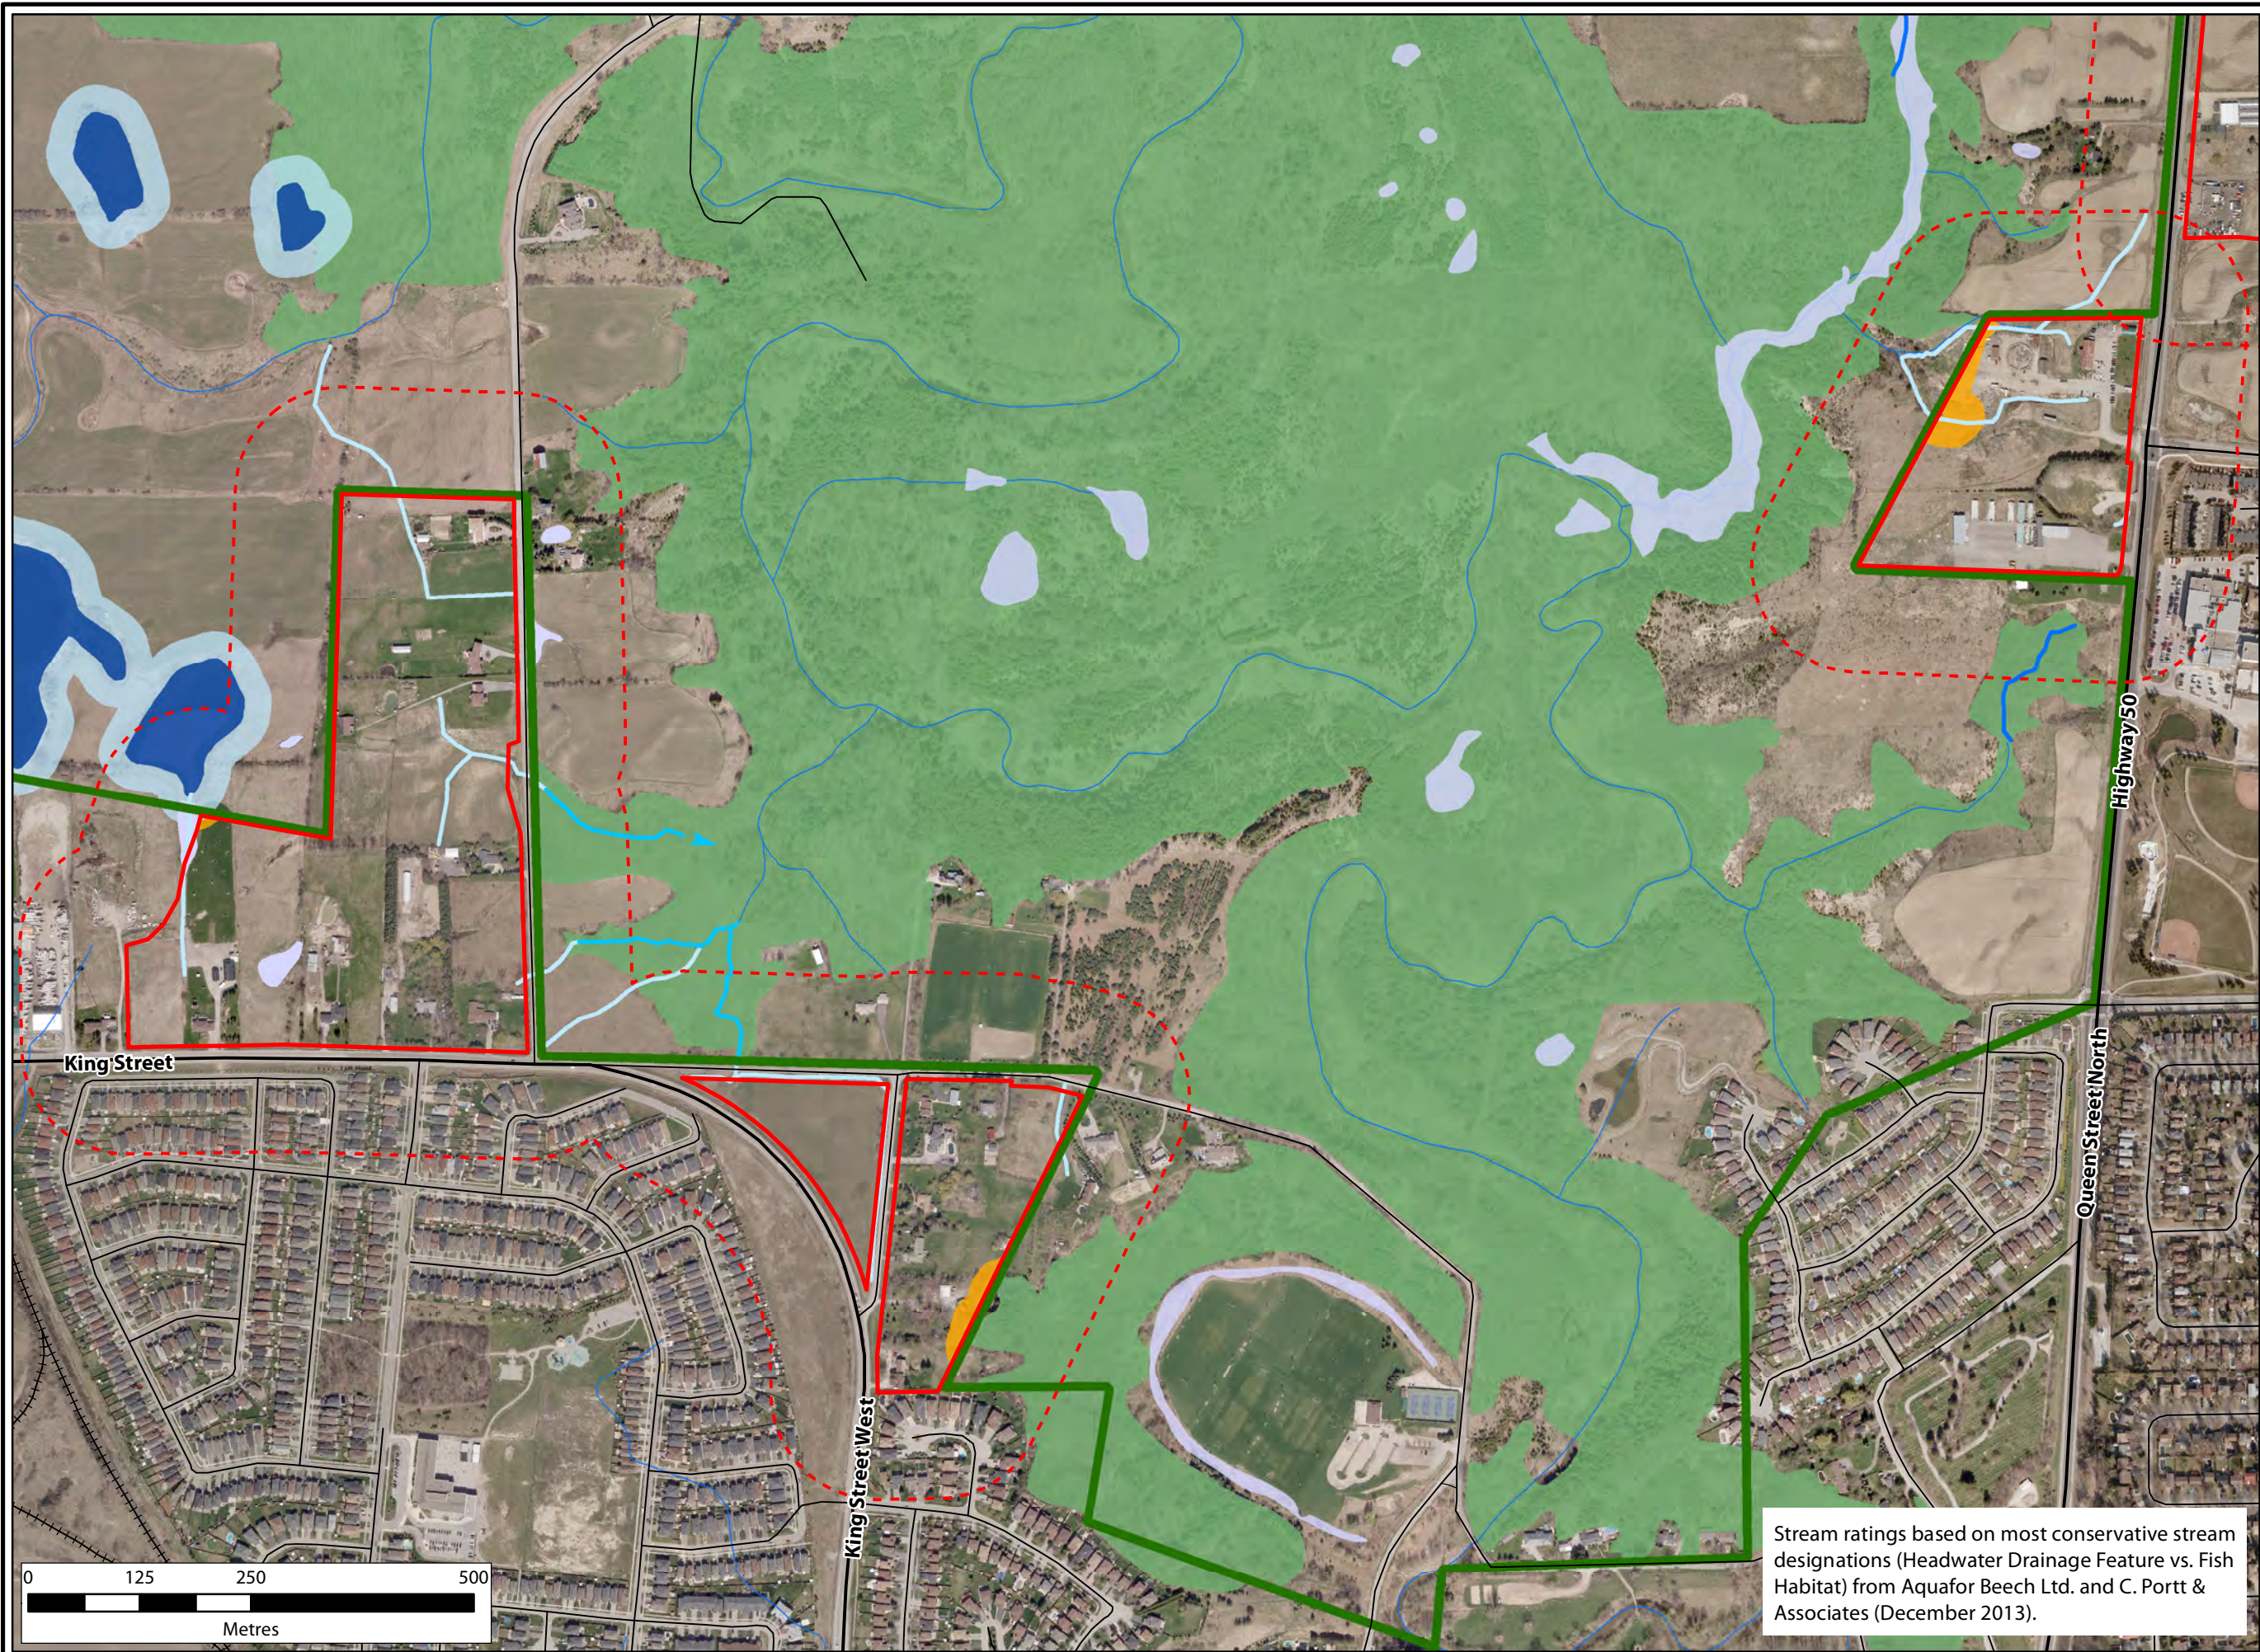
**Legend**

**Aquatic Habitat Classes**

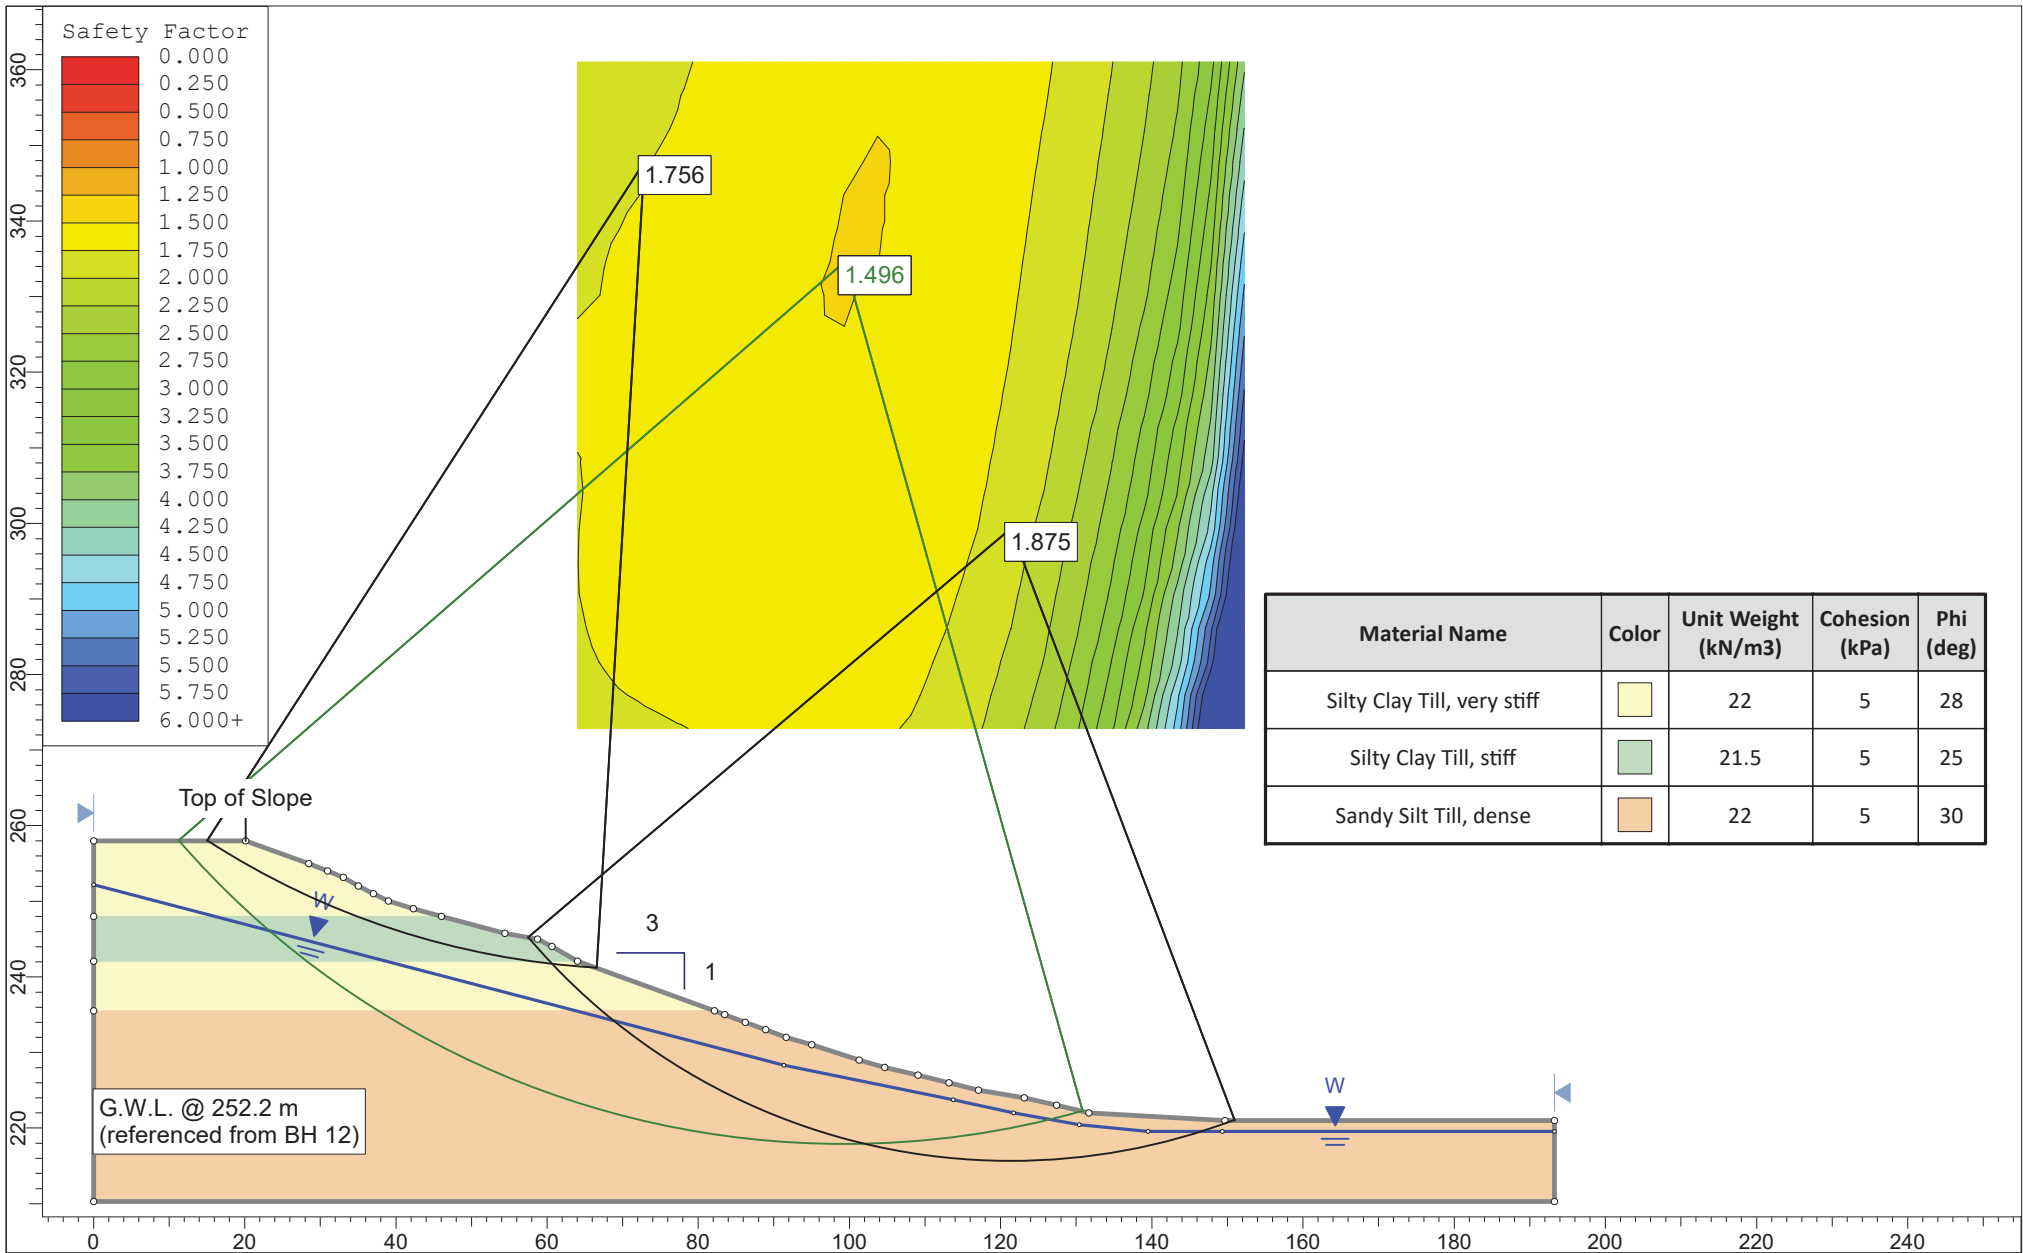
Project Title			Load Case	
Slope Stability Analysis - Cross Section B-B			Existing Condition	
Location				
Chickadee Lane and Glasgow Road, Town of Caledon				
Drawn By	A.L.	Checked By	Scale	Revision
			1:1000	
Date	June 2018		Reference No.	Drawing No.
			1801-S032	5
