# **Chickadee Lane Rounding Out Area B Comprehensive Environmental Impact Study and Management Plan**

**Part A: Existing Conditions and  
Characterization**

**Part B: Impact Assessment**

**Part C: Detailed Analysis and Implementation  
Environmental Impact Study (EIS)**

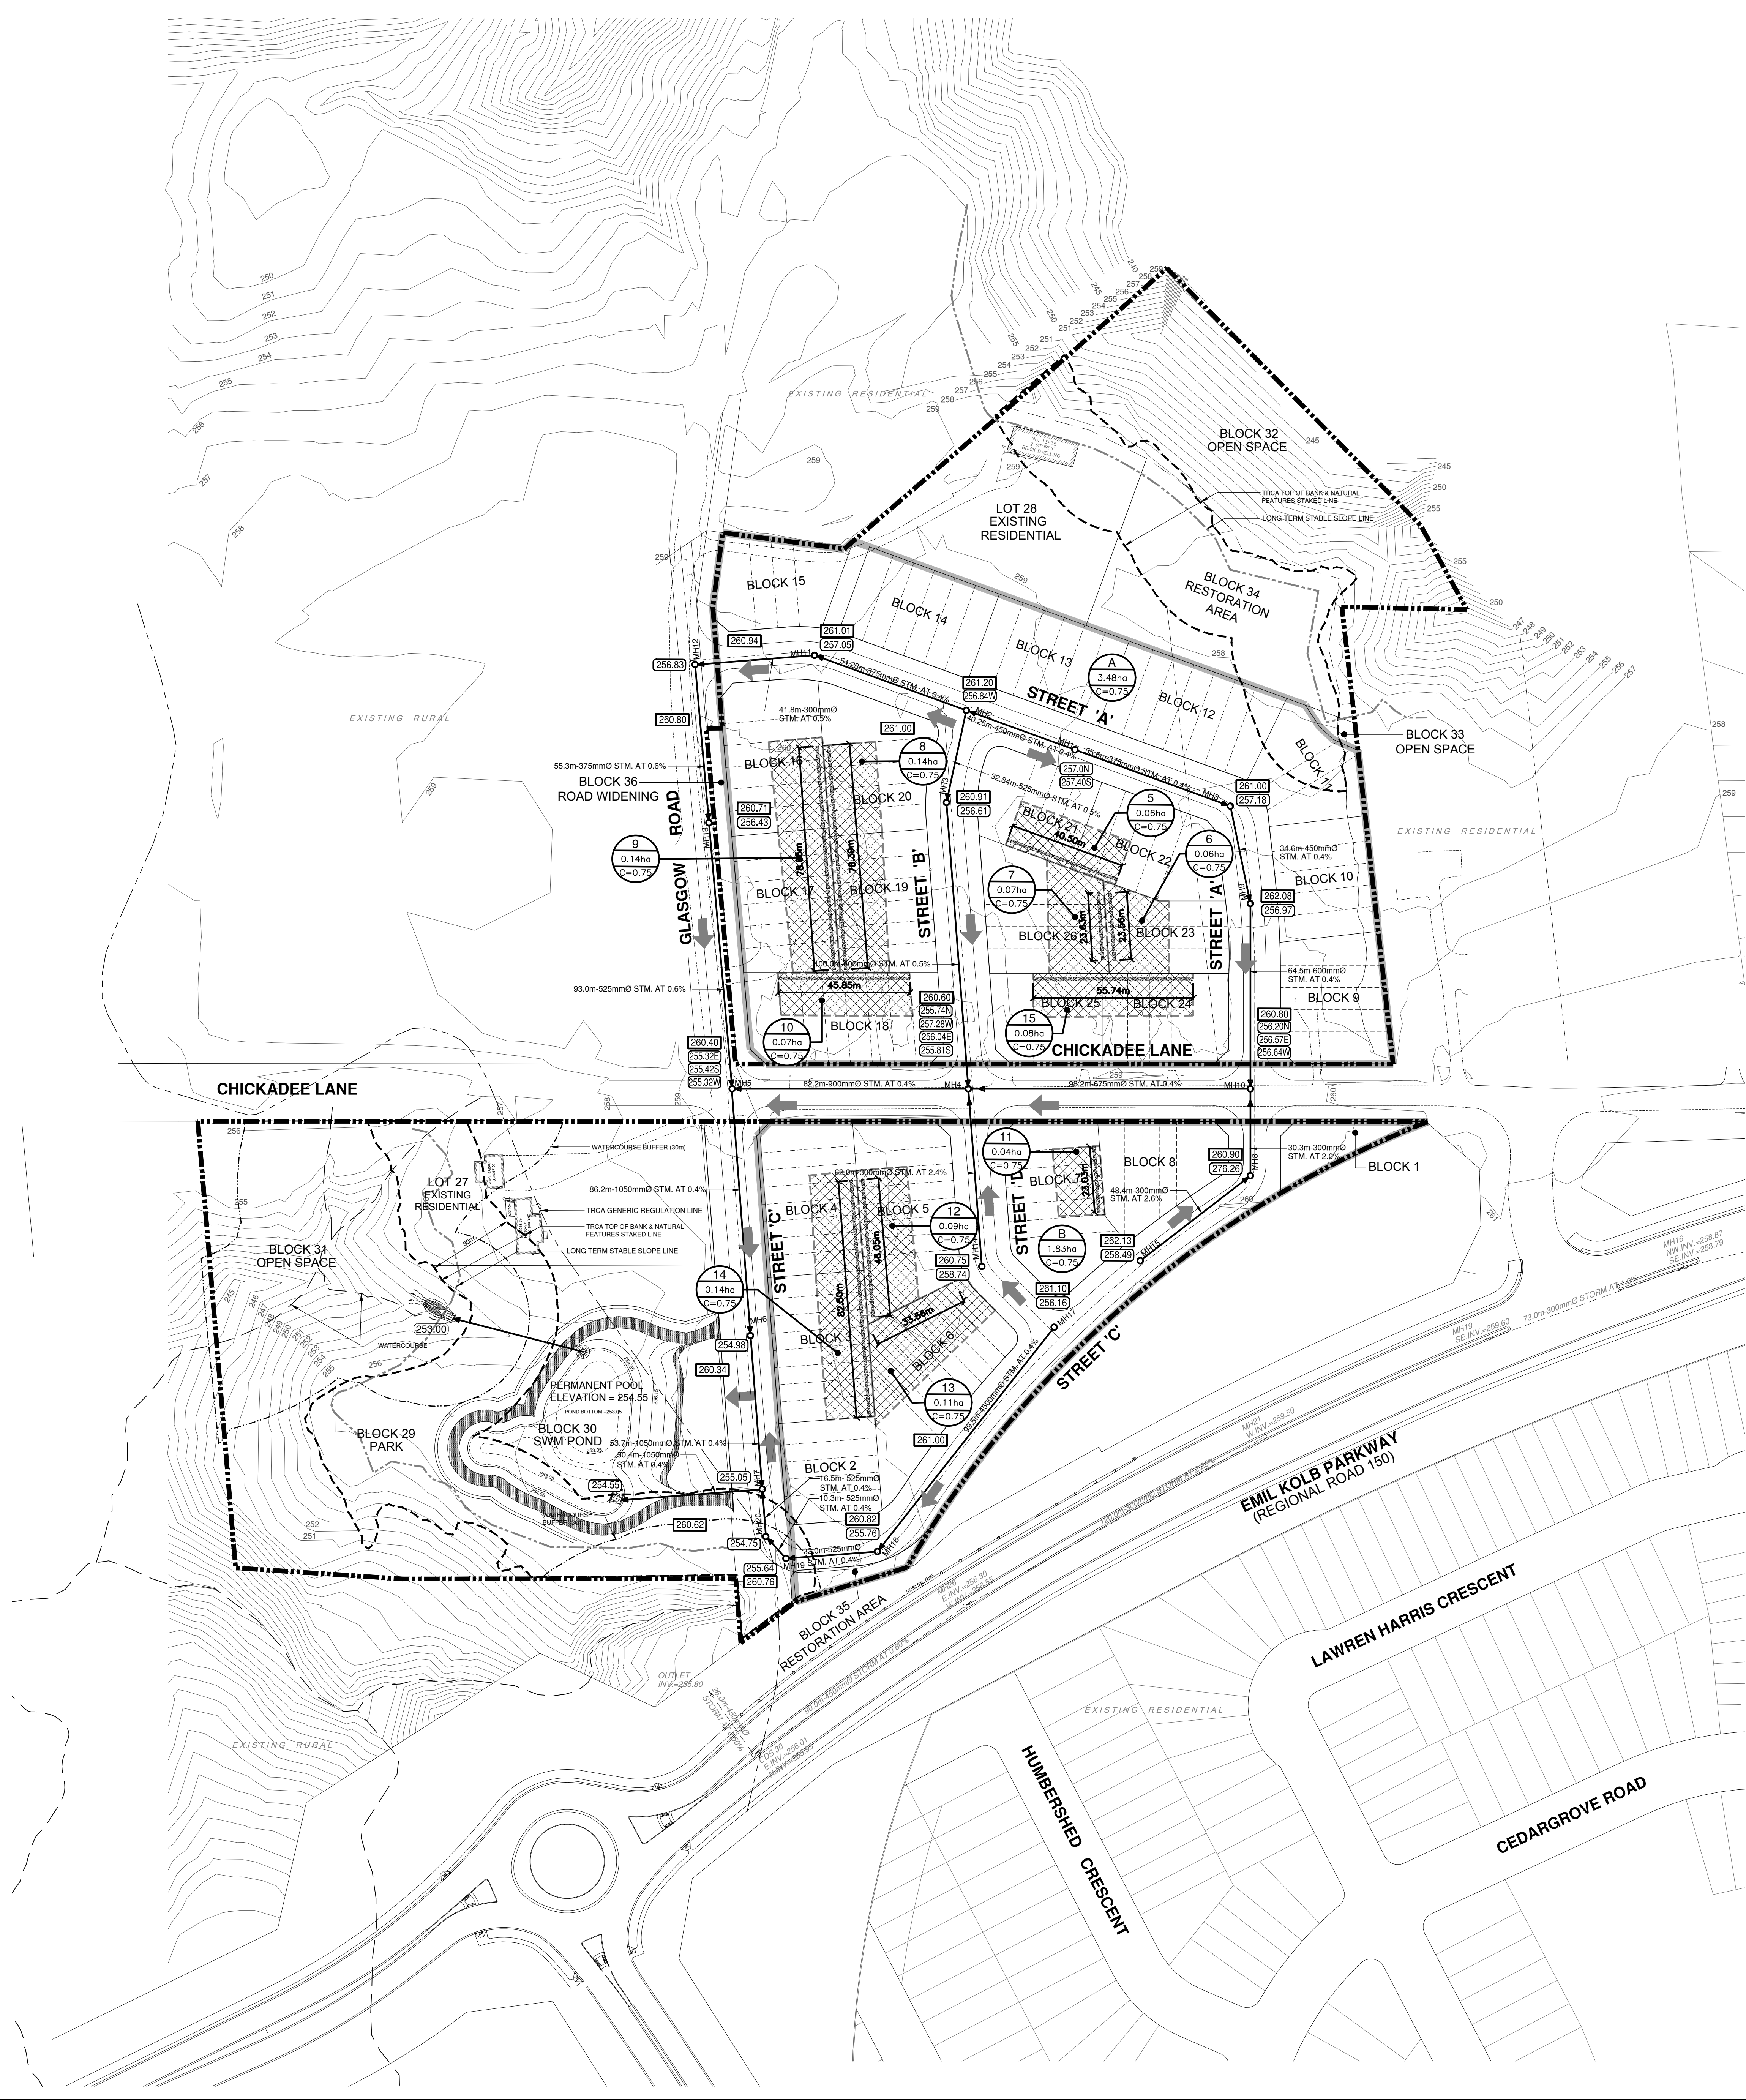
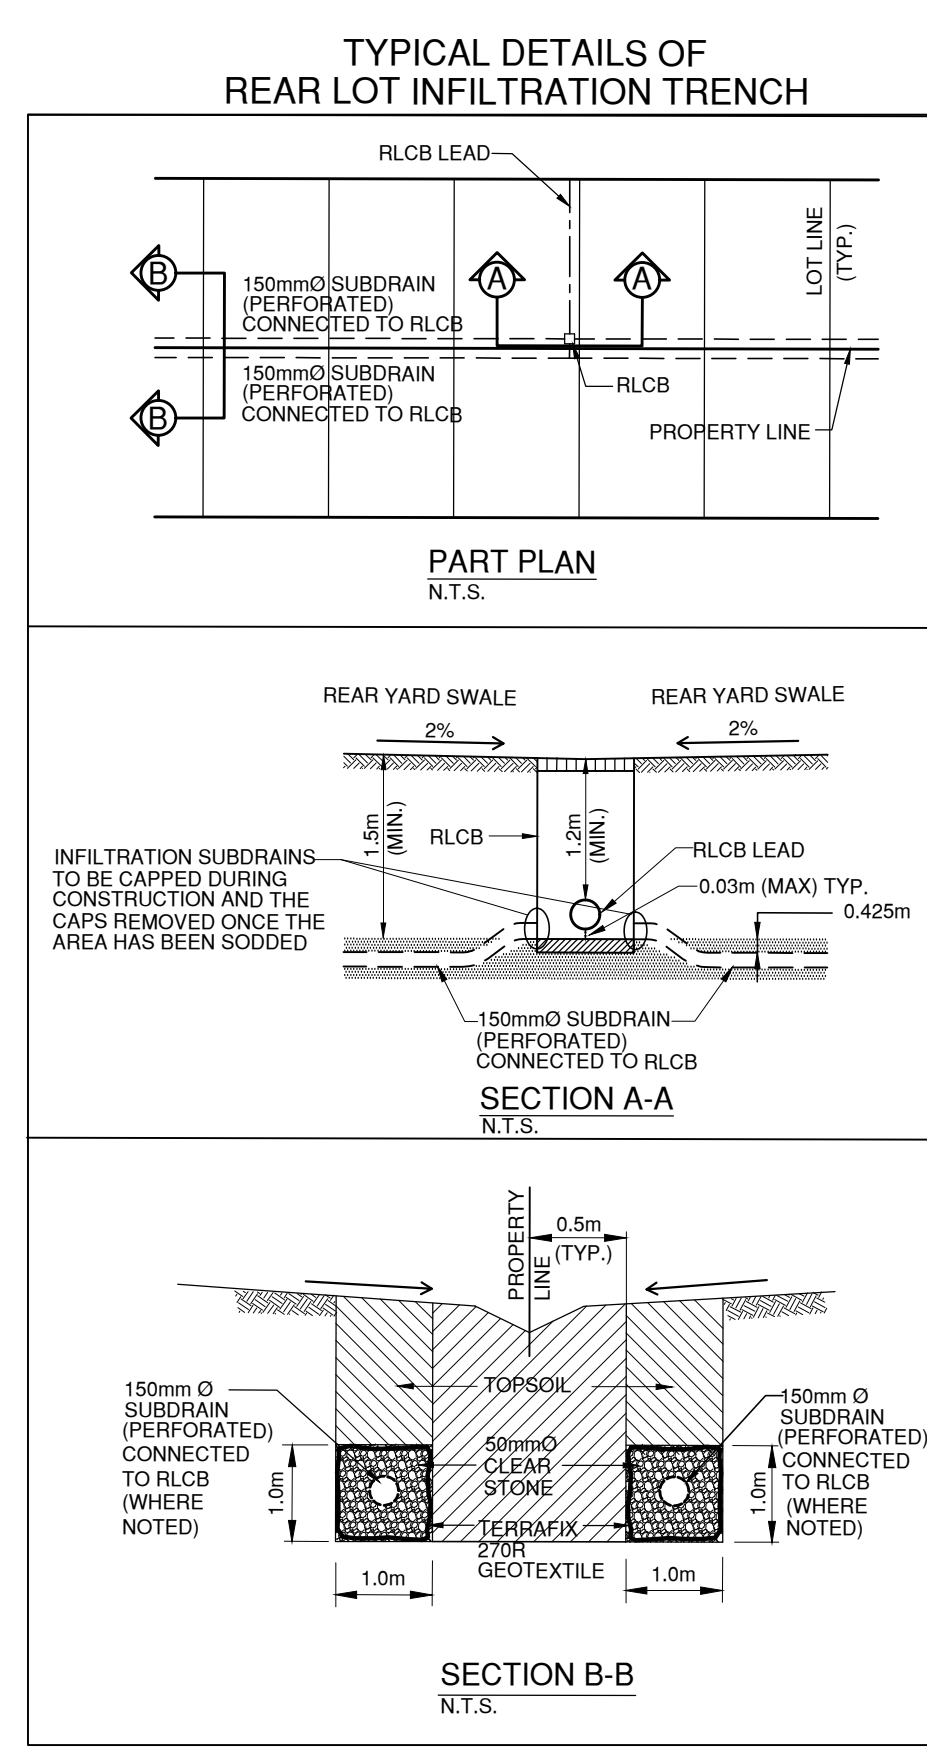
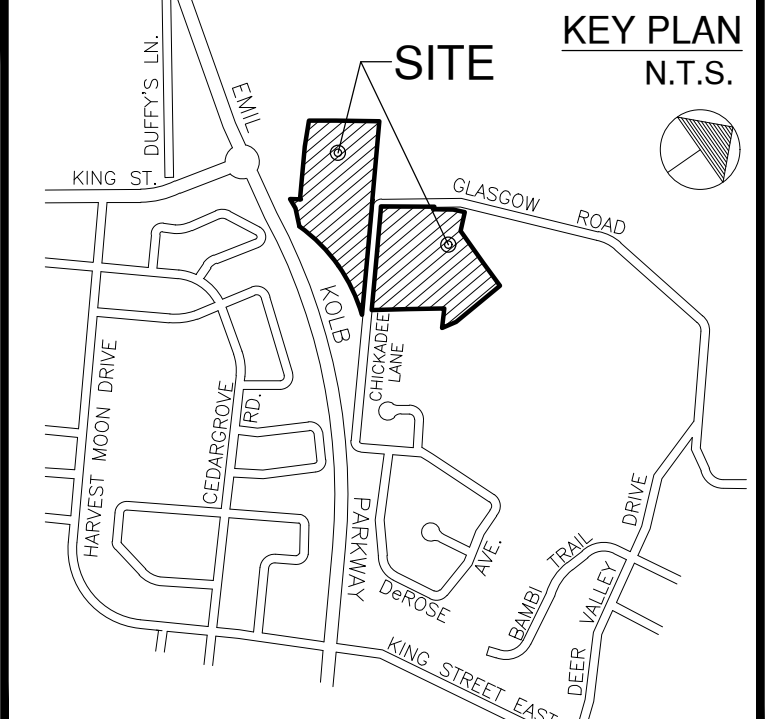
- LEGEND:
- LIMIT OF SUBDIVISION
  - - - EXISTING CONTOUR LINE
  - - - PROPOSED STORM SEWER
  - - - PROPOSED INFILTRATION TRENCH
  - OVERLAND FLOW
  - - - LONG TERM STABLE SLOPE LINE
  - - - TRCA GENERIC REGULATION LINE
  - - - TRCA TOP OF BANK & NATURAL FEATURES STAKED LINE
  - - - WATERCOURSE BUFFER (30m)
  - - - WATERCOURSE

NO.	DESCRIPTION	DATE	BY
REVISIONS			
<b>CD CANDEVCON LIMITED</b> CONSULTING ENGINEERS AND PLANNERS			
9358 GOREWAY DRIVE TEL. (905) 794-0600		BRAMPTON, ONTARIO L6P 0M7 FAX (905) 794-0611	
<b>CHICKADEE LANE ROUNDING OUT AREA "B"</b>			
13935, 13951 & 13999 CHICKADEE LANE, 0 KING STREET AND 550, 600 AND 615 GLASGOW ROAD PART OF LOT 10, CONCESSION 5 & 6 TOWN OF CALEDON REGIONAL MUNICIPALITY OF PEELE			
SHEET TITLE: <b>INFILTRATION PLAN</b>			
DRAWN BY: E.M.		PROJECT No: W17003	
CHECKED BY: D.K.H.		DRAWING No:	
SCALE: 1:1000		<b>IT-1</b>	
DATE: FEB., 19th 2019

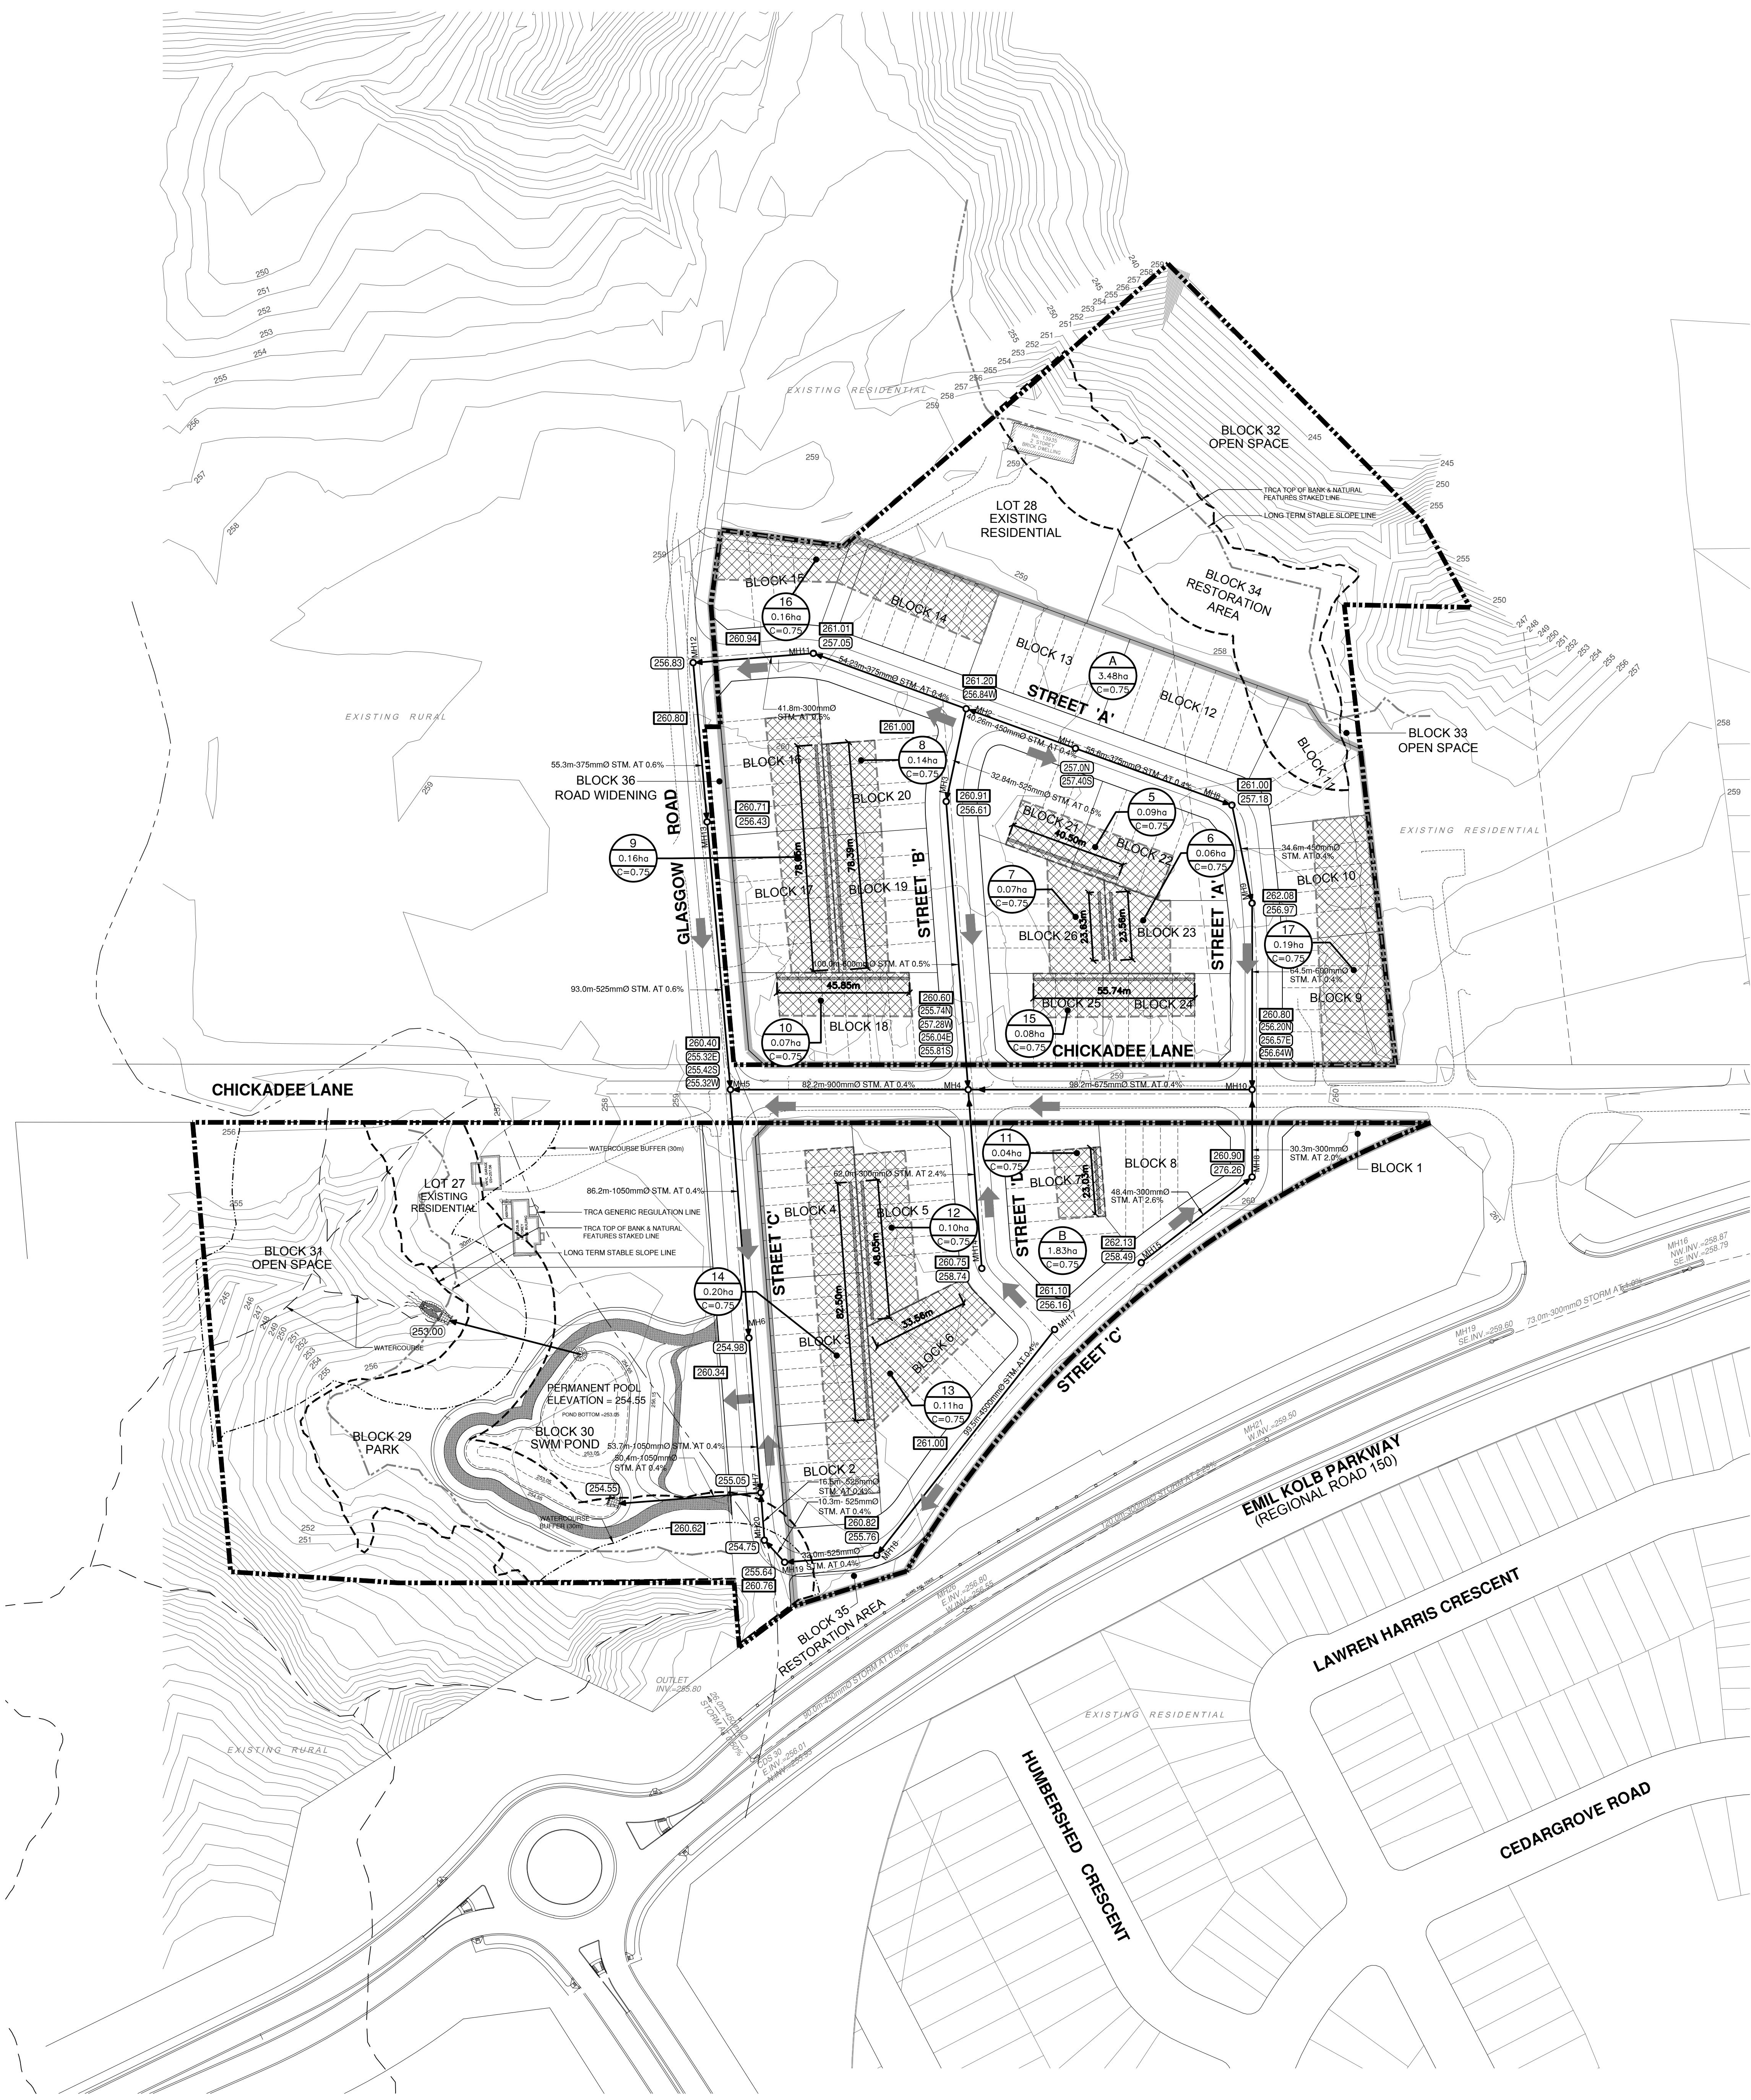
**Infiltration Plan (If Needed)  
(Candevcon, 2019)**
