Memorandum

Date: August 27, 2021

Project #: 1701603

Re: Chickadee Lane Erosion Threshold of Humber River Tributaries

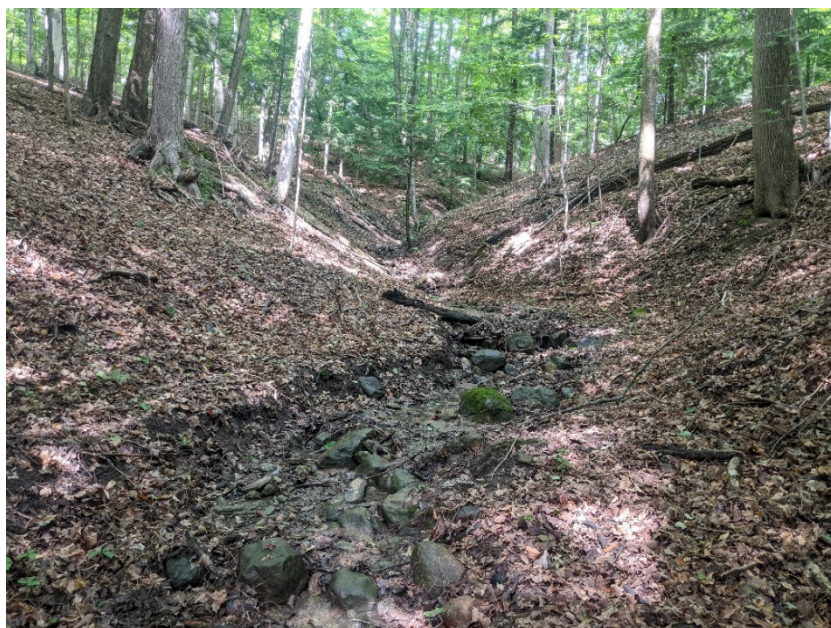
Photo 1. Upstream view of cobbly substrate along the bed near the downstream extent of Reach A5.

Reach A5 exhibits little sign of active erosion along sidewalls and no mass movement failures. The channel has a sinuous planform; however, it is not a function of lateral erosion but forced by valley topography. The gully has a moderate-high gradient (9.54%). The bed and bank material consist of sand and silts as well as localized till exposure, overlain by cobbles and boulders (**Photo 1**). Sand and small gravels are temporarily deposited upstream of boulder clusters and woody debris. Woody debris and exposed tree roots impart structure and roughness along the bed (**Photo 2**). High organic matter (i.e. fallen leaves) increase erosion resistance of the bed and valley substrate. Coarsening of the bed material moderates bed erosion.

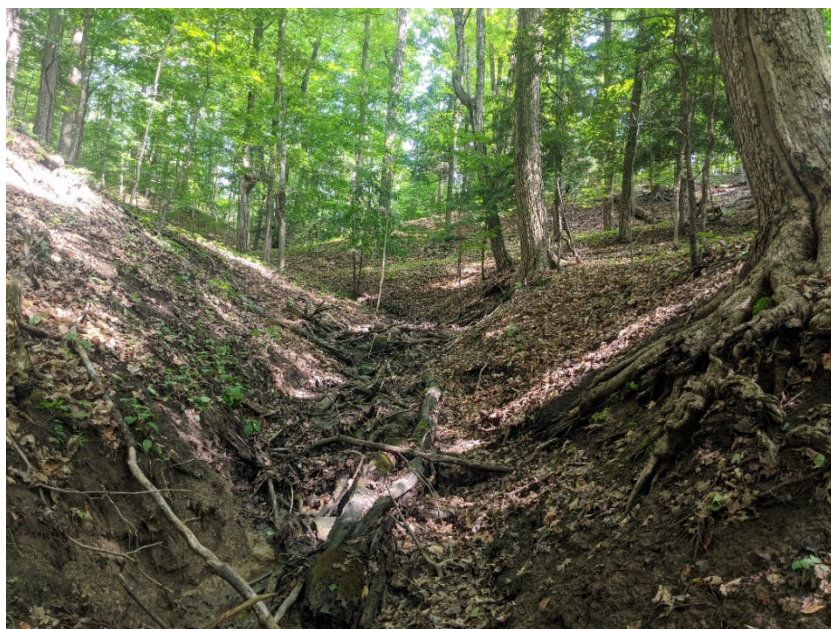
Photo 2. Upstream view of wood debris and organic matter accumulation along the bed which adds additional roughness.

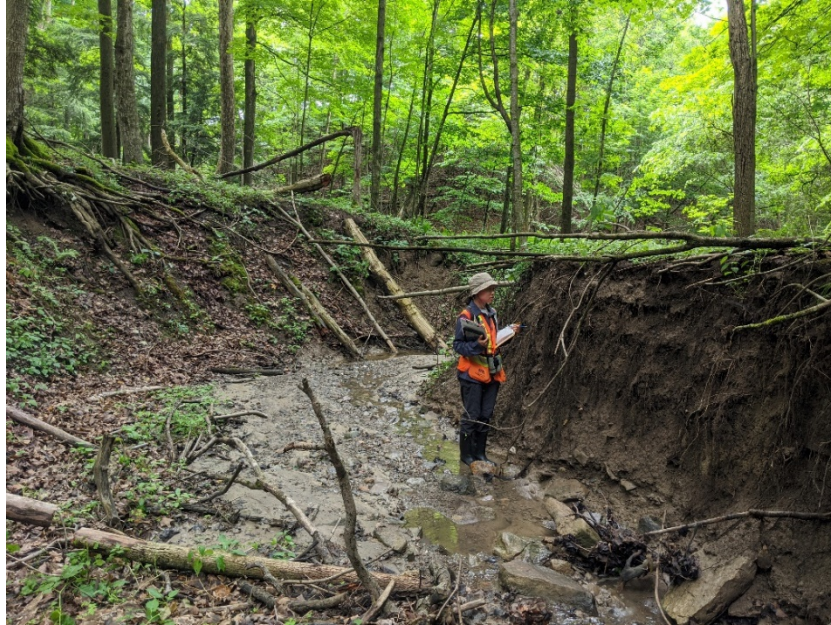
Photo 3. Downstream view of channel incision that has lowered the bed 1.5 to 2.0 m below the floodplain.

Immediately downstream of Reach A2, Reach D2 is morphologically sensitive and is adjusting to unnaturally deep and fast flows resulting from watershed urbanization west of Emil Kolb Parkway (**Photo 3**). Reach D2 is a sinuous channel confined on both sides by terraces (1.5 – 2.0 m high) and prominent valley walls with no accessible floodplain. The channel has incised through alluvial floodplain into underlying

till. Increased peak flows have also begun to widen and deepen the channel, creating a new corridor with a low discontinuous floodplain. The new corridor has a width and depth of 5 m and 1.5 m. The averaged bankfull width and depth are 3 m and 0.4 m, respectively. The bankfull depth is well below the physical top of bank following rapid bed degradation. The average bed gradient along the reach is approximately 4.15%. Bed morphological units (e.g. pools, riffles) are poorly defined due to active degradation. Bed materials are dominated by gravels and cobbles and locally overlain by sand (**Photo 4**). Till is exposed locally along the bed, mostly along the thalweg, and extensively along the lower banks.

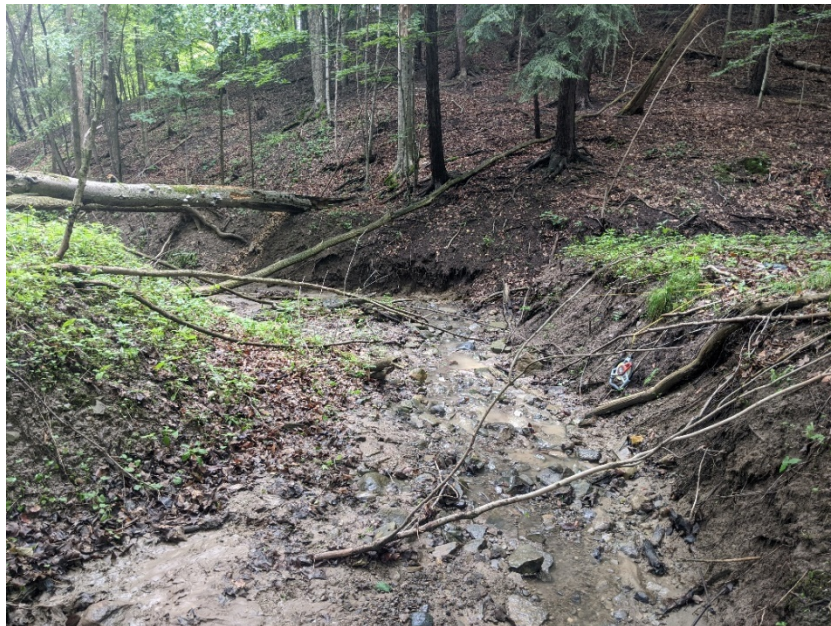
Photo 4. Downstream view of gravel and cobble bed material locally overlain by sand.
