# Phase One Environmental Site Assessment

3035 Old School Road  
Caledon, Ontario.

Argo Kennedy Limited  
4900 Palladium Way  
Burlington Ontario  
L7M 0W7

**DS Project No:** 19-312-100  
**Date:** 2021-07-15

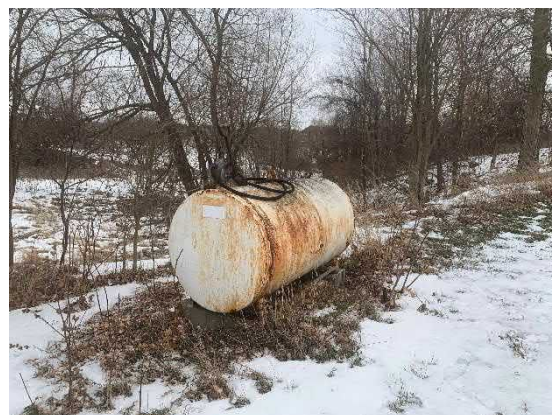
**Picture 6: View of the 1345-litre gasoline AST (PCA-6) located to the west of Quonset Hut 1.**

- ◆ One (1) 1345-litre gasoline AST was observed to be present between Site Building A and Quonset Hut 1 during the site investigation.
- ◆ Two (2) diesel ASTs of unspecified volume were present adjacent to Barn 2 during the site investigation.

APEC-4B	Vicinity of Site Building A and Quonset Hut 1 within the central portion of the Site	#28: Gasoline and Associated Products Storage in Fixed Tanks - One (1) 1345-litre gasoline AST observed to be present between Site Building A and Quonset Hut 1 during the site investigation.	On-Site	PHCs, VOCs, BTEX, Metals, PAHs	Soil and Groundwater
APEC-4C	Area immediately west of Barn 2, located within the central portion of the Site	#28: Gasoline and Associated Products Storage in Fixed Tanks - Two (2) diesel ASTs of unspecified volume were present adjacent to Barn 2 during the site investigation.	On-Site	PHCs, BTEX, PAHs	Soil and Groundwater
APEC-4D	Immediate vicinity of Site Building A, located within the central portion of the Site.	#28: Gasoline and Associated Products Storage in Fixed Tanks - A 200 gallon fuel oil furnace was reported by the property owner to be present within the basement of Site Building A, and is utilised for heating purposes.	On-Site	PHCs, BTEX, PAHs	Soil and Groundwater

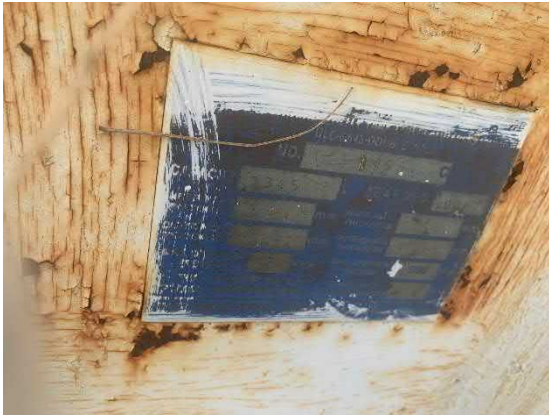
**Picture 7: View of the manufacturer's stamp on the gasoline AST.**

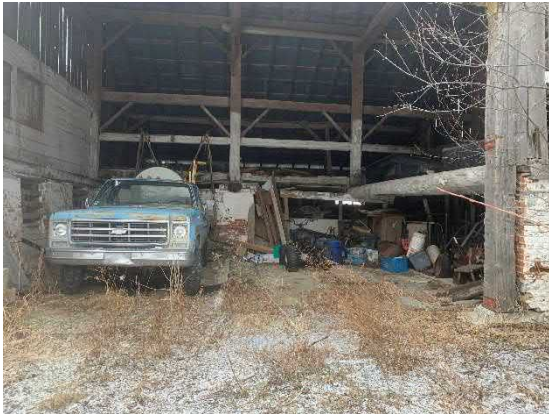
**Picture 9: View of a truck and assorted waste in the southern portion of Barn 1.**

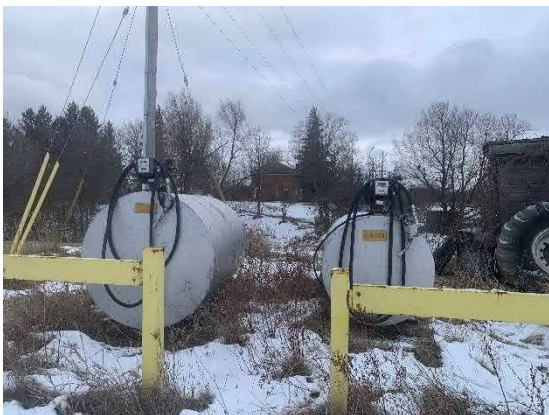
**Picture 11: View of the two (2) diesel fuel ASTs (PCA-7) located west adjacent to Barn 2.**

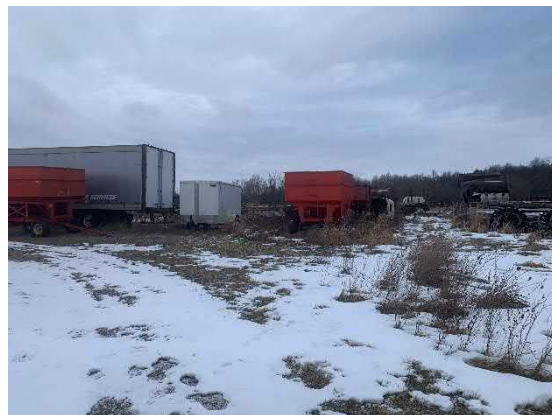
**Picture 12: View of the farm equipment on the eastern side of the farm.**

- ◆ According to the property owner the agricultural equipment utilized by the farm is serviced and repaired onsite (including tractors).
- ◆ The neighbouring properties within the Phase One Study Area appear to have been used for agricultural and residential purposes since the early/mid 1870s.

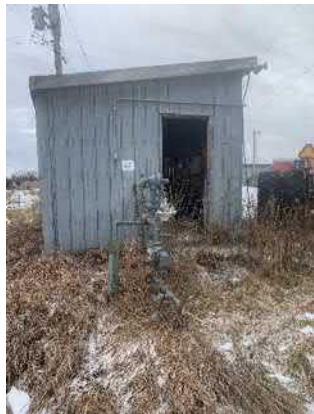
**Picture 15: View of the natural gas connection to the utility shed, located in the central portion of the farm.**

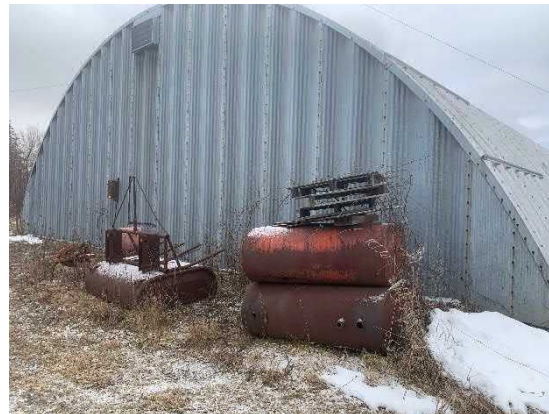
**Picture 16: View of the three (3) empty ASTs on the southern extent of Quonset Hut 1.**

- ◆ Three (3) empty ASTs of unspecified volumes and unspecified former substances were observed to be located to the south of Quonset Hut 1, the historic use of the ASTs is unknown.

PCA-5	#28: Gasoline and Associated Products Storage in Fixed Tanks	Three (3) empty ASTs were observed to be located to the south of Quonset Hut 1.	PCA is located on the Phase One Property.
PCA-6	#28: Gasoline and Associated Products Storage in Fixed Tanks	One (1) 1345-litre gasoline AST observed to be present between Site Building A and Quonset Hut 1 during the site investigation.	PCA is located on the Phase One Property.
PCA-7	#28: Gasoline and Associated Products Storage in Fixed Tanks	Two (2) diesel ASTs of unspecified volume were present adjacent to Barn 2 during the site investigation.	PCA is located on the Phase One Property.
PCA-8	#30: Importation of Fill Material of Unknown Quality	Importation of fill material of unknown quality for grading purposes associated with the construction of Former Buildings B, C, D and E within the northwestern portion of the Site.	PCA is located on the Phase One Property.
