CLEARBROOK DEVELOPMENTS LTD.

PHASE ONE ENVIRONMENTAL SITE ASSESSMENT

0 HEART LAKE ROAD - PARCEL 6, CALEDON,
ON

May 10, 2021

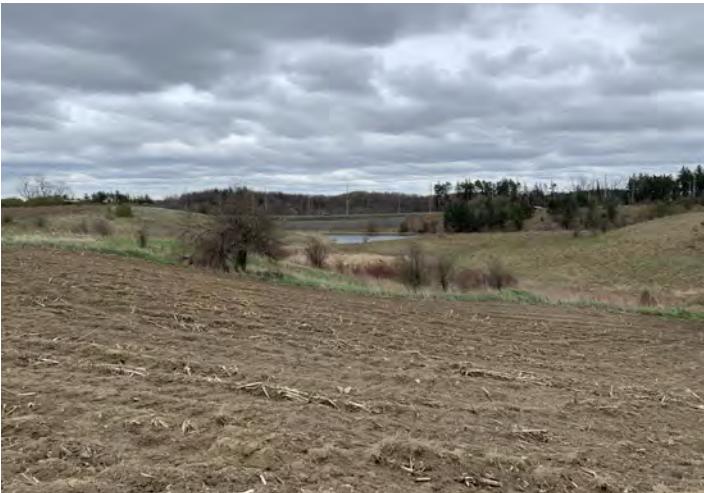
PHOTO 3: View of the tributary located on the southern to southwestern portion of the Site.

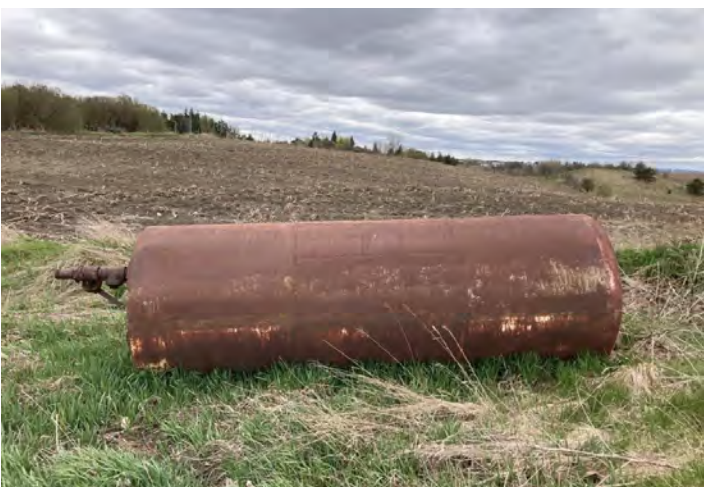
agricultural uses of the property. The cistern appeared to be empty with no staining or odours observed, and therefore not of concern at this time.
iv. Potable and Non-Potable Water Sources	Potable water is not anticipated to service the Site. There were no potable water wells observed on the Site.
UNDERGROUND UTILITIES

PHOTO 5: View of the cistern located on the eastern portion of the Phase One Property
