1.0 INTRODUCTION

1.2 Study Objectives

SNELL'S HOLLOW SECONDARY PLAN
TOWN OF CALEDON

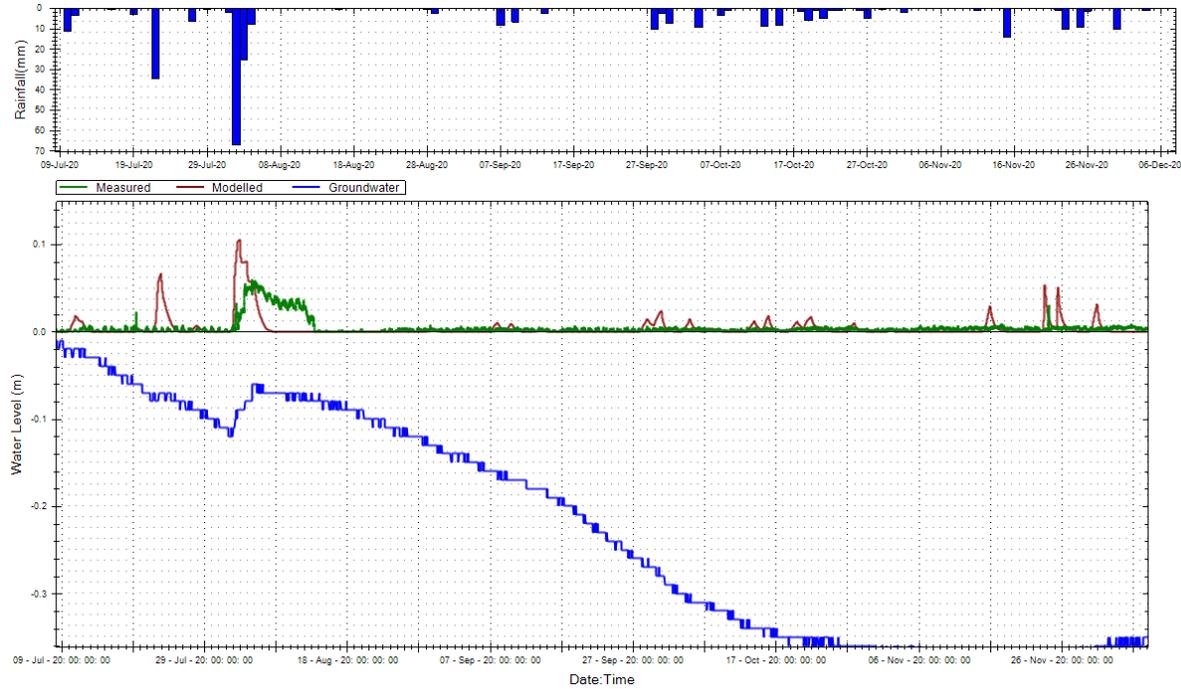
Figure 4.1: Western Wetland - 2020

Model results are presented in the plots below. The observed wetland depth is depicted by the green plot, the observed depths are input into the model as depth vs time. The blue plot depicts the groundwater elevations, input into the model as elevation vs time. The model results are depicted by the red plot.

Table 4-1 Statistical Results for Western Wetland -2020

Percent Difference (%)	R ²	N _{SE}
Average Daily	2.91	0.16	-0.620
Average Weekly	0.16	0.55	0.551
Average Monthly	-10.18	0.97	0.760

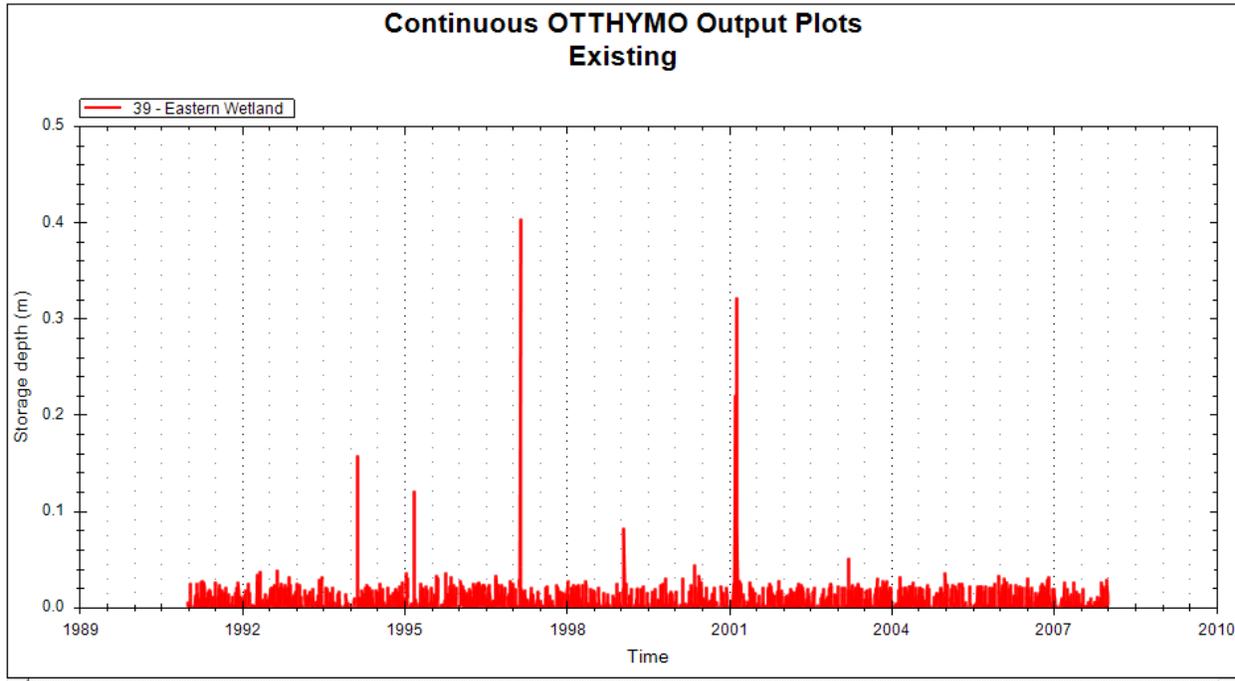
Figure 5.2: Long-Term Model Storage Depth Results for the Eastern Wetland Part

The following figure presents the long-term model storage depth results for the eastern part of the wetland complex.

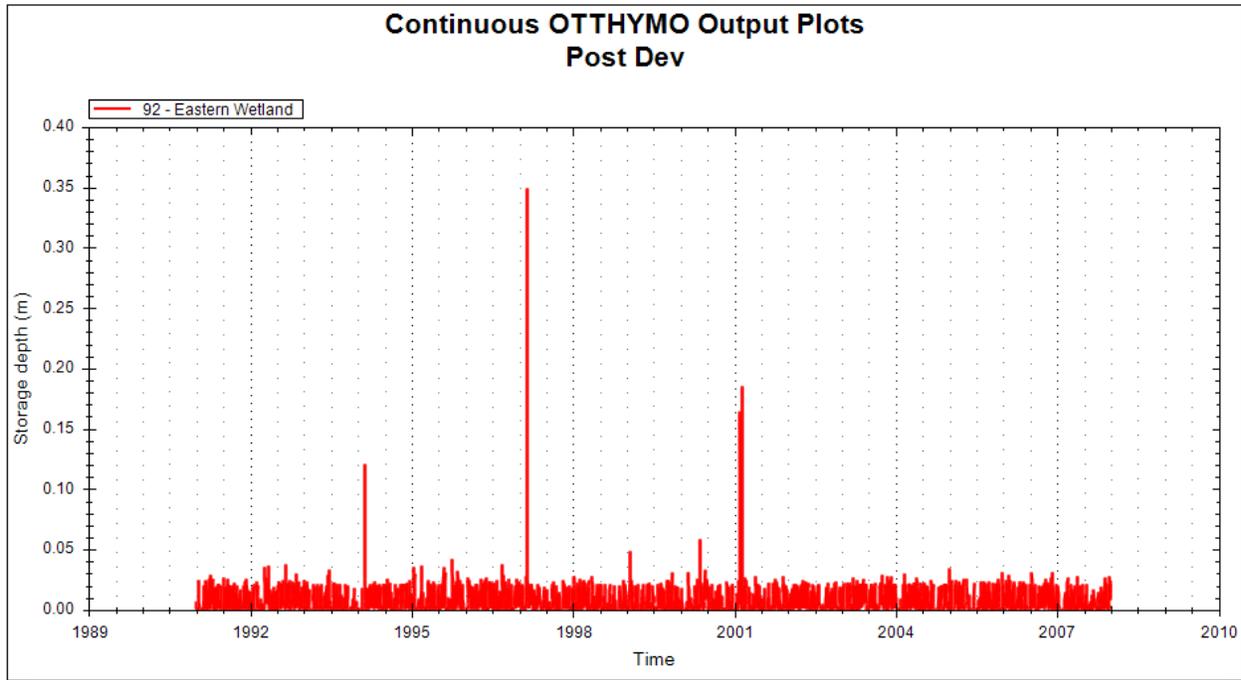
Figure 6.2: Long-Term Model Storage Depth Results for the Eastern Wetland Part

The following figure presents the post-development long-term model storage depth results for the eastern part of the wetland.

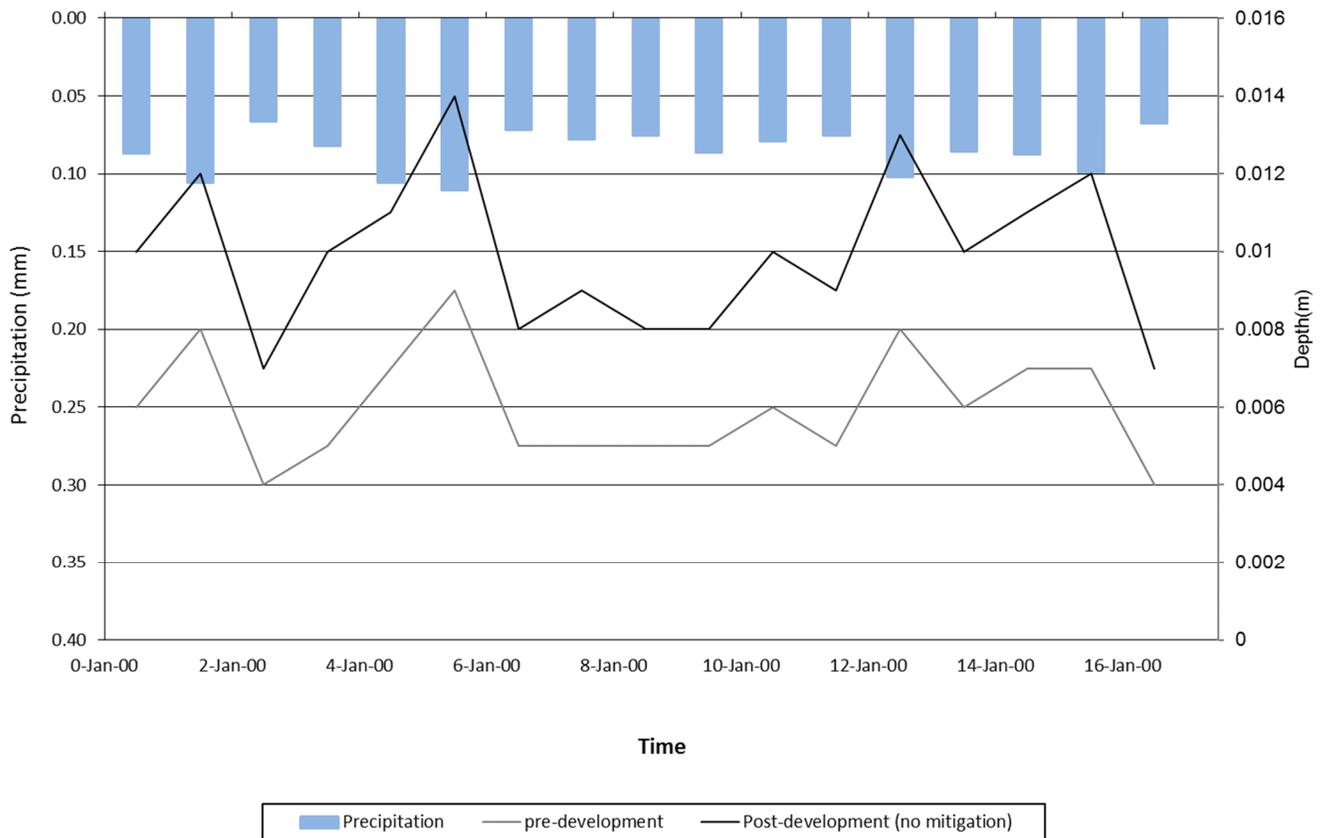
Figure 7.1: Hydroperiod Comparison in Pre and Post Development Conditions for the Western Wetland Part-Average Annual

This section discusses the change between pre and post-development hydroperiods without mitigation. The results are presented in the Figures below for annual average, monthly average, and weekly average timesteps. The wetland depths are expected to increase in post-development.

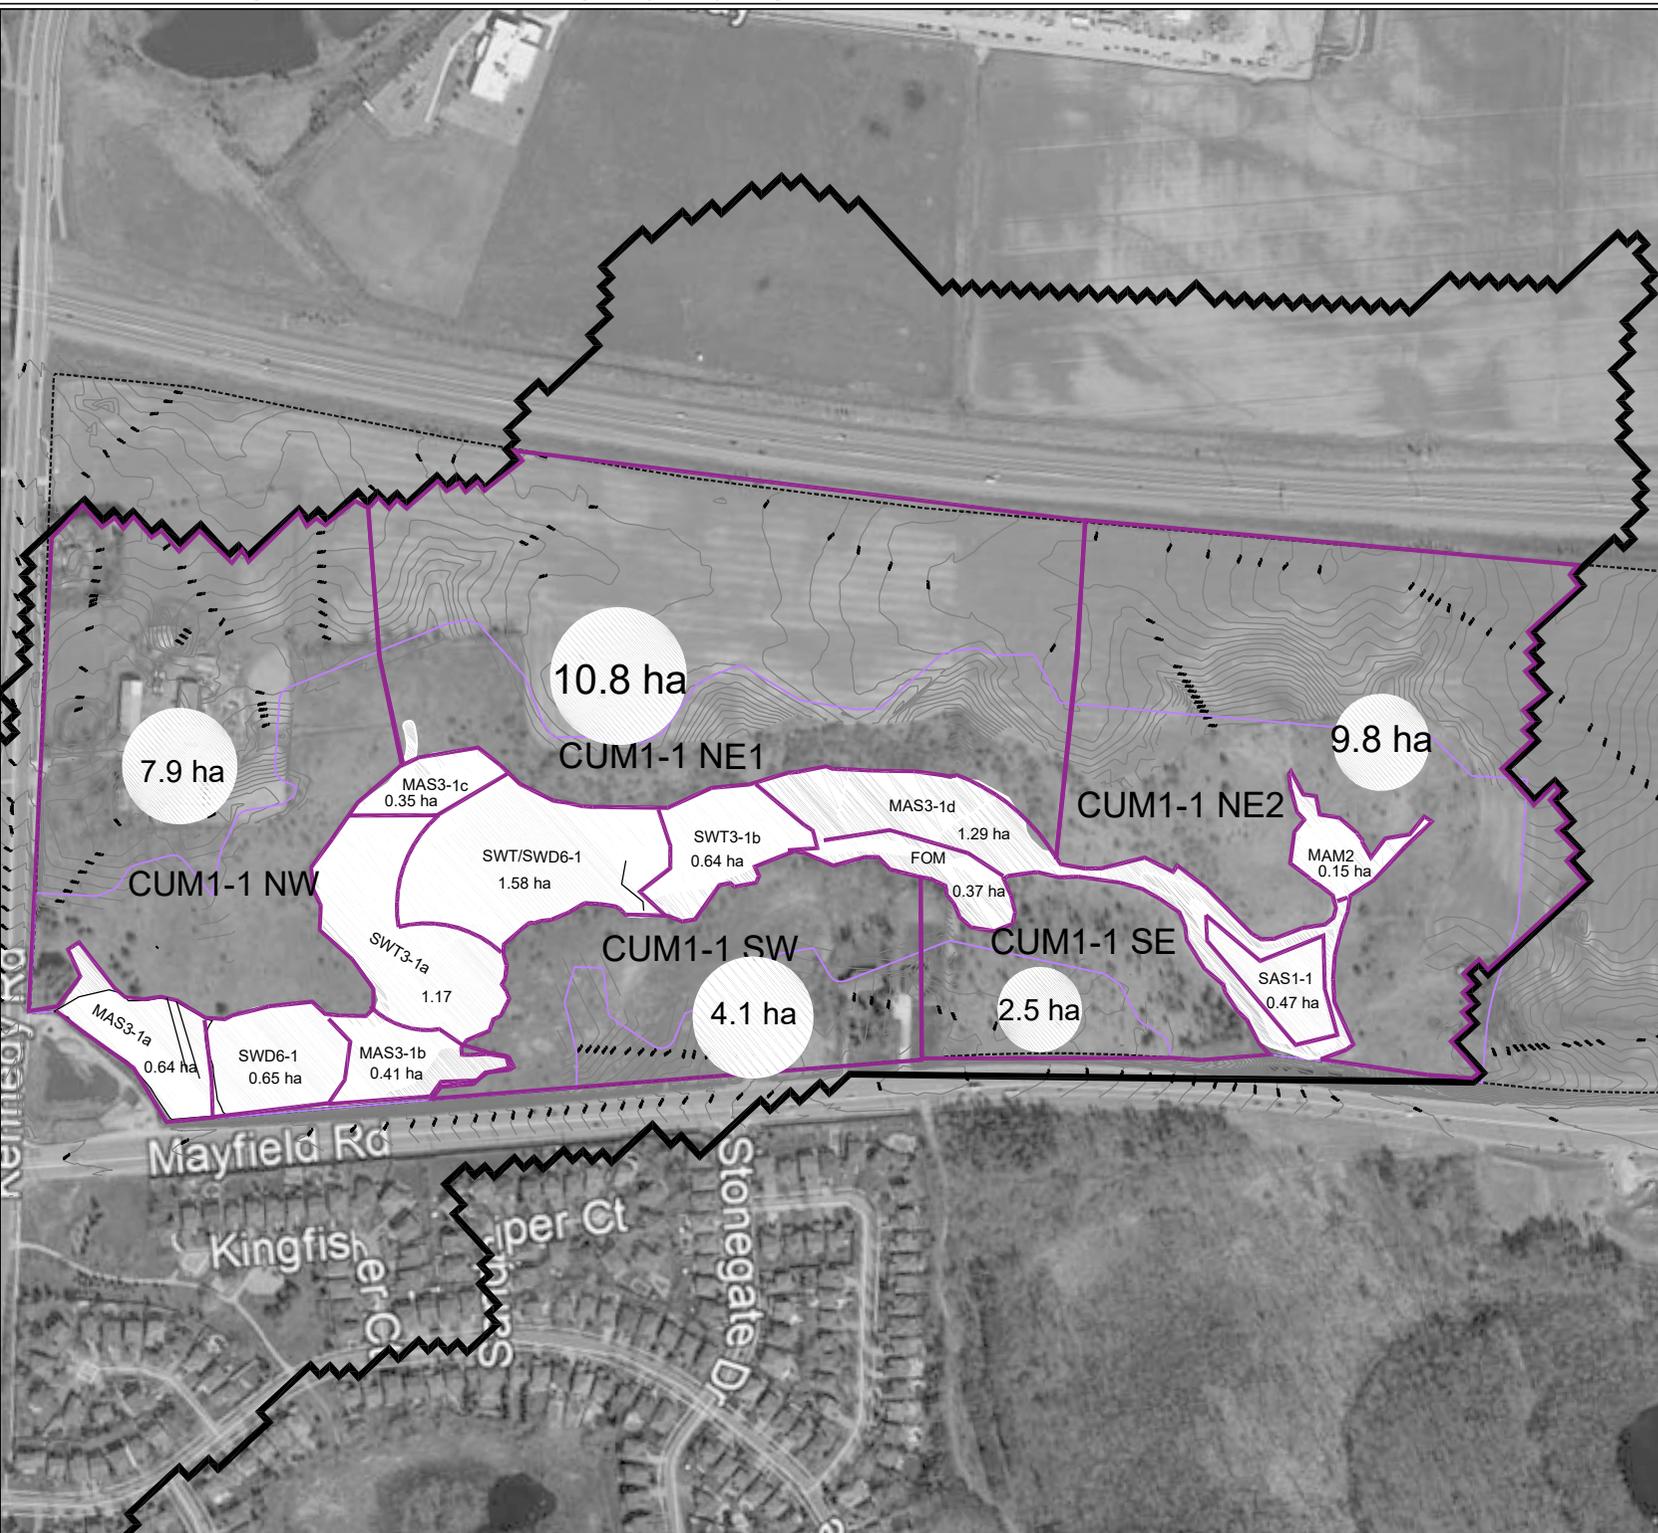
FIGURE 1
WETLAND PRE-DEVELOPMENT
DRAINAGE AREA

PRE DRAINAGE
BOUNDARIES

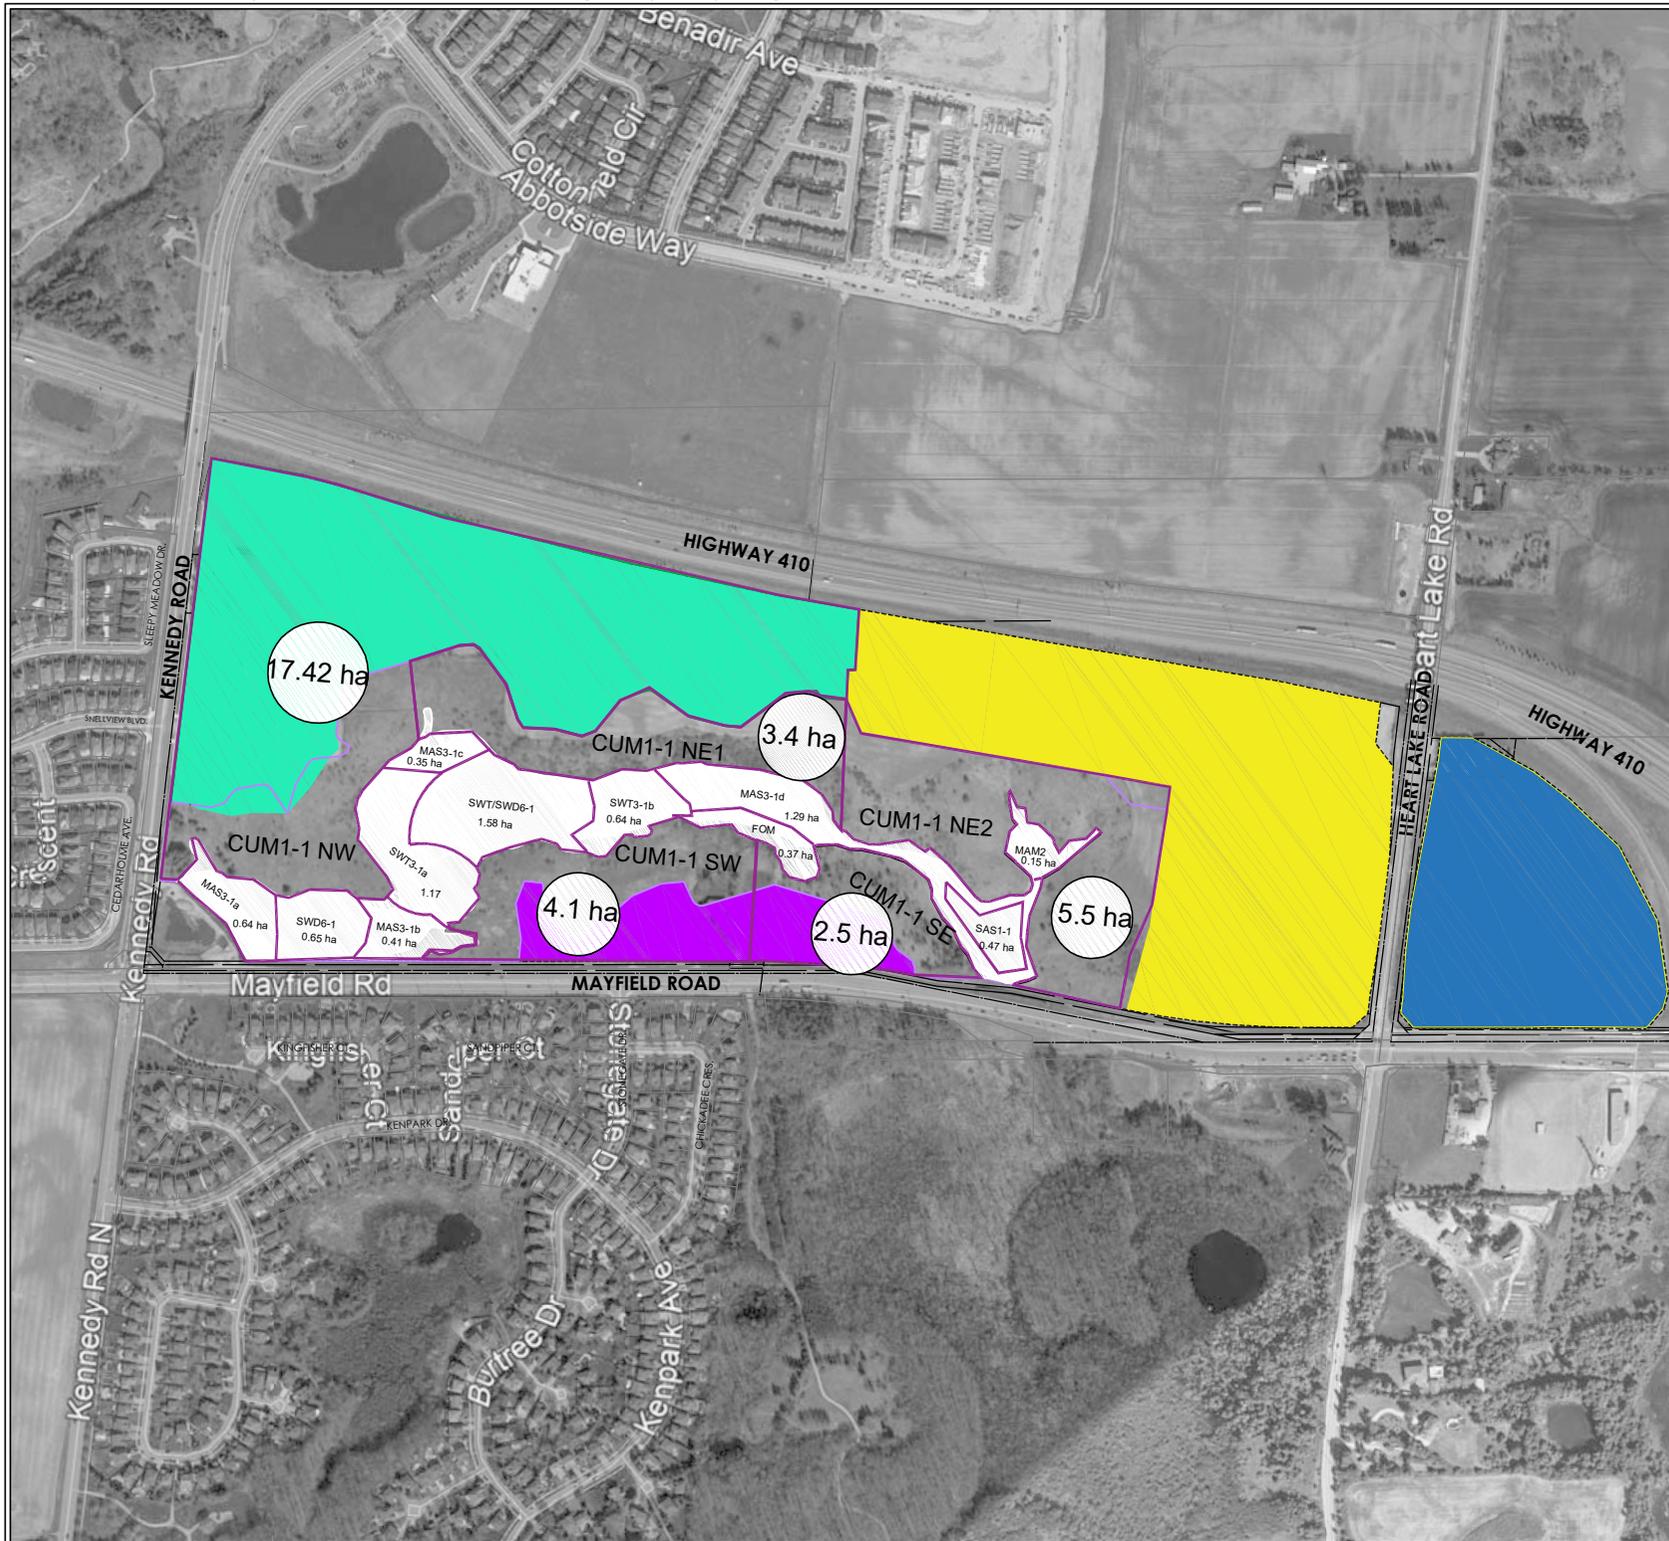
POST DRAINAGE BOUNDARIES

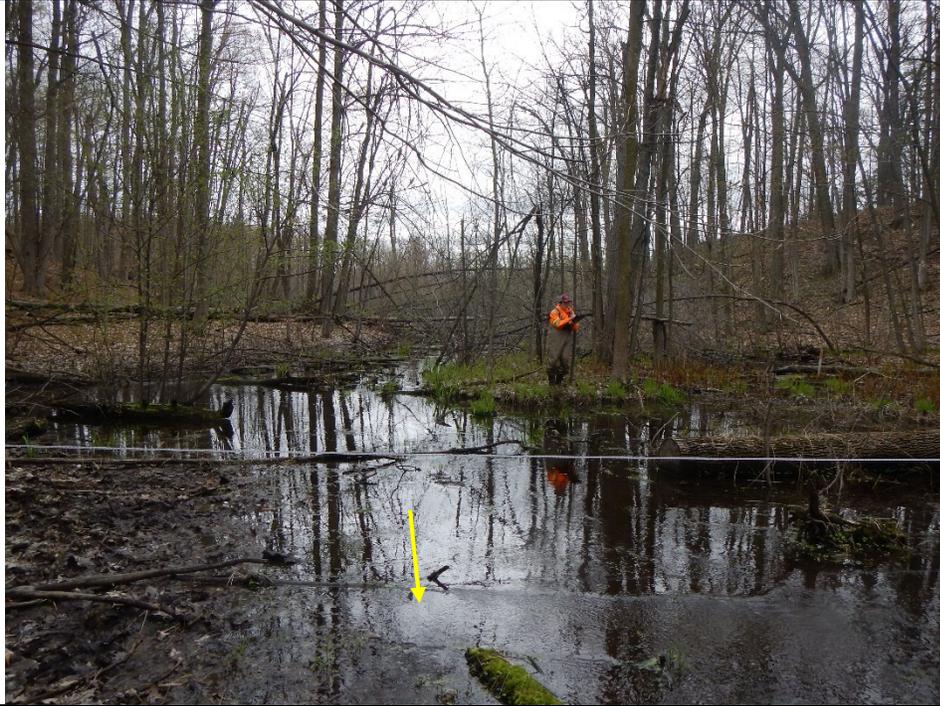
Photo 3
Tributary of Etobicoke Creek
Reach EC-1 Cross section 2

Channel was wide and shallow, with low bank angles on both sides.

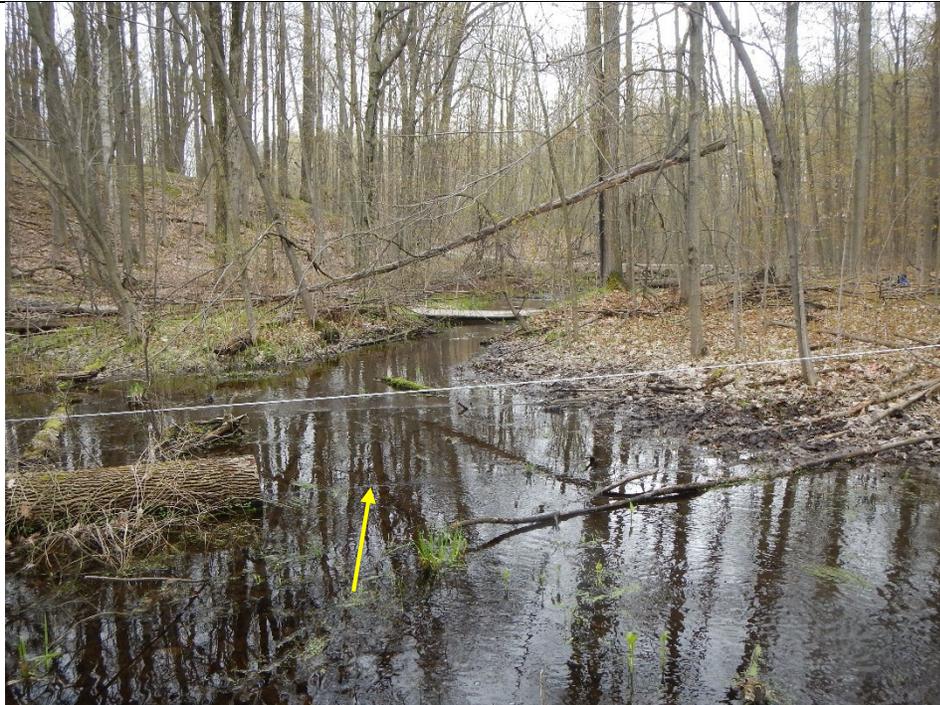
Photo 4
Tributary of Etobicoke Creek,
Reach EC-1 Cross section 2

View of one of two pedestrian crossings observed in the reach.

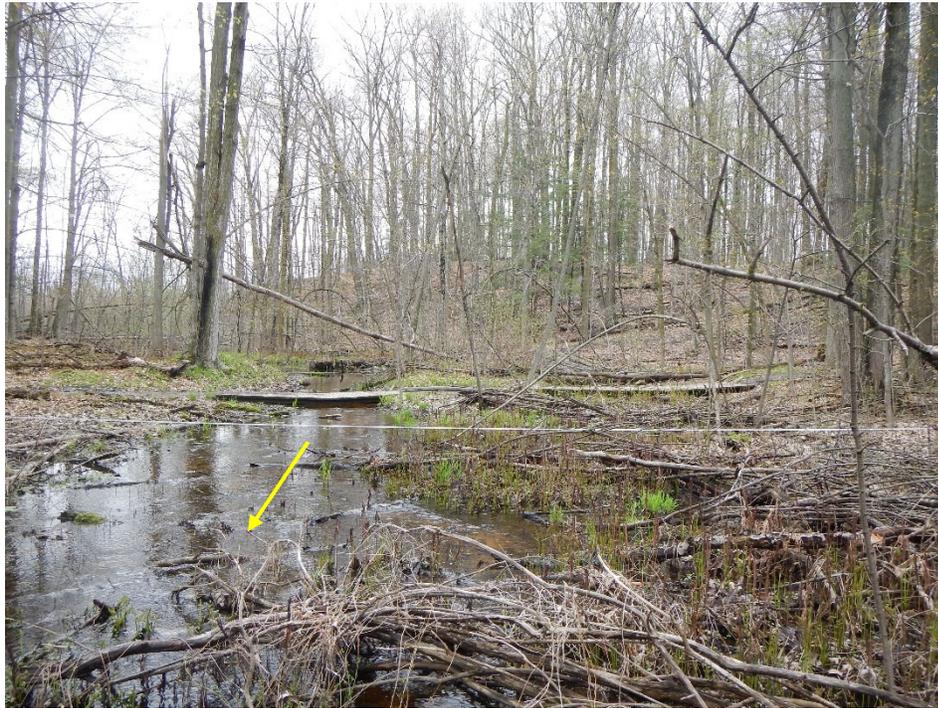
Photo 7
Tributary of Etobicoke Creek
Reach EC-1 Cross section 4-M

Channel showed wetland-like characteristics and contained clay, silt and sand substrates. No riffles or pools were present.

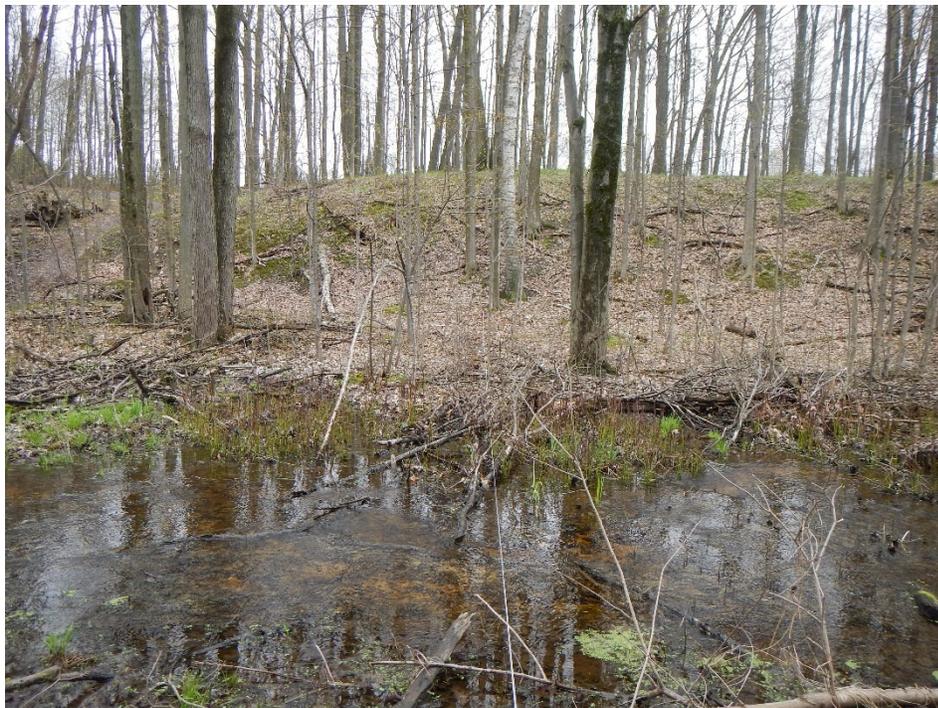
Photo 8
Tributary of Etobicoke Creek,
Reach EC-1 Cross section 4-M

View of the left bank and associated riparian vegetation, which provided shade to the feature.

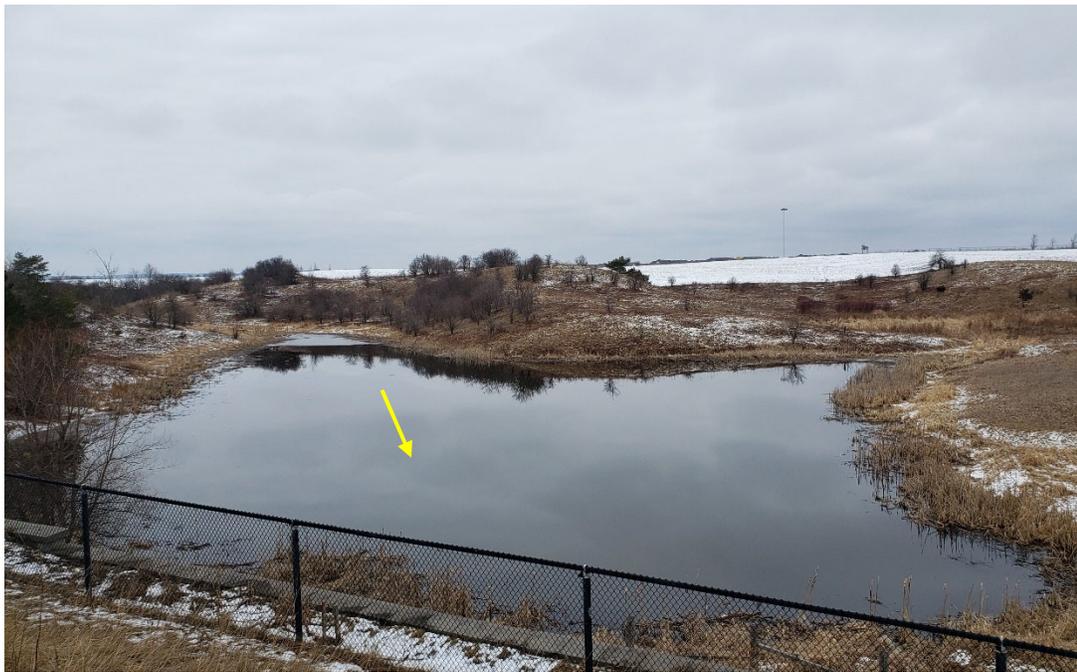
Photo 14
Tributary of Etobicoke Creek
Reach EC-2

Photo taken from Mayfield Road, facing north towards the pond.

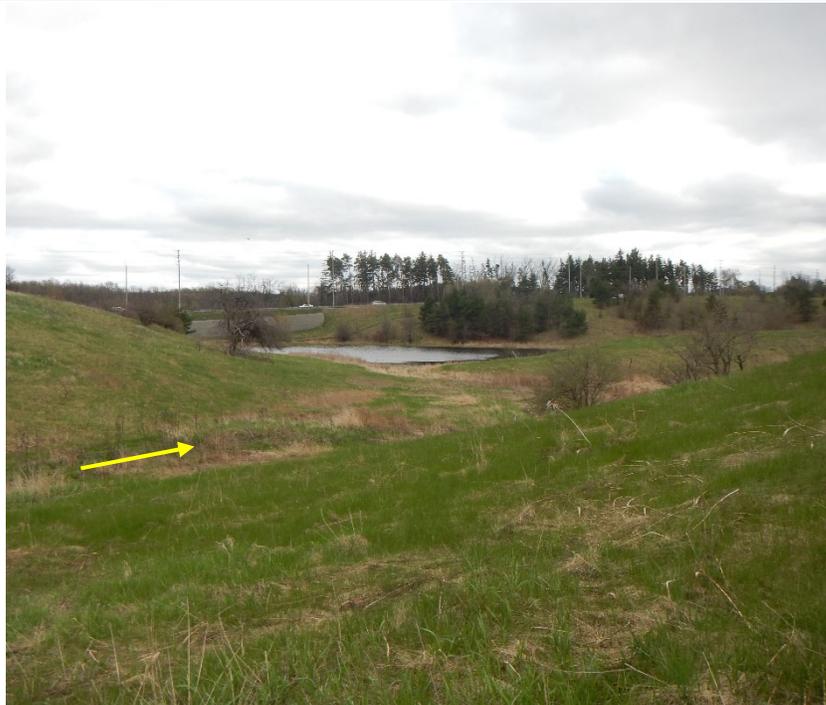
Photo 16
Tributary of Etobicoke Creek
Reach EC-2a

Photo taken from mid-reach towards the pond feature. The channel was poorly defined and lacked riffles and pools

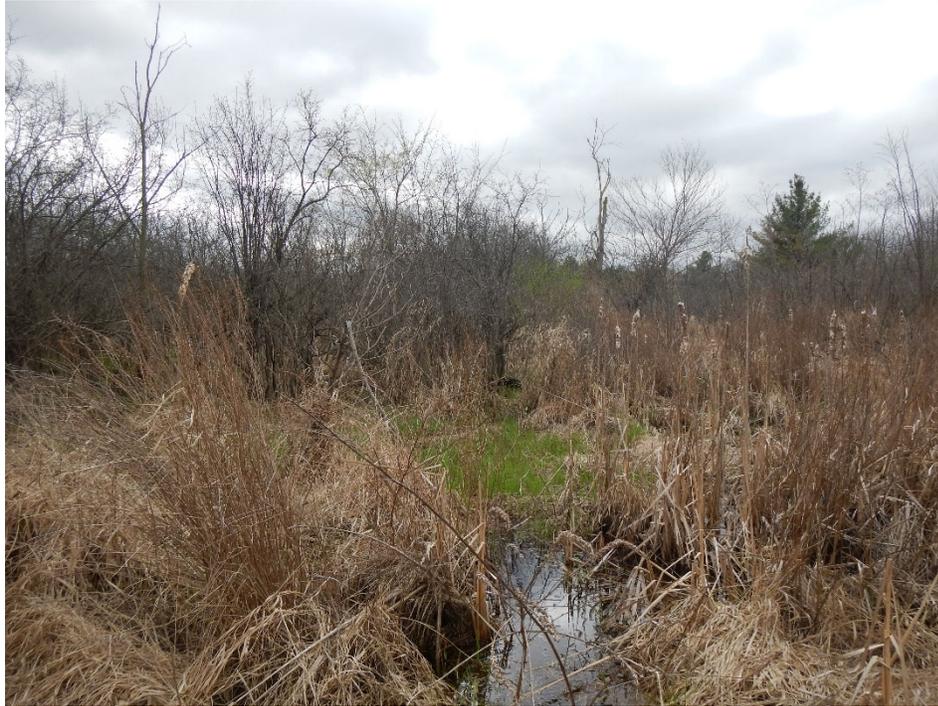
Photo 19
Tributary of Etobicoke Creek
Reach EC-3

Middle of the wetland feature, where standing water was present.

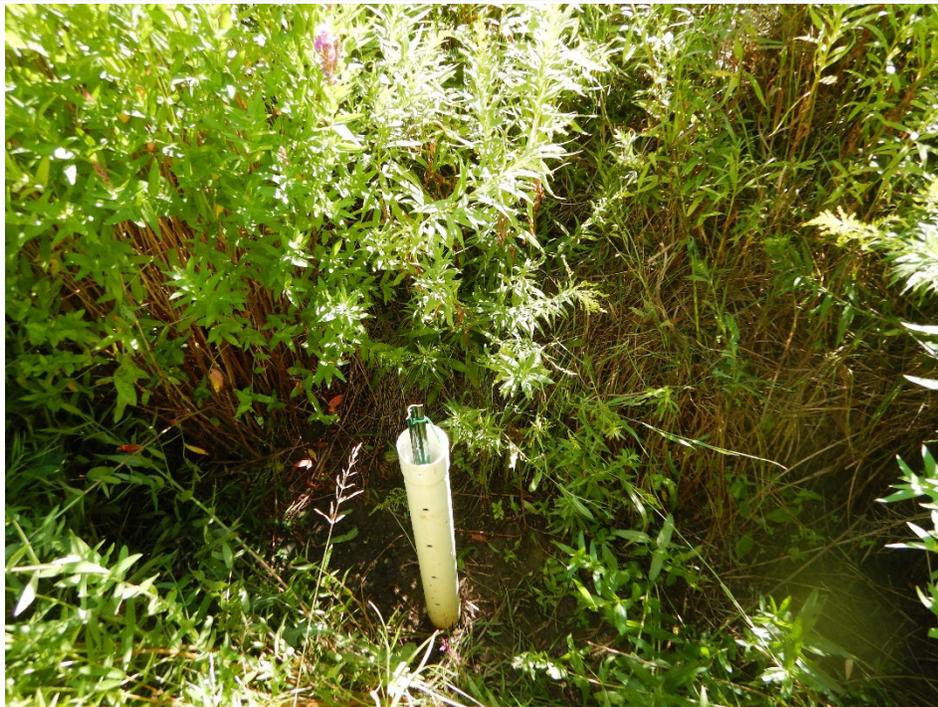
Photo 26
Tributary of Etobicoke Creek
Flow Monitoring Site: W Inlet

Photo taken facing site showing baseline conditions.

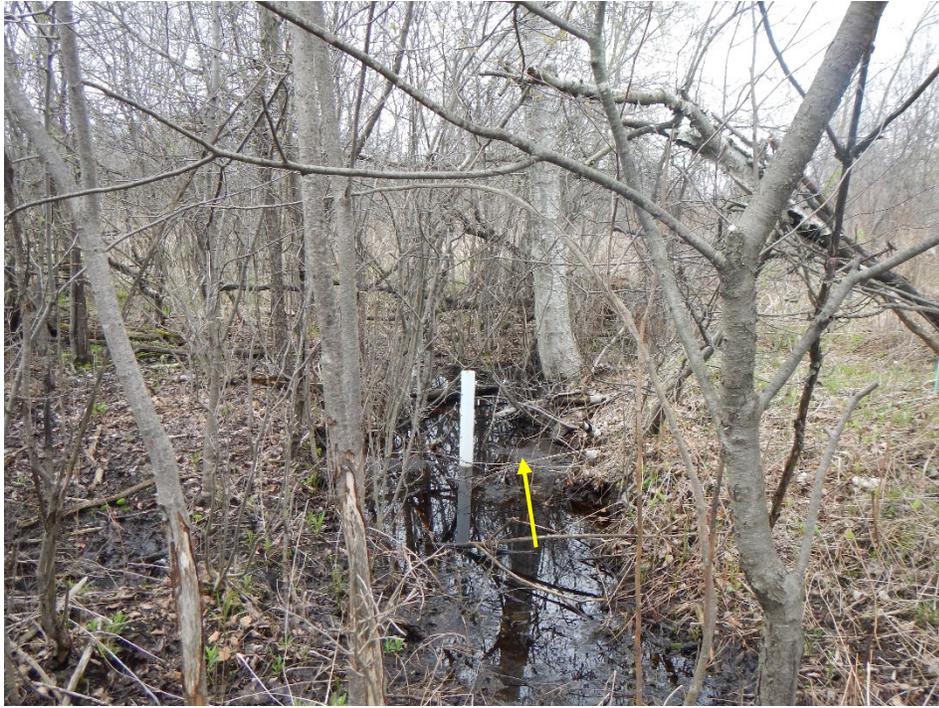
Photo 27
Tributary of Etobicoke Creek
Flow Monitoring Site: S Inlet

Photo taken facing downstream after a 21.59 mm rain event.

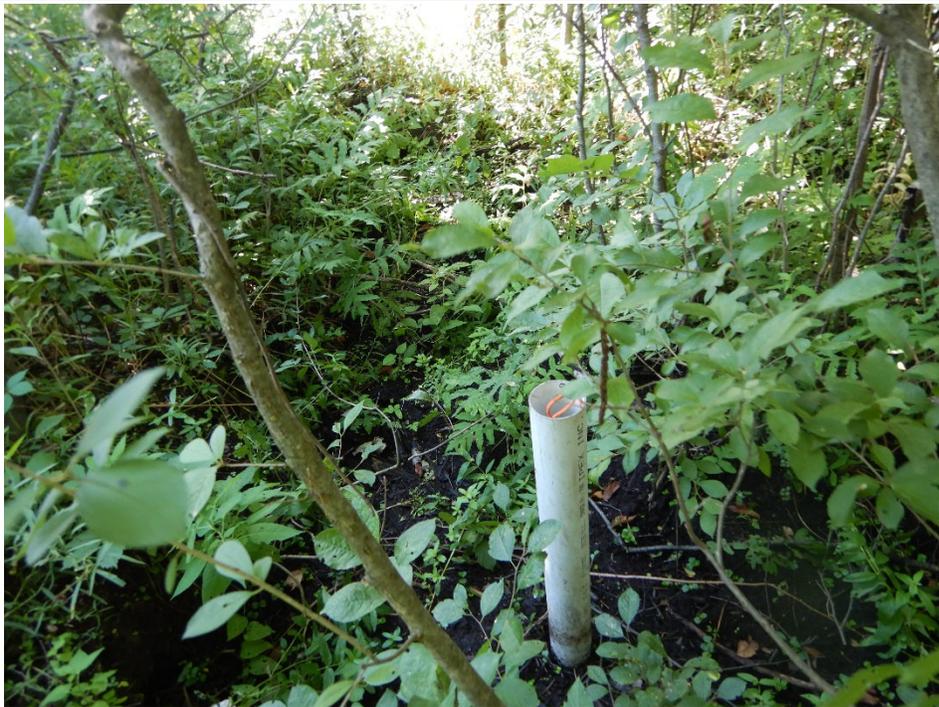
Photo 28
Tributary of Etobicoke Creek
Flow Monitoring Site: S Inlet

Photo taken facing upstream showing baseline conditions.

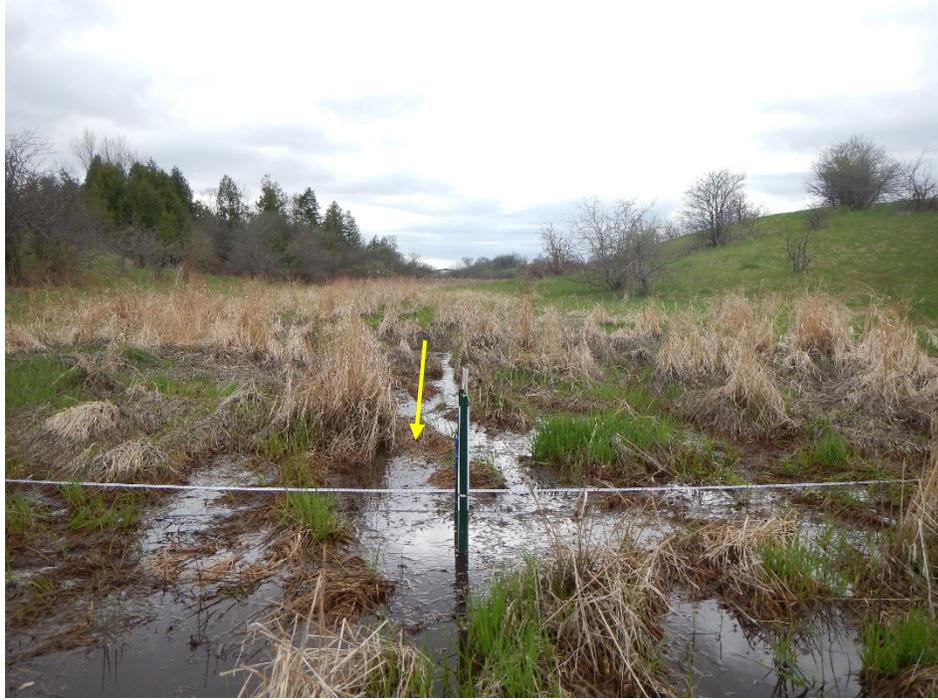
Photo 29
Tributary of Etobicoke Creek
Flow Monitoring Site: Bridge

Photo taken facing upstream after a 21.59 mm rain event.

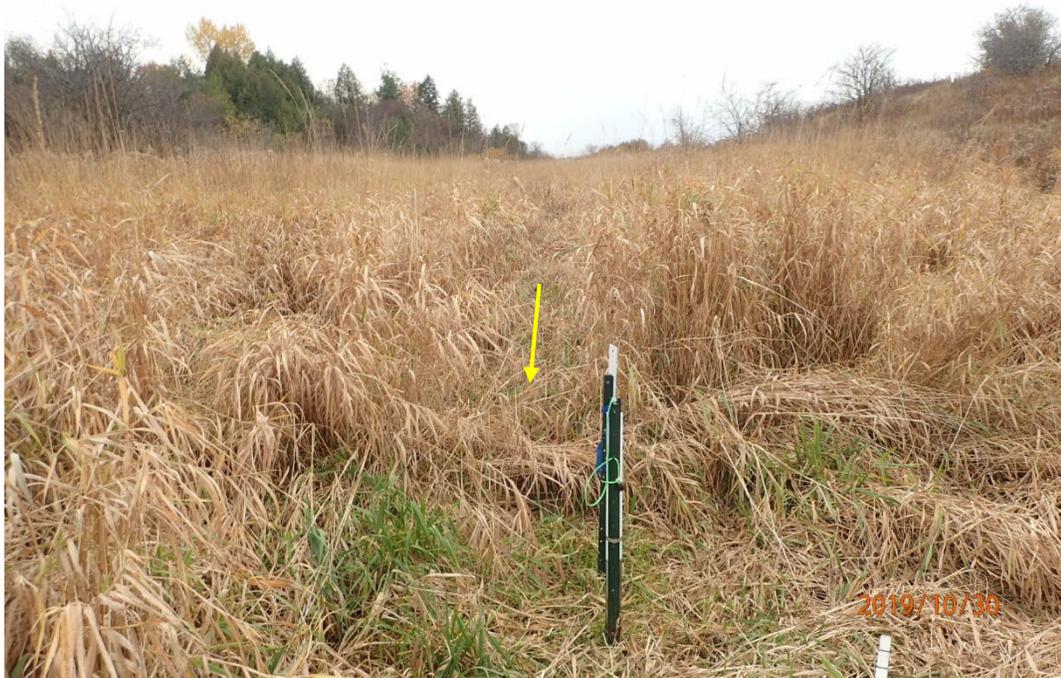
Photo 30
Tributary of Etobicoke Creek
Flow Monitoring Site: Bridge

Photo taken facing upstream showing baseline conditions.

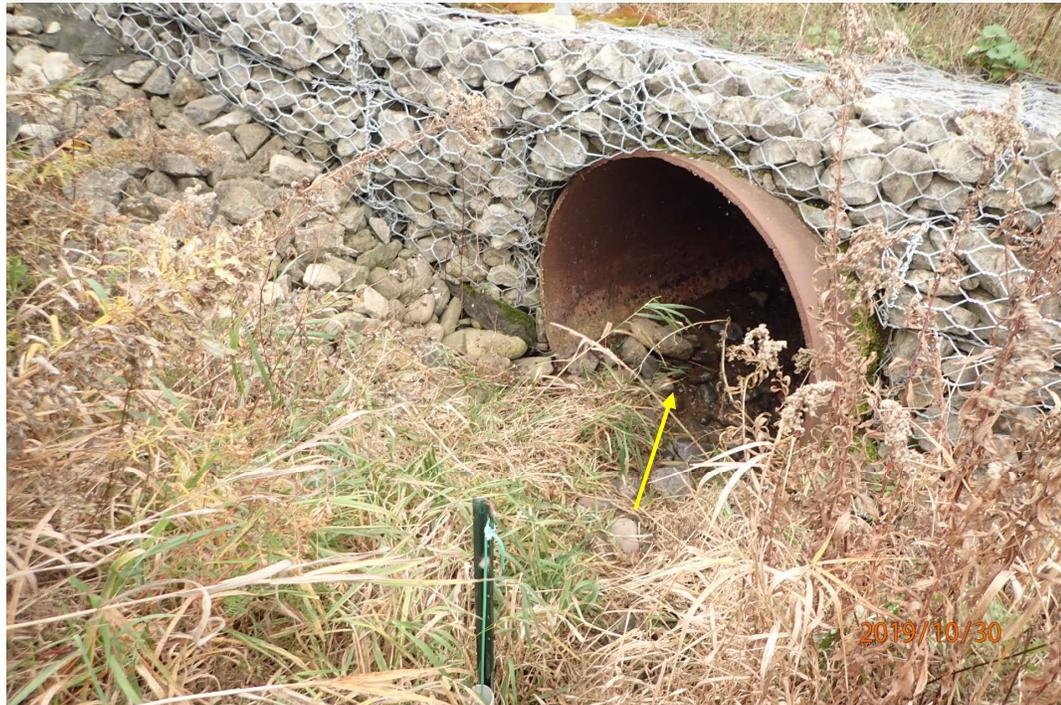
Photo 32
Tributary of Etobicoke Creek
Flow Monitoring Site: Outlet

Photo taken facing downstream showing baseline conditions.

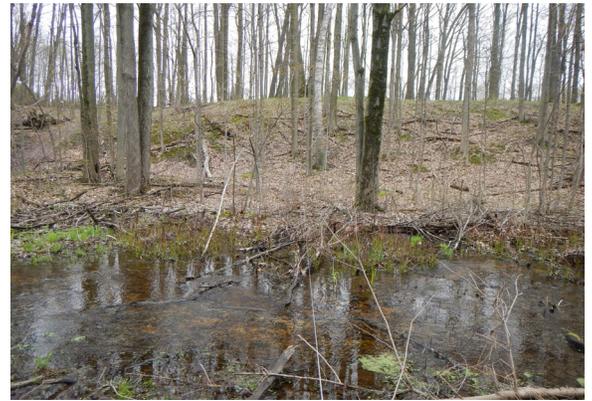
Representative Cross-Section 4

Minimum	Maximum	Average
Bankfull Width (m):	12.70	27.90	17.95
Average Bankfull Depth (m):	0.18	0.49	0.32
Bankfull Width/Depth (m/m):	29	108	61
Wetted Width (m):	4.90	18.50	11.95
Average Water Depth (m):	0.04	0.25	0.13
Wetted Width/Depth (m/m):	48	175	108
Entrenchment (m):		Not measured	
Entrenchment Ratio (m/m):		Not measured	
Maximum Water Depth (m):	0.09	0.54	0.26
Manning's <i>n</i> :		0.050

Photograph at cross section 4 (left bank)

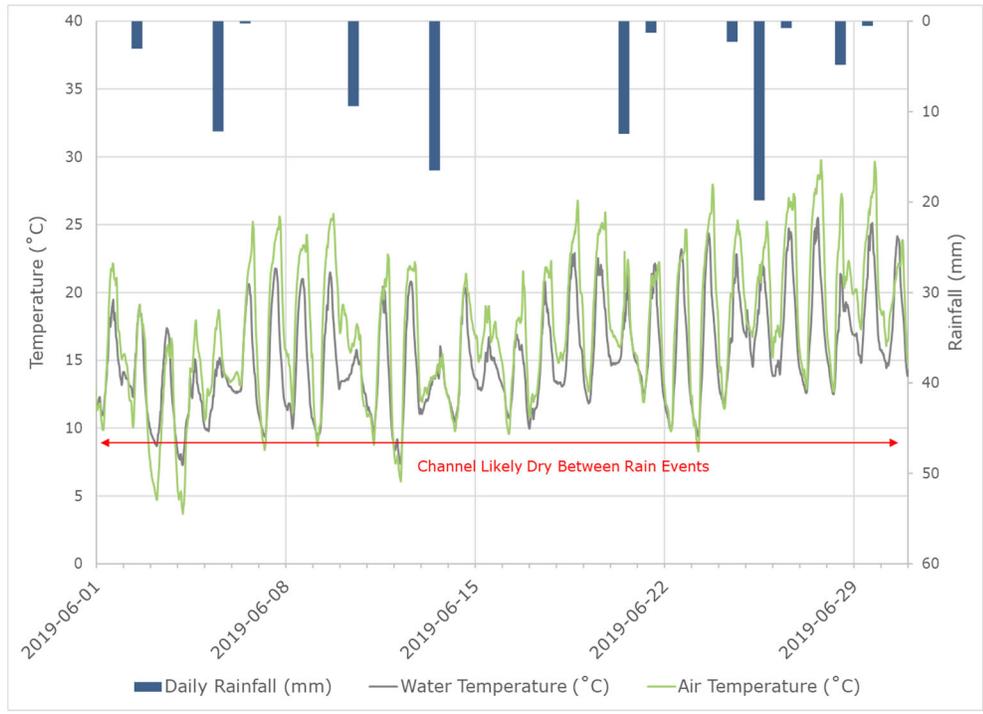
Figure 3

Water temperature, air temperature and daily rainfall at **W Inlet** for June 2019.

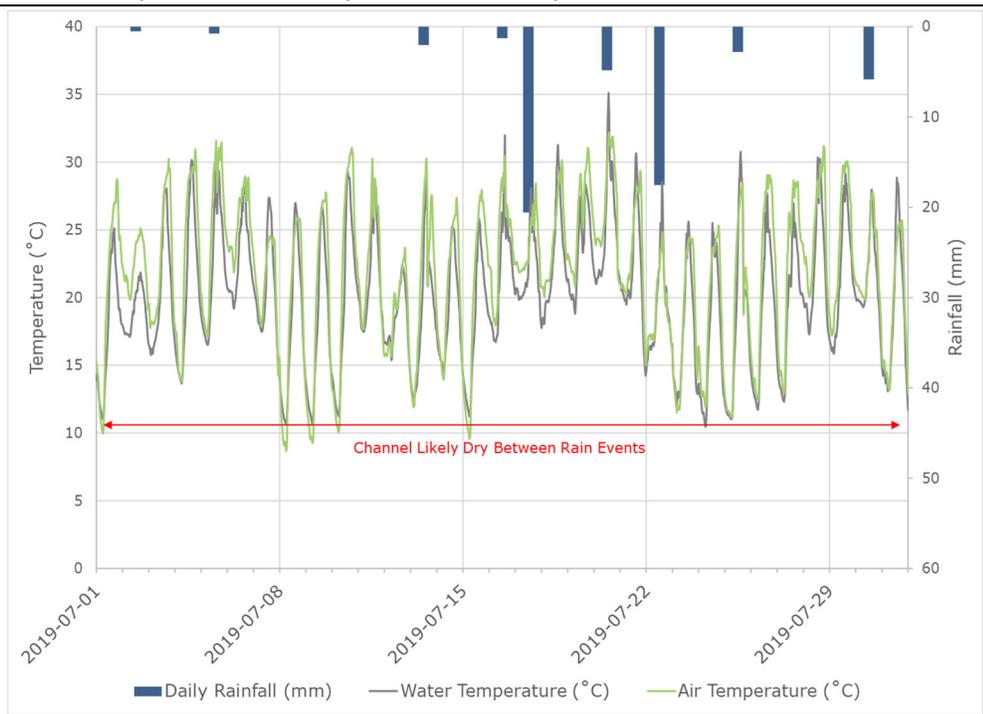
Figure 4

Water temperature, air temperature and daily rainfall at **W Inlet** for July 2019.

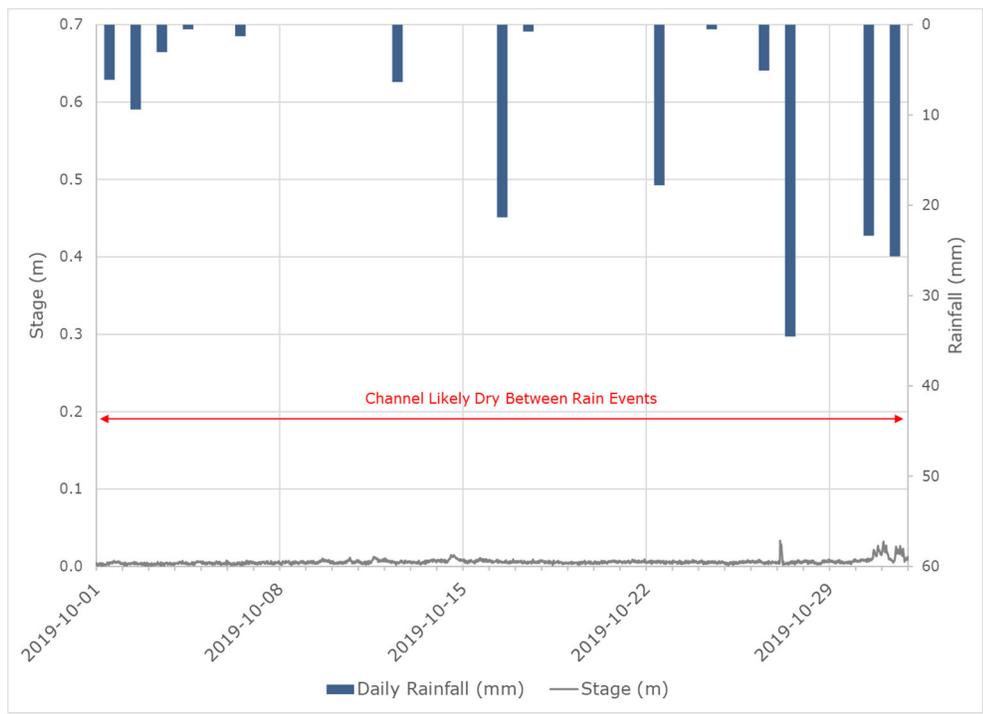
Figure 39

Water level and daily rainfall at **W Inlet** for October 2019.

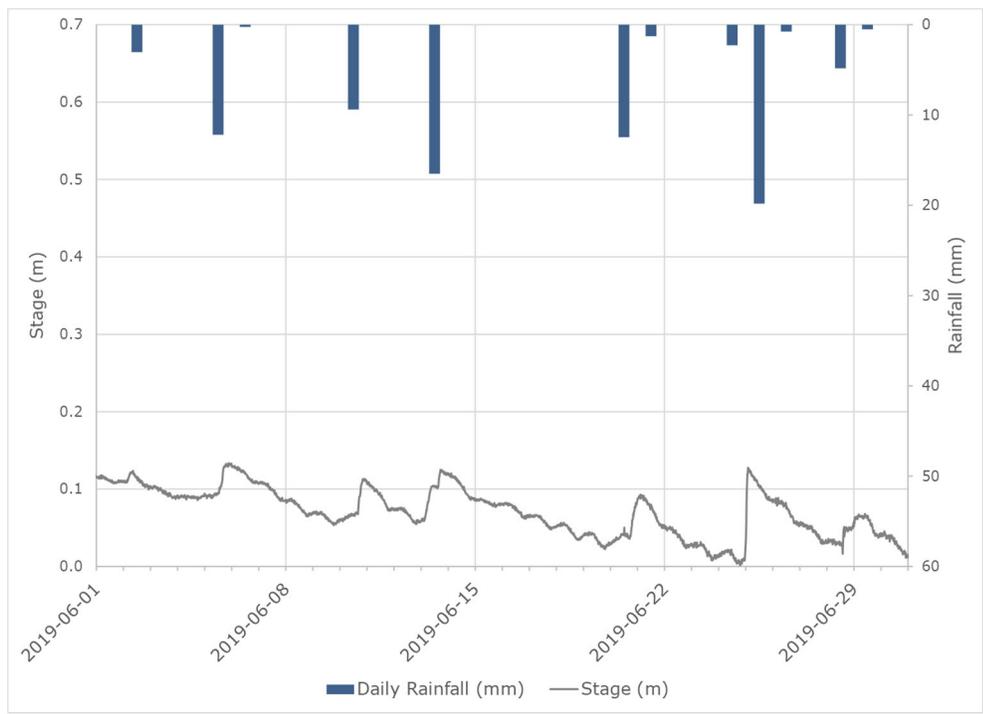
Figure 43

Water level and daily rainfall at **S Inlet** for June 2019.

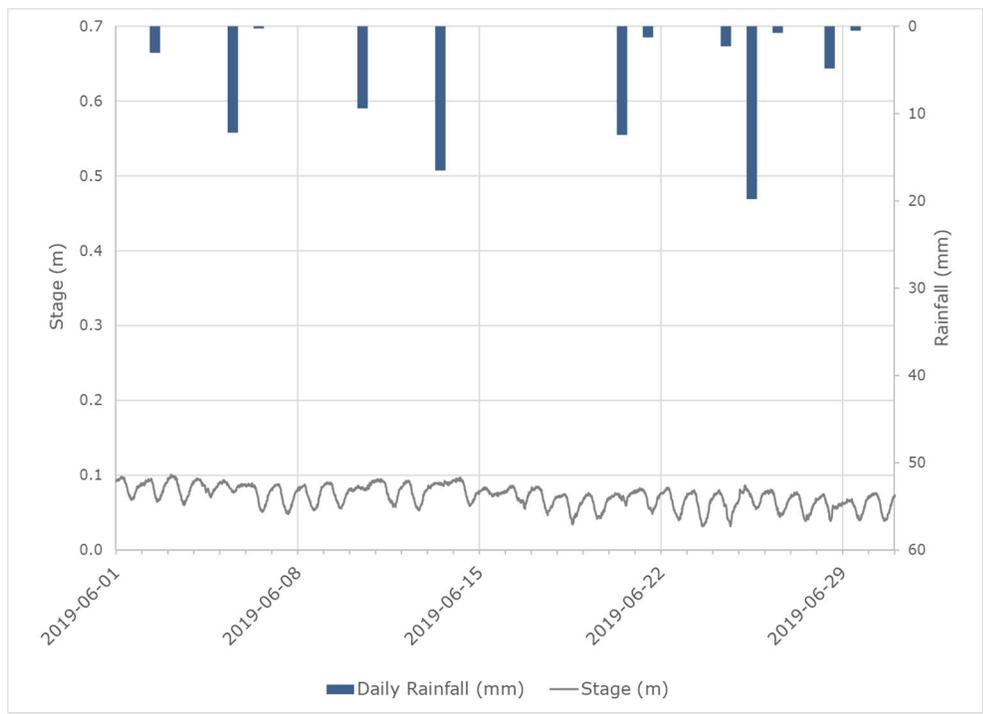
Figure 51

Water level and daily rainfall at **Bridge** for June 2019.

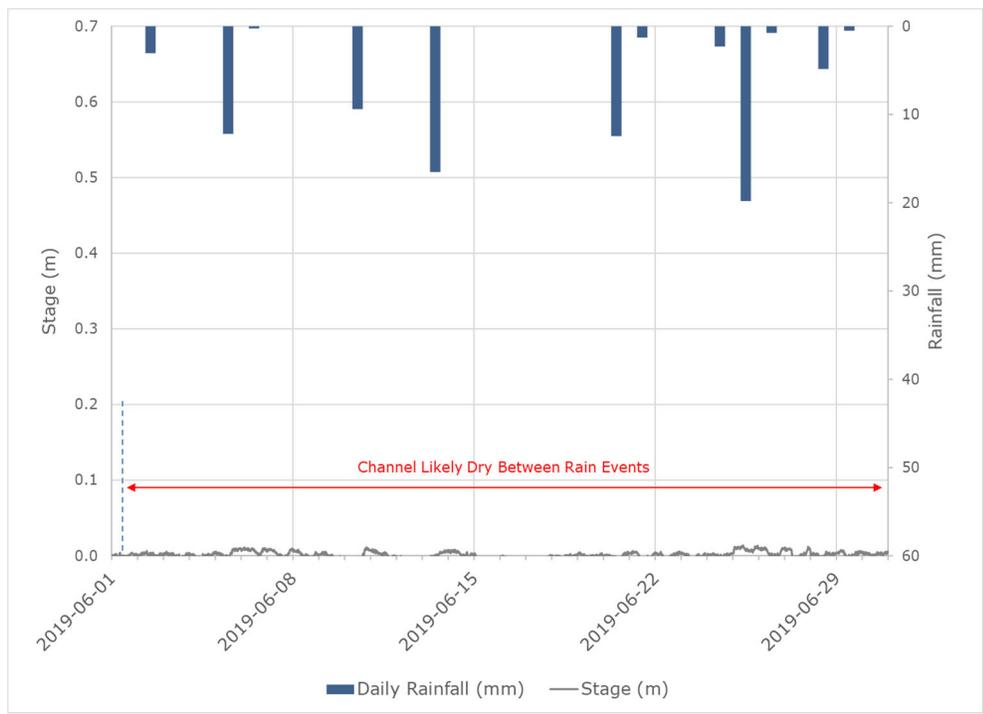
Figure 59

Water level and daily rainfall at **Outlet** for June 2019.
