1.0 INTRODUCTION

1.2 Study Objectives

SNELL'S HOLLOW SECONDARY PLAN
TOWN OF CALEDON

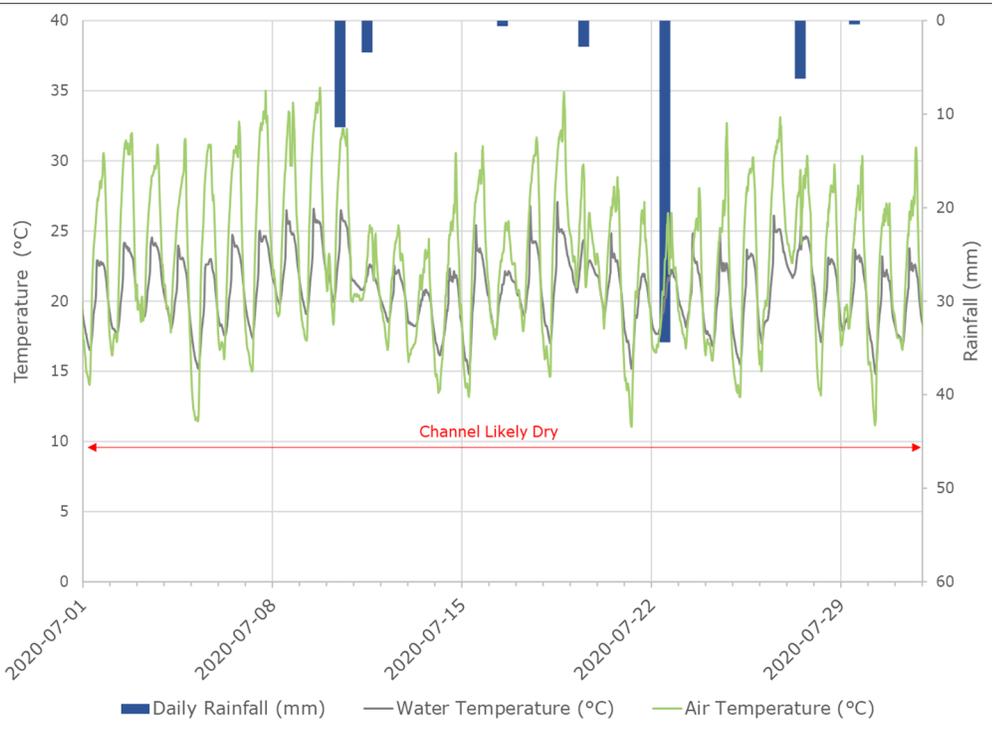
Water temperature, air temperature and daily rainfall at **S Inlet** for July 2020.

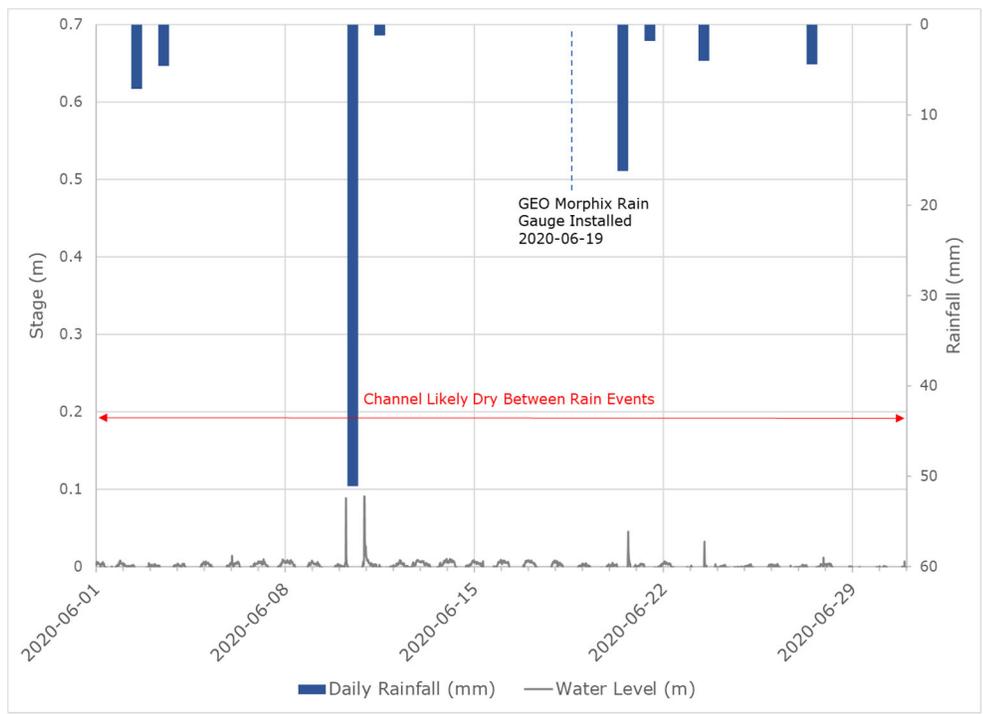
Figure 99

Water level and daily rainfall at **W Inlet** for June 2020.

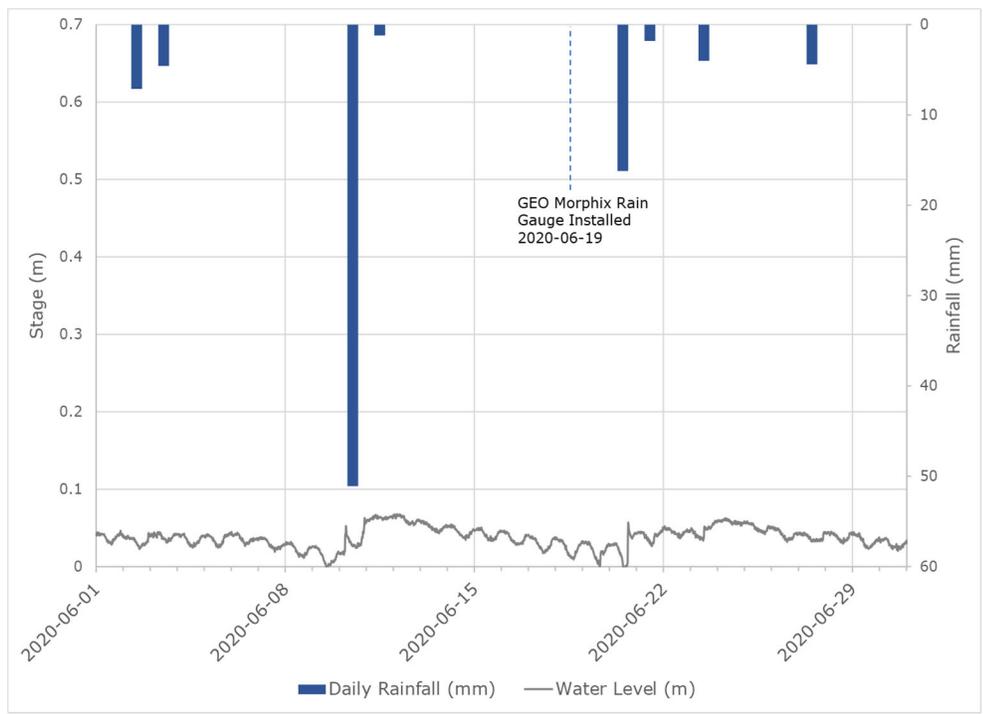
Figure 115

Water level and daily rainfall at **Bridge** for June 2020.
