**Innis Lake Local Subwatershed Study -
Part A Existing Conditions**

**Innis Lake Secondary Plan Area
Landowners
C/O Mattamy (Innis Lake) Limited
6696 Financial Drive
Mississauga ON L5N 7J6**

**R.J. Burnside & Associates Limited
292 Speedvale Avenue West Unit 20
Guelph ON N1H 1C4 CANADA**

**May 2026
300059383.0000**

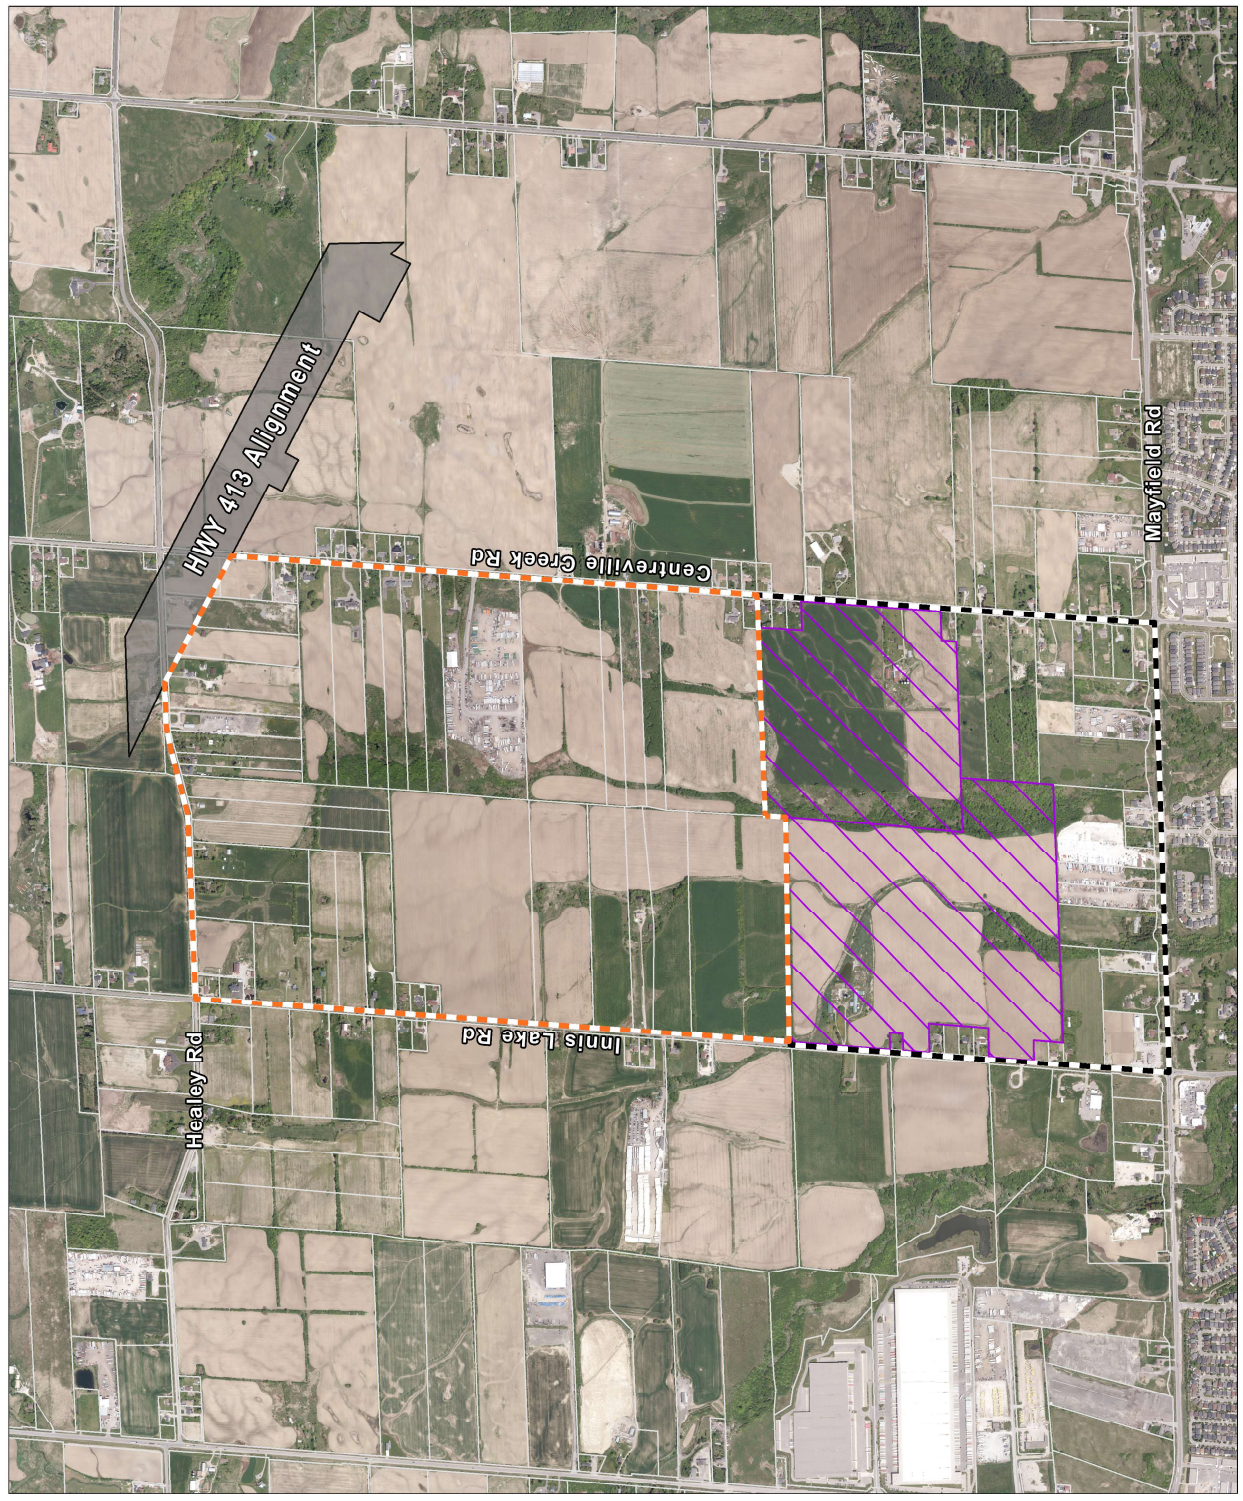
Drawn	Checked	Date	Figure No.
HN	MM	2026/05/06	1
Scale	Project No.		
H 1:15,000	30059383

Figure Title
**INNIS LAKE SECONDARY PLAN -
SUBWATERSHED STUDY**
STUDY AREA

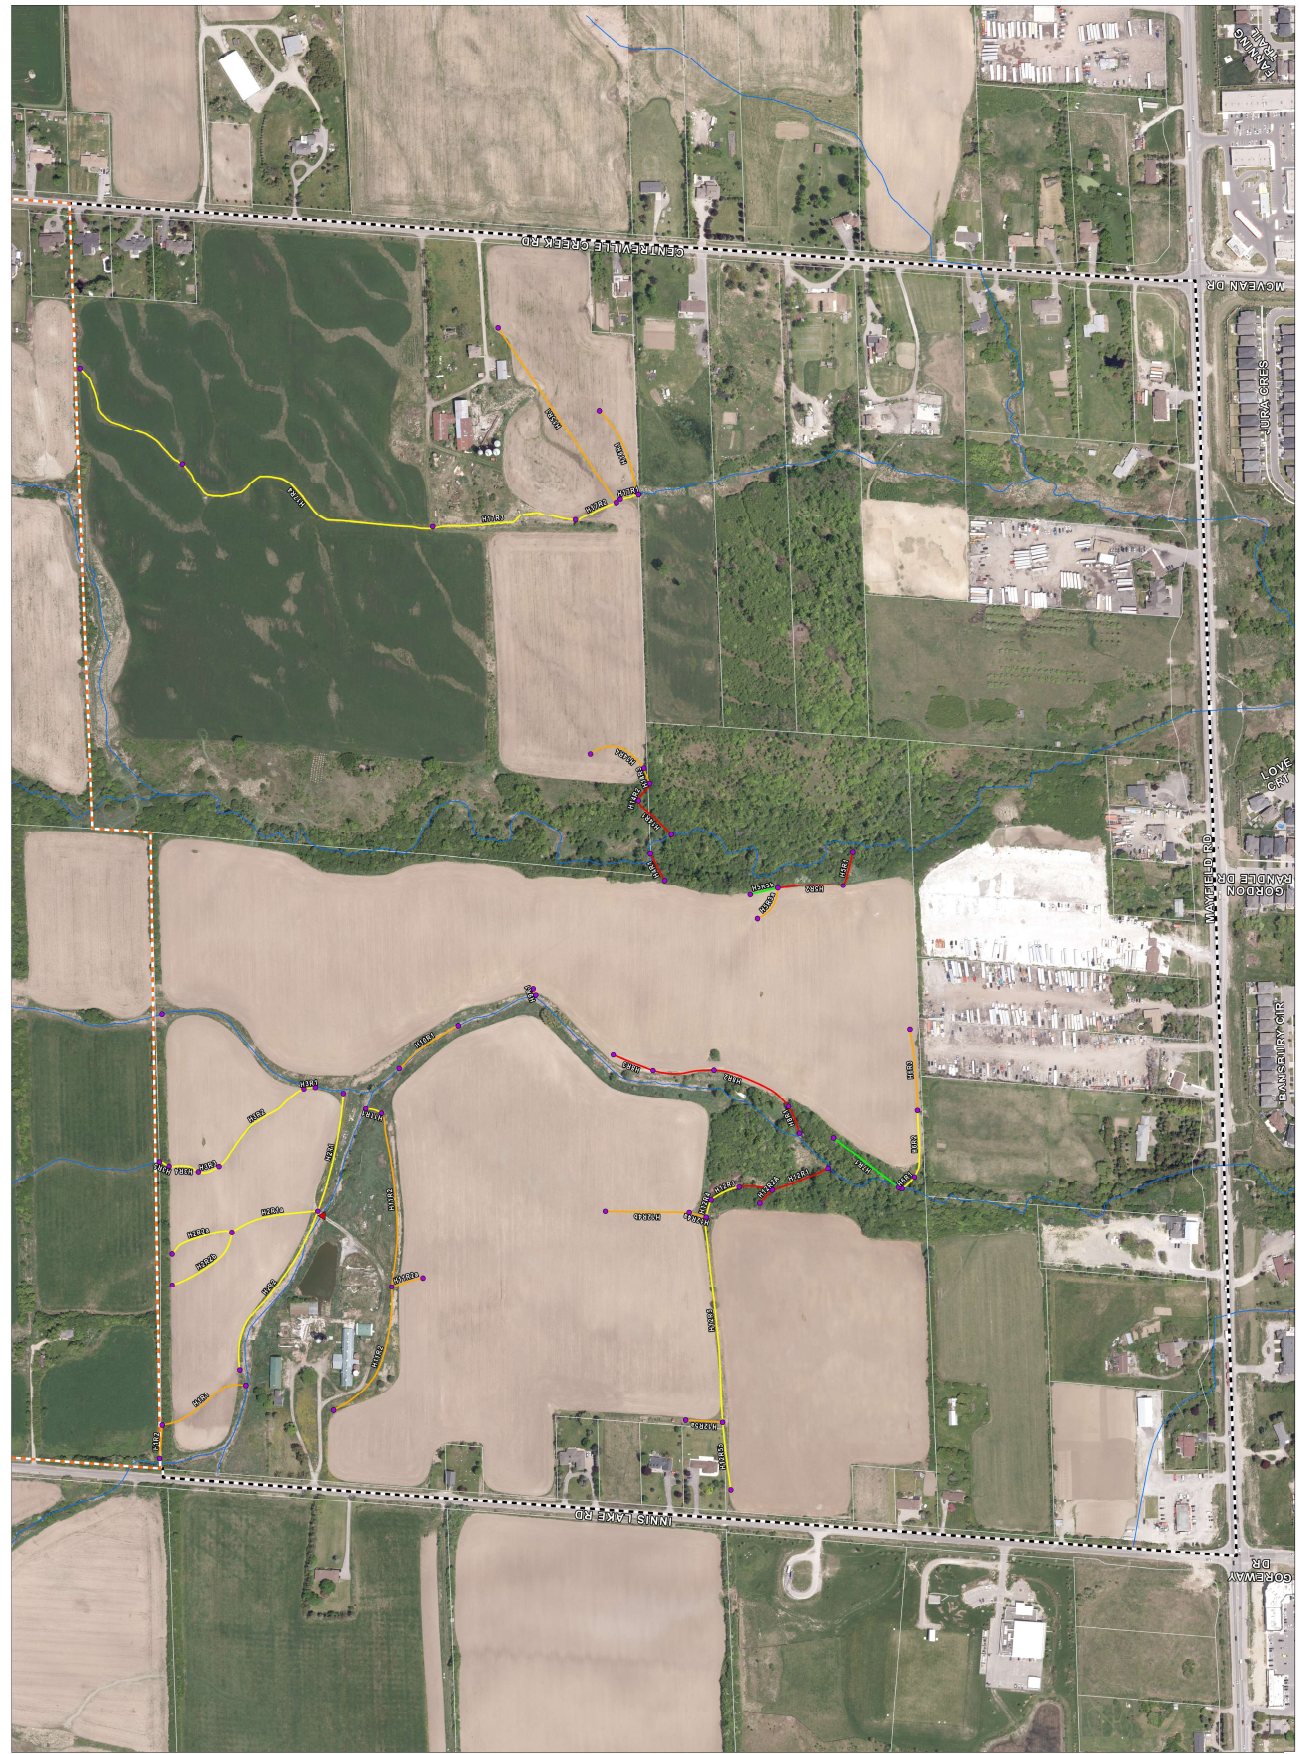
Project No. 202005008
 Date: 11/2/2020
 Scale: 1:5000

INNIS LAKE SECONDARY PLAN - SUBWATER DRAINAGE STUDY HEADWATER DRAINAGE FEATURES

During the background review, ephemeral drainage features were identified on aerial photos as potential HDFs that convey water into the downstream habitat of West Humber River tributaries. Further study of mapped 1st and 2nd order watercourses was recommended through the HDF assessment and classification framework to provide additional information on the function and form of previously unknown features. The annual flow regime and hydrological contributions of these HDFs would also be assessed during the LSS field investigations to determine potential impacts of development to downstream habitat. The assessment, classification and management recommendations following the HDF Guidelines (TRCA & CVC, 2014) are described in Sections 3.2.7 and 3.3.9.

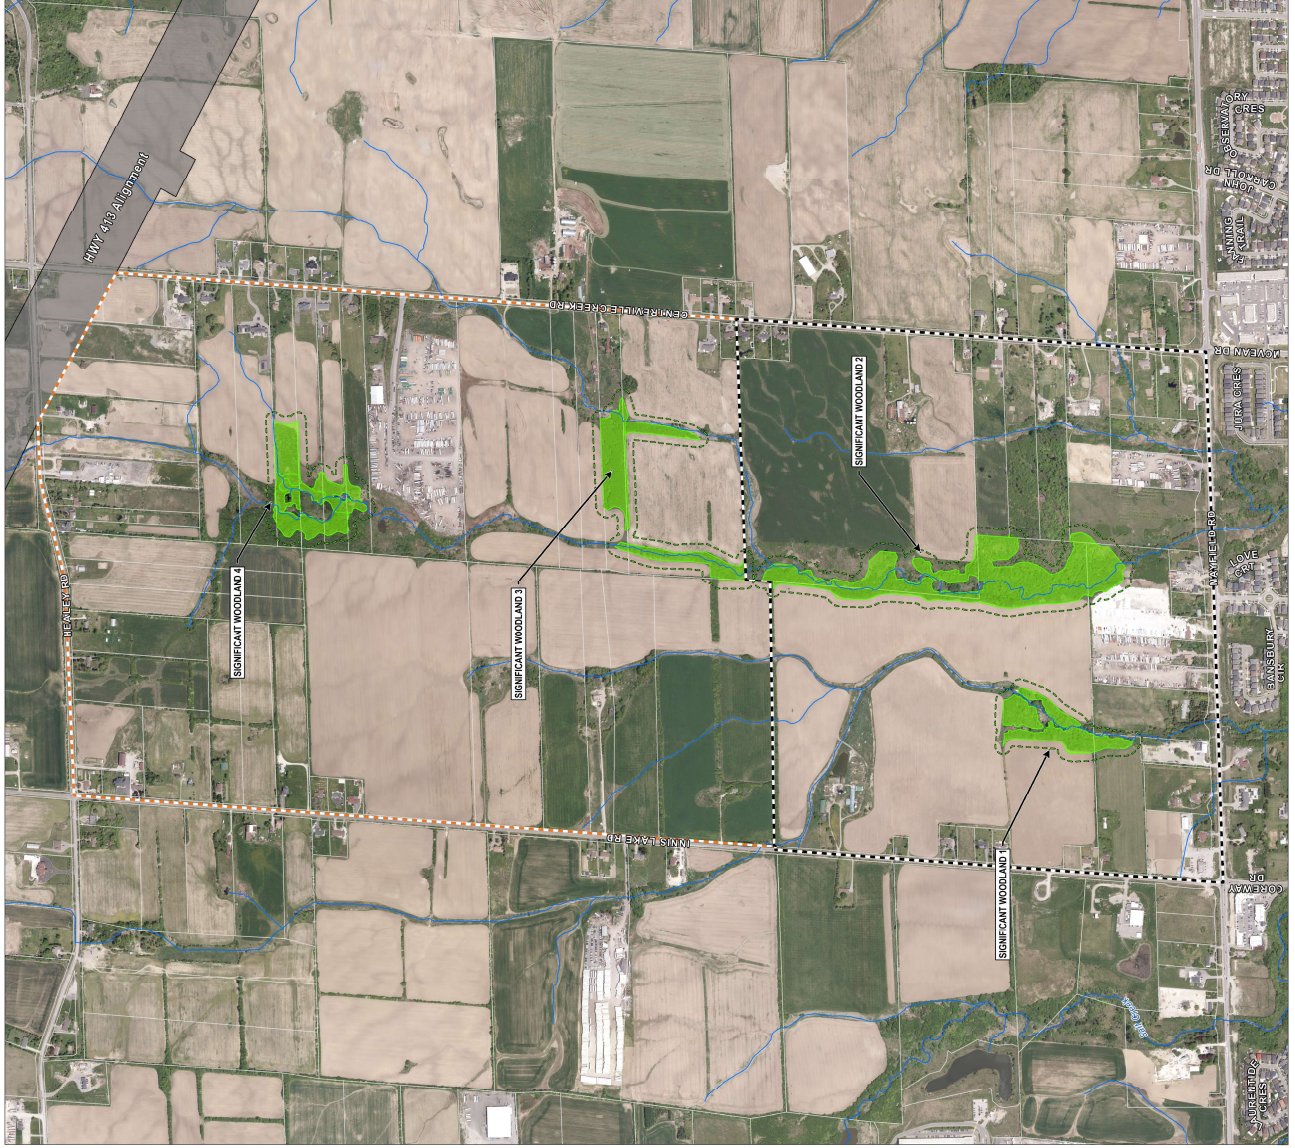
- Watershed (MW)
- Significant Woodland
- 20m Significant Woodland Buffer
- Phase 1 Study Area
- Phase 2 Study Area

The 20 m buffer, as required in the FCOP (2025), around SW4 includes both disturbed agricultural fields that do not currently provide a function of protection and natural communities (i.e. wetland, cultural meadow, and cultural thicket). A dripline survey, as approved by the Town of Caledon, is required in 2026.

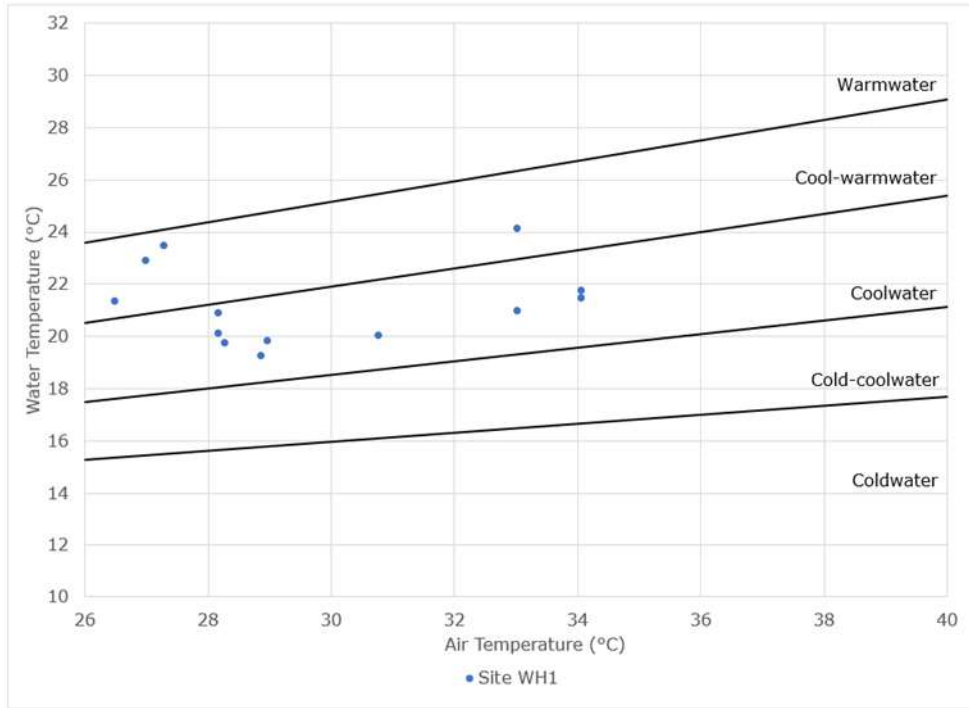
Figure 10: 2025 Thermal Classification of Tributary A East Branch at WH1

Along Tributary A East Branch, the maximum water recorded temperature was 26.8°C, and the summer average temperature was measured to be 18.0°C. These measurements were collected at site WH1, as site WH2 was periodically dry. As such, the thermal classifications along Tributary A East Branch at site WH1 ranged from coolwater to cool warmwater. Along Tributary A, maximum water temperature was 23.3°C, and the summer average temperature ranged from 17.2 to 19.9°C. The thermal regime was classified as cold-coolwater to coldwater. Lastly, along Tributary B, maximum water temperature was 35.3°C, and the summer average water temperature ranged from 19.0 to 21.4°C. The thermal classification along Tributary B ranged from coolwater to warmwater; with site WH6, located at the downstream extent of the Tributary, having a cooler thermal regime than site WH9, which is located at the upstream extent of the reach. Complete continuous temperature data and discrete measurements are provided in Appendix G2.

In 2025, there were six days in July and eight days in August that met the above requirements for thermal classification. Figure 10, **Error! Reference source not found.** and **Error! Reference source not found.** compare the thermal classification for the Tributary A East Branch, Tributary A, and Tributary B, respectively. Site WH2 was also dry in both July and August and was therefore not included in the thermal classification of Tributary A East Branch. Sites WH4, WH5 and WH11 were dry in July and August and was therefore not included in the thermal classification of Tributary A. Sites WH7, WH8 and WH10 were dry in July and August and was therefore not included in the thermal classification of Tributary B. Site WH9 was also dry in August and therefore only dates in July were considered in the thermal classification of Tributary B.

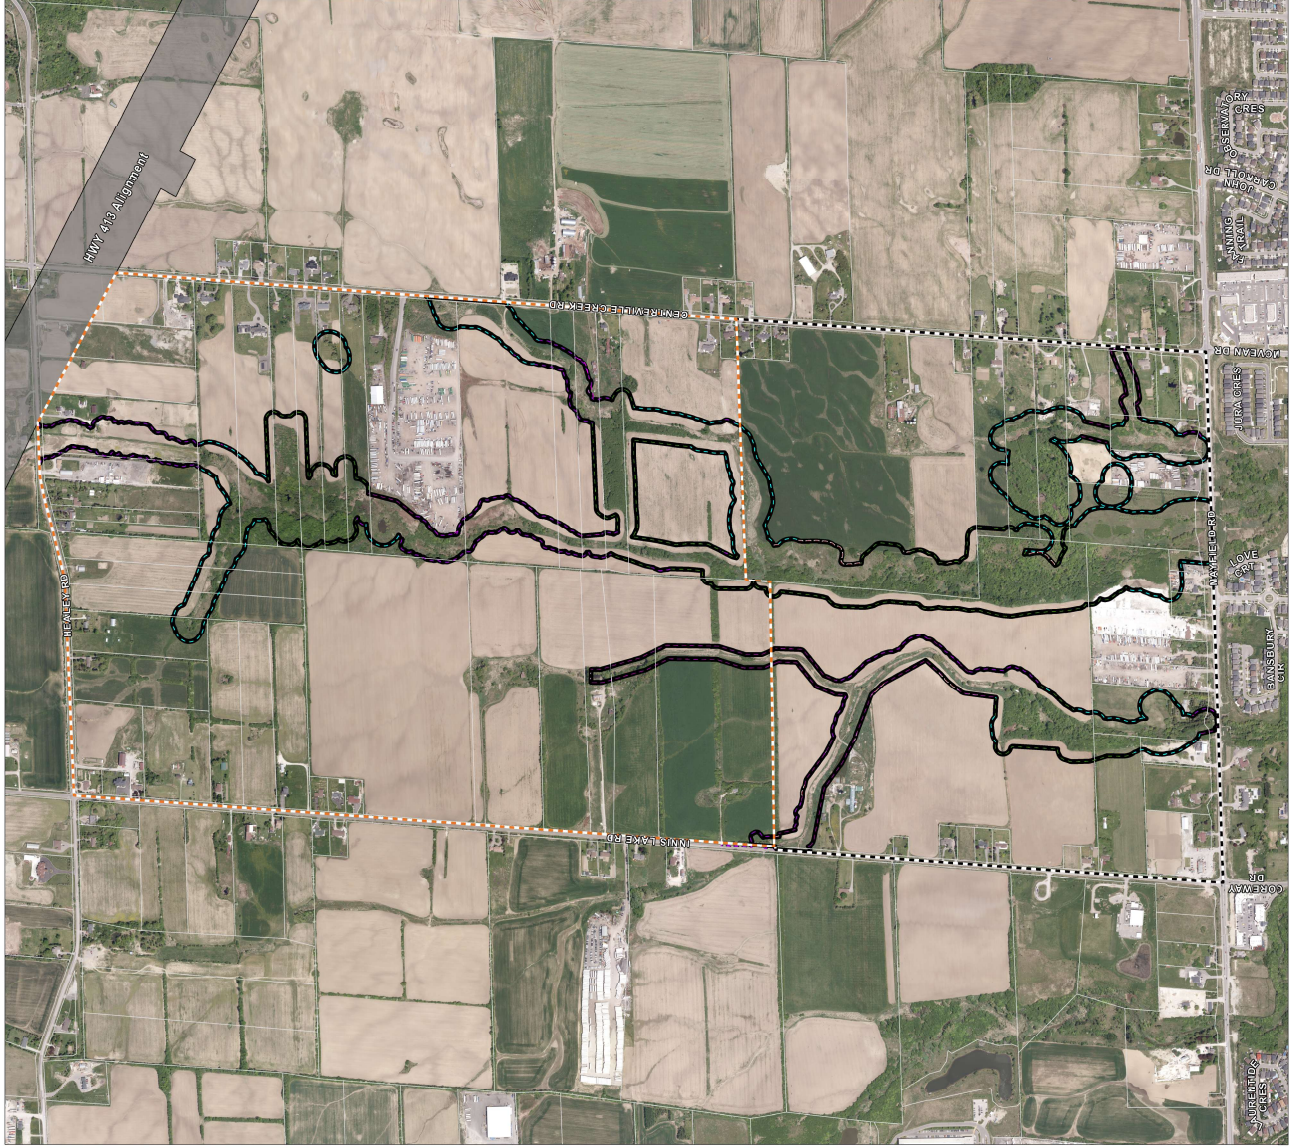
- 10m Slope Network
- Preliminary Regional Floodplain (RSEU)
- Preliminary Regional Floodplain (RSEU) 10m
- 10m Study Area
- Mandated Width = 10m
- Mandated Width (Detention)
- 20m Significant Woodland Setback
- 30m Water Setback
- 30m Water Setback
- Overland Constraint
- Phase 1 Study Area
- Phase 2 Study Area

The details of each of these constraints are shown in Figure 13. These constraints align with the definition of NHS as provided in the Scoped SWS (2022) for the SABE and Future Caledon OP.

The cumulation of these constraints creates a single outer constraint that has been applied as the NHS for the study area. The NHS, as shown in Figure 14, is considered confirmed within the subject properties where detailed field studies were completed. The NHS within the study area, but outside of the subject lands, is considered preliminary until field verification can occur at a later date. Moving forward, this outer constraint will act as the NHS for the Innis Lake LSS. There are areas of the determined NHS that differ from the Preliminary NHS presented in the SABE (2022). These differences are based on refinement through detailed field studies and these refinements will be discussed in detail in the Part B Analysis, Impact Assessment, Mitigations and Recommendations report.
