APPENDIX E – Geotechnical and Hydrogeology

**Appendix E10 – Preliminary Slope Stability Study – Entire Local SWS
Area (GEI 2024)**

Mayfield Tullamore Landowner Group
 Phase 1 - Subwatershed Characterization and Integration Report
 Geotechnical Desktop Study

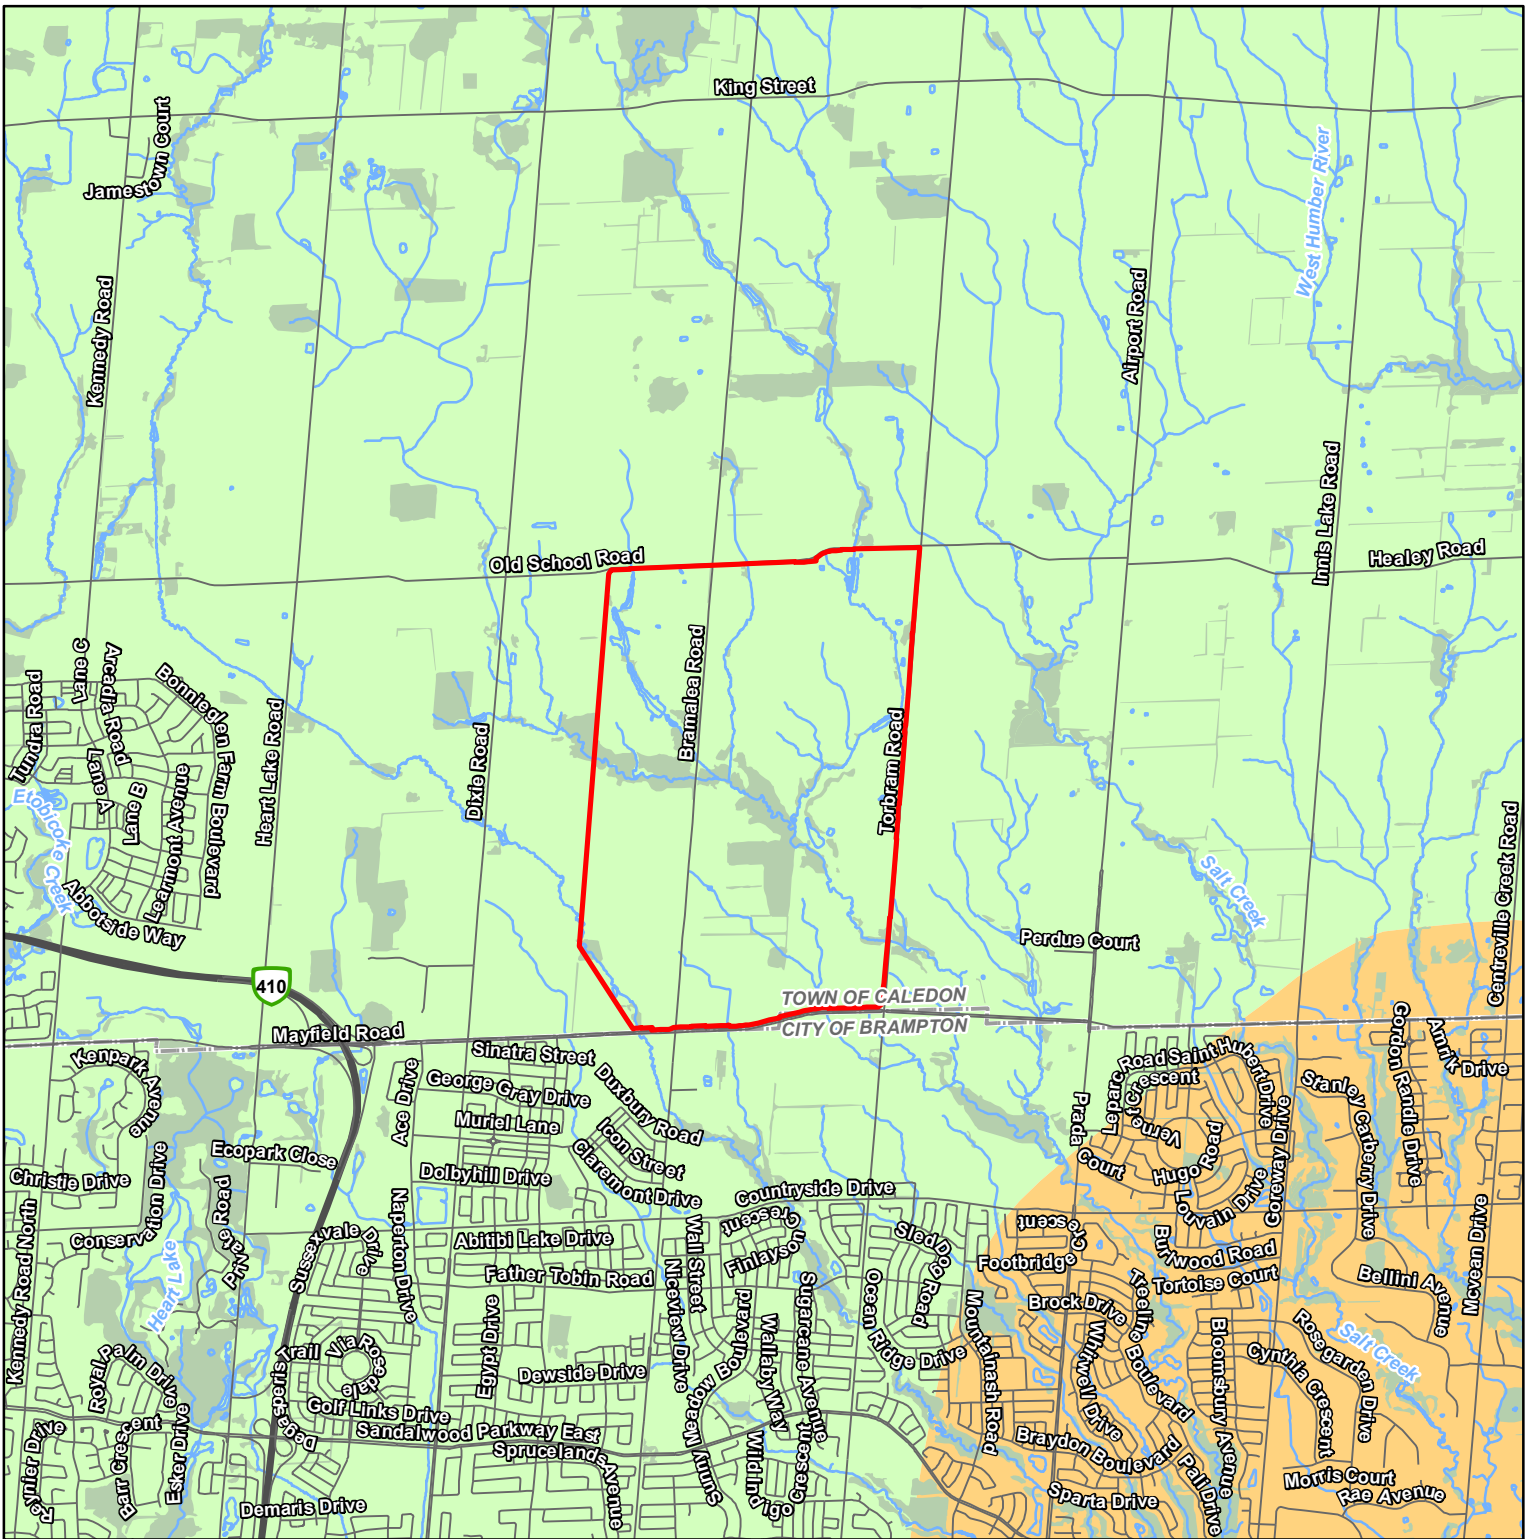
Figure 1
 Physiographic Region

- Study Area
- Watercourse
- Waterbody
- Wooded Area
- Peel Plain
- South Slope

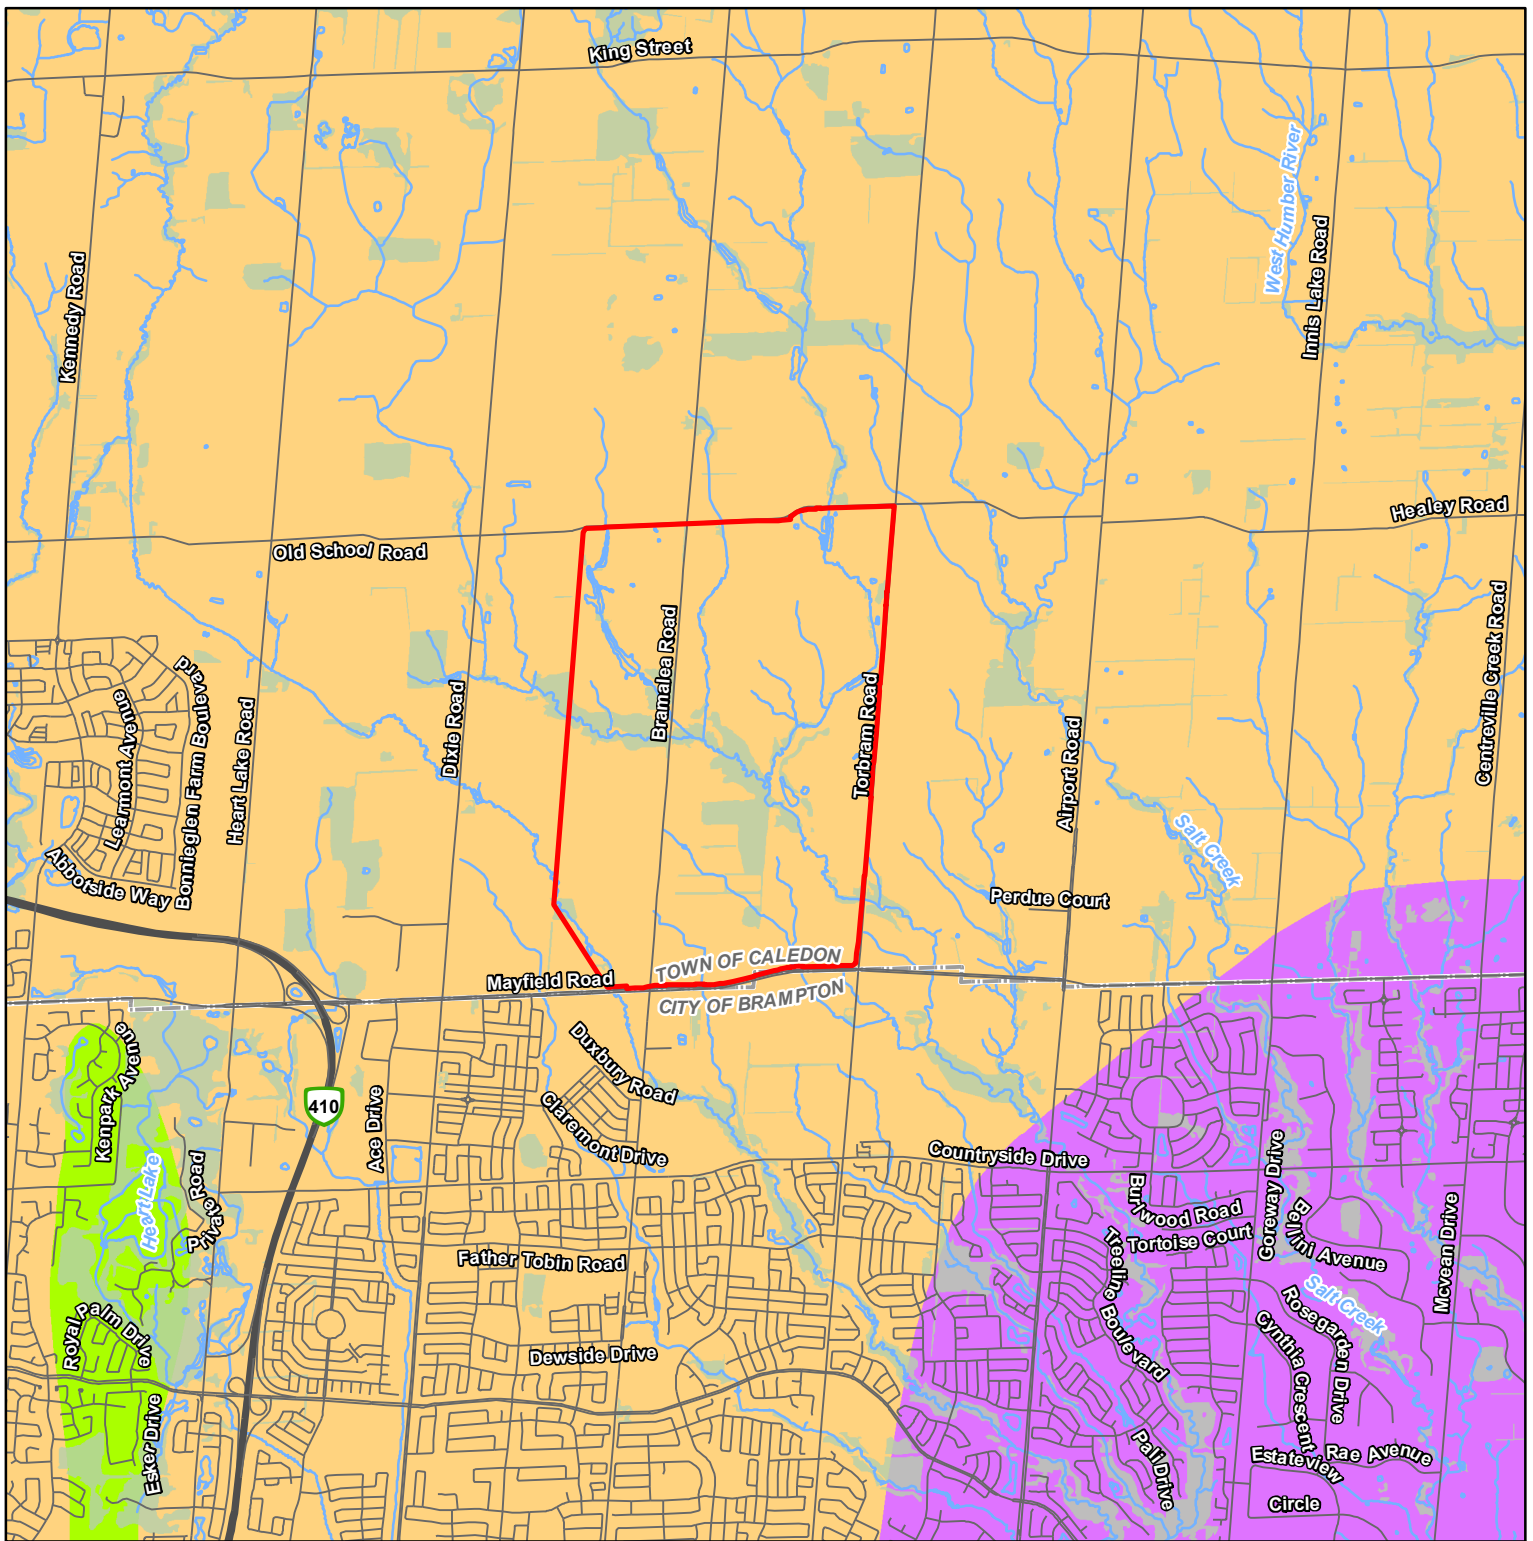
Figure 2
 Physiographic Landform

- Legend**
- Study Area
 - Watercourse
 - Waterbody
 - Wooded Area
 - Bevelled Till Plains
 - Eskers
 - Till Plains (Drumlinized)

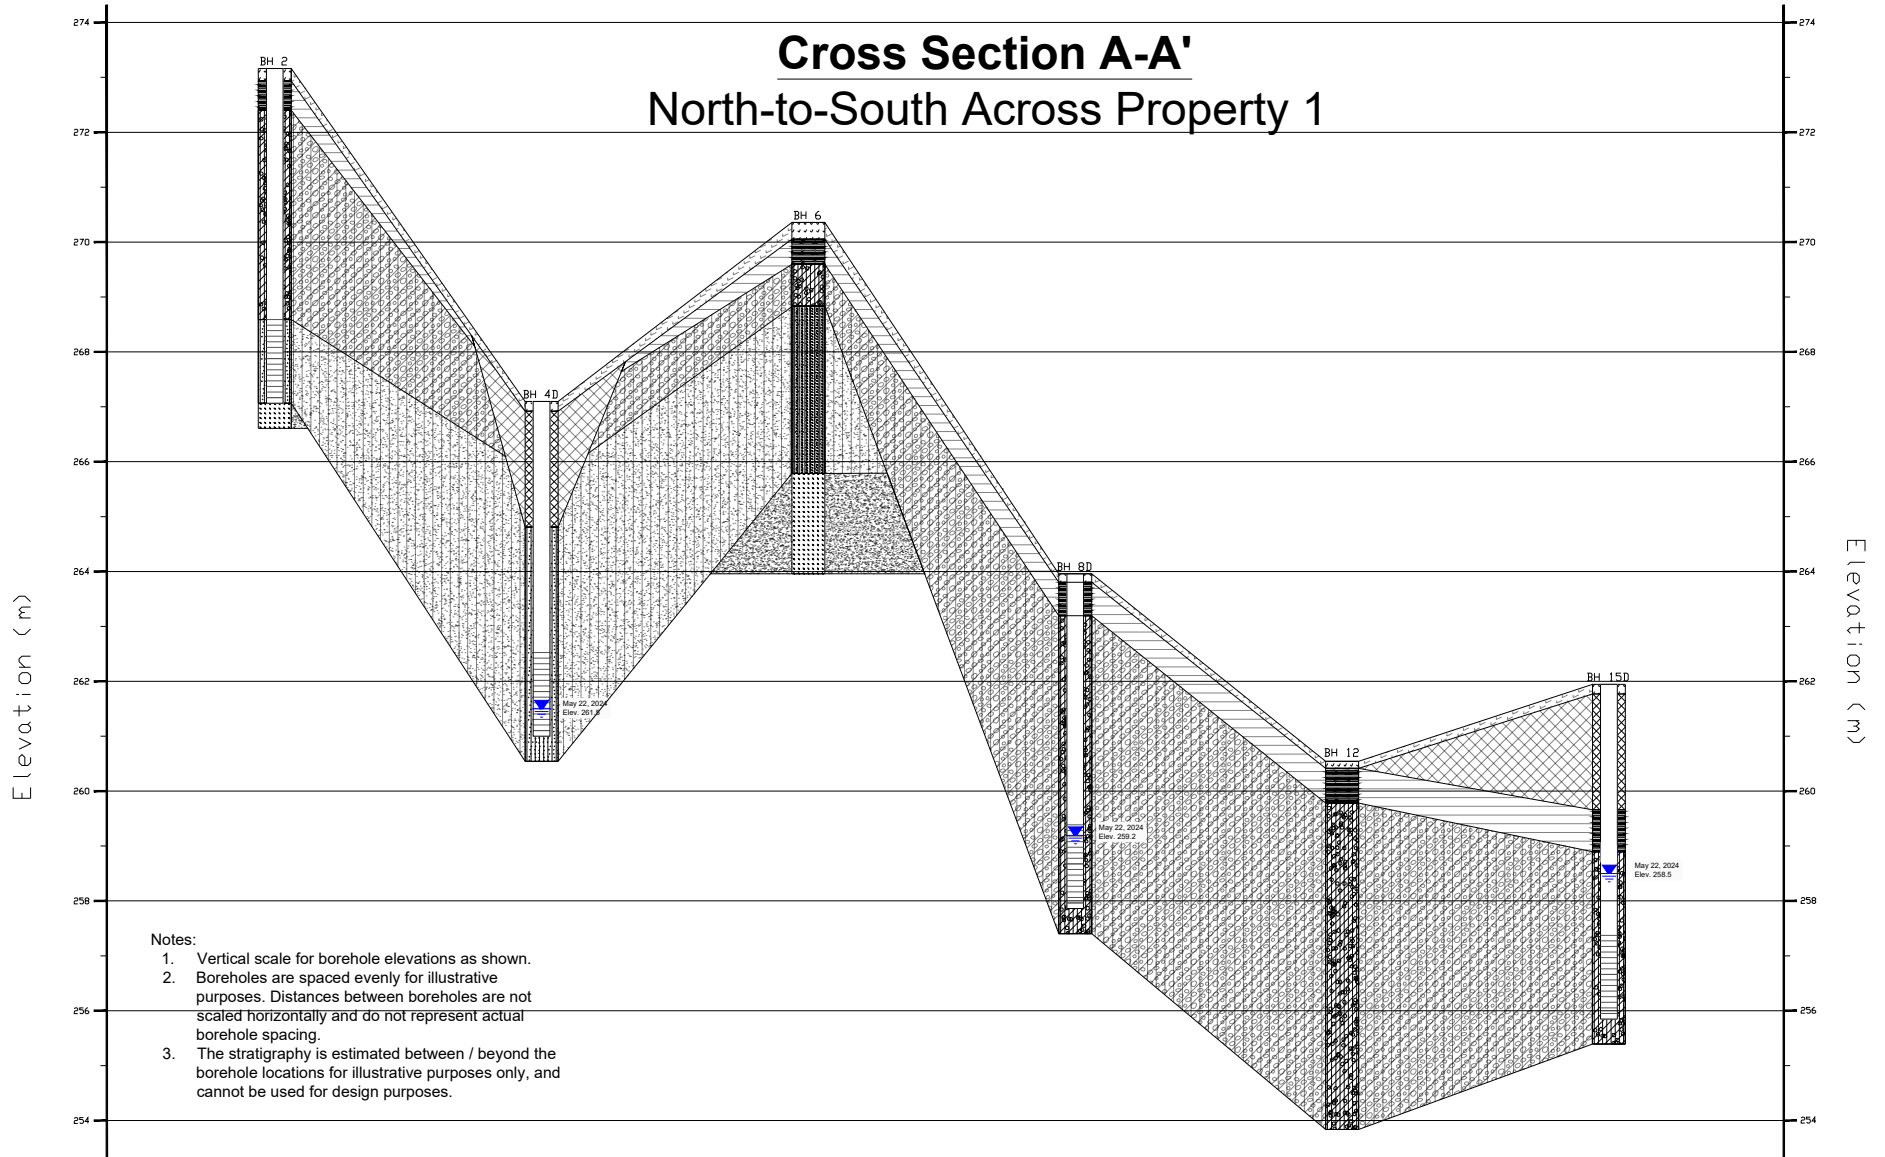
North-to-South Across Property 1

1. Vertical scale for borehole elevations as shown.
2. Boreholes are spaced evenly for illustrative purposes. Distances between boreholes are not scaled horizontally and do not represent actual borehole spacing.
3. The stratigraphy is estimated between / beyond the borehole locations for illustrative purposes only, and cannot be used for design purposes.

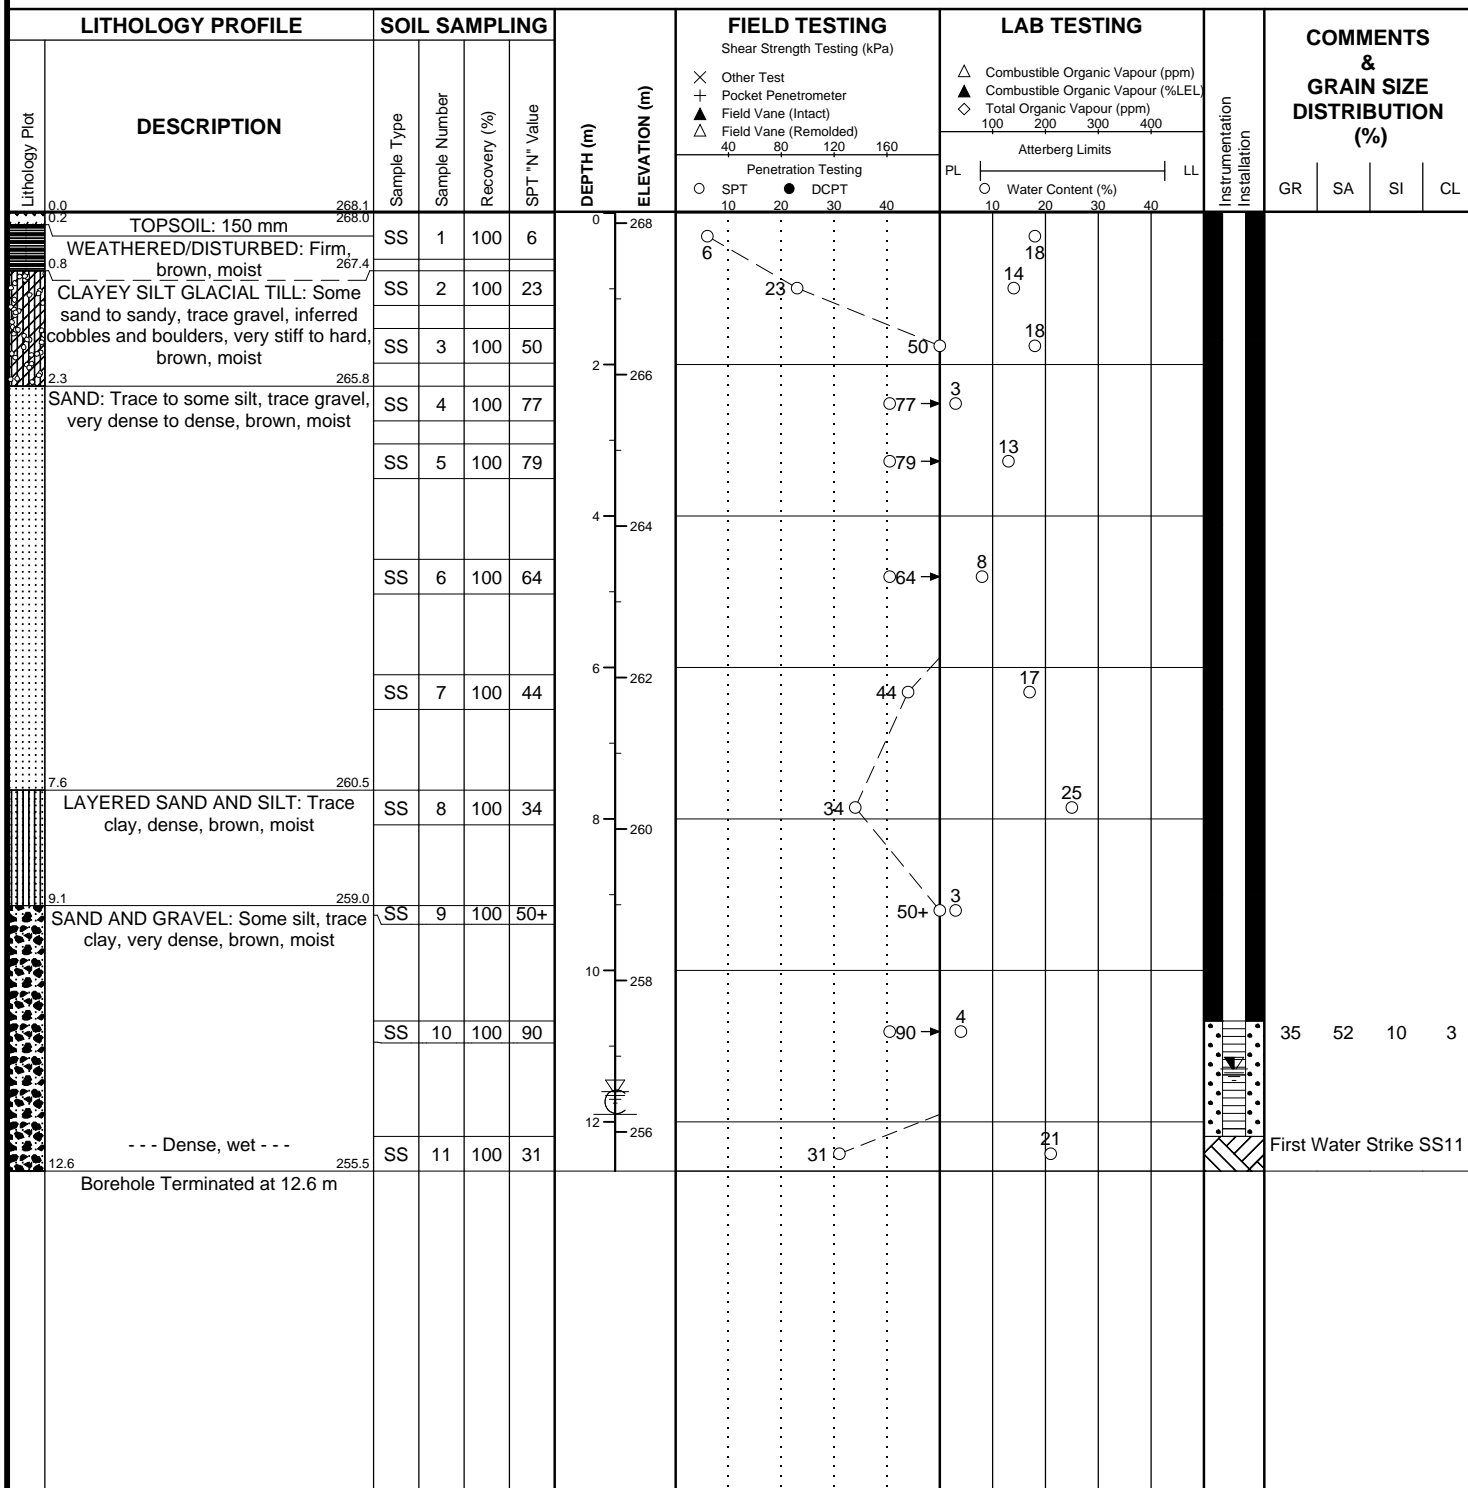
Drilling Method: **Hollow Stem Augers** Drilling Machine: **Track Mount**
 Logged By: **AG** Northing: **4849291** Date Started: **May 02/24**
 Reviewed By: **RW** Easting: **596198** Date Completed: **May 02/24**

Groundwater depth encountered on completion of drilling: 11.6 m. Cave depth after auger removal: 11.9 m.
 Groundwater depth observed on: May 22/24 at depth of: 11.3 m. Groundwater Elevation: 256.8 m

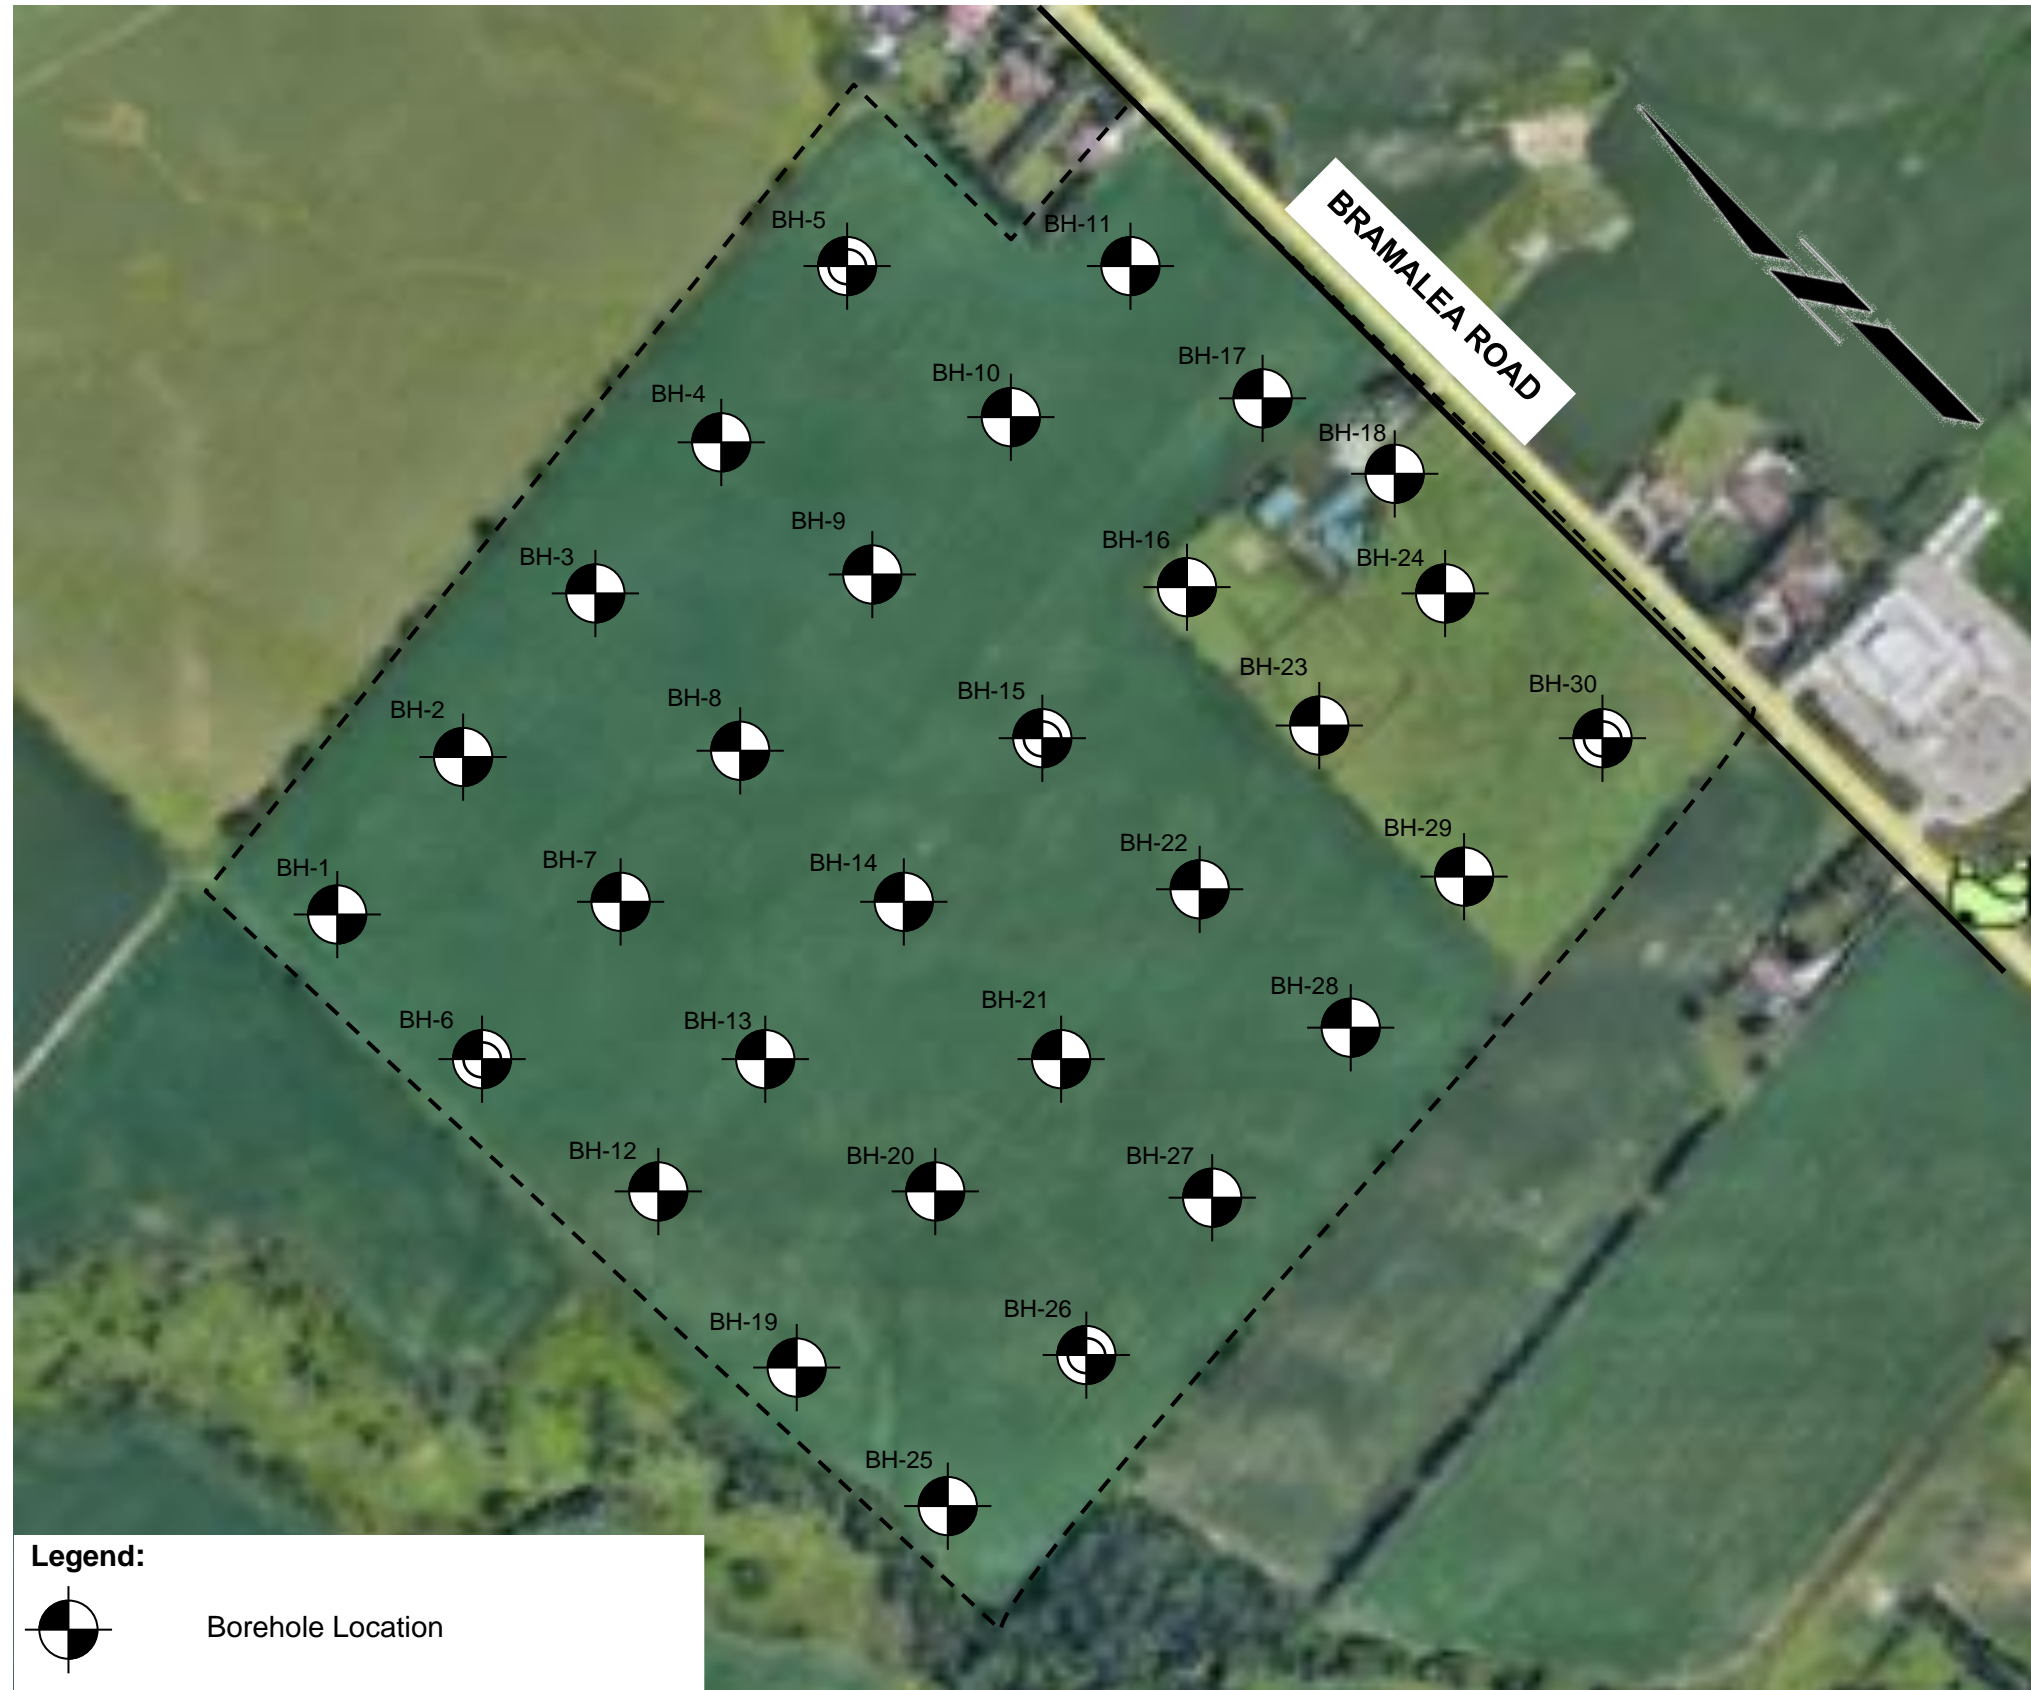
1. The boundaries and soil types have been established only at the borehole locations. Between boreholes the boundaries are assumed and may be subject to considerable error.
2. Soil samples will be retained in storage for 3 months and then destroyed unless the client advises otherwise.
3. Topsoil quantities and/or volumes of unsuitable fill should not be established from the information provided at the borehole locations.
4. Borehole elevations should not be used to design building(s), or floor slab(s), or parking lot(s) grades.
5. This drawing to be read with subject report, project number as shown below.
6. Boreholes located and elevated using portable GPS equipment.
7. Test hole locations are approximate.
8. Dimensions shown on this drawing are in metric units, unless otherwise noted.

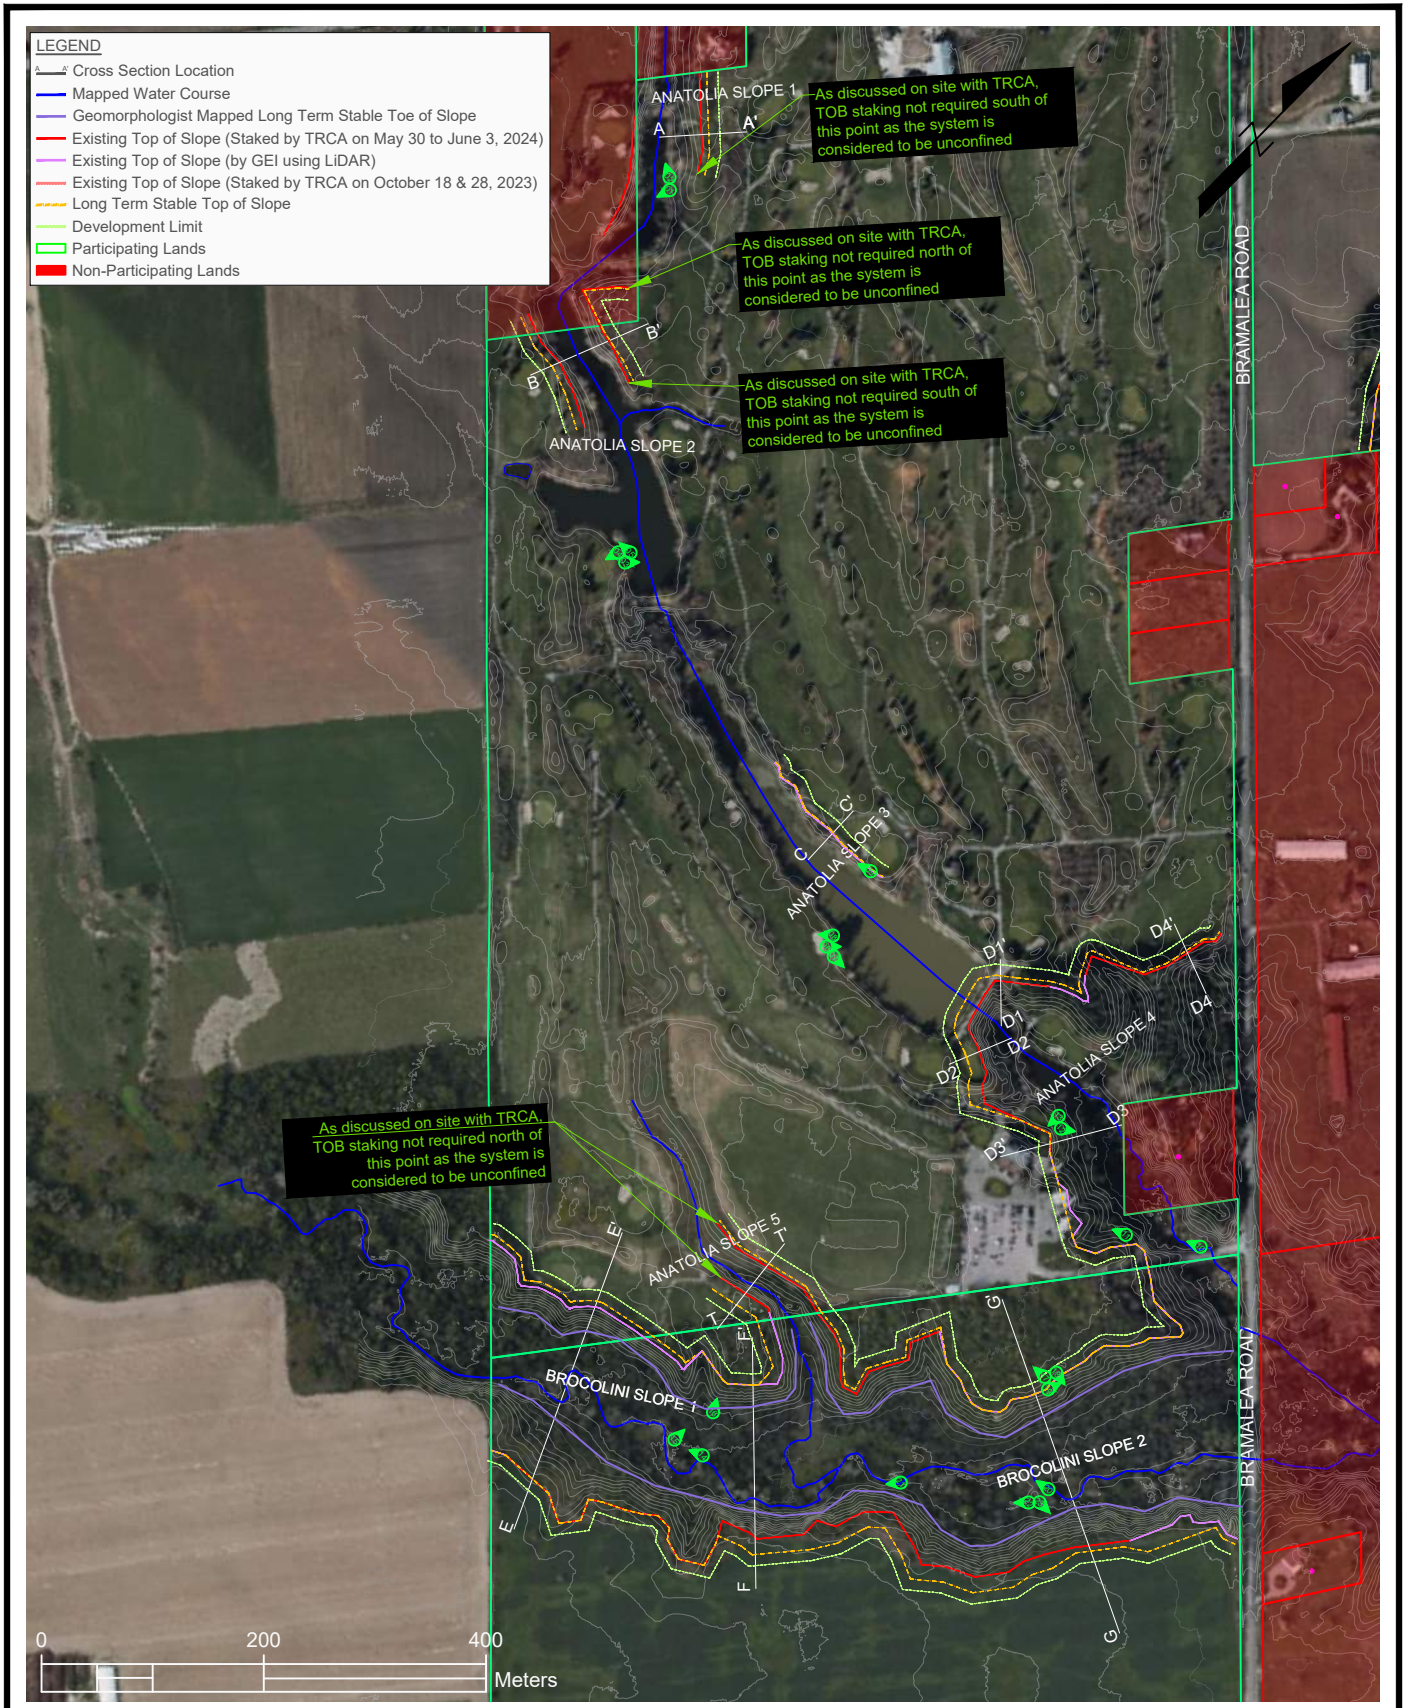
<p>CROSS-SECTION, PHOTOGRAPH & LTSTOS LOCATION PLAN <i>Anatolia and Brocolini</i></p>
<p>Mayfield Tullamore Landowner Group Inc.</p>	<p>Project 2400278</p>	<p>June 2024 Fig. 2A</p>

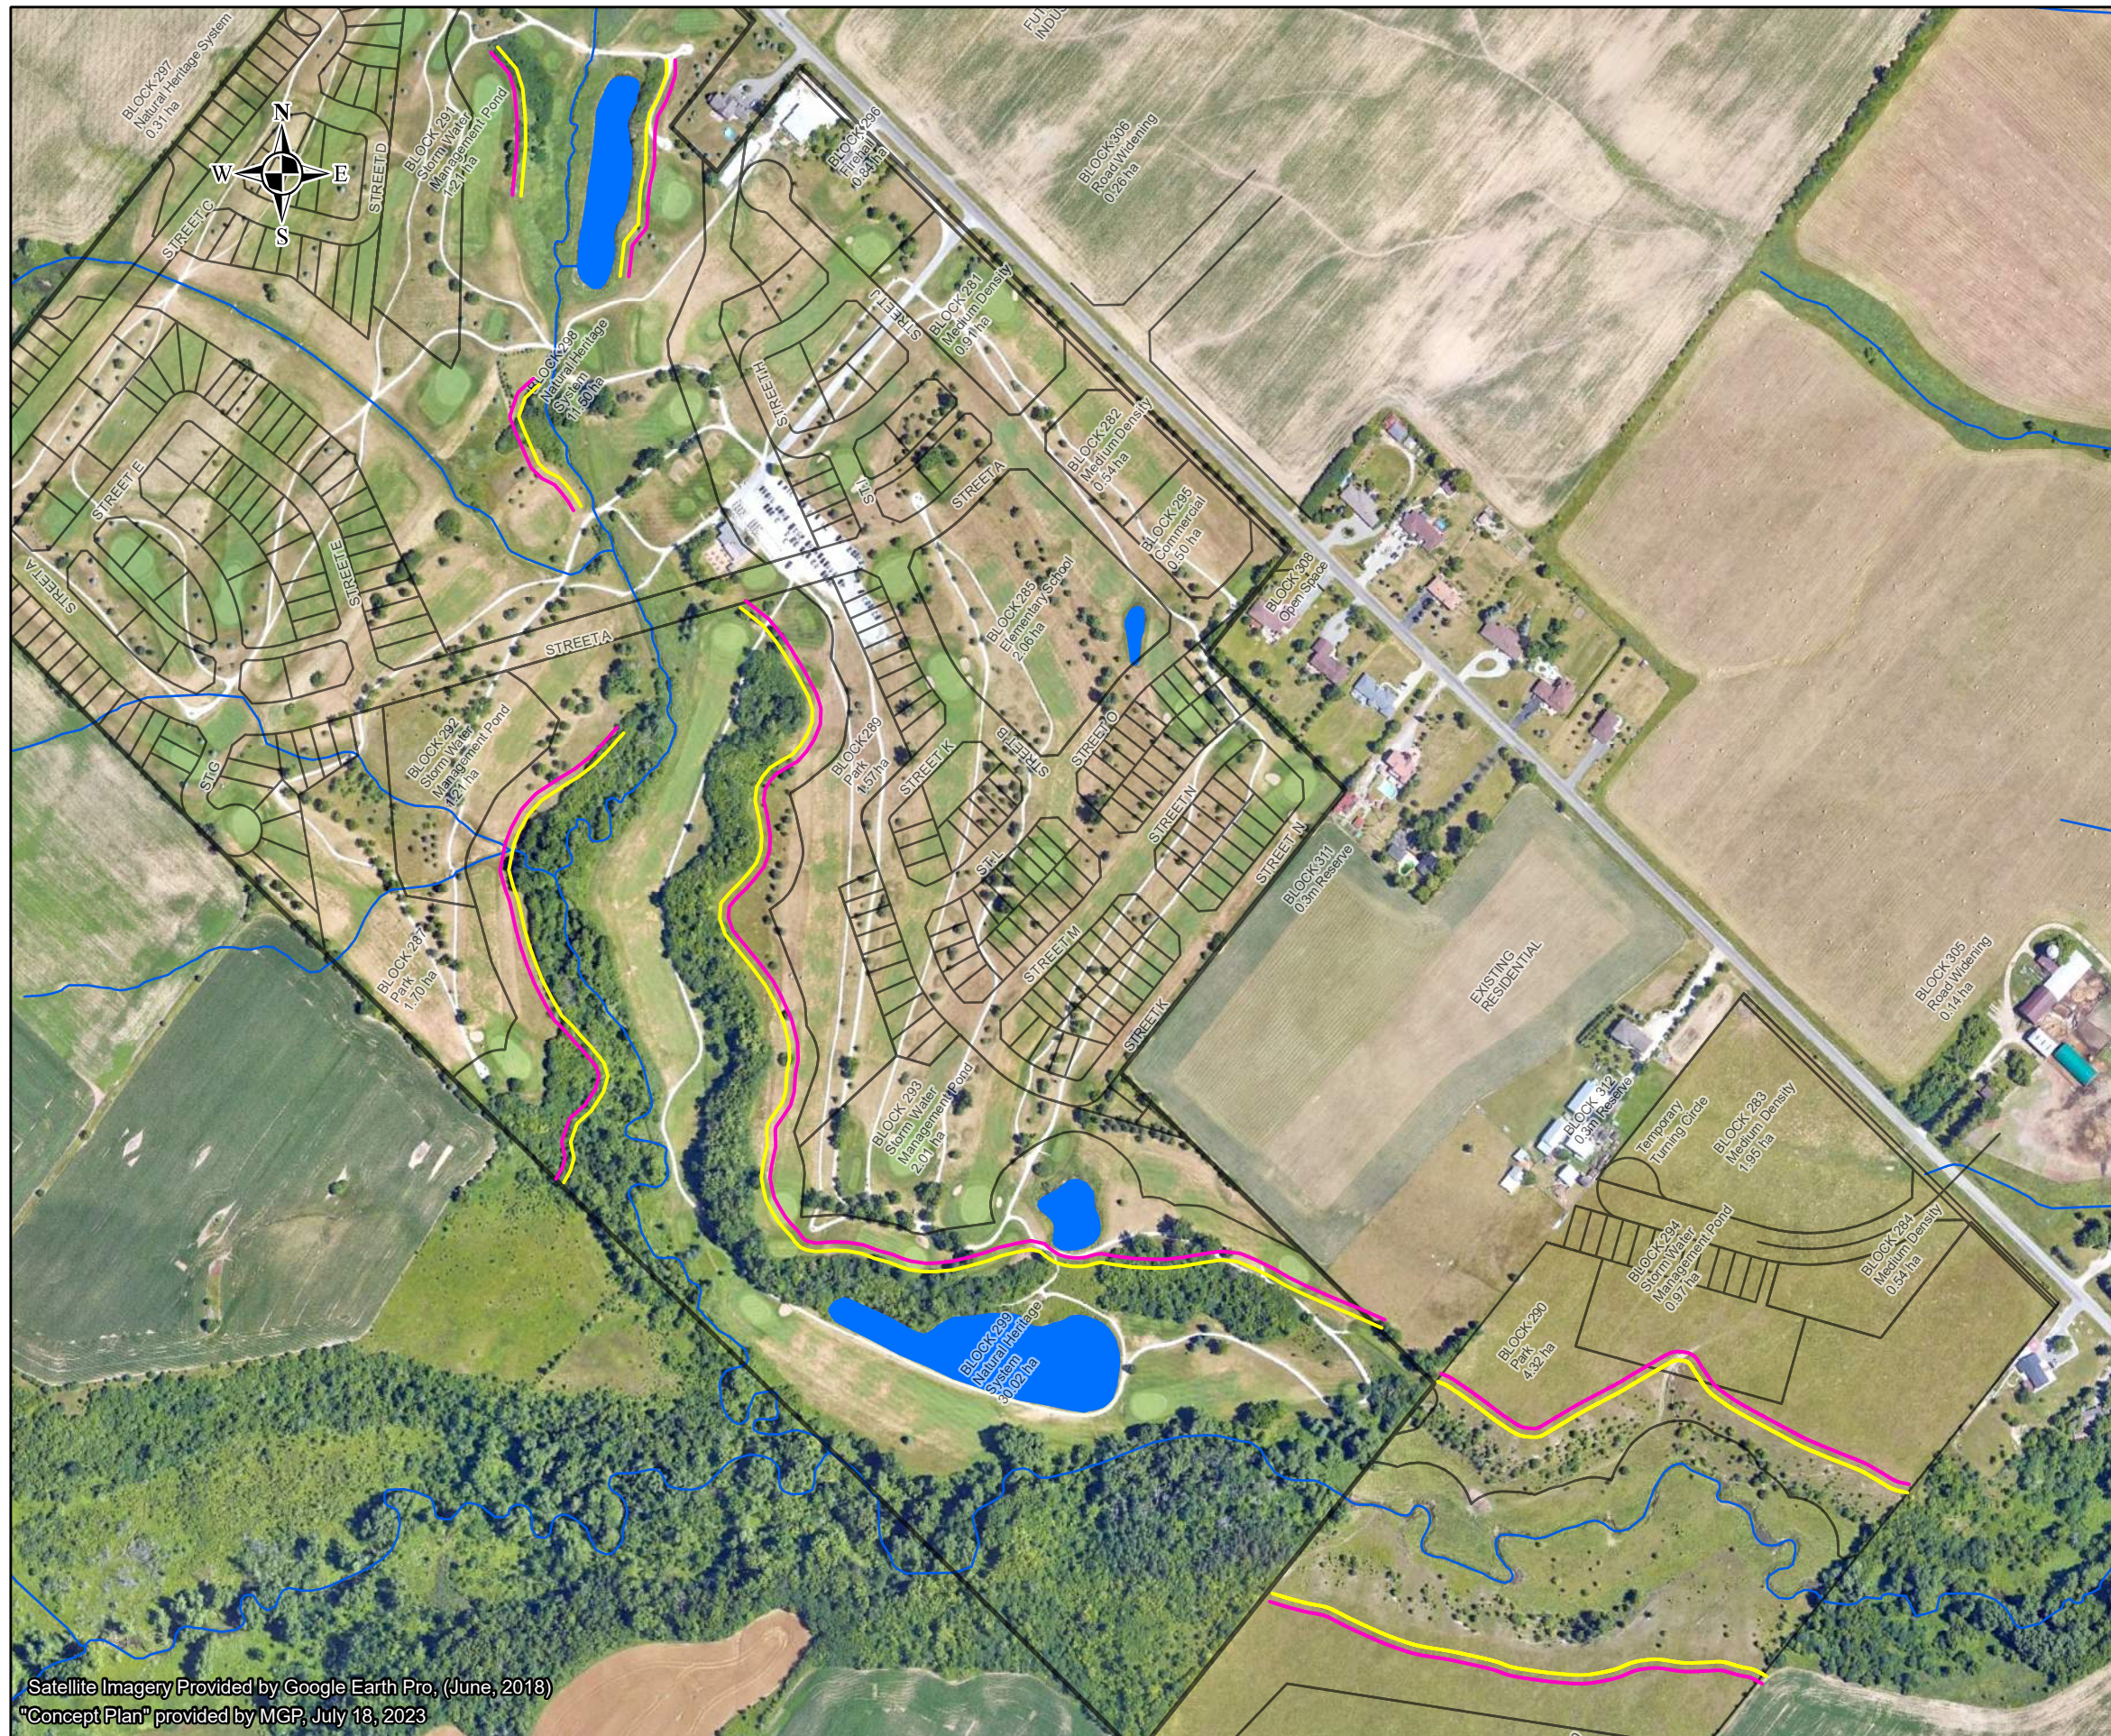
- Legend**
- TOP OF STABLE SLOPE
 - EROSION ACCESS ALLOWANCE
 - APPROXIMATE MAYFIELD GOLF COURSE LANDS BOUNDARY
 - WATERBODY
 - WATERCOURSE

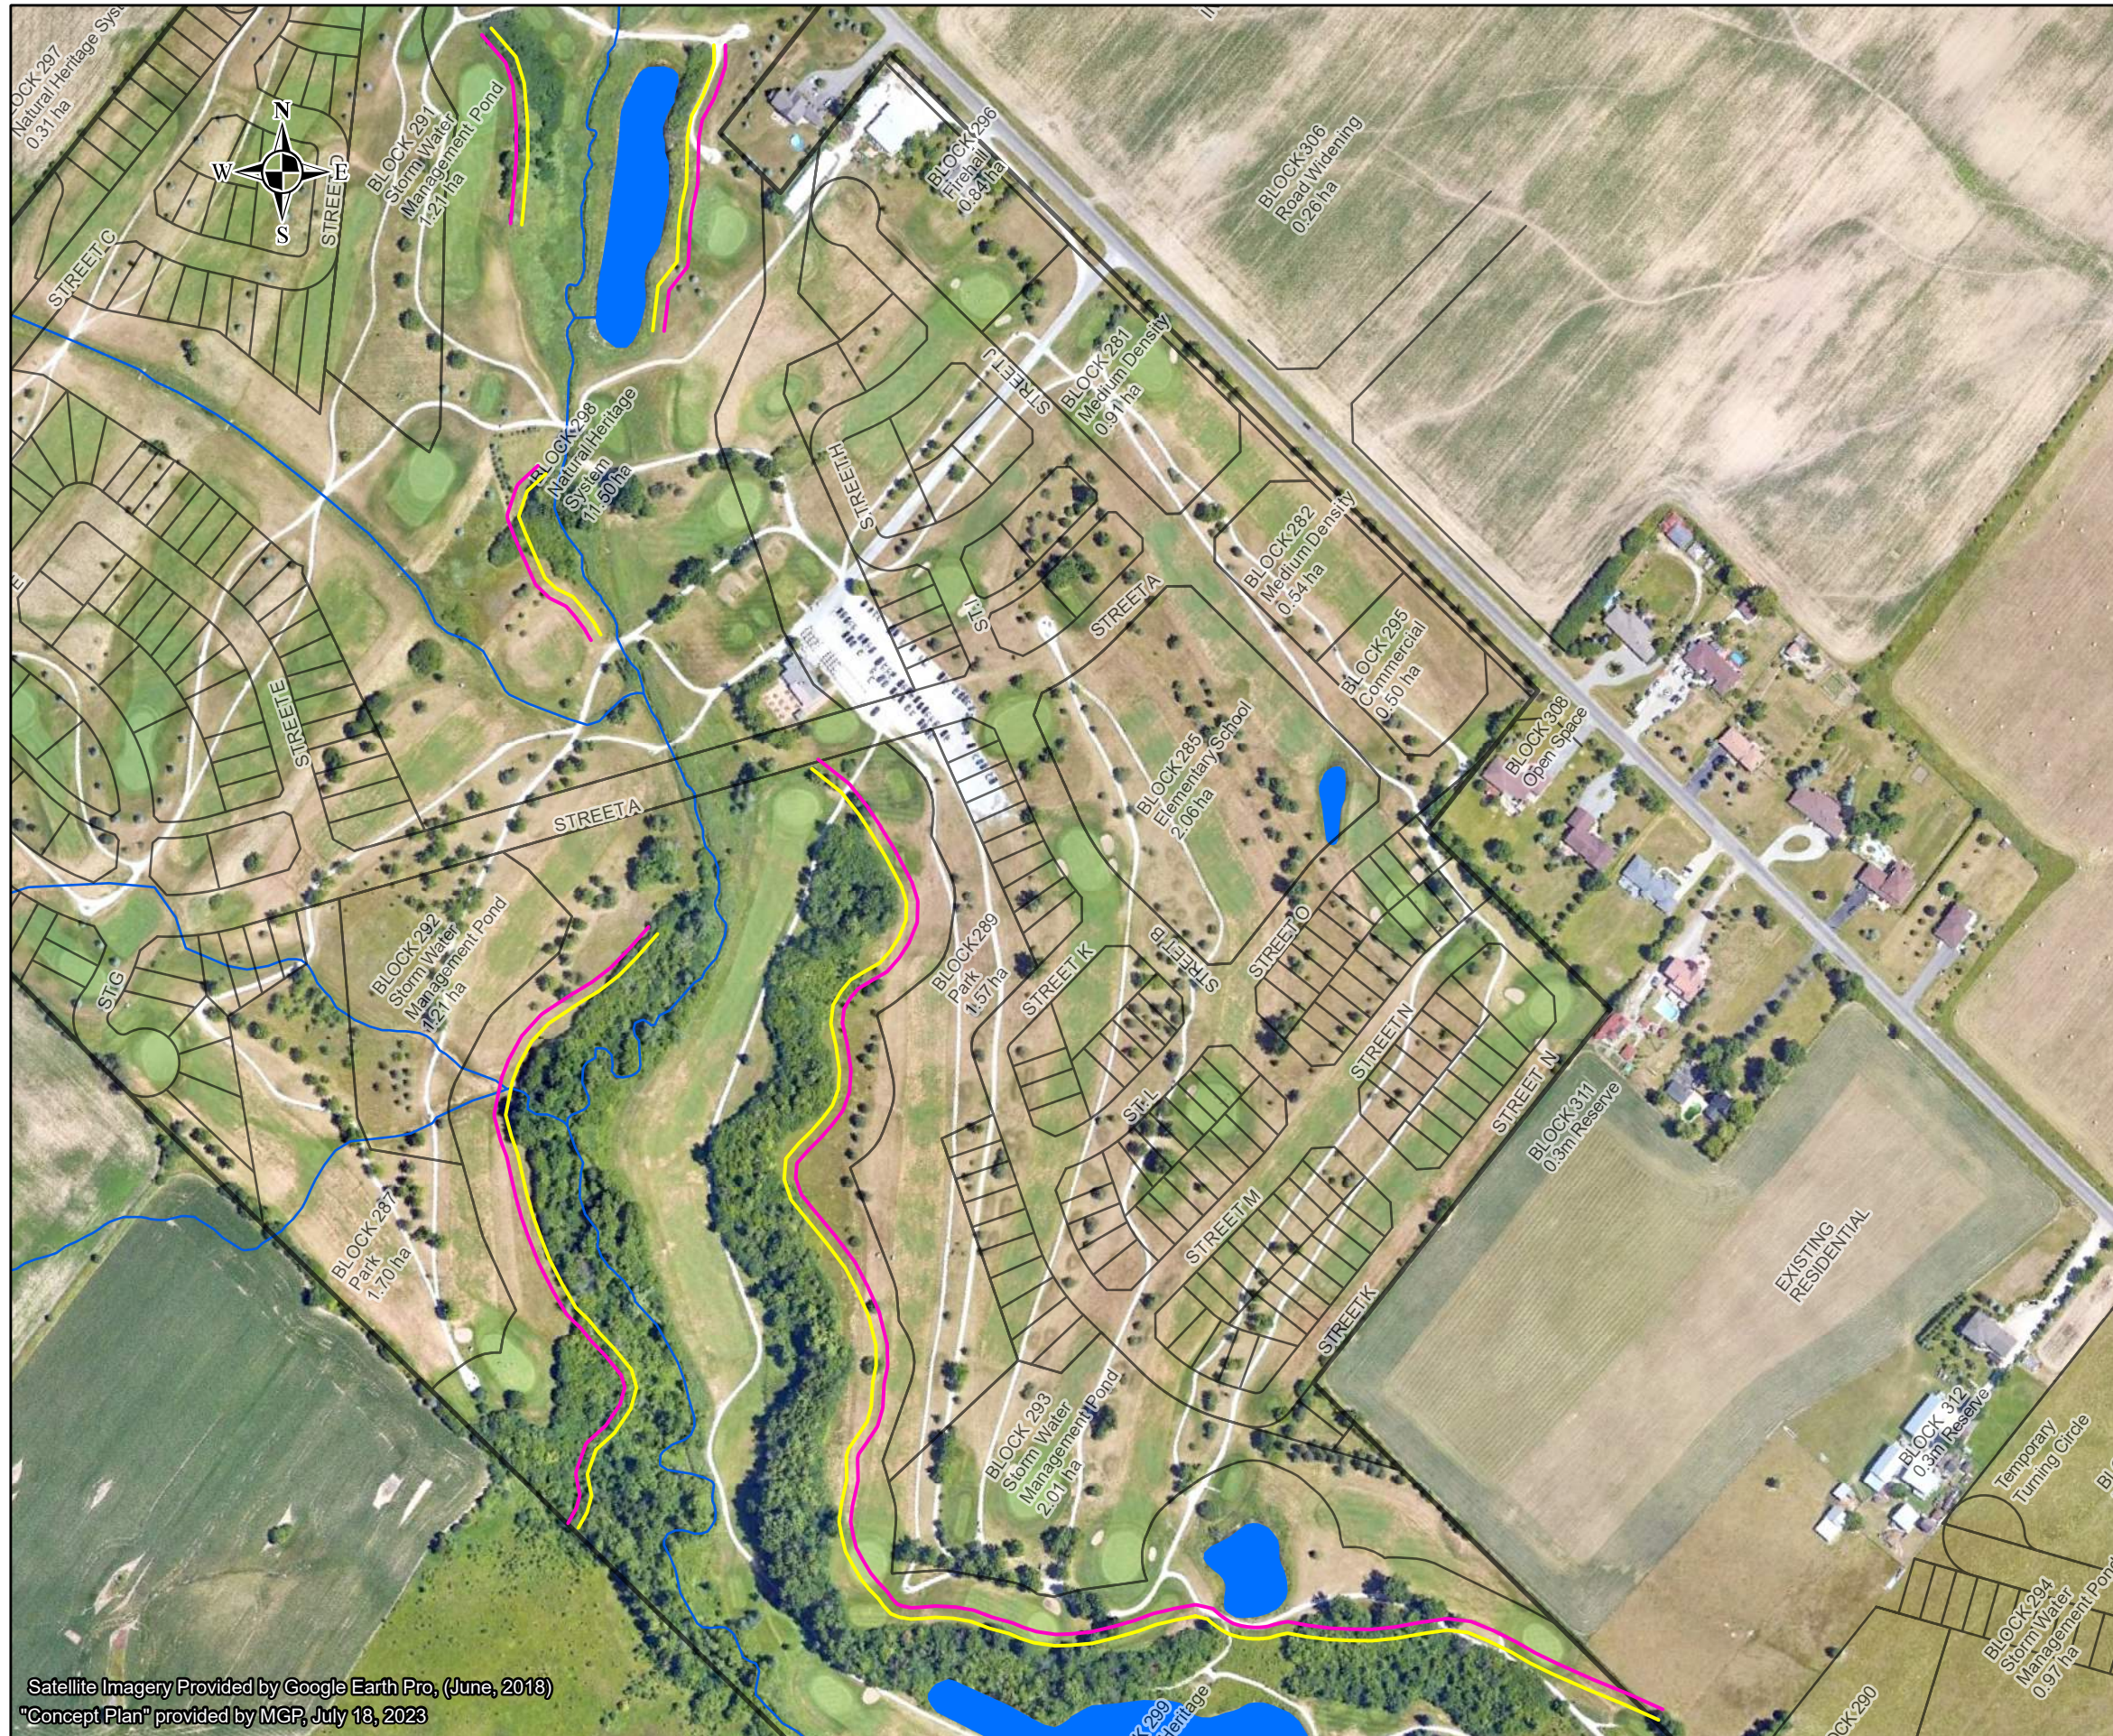
- Legend**
- TOP OF STABLE SLOPE
 - EROSION ACCESS ALLOWANCE
 - APPROXIMATE MAYFIELD GOLF COURSE LANDS BOUNDARY
 - WATERBODY
 - WATERCOURSE
