**Wildfield Village Secondary Plan
Caledon
Local Subwatershed Study
Phase 1 Report**

November 15, 2024

Project Number: 2630

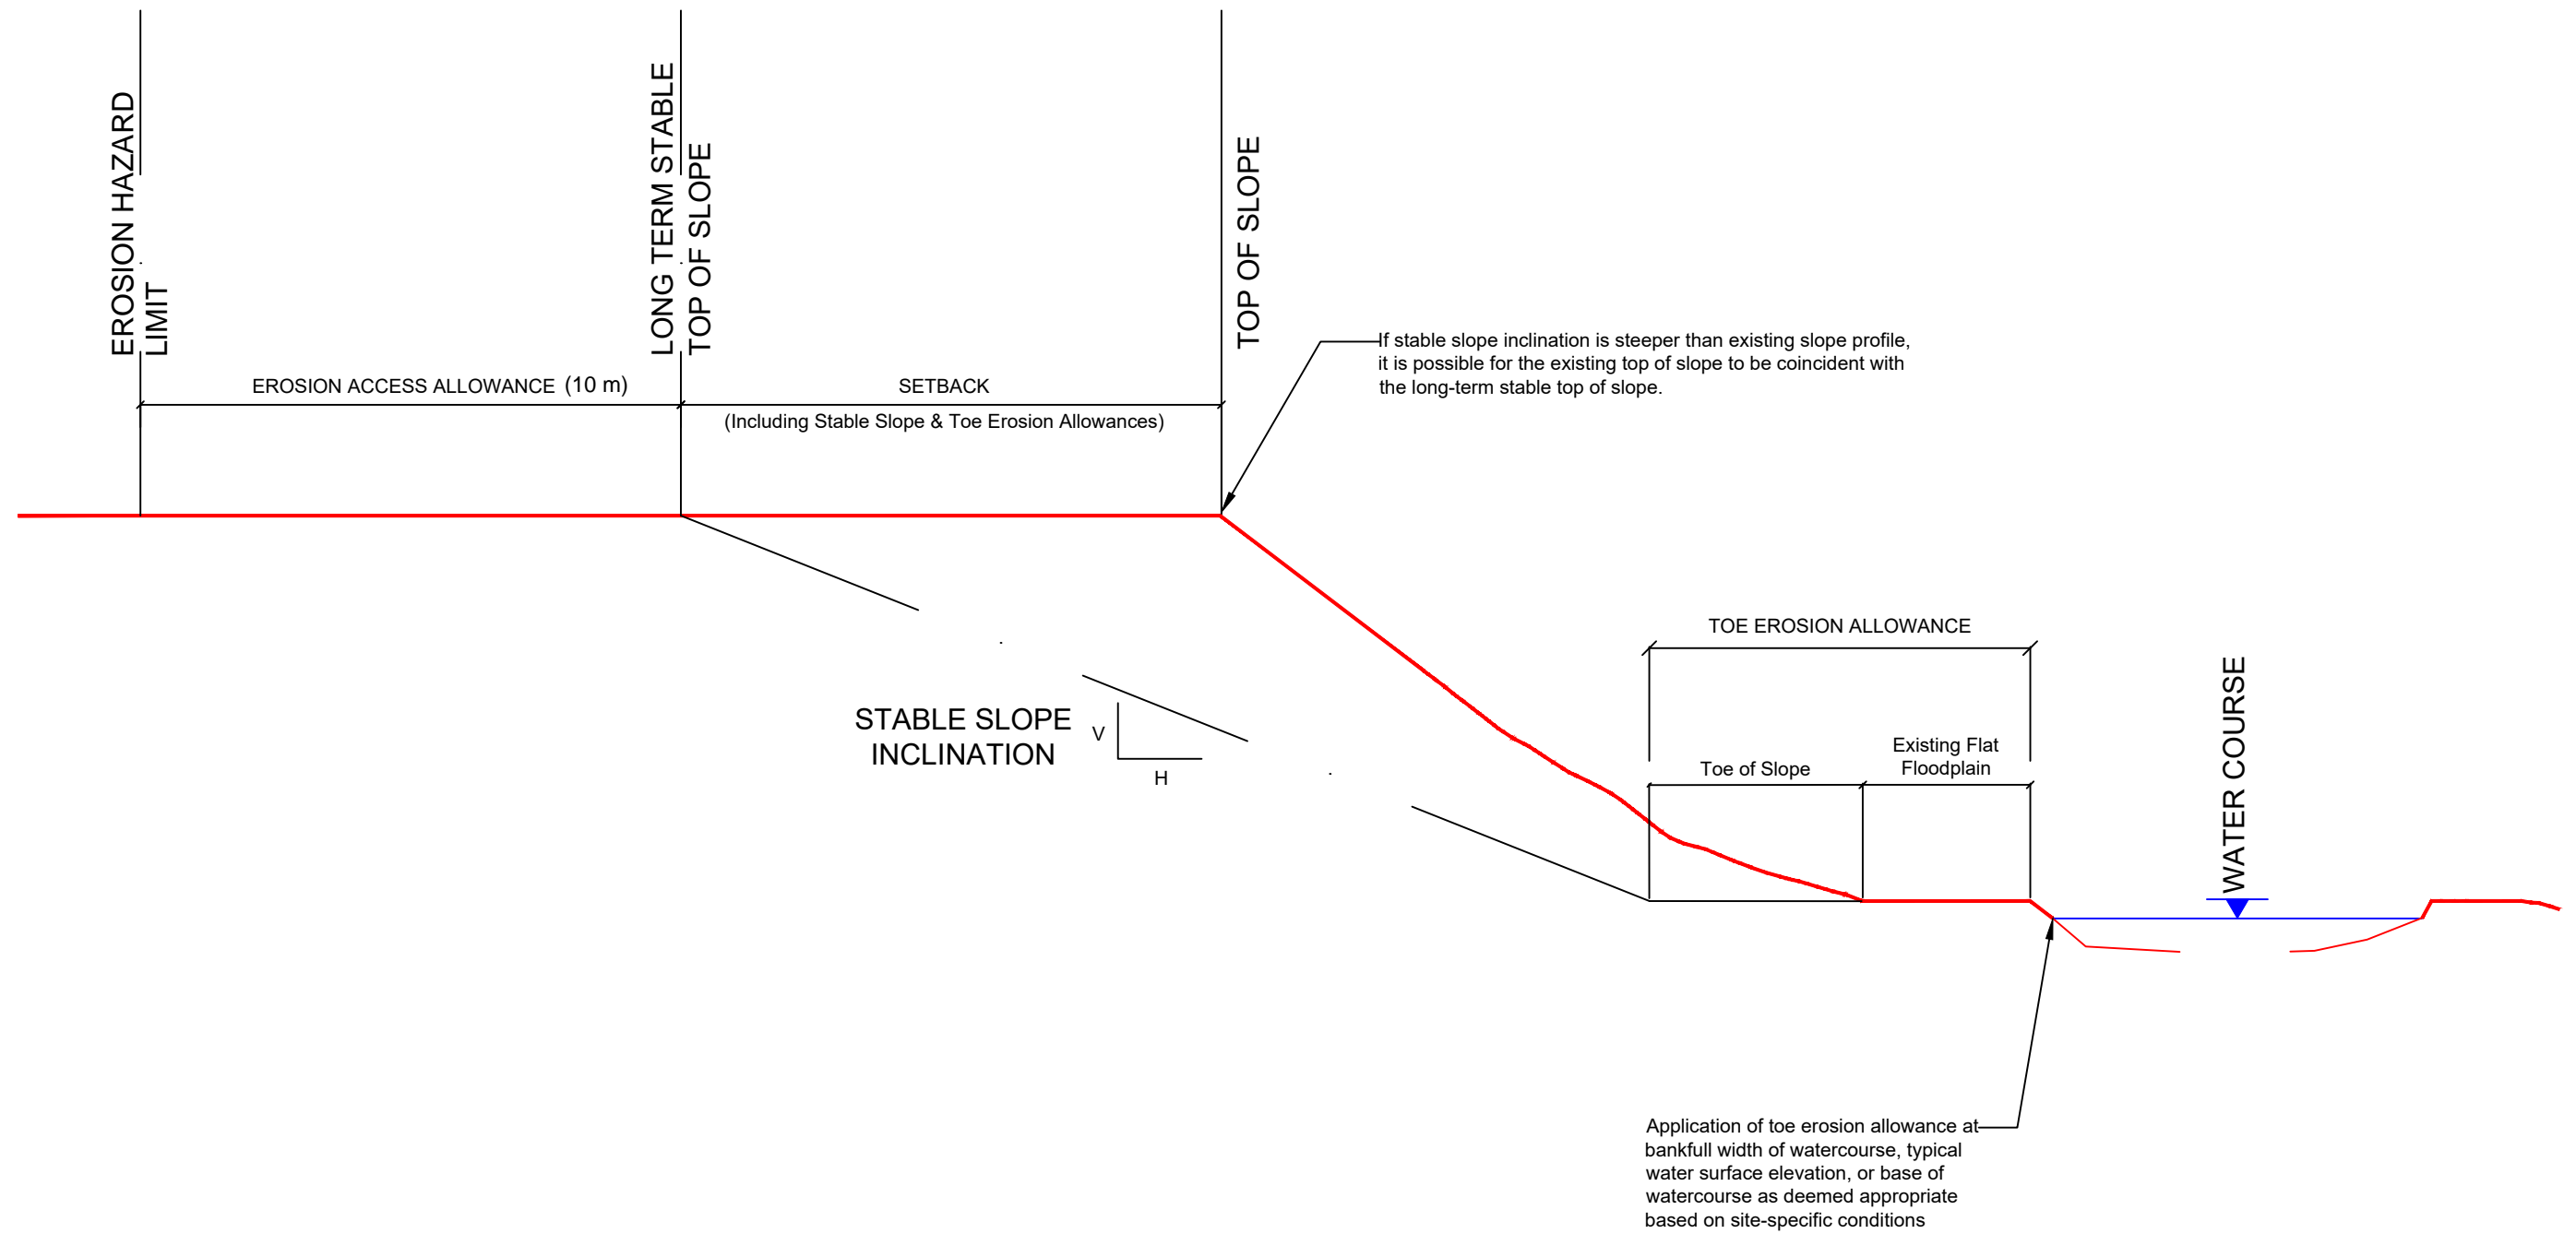
Wildfield Village Local Subwatershed Study	Date: Oct 2024	Project No.: 2400278
	Scale: N.T.S	Figure No.: 2.10

Title: Long Term Stable Top of Slope Model

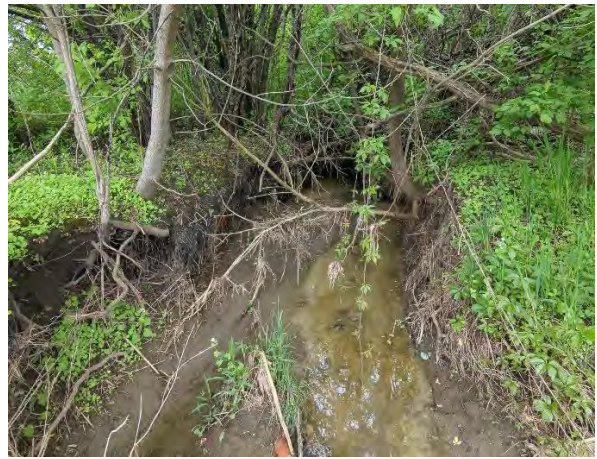
Photo 5 – Sharp meander bend with displaying undercutting in central portion of H5S1.

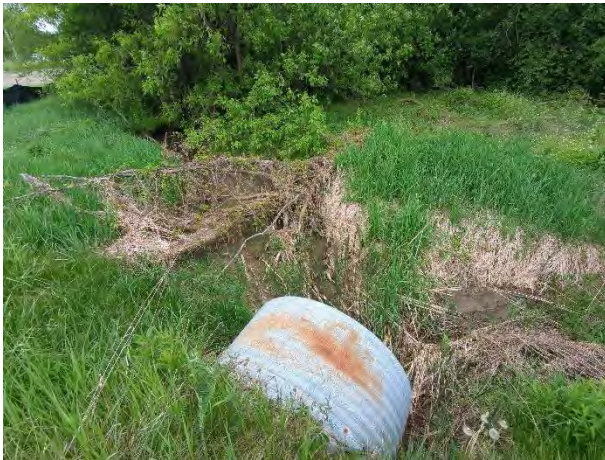
Photo 6 – Forested section of H5S1 near downstream extent. Degraded banks along pools containing silt.
