## Phase One Environmental Site Assessment

TACC Development Lands- Mayfield Tullamore Neighborhood  
SE Corner of Bramalea Road and Old School Road  
Caledon, Peel Region, Ontario

GEI Consultants Canada Ltd.  
650 Woodlawn Road West Block C, Unit 2  
Guelph, ON N1K 1B8  
519.824.8150

Project No. 2407688

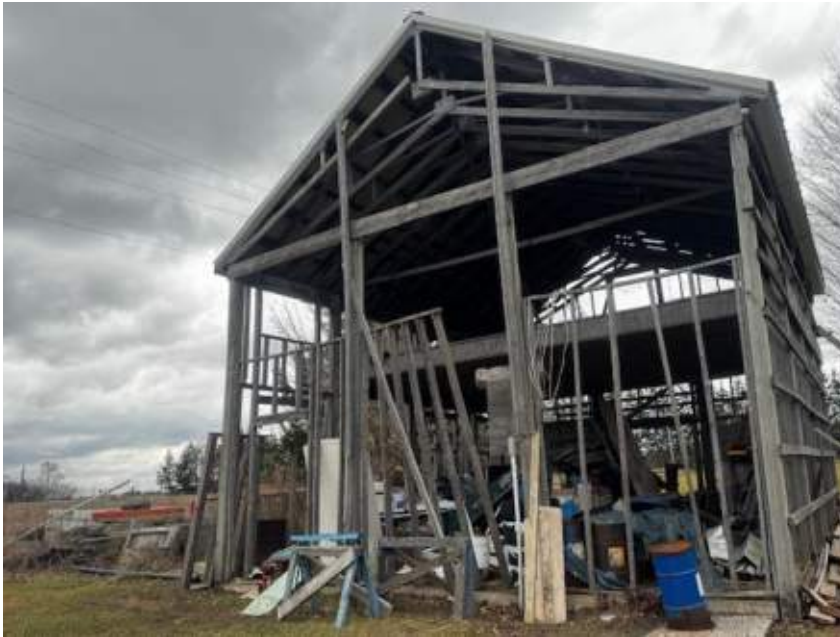
**PHOTOGRAPH 3**

Building E is a partially constructed/unfinished storage shed, consisting of a wooden frame, plywood floor, and metal roof, but no walls. The building was observed to store discarded solid wood waste, household wood materials (e.g., plywood, doors), and rusted metal barrels (typically used for grease or lubricants). The barrels appeared to be empty at the time of the site visit. No staining was noted on the wooden floor underneath.

In the western portion of the Site, within Building E, some scattered surficial debris was observed, including concrete blocks, bricks, black plastic garbage bags, wood logs, and empty plastic jars.

View of Building E

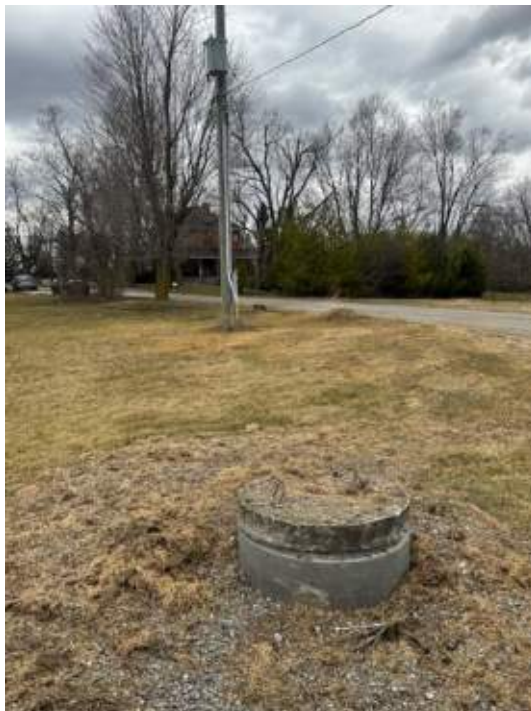
**PHOTOGRAPH 4**

One (1) potable dug water supply well was observed at 12933 Bramalea Road. This well serves as the primary source of potable water for the entire Site, including the residential dwellings along Old School Road.

View of the dug well located west of Building D, current source of potable water to the Site

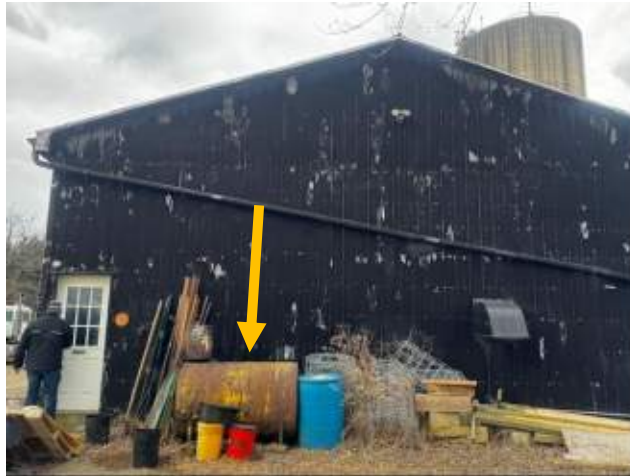
**PHOTOGRAPH 5**

One (1) AST storing waste oil was identified along the north wall of Building B at 12933 Bramalea Road. This AST appeared to be very old and showed signs of rusting; however, no staining or signs of leakage were observed in the surrounding area. This tank is also associated with PCA #28.

View of an  
aboveground old  
waste oil tank  
located outside the  
northern wall of  
Building B (APEC 3)

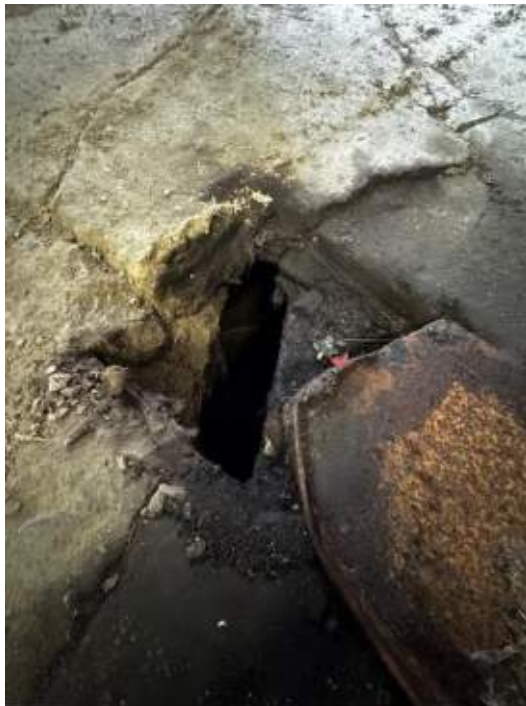
**PHOTOGRAPH 6**

| <b>APEC<sup>1</sup></b> | <b>Location of APEC on Phase One Property</b> | <b>PCA<sup>2</sup></b> | <b>Location of PCA (On-Site or Off-Site)</b> | <b>COPCs<sup>3</sup></b> | <b>Media Potentially Impacted (Groundwater, soil and/or sediment)</b> |
|---|---|---|---|---|---|
| Stained area inside the maintenance shop- Building B<br><br><b>(APEC 4)</b> | Within Northwest quadrant - Phase One Property | PCA #Other - Staining | On-Site<br><br><b>(PCA 4)</b> | Metals, VOCs, BTEX, PHCs, PAHs | Soil |

Some black staining was noted on the concrete floor within northeast portion of the maintenance shop area of Building B. The concrete floor was not in great condition.

Stained area and  
circular pit inferred to  
be an abandoned dug  
well inside the  
maintenance shop -  
north portion of  
Building B (APEC 4).

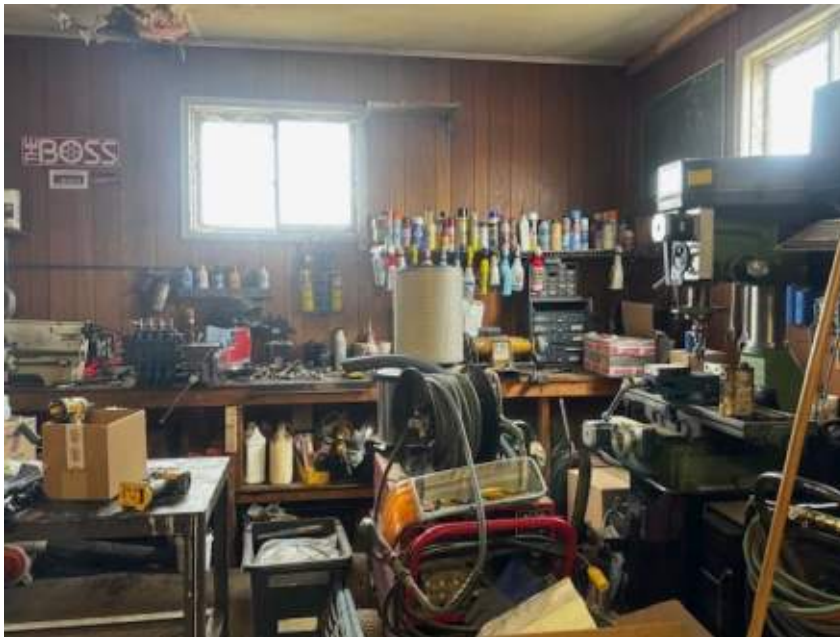
**PHOTOGRAPH 7**

Building B is a single-storey, slab-on-grade structure with metal wall panels, wooden framing, and a metal roof. It is used as a maintenance shop and equipment storage shed. The north portion of the building is used as a shop area with a concrete floor, and was observed to contain various chemicals (in original retail-sized packaging) used for equipment maintenance. These included spray paint cans, heavy oils, and de-icing fluids. Minor black staining was noted on the concrete floor. A circular pit, approximately 1.0 m in diameter and inferred to be an abandoned dug well, was identified inside the shop area. Along the south wall of the shop, three drums of new hydraulic oil and several pails of lubricants were stored on a dirt floor. No staining was observed in this area. According to the site representative, this location previously housed an above-ground storage tank (AST) used for heating oil. The southern portion of the building, with a partially concrete floor, was used for the storage of farm equipment. An AST currently used for storing waste oil is located just outside the building, near its northeast corner. The tank appeared to be in fair to poor condition, with visible rusting, but no staining or stressed vegetation was observed on the surrounding ground. The shop is currently heated by propane, with three vertical propane tanks located along the north exterior wall.

View of the maintenance shop – north portion of the Building B.

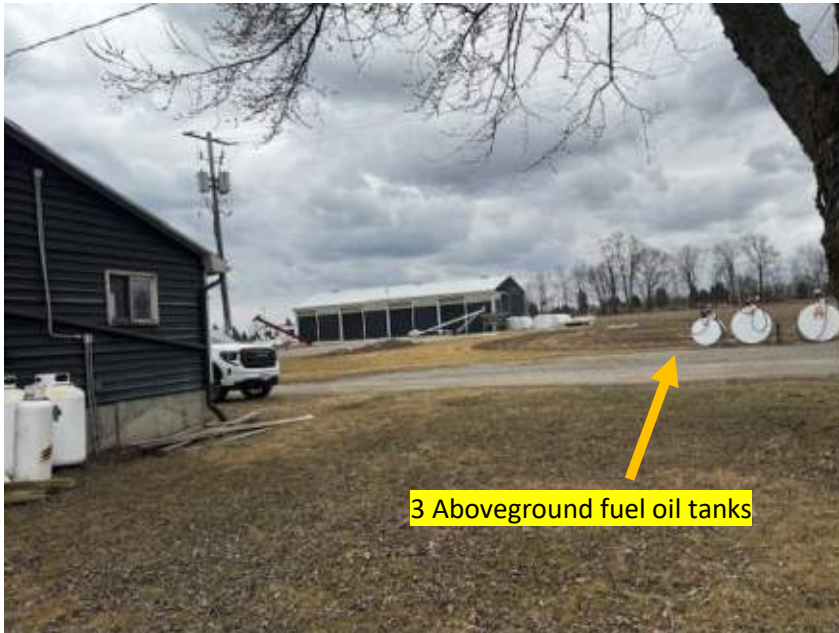
**PHOTOGRAPH 9**

These metal tanks were placed adjacent to each other directly on bare soil, without secondary containment. The ASTs appeared to be in good condition, and no staining or evidence of leakage was

observed in their vicinity. These tanks are associated with PCA #28 – Gasoline and Associated Products Storage in Fixed Tanks.

View of three (3) aboveground fuel oil tanks for refueling farm equipment (APEC 2).

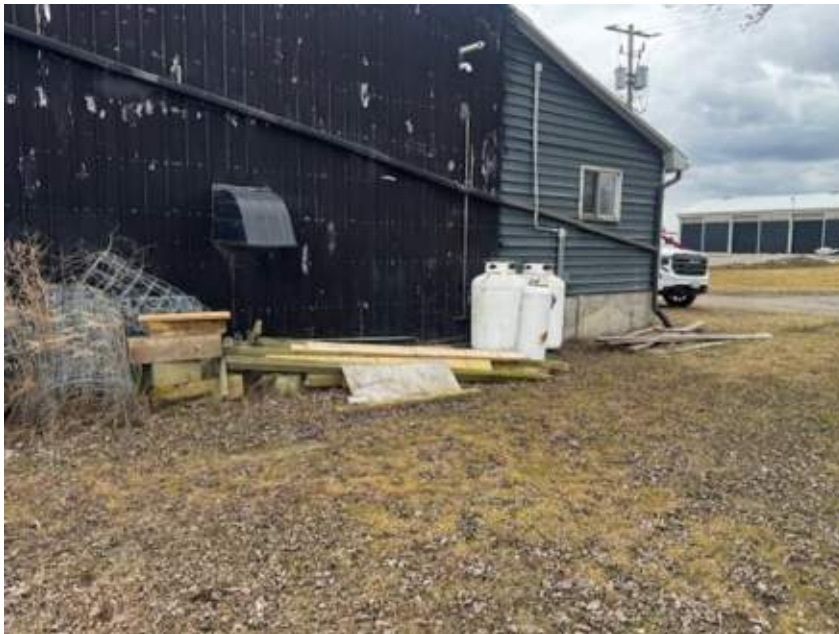
**PHOTOGRAPH 10**

View of three (3) propane tanks located outside the Building B.

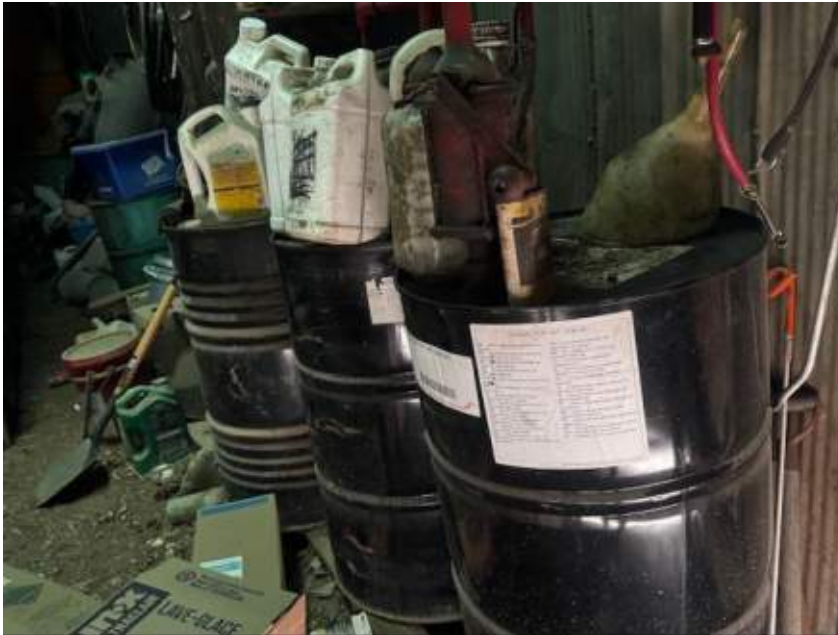
**PHOTOGRAPH 11**

| <b>APEC<sup>1</sup></b> | <b>Location of APEC on Phase One Property</b> | <b>PCA<sup>2</sup></b> | <b>Location of PCA (On-Site or Off-Site)</b> | <b>COPCs<sup>3</sup></b> | <b>Media Potentially Impacted (Groundwater, soil and/or sediment)</b> |
|---|---|---|---|---|---|
| Hydraulic oil drums and plastic pails storing lubricant placed inside the maintenance shop- Building B on bare ground.<br><br><b>(APEC 5)</b> | Within Northwest quadrant - Phase One Property | PCA#52 Storage, maintenance, fueling and repair of equipment, vehicles, and materials used to maintain transportation systems | On-Site<br><br><b>(PCA 5)</b> | Metals, VOCs, BTEX, PHCs | Soil |

Building B is used as a maintenance shop and equipment storage shed. The north portion of the building is used as a shop area where various chemicals and tools typically employed for maintenance activities were identified. These maintenance chemicals including retail size packing of degreaser, exhaust fluid, cleaner, truck wash and wax, gear lube, synthetic oil, pump oil, engine oil, hydraulic. Some black staining was noted on the concrete floor within northeast portion of the shop area. The floor was not in great condition. Further, along the south wall of the shop, three drums of new hydraulic oil and several pails of lubricants were stored on a dirt floor. No staining was observed in this area.

View of hydraulic oil drums and plastic pails storing lubricant placed inside the maintenance shop-Building B on bare ground (APEC 5).

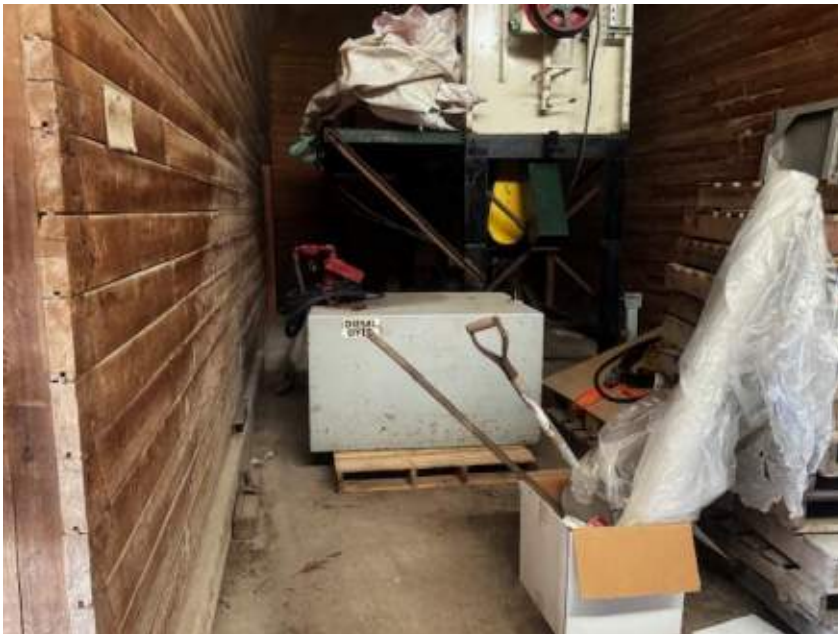
**PHOTOGRAPH 12**

Inside Building A, a small rectangular tank containing dyed diesel was observed, placed on a wooden skid. This is not a fixed tank and being a mobile tank, it is not considered PCAs.

View of portable, mobile diesel tank, located inside Building A.

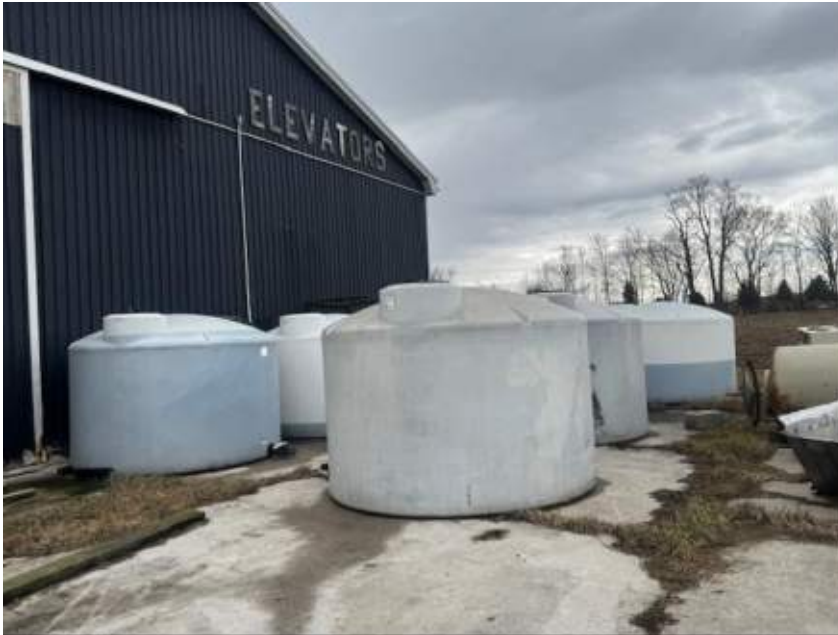
**PHOTOGRAPH 13**

Six (6) 1,550-gallon plastic tanks containing liquid fertilizer were observed placed on a concrete pad north of Building A. The totes are associated with PCA#22 – Fertilizer Manufacturing, Processing and Bulk Storage. The concrete pad was observed to be in poor condition with several cracks.

Bulk storage of liquid fertilizer in plastic vertical aboveground tanks located north side of Building A (APEC 6).

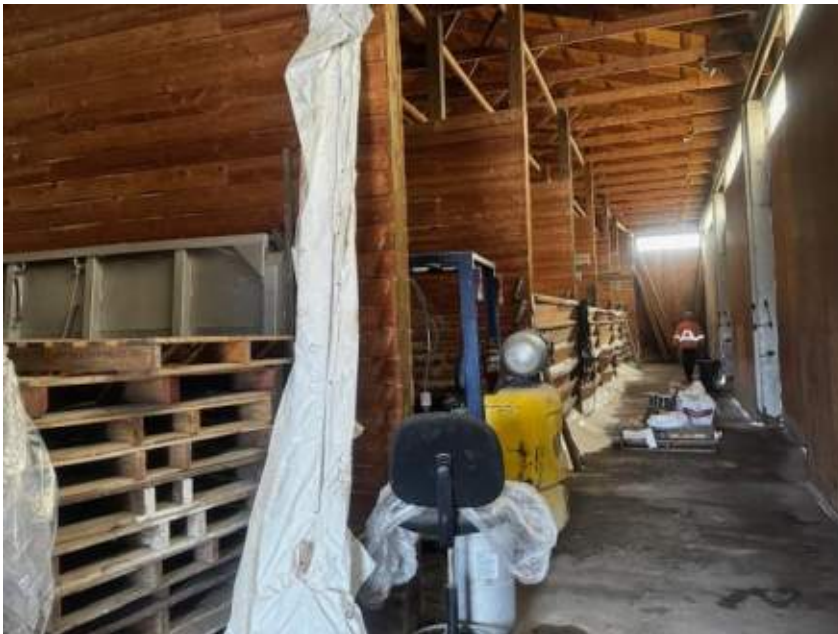
**PHOTOGRAPH 14**

View of bulk storage of granular/powder fertilizer inside Building A (APEC 7).

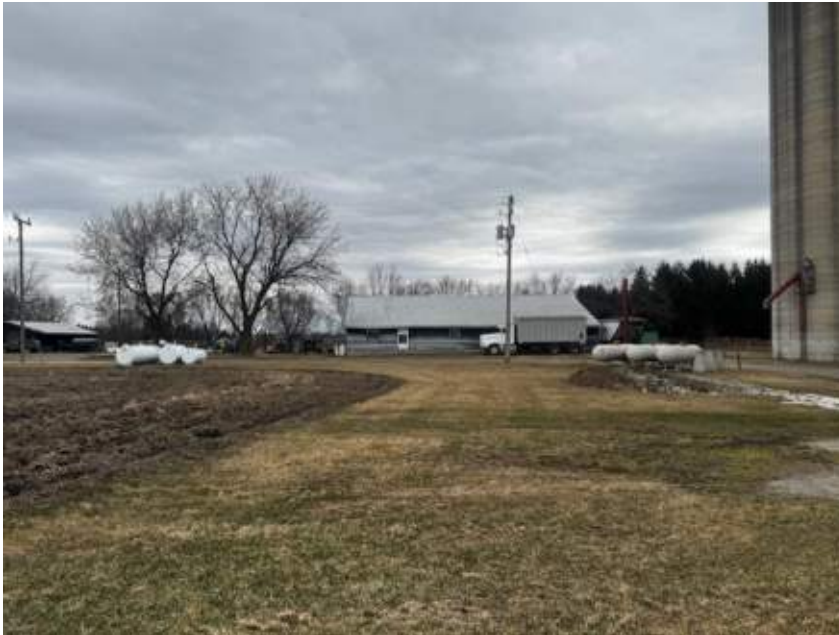
**PHOTOGRAPH 15**

A total of four (4) pole-mounted transformers were observed on Site. Three (3) pole-mounted transformers were identified west of Building B. One (1) pole-mounted transformer was identified west of Building D. The transformers appeared to be in good condition, free of rust or strains. No staining was identified on the surrounding grounds. The transformers are considered associated with PCA#55 – Transformer Manufacturing, Processing and Use.

Presence of pole mounted transformer located west of Building B and D (APEC 9, 10).
