**PHASE I ENVIRONMENTAL SITE ASSESSMENT  
CSA STANDARD**

**PROPOSED RESIDENTIAL DEVELOPMENT**

**EAST OF JACK KENNY COURT, NORTH OF GRAPEVINE ROAD  
TOWN OF CALEDON**

**Reference No. 1305-E166**

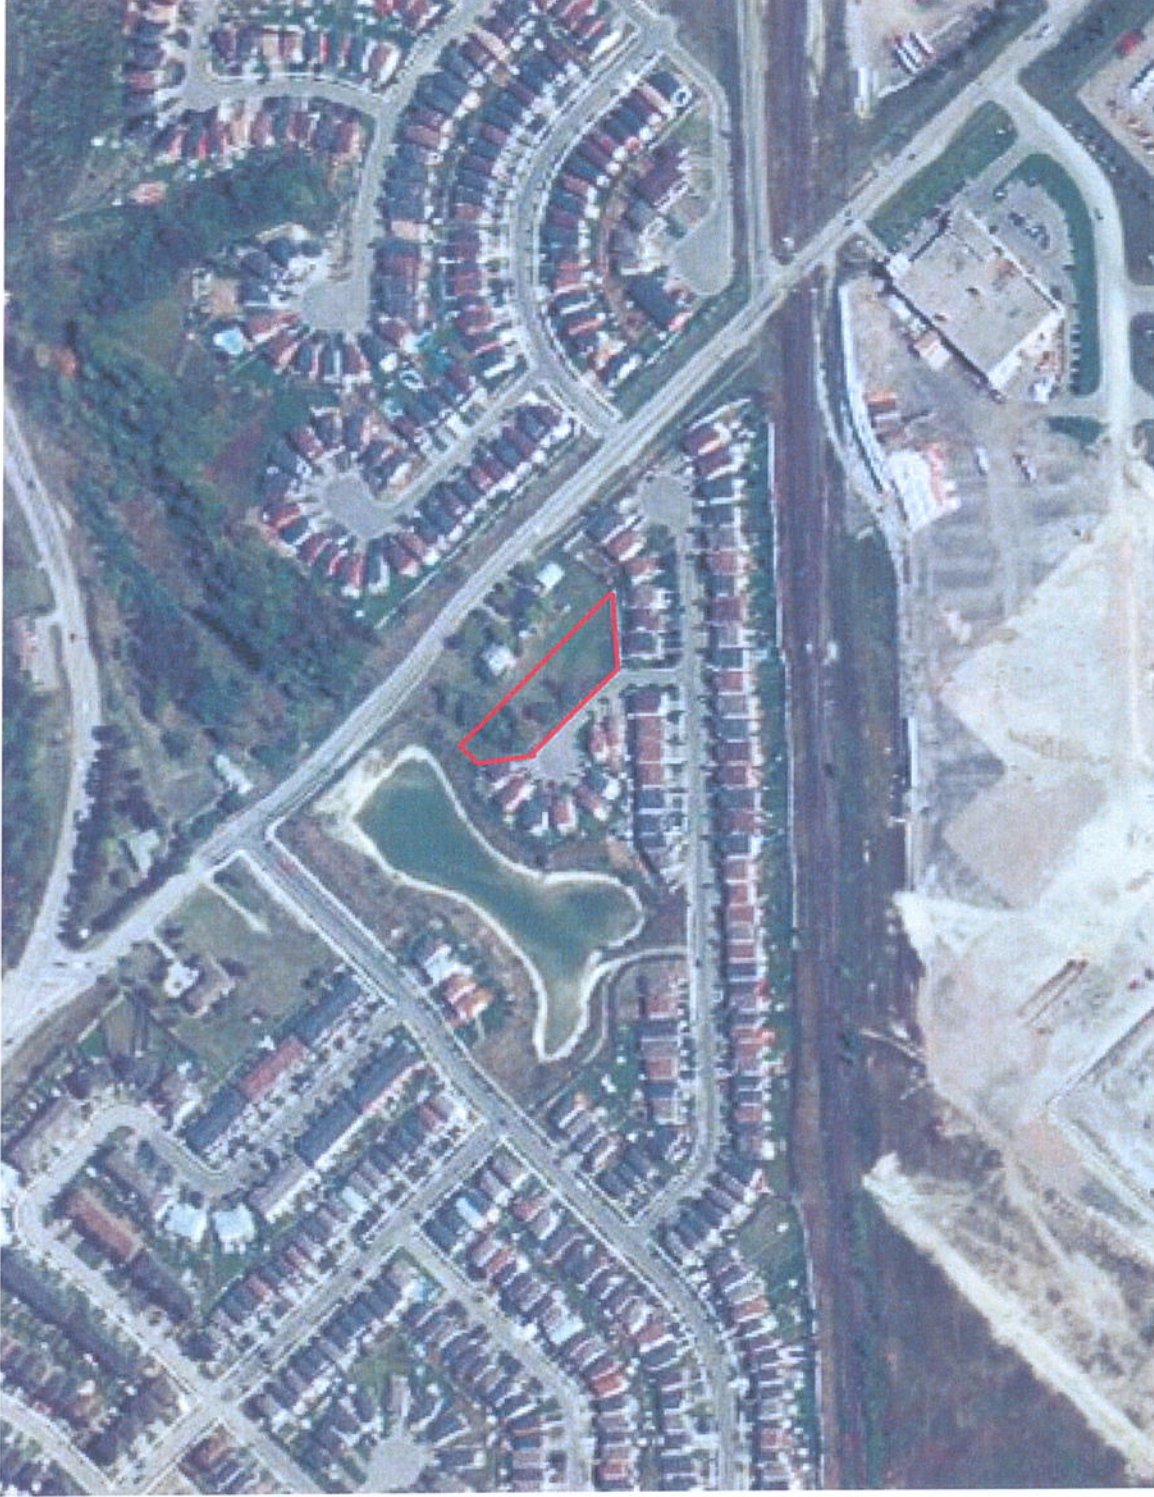
Title	Site Location Plan
Project	Proposed Residential Development east of Jack Kenny Court, north of Grapevine Road Town of Caledon
Reference No.	1305-E166
Date	June 12, 2013
Scale	As drawn
Drawing No.	1

The location of the site is shown in the Site Location Plan, Drawing No. 1. The Property Identification Numbers (PIN) of the subject site is 0124, 1784, and 0728, as shown on the Property Index Map (Block 14326), Drawing No. 2.

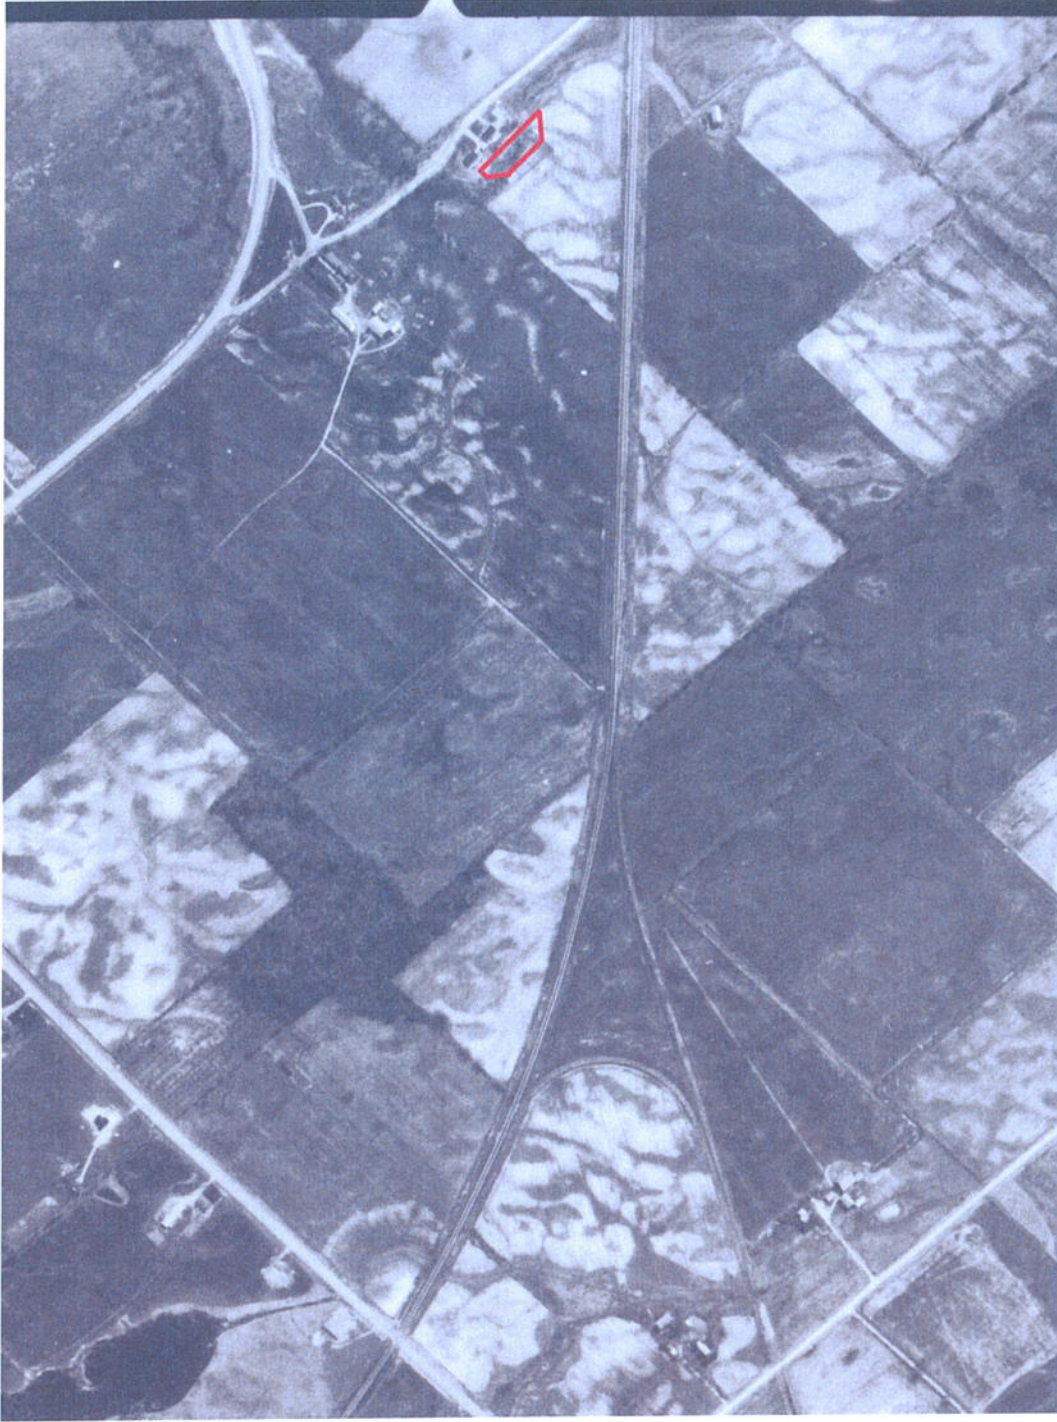
Title	1954 Aerial Photograph
Project	Proposed Residential Development east of Jack Kenny Court, north of Grapevine Road, Town of Caledon
Reference No.	1305-E166
Date	June 12, 2013
Scale	As drawn
Appendix 'B'	1 of 5

The 1954, 1964, 1978, and 1988 aerial photographs show the subject site was part of a large agricultural land. In the 2010 aerial photograph, the subject site is vacant and is surrounded by residential developments in all directions, with a new roadway (i.e. Jack Kenny Court) bordering the western section of the subject site. A new storm water management pond is observed northwest of the subject site. In all these aerial photographs, a railway track (i.e. Canadian Pacific Railway) is located approximately 90 m south of the subject site. Copies of the aerial photographs are presented in Appendix 'B'.

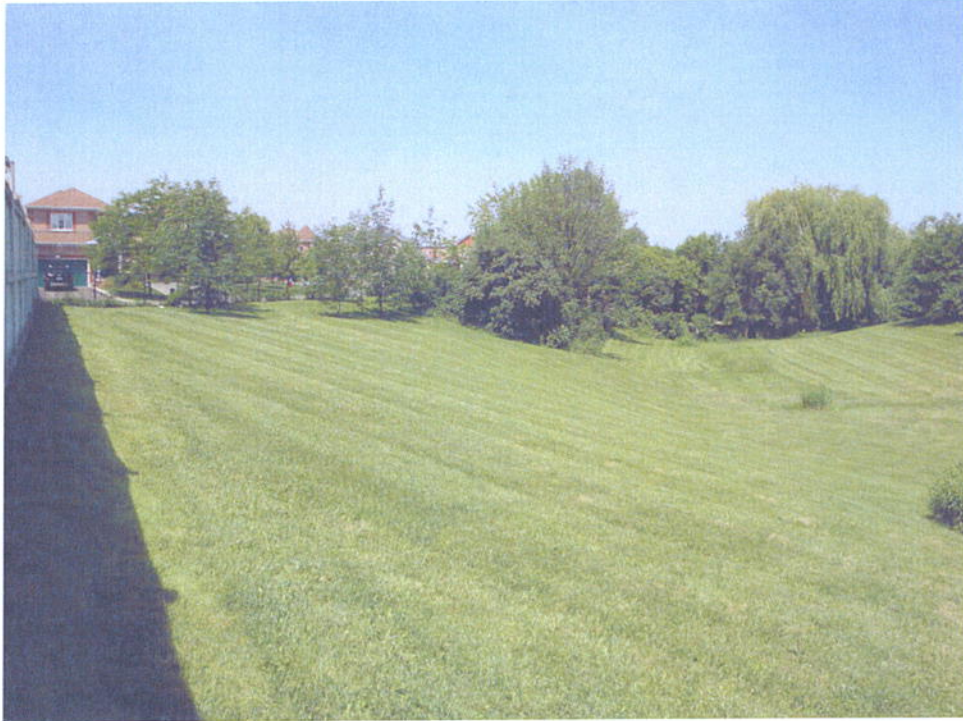
General view of the subject site (viewing north)

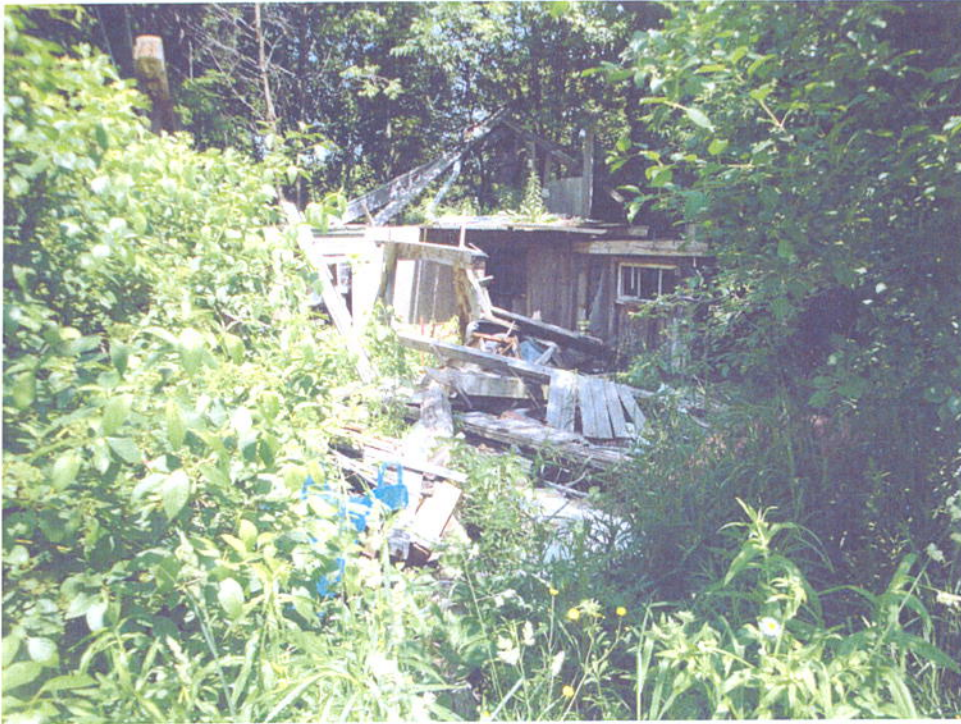
Our representative checked for the presence of substance containers such as oil drums, used oil containers, gasoline jerry cans, paint cans, etc. At the time of our inspection, empty plastic drums were observed within the collapsed barn premises.

Currently, no waste is generated on the subject site. However, domestic debris such as empty plastic drums was observed within the collapsed barn premises.

- Domestic debris with collapsed barn is observed in the central section of the subject site. (Source: Site Inspection)

View of the collapsed barn located in the northern section of the subject site (viewing north)

Debris from the remained of the collapsed barn are founded at the central section of the subject site. As no material of concern was noted during our site reconnaissance, debris items are considered more of a nuisance than a hazard. It is recommended that during construction, any deleterious debris found on the surface or buried on the subject site must be removed and disposed off properly.

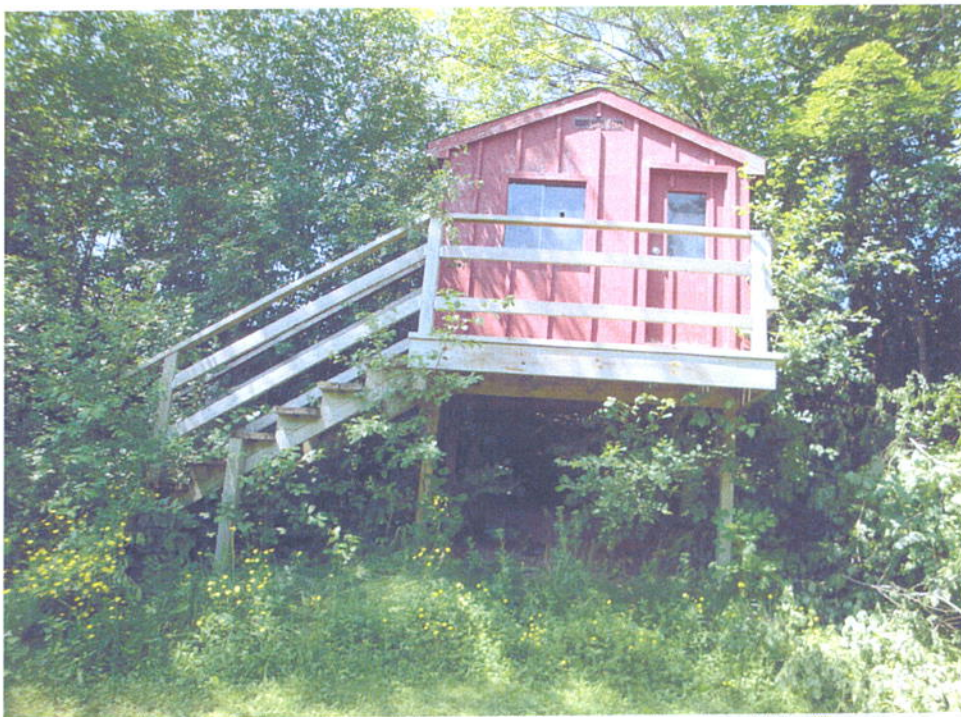
Silica is a natural material found in rocks and masonry units. As the tree house and the collapsed barn were built with wooden material, it is unlikely that Silica is present on the subject site.

View of the tree house located in the northern section of the subject site (viewing west)

It should be noted that certain hazardous materials (i.e. lead paint) may be present on the subject site. Since the structures are not part of the development plan, the designated substances will normally be dealt with by the builders or constructors, prior to any demolition of the structures, through the Occupational Health and Safety Act. This is not considered as an environmental concern in this report.

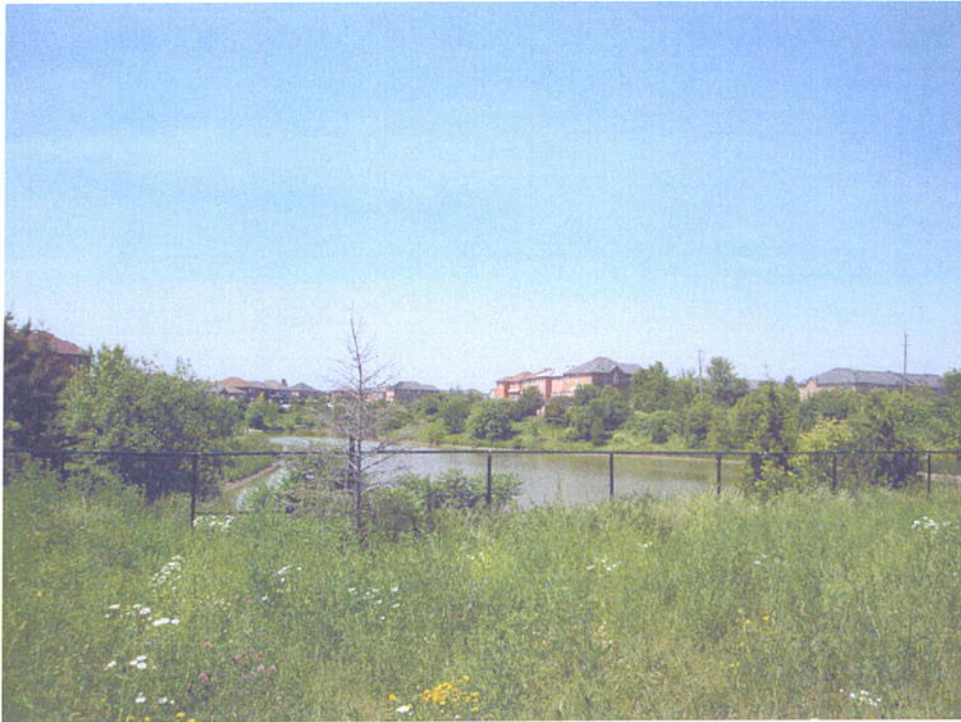
View of the storm management pond located north of the subject site(viewing north)
