**CULTURAL HERITAGE RESOURCE ASSESSMENT:
BUILT HERITAGE RESOURCES AND CULTURAL HERITAGE LANDSCAPES**

EXISTING CONDITIONS AND PRELIMINARY IMPACT ASSESSMENT

**THE MANORS OF BELFOUNTAIN, PART OF THE EAST HALF AND WEST HALF OF LOT 9,
CONCESSION V, W.H.S**

**FORMER TOWNSHIP OF CALEDON, COUNTY OF PEEL
TOWN OF CALEDON, REGIONAL MUNICIPALITY OF PEEL, ONTARIO**

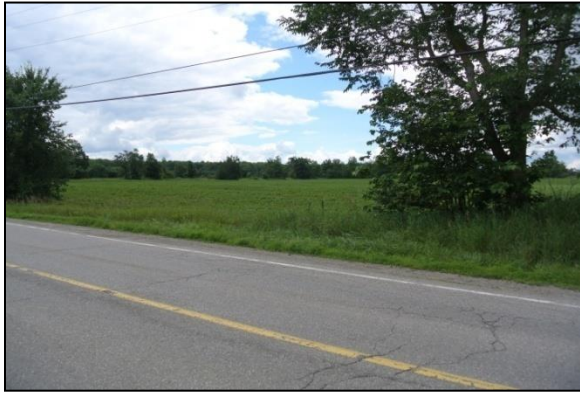
Plate 1: Southwest view into the study area from the Blair-Belfountain Cemetery (July 2014).

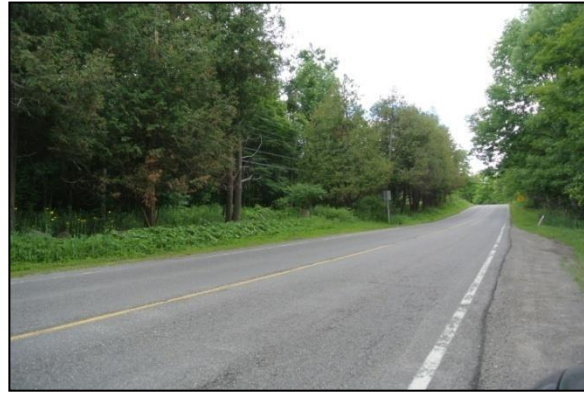
Plate 2: Looking southwest into the study area along Mississauga Road (July 2014).

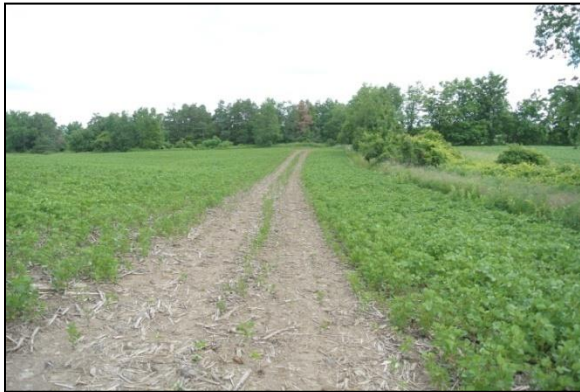
The south half of the study area consists of agricultural fields under cultivation separated by mature tree lines consisting of ash, oak, and maple (Plates 3 and 4). These field dividers also feature low-lying stone deposits resulting from stone-throw from field-clearing activities and delineate one section of agricultural field from the next (Gage 2014). The western portion of the agricultural fields adjacent to Shaw Creek Road also features several large stone piles up to two metres in height that are a result of field clearing activities (Town of Caledon, personal communication). These stone field dividers and small stone mounds are featured in many areas in the agricultural portion of the study area (Plates 5 to 8). A small area in the eastern portion, directly adjacent to Mississauga Road, is made up of woodlot. Blair-Belfountain Cemetery (CHL 1) is located adjacent to the southeast corner of the study area on the opposite side of Mississauga Road.

Plate 3: View of agricultural fields, tree lines, and access road within the centre of the study area, looking east (July 2014).

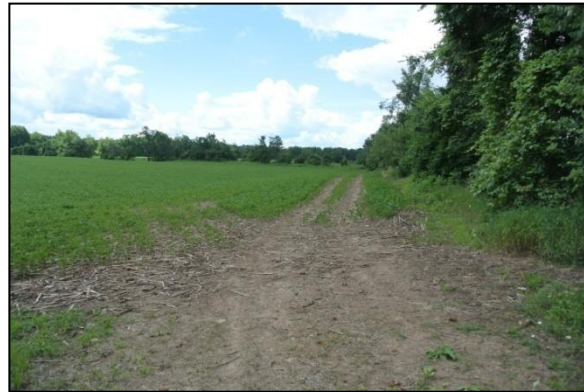
Plate 4: Southwest view of agricultural fields and access road (July 2014).

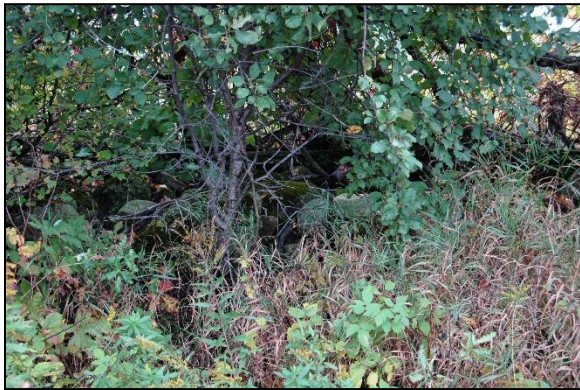
Plate 5: Stone-throw in vegetated field divider in southwest portion of the study area (Douglas McGlynn, Town of Caledon, October 2018).

3. According to the development plan the vegetated stone field dividers and stone mounds in CHL 2 and in the southwestern portion of the study area will be suitably preserved in the proposed development application. The proposed undertaking should be designed in a manner that incorporates existing stone features in situ to delineate lot lines, roadways, and parks, where appropriate. Where retention and avoidance of the vegetated stone field dividers and stone mounds associated with agricultural field clearing is determined to be infeasible, a suitable commemoration/interpretation plan should be implemented. Suitable commemoration and/or interpretation could entail, but is not limited to, creation of landscape features, gateway structures, or similar commemorative displays using the remnants of these stone features as a construction material;

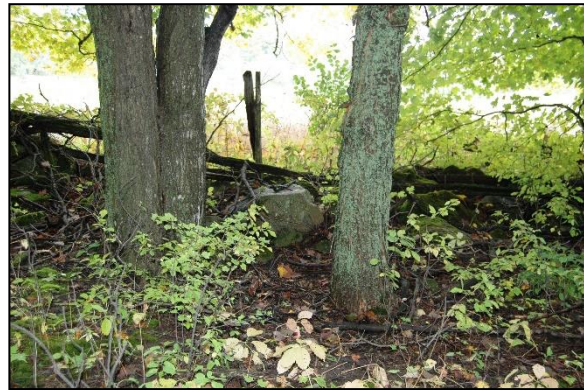
Plate 6: Vegetated field divider with stone-throw and split-rail fence in the southwest portion of the study area (Douglas McGlynn, Town of Caledon, October 2018).

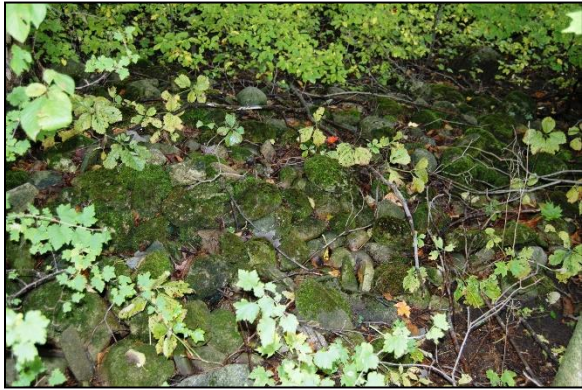
Plate 7: Stone rubble mound resulting from field clearing activities in the southwest portion of the study area (Douglas McGlynn, Town of Caledon, October 2018).

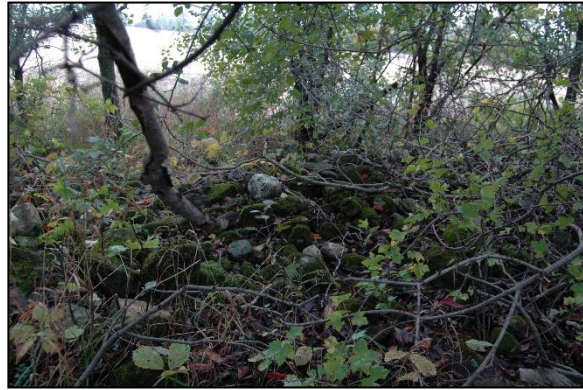
Plate 8: Stone rubble mound resulting from field clearing activities in the southwest portion of the study area (Douglas McGlynn, Town of Caledon, October 2018).

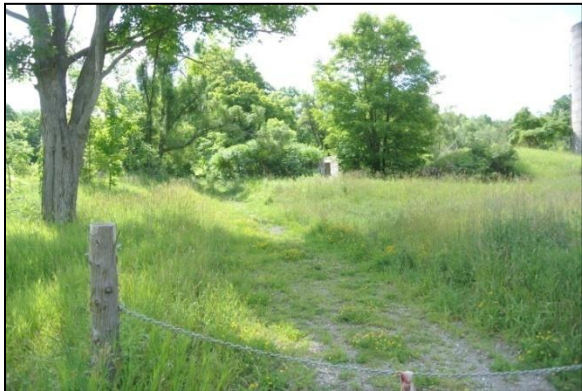
Plate 9: Looking southeast into the study area from Mississauga Road. Note the circulation route leading into CHL 2 (July 2014).

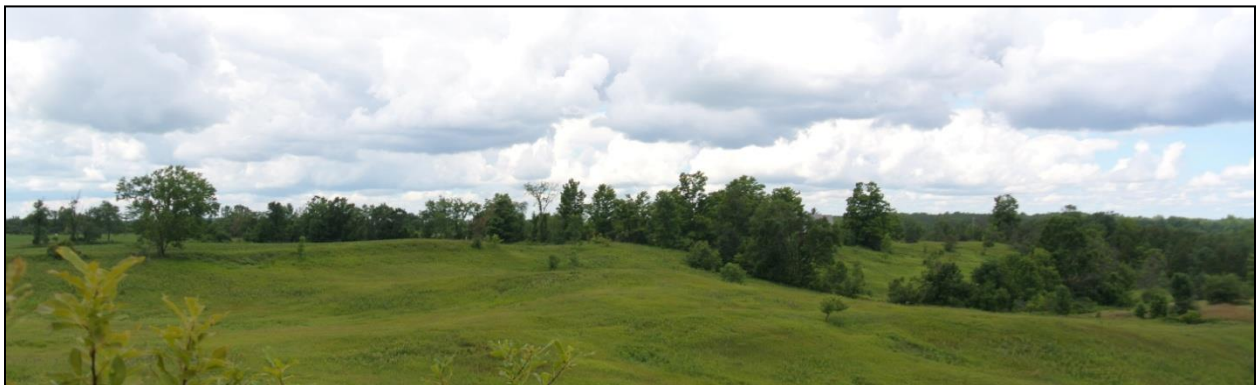
Plate 11: Northwest view toward Belfountain (July 2014).

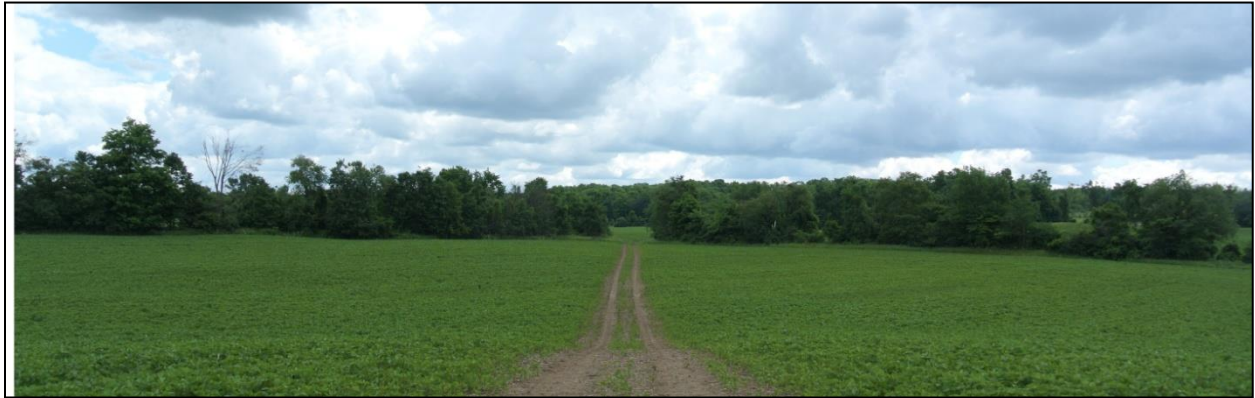
Plate 12: East view along access road to the agricultural fields making up the southern portion of the study area (July 2014).

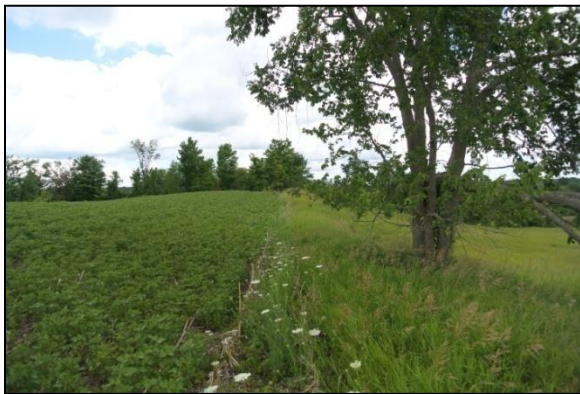
Plate 13: Northwest view toward Belfountain. Note the boundary between agricultural land and grassland (July 2014).

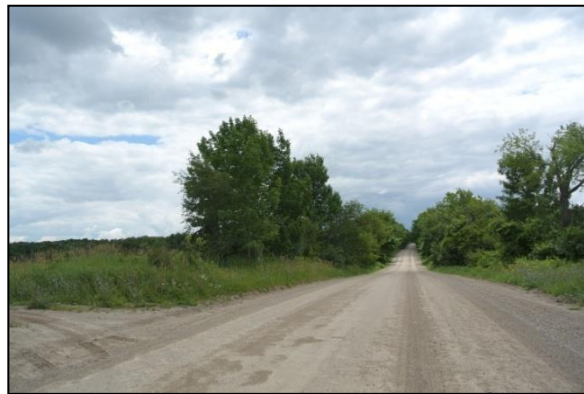
The north half of the study area consists of three distinct areas. The first is comprised primarily of woodlot and grassy fields, defined in part by a steep grade sloping northward from the agricultural fields to the south and toward Mississauga Road. This natural boundary stretches generally east-west, approximately 170 metres to the south of Mississauga Road. An abandoned farm complex (CHL 2), consisting of a silo, remnant stone barn, and the concrete foundations of two outbuildings, sits adjacent to Mississauga Road. The second area is comprised of grassy fields generally south of Belfountain (Plates 9 and 10). Two grassy fields are separated by CHL 4, which consists of a nineteenth-century brick gothic farmhouse, a nineteenth-century barn on stone foundations, as well as a tennis court, pool, and outbuilding. Post-and-rail fencing and field stone retaining walls are visible within the property. The third area is defined by agricultural fields under cultivation bounded by mature tree lines (Plates 11-13). Plate 14 captures Shaws Creek Road which defines the western boundary of the study area (CHL 6).

Plate 14: Southeast view along Shaws Creek Road. Note the entry to the study area via an agricultural access road on the left-hand side (July 2014).

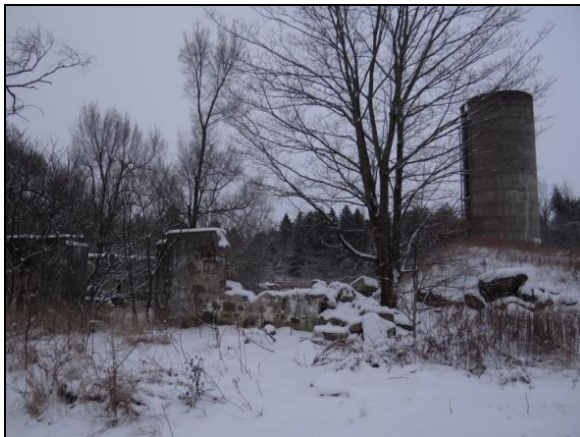
Plate 15: Remnant farmscape (CHL 2) structures, looking southwest from Mississauga Road (December 2017).

2. CHL 2 is expected to be impacted through alteration to setting by the removal of replaceable landscape features (i.e. vegetation and mature tree-lined agricultural fields with low stone dividers and mounds). The feasibility of implementing tree protection proposed by BTI in Figure 9 should be investigated for all identified cultural heritage resources where tree removals are planned. If possible, tree protection proposed by BTI in Figure 9 should be implemented for established tree-lined field dividers and circulation routes in CHL 2;

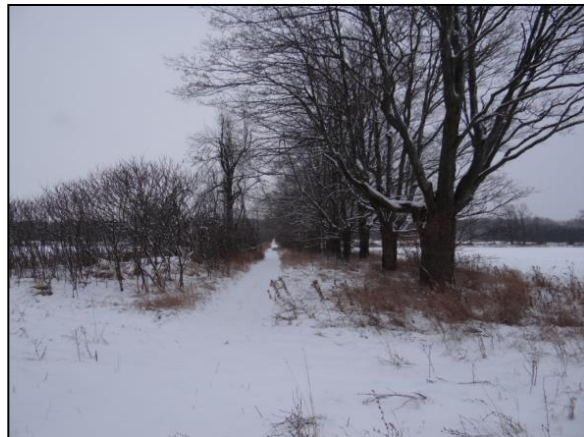
Plate 16: Mature tree-lined farm road in the eastern portion of the study area, looking south (December 2017).

7. Where possible, mature trees within the Manors of Belfountain study area should be preserved. The feasibility of implementing tree protection proposed by BTI, as depicted in Figure 9, should be investigated where removal of mature trees is planned. Where mature trees are anticipated to be removed, replanting with native species should be undertaken, where feasible. In this respect a qualified arborist or landscape architect should be consulted to determine the most appropriate species;

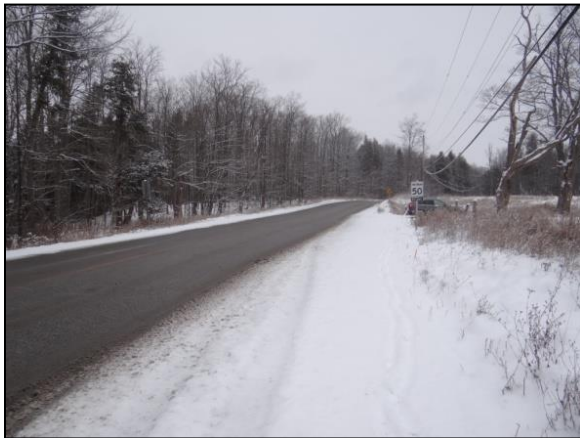
Plate 17: Mississauga Road, looking southeast towards CHL 2 (December 2017).

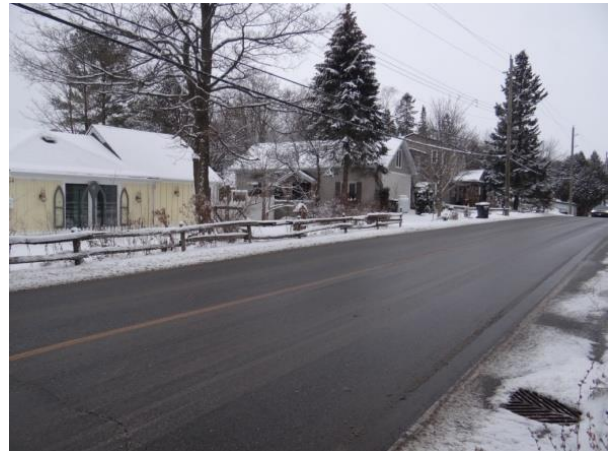
Plate 18: Old Main Street, looking northwest towards Belfountain (December 2017).

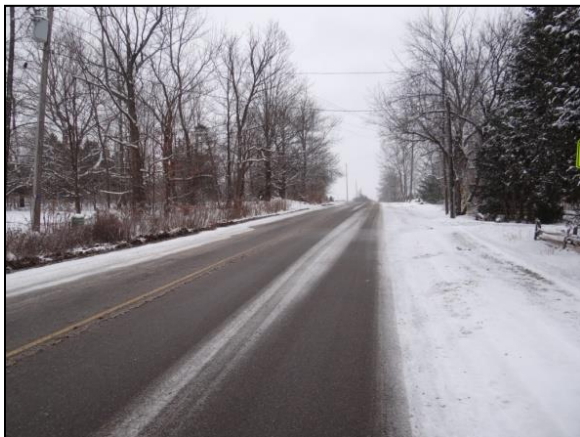
Plate 19: Shaw's Creek Road, looking south from Bush Street (December 2017).

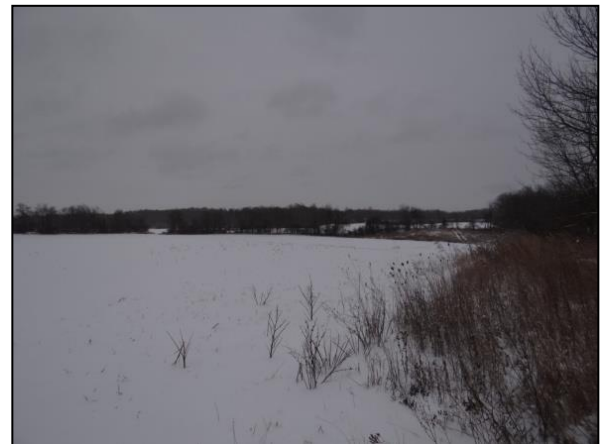
Plate 20: Agricultural fields with established tree lines, looking southeast from Shaw's Creek Road (December 2017).

CHL 2 is anticipated to be directly impacted as a result of soil grading and construction related activities, change in land use from agricultural to residential, and the destruction of established vegetated field dividers, some of which feature mature trees, stone mounds, and remnant fencelines. Where feasible vegetated field dividers featuring stone-throw in CHL 2 should be retained and avoided within the proposed development. The proposed undertaking should be designed in a manner that incorporates existing stone features in situ to delineate lot lines, roadways, and parks, where appropriate. The extent of the vegetated field dividers featuring stone-throw are illustrated in Appendix C (Figures 8 and 9), with only small portions where the field dividers intersect with roadways, residences, and storm management pond resulting in their removal. According the available documentation, these vegetated field dividers featuring stone-throw within CHL 2 and extending into the southwestern portion of the study area will be suitably preserved in the proposed development application.

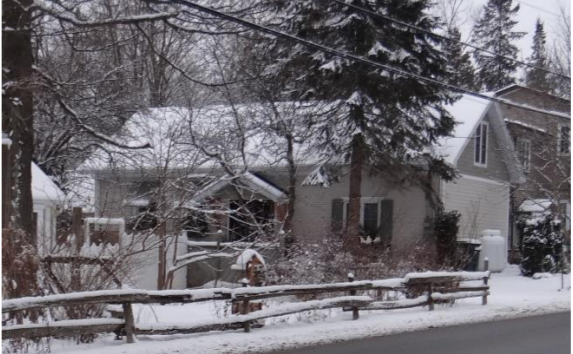
Resource	Type	Address/Location	Level of Significance	Description of Cultural Heritage Value or Interest	Photos
BHR 1	Residence	17170 Old Main Street	Listed, Town of Caledon BHR Inventory	<p>Historical Value The Town’s BHR inventory indicates that the house as an altered cottage built between 1900-1924. The structure is visible on mapping dating to 1994 as well as aerial photography dating to 1954.</p> <p>Design Value The structure appears to be a frame building with vinyl siding, a gable roof covered with asphalt shingles, and modern windows. The type of foundation upon which the structure rests was unable to be determined during field review.</p> <p>Contextual Value This early twentieth-century 1 ½ storey residence sits on the south side of Old Main Street, just north of the study area.</p>

<p>View of the east elevation of the residence.</p>
BHR 2	Residence	17176 Old Main Street	Listed, Town of Caledon BHR Inventory	<p>Historical Value The Town’s BHR inventory indicates that the house was built between 1900-1924. The structure is visible on mapping dating to 1994 as well as aerial photography dating to 1954.</p> <p>Design Value This two-storey residence built retains clapboard and board-and-batten cladding, a gable roof with asphalt shingles. The foundation material was undetermined during field review. The property retains a driveshed/carriage house of frame construction and board-and-batten cladding.</p> <p>Contextual Value Located on Old Main Street, an historical surveyed road in the settlement of Belfountain. Demonstrates early-twentieth century residential patterns in the Town of Caledon.</p>

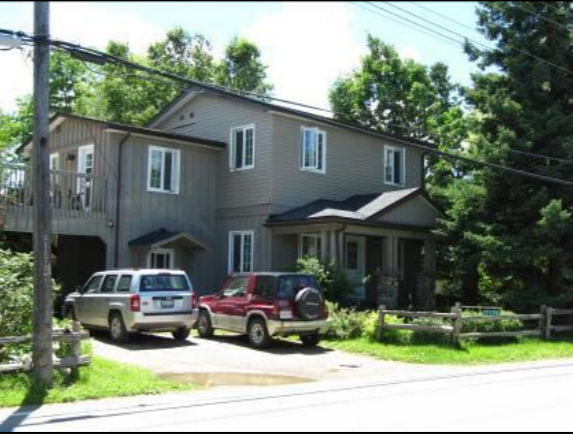
<p>View of the north and east elevations of the residence.</p>

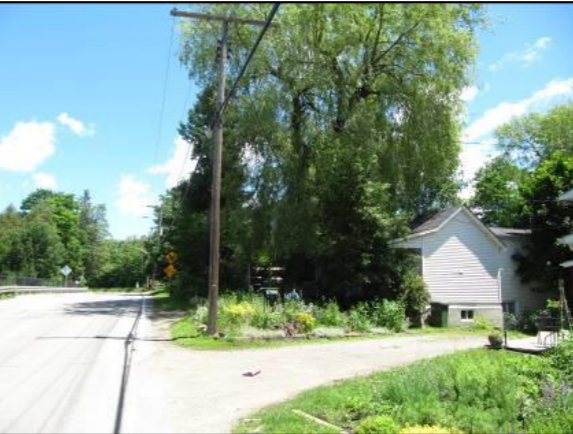
BHR 3	Residence	17180 Old Main Street	Listed, Town of Caledon BHR Inventory	<p>Historical Value The Town’s BHR inventory indicates that the house was built between 1900-1924. The structure is visible on mapping dating to 1994 as well as aerial photography dating to 1954.</p> <p>Design Value This early twentieth-century, one-storey vernacular residence retains a two-storey rear extension. A gabled roof with asphalt shingles rests upon the original structure while a flat roof covers the addition. The structure retains clapboard siding, a front porch, and concrete foundations.</p> <p>Contextual Value Located on Old Main Street, an historical surveyed road in the settlement of Belfountain. Demonstrates early-twentieth century residential patterns in the Town of Caledon.</p>

<p>View of the west elevation of the residence.</p>

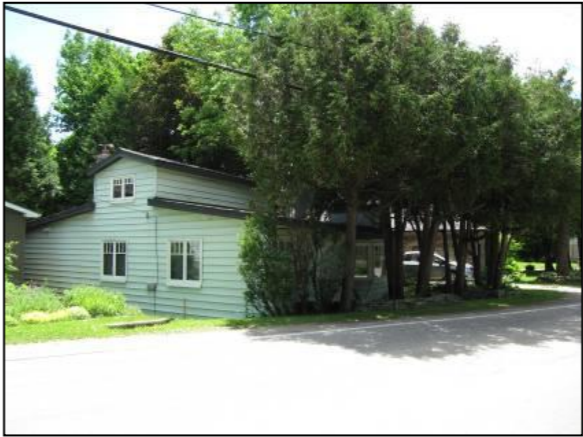
Resource	Type	Address/Location	Level of Significance	Description of Cultural Heritage Value or Interest	Photos
BHR 4	Residence	17190 Old Main Street	Listed, Town of Caledon BHR Inventory (also in Stewart and Dilse; 24)	<p>Historical Value The Town's BHR inventory indicates that the house was built between 1900-1924. The structure is visible on mapping dating to 1994 as well as aerial photography dating to 1954.</p> <p>Design Value This residence appears to be an early twentieth-century vernacular one-and-a-half storey structure. The house retains vinyl siding, gabled roof with asphalt shingles, modern casement windows, and enclosed front porch. The foundation was not visible from the Old Main Street right of way.</p> <p>Contextual Value Located on Old Main Street, an historical surveyed road in the settlement of Belfountain. Demonstrates early-twentieth century residential patterns in the Town of Caledon.</p>

<p>View of the north and west elevation of the residence.</p>

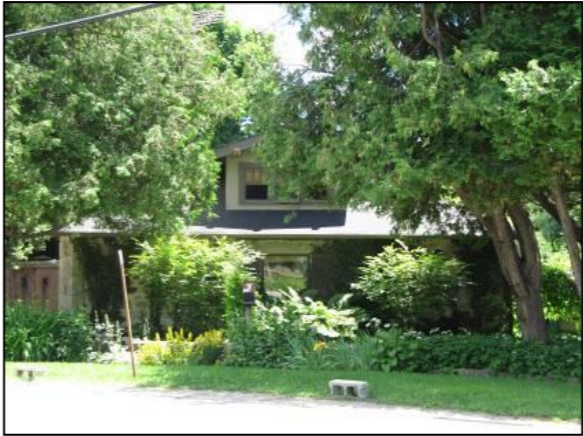
BHR 5	Residence	17196 Old Main Street	Listed-High Significance, Town of Caledon BHR Inventory (also in Stewart and Dilse; 24)	<p>Historical Value The house is listed on the Town's BHR inventory as a building of high significance and confirms that the building was constructed between 1850-1874. The house is not individually depicted on the 1877 <i>Illustrated Historical Atlas of the County of Peel</i> as this map indicates the properties flanking Old Main Street as urban settlement. The structure is visible on mapping dating to 1994 as well as aerial photography dating to 1954.</p> <p>Design Value This one-and-a-half storey, nineteenth century stone regency cottage is built on the stone foundation of an early Methodist Church. The structure is of rubblestone construction and retains a hipped roof with asphalt shingles, a single internal rear brick chimney, a gabled dormer on the front façade, and modern casement windows.</p> <p>Contextual Value Located on Old Main Street, an historical surveyed road in the settlement of Belfountain. Demonstrates mid-late-nineteenth-century residential patterns in the Town of Caledon.</p>

<p>View of the north elevation of the residence.</p>

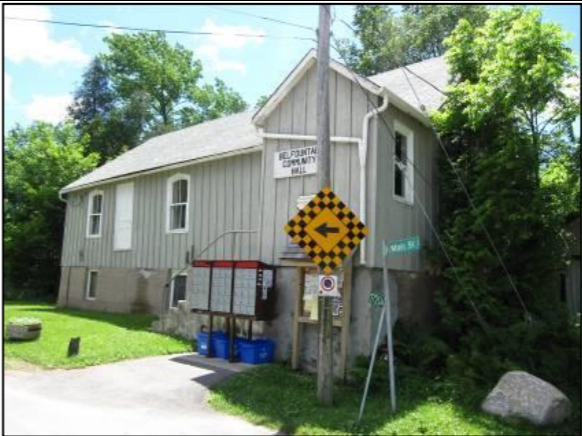
Resource	Type	Address/Location	Level of Significance	Description of Cultural Heritage Value or Interest	Photos
BHR 6	Community Hall	17204 Old Main Street	Listed-High Significance, Town of Caledon BHR Inventory	<p>Historical Value This building, known as the Belfountain Community Hall, was built in 1893. The structure is visible on mapping dating to 1994 as well as aerial photography dating to 1954.</p> <p>Design Value The structure has two storeys and a generally rectangular footprint sitting on stone foundations faced with concrete. The building retains wooden vertical board-and-batten siding, a gabled roof with asphalt shingles, 2/2 sash windows in original wooden frames, and an enclosed portico. The building was originally used as a public hall and later was home to a mechanic's institute. The structure is listed on the Town's BHR inventory as a building of high significance.</p> <p>Contextual Value Located on Old Main Street, an historical surveyed road in the settlement of Belfountain. Demonstrates late nineteenth-century residential patterns in the Town of Caledon.</p>

<p>View south towards the east elevation of the hall.</p>

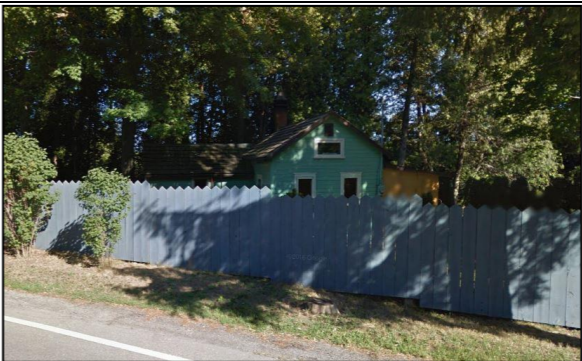
BHR 7	Residence	17153 Old Main Street	Listed, Town of Caledon BHR Inventory	<p>Design Value This one-and-a-half storey frame structure retains an L-shaped plan and gable roof. Exterior details of the residence are difficult to determine due to a high fence and significant tree cover. The house is listed on the Town's BHR inventory.</p> <p>Historical and Contextual Value Located on Old Main Street, an historical surveyed road in the settlement of Belfountain. Demonstrates early-twentieth century residential patterns in the Town of Caledon.</p>

<p>View south towards the east elevation of the hall.</p>
CHL 1	Cemetery	17025 Mississauga Road	Listed-High Significance, Town of Caledon BHR Inventory (also in Stewart and Dilse 2008; 42)	<p>Historical Value Cemetery not depicted in historical mapping consulted as part of this study. Headstones demonstrate interments dating from the late-nineteenth/early twentieth centuries.</p> <p>Design Value This landscape consists of the Blair-Belfountain Community Cemetery. It is situated on elevated ground, on the crest of a hill where Mississauga Road starts to decline into the valley where Belfountain is located. The property is bounded by tree lines and Mississauga Road. A laneway leads into the cemetery with stone pillars to mark the entrance. A modern retaining wall accommodates road grading activities and a metal culvert is also extant. The cemetery has been expanded to the southeast for new interments. This landscape can be described as a designed and evolved cultural heritage landscape.</p> <p>Contextual Value Located on Mississauga Road, an historical surveyed road south of the settlement</p>

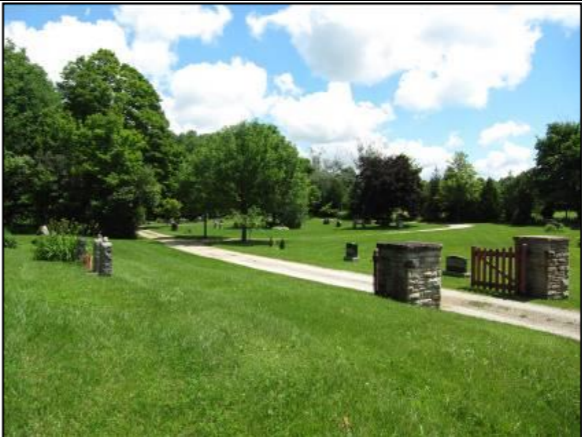
<p>View east towards the cemetery.</p>

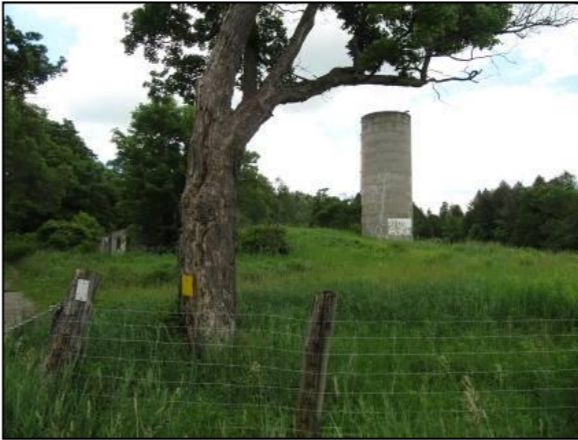
Resource	Type	Address/Location	Level of Significance	Description of Cultural Heritage Value or Interest	Photos
				of Belfountain. Demonstrates late-nineteenth/early-twentieth century mortuary patterns in the Town of Caledon.	
CHL 2	Remnant Farm Complex	n/a	Listed, Town of Caledon BHR Inventory	<p>Historical Value Remnant late-nineteenth-century farmstead established (ASI 2019).</p> <p>Design Value This remnant agricultural landscape consists of a silo, a remnant stone barn, and scattered concrete foundations. The silo is of concrete construction and sits atop a hill overlooking Mississauga Road. The remnant rubblestone barn is located directly to the south of the silo and is generally rectangular in shape and consisted of at least two separate rooms. Various circulation routes, including wooden doorframes, are visible within the remnant structure. The walls reach only ten feet at their highest. A rectangular concrete foundation is located approximately 20 metres to the west of the remnant barn structure while another generally square concrete foundation sits approximately 15 metres south of the remnant barn structure. The property is bounded by post and wire fencing and tree lines. A centrally located driveway is still extant and the vegetation is generally overgrown. This landscape can be described as an evolved cultural heritage landscape.</p> <p>Contextual Value Located on Old Main Street, an historical surveyed road in the settlement of Belfountain. Demonstrates late-nineteenth century residential patterns in the Town of Caledon.</p>

<p>View south towards the remnant farm complex.</p>

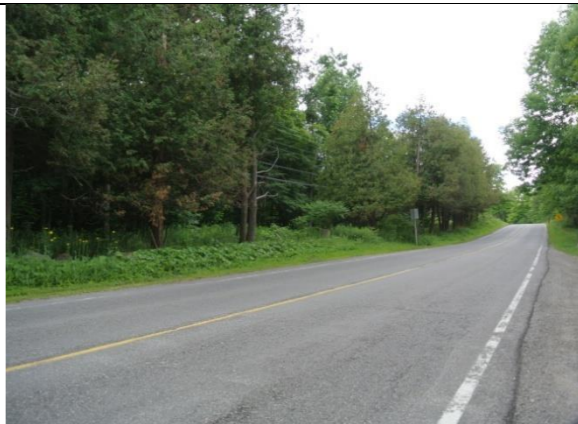
CHL 3	Roadscape	Mississauga Road/Old Main Street	No official recognition; Identified during field review	<p>Historical Value This landscape consists of buildings forming part of a historic settlement, historic fencelines, and the historic alignment of Mississauga Road.</p> <p>Design Value The generally north-south portion of the road retains gravel shoulders and mature treelines. The buildings on the south side of the generally east-west portion of the road are set close to the road ROW and consist of a mixture of nineteenth and twentieth century residential buildings. The streetscape lacks curbs and sidewalks and there are minimal shoulders. Mature vegetation and wooded fence lines are found throughout. This landscape can be described as an evolved cultural heritage landscape.</p> <p>Contextual Value Demonstrates nineteenth-century residential and transportation patterns in the Town of Caledon.</p>

<p>View west along Mississauga Road toward the remnant farm complex.</p>

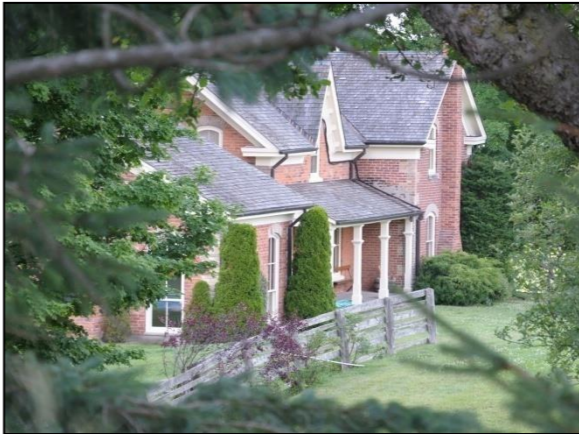
Resource	Type	Address/Location	Level of Significance	Description of Cultural Heritage Value or Interest	Photos
CHL 4	Farm Complex	17200 Mississauga Road	Listed-High Significance, Town of Caledon BHR Inventory (also in Stewart and Dilse; 24)	<p>Historical Value Both the residence and the barn are listed on the Town’s BHR inventory as structures of high significance, indicating that both buildings were constructed between 1875 and 1899. However, it is likely that the original farmhouse was constructed prior to 1877 as it is indicated on the <i>Illustrated Historical Atlas of the County of Peel</i>, published in 1877. The structure is also visible on mapping dating to 1994 as well as aerial photography dating to 1954.</p> <p>Design Value This landscape consists of a farmhouse, outbuilding, barn, tennis court, and pool. The one-and-a-half storey nineteenth-century farmhouse is of brick construction and reflects the Ontario Gothic architectural style. Two sympathetic brick additions are located at the north and the south of the farmhouse, the north retaining a rectangular footprint and one-and-a-half storeys and the south retaining a square footprint and single story. The Barn retains an L-shaped footprint and consists of a steel roof, vertical barnboard, and stone foundations. This landscape can be described as an evolved cultural heritage landscape.</p> <p>Contextual Value Located on Old Main Street, an historical surveyed road in the settlement of Belfountain. Demonstrates late nineteenth-century residential patterns in the Town of Caledon.</p>

<p>Oblique view of the east elevation of the residence.</p>

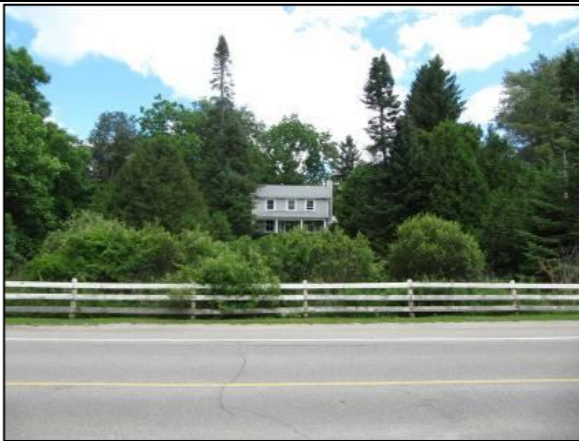
CHL 5	Residence; former farm complex	699 Bush Street	Listed-High Significance, Town of Caledon BHR Inventory (also in Stewart and Dilse 2008: 24; Scheinman 2009: 7-38, BC-7)	<p>Historical Value The farmhouse, known as the Drury Residence, was constructed ca.1860. Due to its location in the centre of Belfountain, no residence was recorded on the 1877 <i>Illustrated Historical Atlas of the County of Peel</i>. However, the structure is visible on mapping dating to 1994 as well as aerial photography dating to 1954.</p> <p>Design Value This landscape consists of a farmhouse, outbuilding, and landscape features. The residence is a 2-storey 3-bay structure with symmetrical facade, central entrance and gable roof; 2/2 sash windows; wood clapboard exterior; exterior chimney stack on west elevation; and a porch on front elevation covering the entire façade width. The house is located on elevated land, is set back from the ROW, and is surrounded by mature trees. Shrubbery and wooden fencing are located along the ROW. Aerial photographs show outbuildings behind the house. This is an evolved cultural heritage landscape. The residence is listed on the Town’s BHR inventory as a property of high significance.</p> <p>Contextual Value Located on Old Main Street, an historical surveyed road in the settlement of Belfountain. Demonstrates mid-late nineteenth-century residential patterns in the Town of Caledon.</p>

<p>View toward the north elevation of the residence, looking south.</p>

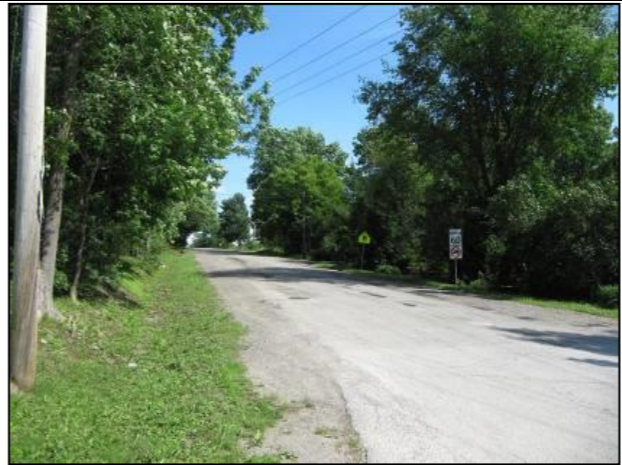
Resource	Type	Address/Location	Level of Significance	Description of Cultural Heritage Value or Interest	Photos
CHL 6	Roadscape	Shaw Creek Road (south of Bush Street)	Previously identified (ASI 2010)	<p>Historical Value This transportation corridor follows the original road allowances as indicated on historic mapping and contains elements evocative of its historic origin.</p> <p>Design Value The roadway features a narrow two-lane ROW; mostly gravel surface; and lacks shoulders. Undeveloped lands are located to either side of the ROW. Mature vegetation and wooded fence lines are found throughout. This landscape can be described as a designed cultural heritage landscape.</p> <p>Contextual Value Demonstrates nineteenth and twentieth-century transportation patterns in the Town of Caledon.</p>

<p>View south along Shaw Creek Road.</p>
CHL 7		Belfountain and the Credit River Gorge	Identified in the Town of Caledon's Cultural Heritage Landscapes Inventory (Candidate CHL)	<p>Historical Value The development of a milling industry at the waterfalls of the West Branch and East Branch of the Credit River led to a steady population growth from 1825. The village of Belfountain was itself laid out between Mill Street (River Road) and the river by 1850. By the 1870s, stone for construction material was in great demand, leading to the development of quarries along the escarpment and increased wealth to the area. This area of the Credit River is now a popular recreation area.</p> <p>Design Value This evolved landscape features remnant industrial and railway-related structures that were designed to integrate with the landscape of the surrounding Credit River.</p> <p>Contextual Value This evolved landscape combines settlements, both existing and disappeared, former milling and quarrying sites, railway heritage, recreational sites, and natural sites, all with strong cultural associations within the context of the Credit River Gorge. It is associated with a number of major themes central to Caledon's early settlement, namely the milling industry and Credit River Railway.</p>
