## Phase One Environmental Site Assessment

0 Atchison Drive, Caledon, Ontario  
G2S18845

Pluribus Corp.  
7681 Highway 27 (Unit # 16)  
Woodbridge, Ontario, L4L 4M5

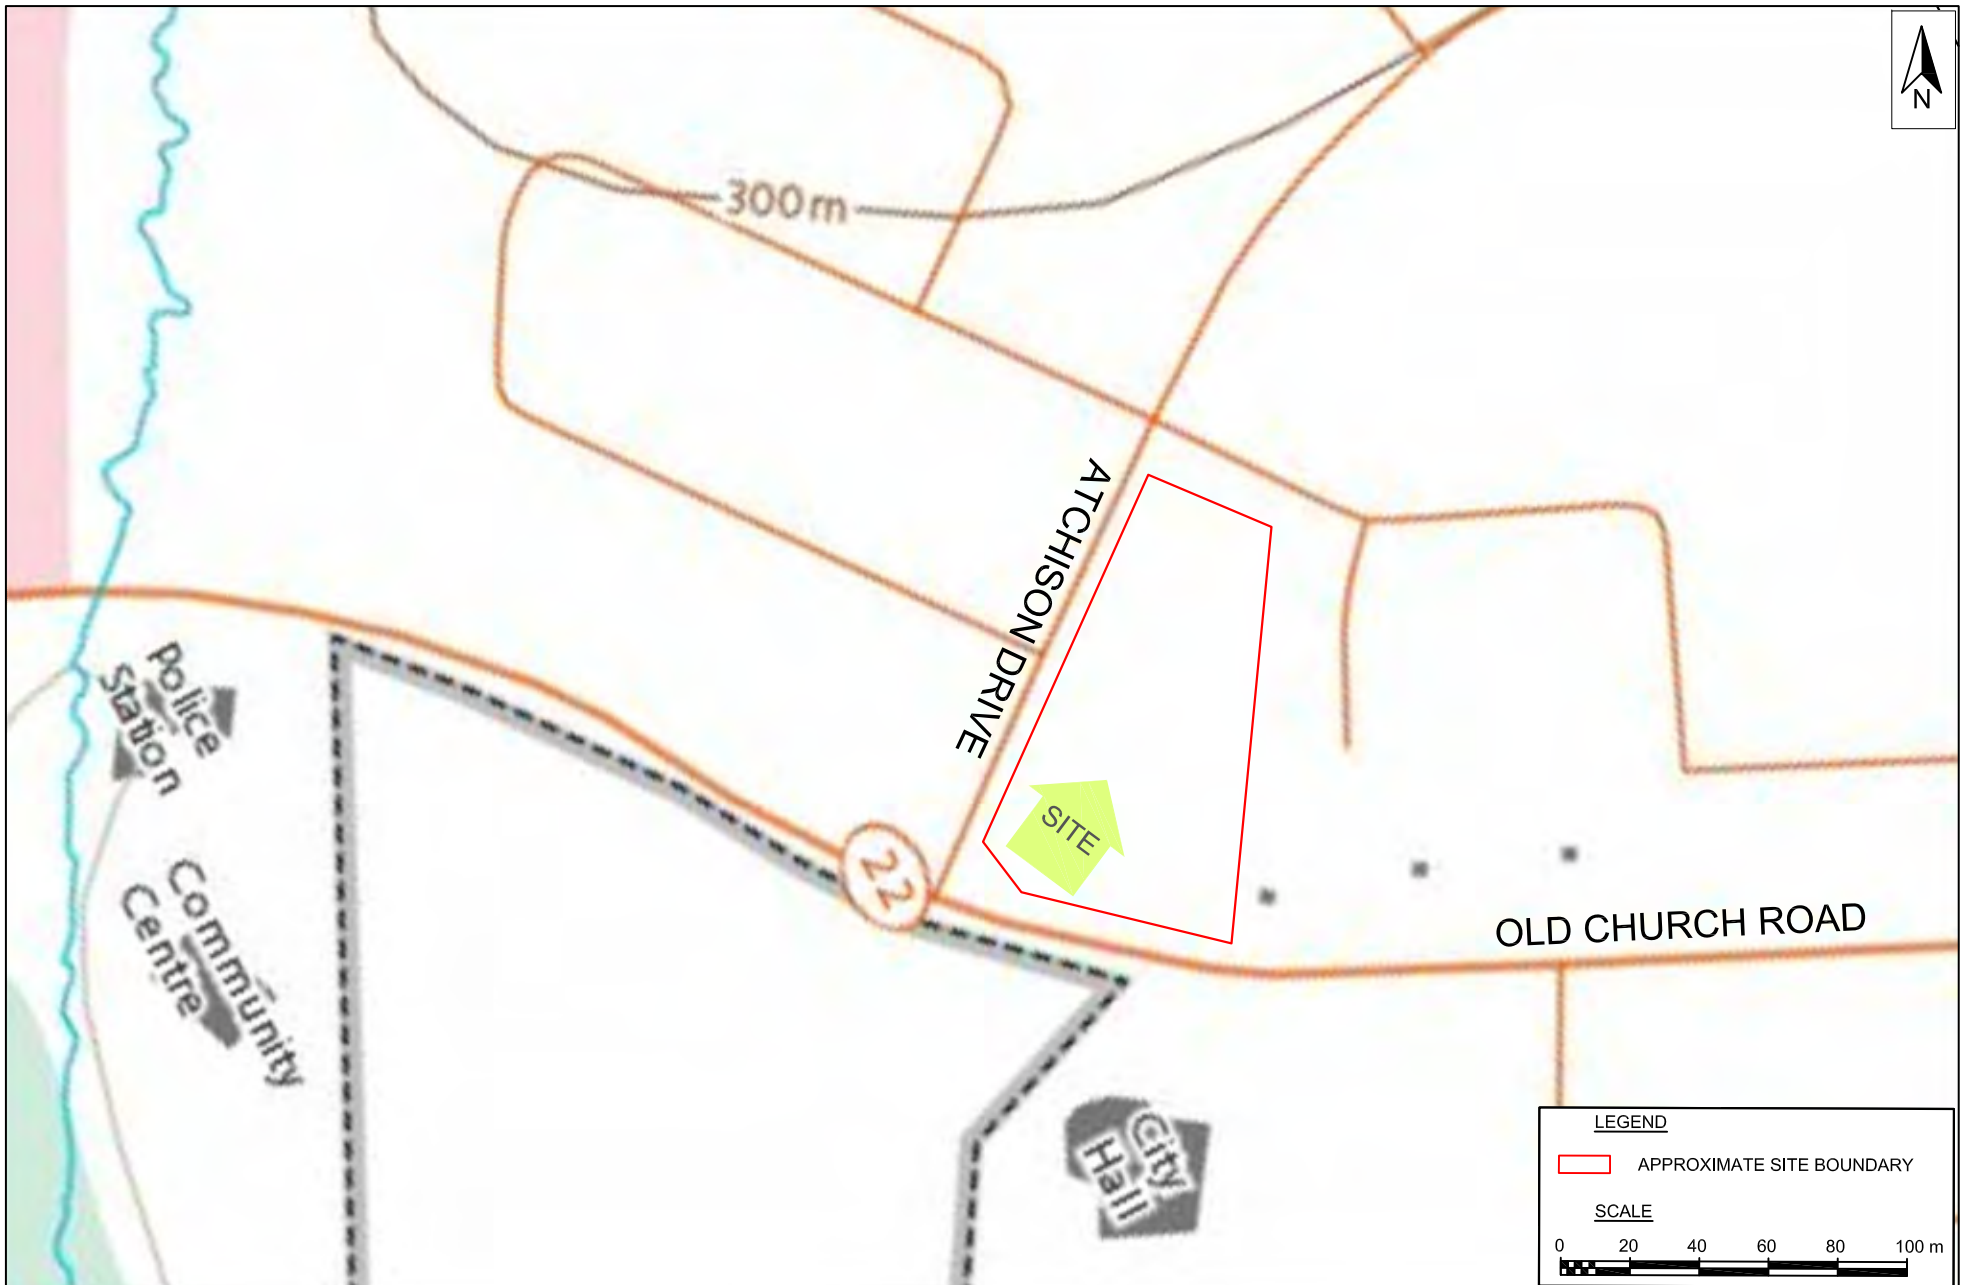
0 ATCHISON DRIVE  
 2018 TOPOGRAPHIC MAP

Surface water from the Site is expected to infiltrate through the grassed/vegetated surfaces of the Site. Topographic maps show surface elevations to be decreasing in a south/southeast direction. Based on our observations and review, the expected direction of groundwater flow in the area of the Site is to the south/southeast, following surface topography towards Innis Lake, located approximately 1.09 km southeast of the Site.
