ARBORIST REPORT

**SHACCA CALEDON HOLDINGS
PROPOSED MIXED USE DEVELOPMENT
16114 AIRPORT ROAD
CALEDON EAST, TOWN OF CALEDON
ONTARIO**

**ISA CERTIFIED ARBORIST
MATTHEW GEHRES ON-1114A
OUR PROJECT NO:
16-4898**

April 4, 2017

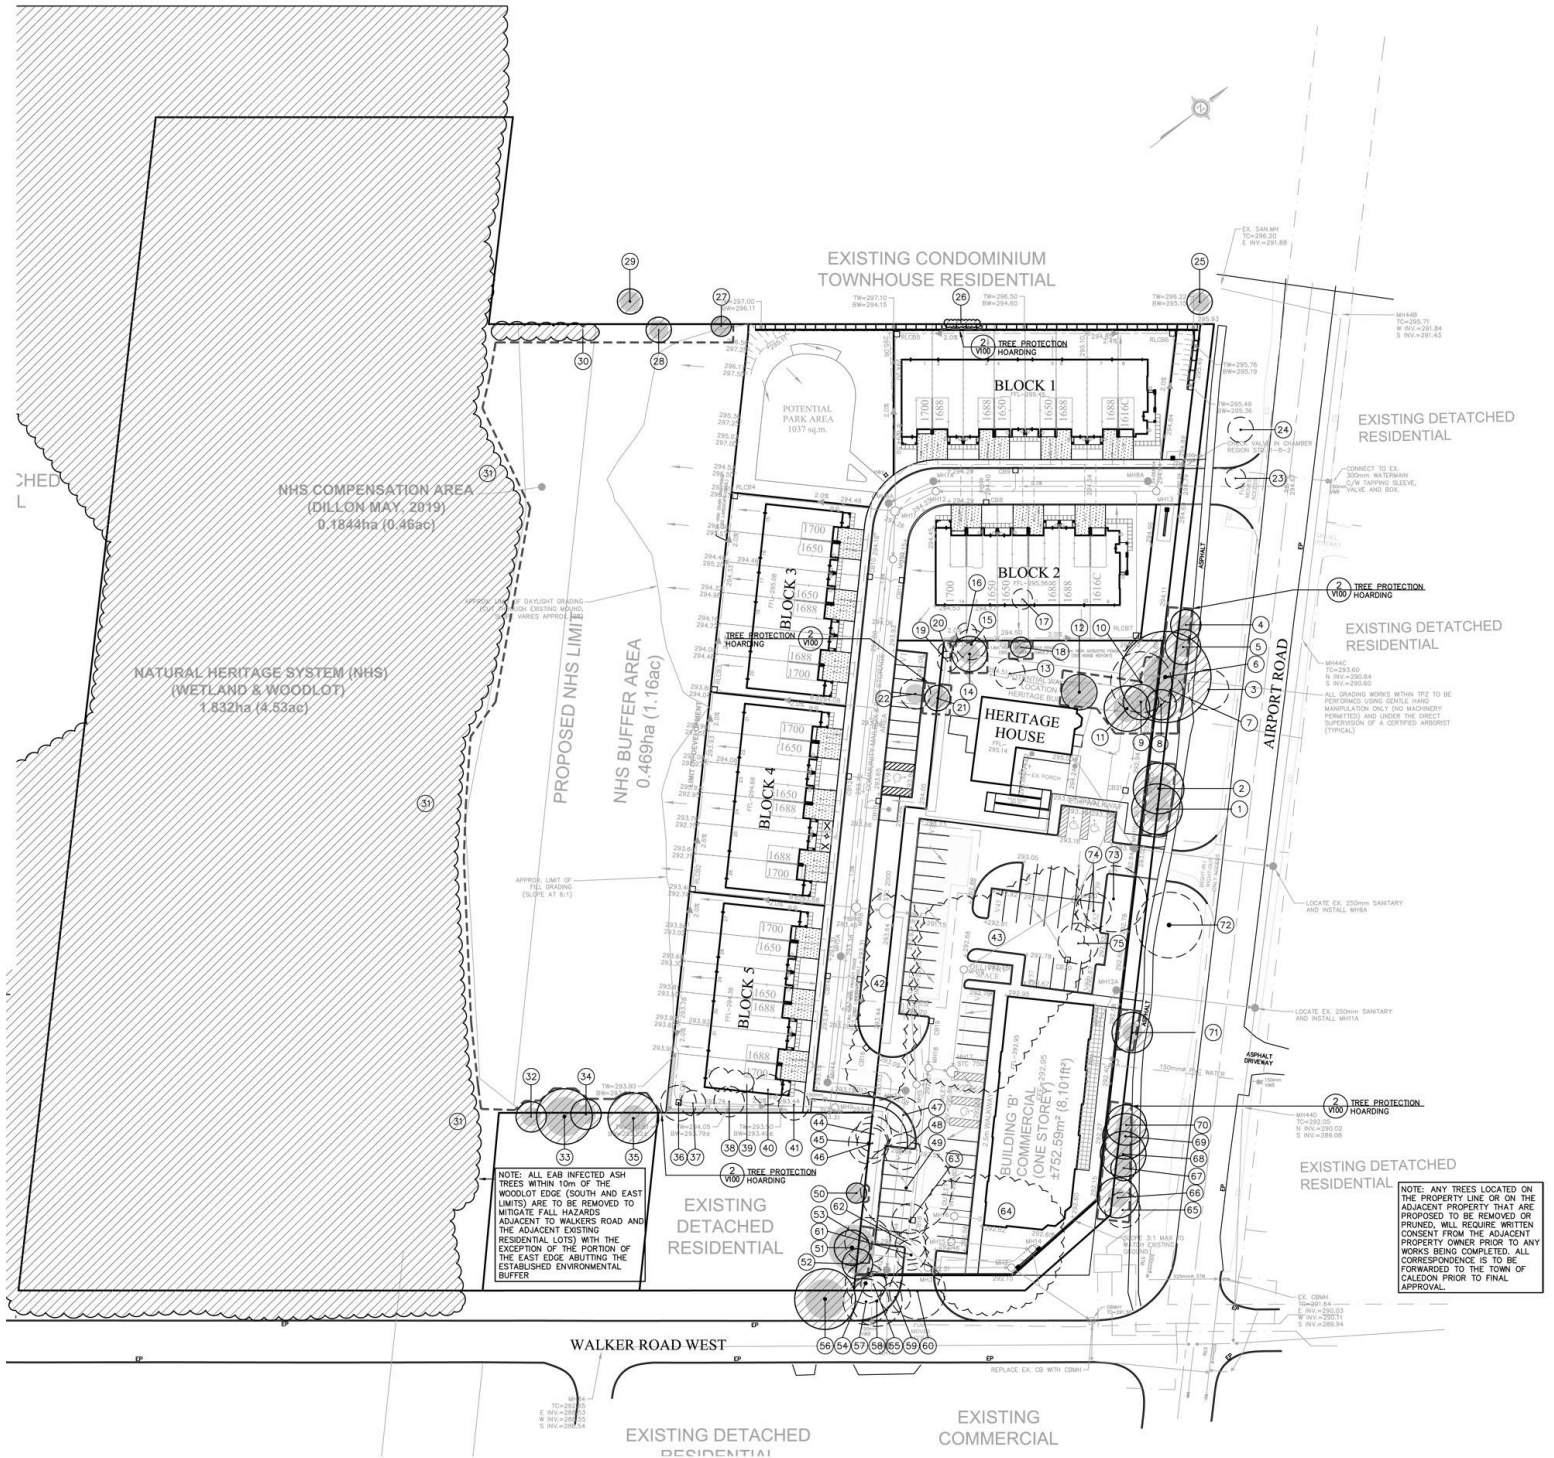
Appendix B – Contextual Tree Inventory & Preservation Plan

Refer to attached Appendix B and attached plan V100 - *Tree Inventory and Preservation Plan* for locations of, and details pertaining to specific trees.

The associated Tree Inventory & Preservation Plan (V100) prepared by our office offers detailed tree information, locations and removal/preservation recommendations.

Town of Caledon approved tree protection hoarding is proposed along the limit of the woodlot dripline as well as around all other trees to be preserved and protected. Tree protection hoarding limits and locations are detailed on the attached V100.

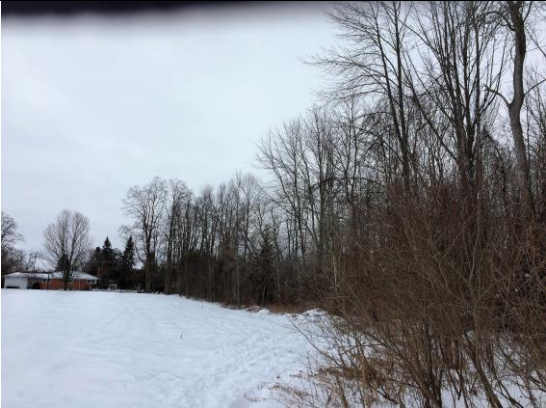
The entire area west of the limit of development is composed of existing woodlot. The edge of this portion of the woodlot is primarily composed of Poplar, and Green Ash trees. There is a small number of less mature Sugar Maple, Black Cherry, Common Beech and Black Walnut along the edge. The species composition of the woodlot edge changes slightly within the southern 1/3 of the edge. The species along this edge are composed mainly of Black Locust, Green Ash and Black Cherry. Many of the semi-mature Ash trees are exhibiting signs of decline likely due to Emerald Ash Borer (EAB). Several slash piles are located along the woodlot edges. There is a sparse shrub edge mainly limited to small clusters of Red Osier Dogwood. Because the limit of development has been set well to the east of the woodlot, it can be properly preserved and protected during the development process.

<p>Woodlot edge beyond west limit of development (looking south)</p>	<p>Woodlot edge beyond west limit of development (looking north)</p>

- All EAB effected Ash trees within 10m of the South and East limits of the woodlot edge are to be removed, or cut to a height where a stump is far enough away from sidewalks and private property. This is to mitigate fall hazards adjacent to walker Road and the adjacent existing residential lots. An EAB effected trees along the woodlot edge adjacent to the NHS buffer area will be left to become snags and provide wildlife habitat

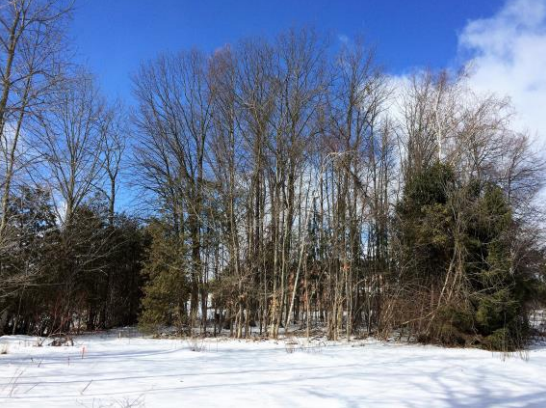
Much of the southeast corner of the property contains a mixed plantation as well as naturalized deciduous groupings and cedar hedgerow. The mixed plantation is composed of several species planted in rows. The species include: Larch, White Spruce, Ash, Red Oak and Basswood. The largest species in size within the plantation are Larch and Ash, with the smaller species limited to Red Oak, Basswood and White Spruce. A deciduous understory of saplings has begun to regenerate the plantation. A mature cedar hedgerow occurs immediately west of the plantation and is situated along a remnant paige wire fence.

<p>Mixed Plantation and Cedar Hedge</p>	<p>Naturalized Grouping and Birch Stand at southeast corner of property</p>

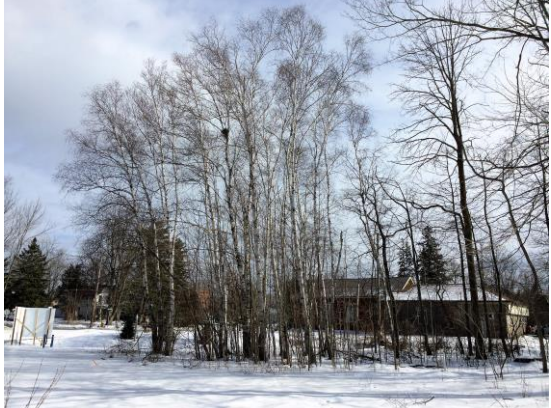
A mixed, naturalized grouping of trees as well as a stand of Paper Birch occurs at the southeast limit of the property. A number of semi-mature to mature trees including: Black Locust, Green Ash, Black Walnut, White Elm and Sugar Maple are located along an existing slope just beyond the east limit of #5 Walker Road West. A number of these trees flank the shared property line between the subject property and #5 Walker Road West. The health and condition of these trees vary from poor to good. Several Ash trees within this grouping are dead. The east limit of this grouping is dominated by a mixed stand of trees composed mainly of Paper Birch. Several Green Ash saplings ring the outside edge of the stand. A cluster of dead, semi-mature green ash trees occur along the southwest corner of the stand.

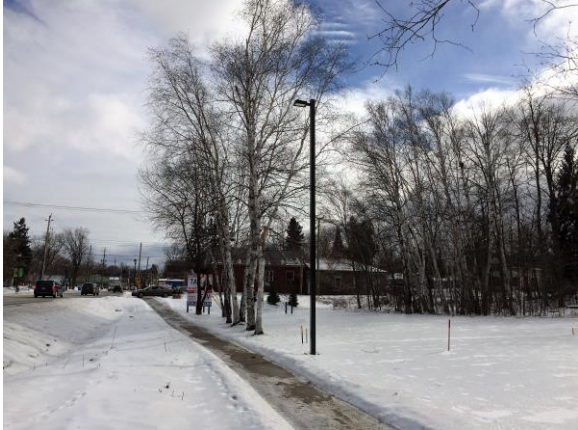
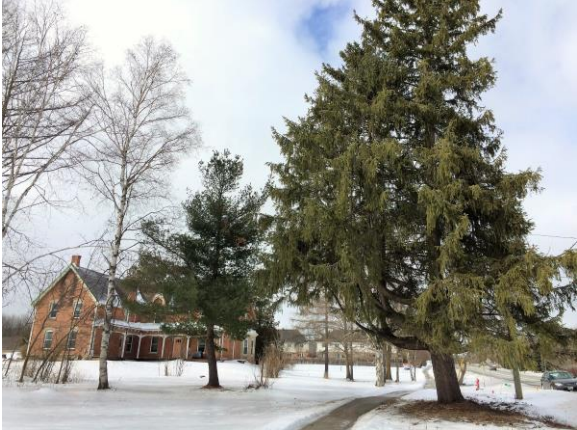
An existing row of primarily Paper Birch trees flanks the right of way along Airport Road. These semi-mature trees are in generally fair to good overall health and condition. Based on the development concept plan, preservation of these trees is likely. One mature Norway Spruce and two White Cedar trees will need to be removed to accommodate the new driveways.

<p>Regional Right of Way Trees</p>	<p>Regional Right of Way Trees</p>
