**PHASE TWO
ENVIRONMENTAL SITE ASSESSMENT
PART OF LOT 4, CONCESSION 6, PART 1, PLAN 43R-20293,
BLOCK 4, 5 & 6, CALEDON, ONTARIO**

File No. 1-16-0543-42.2
February 20, 2020

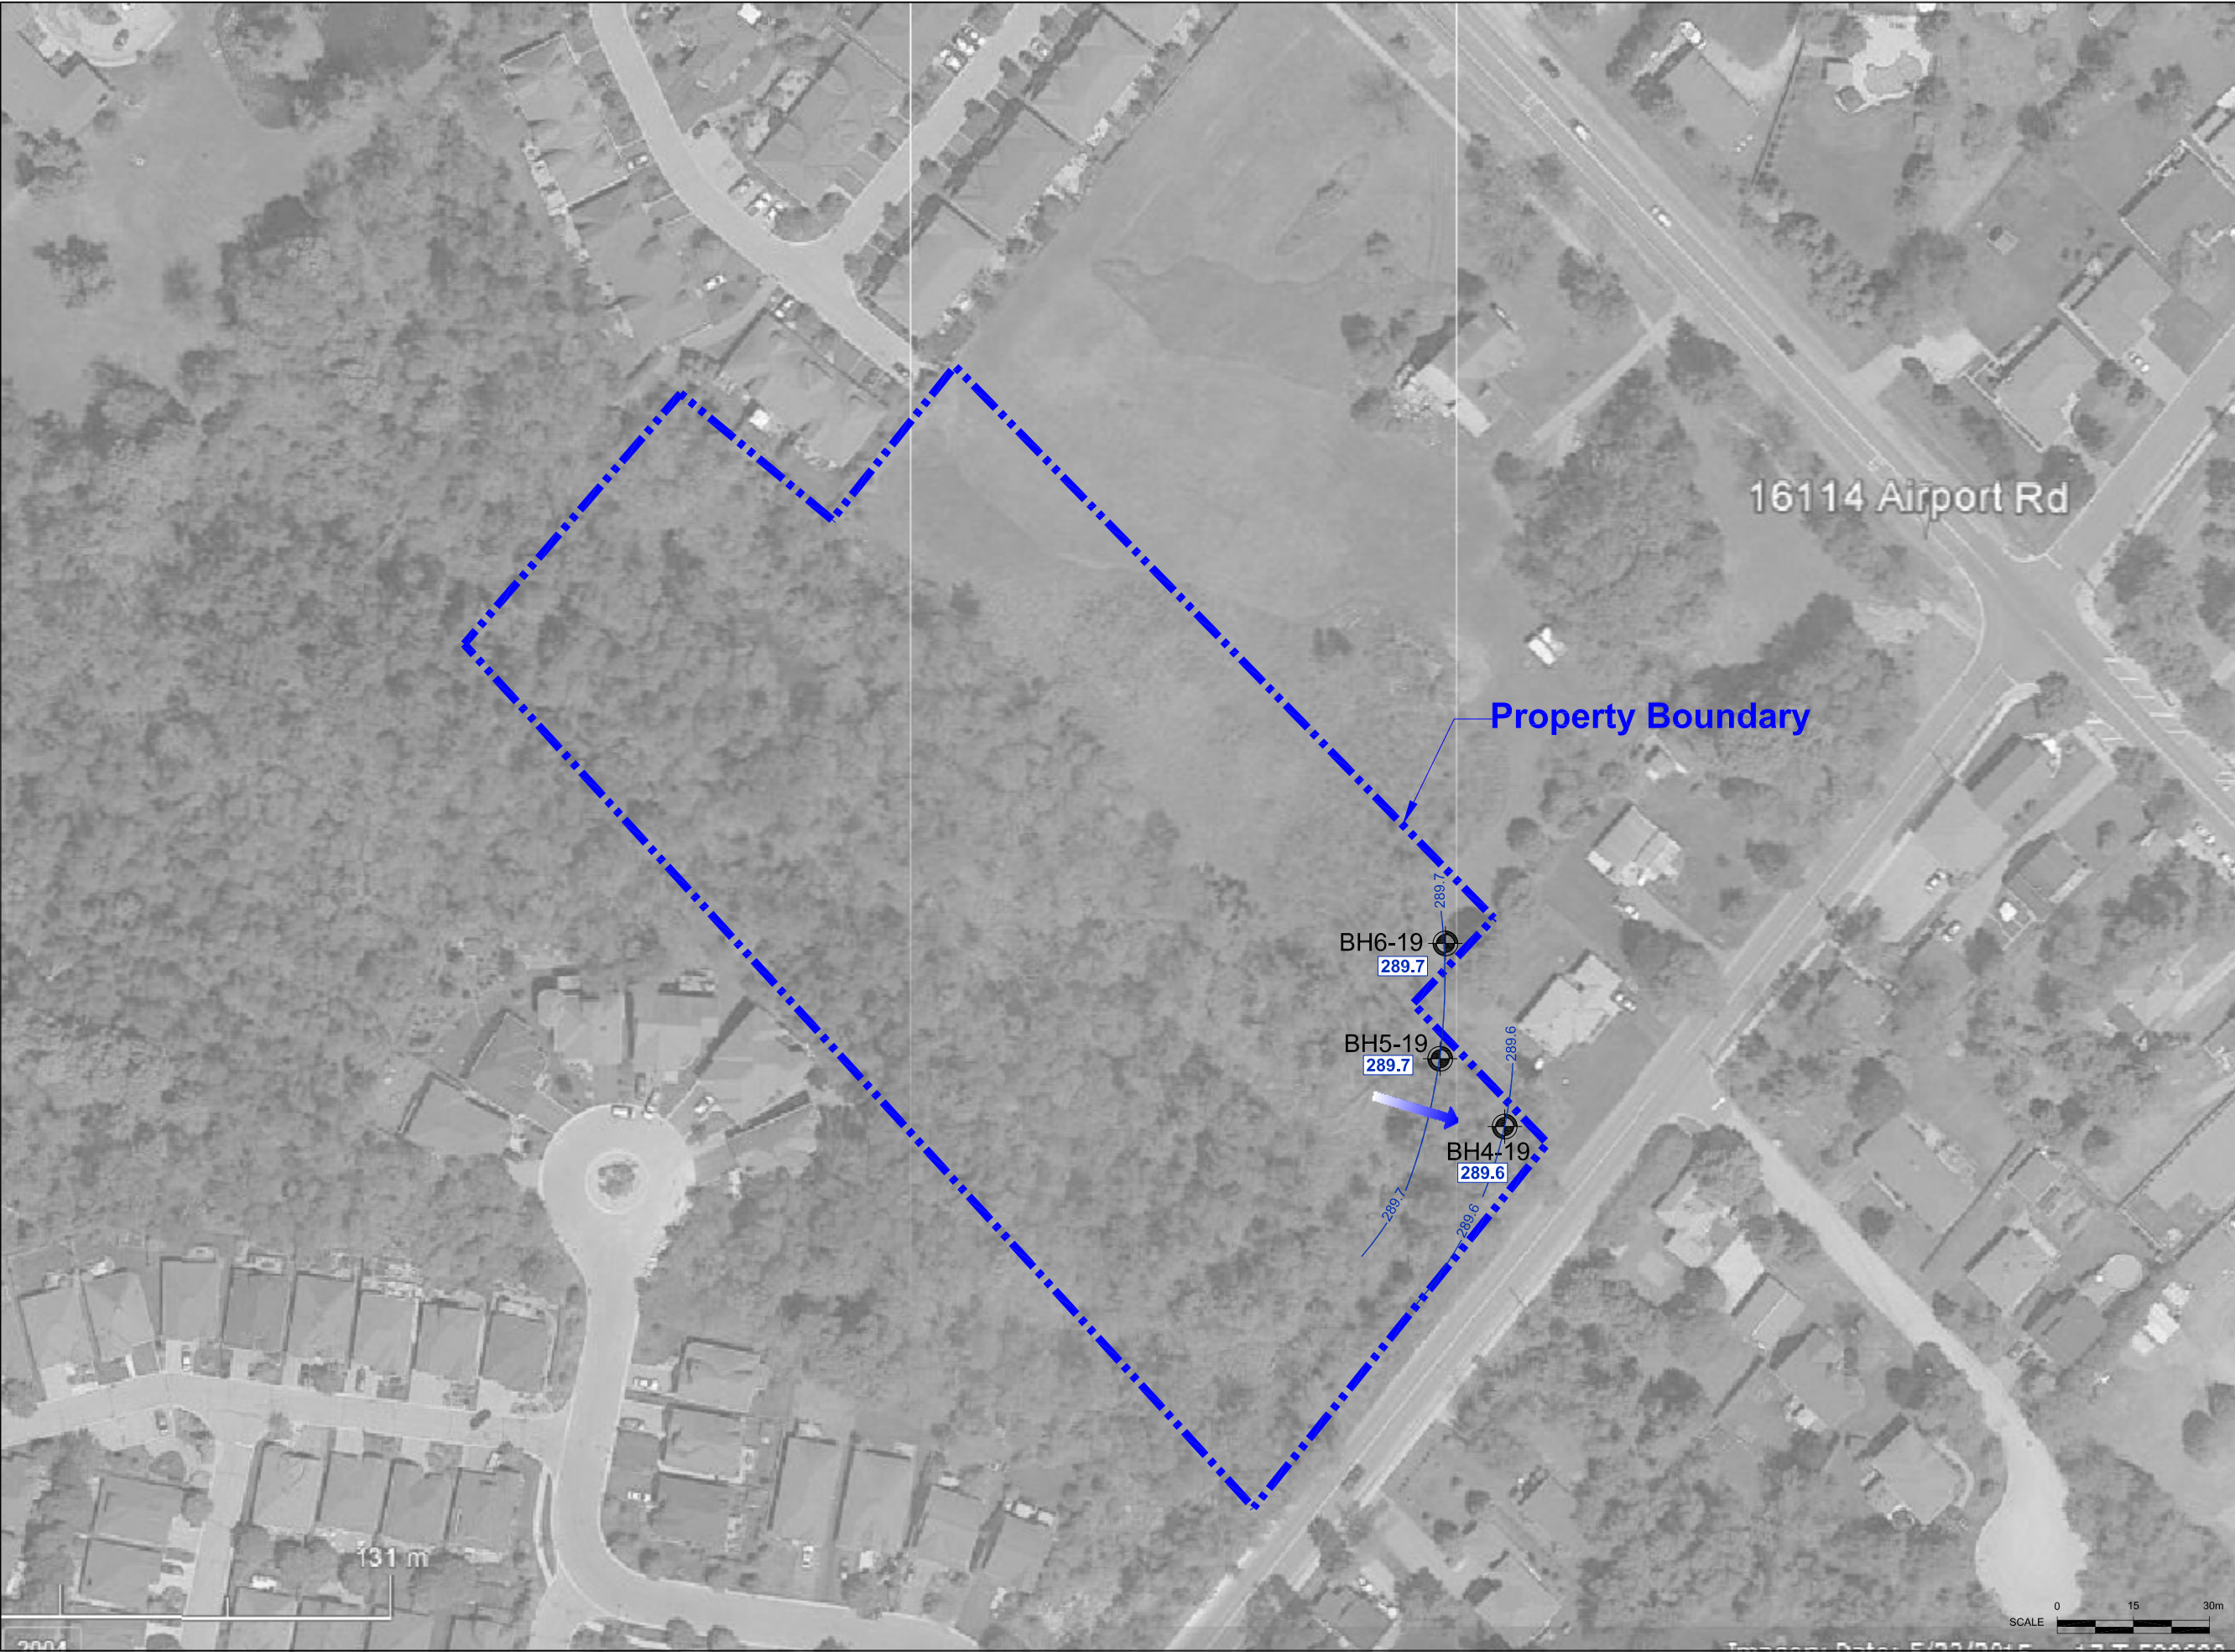
Based on the October 9, 2019 readings, the interpreted direction of ground water flow is to the south/southeast. It should be noted that the water levels may not have stabilized. The inferred ground water direction is expected to be southeast towards the Lake Ontario. Ground water flow direction and ground water elevation contours are presented on Figure 4.
