TRIPLE CROWN LINE
DEVELOPMENTS INC.

Environmental Impact Study

15717 Airport Road

April 2017

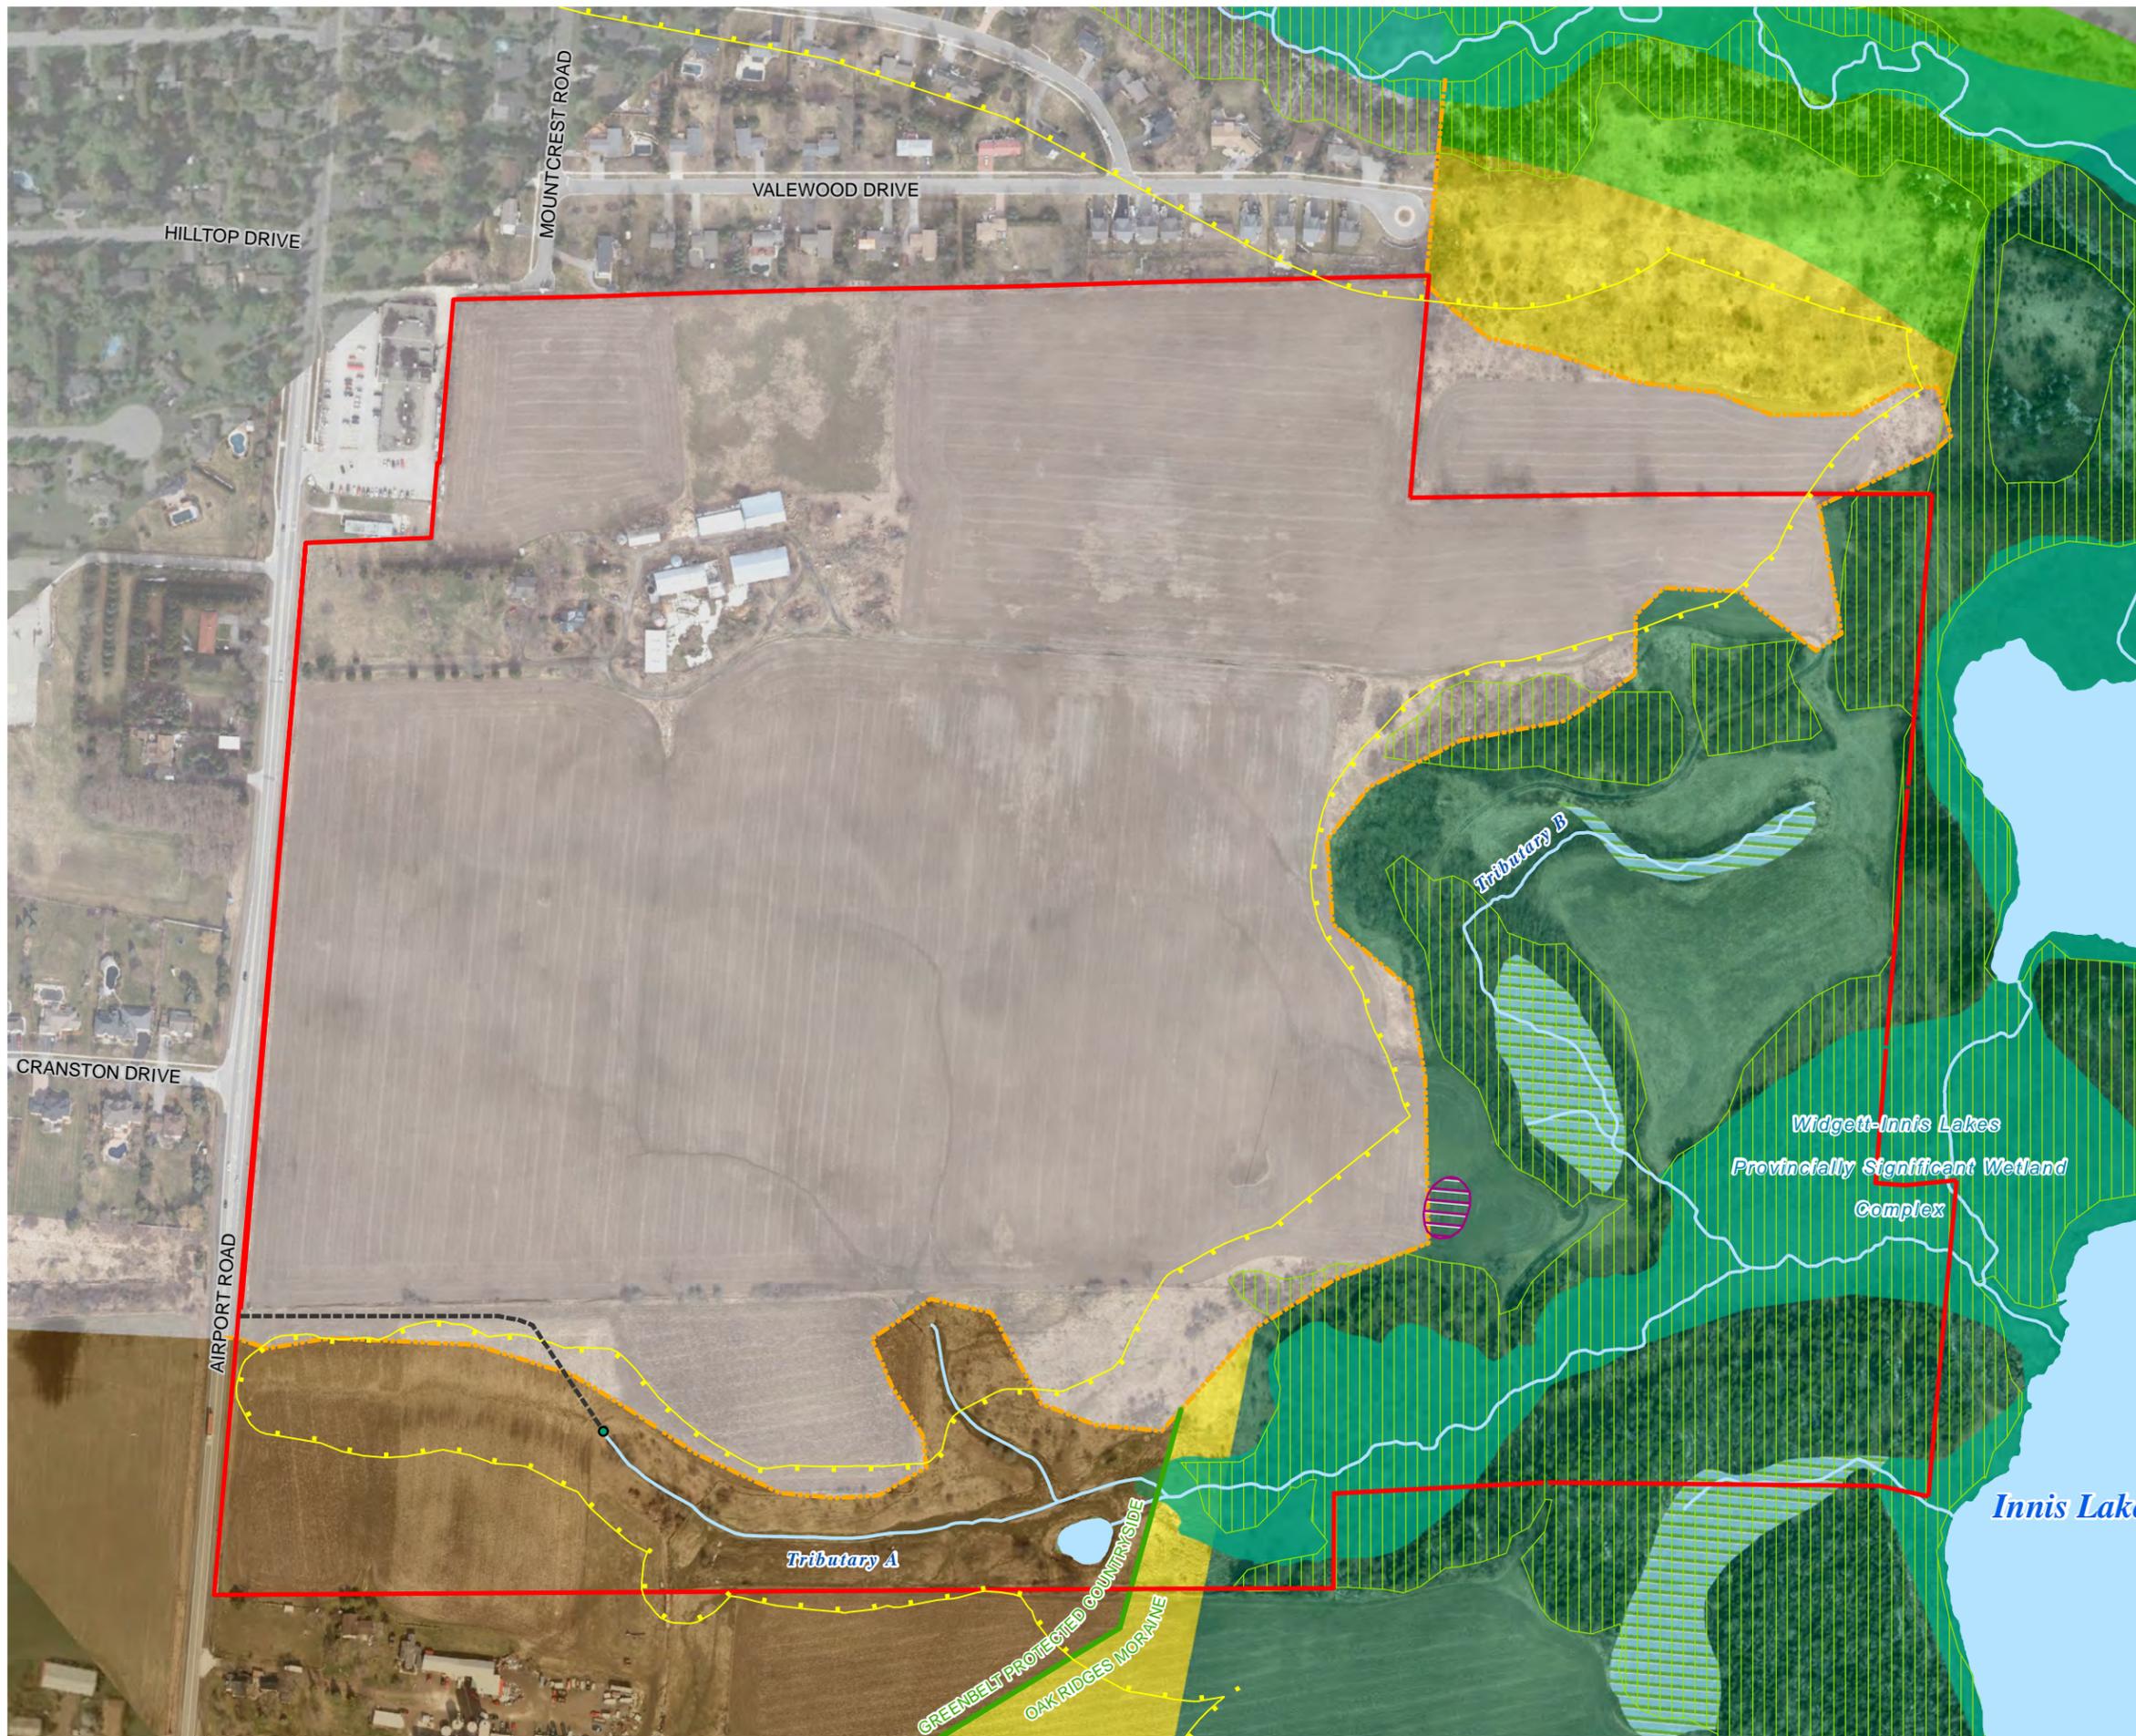
PROVINCIAL LAND USE AND AGENCY DESIGNATIONS
FIGURE 2

Portions of the Study Area fall within Towns and Villages, Oak Ridges Moraine (ORM) Area, and the Protected Countryside of the Greenbelt Plan (Figure 2). In accordance with Policy 2.1, the Protected Countryside policies do not apply to lands within the ORM, as the requirements of the ORMCP continue to apply. As per Policy 3.4.2, the Greenbelt Plan does not apply to lands within the boundaries of Towns and Villages and Hamlets as they existed on the day the Plan came into effect. The policies of the Greenbelt Plan apply where expansions are proposed to settlements permitted by the Plan. The Greenbelt Plan defers to municipal official plans for detailed delineation of settlement boundaries and to govern land use within these areas. For lands within the Protected Countryside, 4.0 *General Policies for the Protected Countryside* apply in their entirety.

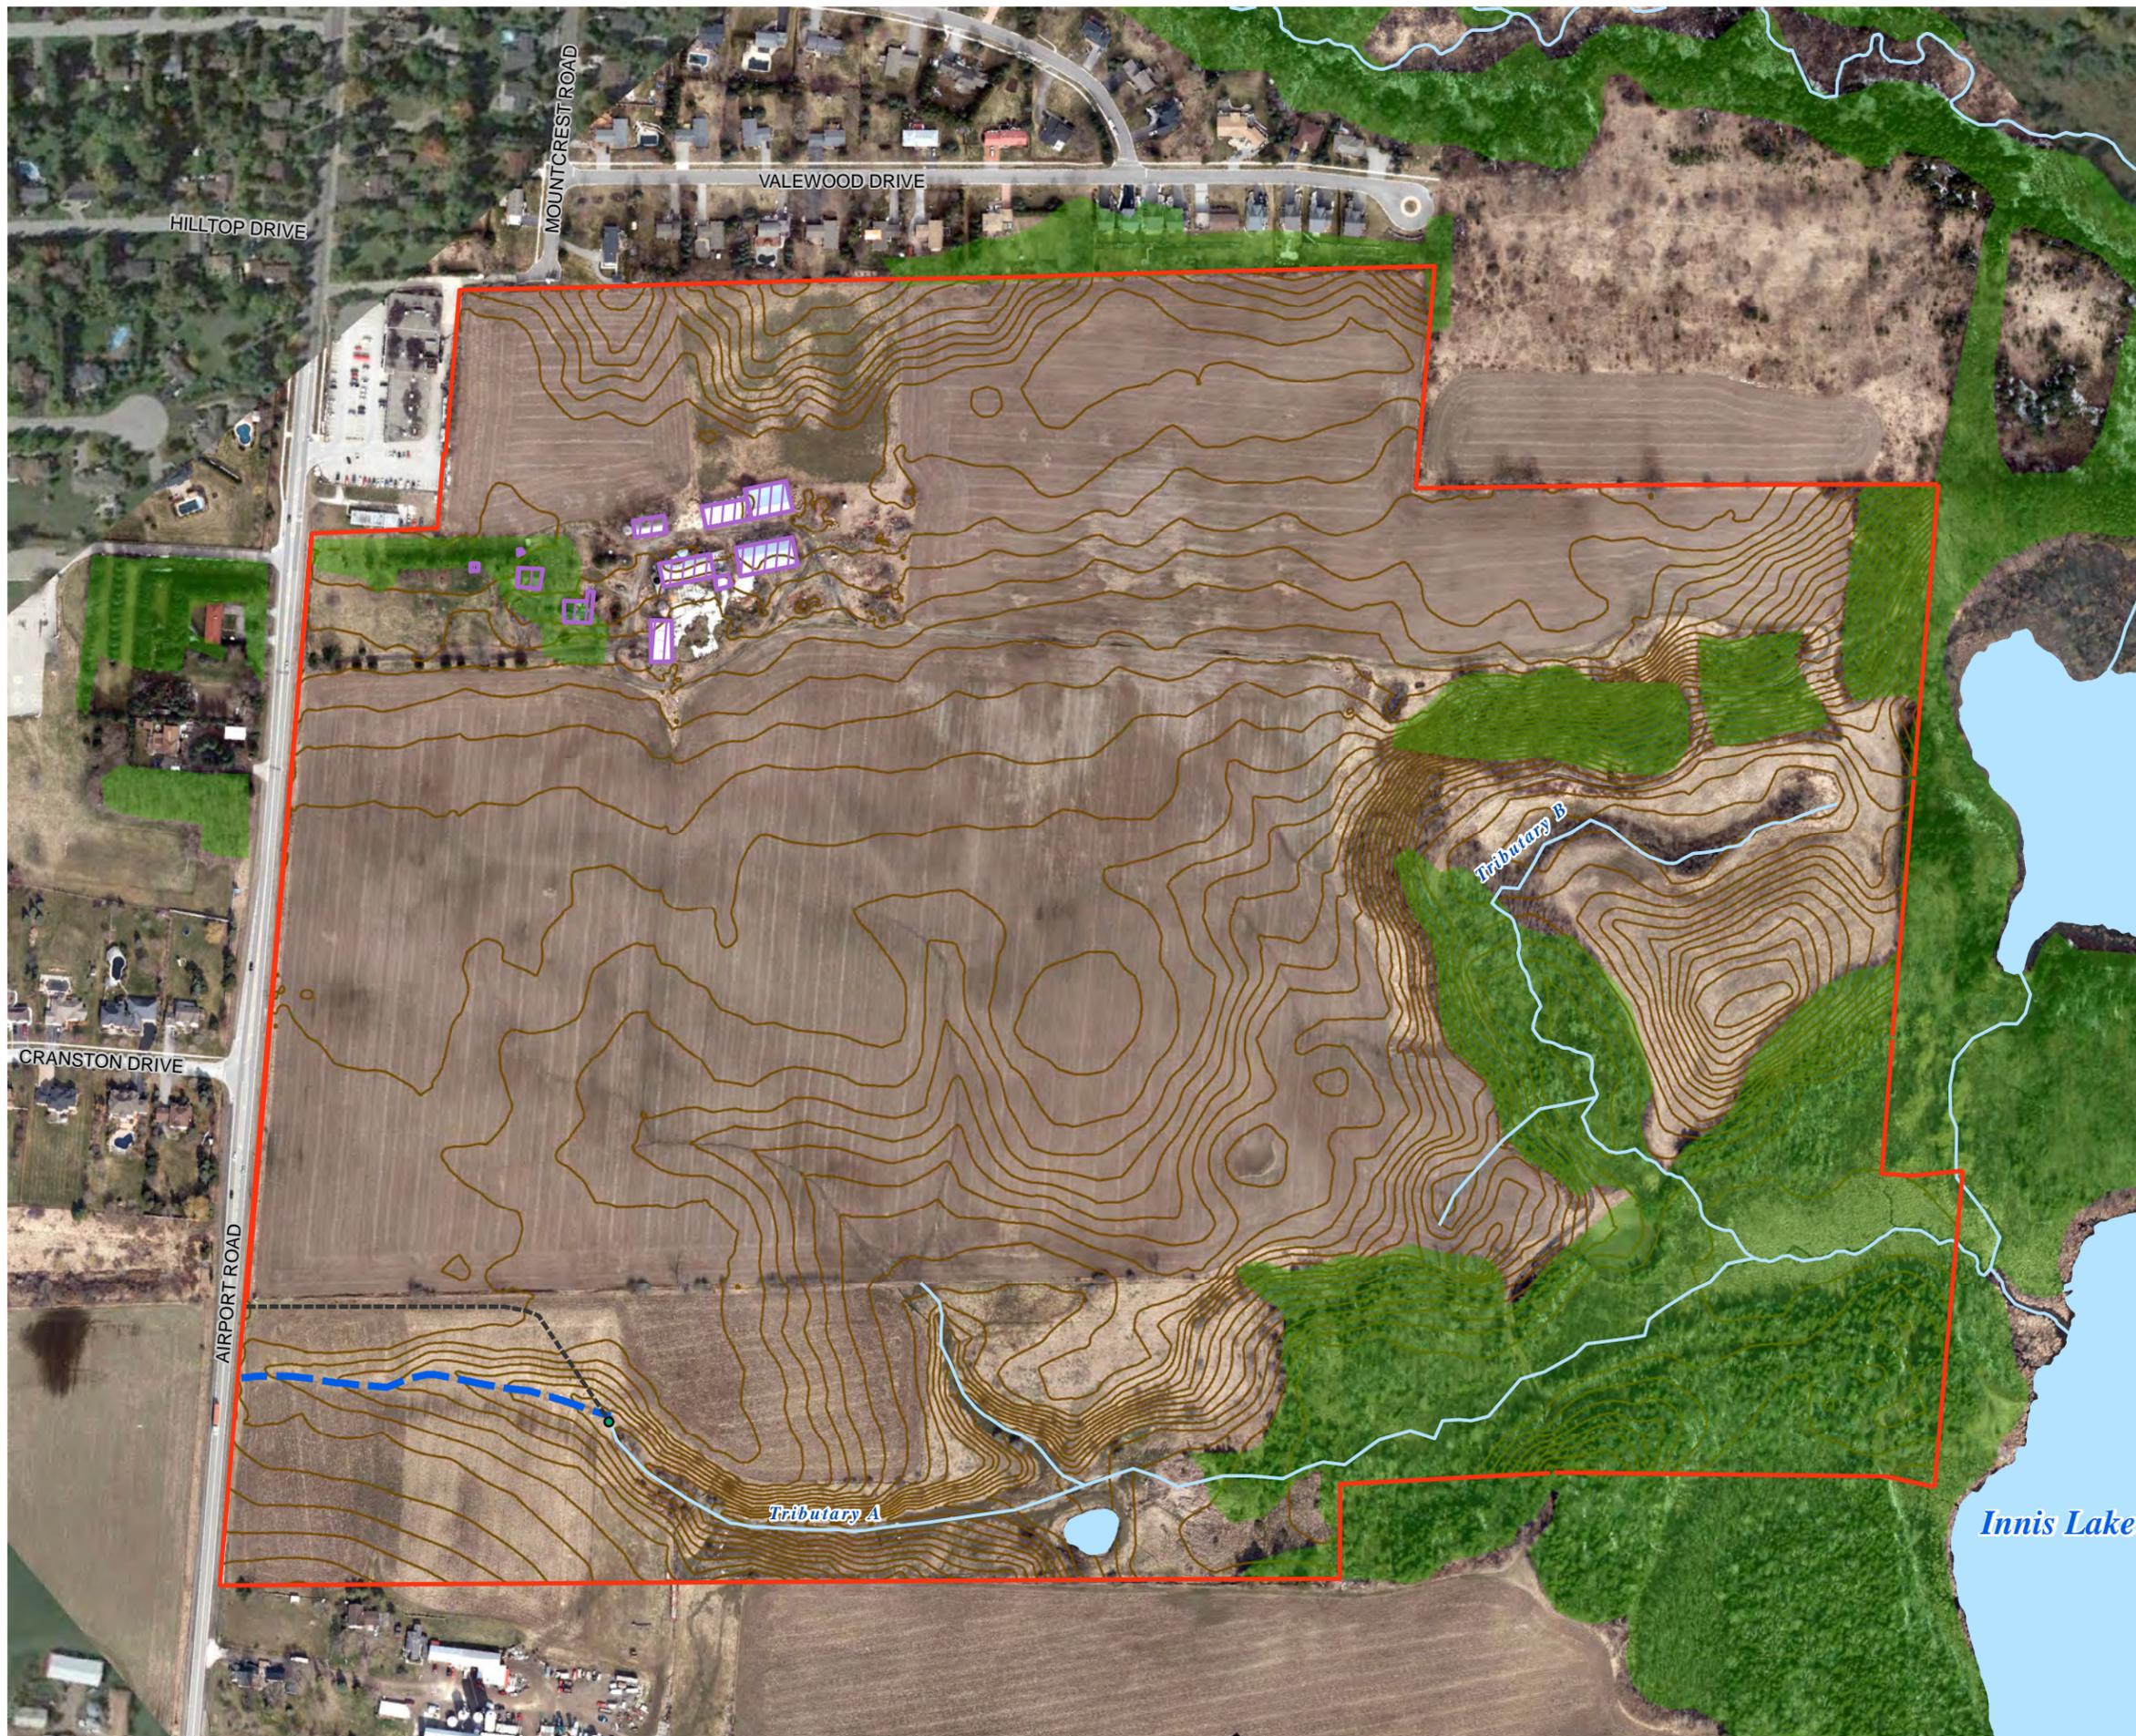
2017 SURVEY LOCATIONS
FIGURE 3

A HDF assessment occurred on March 8, 2017 following methods outlined in the *Evaluation, Classification, and Management of Headwater Drainage Features* (TRCA & Credit Valley Conservation 2014). Due to weather conditions during the month of February and the resulting lack of snow and ice to contribute to spring freshet; the first site visit was done after rain events on March 6th and 7th in order to try and recreate spring freshet-like conditions. During the first visit the site was walked to inventory and assess any potential HDF's present within the Study Area boundaries, specifically focussing on an area identified by the TRCA during initial consultations as a potential HDF (Figure 3).

During the HDF assessment conducted in March, no flow was observed within the potential HDF identified by TRCA and depicted on Figure 3. Further, the potential feature had no defined bed or banks, no evidence of previous downstream flow, and no connections upstream or downstream.

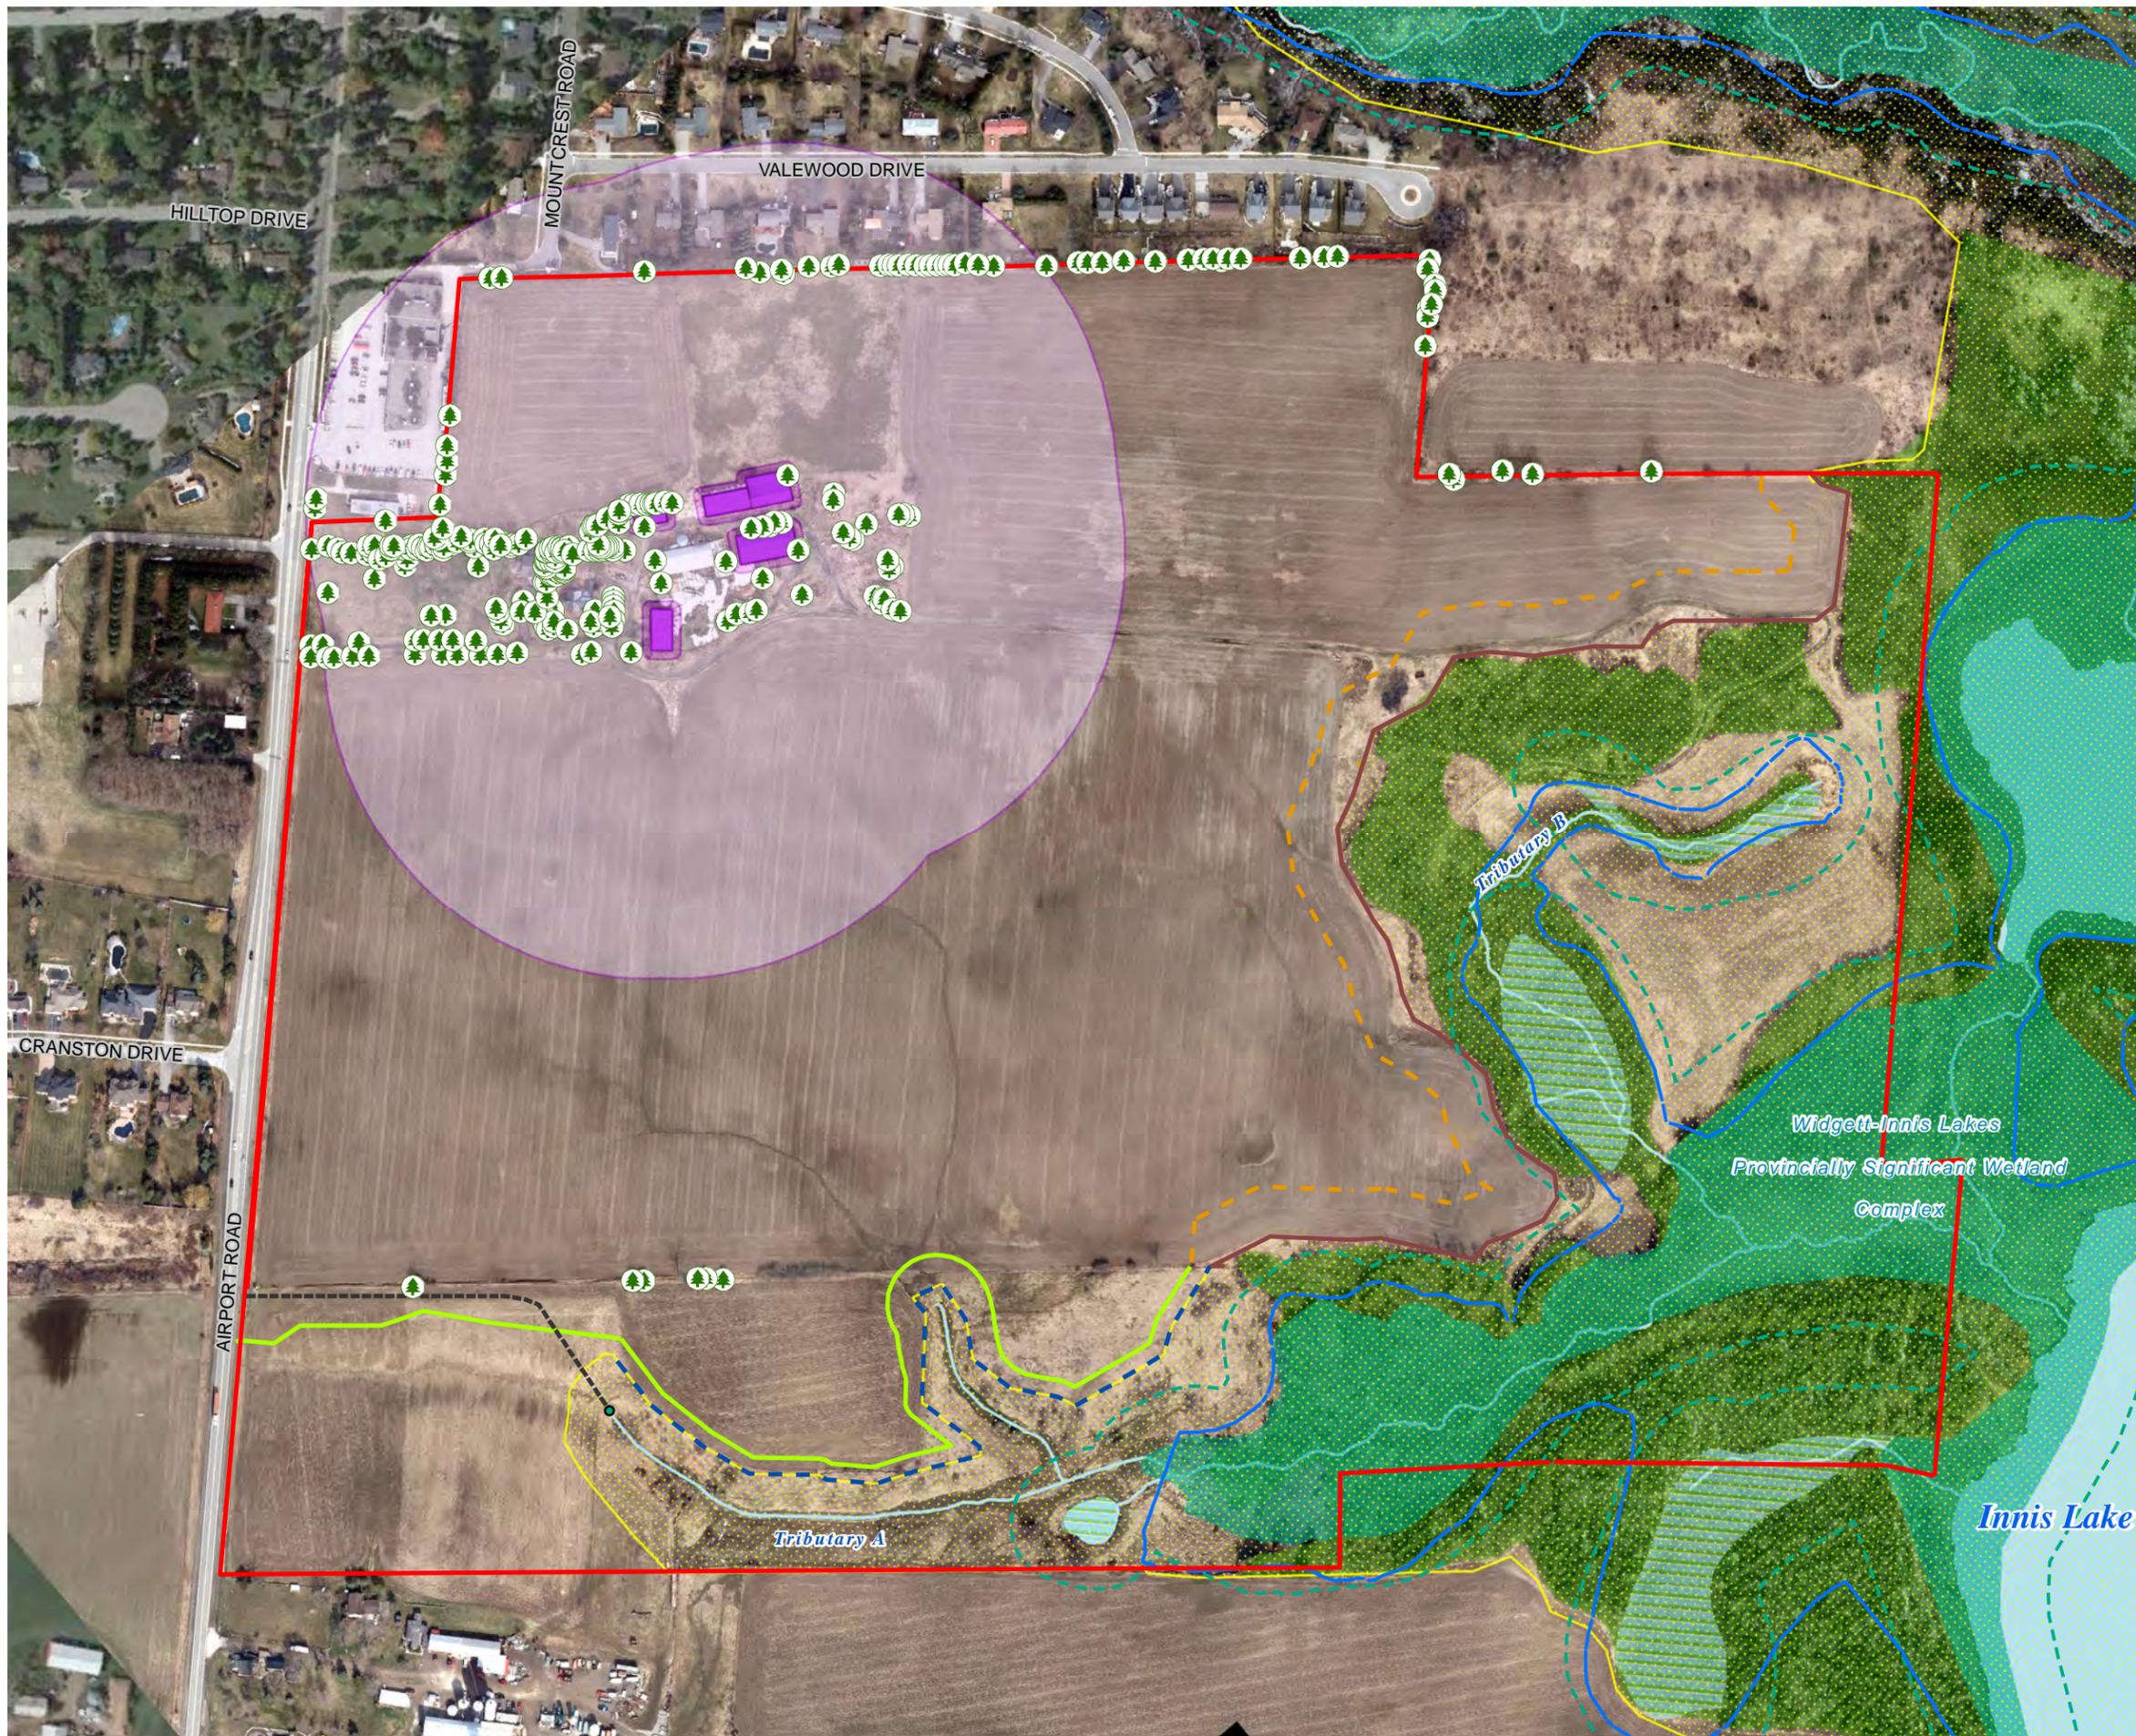
NATURAL HERITAGE FEATURES
FIGURE 4

During the Barn Swallow nest search, a total of seven nests were observed and appeared to be in relatively good condition. See Figure 4 for the locations of the Category 1, 2 and 3 Barn Swallow Nesting Habitat observed within the Study Area. A Notice of Activity has been submitted to the MNRF Registry for removal of the nests. A mitigation plan is currently being prepared for compensation of the nests removed, and will be finalized in consultation with the MNRF. See Figure 5 for potential locations of compensation structures.

The proposed development plan includes removal of structures within the Study Area that contain nesting habitat for Barn Swallow. This will result in loss of Category 1, 2, and 3 habitat for Barn Swallow, as shown on Figure 4. Since Category 2 Habitat includes the structures and the immediate area around the structures; and Category 3 Habitat consists of agricultural lands, the farm residence, and developed area, removal of this habitat is not anticipated to cause a negative impact to the species, and habitat is not limited within the general area. Removal of Barn Swallow nests and the required compensation details are being coordinated with the MNRF through a Barn Swallow Mitigation Plan to be submitted under separate cover.

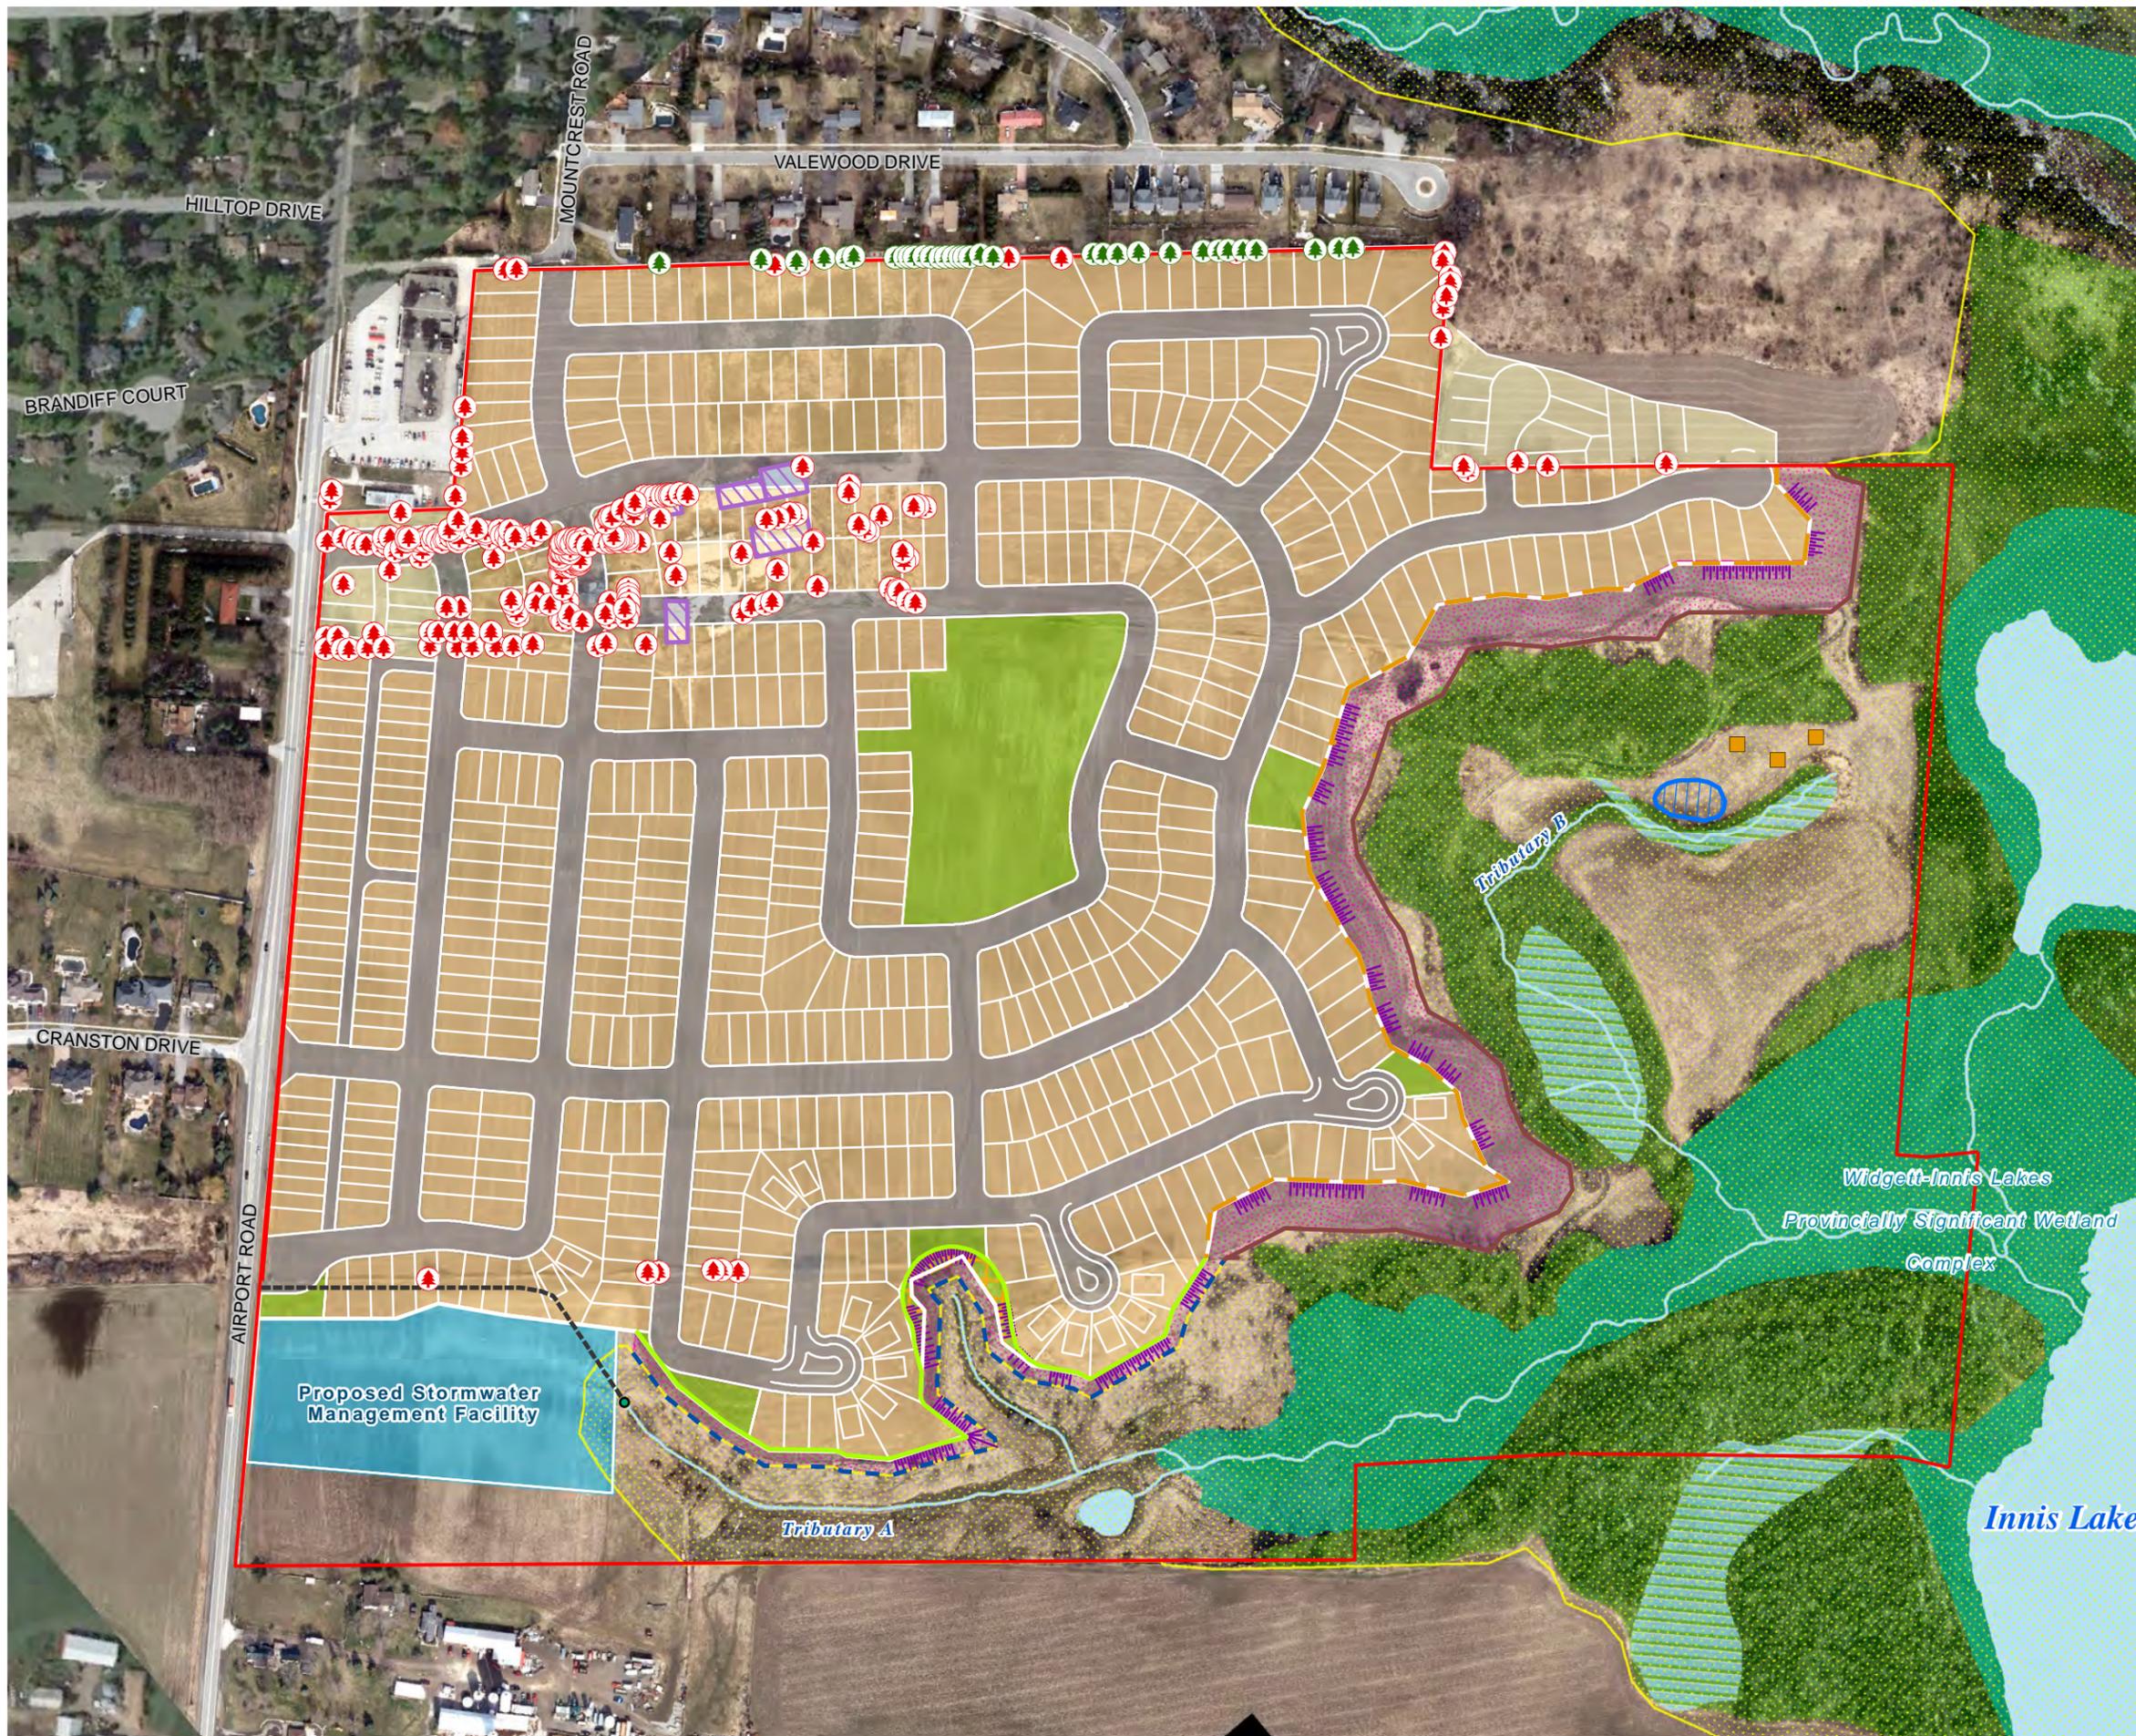
PROPOSED DEVELOPMENT PLAN AND
IMPACT ASSESSMENT

Three access points into the development are proposed via residential street (Figure 5). Construction of the proposed development would include the removal of trees and vegetation from the development area, construction of dwellings, placement of hardscape (driveways, sidewalks) and underground servicing for stormwater and sanitary water. Landscaping would include, but is not limited to, the installation of patios, fencing, sod, and tree plantings.

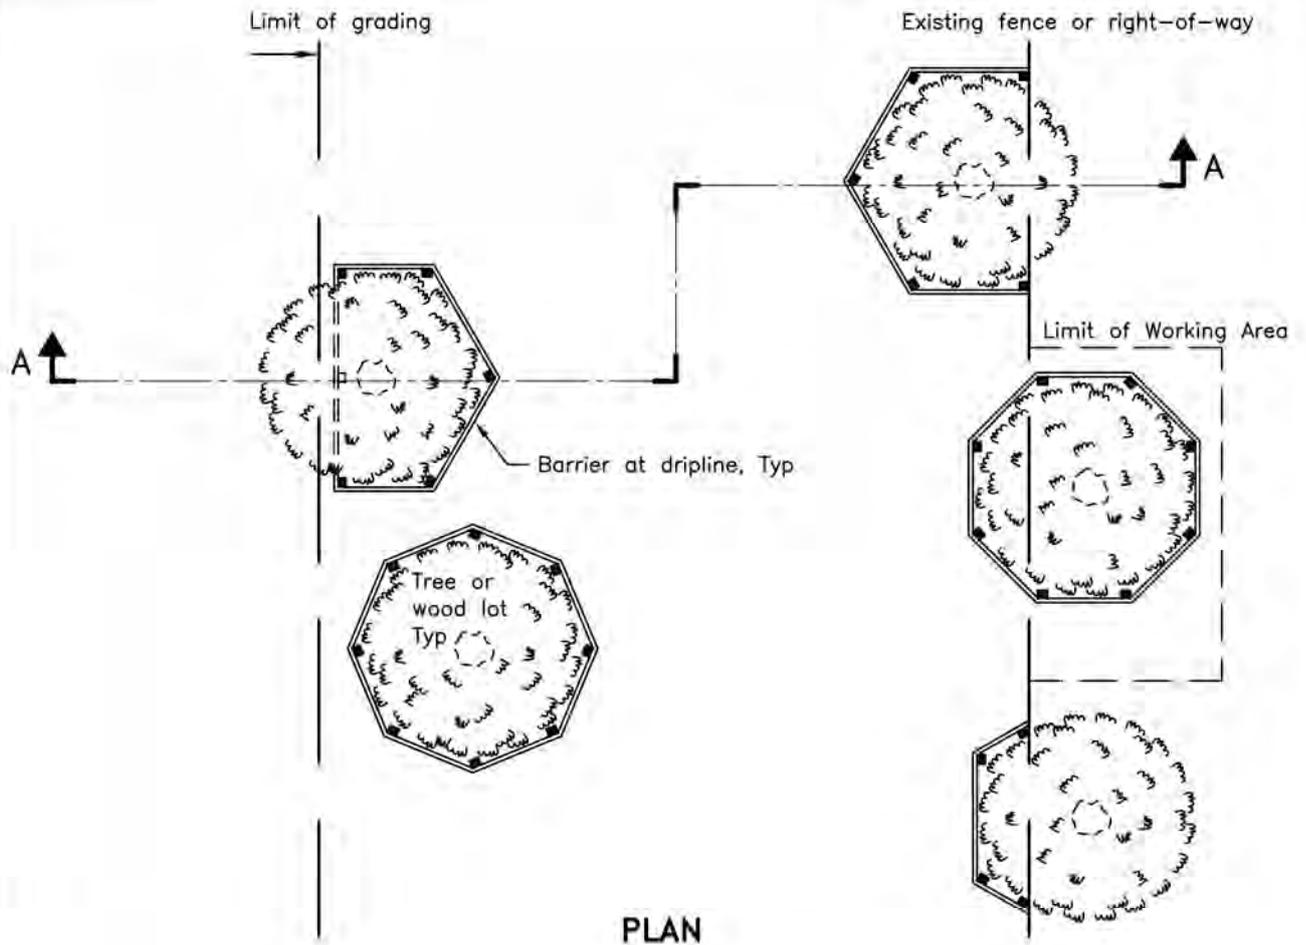
PLAN

Ontario Standard Tree Protection

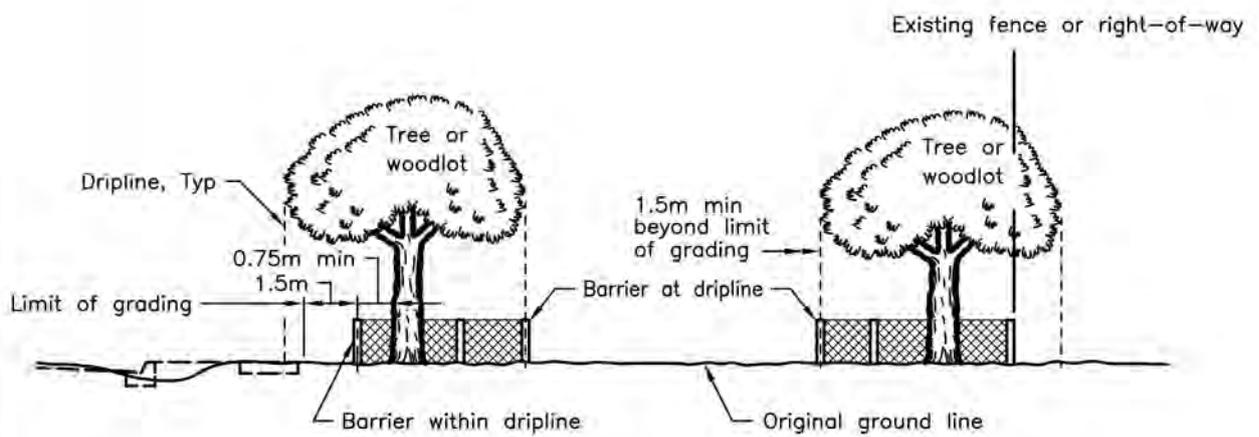
SECTION A-A

ONTARIO PROVINCIAL STANDARD DRAWING

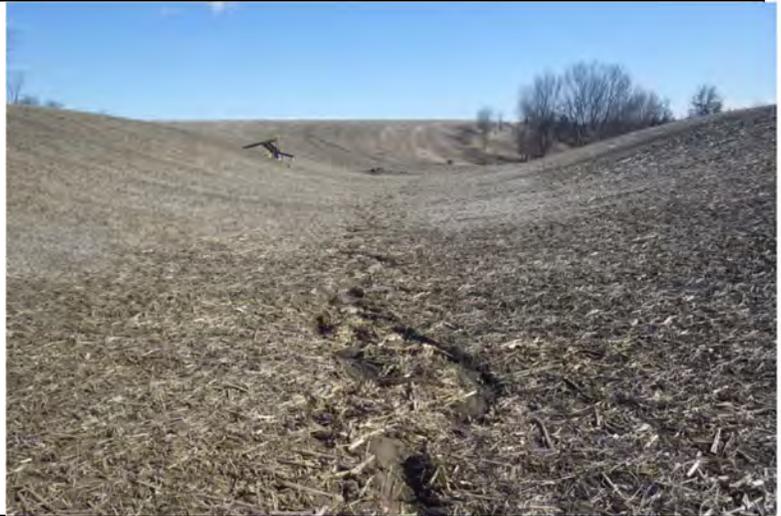
Photo 4

Looking directly at the storm drain outlet.

Tributary A is located downstream of this feature, originating from a stormwater outfall (refer to Photos 4 and 11 in *Appendix F*). During the assessment, a connection between the potential feature and *Tributary A* was not observed. It appeared as though *Tributary A* receives inputs by way of sheet flow from adjacent agricultural fields and lands within the stream valley; evidenced by the presence of rills along the banks of the tributary. In the area where the potential feature meets *Tributary A*, the surface flattens out and sheet flow accumulating this area appears to spread out rather than outlet directly into the tributary at a given point (see Photos 5, 9 and 10 in *Appendix F*).

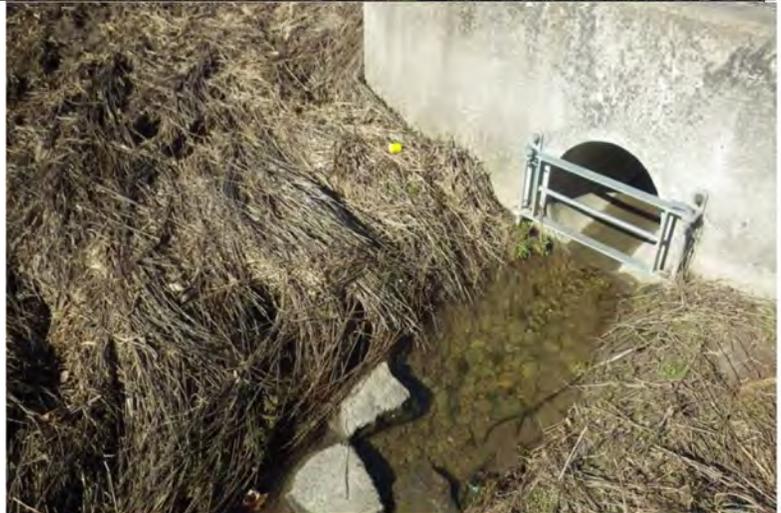
Photo 5

Facing southwest, looking at the feature in its entirety and the storm drain outlet with Airport Road in the distance.

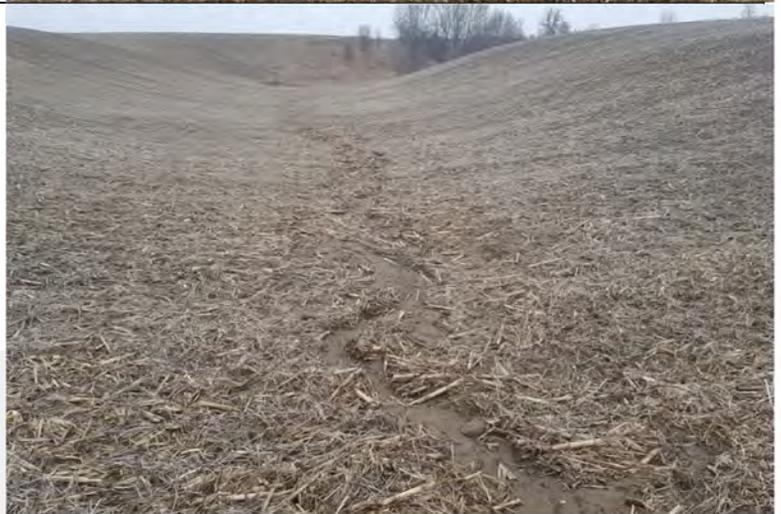
Photo 9

Facing southwest, looking directly at Airport Road from 'downstream' end of feature.

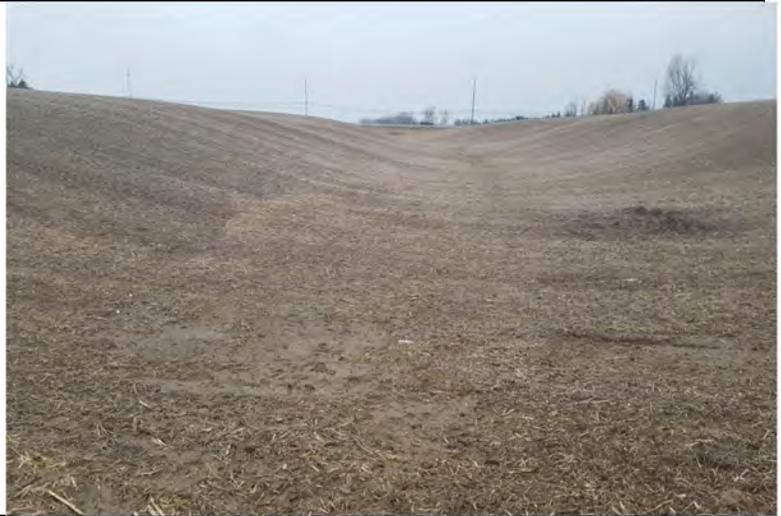
Photo 10

Where agricultural field transitions to meadow, directly adjacent to the storm drain outlet (confluence).
