HERITAGE IMPACT ASSESSMENT 15717 AIRPORT ROAD TOWN OF CALEDON

DG Group

Scarlett Janusas Archaeology Inc.
269 Cameron Lake Road
Tobermory, Ontario N0H 2R0
Phone 519-596-8243, cell 519-374-1119
jscarlett@amtelecom.net www.actionarchaeology.ca

April 21st, 2017

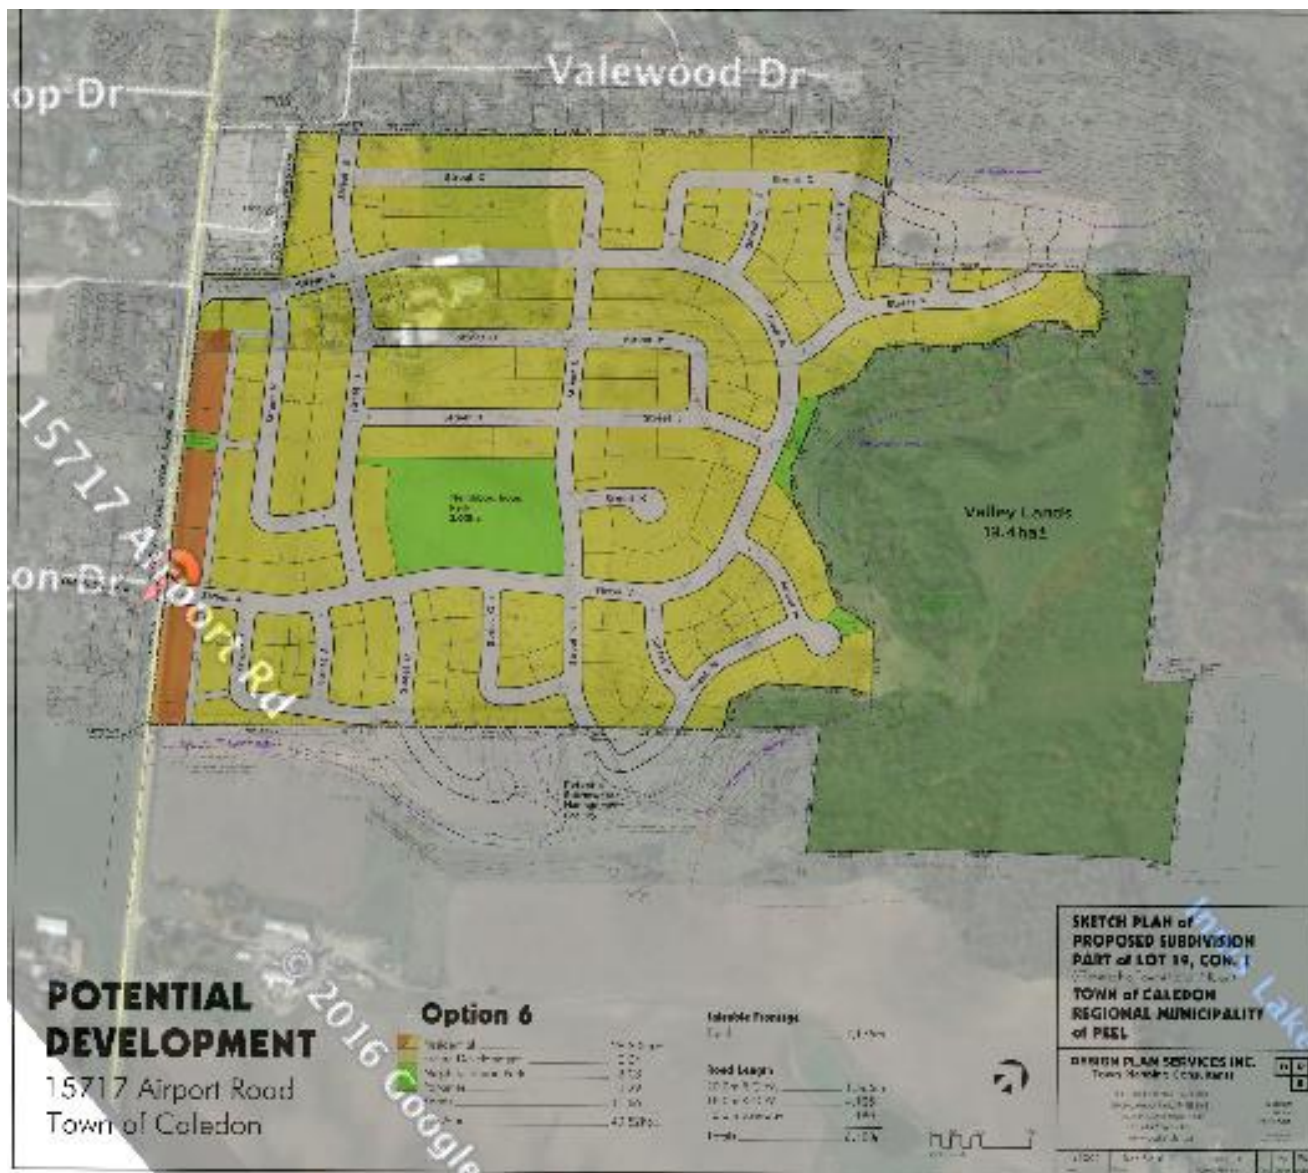
Figure 3: Keyed Structures in Study Area

Individual structures (n=19) for the study area are presented below in Table 1 and are also keyed by structure number on Figure 3.

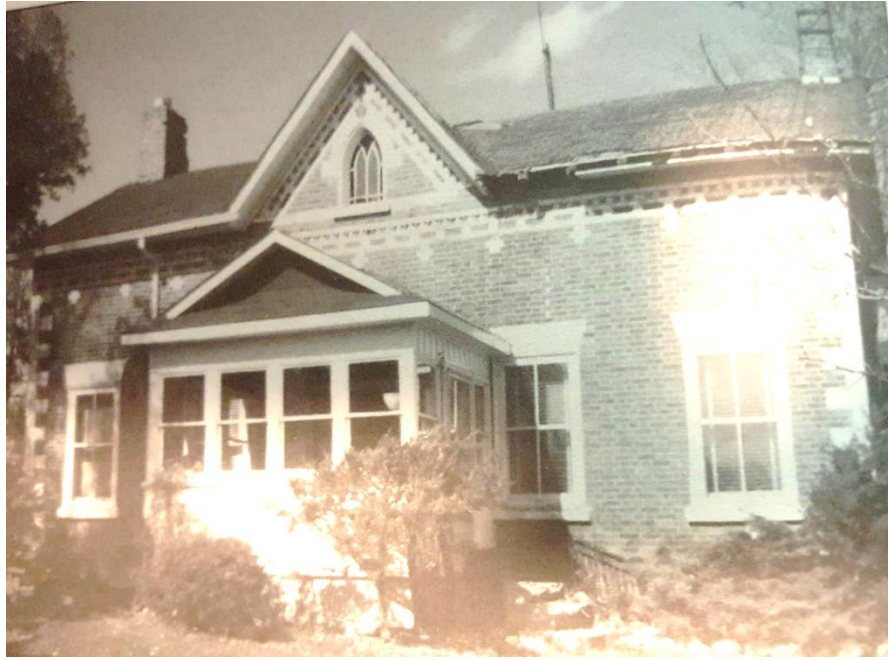
Built in a style typical of that era in Ontario, the house has a central front dormer and a five window front façade. Four sash windows run symmetrically along the ground floor with a small Gothic style window within the dormer. It is constructed of red brick with a string course of buff brick running around the top of the house below the eave line and inside the front dormer. There are also buff brick quoins, window lintels, and an open gable roof. The enclosed portico at the front appears to be a later addition. The buff brick accents were typical in the Albion/Caledon area due to the prevalence of buff coloured clay from the prehistoric lakebed (Figure 15).

Figure 15: Photograph of Brick House, 1985 (Settling the Hills: Historic Reflections of Caledon East and District, Pg. 16)

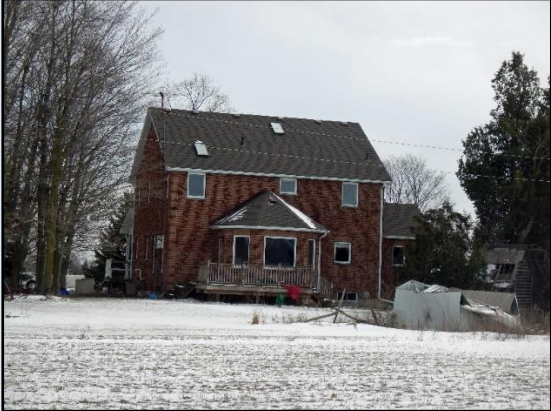
From Table 1, numeric sequence within report	Photos (Numbered 1-1, 1-2, etc.)	comments	Value
<p>1 – residence</p> <p>1-1</p>

<p>West face of house, facing SE.</p>	
<p>1-2</p>

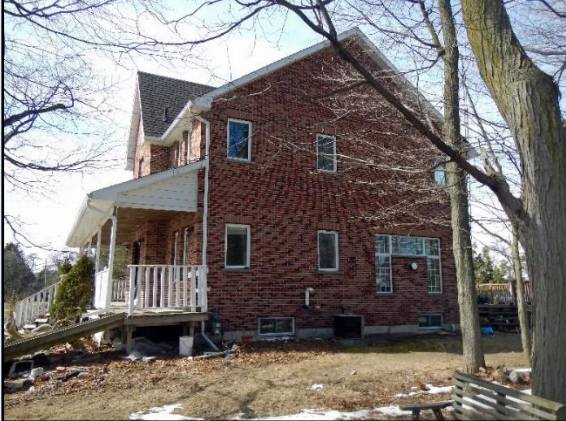
<p>North face of house, facing SSW.</p>

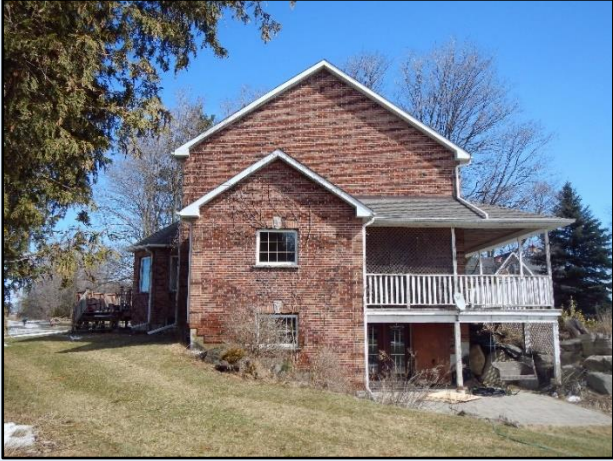
From Table 1, numeric sequence within report	Photos (Numbered 1-1, 1-2, etc.)	comments	Value
1-3

South face of house, facing NNE.	
1-4

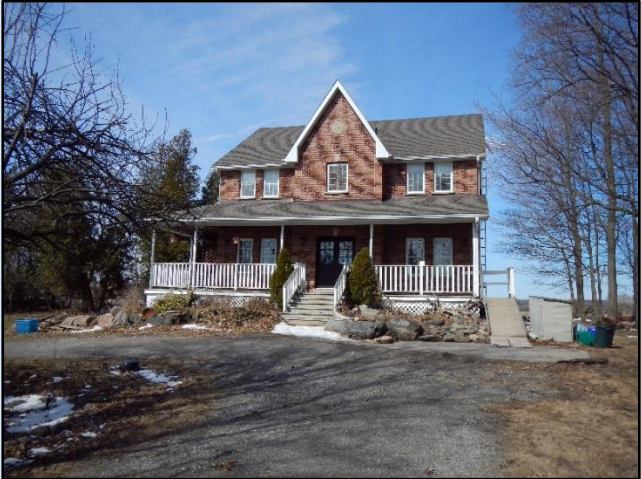
East face of house, facing NNW.

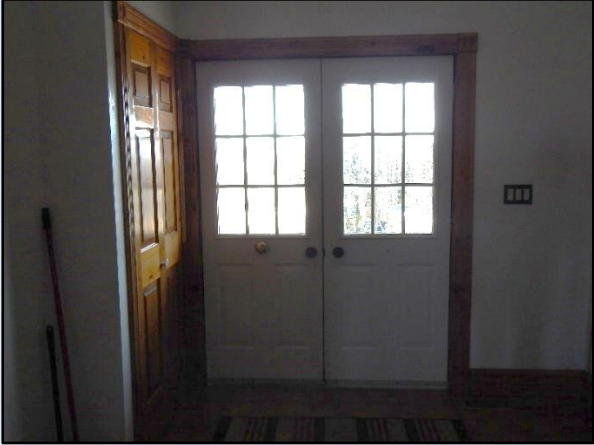
From Table 1, numeric sequence within report	Photos (Numbered 1-1, 1-2, etc.)	comments	Value
1-5

Ground floor - eastern double-door entrance, facing east.	
1-6

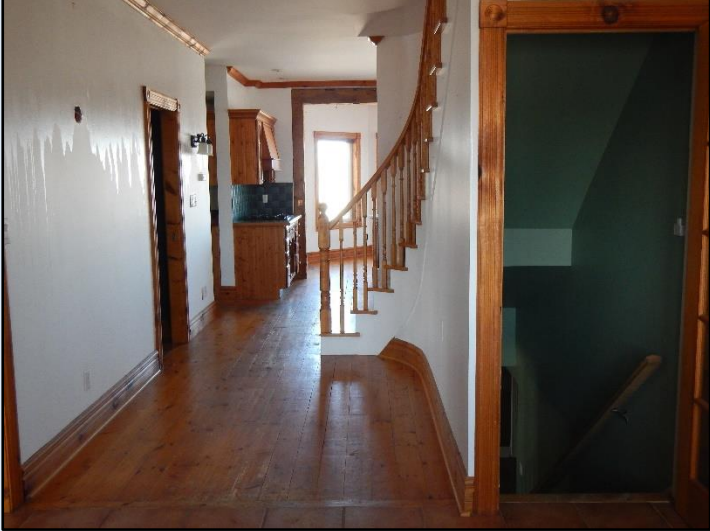
Ground floor - eastern entrance and foyer showing basement stairs and hallway into kitchen area. Facing west.

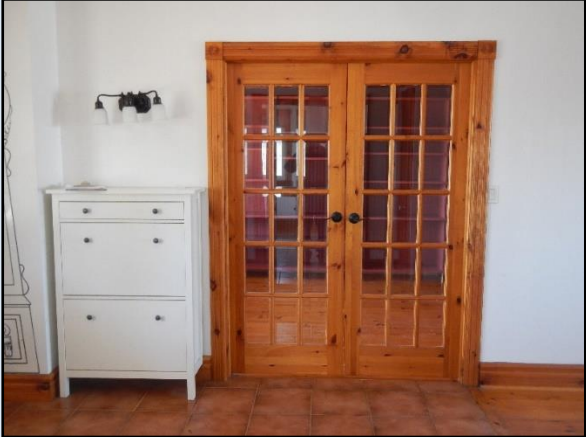
From Table 1, numeric sequence within report	Photos (Numbered 1-1, 1-2, etc.)	comments	Value
1-7

Ground floor - foyer, showing French doors leading into Room #1. Facing south.	
1-8

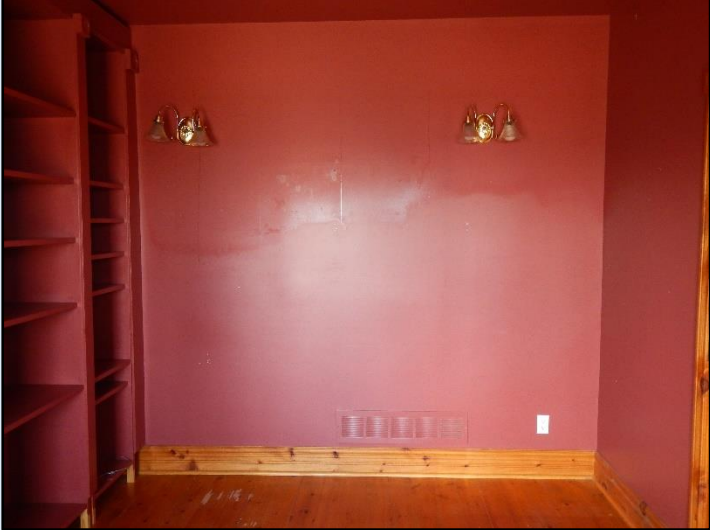
Ground floor - Room #1, showing west wall with modern light fixtures, air vent, and trim. Facing west.

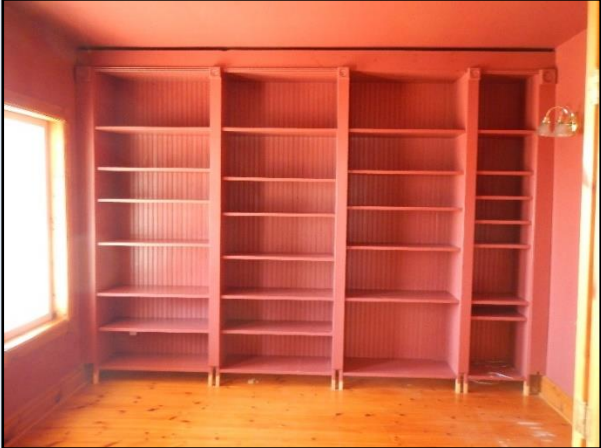
From Table 1, numeric sequence within report	Photos (Numbered 1-1, 1-2, etc.)	comments	Value
1-9

Ground floor – View of Room #1 from eastern entrance foyer, showing south wall with modern plywood bookshelves. Facing south.	
1-10

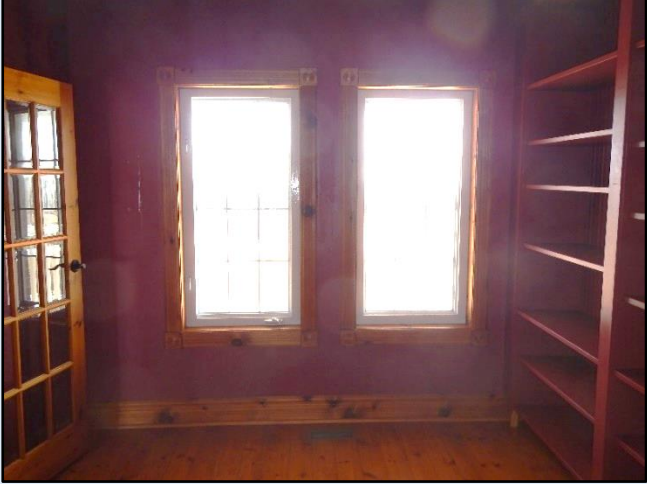
Ground floor – View of Room #1 east wall showing modern double windows. Facing east.

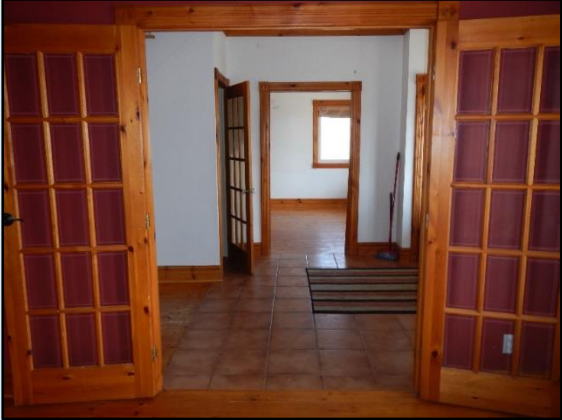
From Table 1, numeric sequence within report	Photos (Numbered 1-1, 1-2, etc.)	comments	Value
1-11

<p>Ground floor – View from Room #1 into foyer and main (living) room, with basement stair door on left. Facing north.</p>	
1-12

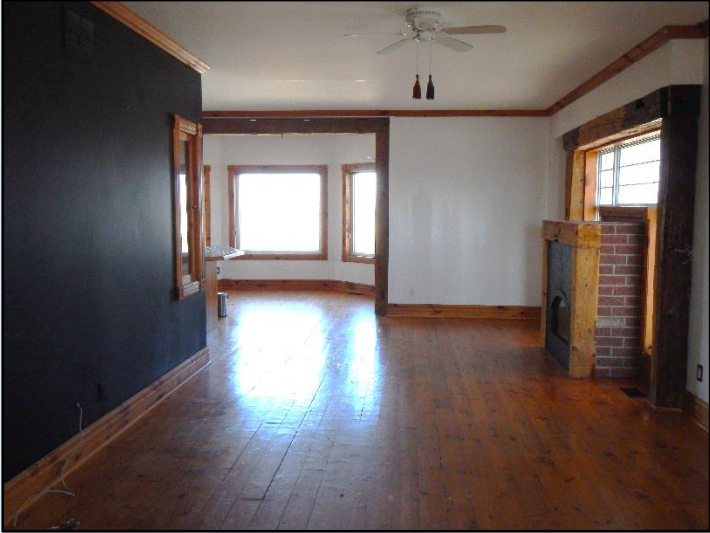
<p>Ground floor – View of main room partial west wall showing modern hardwood floor, windows, trim, and brick fireplace on right. Note the bay window enclave area at the far end of the main floor. Facing west.</p>

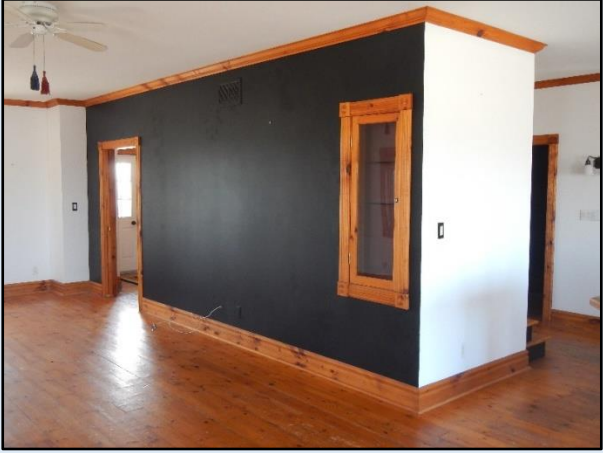
From Table 1, numeric sequence within report	Photos (Numbered 1-1, 1-2, etc.)	comments	Value
1-13

Ground floor – View of main room showing south wall. Facing southeast.	
1-14

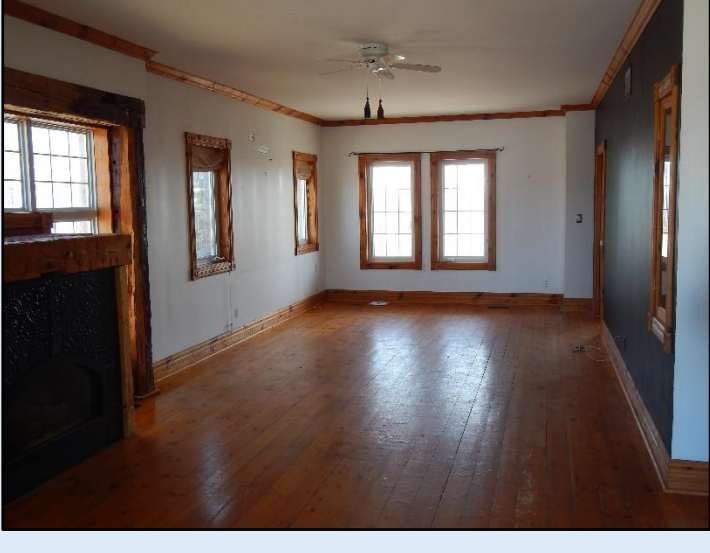
Ground floor – View of main room showing east and north walls (north wall includes fireplace). Facing east.

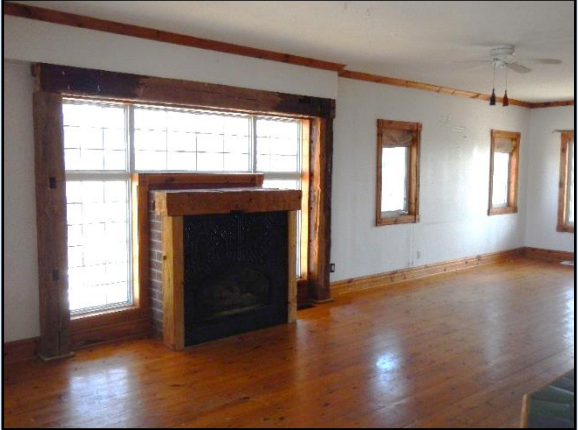
From Table 1, numeric sequence within report	Photos (Numbered 1-1, 1-2, etc.)	comments	Value
1-15

Ground floor – View of main room showing north wall including fireplace. Facing northeast.	
1-16

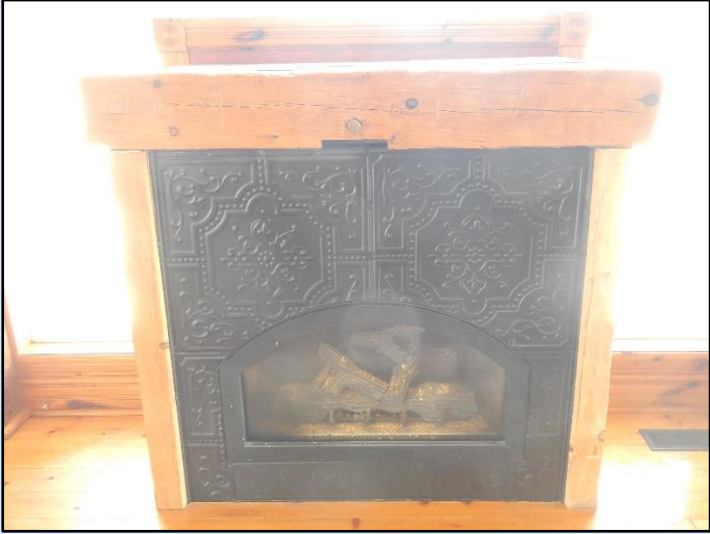
Ground floor – View of modern fireplace on north wall of main room. Facing north.

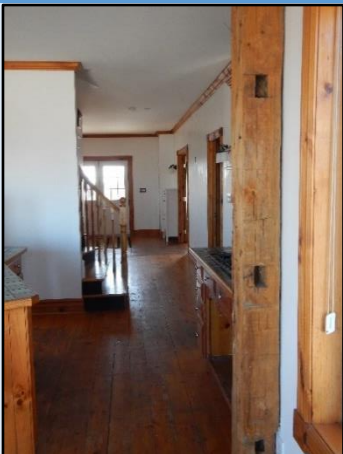
From Table 1, numeric sequence within report	Photos (Numbered 1-1, 1-2, etc.)	comments	Value
1-17

<p>Ground floor – View of hallway and foyer from kitchen area showing stairs leading to 2nd storey on left. Note the re-purposed barn beam for the bay window enclave on right (foreground). Facing east.</p>	
1-18

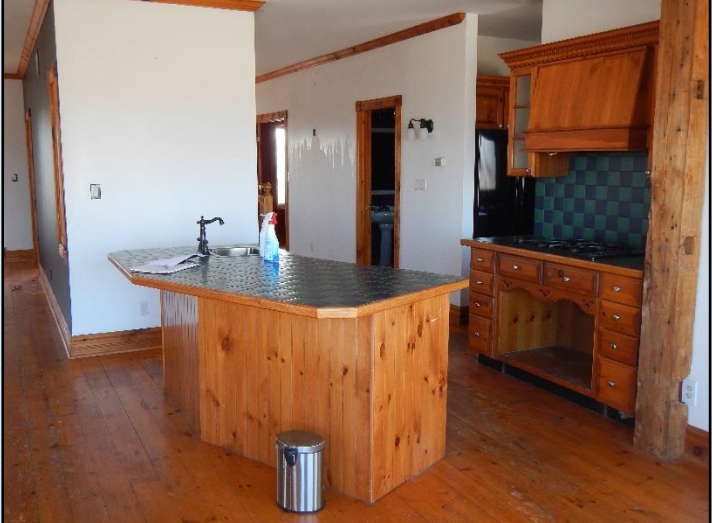
<p>Ground floor – View of kitchen/dining area from bay window enclave showing re-purposed barn beam on right. Facing southeast.</p>

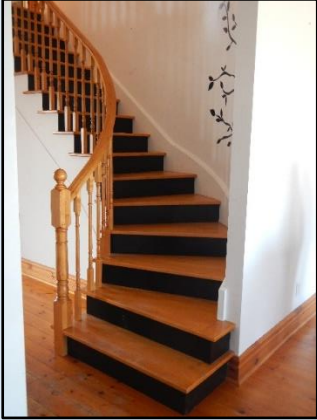
From Table 1, numeric sequence within report	Photos (Numbered 1-1, 1-2, etc.)	comments	Value
1-19

<p>Ground floor – View of stairs leading to 2nd storey from kitchen/dining area. Facing northeast.</p>	
1-20

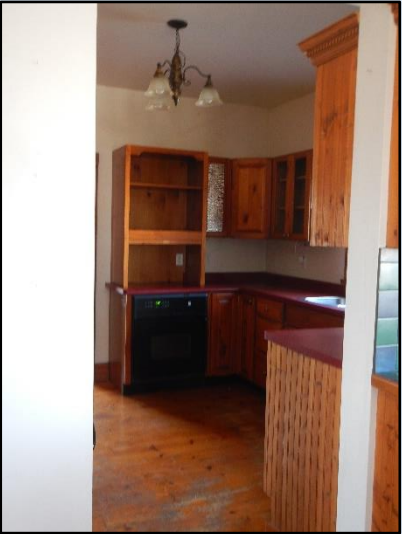
<p>Ground floor – View of south wall of kitchen/preparation/storage room from main room kitchen/dining area. Facing southwest.</p>

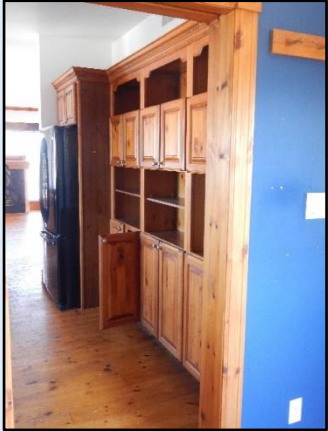
<p>Ground floor – View of east wall of kitchen/preparation/storage room from laundry room. Facing northeast.</p>

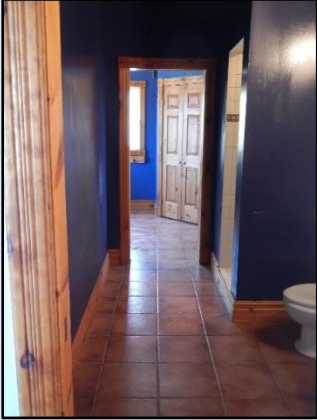
From Table 1, numeric sequence within report	Photos (Numbered 1-1, 1-2, etc.)	comments	Value
1-23

Ground floor – View of south wall of laundry room (blue) and bathroom from bottom of stairs in main room kitchen/dining area hallway. Facing south.	
1-24

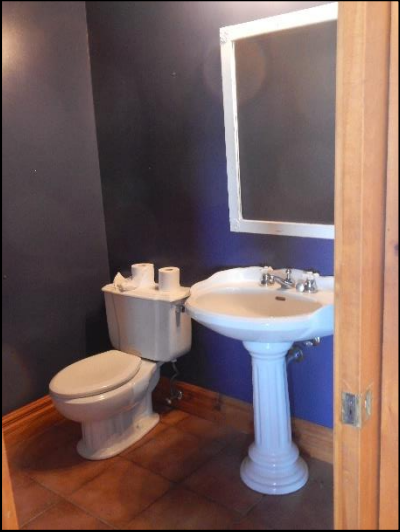
Ground floor – View of east wall of bathroom showing toilet and sink. Facing northeast.

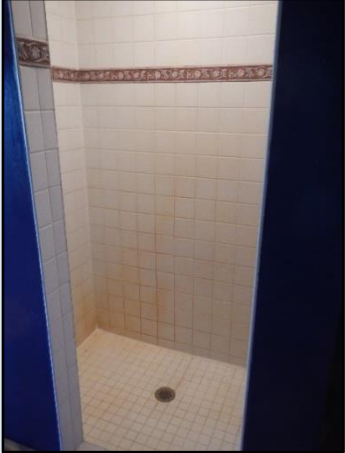
From Table 1, numeric sequence within report	Photos (Numbered 1-1, 1-2, etc.)	comments	Value
1-25

A photograph showing a view into a bathroom shower area from a doorway. The shower walls are covered in light-colored square tiles, and a blue shower curtain is visible on the left side. The floor is also tiled.	Ground floor – View of east wall bathroom shower from laundry room doorway. Facing northeast.	
1-26

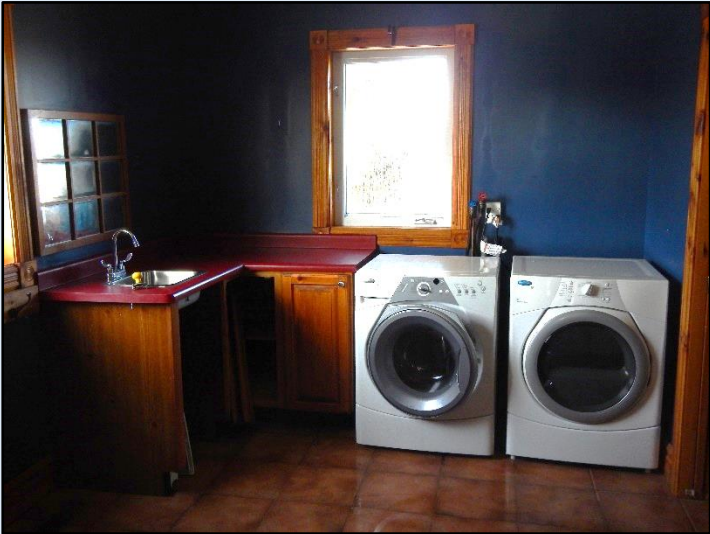
A photograph of a laundry room. On the left is a wooden vanity with a red countertop and a sink. In the center, a window with a wooden frame is set into a dark blue wall. To the right of the window are two white front-loading laundry machines (washer and dryer) side-by-side. The floor is made of large, reddish-brown tiles.	Ground floor – View of laundry room west wall, facing west.

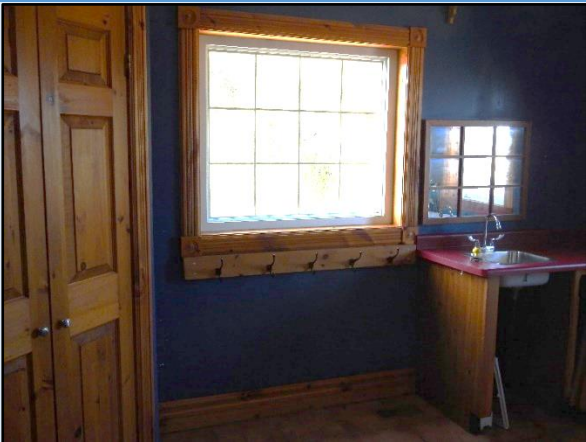
From Table 1, numeric sequence within report	Photos (Numbered 1-1, 1-2, etc.)	comments	Value
1-27

Ground floor – View of laundry room south wall, window, and closet on left. Facing south.	
1-28

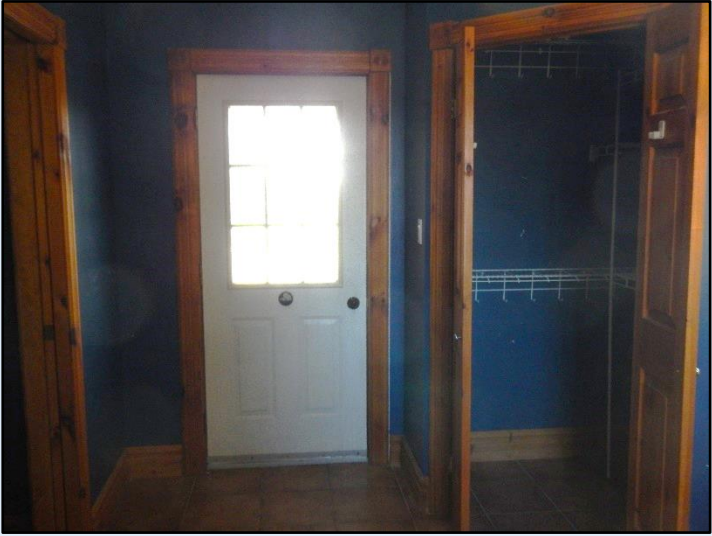
Ground floor – View of laundry room east wall, showing door to veranda, and closet on right. Facing east.

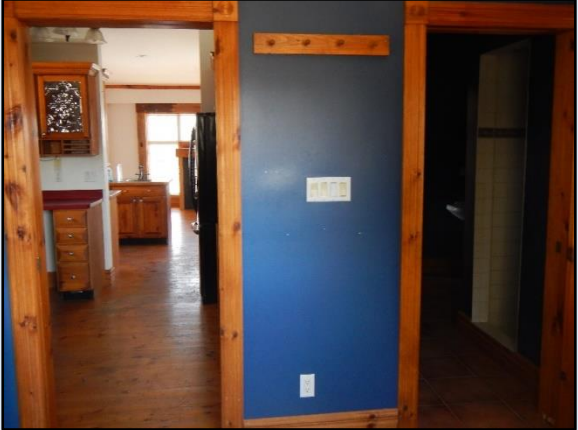
From Table 1, numeric sequence within report	Photos (Numbered 1-1, 1-2, etc.)	comments	Value
1-29

<p>Ground floor – View of laundry room north wall, showing doors to kitchen area (left) and bathroom (right). Facing north.</p>	
1-30

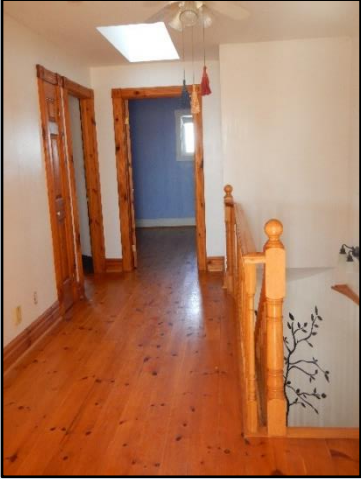
<p>2nd Storey – View of landing area showing stairs to main floor on the right. Facing west.</p>

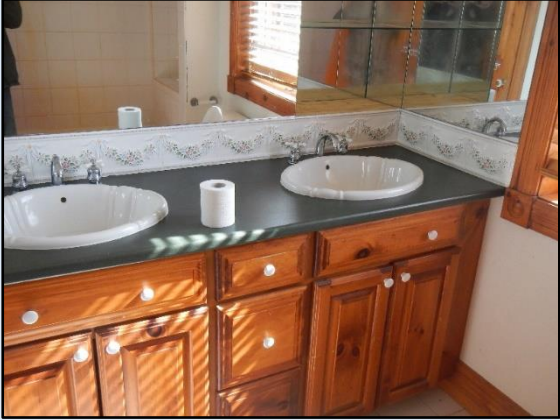
From Table 1, numeric sequence within report	Photos (Numbered 1-1, 1-2, etc.)	comments	Value
1-33

<p>2nd Storey – View of bathroom (#1) north wall showing double sink. Facing northeast.</p>	
1-34

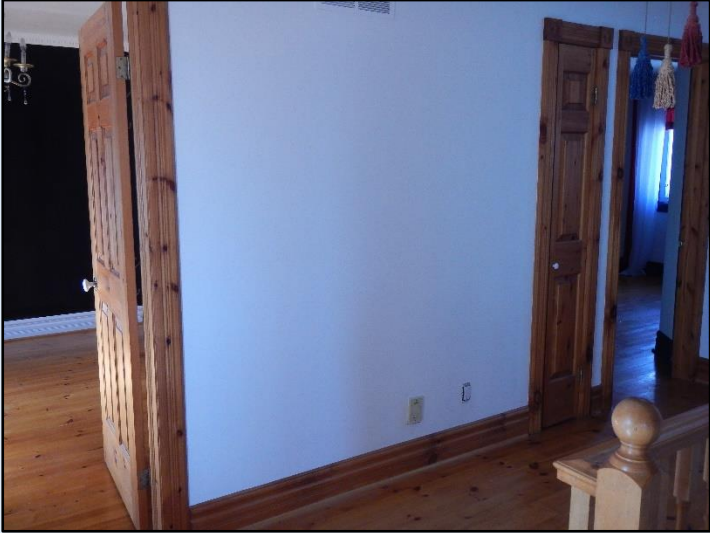
<p>2nd Storey – View of landing area south wall showing stairs to main floor on the right (bannister in foreground), and doors to room #'s 2 (left) and 3 (right). Facing southwest.</p>

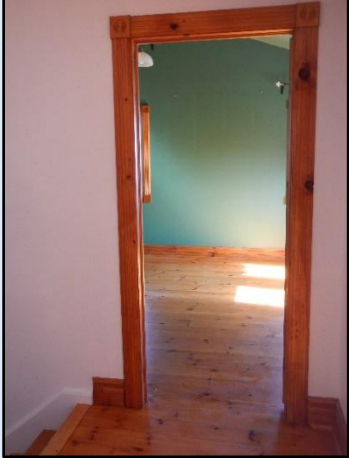
<p>2nd Storey – View of landing area north wall showing stairs to main floor on the left, and the doorway to room #1. Facing north.</p>	
1-36

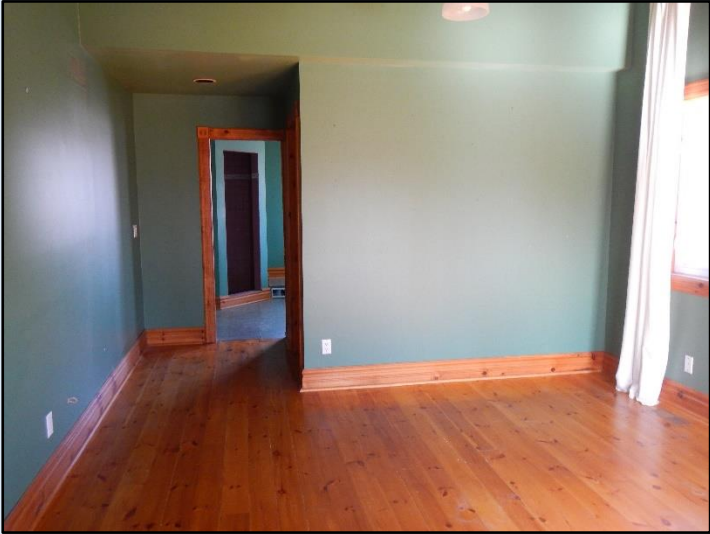
<p>2nd Storey – View of west wall of room #1 from landing area doorway, showing doorway to bathroom #2 and walk-in closet (next to bathroom door). Facing west.</p>

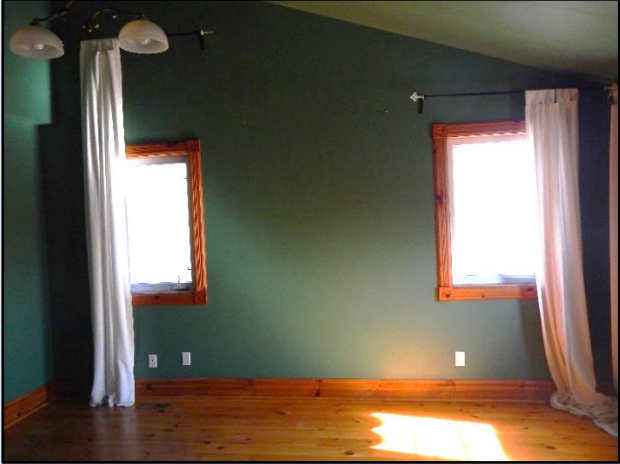
<p>2nd Storey – View of north wall of room #1 from landing area doorway, showing modern lighting fixture and windows. Facing north.</p>	
1-38

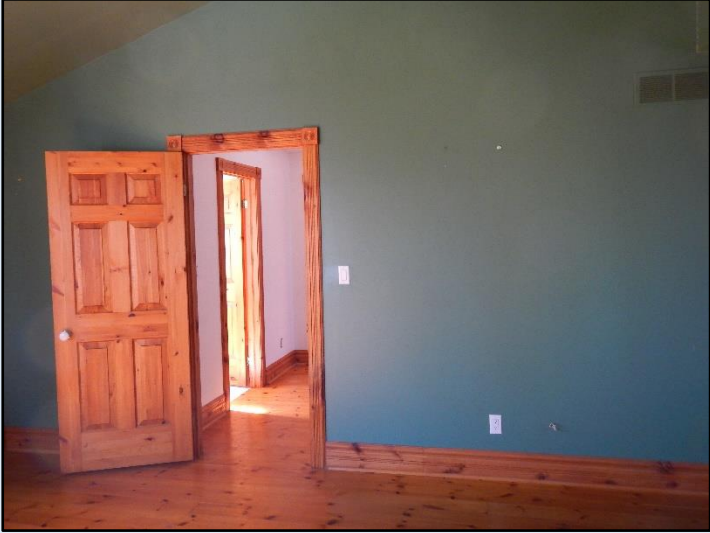
<p>2nd Storey – View of south wall of room #1 showing doorway to landing area. Facing southeast.</p>

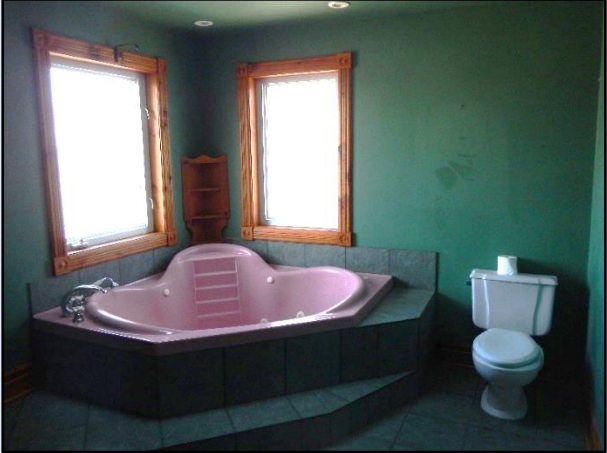
<p>2nd Storey – View of Jacuzzi and toilet in NW corner of bathroom #2, from doorway to room #1. Facing northwest.</p>	
<p>1-42</p>

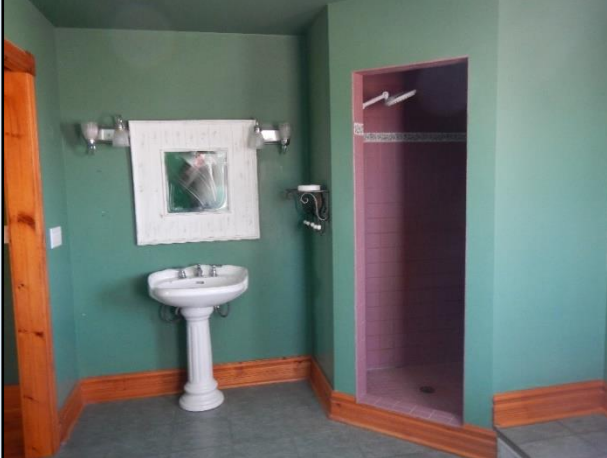
<p>2nd Storey – View of shower and sink on south wall of bathroom #2, showing doorway to room #1 on left. Facing southwest.</p>

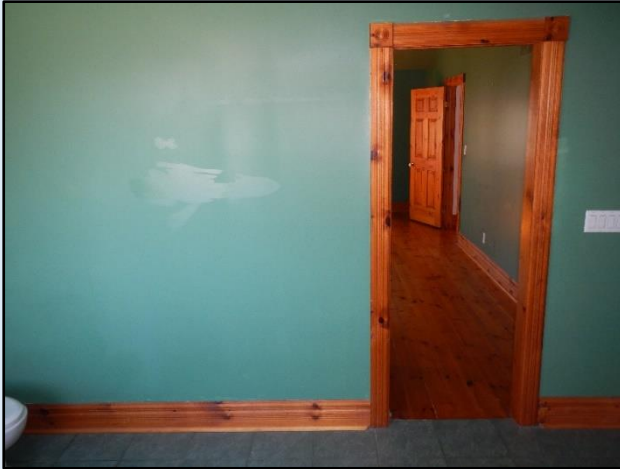
2nd Storey – View of east wall of bathroom #2, showing doorway to room #1 (foreground) and door to landing area. Facing east.

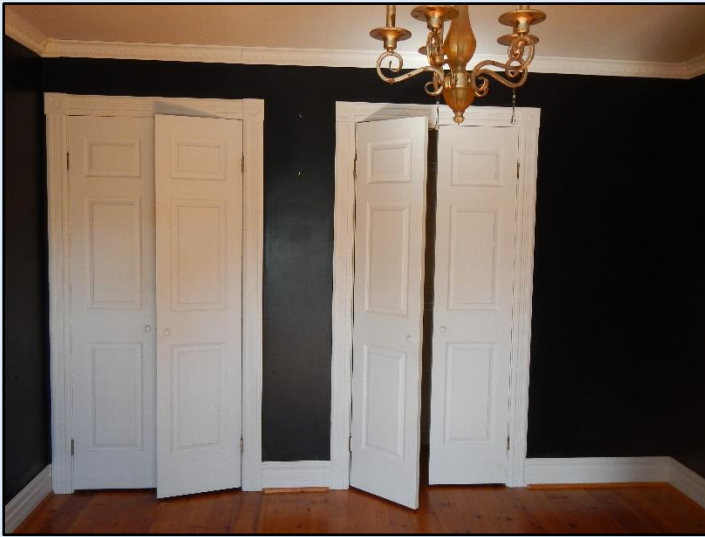
2nd Storey – View of west wall of room #2, showing two double-door closets and modern lighting fixture. Taken from landing area doorway. Facing west.

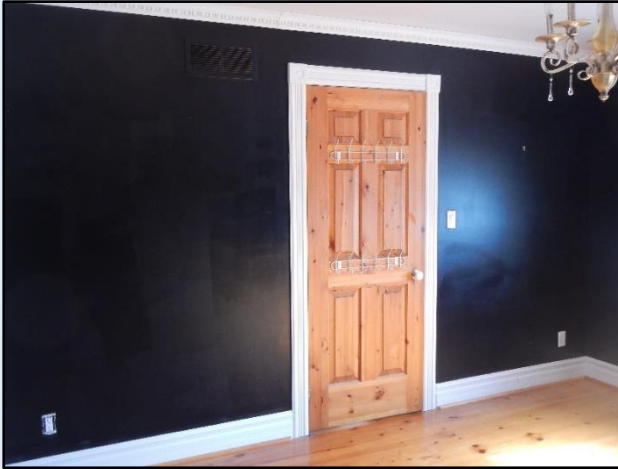
2nd Storey – View of east wall of room #2, showing door to landing area. Facing southeast.

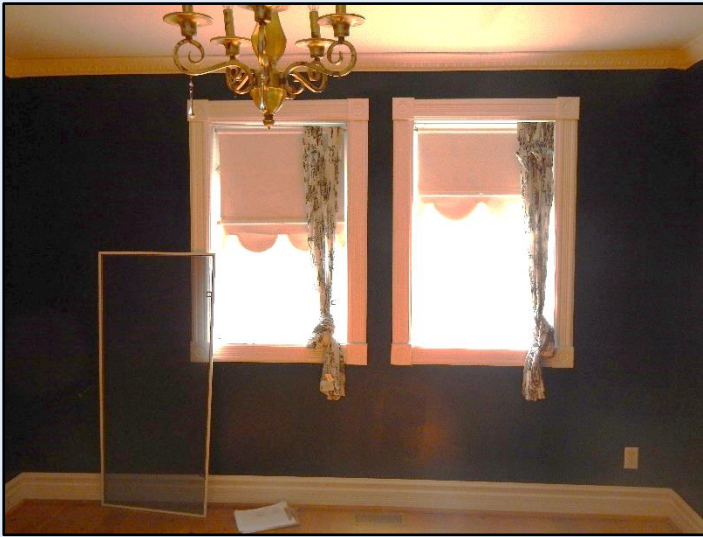
2nd Storey – View of north wall of room #2, showing double windows, from doorway to landing area. Facing north.

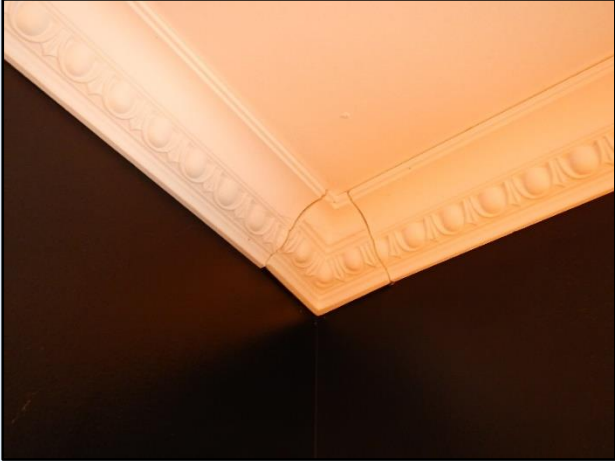
2 nd Storey – View of modern wainscoting in room #2. Facing southwest.	
1-48

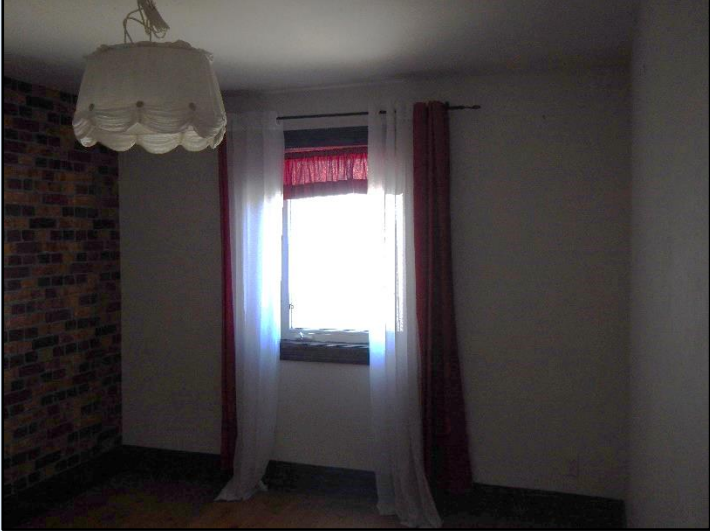
2 nd Storey – View of west wall of room #3, showing single window and modern lighting fixture, from doorway to landing area. Facing southwest.

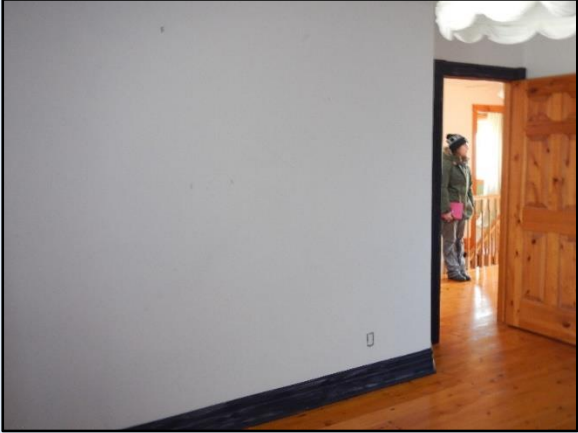
A photograph showing the north wall of room #3. The wall is white and has a single electrical outlet near the bottom. To the right, there is a doorway leading to a landing area with wooden floors. In the background, a person is visible near a staircase.	2 nd Storey – View of north wall of room #3, showing door to landing area and stairs leading to main floor (on far right in background). Facing northeast.	
1-52

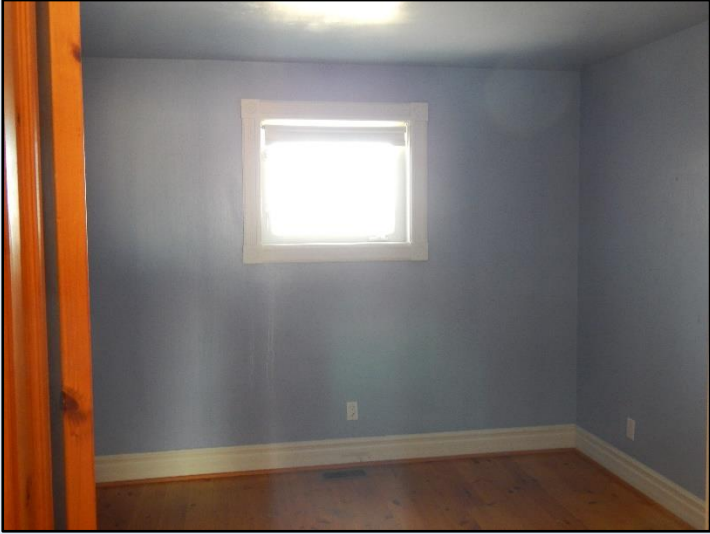
A photograph showing the west wall of room #4. The wall is painted a light blue color and features a single window with a white frame. The room has wooden floors and white baseboards. A doorway is visible on the left side of the frame.	2 nd Storey – View of west wall of room #4, showing single window, from doorway to landing area. Facing west.

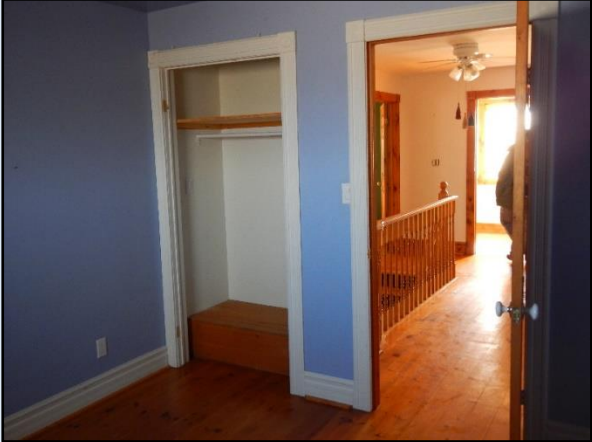
2 nd Storey – View of east wall of room #4, showing closet and doorway to landing area and stairs. Facing northeast.	
1-54

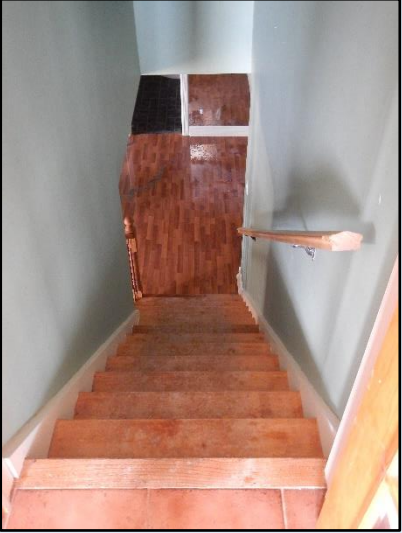
Ground floor - showing basement stairs from double-door eastern entrance and foyer area. Facing west.

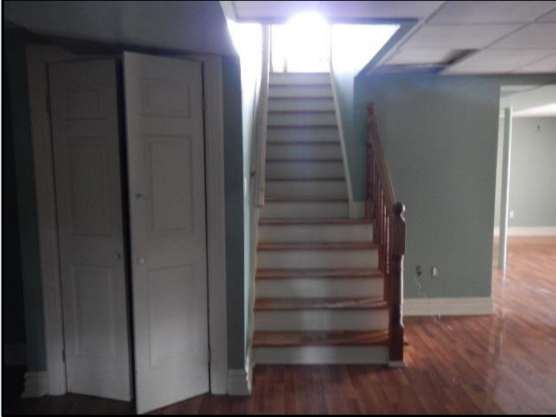
Basement - showing stairs to eastern entrance and main floor foyer area from bathroom doorway. Facing east.	
1-56

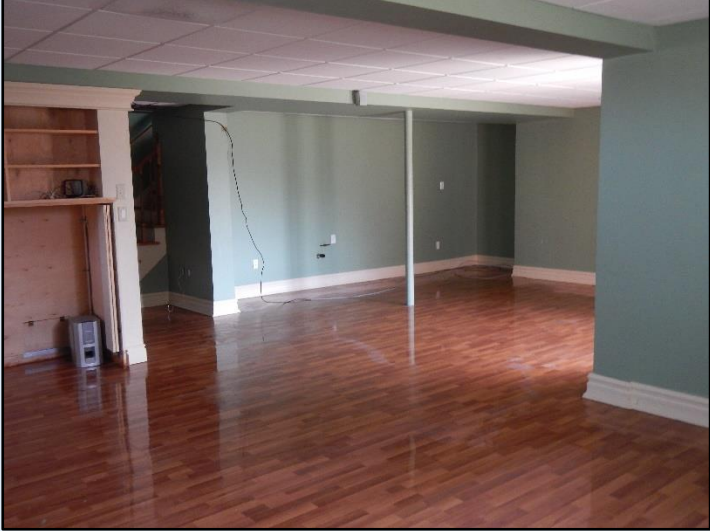
Basement – showing main room and stairs to eastern entrance main floor foyer area (left). Facing northeast.

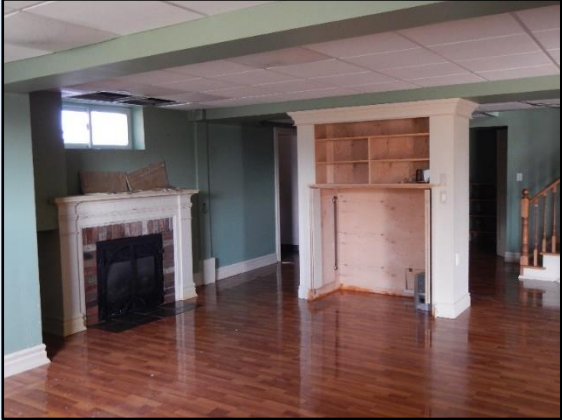
<p>Basement – showing, extant gas fireplace (and possible former fireplace frame), bathroom door (left), and stairs to main floor foyer area (right). Facing northwest.</p>	
<p>1-58</p>

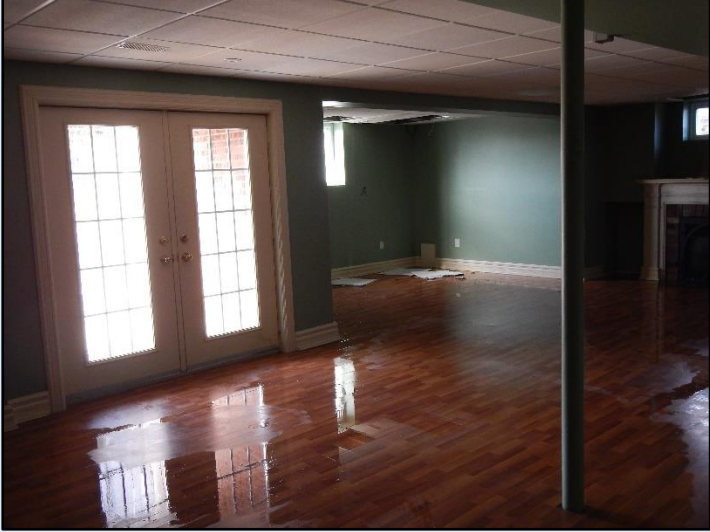
<p>Basement – showing SE corner of main room with gas fireplace (right), and double-doors leading to patio area. Facing southeast.</p>

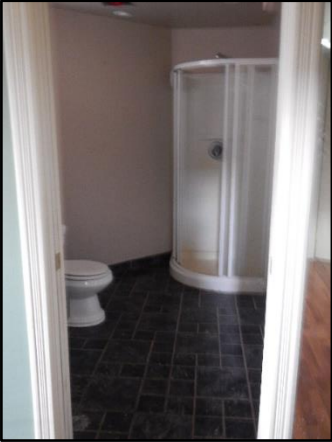
Basement – bathroom showing shower and toilet. Facing south.	
1-60

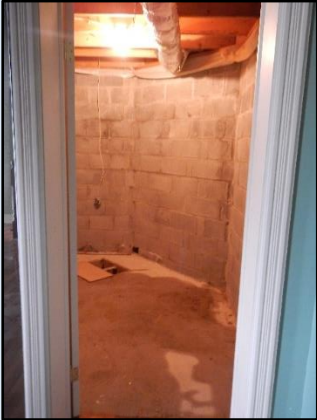
Basement – storage room next to bathroom on south wall showing cinder-block foundation. Facing south.

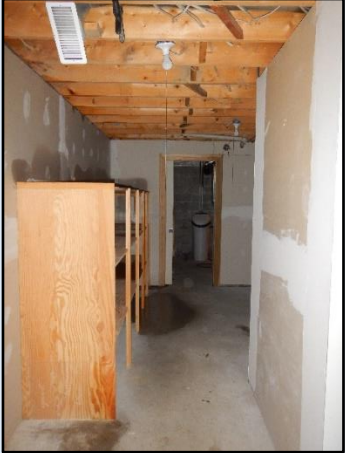
Basement – second storage room leading to utilities room (located to the west of smaller storage room above). Facing north.	
1-62

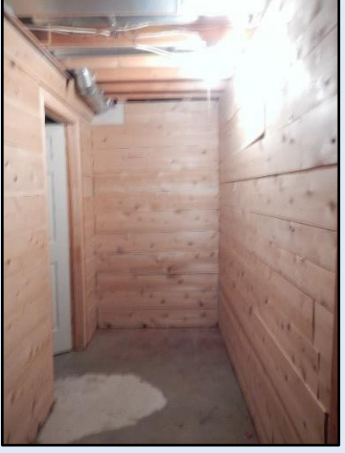
Basement – third storage room near utilities room (located under the basement stairs). Facing east.

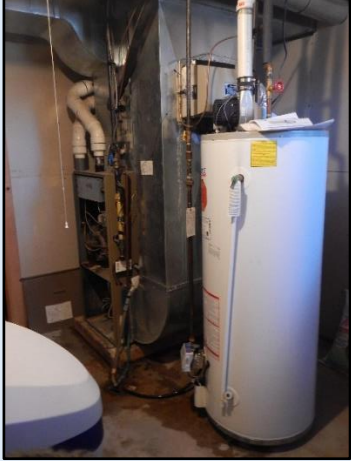
Basement –utilities room showing furnace and water-heater. Facing southeast.	
1-64

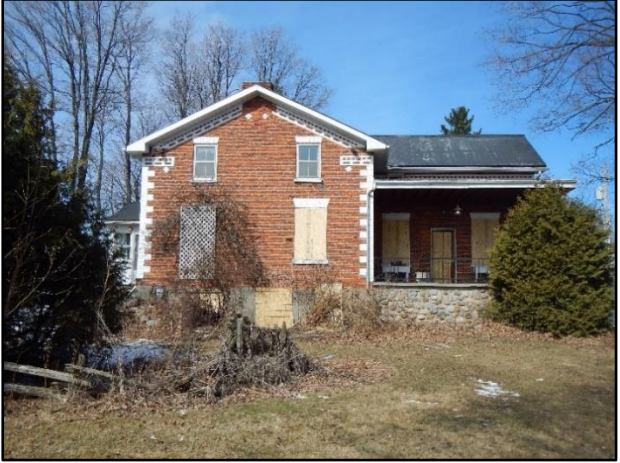
<p>East face of house, facing NW. Note modern poured concrete porch with stone facing.</p>	<p>Yes</p>
<p>2-2</p>

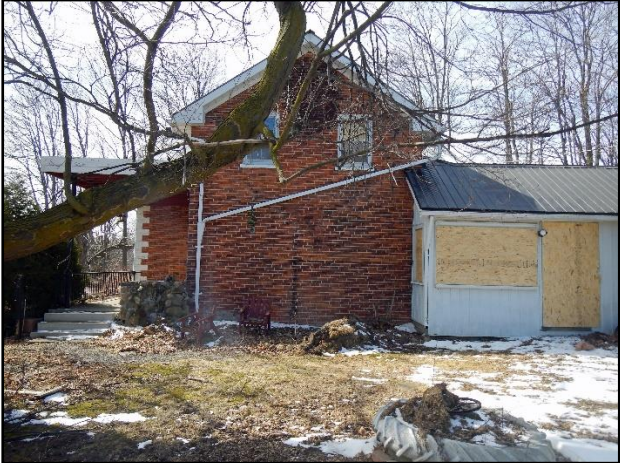
<p>North face of house, facing SW. Note addition.</p>

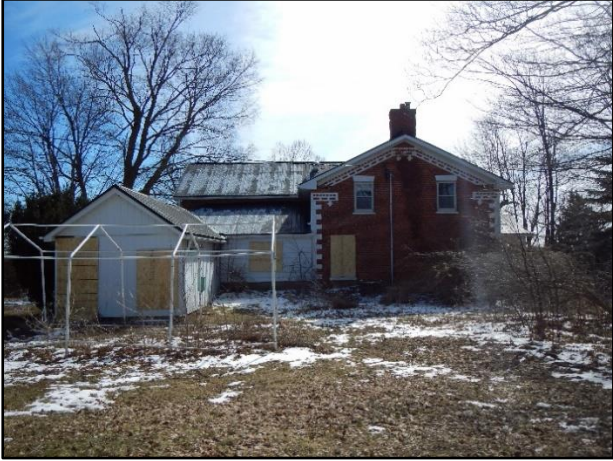
West face of house, facing SE. T- shaped plan.	
2-4

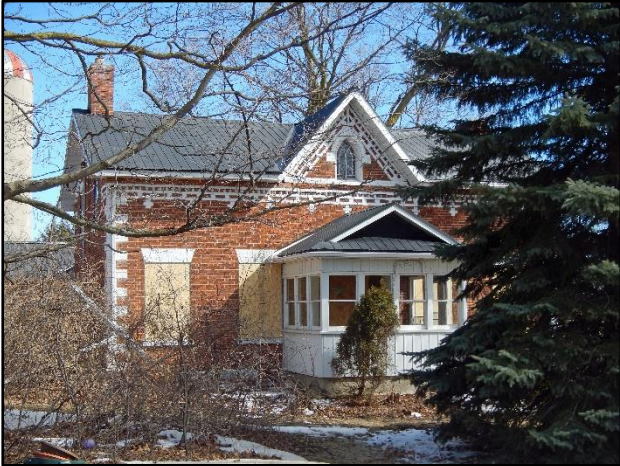
South face of house, facing NE. Main façade with covered porch, central gable.

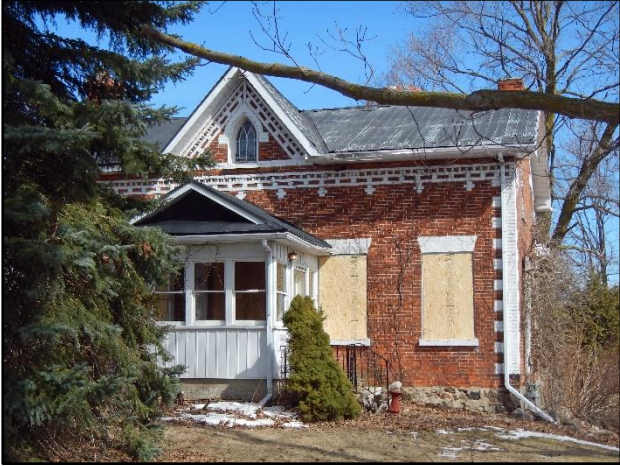
South face of house, facing NW.	
2-6

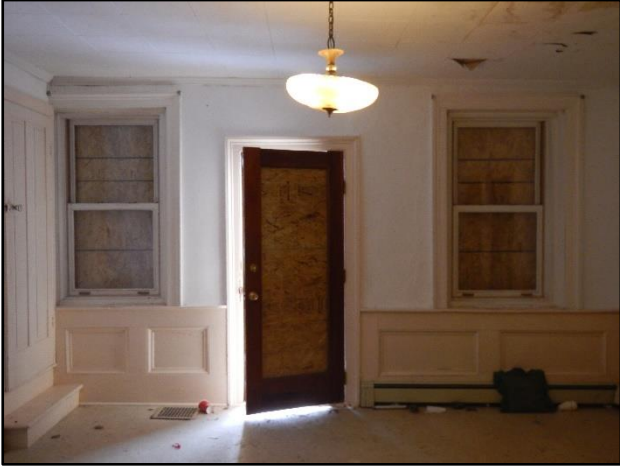
Ground floor – east wall of anteroom from poured concrete porch showing entrance and original double window frames wainscoting. Door to 2 nd storey on far left at step. Facing east.

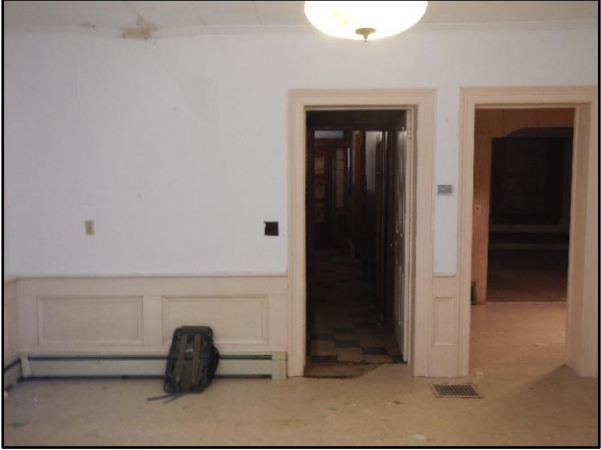
Ground floor – View of anteroom south wall, showing original doorways to hallway/upper-level stairwell (left), and room #2 (right). Facing south. Note wainscoting and cut away to accommodate electric baseboards.	
2-8

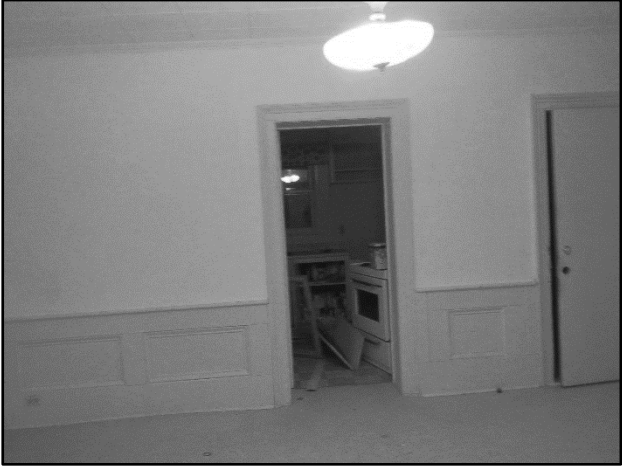
Ground floor – View of room anteroom west wall, showing original doorway to kitchen (left) and modern doorway to exterior addition of house (right). Facing west.

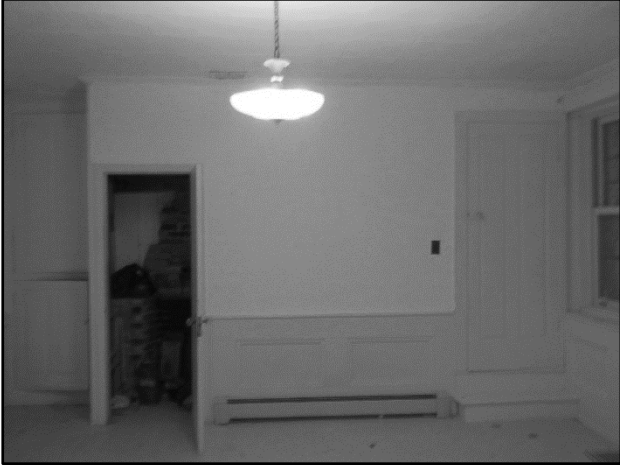
Ground floor – View of anteroom north wall, showing original doorway to 2 nd storey stairs (right) and enclosure for former fireplace (open door on left). Facing north.	
2-10
