HERITAGE IMPACT ASSESSMENT 15717 AIRPORT ROAD TOWN OF CALEDON

DG Group

Scarlett Janusas Archaeology Inc.
269 Cameron Lake Road
Tobermory, Ontario N0H 2R0
Phone 519-596-8243, cell 519-374-1119
jscarlett@amtelecom.net www.actionarchaeology.ca

April 21st, 2017

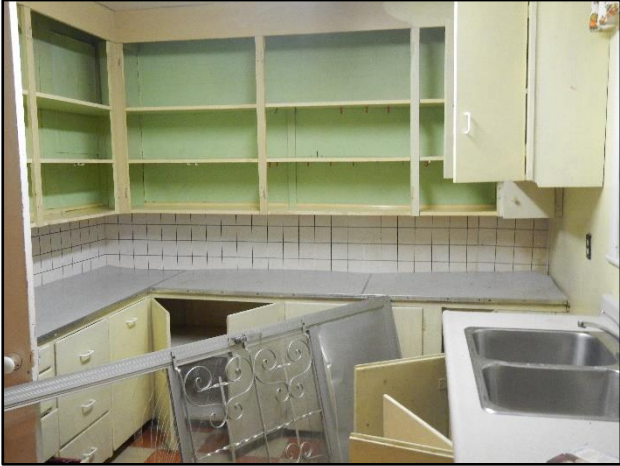
Ground floor – View of south wall of kitchen taken from doorway to ante room. Facing south.

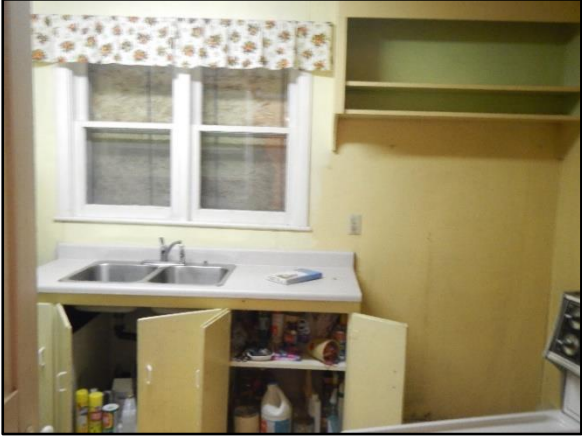
A photograph of a kitchen sink area. The sink is white with a chrome faucet. Above the sink is a window with white trim and a floral patterned valance. To the right of the sink is a yellow wall with a built-in shelf. Below the sink, the yellow cabinets are open, revealing various items inside.	Ground floor – View of west wall of kitchen taken from doorway to ante room. Facing west.	
2-12

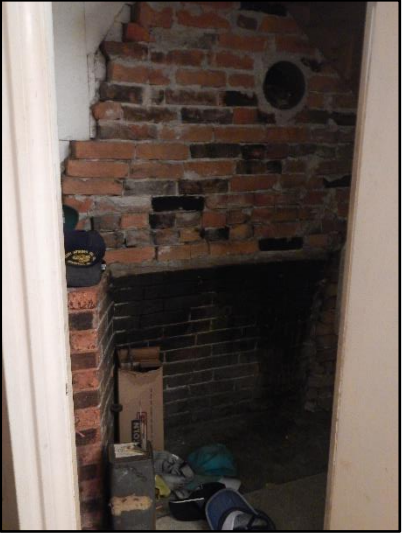
A photograph of a former fireplace. The fireplace is made of red brick and is partially covered by a white curtain on the left. The interior of the fireplace is dark and contains some debris. The brickwork is visible on the walls and floor.	Ground floor – View of former fireplace on north wall of anteroom, now under staircase. Facing north.

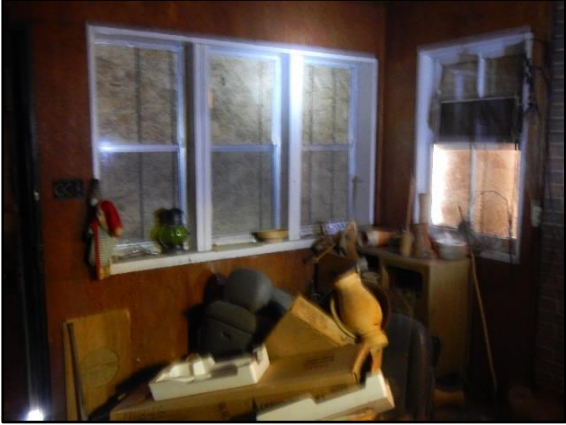
Ground floor – View of NE corner of exterior addition to house (modern). Facing northeast.	
2-14

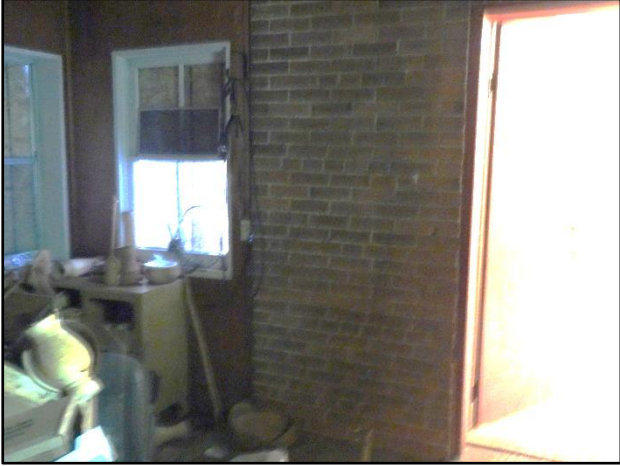
Ground floor – View of east wall of exterior addition to house (modern), showing doorway into anteroom. Facing northeast.

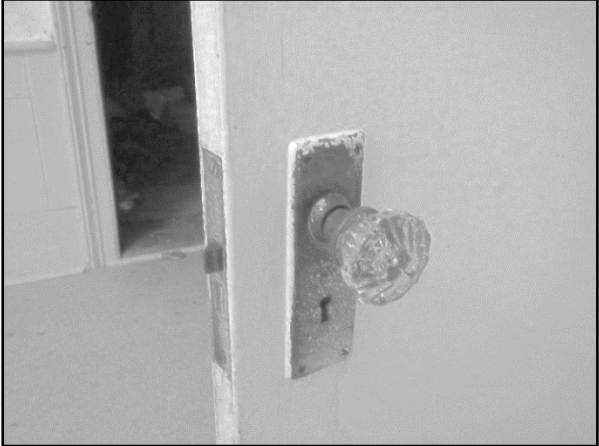
<p>Ground floor – View of original crystal doorknob on door for closet now housing former fireplace on north wall of anteroom. Facing west.</p>	
2-16

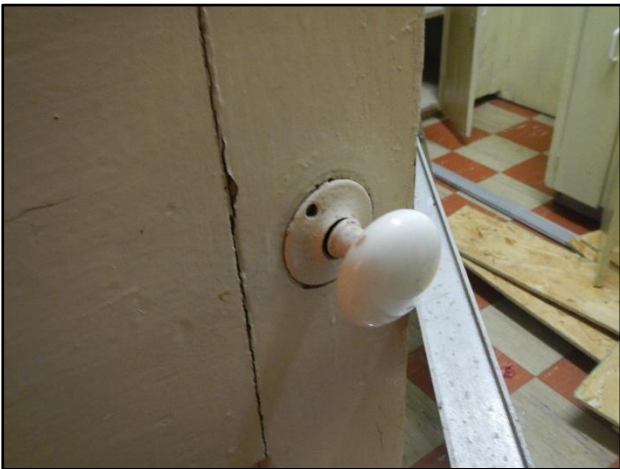
<p>Ground floor – View of original metal doorknob on door to kitchen on west wall of ate room. Facing southwest.</p>

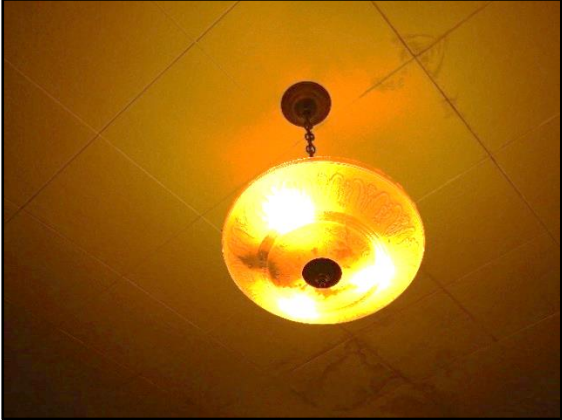
Ground floor – View of original light fixture in anteroom. Facing west.	
2-18

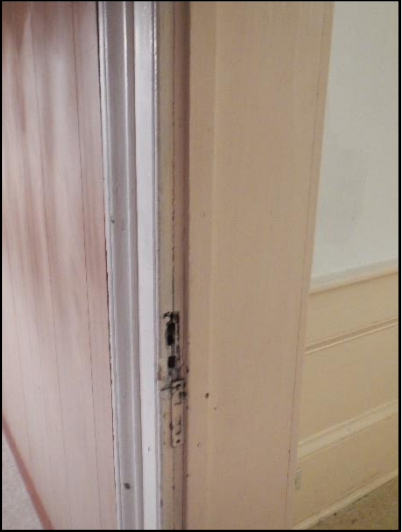
Ground floor – View of original doorframe on south wall of anteroom, leading into adjacent room. Facing northeast.

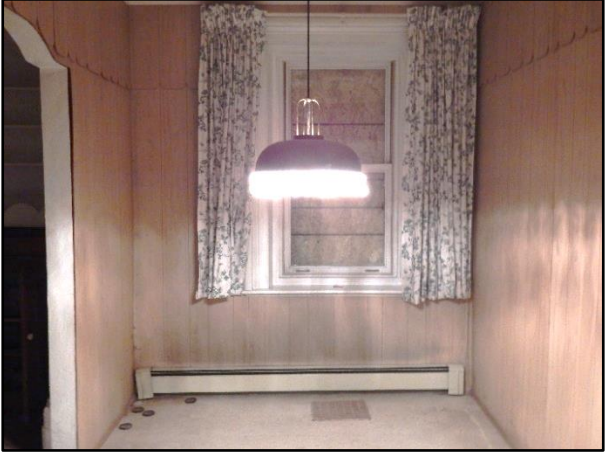
Ground floor – View of west wall, window, and light fixture in possible dining room, taken from doorway to ante room, showing entrance to living room (left). Facing west.	
2-20

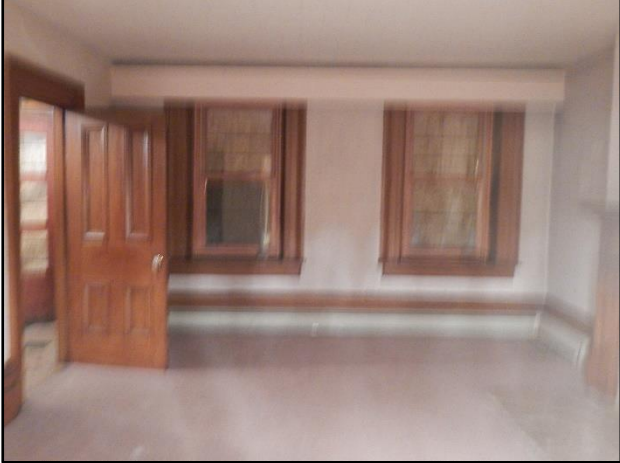
Ground floor – View of south wall in living room, showing double hung windows, and doorway to south entrance and hallway area (left). Taken from doorway to possible dining room. Facing south.

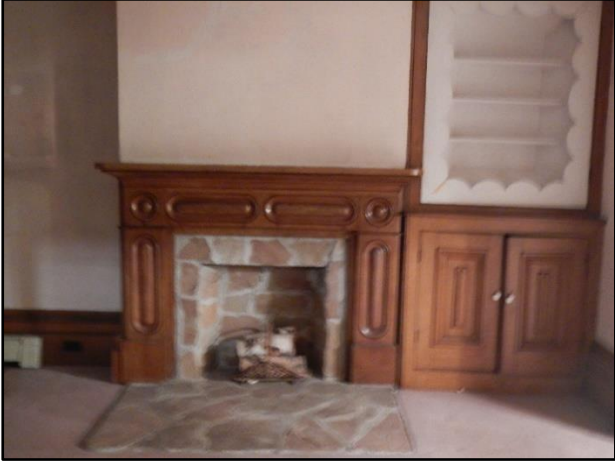
<p>Ground floor – View of west wall in living room, showing fireplace mantel and corresponding cabinet. Facing west. Fireplace sealed.</p>	
2-22

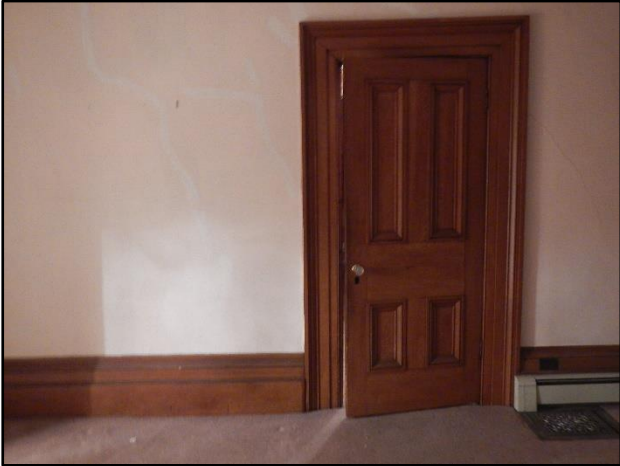
<p>Ground floor – View of east wall in living room, showing doorway to south entrance, stairs to second floor, and hallway area. Facing east. Original door, frame and baseboards. Note baseboards cut away for electric heaters.</p>

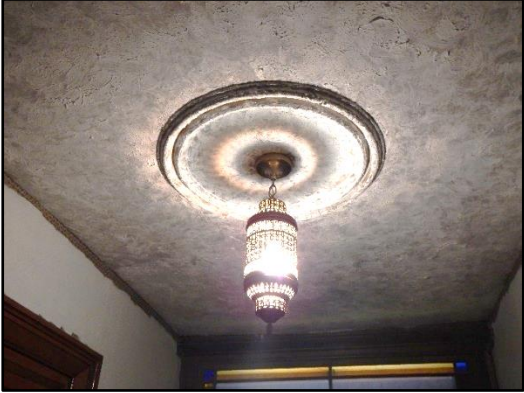
<p>Ground floor – View of original light fixture at bottom of stairs at south entryway and hallway area. Facing south. Plaster and painted ceiling.</p> <p>Vintage lighting.</p>	
2-24

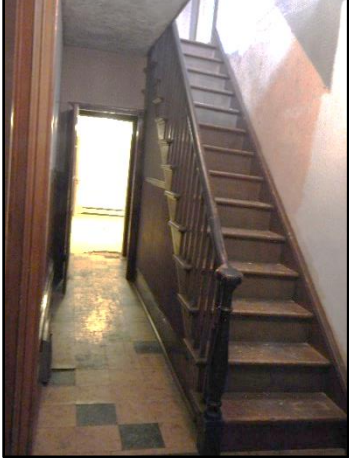
<p>Ground floor – View of stairs leading to 2nd storey in south entrance and hallway area, showing doorway to vestibule on left. Taken from doorway to living room/main south entrance. Facing north. No decorative elements on staircase.</p>	
<p>2-26</p>

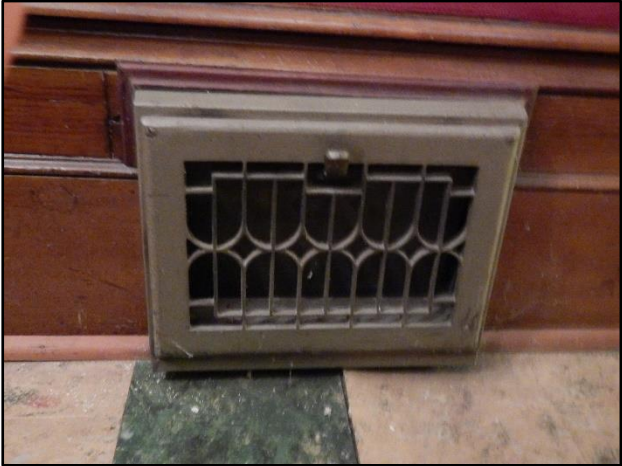
<p>Ground floor – View of heating vent grate and trim on west wall at base of stairs leading to 2nd storey in south entrance and hallway area. Facing west. Note high baseboard.</p>

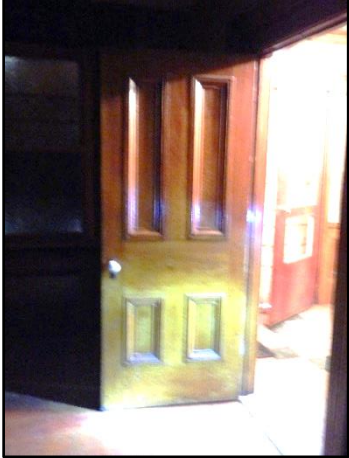
Ground floor – View of original door on west wall of adjacent living room showing south entrance and hallway area on right. Facing southwest.	
2-28

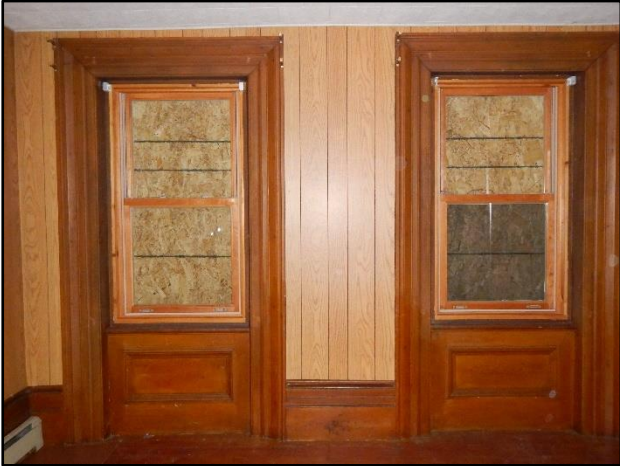
Ground floor – View of original double windows and trim on south wall of adjacent living room. Facing south. Note high baseboard. Note fake wood paneling.

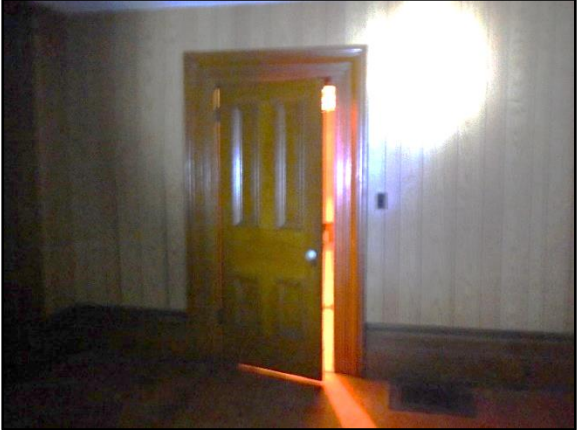
<p>Ground floor – View of west wall of adjacent living room showing original door to south entrance and hallway area. Facing southwest.</p> <p>Note high baseboard.</p>	
2-30

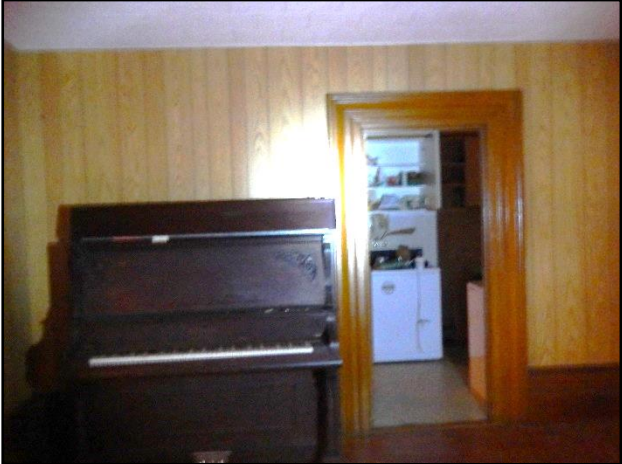
<p>Ground floor – View of north wall of adjacent living room showing original door/framing to laundry room area. Facing north. Note high baseboard.</p>

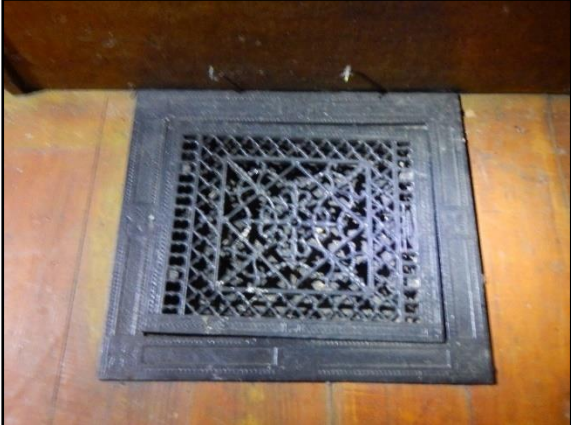
<p>Ground floor – View of original floor grate at base of west wall in adjacent living room next to doorway leading to south entrance and hallway area. Facing west. Wide plank wooden flooring.</p>	
2-32

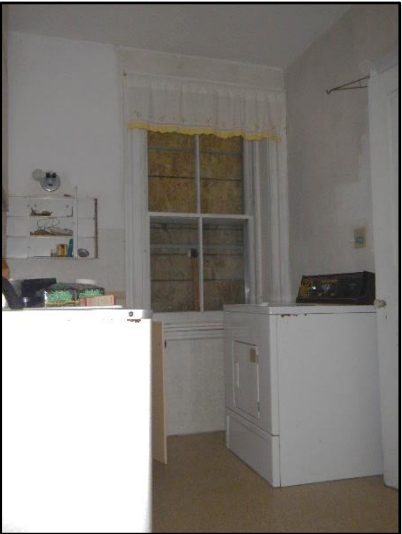
<p>Ground floor – View of southeast corner of laundry room area, showing original window frame with modern windows. Facing southeast.</p>

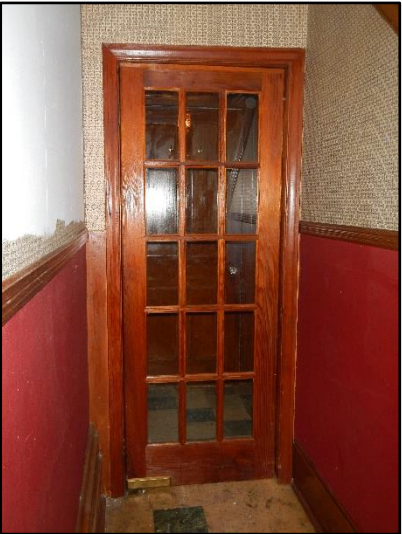
<p>Ground floor – View of door leading to ante room and basement stairs landing next to stairs leading to 2nd storey in south entrance and hallway area. Facing north.</p>

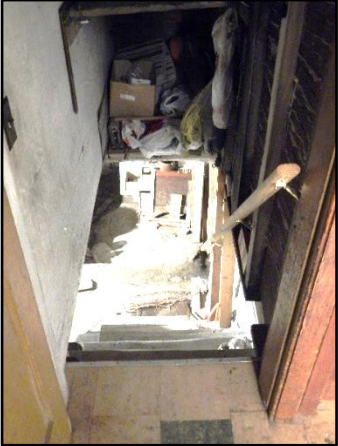
<p>Ground floor – View from landing at top of wooden basement stairs. Facing south.</p>	
<p>2-36</p>

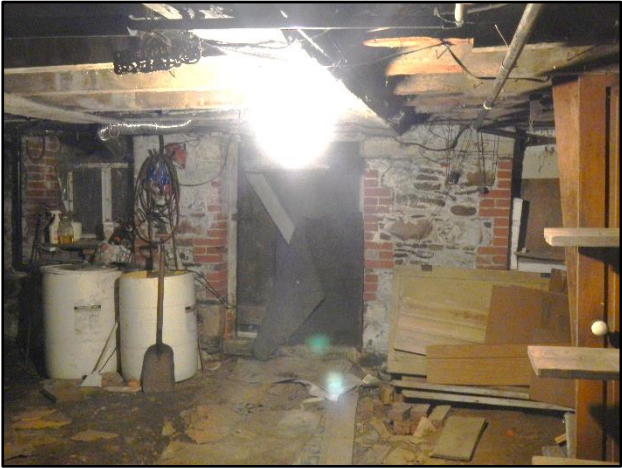
<p>Basement – View of east wall in room 1 of basement taken from base of stairs and entryway to room 2 of basement. Facing northeast. Brick pillars with fieldstone. Dirt and concrete floors.</p>

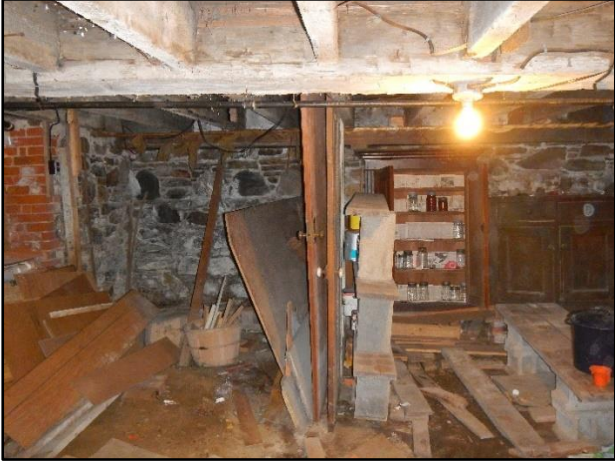
<p>Basement – View of south wall in room #1 of basement taken from base of stairs and entryway to room #2 of basement. Facing south.</p> <p>Note fieldstone foundation</p>	
2-38

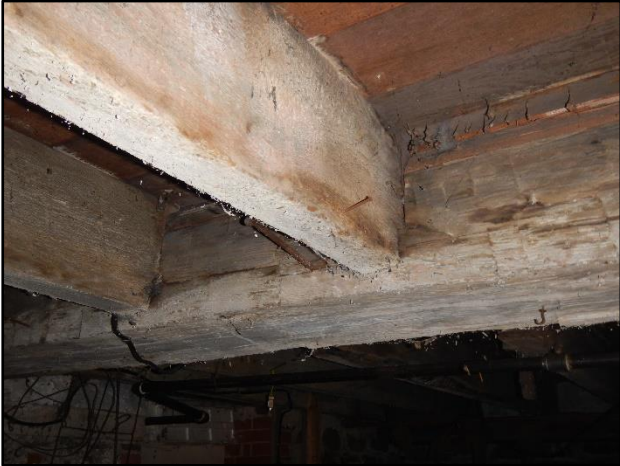
<p>Basement – View of basement ceiling/ground level floor beams and joists in room #1. Facing southeast. Adze marks on beam. Floors above are milled, as are the joists.</p>

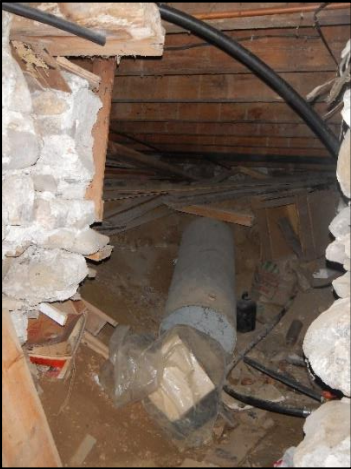
Basement – View of unexcavated basement area taken from next to stairs in room #1 (located under room #1 of main floor). Facing northwest.	
2-40

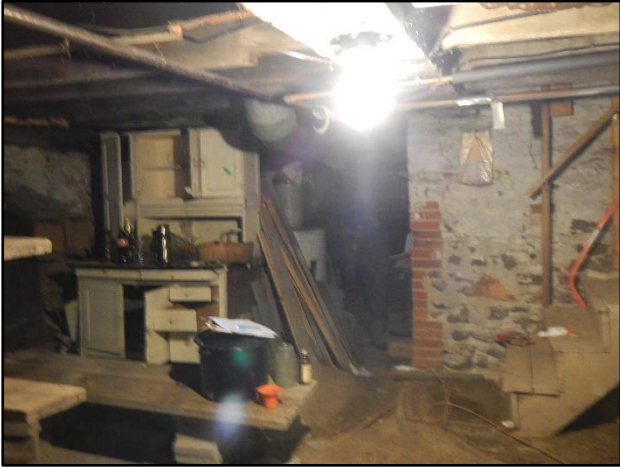
Basement – View of west wall in room #1 showing entrance to room #2 at base of stairs. Facing southwest.

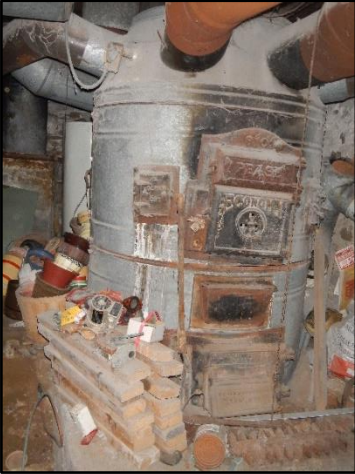
Basement – View of soft coal burning furnace on east wall of room #2 next to entrance to room #1. Facing northeast. Pease Foundry.	
2-42

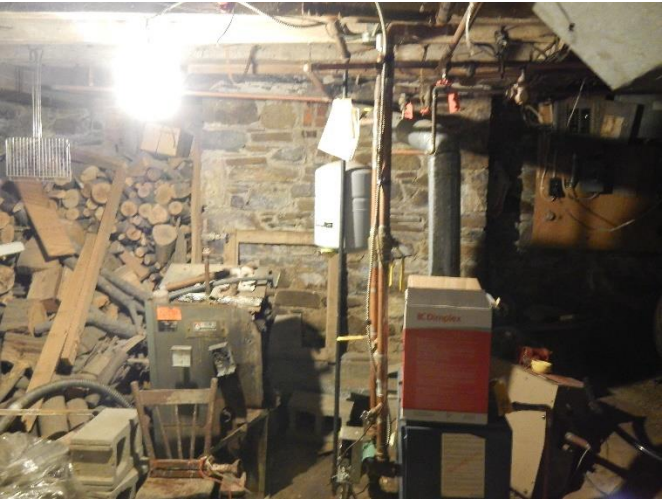
Basement – bump out for fireplace above on main floor – field stone construction.

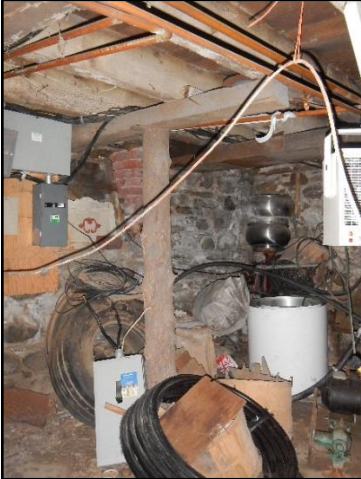
Basement – View of northwest corner of room #2 taken from entrance to room #1, showing re-purposed log as support post. Facing northwest.	
2-44

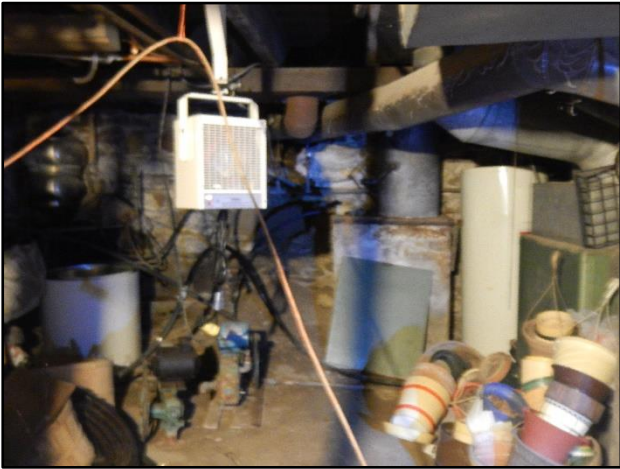
Basement – View of west wall of room #2 taken from entrance to room #1. Facing west.

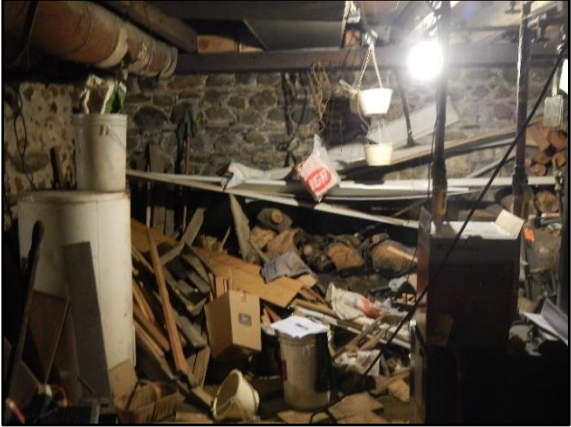
Basement – View of south wall of room #2 taken from entrance to room #1. Facing southwest.	
2-46

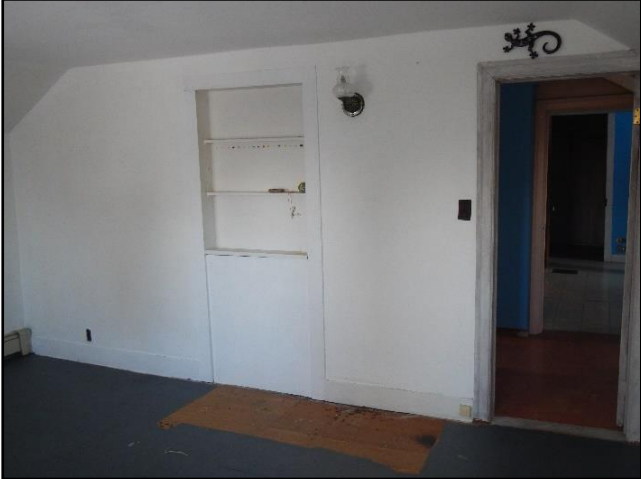
2 nd story – View of south wall of room #1 from top of stairs, showing door to 2 nd storey hallway. Facing southeast.	
2-48

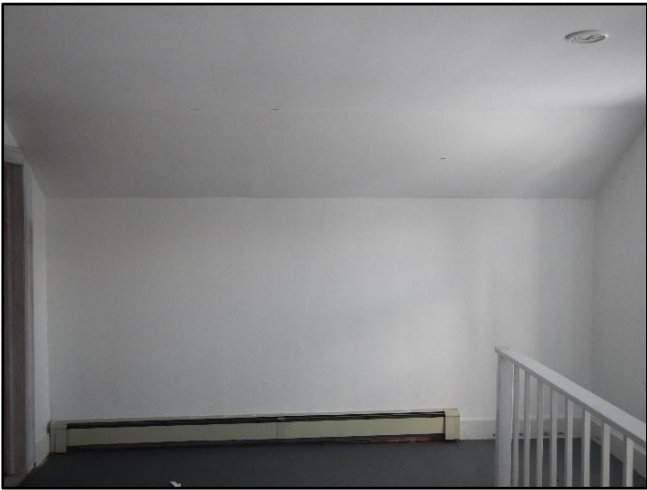
2 nd story – View of west wall of room #1 showing top of stairs and door to 2 nd storey hallway (left). Facing west.

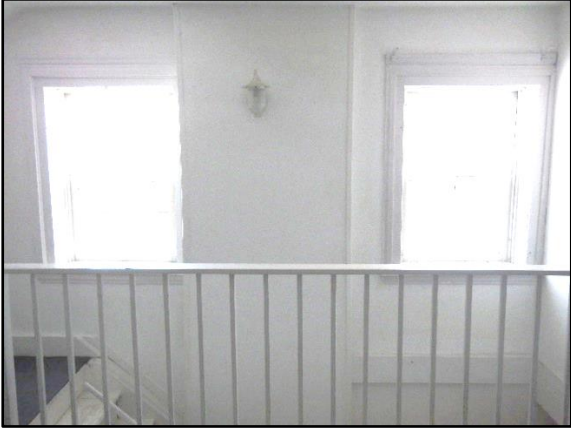
2 nd story – View of north wall of room #1 showing stairs and double-windows. Facing north.	
2-50

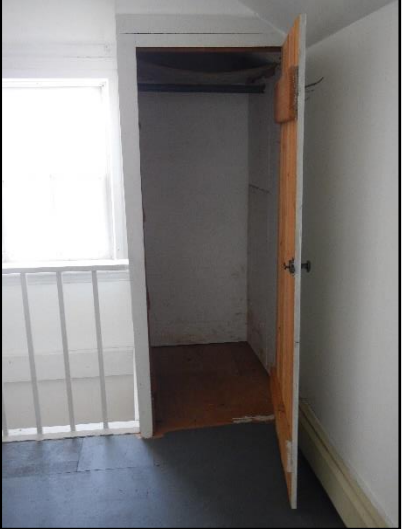
2 nd story – View of closet in northeast corner of room #1 showing stairs and window. Facing north.

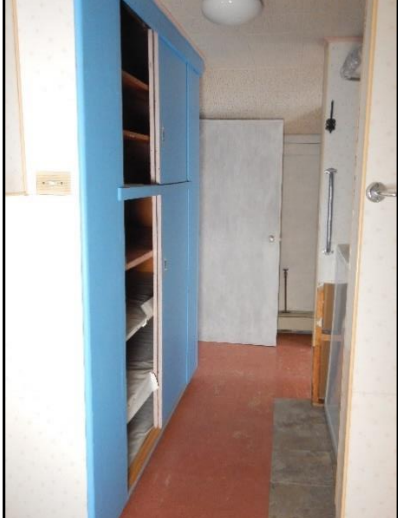
2 nd story – View of shelving across from bathtub on south wall of bathroom, showing door to room #2. Facing southwest.	
2-54

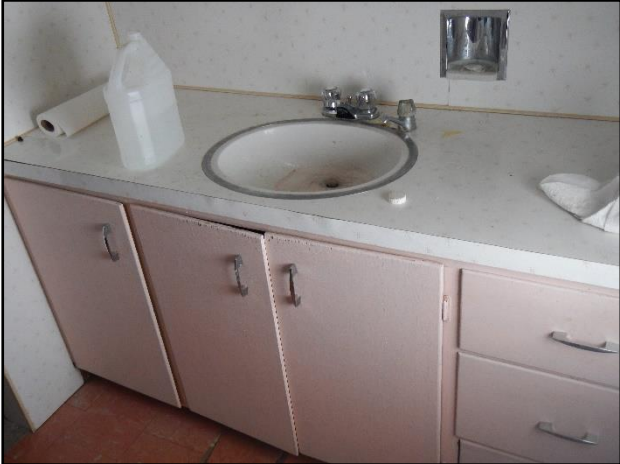
2 nd story – View of sink and cabinet on north wall of bathroom. Facing northwest.

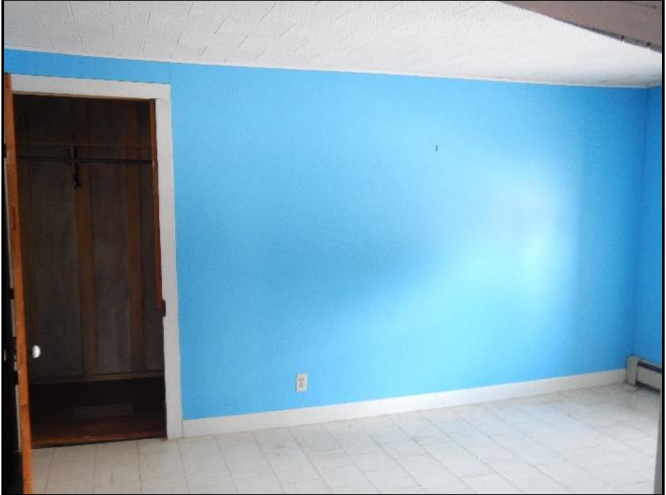
2 nd story – View of south wall in room #2 showing closet on left. Facing southwest.	
2-56

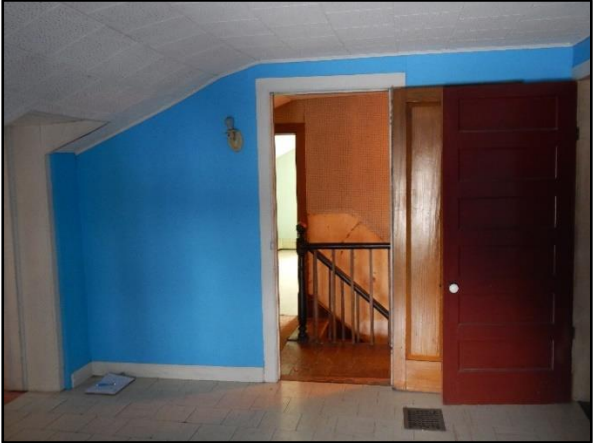
2 nd story – View of east wall in room #2 showing closet door (right), and doorway to stairs and room #1 beyond. Facing northeast.

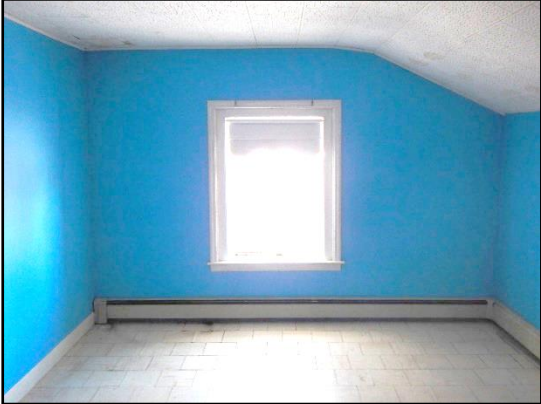
2 nd story – View of west wall in room #2 showing window from doorway to stairs. Facing west.	
2-58

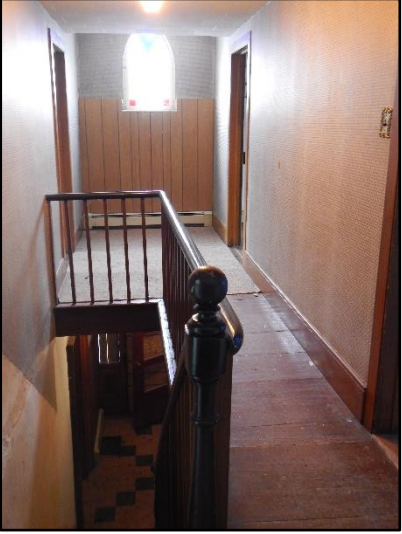
2 nd story – View of hallway and stairwell to main floor southern entrance landing area, showing doors to room #2 (right foreground), room #5 (distant right), and room #4 (left), taken from doorway of room #3. Facing south. Note fake wood paneling.

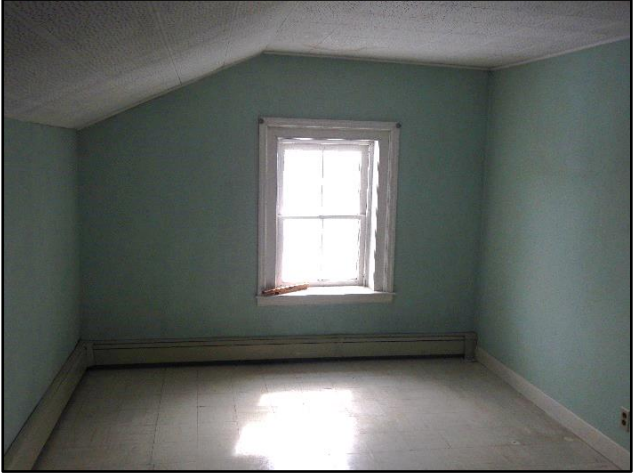
A photograph of an empty room with light green walls and a white ceiling. A single window with a white frame is centered on the wall. The floor is light-colored and appears to be made of wood or laminate. The room is brightly lit by natural light from the window.	2 nd story – View of window and east wall of room #3 taken from doorway to stairs. Facing east.	
2-60

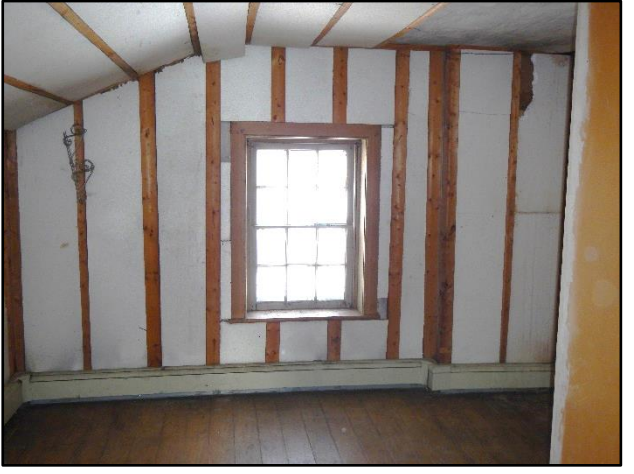
A photograph of an empty room under construction. The walls are white with vertical wooden studs exposed. A window with a wooden frame is centered on the wall. The floor is made of dark wood. The room is brightly lit by natural light from the window.	2 nd story – View of window and east wall of room #4 taken from doorway to stairs. Facing east. Strapping and insulation.

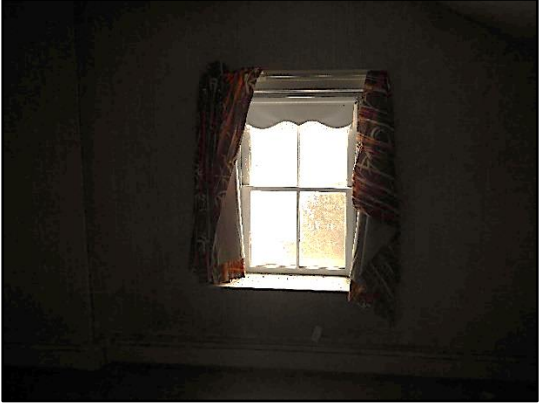
<p>2nd story – View of window and west wall of room #5 taken from doorway to stairs. Facing west.</p>	
2-62

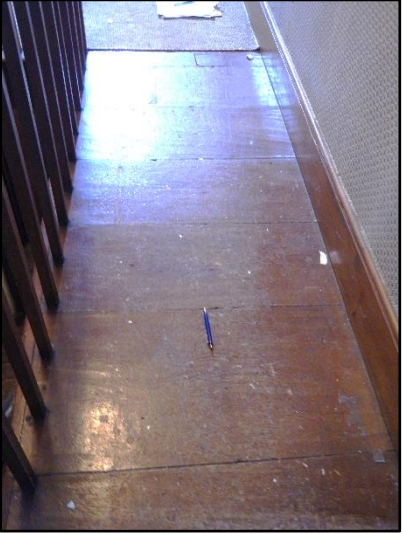
<p>2nd story – View of floor boards at top of stairs at 2nd storey landing near doors to room #s 2 and 3. Note the pen for scale showing different floorboard widths. Facing down and south.</p>

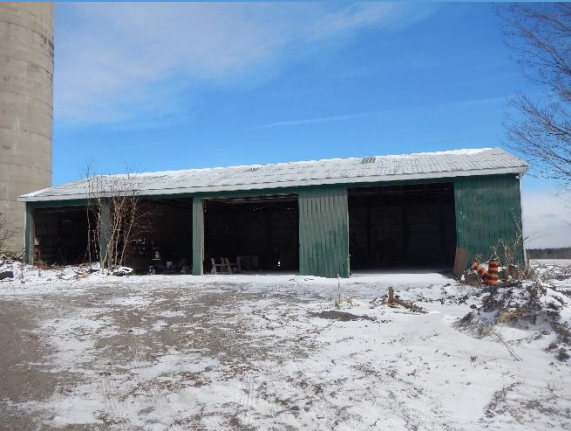
4 large bay doors, metal clad driveshed facing NNE	NO
3-2

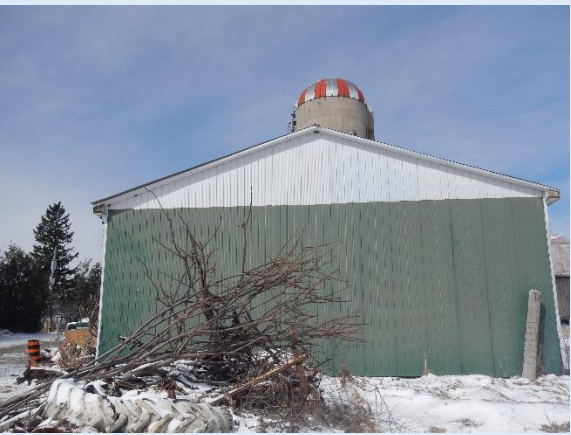
Metal clad exterior facing NNW

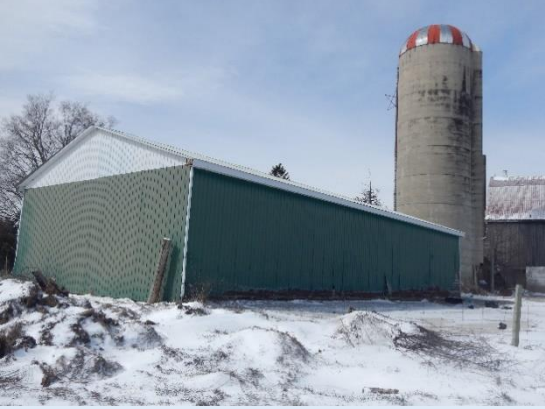
Rear of structure with structure #4 in background facing west	
4 – silo 4-1

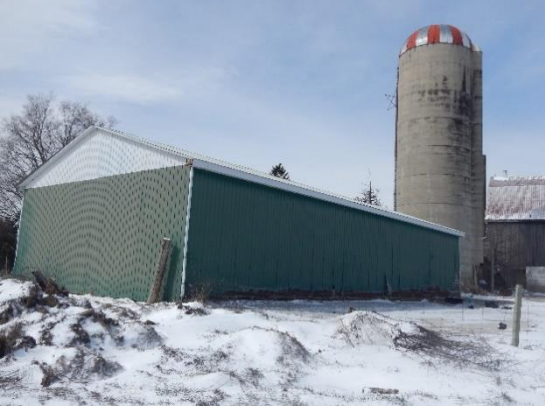
Structure #3 in foreground, stave silo with domed roof in background facing west	NO

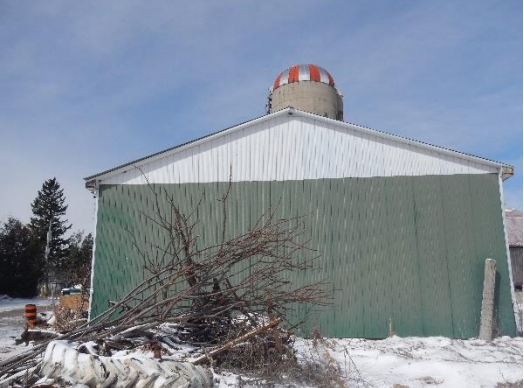
Structure #3 in foreground, stave silo with domed roof in background facing west	
4-3

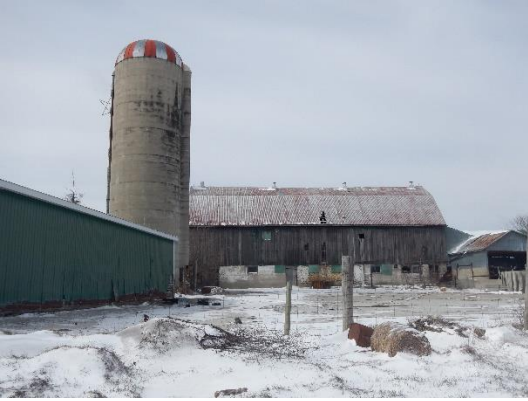
Silo in relation to barn and driveshed facing NW

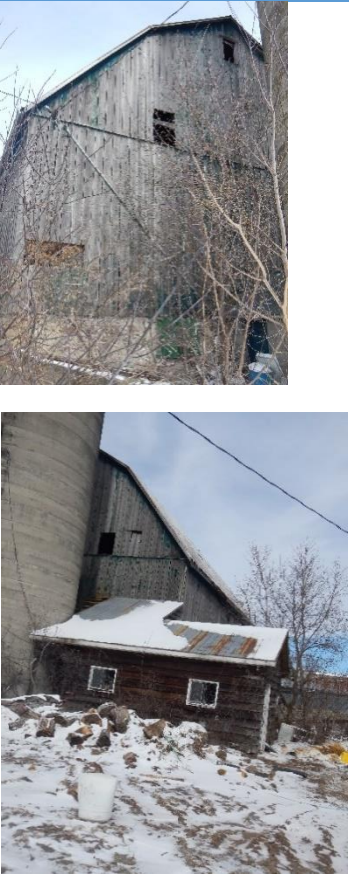
<p>Facing east, barn end. Vertical wooden planks with fieldstone foundation. One open window below roof apex, and two “cut out” openings (not structured windows). Evidence of green paint.</p> <p>Facing NNE, barn end with attached lean to (metal roof, clapboard construction), possibly “farm office”.</p>	<p>Limited</p>

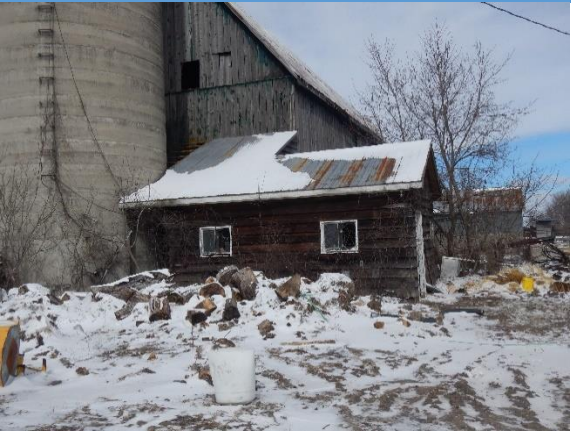
<p>Lean to, metal roof, wooden clapboard construction, modern eaves trough, low gable roof, attached to barn, abuts silo #4. Barn, note window and cut out section for ventilation. Facing north</p>	
6-4

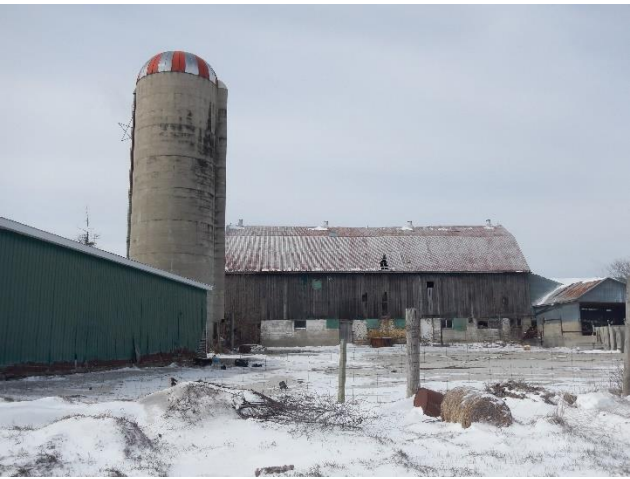
<p>Barn in relation to silo (#4), driveshed (#3) and outbuilding (#11). Concrete cattle yard in foreground. This photograph shows the 4 ventilators on top of the barn roof, the metal clad barn roof, the mow, and the byre.</p>

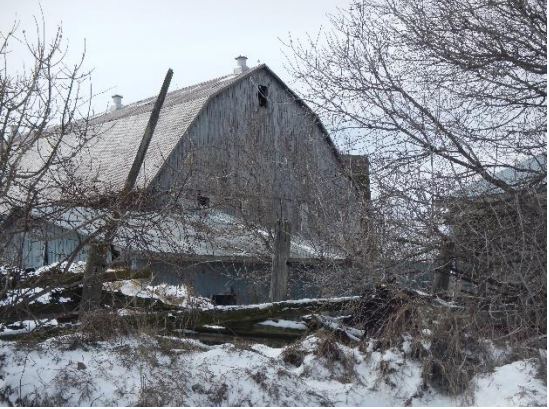
<p>Gambrel metal roof with window below roof apex, ventilators on roof ridge, structure attached to roof along one wall. Vertical plank board. Facing WNW. Split rail fence in foreground.</p>	
6-6

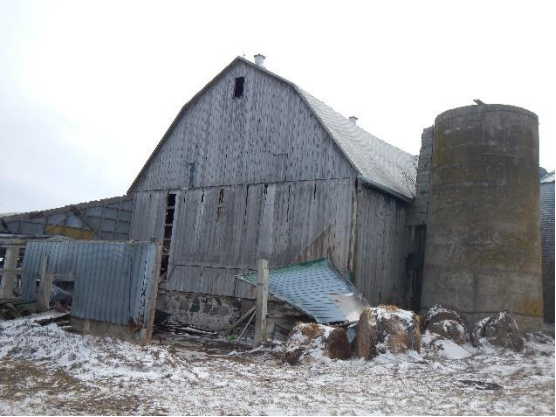
<p>Gambrel shaped metal roof with window below roof apex, ventilators on roof ridge, silo #8 Attached to barn, structure #11 is metal clad and a ruin. Barn has field stone construction on this side. Facing south.</p>

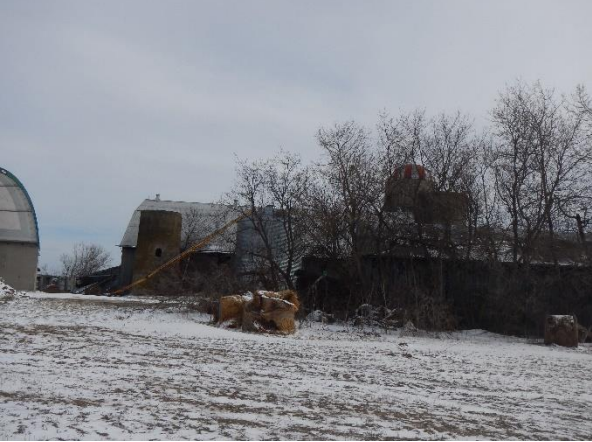
View of barn from field with silo # 8 in foreground, facing SSE	
6-8

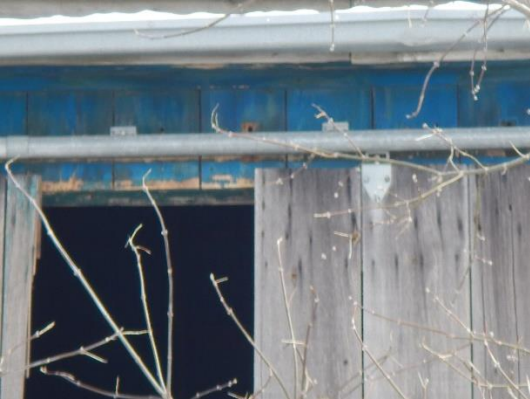
Detail of metal sliding barn door rail, note blue paint of boards above the rail, facing NNW

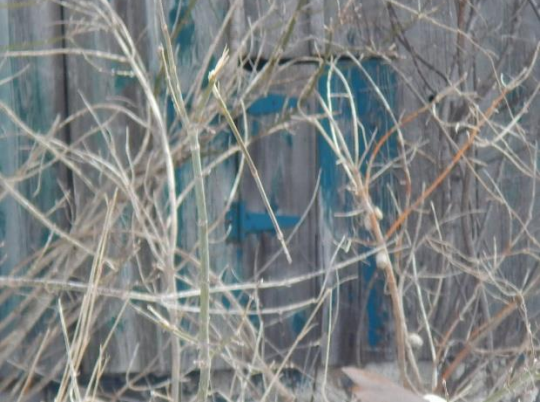
<p>Eye of the needle doorway, located to NE of sliding barn door, note green barn paint, T-hinges used to secure door. Small, most likely for an animal rather than a human.</p>	
6-10

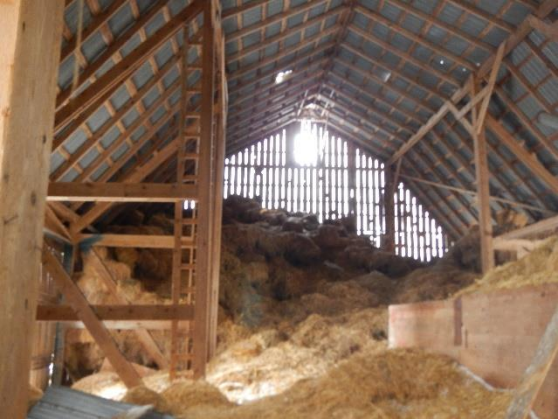
<p>Mow (upper floor). Visible are rafters (bracing the roof), the purlins (long beam at apex of the gambrel roof shape sides, supported by struts, v-shaped). There is a ladder on the left. All wood is milled (i.e. sawmill) and there is no evidence of adze work. All wood appears fresh (i.e. relatively new construction) and is attached with wire spikes/nails. Facing NE</p>

The exterior of the barn (excluding the metal roof) is a banked or Pennsylvania type barn with fieldstone foundation and vertical wood planking, banked on one side. This planking has started to tear away with the elements but is not unrepairable. The interior of the mow floor shows new frame construction, although it has been framed in the traditional barn style with rafters, purlins and support struts. The floor of the mow appears to be original. The byre (cattle stalls) has been used for milking cows, and has some modern elements (poured concrete floor and drains and trough), metal cow stalls, as well as some horizontal plank stalls. The barn was an important aspect in the farm complex, but it has seen updates, repairs and major reframing.

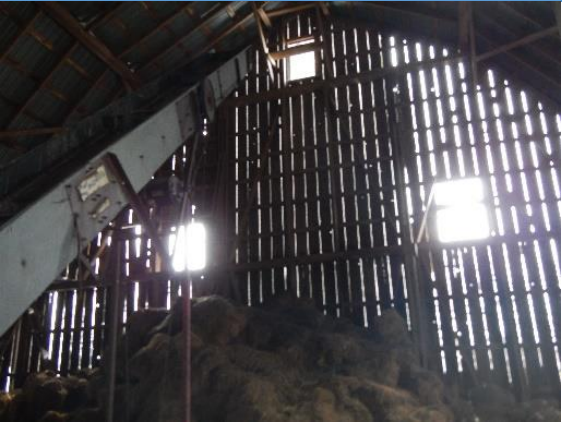
Facing SW, barn wall, which faces towards Airport Road. Three openings for ventilation and machinery.	
6-12

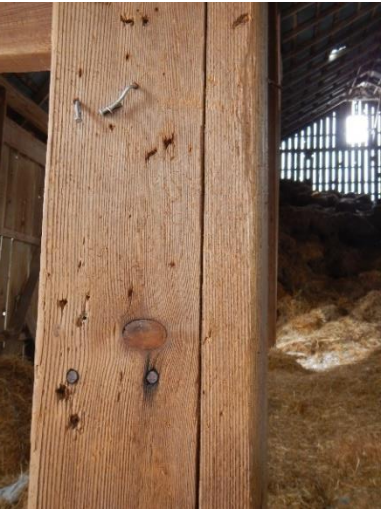
Interior barn post. Note use of wire nails and spikes, milled wood, and "freshness of wood", indicating that the interior (all of similar milled wood and "freshness" is "new construction").

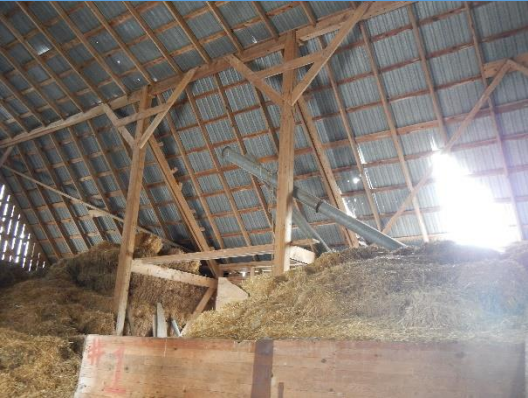
<p>Interior of barn facing west. Note rafters, metal roofing, purlin, and bracing struts. There is a wooden box for storage in the foreground. There is a metal chute behind one of the bracing posts.</p>	
6-14

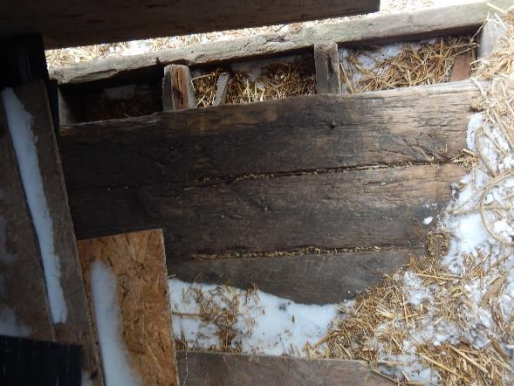
<p>Low level flooring. Note the weathered look of wood. Flooring is probably original. Facing SE and down.</p>

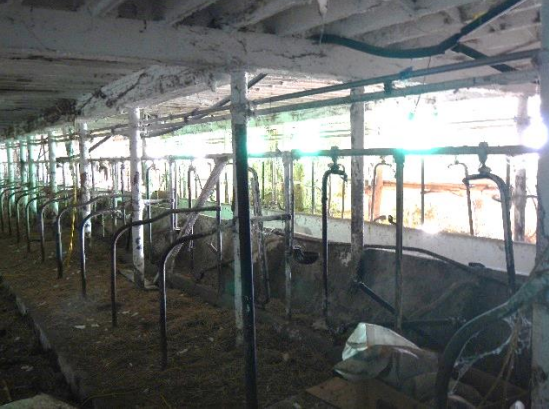
Dairy cow stalls, concrete floors and troughs (waste and food troughs), and white washed wooden ceiling. Located in the byre (below mow floor).	
6-16

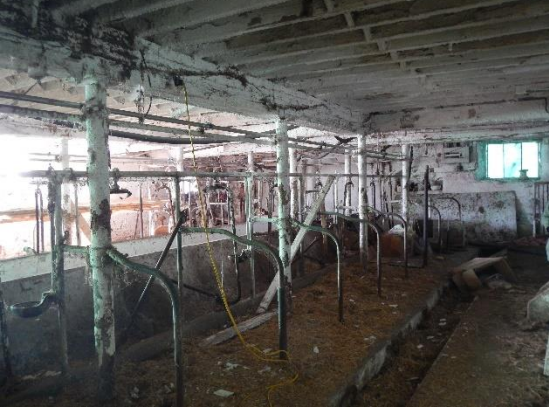
Dairy cow stalls, concrete floors and troughs (waste and food troughs), and white washed wooden ceiling. Some metal posts also whitewashed. Located in byre.

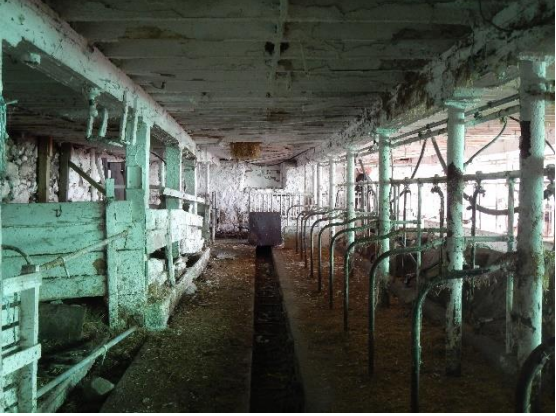
<p>Dairy cow stalls, concrete floors and troughs (waste and food troughs), and white washed wooden ceiling, and some metal posts. To the left of the milking area are wooden stalls with horizontal wooden boards, also white washed. The stalls also have concrete floors. Located in the byre.</p>	
6-18

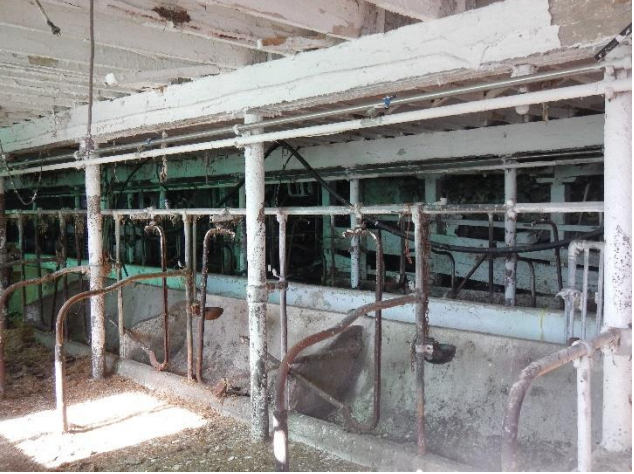
<p>Dairy cow stalls showing individual separators, drinking dishes and troughs. Located in the byre.</p>

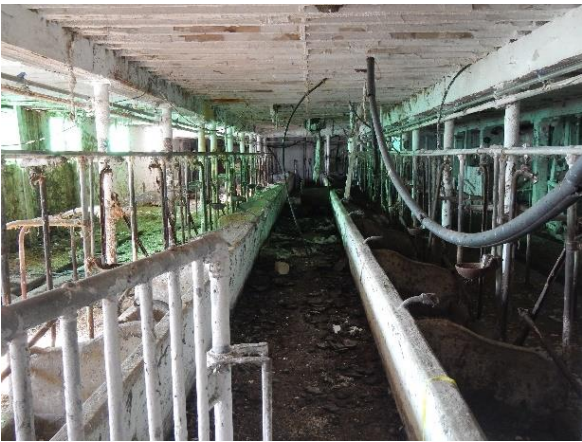
A photograph showing a long, narrow trough located between two rows of milking stalls. The trough is made of a light-colored material, possibly concrete or metal, and runs the length of the aisle. On the right side of the trough, there is a prominent white PVC pipe that curves upwards and then back down. The stalls on either side have metal railings and wooden partitions. The floor appears to be dark and possibly wet or soiled.	Trough between two rows of milking stalls. Notice PVC piping.

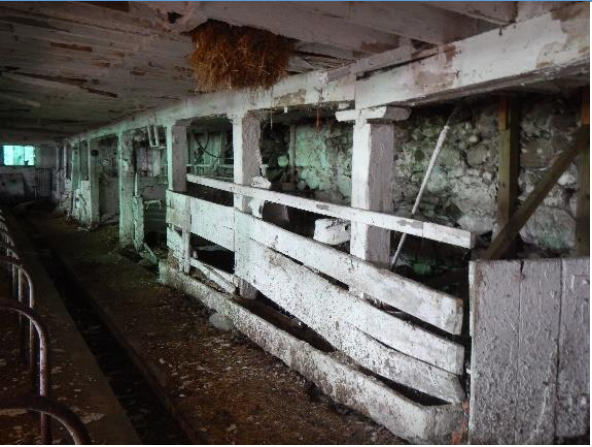
<p>Stalls with white washed horizontal plank board, white washed fieldstone foundation in background. Note hay access hole on ceiling.</p>	
6-22

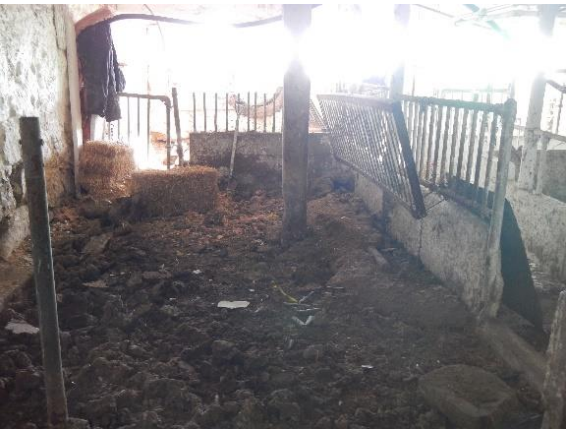
<p>Floor drain leading outside.</p>

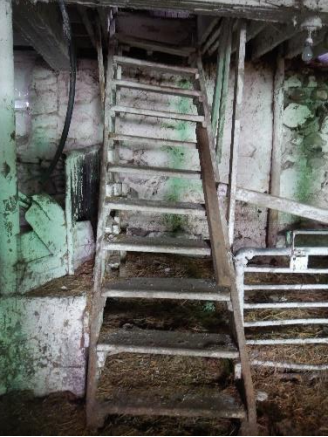
Wooden stairs ascending to mow.	
6-26

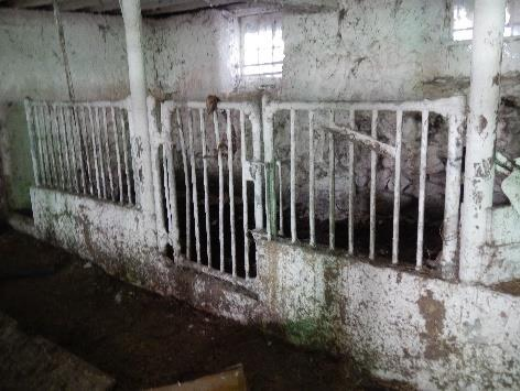
Stall enclosed with concrete and metal grating. Whitewashed.

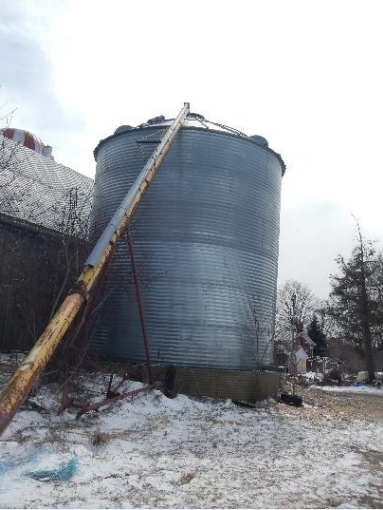
<p data-bbox="1171 521 1717 581">Metal silo with poured concrete base, facing SSW</p>	NO
7-2

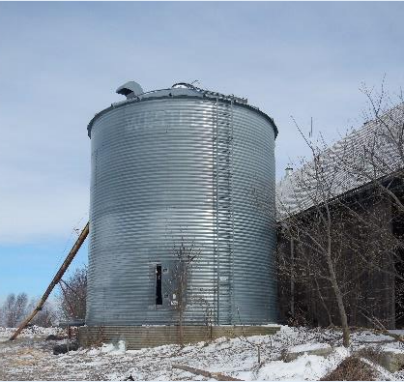
<p data-bbox="1171 1024 1751 1182">Metal silo, “Westeel” product, with exterior wall ladder, roof vent, and “Century” door (tradename). Sits on a poured concrete foundation. Westeel has been in operation since 1905. Facing NE.</p>
