HERITAGE IMPACT ASSESSMENT 15717 AIRPORT ROAD TOWN OF CALEDON

DG Group

Scarlett Janusas Archaeology Inc.
269 Cameron Lake Road
Tobermory, Ontario N0H 2R0
Phone 519-596-8243, cell 519-374-1119
jscarlett@amtelecom.net www.actionarchaeology.ca

April 21st, 2017

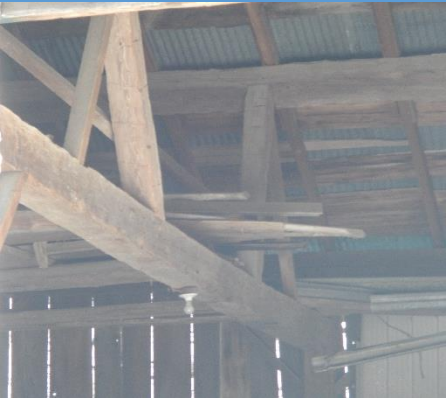
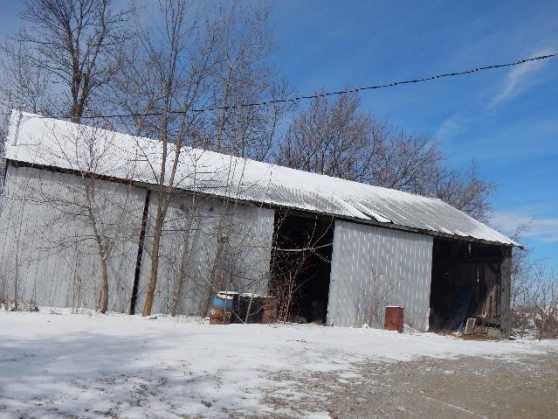
<p>Worn rafters, beams, and support struts. Some have adze marks, and other wooden elements are “new” (milled). The metal corrugated roof can be seen through the rafters. Facing WNW</p> <p>Two door metal clad front drive shed, two sides and rear of building are vertical wooden plank. Low gable roof with corrugated steel roofing. Facing west.</p>	<p>NO</p>

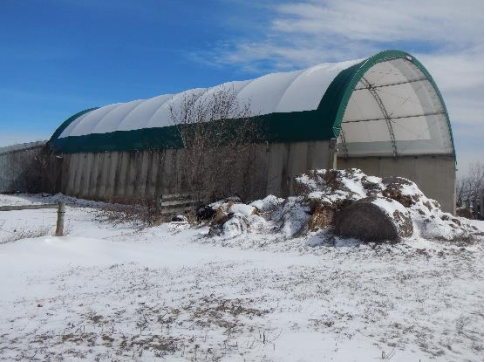
Poured concrete on floor, and three sides, reaching up about 6' in height and covered with heavy polyethylene materials with steel framing. Modern. Facing east.	NO

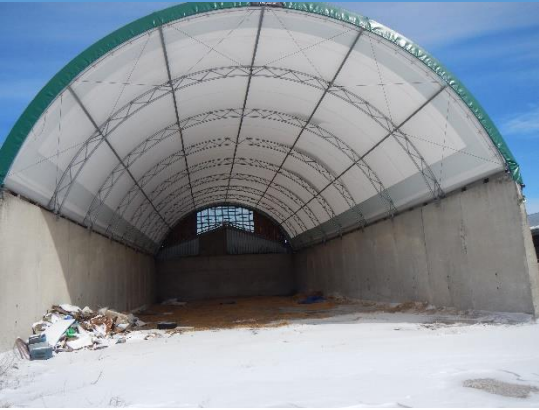
<p>Entrance to storage. Based on residual evidence, this has been used for straw/hay storage. Facing NNE.</p>	
11 – drive shed 11-1	 	<p>Shed roof shape, one end shorter than the other, metal roof, poured concrete foundation (about 3 feet high) supporting metal wall sheeting. Small former window that was once covered with sheet metal. This building is partly in ruins towards the west end. Facing west.</p>	NO

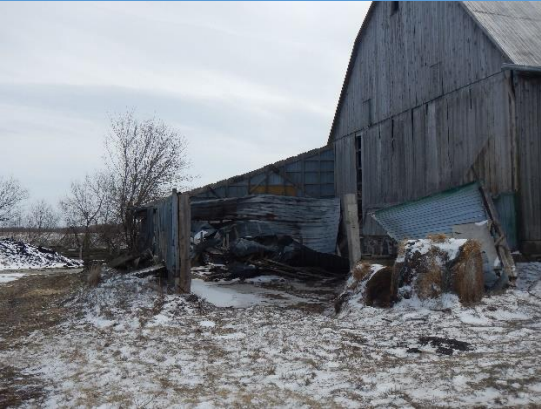
Ruin of the west end of the drive shed. At one time attached to barn wall. Facing SE.	
12 – Grain Storage 12-1

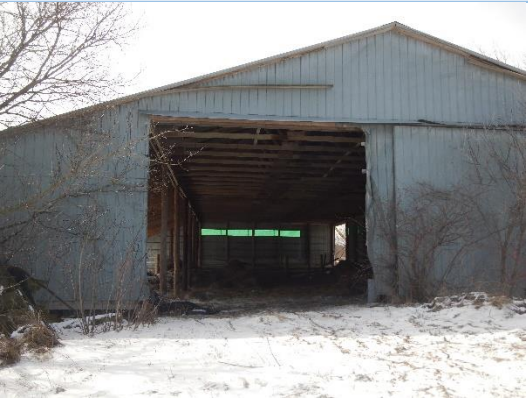
Asymmetrical roofline, metal roof. One side of structure is poured concrete and corrugated metal sheeting. Timber posts are milled. Facing SSW.	NO

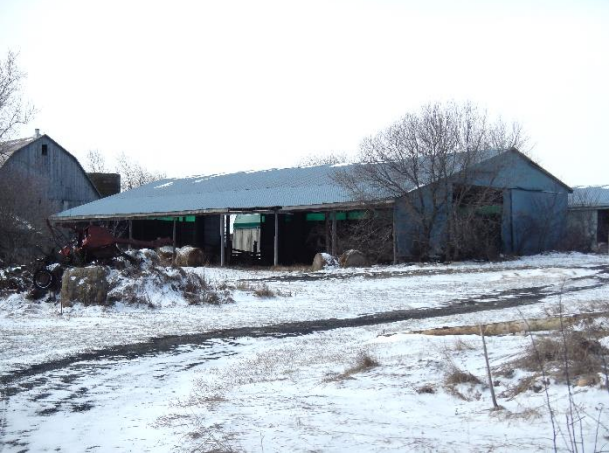
Facing west. Open end, once had sliding doors.	
12-3

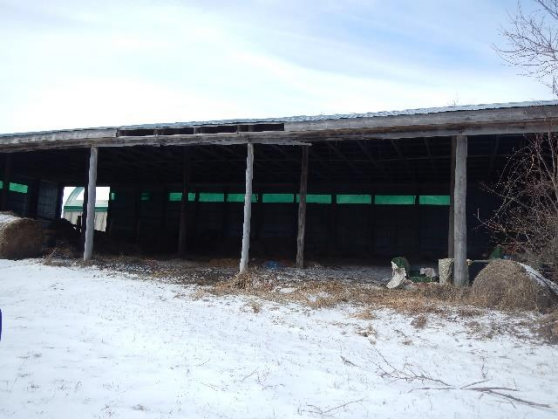
Interior framing is milled wood. Remnant hay bales. Facing west.

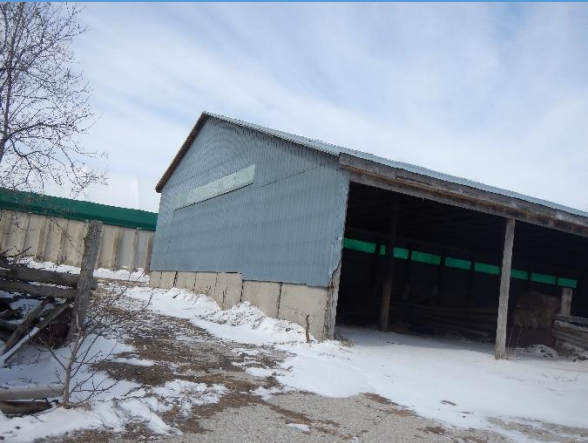
Facing north. End of storage shed for hay – note concrete foundation at this end.	
13 Storage Shed 13-1

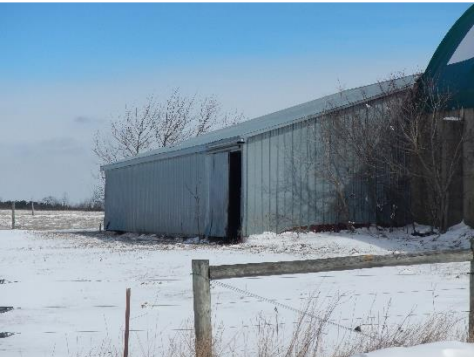
Facing NNE, metal siding and roof – note attachment to Structure #10.	NO

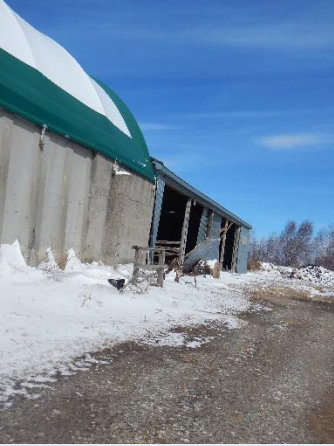
Facing north. Open end of structure in background and attachment to Structure #10.	
13-3

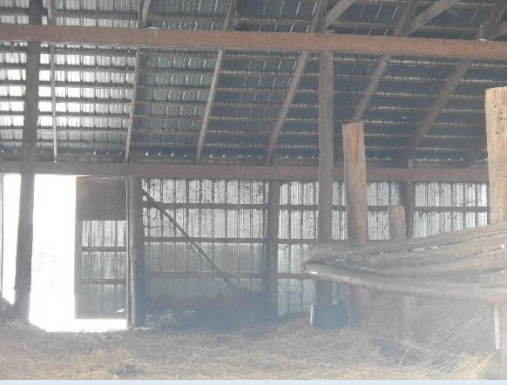
Interior of storage shed. Rafters, purlin, and support beams. All milled. Facing NW. The interior short posts are some cribbing areas for retention of loose hay.

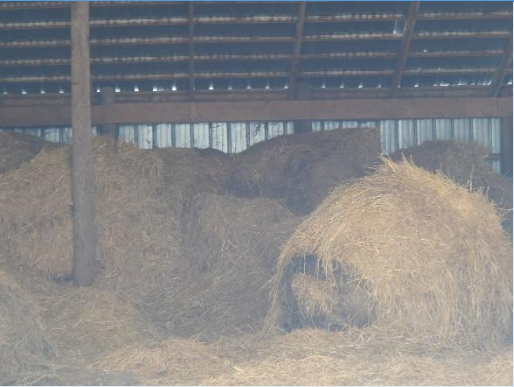
Interior of storage shed facing NW.	
14 – Silo 14-1

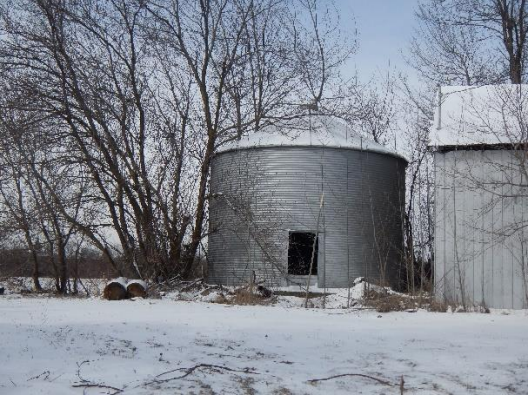
Metal circular silo with “century” door and vented rooftop. Facing west	NO

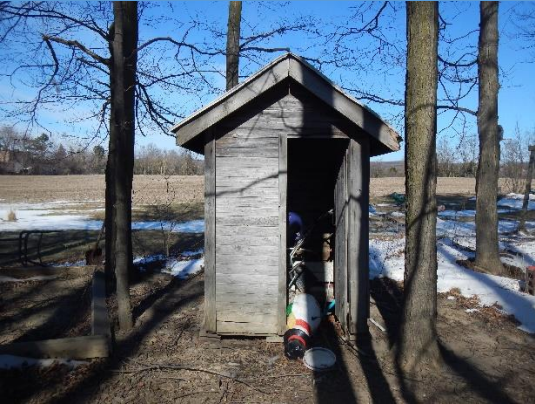
Former privy, now storage shed, facing NNW. Horizontal wood plank construction, sitting on concrete blocks.	NO
15-2

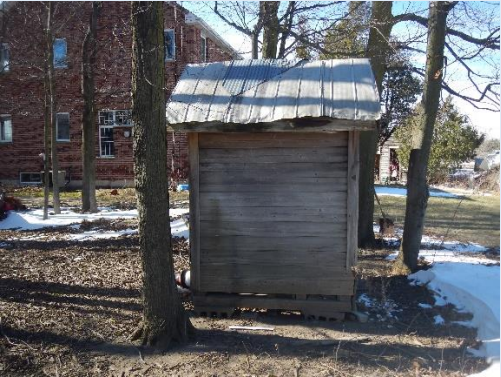
Metal roof, two different types showing repair of original roof. Facing SW.

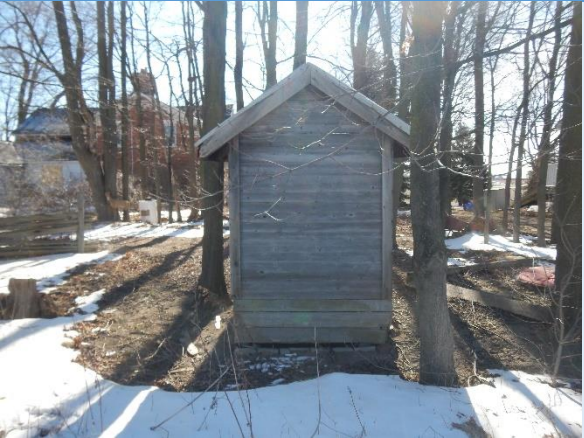
Back of privy facing SE.	
15-4

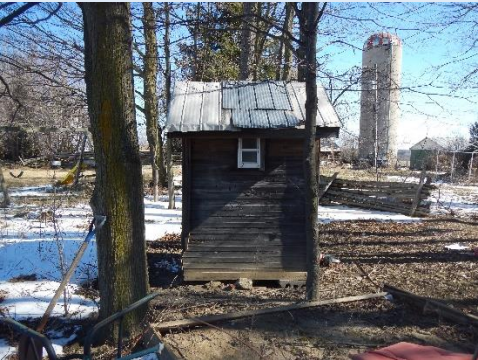
Side of privy with small modern window. Note the two different roofing materials (both metal).

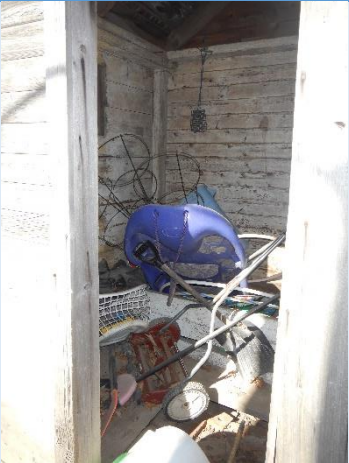
Interior of former privy – note “bench” where toilet hole would have been.	
16 – Tool Shed 16-1

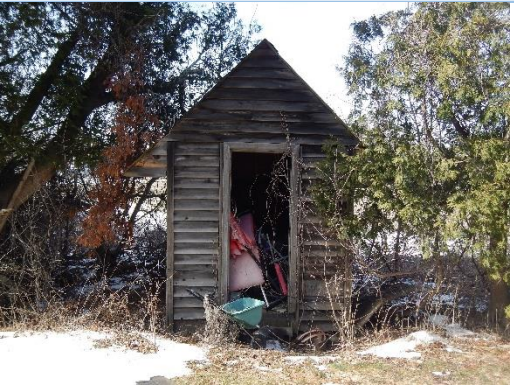
Clapboard construction tool shed, facing NW	NO

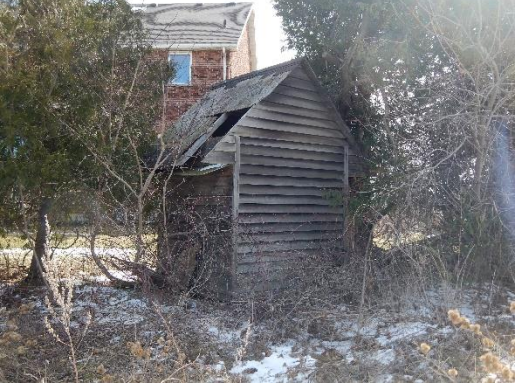
Facing east. High gable roof with asphalt shingling.	
17 – Tool Shed/Ruin 17-1

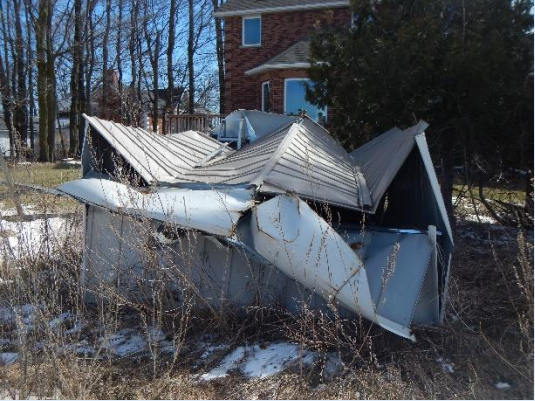
Facing NE, collapsed steel tool shed.	NO

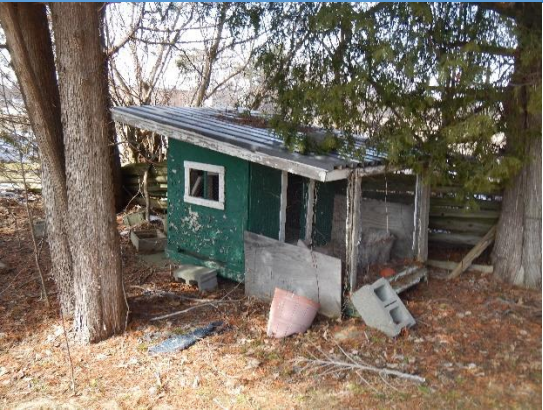
<p>Plywood construction lean to with screened outdoor area for animals, probably rabbits. One window for light (modern). Steel roof, facing NW.</p>	<p>NO</p>
<p>19- Horse Lean To</p> <p>19-1</p>

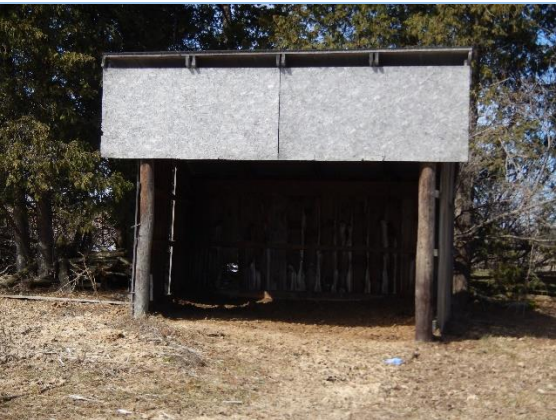
<p>Plywood and unfinished log (support posts) construction.</p>	<p>NO</p>

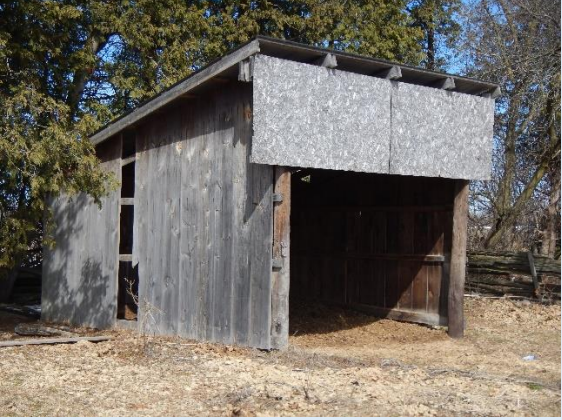
From Table 1, numeric sequence within report	Photos (Numbered 1-1, 1-2, etc.)	comments	Value
19-2

Sides of structures are vertical wooden planks.

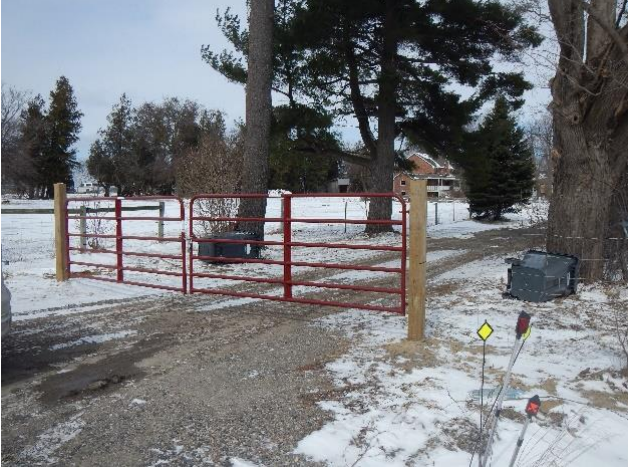
<p>15717 Airport Road laneway R2-1</p>	<p>Gravel and dirt laneway, single lane, gate at entrance, facing N</p>

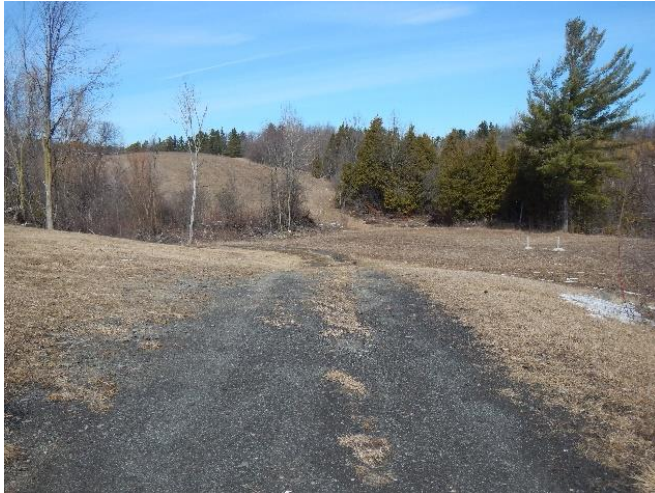
R2-7	Laneway facing NE near back of property. Note that road is now more broken asphalt consistency.

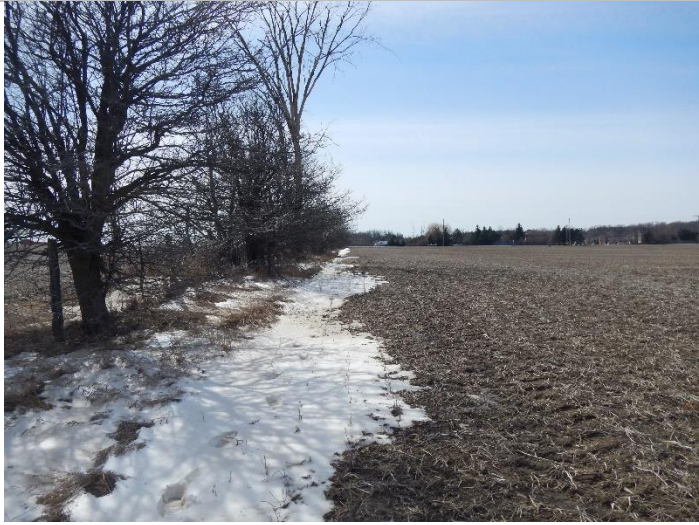
F-1	0591096, 4857205 From Airport Road, study area boundary, page wire and post fencing, facing NE

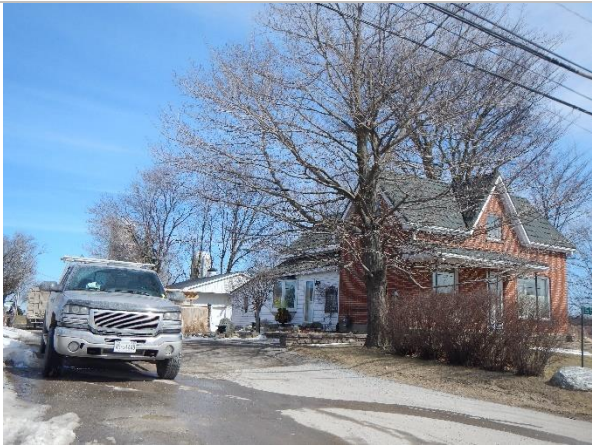
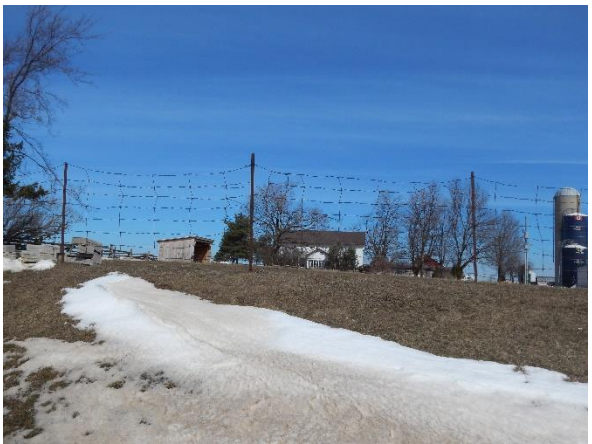
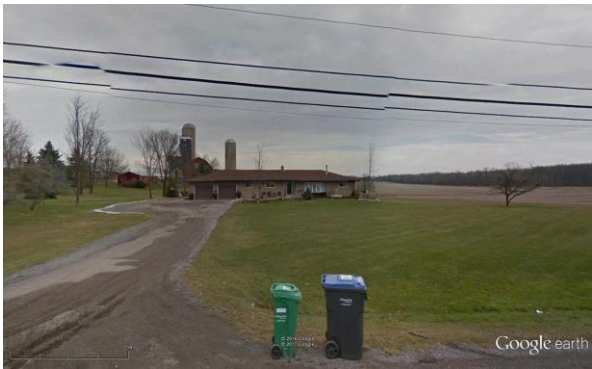
Municipal Address or GPS reading	Descriptor	Photographs	Value
<p>15535 Airport Road 1-A</p> <p>1-B</p> <p>1-C</p>	<p>Three residences and a farm complex with five silos and at least five barn/outbuilding</p> <p>Residence 1 – Gothic Revival Style brick with rear addition facing E</p> <p>Residence 2 – white – no other details visible from roadside, facing NE</p> <p>Residence 3 – bungalow, facing NE</p>

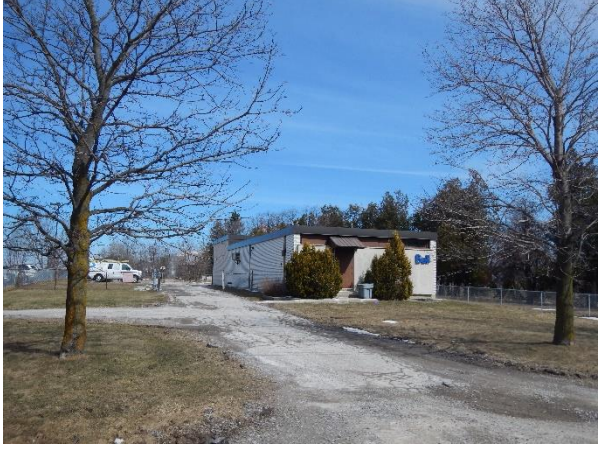
Municipal Address or GPS reading	Descriptor	Photographs	Value
15749 Airport Road 2-A	Bell utility building, facing NNE

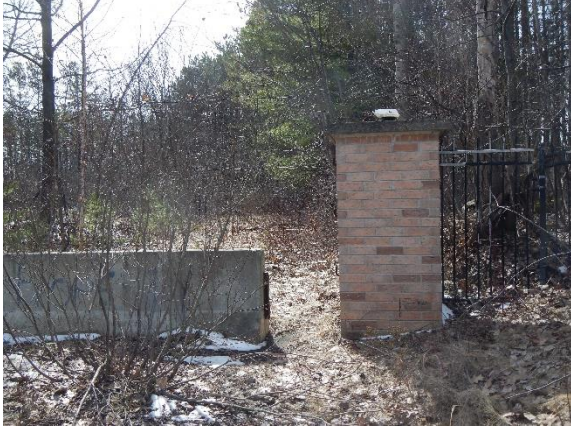
Municipal Address or GPS reading	Descriptor	Photographs	Value
<p>No address, Innis Lake Road</p> <p>5-A</p>	<p>Abandoned private laneway, 0592464, 4858556, facing SW</p>

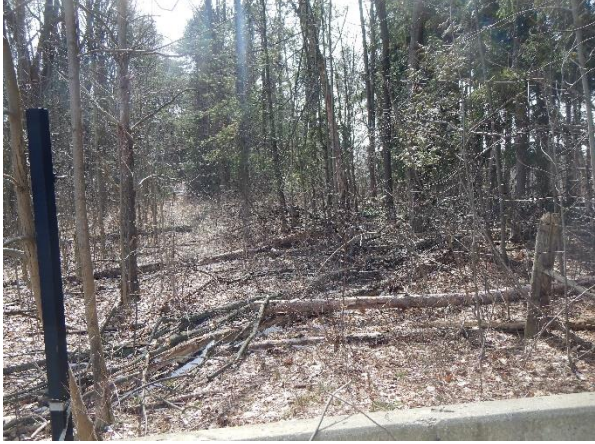
<p>No address, Innis Lake Road</p> <p>6-A</p>	<p>Abandoned private laneway: 0592606, 4858407, facing SW</p>

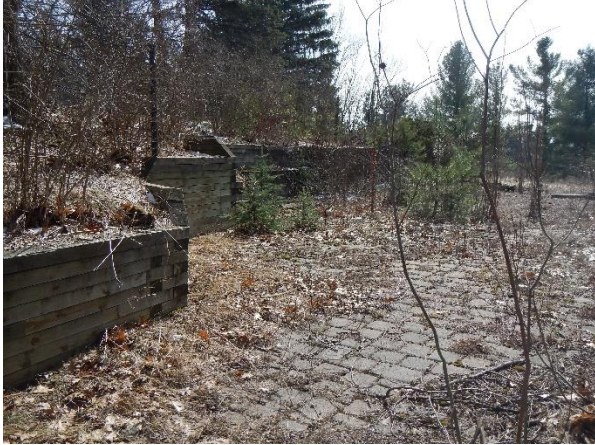
<p>No address, Innes lake Road</p> <p>7-A</p>	<p>Abandoned private laneway: 0592512, 4858492, facing SW</p>

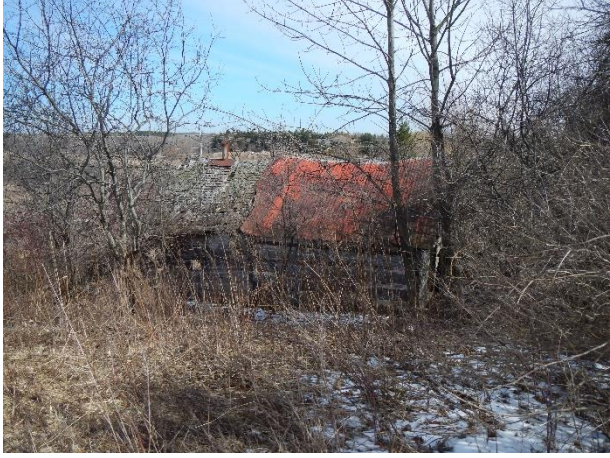
Municipal Address or GPS reading	Descriptor	Photographs	Value
No address, Innis Lake Road 8-A	Log cabin ruins, 0592799, 4858187, facing SE

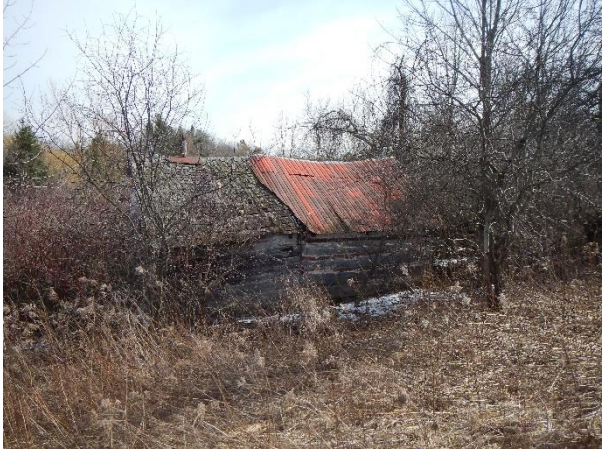
A photograph showing the ruins of a log cabin with a red metal roof, surrounded by bare trees and dry grass in a winter setting.	
8-B	Facing NW

A photograph showing the ruins of a log cabin with a red metal roof, viewed from a different angle than the previous photo, showing more of the surrounding brush and trees.
