TRIPLE CROWN LINE
DEVELOPMENTS INC.

Environmental Impact Study

15717 Airport Road

September 2018

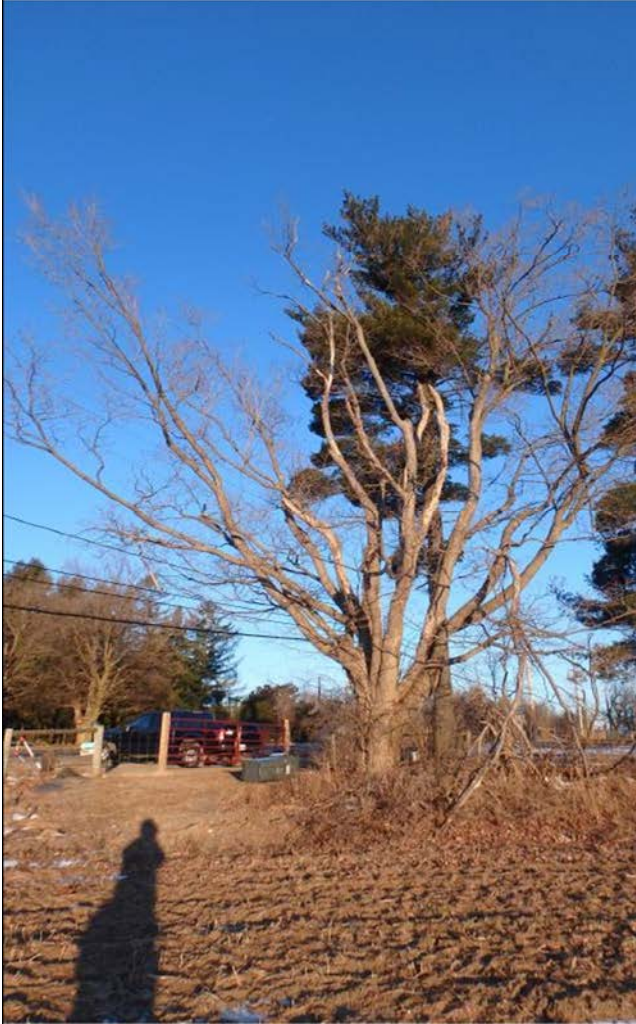
Tree #2 (Tag 002) – Sugar Maple – fair condition

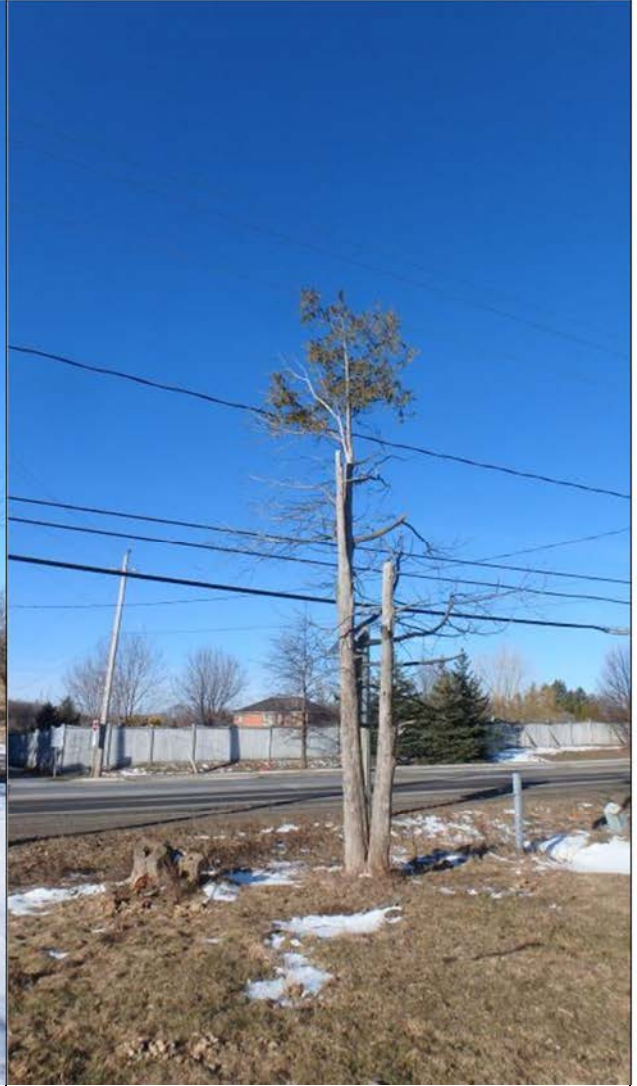
Tree #31 (Tag 031) – Eastern White Cedar – dead

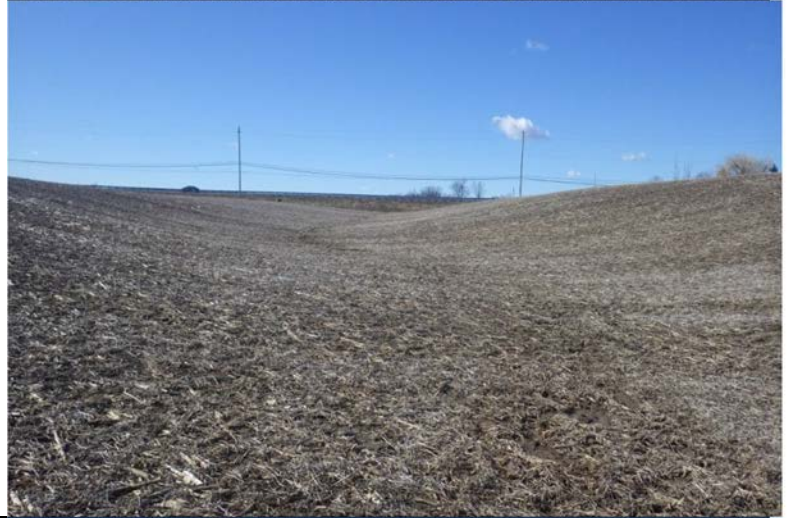
Photo 3

Facing northeast towards the storm drain outlet from within the feature.

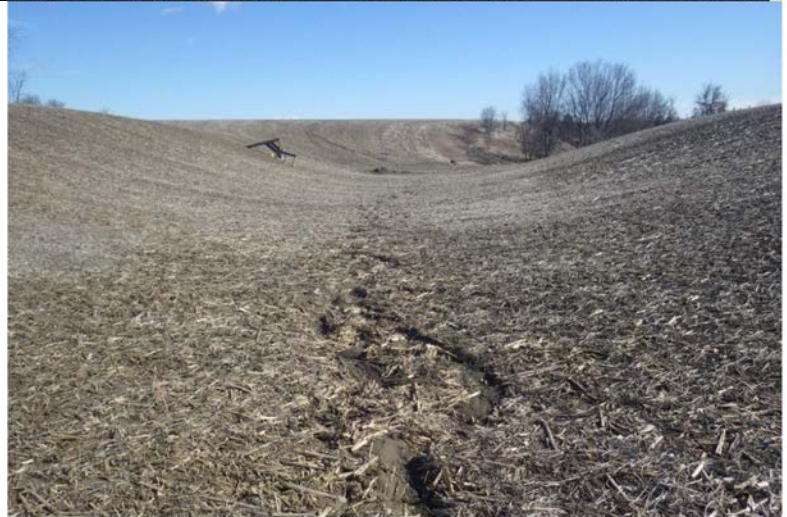
Photo 4

Looking directly at the storm drain outlet.

Tributary A is located downstream of this feature, originating from a stormwater outfall (refer to Photos 4 and 11 in Appendix F). During the assessment, a connection between the potential feature and *Tributary A* was not observed. It appeared as though *Tributary A* receives inputs by way of sheet flow from adjacent agricultural fields and lands within the stream valley; evidenced by the presence of rills along the banks of the tributary. In the area where the potential feature meets *Tributary A*, the surface flattens out and sheet flow accumulating this area appears to spread out rather than outlet directly into the tributary at a given point (see Photos 5, 9 and 10 in Appendix F).

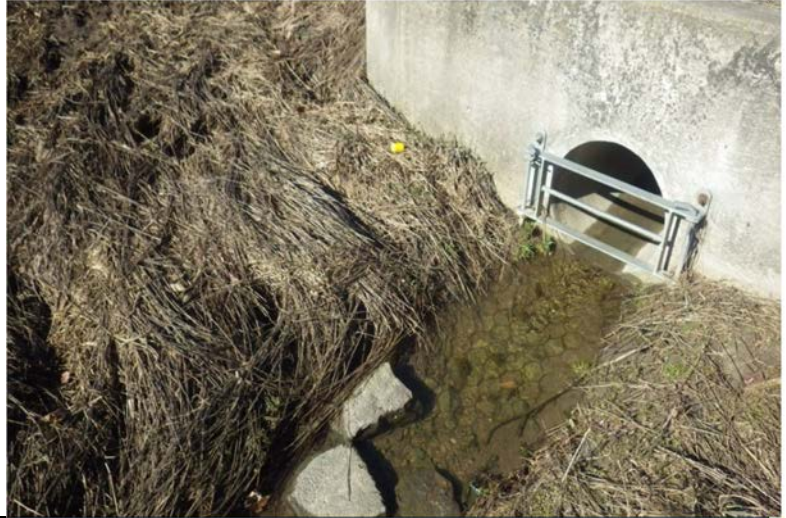
Photo 5

Facing southwest, looking at the feature in its entirety and the storm drain outlet with Airport Road in the distance.

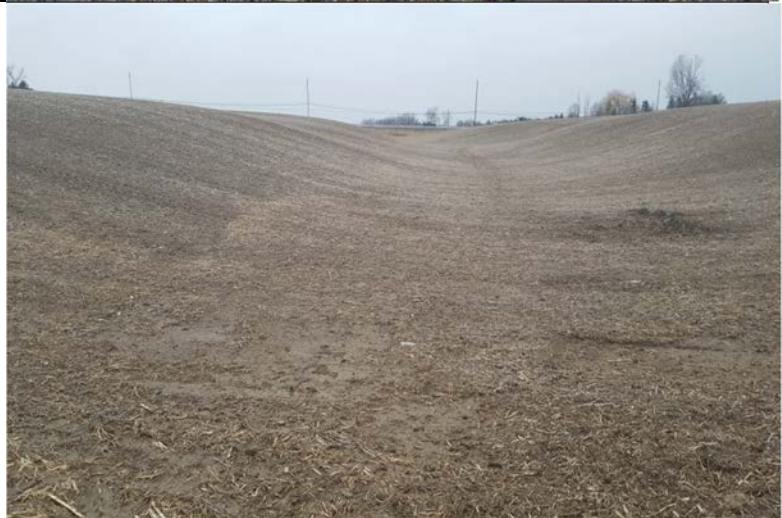
Photo 10

Where agricultural field transitions to meadow, directly adjacent to the storm drain outlet (confluence).
