Triple Crown Line Development Inc.

**Geotechnical Investigation
Proposed Residential Development
Airport Road and Cranston Drive
Caledon East, Ontario**

Project Number
BRM-00235186-D0

Date Submitted
September 11, 2018 (Revised)

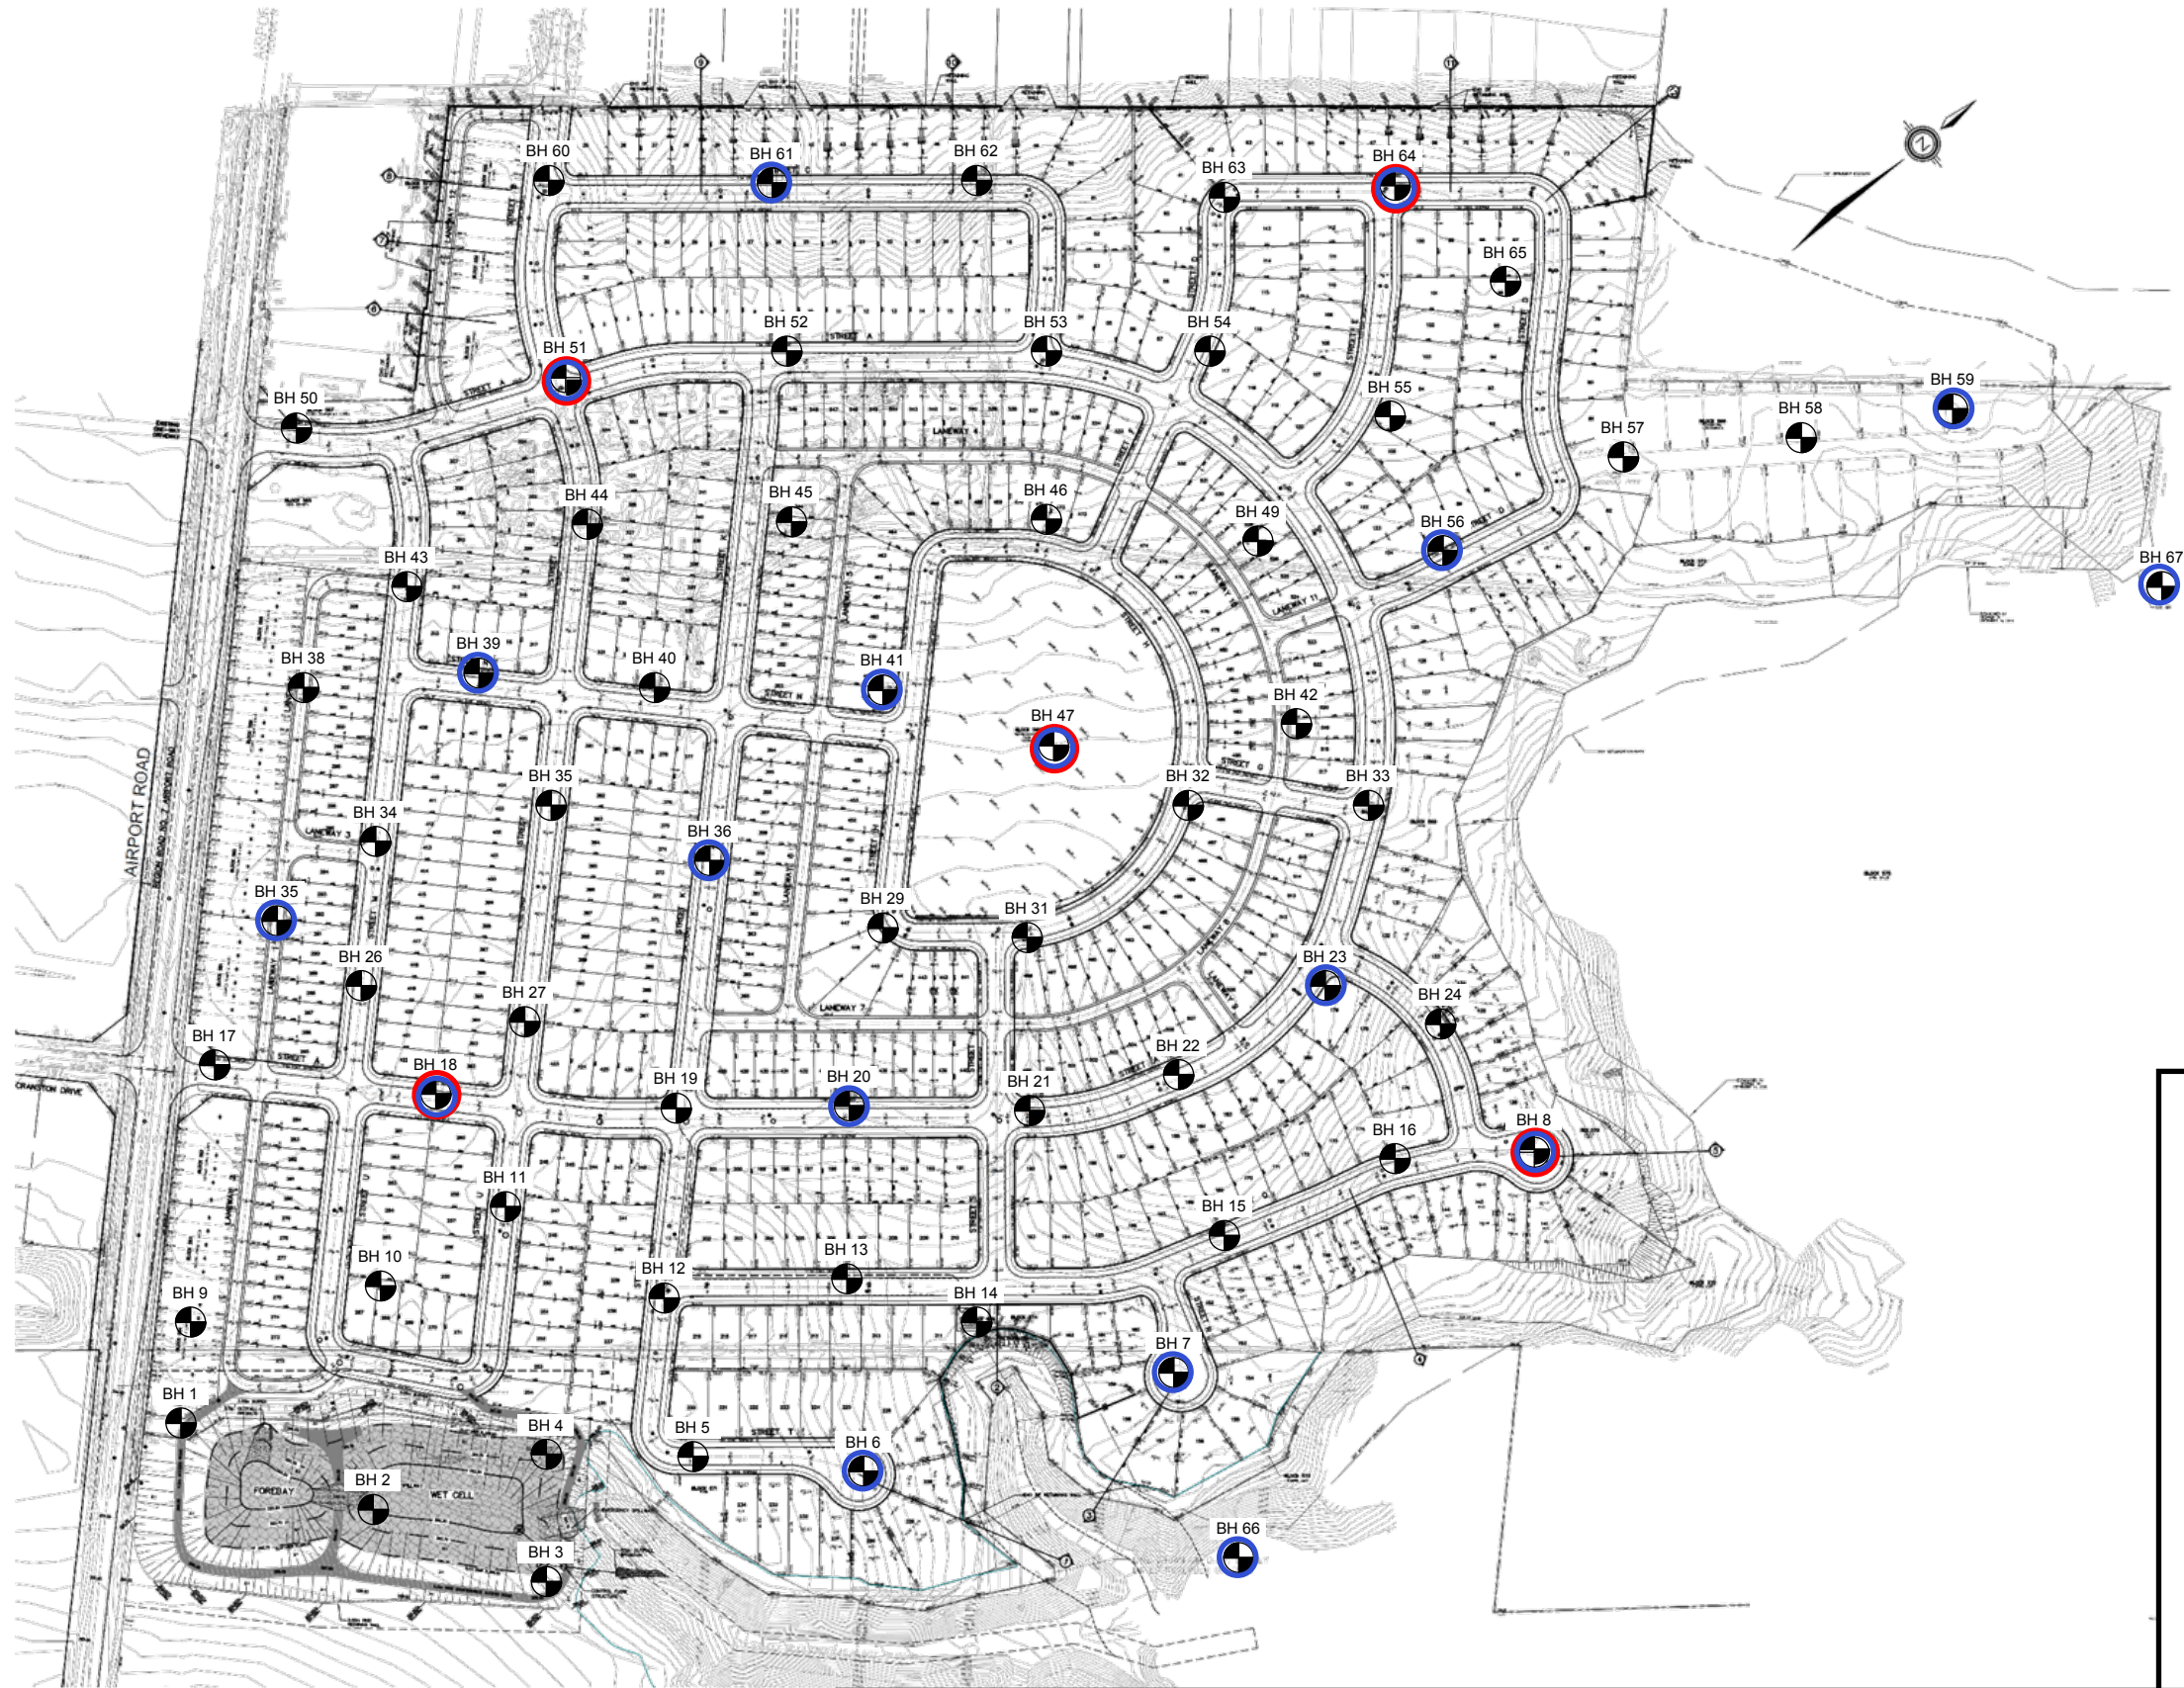
- LEGEND:**
- BH 58 Borehole
 - BH 56 Monitoring Well
 - BH 47 Nested Monitoring Wells

- Note:**
- The boundaries and soil types have been established only at the borehole locations. Between boreholes the boundaries are assumed and may be subject to considerable error.
 - Soil samples will be retained in storage for 3 months and then destroyed unless the client advises otherwise.
 - Topsoil quantities and/or volumes of unsuitable fill should not be established from the information provided at the borehole locations.
 - Borehole elevations should not be used to design building(s), or floor slab(s), or parking lot(s) grades.
 - This drawing to be read with subject report, project number as shown below.
 - See report text for site datum.
 - Test hole locations are approximate.
 - Dimensions shown on this drawing are in metric units, unless otherwise noted.

The field work comprised drilling of sixty-three (63) sampled boreholes designated Boreholes 1 to 27, 29, 31 to 36, 38 to 47 and 49 to 67. It should be noted that Boreholes 28, 30, 37 and 48 were eliminated from the program by the Client. Boreholes 1 to 4, 66 and 67 were drilled in the valley lands near the toes of slopes located at the south and east boundaries of the site. 50 mm diameter monitoring wells were installed in Boreholes 2, 6, 7, 20, 23, 25, 36, 39, 41, 56, 59, 61, 66 and 67. Nested configurations comprising deep and shallow monitoring wells were installed at locations of Boreholes 8, 18, 47, 51 and 64. The deep and shallow monitoring well logs were assigned the suffixes D and S respectively, following the borehole numbers. The fieldwork was carried out between April 26 and May 17, 2017. The sixty-three (63) sampled boreholes were drilled to depths of approximately 6 to 18 m below existing grades at the approximate locations shown on the attached Borehole Location Plan (Drawing No. 1).
