HYDROGEOLOGICAL IMPACT STUDY PROPOSED NEW SUB-DIVISION

0 MT. PLEASANT ROAD, TOWN OF CALEDON, ON.

Prepared For: 1029629 Ontario Inc.

Project No.: SP17-212-30

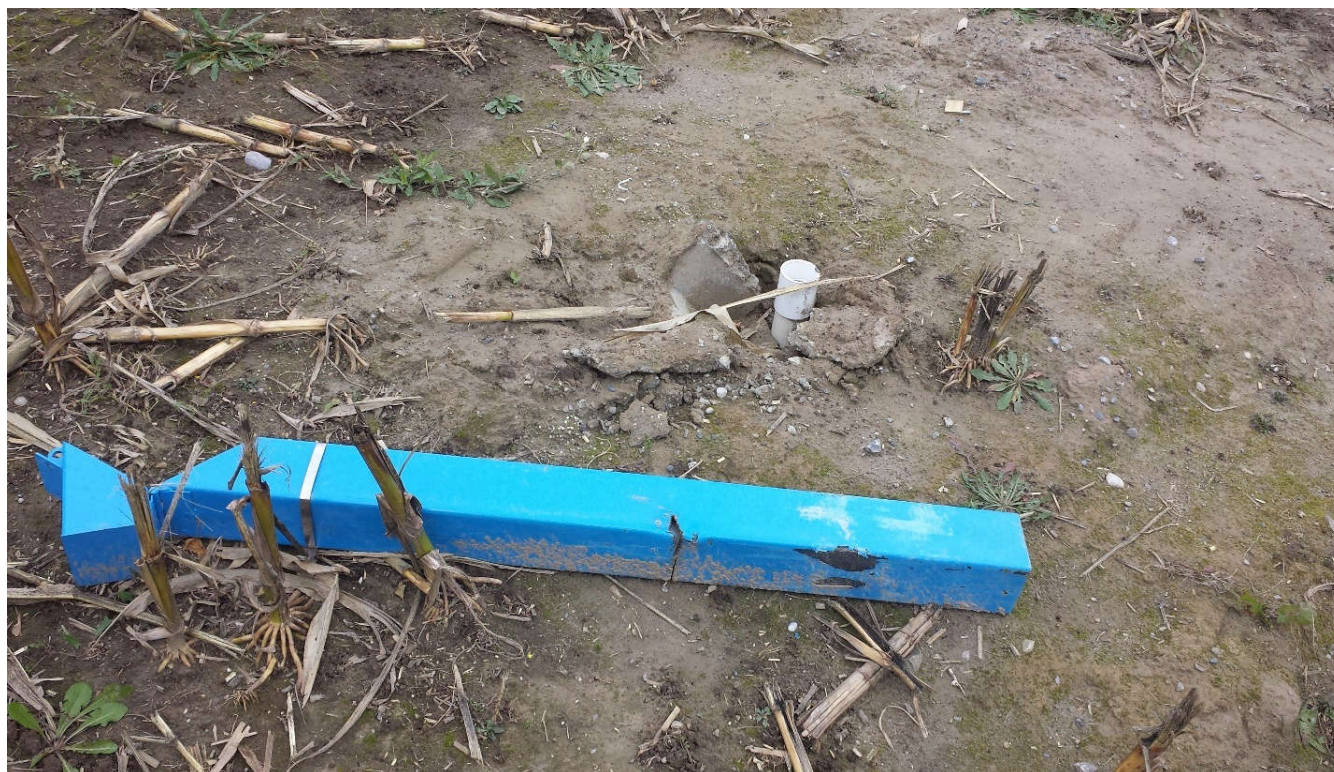
Picture 1.0

First site visit of the six-month groundwater monitoring program was completed on October 2017 and continued in subsequent months from November to December, 2017 and January to March 2018. As observed during the Site visits there was no surficial flow within the Subject Property and no surface water ponding was observed. During the October 2017 Site visit it was observed that the monitoring well MW8 was uprooted and a cut was made at the bottom on both the protective steel casing and the PVC pipe, as shown in the attached pictures 1.0 and 2.0. The PVC casing pipe was put back in place, however, it had a big cut at the bottom. If there had been a heavy rainfall, the surface water would have likely penetrated into the well. So, it was imperative to repair the well as soon as possible.

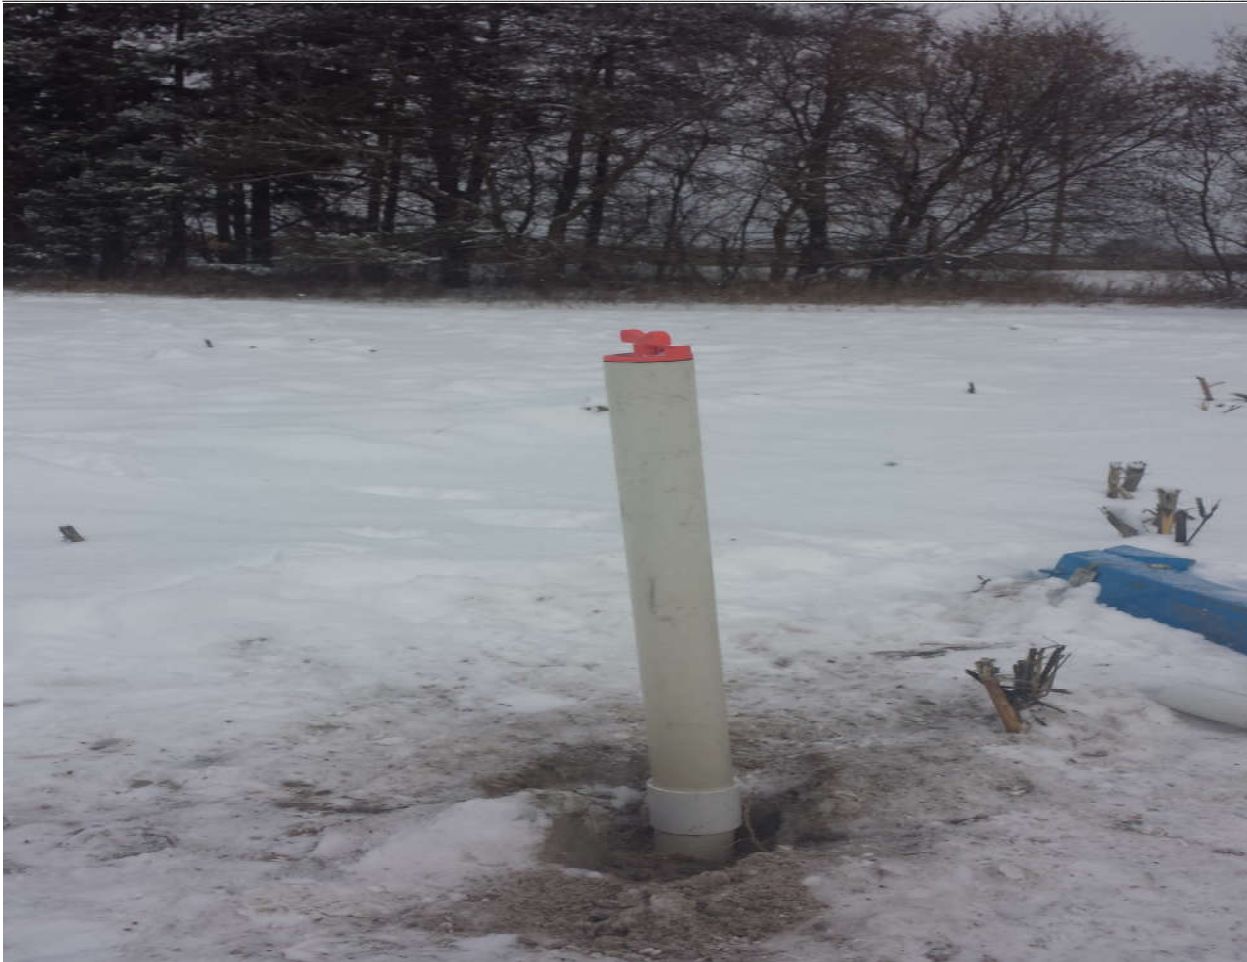
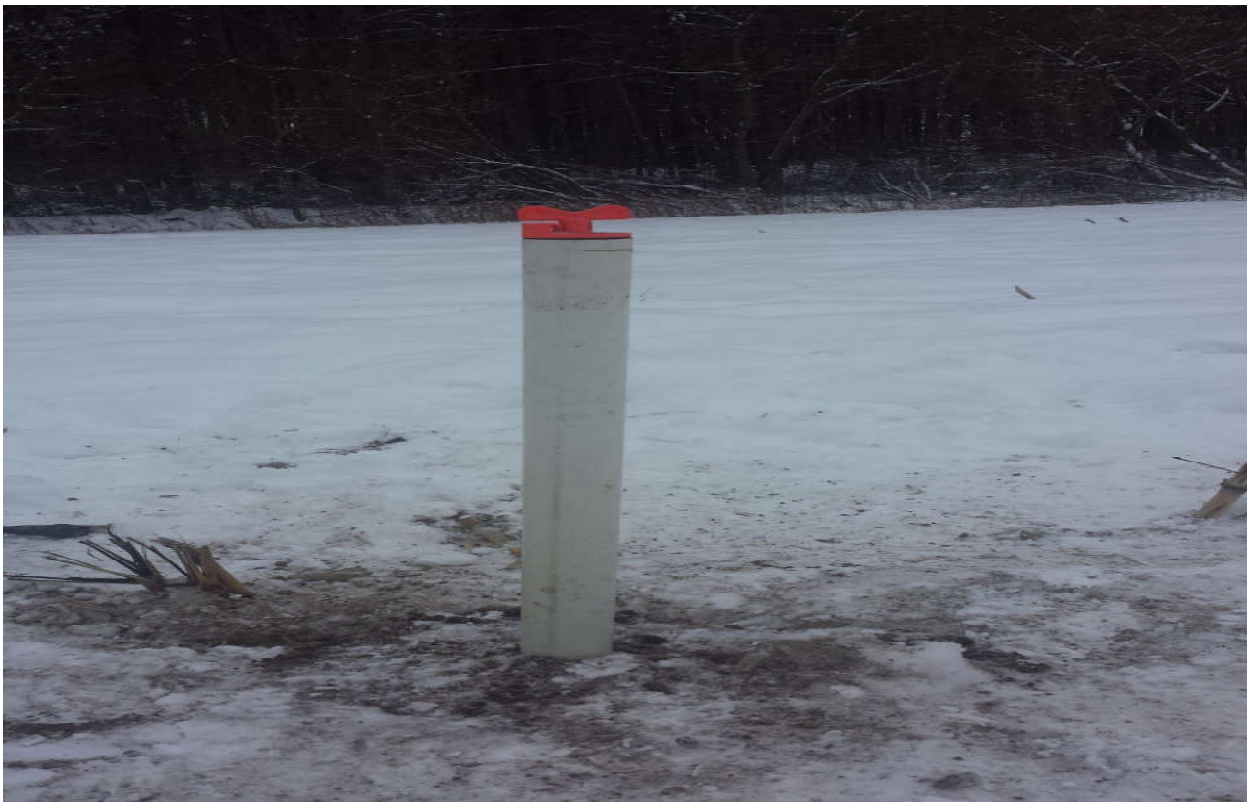
During the December 2017 monitoring event, the damaged monitoring well MW8 was restored to its original position, as depicted in the pictures below. However, the protective steel casing could not be set in place due to the hard ground.

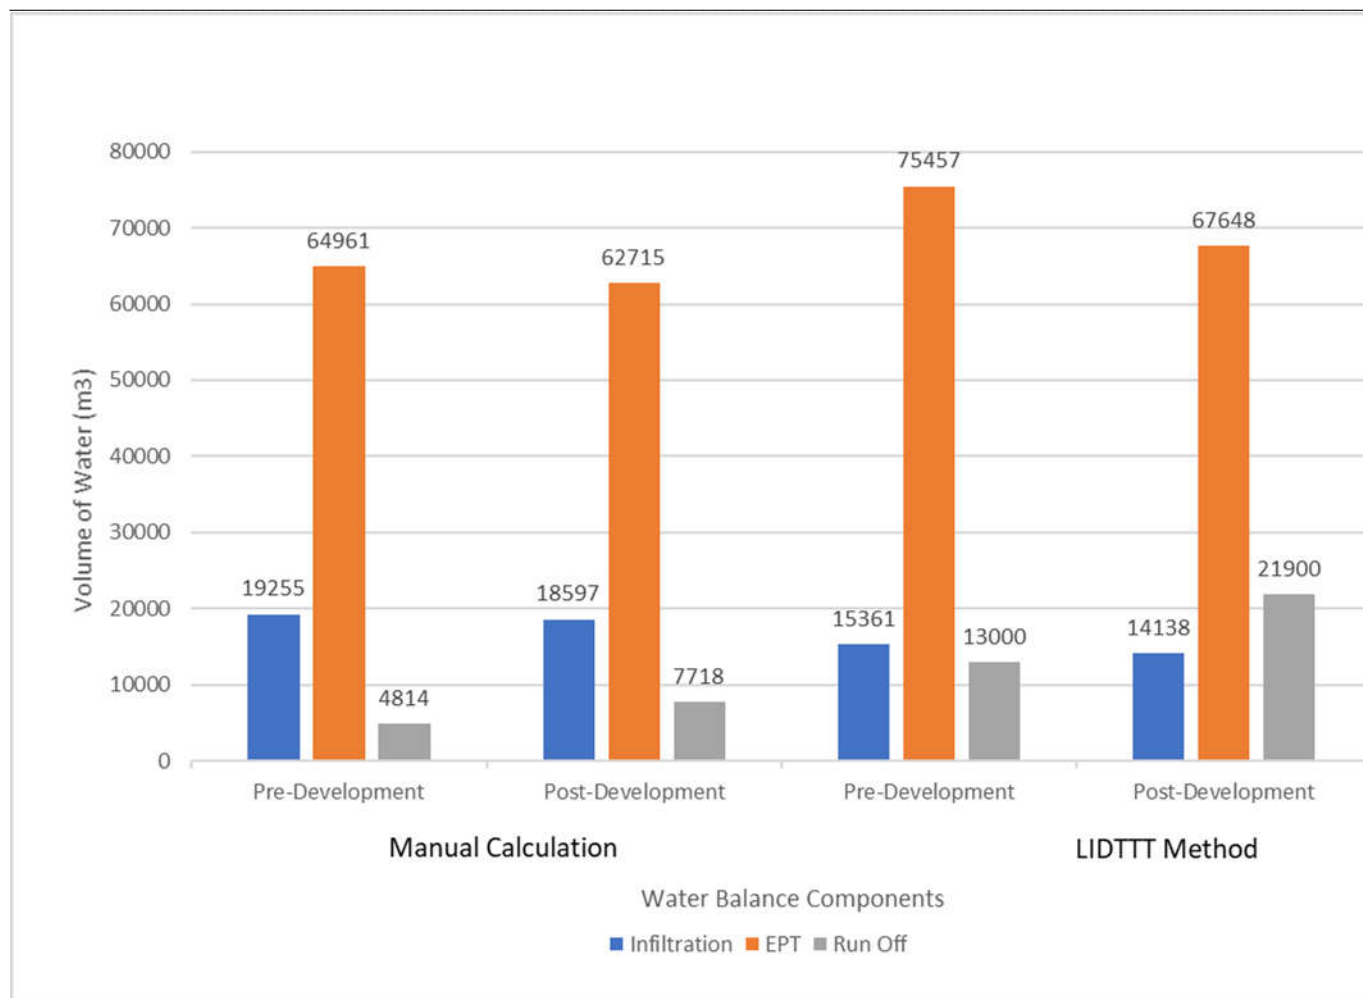
Figure 14-5. Comparison of Manual and LIDTTT Water Balance Components

Accordingly, water balance was also calculated alternatively using the new Version 1.2.1 of the LID TTT and the infiltration deficit as a result of site development was calculated to be at 1,223 m³ whereas run-off was increased by 8,900 m³. A report generated by LIDTT Tool is presented in Appendix D.

The Property mainly includes sandy silt to silty sand and clayey silt till. Appropriate low-impact development techniques can be applied to maintain the overall groundwater recharge across the Site area. The net increase in run-off provides huge potential to compensate the infiltration deficit and an opportunity for maintenance of groundwater recharge through a variety of infiltration techniques. The amount of deficit in infiltration upon development of the Site does seem to be low being about 658 m³/annum or about 2 m³/day.

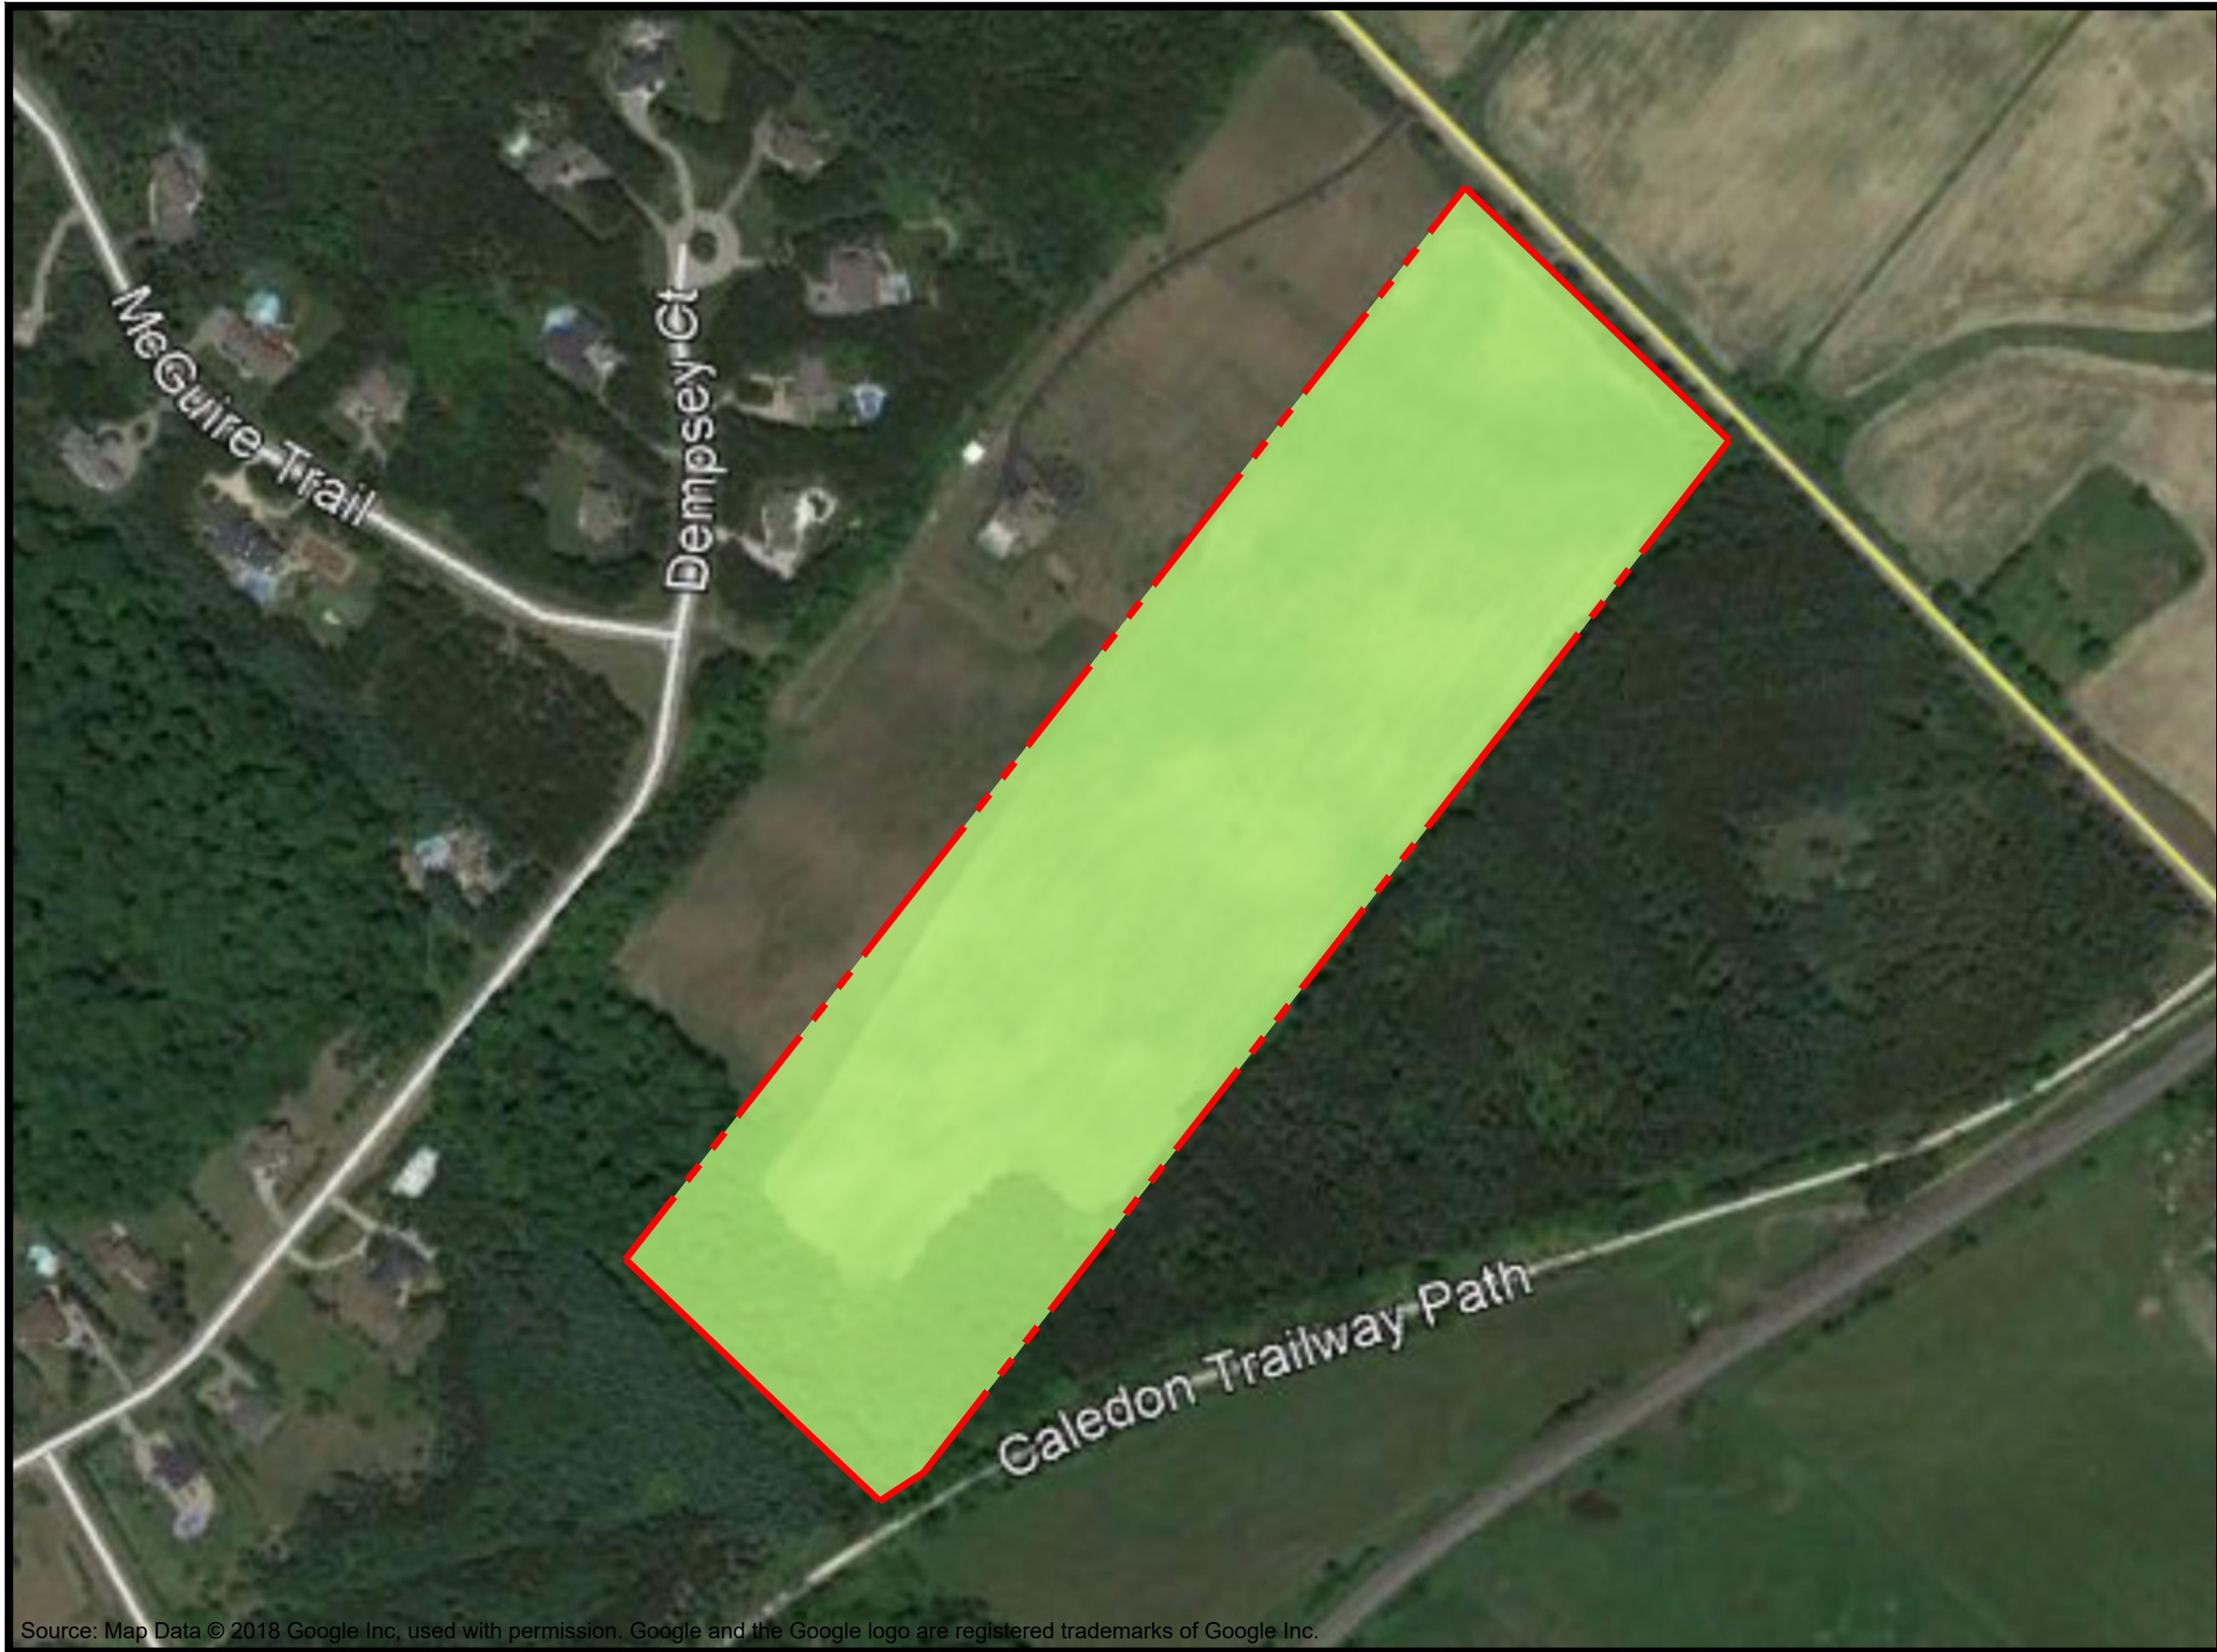
3-2

The pre- and post-development plans are shown in Figure 3-1 and 3-2. The Site statistics presented in these maps were used for the water balance calculations. Based on the Site grading plan provided by the client (Figure 3-3), the average grade elevations at each lot were estimated. Accordingly, the average highest-grade elevation was noticed at the lot number 3 at 297.69 mASL, while the lowest average grade elevation was found at lot 8 at 294.59 mASL.

The client is proposing roadside bioretention swales (Figure 3-2), as per the Town’s standard detail, to capture and convey road run-off. The water will flow along the length of the bioretention swale and filter through a 0.50 m deep filtration media to a 1.2 m wide by 1.2 m deep stone trench below for infiltration. Bioswales protect water quality by protecting local waterways from stormwater pollutants and reduce standing water (puddles) that can attract mosquitoes.

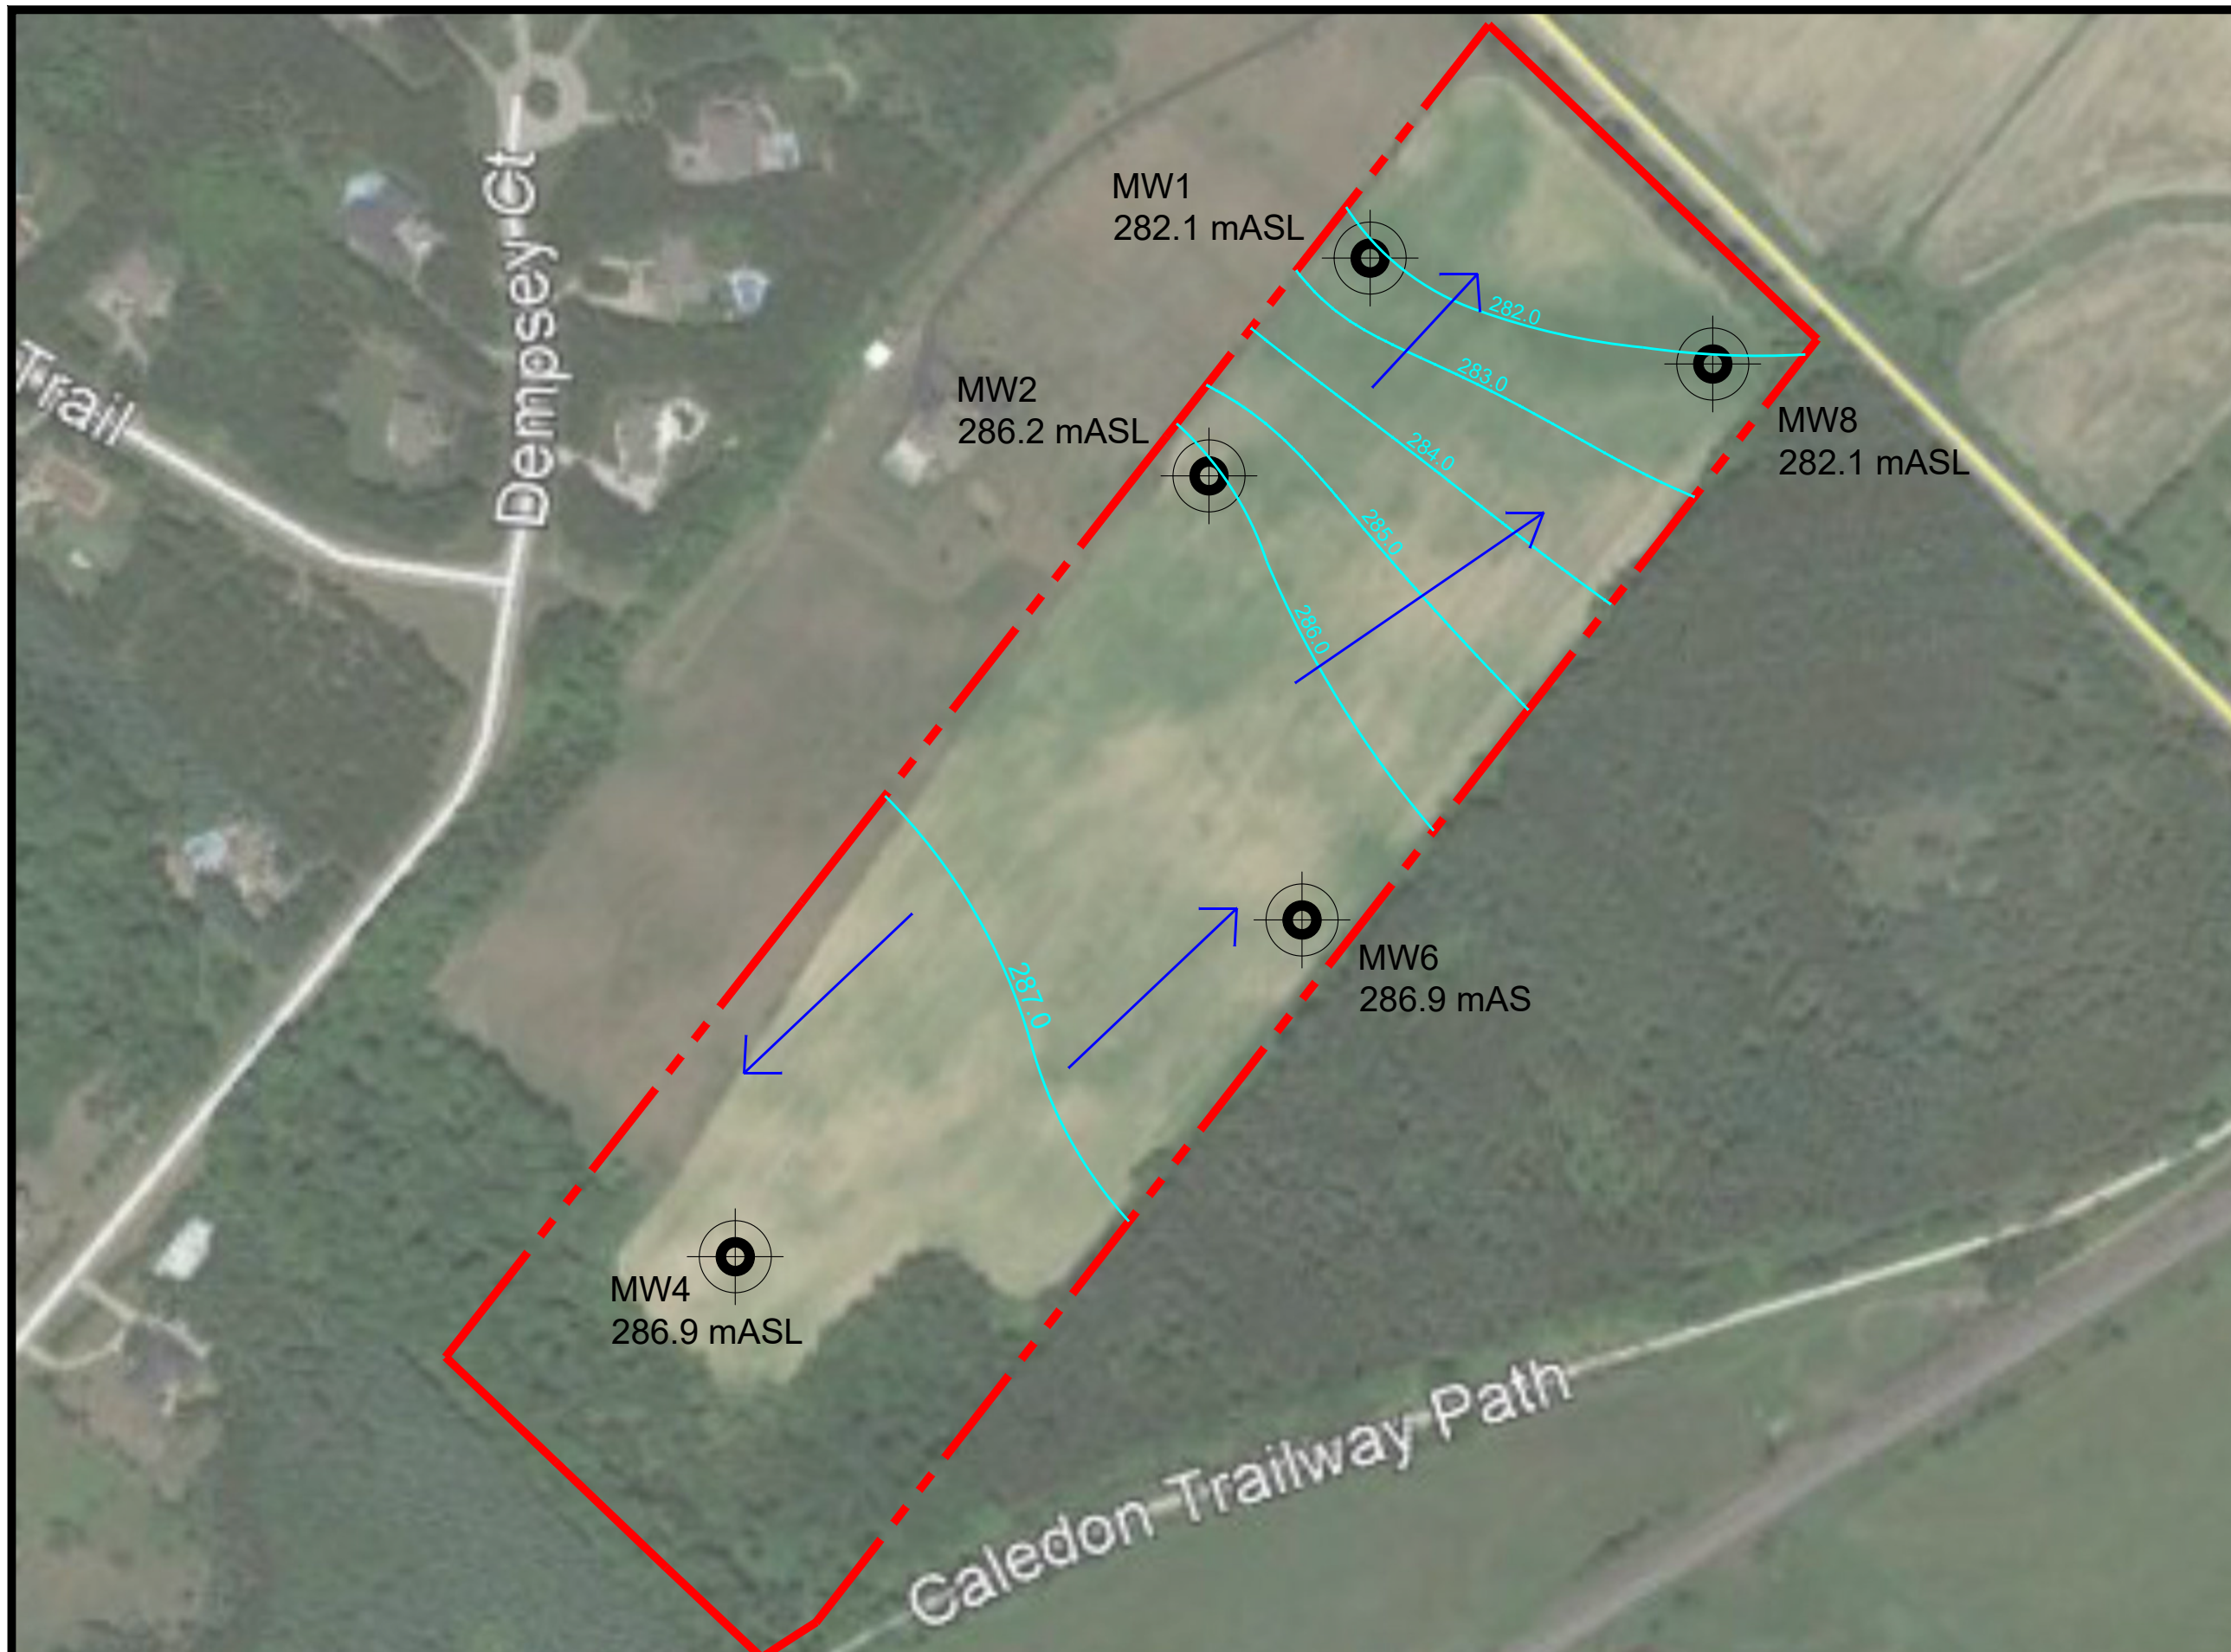
Groundwater contours were drawn using Surfer program, presented on the Figures 9-1 to 9-6 and as observed the highest water table elevation (288.20 mASL) was encountered at monitoring well MW6 and groundwater flow was divergent from this location. It appears that the Subject Property is situated at the watershed boundary with the surface drainage flowing towards opposite directions from a common highest point in correspondence of monitoring well MW6 area. This trend was consistent throughout the entire monitoring period, as shown in the groundwater table contour maps. Also, the flow of surficial drainage was divergent from MW6, following the surface topography.

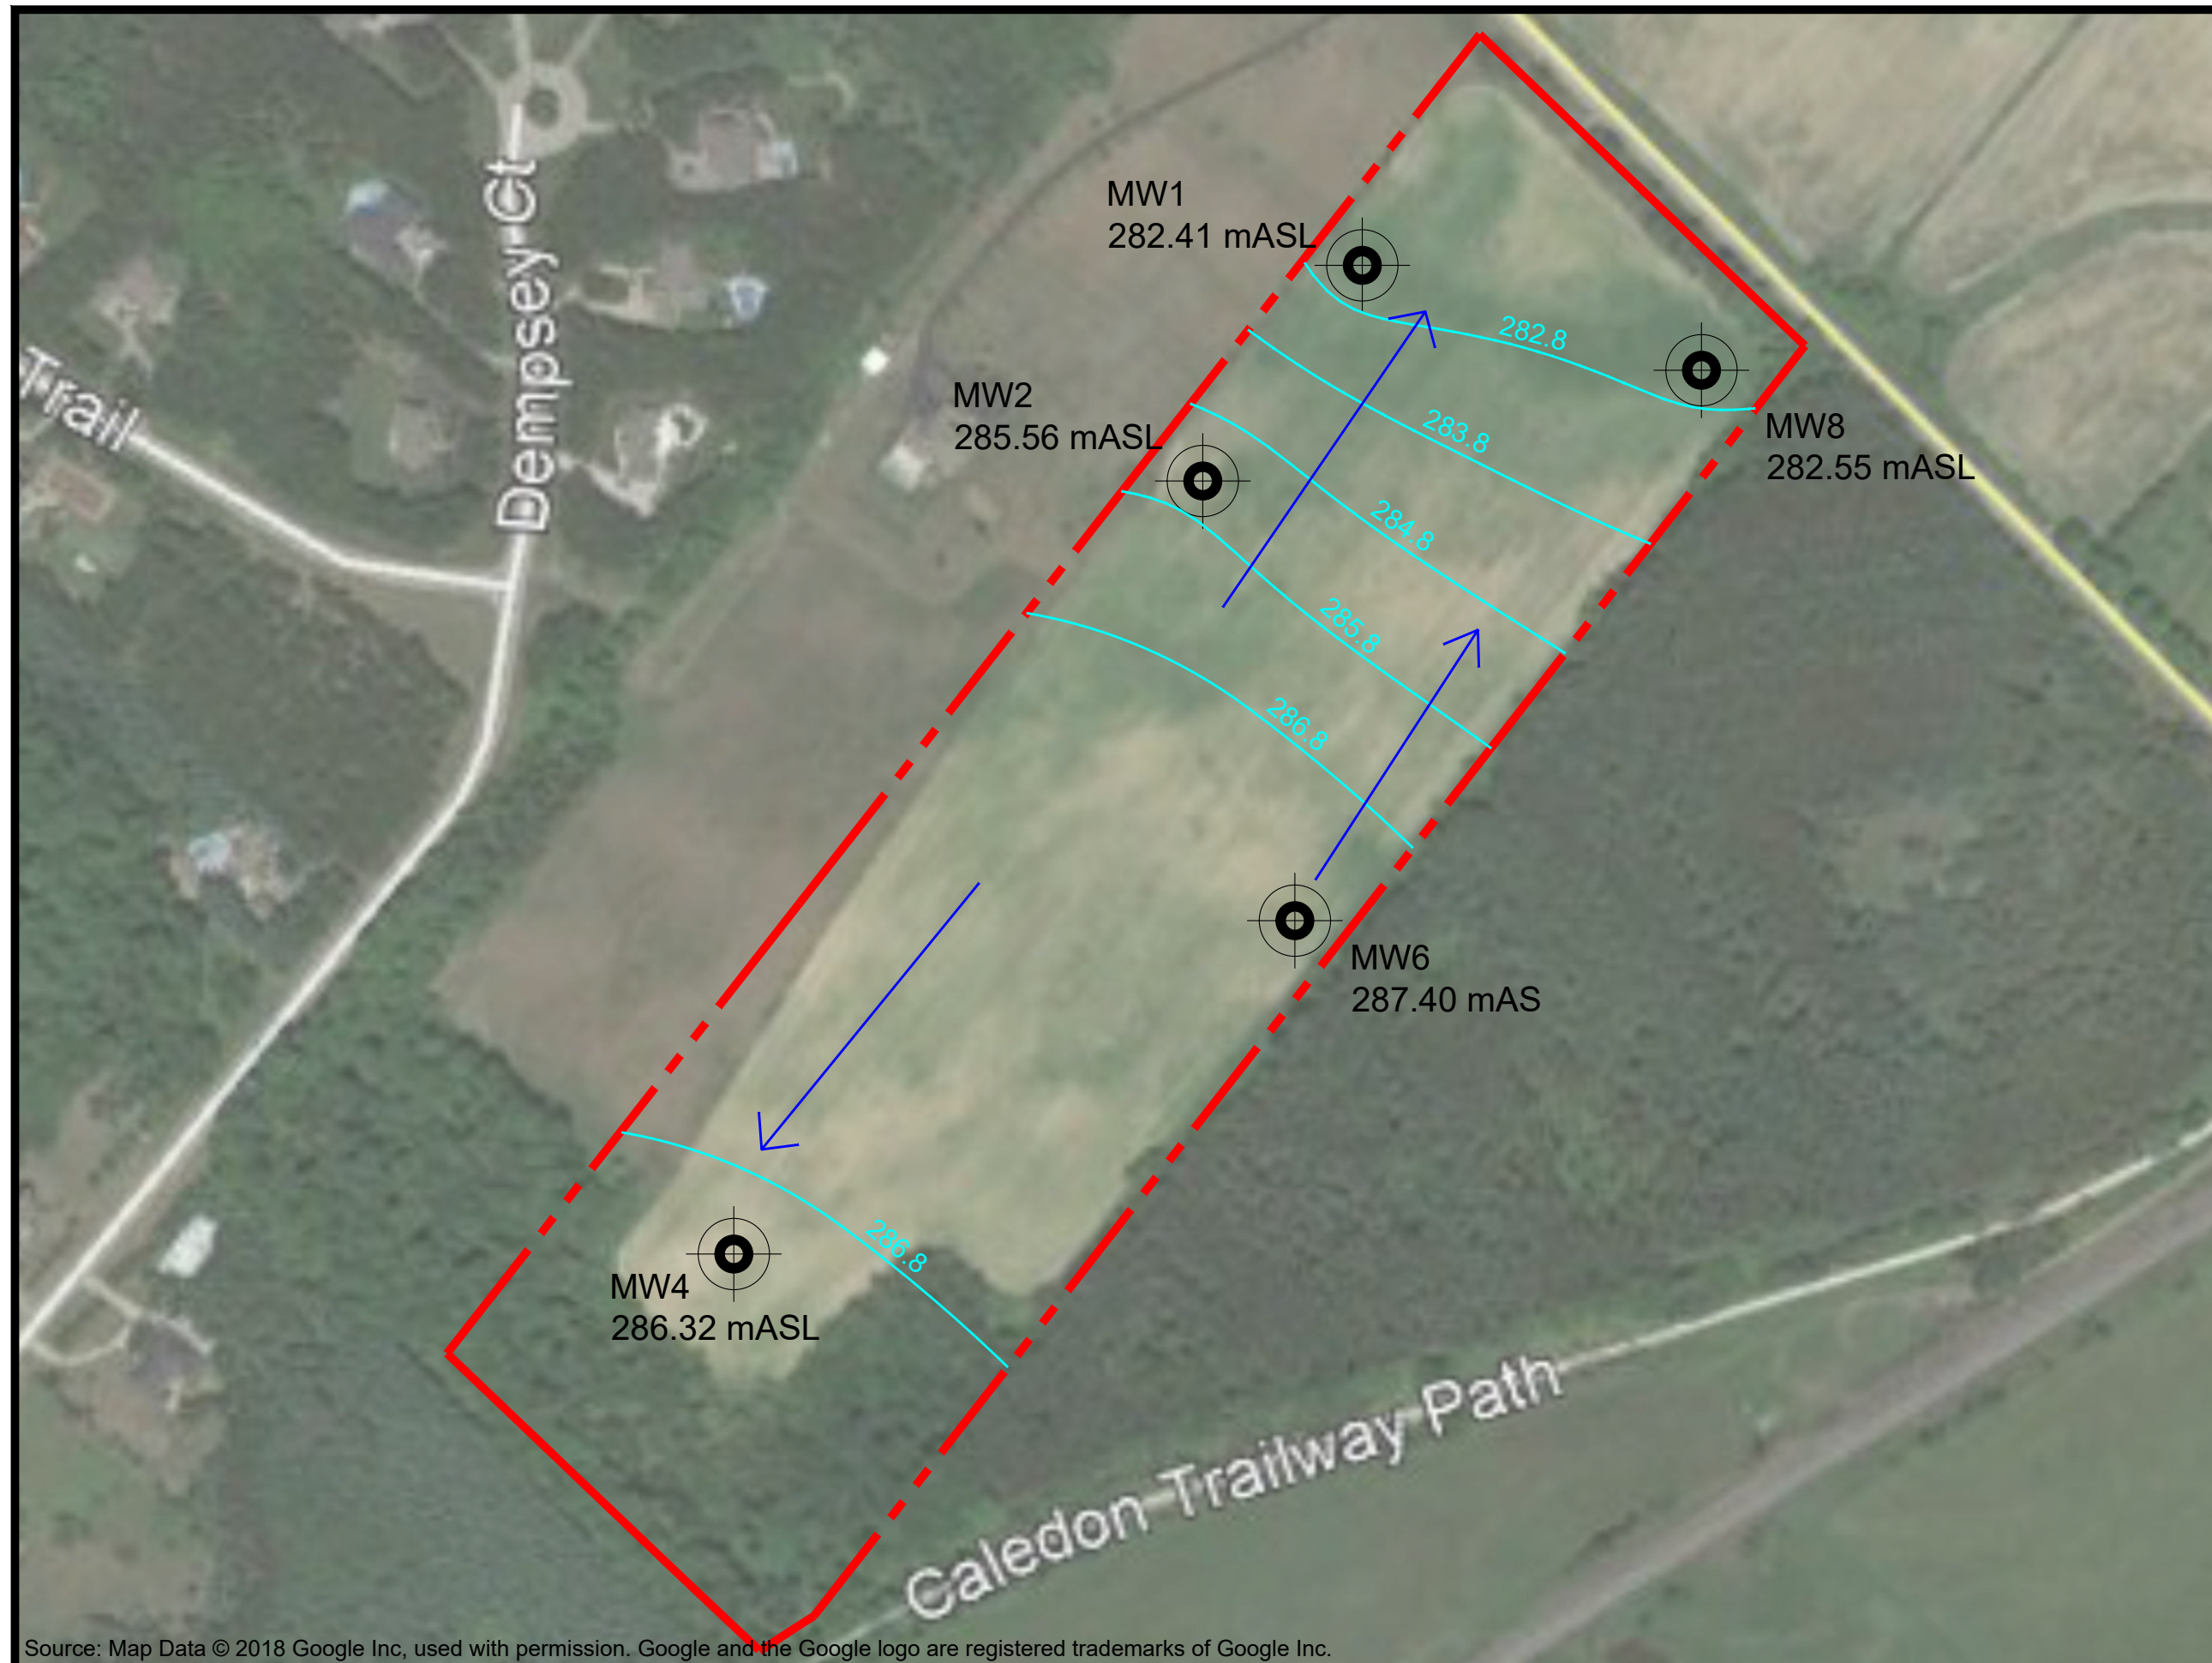
11-2

The proposed development includes a set of individual homes and as such do not require an elaborate drainage system for long term dewatering. Considering the depth to the one level basement (Figures 11-1 and 11-2) where the drainage tiles are proposed to be situated to lower the hydrostatic pressure acting on the footing walls, it appears evident that the existing groundwater table is well below this level and hence no long-term dewatering estimates related to the groundwater table are possible.

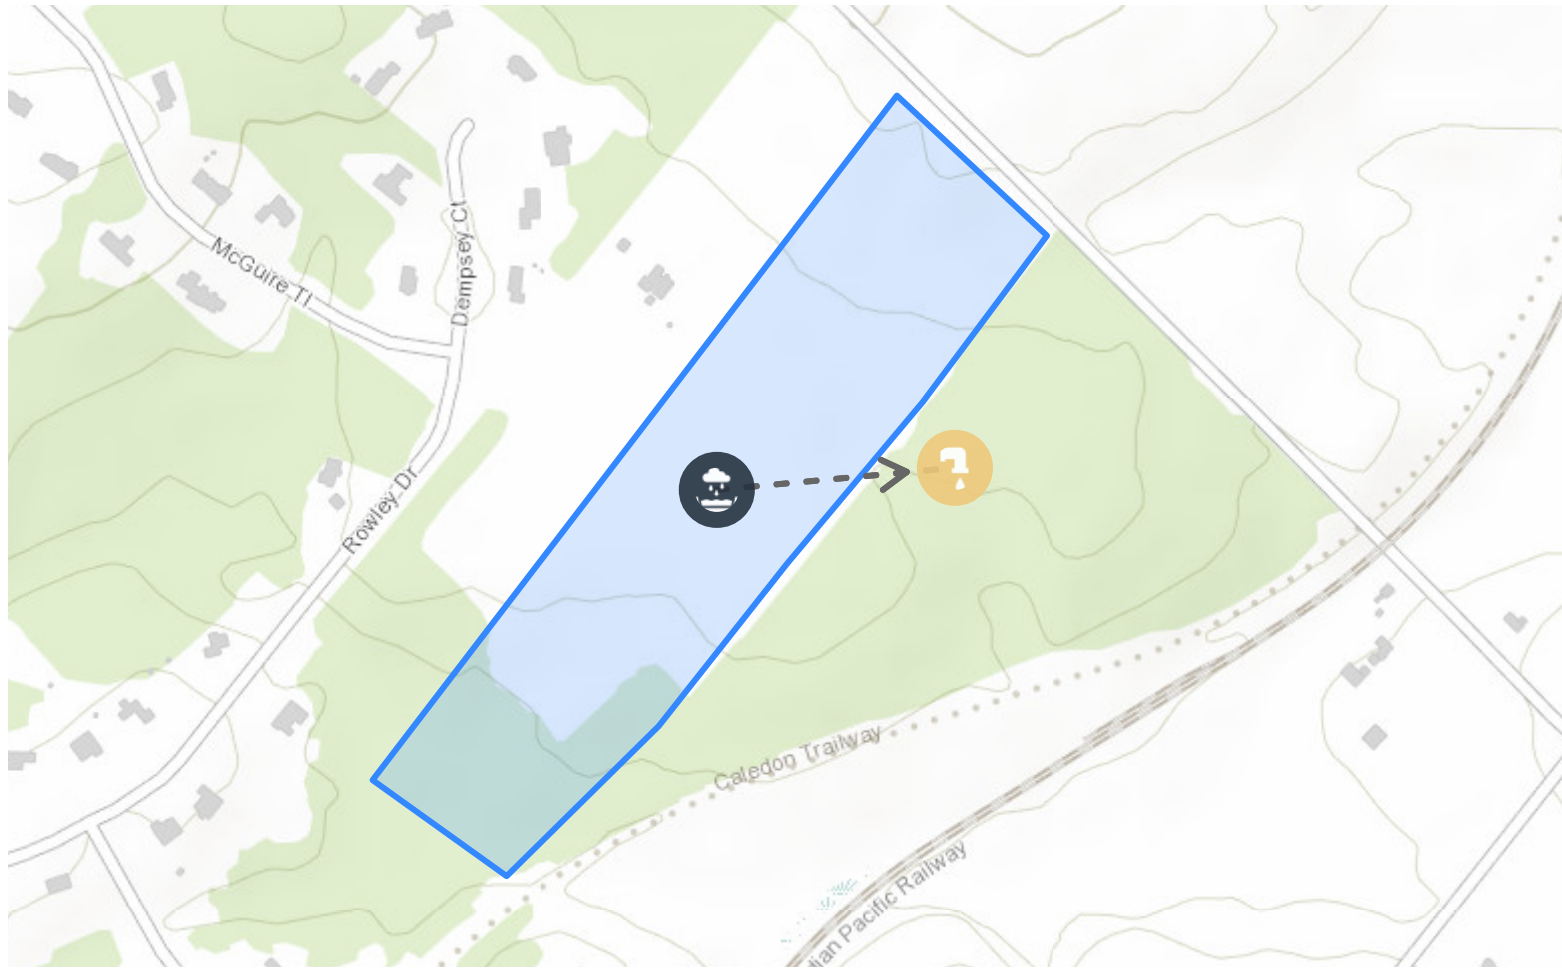
Map | Pre-Development

Catchment	Site Area	Site Rainfall In	Site Infiltration	Site Evapotranspiration	External Outflow	Rainfall Reduction
		(mm) (m ³)	(mm) (m ³)	(mm) (m ³)	(mm) (m ³)	(mm) (%)
1	12.28 ha	847.60 mm 104,076.80 m ³	115.14 mm 14,138.04 m ³	550.92 mm 67,647.47 m ³	178.35 mm 21,900.00 m ³	669.25 mm 78.96 %
TOTAL	12.28 ha	847.60 mm 104,076.80 m³	115.14 mm 14,138.04 m³	550.92 mm 67,647.47 m³	178.35 mm 21,900.00 m³	669.25 mm 78.96 %
