### **TRAFFIC MEMORANDUM**

Re: Growth Related Roads Detailed Design 2022  
Mill Street Municipal Class Environmental Assessment (Schedule "B")  
**Existing Conditions Traffic Memorandum**

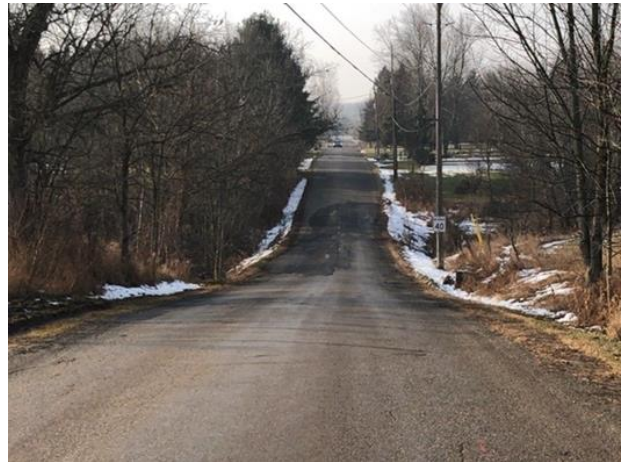
*Figure 2: Rolling Roadway*

The section of Mill Street from Mississauga Road to the beginning of the series of notable curves in the road's horizontal alignment is currently generally straight with a rolling vertical alignment resulting in several crests and sags in the roadway surface, as shown in **Figure 2**.

The existing pavement width is approximately 6.6 metres wide in this area, which assumes 3.3-metre-wide lanes, and has a rural cross-section with generally no (or little) defined gravel shoulder. TAC recommends 1.0-metre-wide shoulders on local rural roads. This pavement width is narrower than the minimum 8.7-metre-wide width shown in the Town's design standards (Standard No.203) for a local rural road, which has 4.35-metre-wide lanes. Furthermore, this is also narrower than the narrowest pavement width and lane width permitted for a Town local road, which is 7.9 metres and 3.95 metres, respectively, as shown in Standard No.202 for a narrower 18 metres right-of-way in an urban context. The TAC Geometric Design Guide recommends travel lane widths between 3 metres to 3.7 metres for rural roads with design hour directional volumes less than 450 vehicles per hour and a posted speed limit less than 60 km/h. There are no traffic signs restricting truck traffic on Mill Street. The nearest truck traffic restrictions in the vicinity are on Mississauga Road and Creditview Road which restrict truck traffic between March 15 to May 15. Based on these considerations, and for accommodation of snow storage, snow ploughs, garbage trucks, and school buses (if any), a minimum pavement width of 6.6 metres (which assumes 3.3-metre-wide lane widths) is considered desirable for this section of Mill Street, which is consistent with existing conditions.

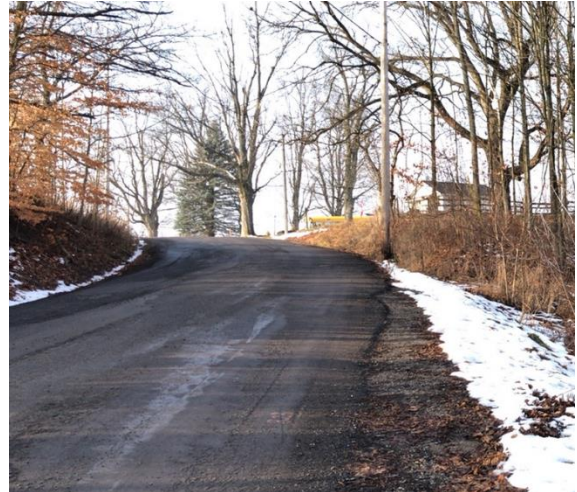
Figure 3: Westernmost Curve

The westernmost curve, as shown in **Figure 3**, has a notable grade change resulting in a crest which in combination with encroaching vegetation results in restricted sightlines.

All three of the horizontal curves have radii less than what is required by TAC for a posted speed limit of 40 km/h. The combination of back-to-back substandard horizontal curves, steep profile grades, and encroaching vegetation, limits the available decision and stopping sight distance for a motorist to see, react, and stop to safely avoid a collision with an object or pedestrian within the travelled portion of the roadway. This sightline concern, combined with the narrow pavement width through the curves and lack of pedestrian/cyclist facilities to provide separation between vulnerable road users and vehicular traffic (or refuge should a vehicle become errant through the curves under winter or wet conditions) is a safety concern. Furthermore, there is potential for vehicles to track over the centreline within the curves given the substandard radii, which creates a safety concern if pedestrians/cyclists are present, if a vehicle is stopped on the roadside, or if an opposing vehicle is travelling through the curve simultaneously.

- Improve sight distances at the back-to-back curves through a combination of cutting-back encroaching vegetation, increase horizontal curve radii, and flattening steep road profile slopes.

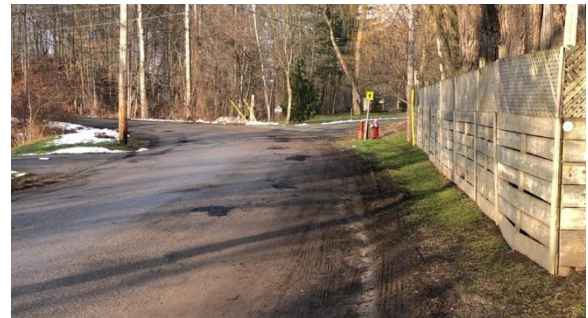
Figure 4: Middle Curve

The middle curve, as shown in **Figure 4**, has physical evidence (tire marks) of vehicles oversteering into the boulevard in close proximity to the backyard privacy fence and mature trees. The roadway surface is in poor shape with numerous potholes and evidence of poor drainage.

recommended by TAC. Furthermore, TAC recommends 1.0-metre-wide shoulders on local rural roads, which is not provided. Based on these considerations and given the centreline radii of the curves are substandard as per TAC based on the current posted speed limit (as discussed further below), it is recommended the travel lanes should be widened to 4.0 metres at the curves.

- Maintain the existing 3.3m travel lanes through the tangent section of the road and widen to at least 4.0m at the horizontal curves to better accommodate maintenance vehicles, snow storage, potential vehicle tracking, and improve overall road user safety.

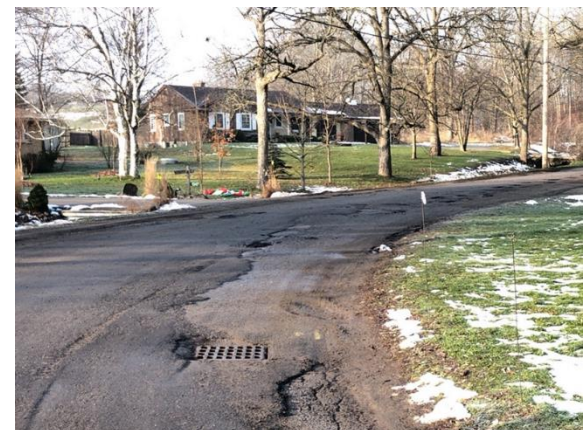
Figure 5: Easternmost Curve

The easternmost curve, as shown in **Figure 5**, similarly has evidence of vehicles oversteering into the boulevard and is in poor shape with numerous potholes and evidence of poor drainage.

Due to the significant asphalt raveling at the pavement edge in this section, the pavement width is approximately 6 metres. It is reasonable to assume the pavement width here would be consistent with the rest of Mill Street, which is 6.6 metres. The resulting width assumes 3.0-metre-wide travel lanes. This lane width is narrower than the Town's recommended pavement width as noted in the previous section of this memorandum and is at the absolute minimum width for the acceptable range provided by TAC. Furthermore, given TAC design guidelines require lane widening through curves to accommodate vehicle tracking, the existing width of the pavement is considered below the recommended minimum limit

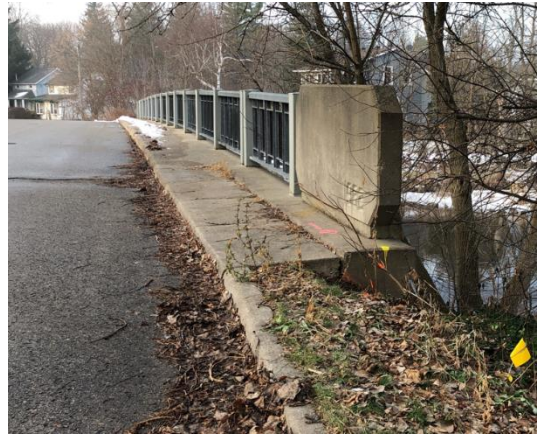
*Figure 6: Bridge over Credit River*

There are no active transportation facilities along this section of the road except for sidewalks along the bridge, with pedestrians and cyclists required to share the roadway with motorized vehicles through most of the corridor given the lack of defined shoulder. As shown in **Figure 6**, the bridge has no sidewalk let-downs to accommodate accessible pedestrian movement between the roadway and the sidewalk as per Accessibility for Ontarians with Disabilities Act (AODA) requirements, nor is their sufficient physical separation (i.e., a barrier) to separate pedestrians using the sidewalk from the unprotected embankments at the bridge ends (shown in **Figure 6**).

- Isolated guide rail treatments at non-breakaway objects within the clear zone, and at steep road embankments.
- Yellow painted centreline and white edge lines at the horizontal curves.
