Growth Related Roads Detailed Design 2022 – Mill Street

Natural Environment Assessment Memo

**Prepared for:
Town of Caledon**

December 22, 2022

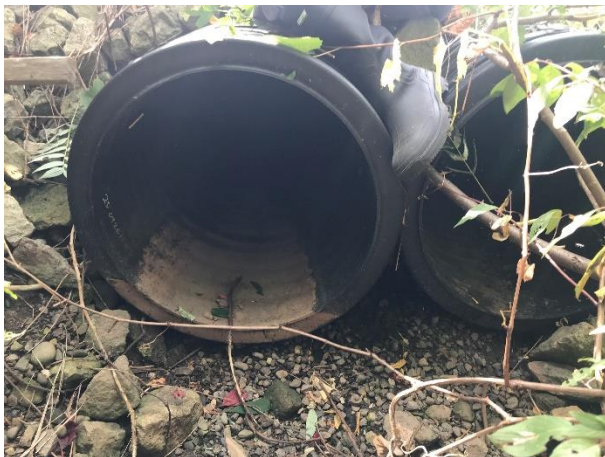
3 – 20210826 – S of Mill St. at the M3-1 crossing, looking N at culvert outlets.

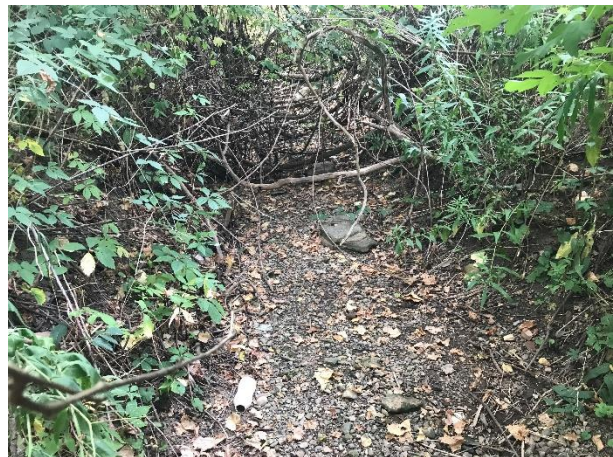
4 – 20210826 – From the M3-1 outlets looking S at dry D/S channel.

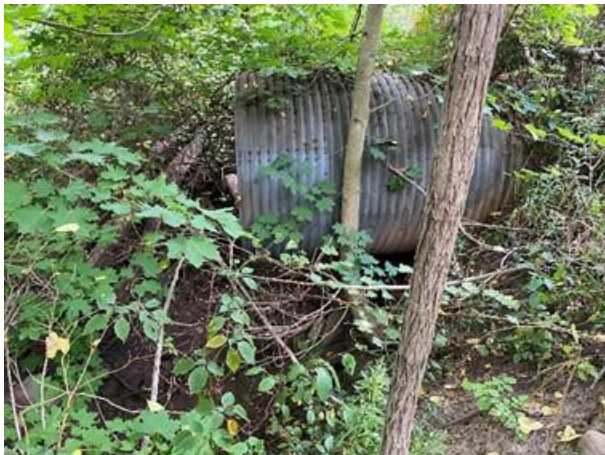
East of the roadway, the culvert extended more than a meter from the road embankment to overhang the dry channel. The outlet was perched approximately 2 m above the channel bed, preventing upstream fish passage. Erosion around the CSP where the culvert protrudes from the embankment was also observed to cut deep into the slope below the culvert, further exposing the culvert barrel. While dry, the culvert appears to discharge into a large pool area receiving additional flow from a deep, narrow ditch that extends parallel to the road northeast of the culvert. Downed trees were also observed to cross the dry channel, downstream of the culvert, and likely function as instream cover under bankful conditions.

9 – 20210826 – S of Mill St. looking SW at the perched M3-2 outlet overhanging the dry channel.

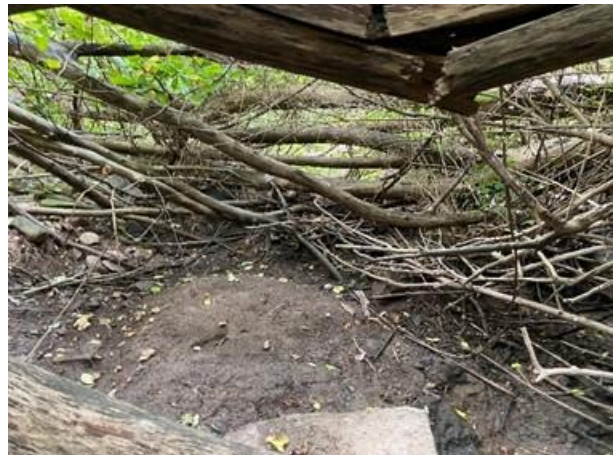
10 – 20210826 – From the M3-2 outlet looking SE at D/S channel towards accumulation of in-channel woody debris.

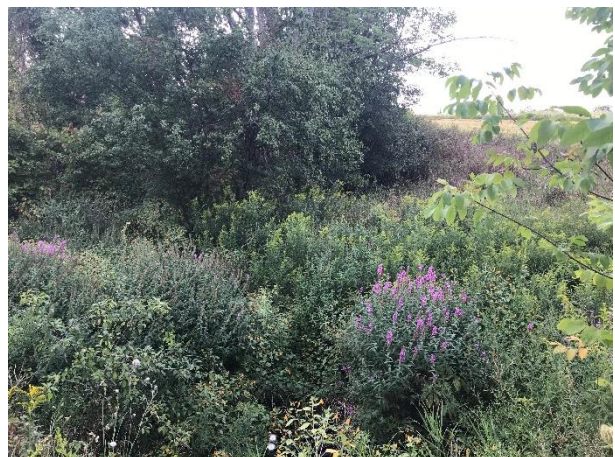
On August 26, 2021, the watercourse was experiencing low flow conditions. While no flow was observed within the upstream channel, west of the roadway, water was observed to pool at the inlet and continuously drain into the culvert suggesting the presence of a seep. Upstream, a distinct channel, with a saturated bare earth bottom and poorly defined banks extended through a retained natural corridor that transitioned from a forest to a meadow marsh vegetation community within the ROW. A dry ditch was also present northeast of the crossing, which collects runoff from the roadway to the

12 – 20210826 – From Mill St. at the M3-3 inlet looking W at U/S reach.

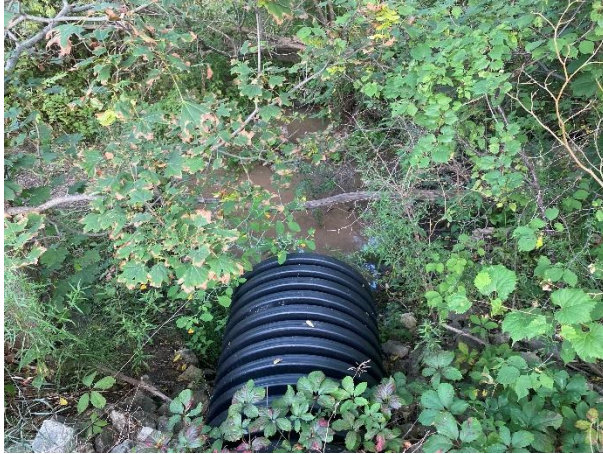
East of the roadway, flow discharged from the culvert into a pool before continuing east down a gradual slope through a narrow unstable channel. At the culvert, erosion was noted beneath the perched outlet and along the north bank immediately adjacent to the road. Erosion was also observed along the south downstream bank in the form of undercutting, slumping, and scour, exposing tree roots and toppling trees, which would provide cover to fish during periods of high flow. Downstream of the pool, fine and coarse substrates form the channel bed, including rip rap indicating past efforts to stabilize this reach.

13 – 20210826 – From Mill St. at the M3-3 outlet looking E at D/S reach.

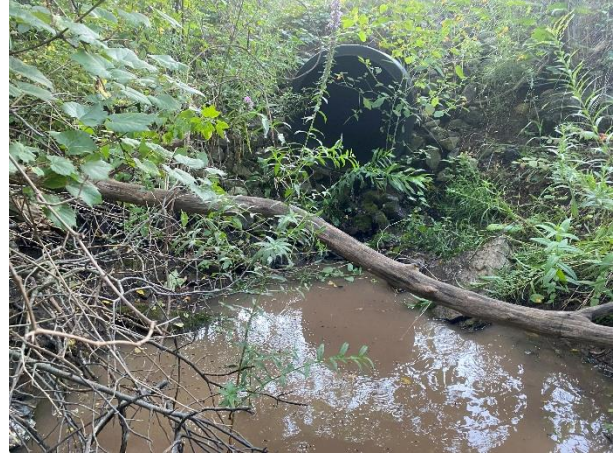
14 – 20210826 – E of Mill St. looking W at M3-3 outlet from D/S reach.

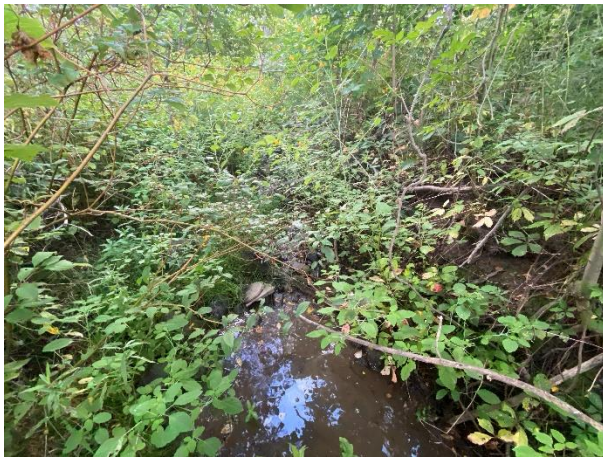
15 – 20210826 – From M3-3 outlet, E of Mill St., looking E at D/S channel.

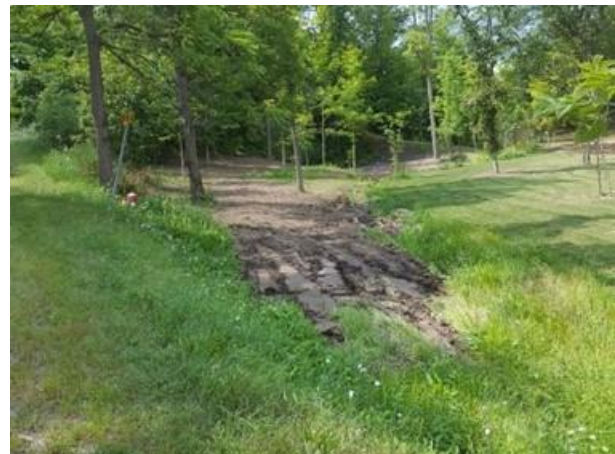
M3-4 (1+812) – At this location, a CSP culvert conveys flow southeast diagonally under Mill Street, approximately 560 m west of Creditview Road. In the summer of 2021, ground cover along the west upstream bank had been cleared leaving only the riparian trees, suggesting the upstream reach was recently altered. Due to the west bank being exposed and manicured lawn forming the east bank, little cover was provided to the upstream reach. At the culvert, dense vegetation and boulders were present and slumping was observed around the inlet, which encroached on the roadway. Though no

18 – 20210826 – From Mill St. looking NW at watercourse extending to M3-4 culvert through private land that has been modified by landowner.

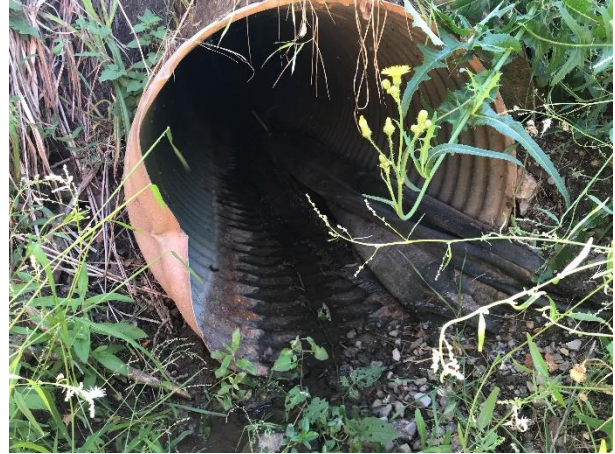
flow was observed within the upstream reach, water was pooling at the inlet, which trickled through the culvert, suggesting the presence of groundwater. While failed silt fence had washed down into the culvert at the inlet, no erosion and sediment controls were observed within the vicinity of the crossing.

20 – 20210902 – N of Mill St. looking SE at M3-3 inlet with geotextile of failed silt fence extending into culvert. Water ahead of inlet trickling through culvert.

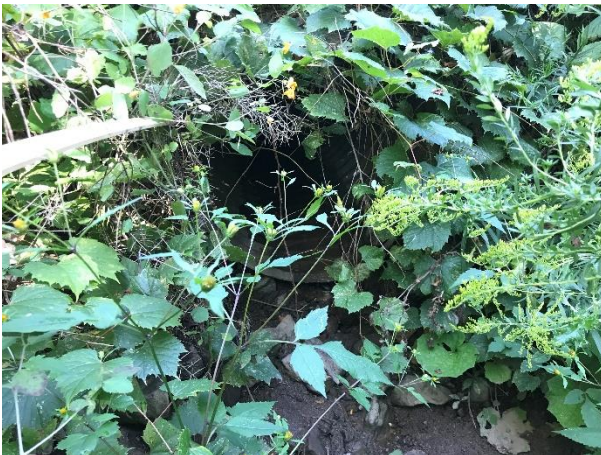
Downstream, the culvert discharges into a regulated ditch, which is channelized to conform with the shape of the road alignment, extending northeast adjacent to the eastbound side of the roadway. Due to low flow conditions, while water was conveyed through the culvert during the summer site visit, flow was not observed throughout the downstream reach, which was predominantly dry with water restricted to shallow pool areas. South of the roadway, vegetation covered the outlet, which was slightly perched and discharging into a pool area before turning sharply northeast, extending towards the M3-6 outlet. Erosion was present along both the north and south banks in the form of bank scour, undercutting, and slumping; however, scour along the north bank was observed to encroach towards the roadway at multiple locations. Riparian trees stabilized the south bank, and completely shaded the channel, with vascular plants dominating the north slope. In the Spring of 2022, the riparian vegetation along the north downstream bank had been cut, and flow was observed throughout the channel.

21 – 20210902 – S of Mill St. looking NW at M3-4 outlet.

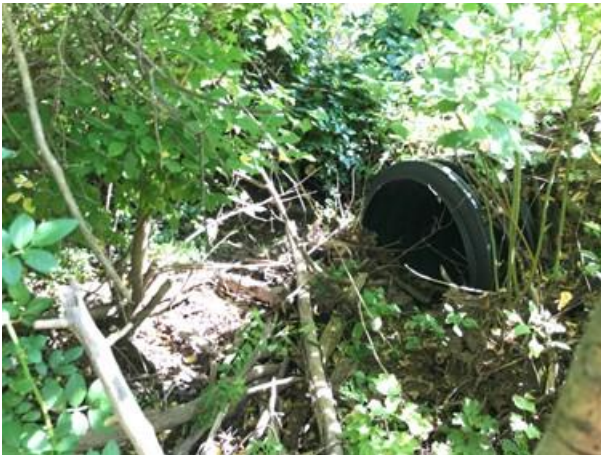
27 – 20210902 – N of Mill St. looking at the M3-6 inlets when crossing is dry.

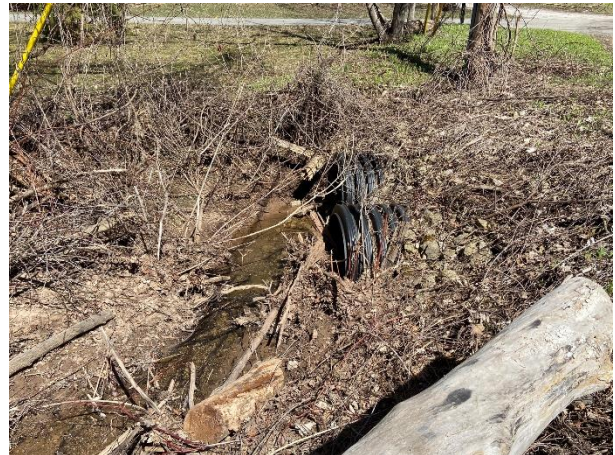
28 – 20220412 – N of Mill St. looking at M3-6 inlets when crossing is wet. Note vegetation along road embankment has been cut.

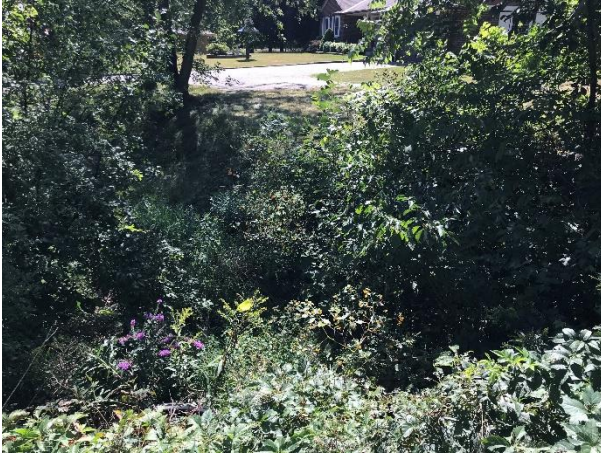
31 – 20210902 – From M3-6 outlets looking SE when channel is dry. Note extensive vegetation around outlets.

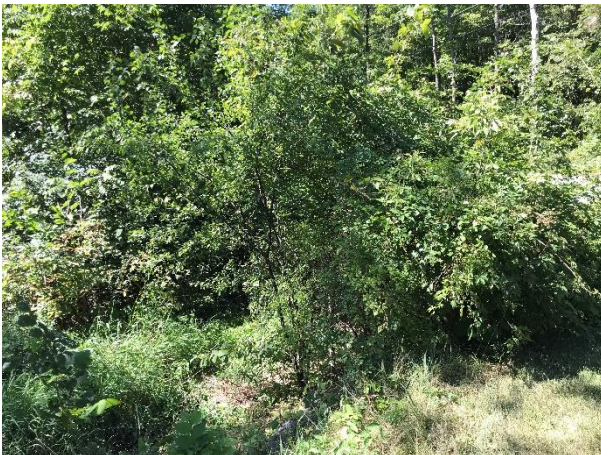
33 – 20210902 – E of M3-6, looking W at outlets when dry. Note extensive vegetation around outlets.

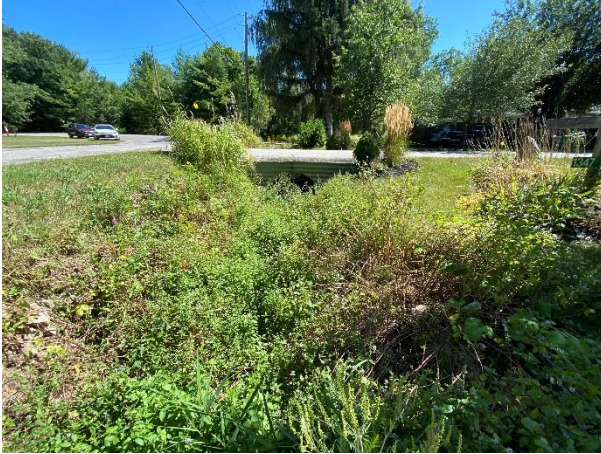
noted along the banks at both the culvert inlet and outlet, and minor erosion was present along the east upstream bank. Due to the channel being dry in the summer of 2021 but flowing in the spring of 2022, the M3-8 crossing conveys intermittent flow that supports direct fish habitat during periods of high flow and indirect fish habitat when under low flow conditions.

37 – 20210902 – From regulated ditch looking SE at M3-8 inlet when channel is dry.

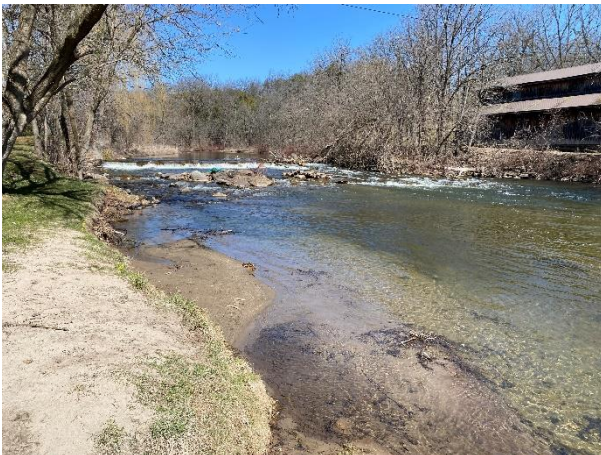
Beyond the ROW, approximately 400 m downstream of the bridge, an old weir structure was observed and likely obstructs upstream fish passage during periods of low flow. Immediately downstream of this structure, the regulated watercourse associated with the M3-4 (Sta. 1+812) to M3-10 (Sta. 1+988) culverts converges with the Credit River. As discussed below, three additional tributaries drain to the Credit River further downstream.

45 – 20220412 – E of Mill St. Looking at in-stream dam within the Credit River, U/S of ditch confluence.

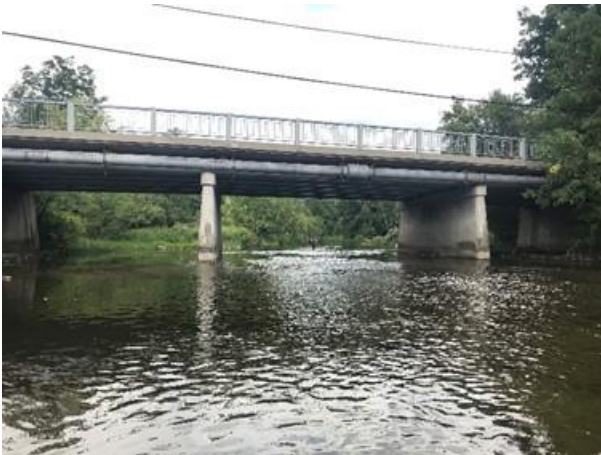
At the Mill Street Bridge, the Credit River morphology consisted of runs, riffles, and pools. The wetted channel, which varied in width from 24.7 m to 29.9 m within the ROW, was comprised of coarse and unconsolidated material. Watercress was observed along the west upstream bank. Along the east bank, the ditch associated with the M3 –13 (Sta. 2+435 Rt) and M3-14 (Sta. 2+460 Rt) culverts (see description of ditch below), abuts the south side of the road alignment and drains southwest down a steep gradient before discharging into the Credit River.

51 – 20210826 – D/S of the Mill St. Bridge crossing over the Credit River, looking U/S.
