### **PAVEMENT EVALUATION REPORT**

**2022 GROWTH RELATED ROADS DETAILED DESIGN**

**PAVEMENT EVALUATION REPORT  
PROJECT #: 2020-97**

**MILL STREET  
FROM MISSISSAUGA ROAD TO CREDITVIEW ROAD  
TOWN OF CALEDON, ONTARIO**

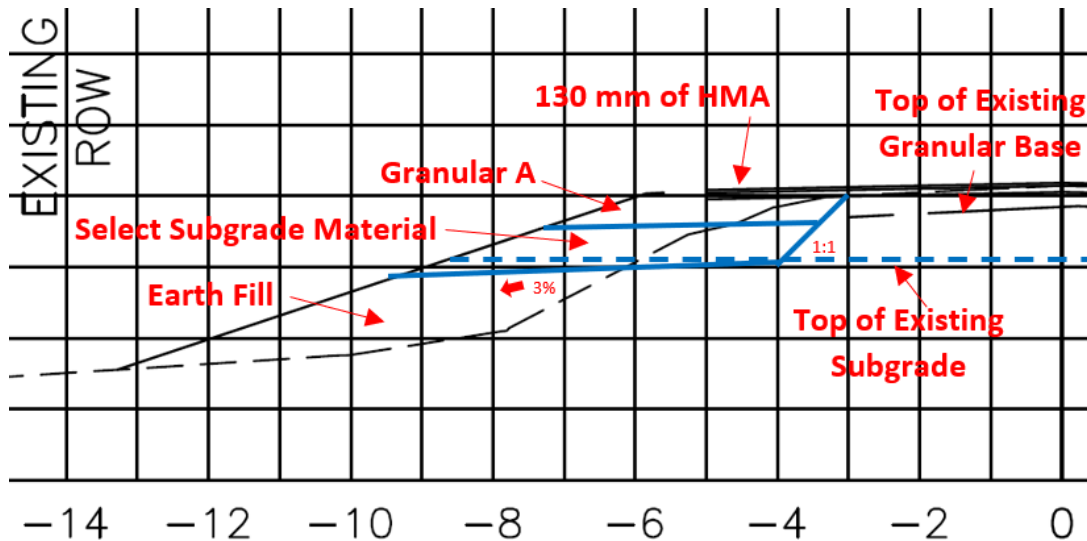
**Figure 4.1: Typical Conventional Pavement Widening Cross-Section**

subgrade should be graded with a 3 percent slope across the width of the embankment. Fill material in the embankment widening below the top of subgrade can be constructed using suitable earth material from cut sections within the project limits.

A typical cross-section for a conventional pavement widening design is provided in Figure 4.1.

To save project costs, the additional granular material in the widening excavation (for drainage purposes) can be substituted with Select Subgrade Material (SSM); however, in order to maintain structural adequacy, a minimum of 225 mm of new Granular A (or FDR processed) material will be required. The recommended pavement structure for widening along Mill Street shall consist of:

The pulverized material may be graded from the adjacent lane and partially comprise the new granular base layer. Design considerations in pavement widening areas must consider the minimum pavement structure required to meet the traffic and subgrade design requirements; however, subsurface drainage at the top of subgrade must also be maintained across the widening areas. The recommended total pavement thickness should meet the average thickness of the existing pavement; however, localized deepening may be required and should be completed using Granular A, FDR processed material, or SSM.

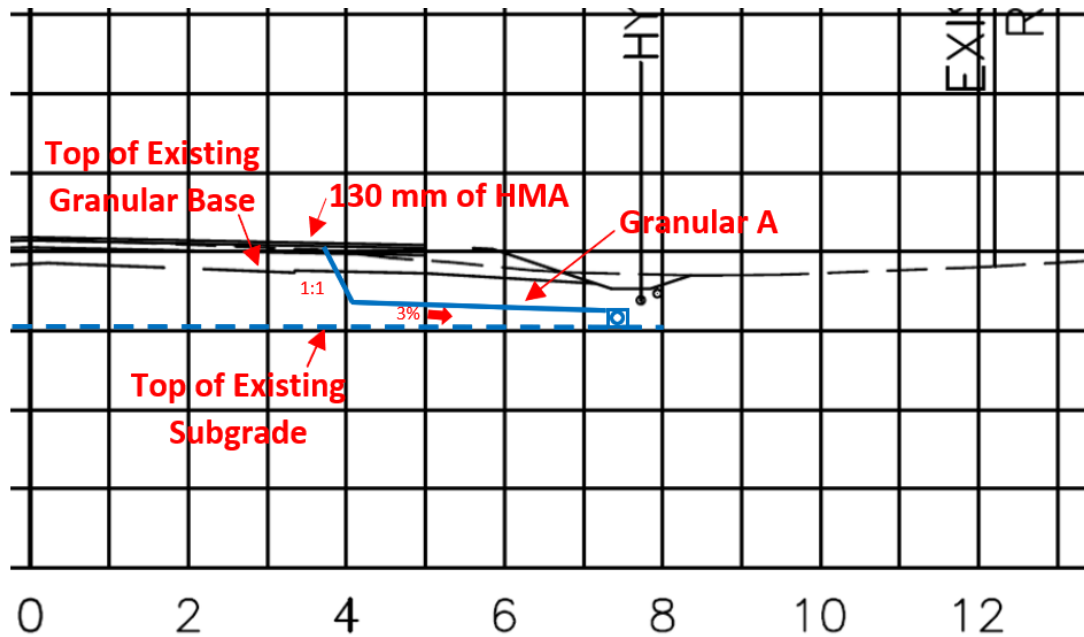
**Figure 4.2: Proposed Alternate Pavement Widening Cross-Section**

It is understood that conventional pavement widening may not be possible in cut sections, as the available roadway Right-Of-Way (ROW) in these areas may not permit an appropriate ditch depth. An alternative to reduce the depth of excavation in cut areas, while maintaining adequate drainage, includes the installation a new subdrain beneath the new ditch and grade the top of subgrade across the widening area toward the new subdrain.

A typical cross-section of the pavement widening design is provided in Figure 4.2.

Excavation for the pavement widening should commence at the edge of existing pavement, and extend to the required depth, with an excavation slope of 1(H): 1(V). The depth of the new subdrain should be installed beneath the new ditch at the top of subgrade. Across the widening area, the top of subgrade should be sloped toward the subdrain at a 3 percent grade, which should be installed at a minimum depth of 700 mm. The new pavement structure should consist of:

This design approach improves the constructability of the pavement widening areas by providing a consistent excavation and subdrain depths and better compaction of subgrade soils, while reducing the potential of deeper excavations encountering unstable soil conditions in areas with higher groundwater levels. Other benefits to this design approach, include reduced vertical excavation at edge of pavement, reduced potential to undermine existing pavement at widening interface, reduced clearance of traffic to edge of excavation, and improving sub-surface drainage beneath the existing pavement by reducing distance to the outside ditch. In addition to the identified benefits to this design approach, it is expected that there should be no effect to the

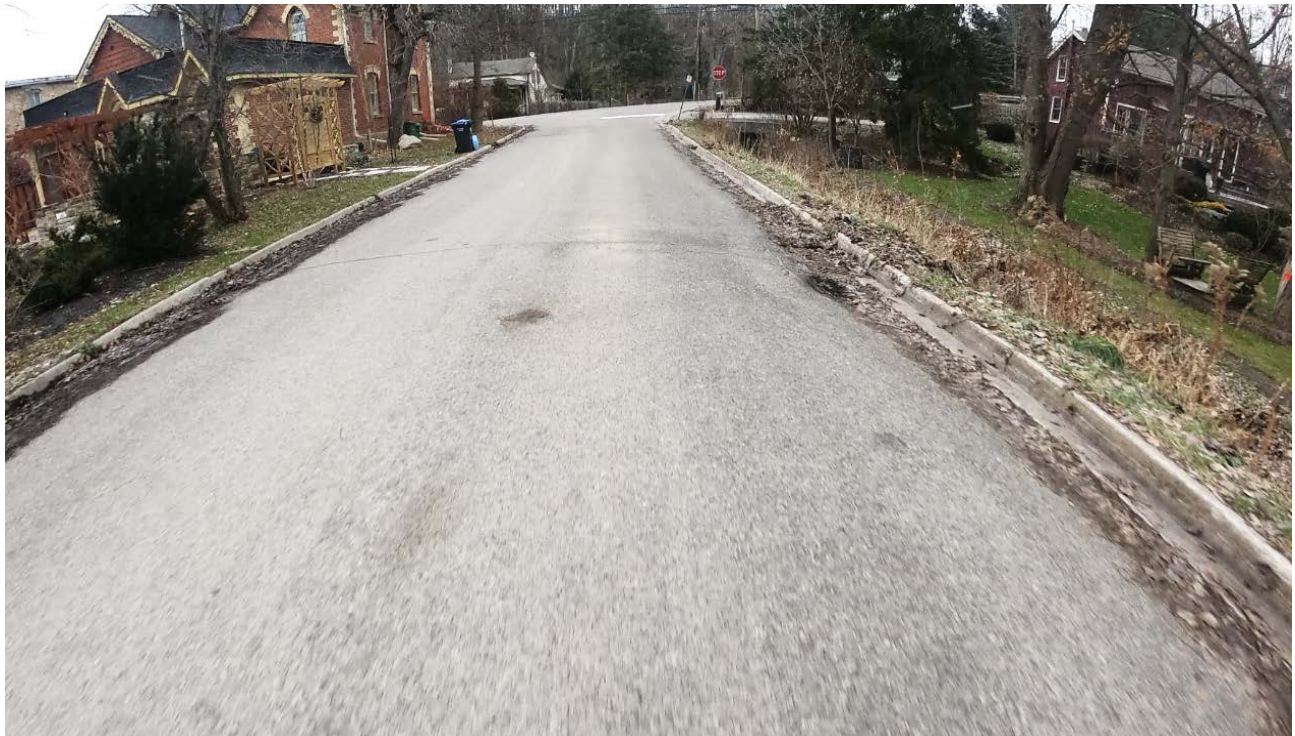
**Typical Photograph # 8**  
Mill Street - Station 11+420 - EB Lane

In the urban pavement area, the general condition of the pavement surface is considered to be in good condition; although considerable random cracking was observed on the bridge deck over the Credit River. In the approach pavement sections, limited cracking was observed in the travel lanes; however, alligatored cracking was observed at the pavement edge.

In the urban pavement area with curb and gutters, the recommended rehabilitation strategy includes removal of the existing asphalt, with the exposed granular material graded as required for the placement of 130 mm of new HMA. Similar to the adjacent pavement section, the recommended asphalt type and lift thicknesses should consist of:

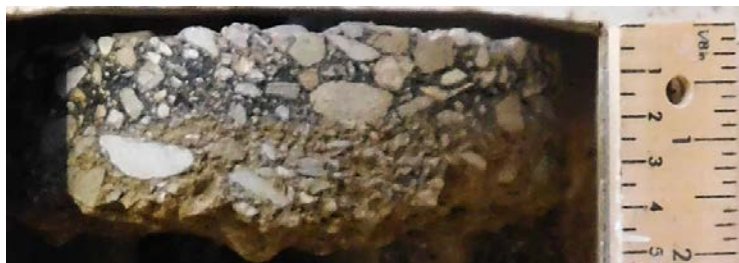
**Pavement Core Photo # 1**

Mill Street  
Station 10+640 - WB Lane

Layer	Thickness (mm)
Surface	20
<b>Total</b>	<b>20</b>

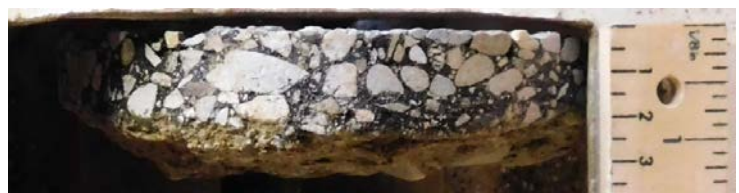
**Pavement Core Photo # 2**

Mill Street  
Station 11+240 - EB Lane

Layer	Thickness (mm)
Surface	20
<b>Total</b>	<b>20</b>
