Mill Street (Mississauga Road to Creditview Road)

Municipal Class Environmental Assessment

Project File Report

Final

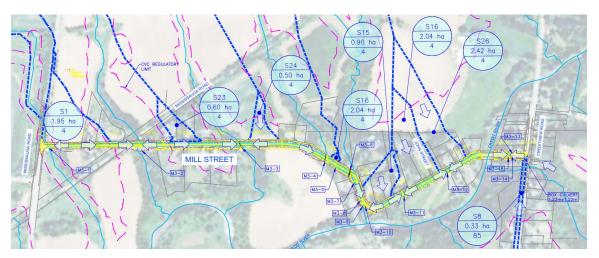
Figure 2.1 – Existing Drainage Area

Under existing conditions, as highlighted in **Figure 2.1**, roadway drainage is generally conveyed via roadside grassed ditches throughout the Study Area to culvert outlets ultimately discharging to the Credit River, with no existing storm water management control. For the 120m section of Creditview Road to the west end of Mill Street Bridge ((structure ID# B20304037), roadway stormwater runoff is conveyed via catchbasins and drain outlets on the bridge along the curb and gutter. An additional catchbasin is found at 1346 Mill Street which collects roadway stormwater on the north side of the road in the absence of a ditch between 1328 Mill Street and 1382 Mill Street.

Most properties on both sides of the road between the area of east of the area of 1260 Mill Street and Creditview Road are located within the 100-Year and Regulatory Floodplains for the Credit River. The Credit River flood plain elevations control the water levels for the creek which flows adjacent to Mill Street in the vicinity of 1347 and 1499 Mill Street. Due to both properties' proximity to the Credit River and being located within the regulatory floodplain, it is expected that these properties will experience flooding during most storms.

The full Design Brief is provided in Appendix 3.

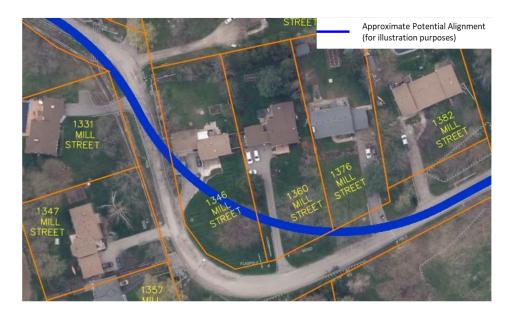
Alternative 2 – Adjust Alignment Completely to Fully Meet TAC Standard: Under this alternative, the roadway alignment would be adjusted completed to fully meet TAC standards, significantly increasing the radius of the curves and improving vehicle, pedestrian and cyclist safety as shown in Figure 4.2. Safety concerns related to vehicles, pedestrians and cyclists navigating the curves are fully addressed, however vehicle speeds are likely to increase. Additionally, significant property impacts are required to accommodate the new roadway alignment, including the complete purchase of the property at 1346 Mill Street.

Figure 4.2 – Alternative 2: Adjust Alignment Completely to Fully Meet TAC Standard Alternative 3 – Adjust Alignment Slightly to Improve Curve Radius: A slight realignment of the roadway to reduce the radius through the curve, and sight distance improvements (tree trimming) to improve vehicle, pedestrian and cyclist safety through the curve as shown in Figure 4.3. The natural traffic calming barrier of the s-curve remains mostly intact, and concerns regarding vehicle and pedestrian/cyclists safety are mitigated through a slightly improved radius and operational improvements including cutting back existing vegetation, improved signage and pavement marking, and providing a 1.5 meter wide sidewalk to accommodate pedestrians. Minor property impacts limited to the south side of the road; however, TAC standards are not fully met.

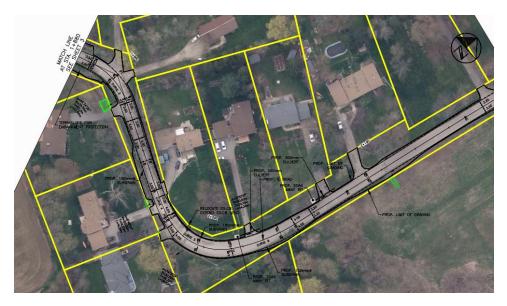
Figure 4.4 – Alternative 4: Operational Improvements in Current Alignment

Alternative 4 – Operational Improvements in Current Alignment:¹ The roadway curve would remain as is, with operational improvements (pavement paint marking, traffic signage) as shown in Figure 4.4.

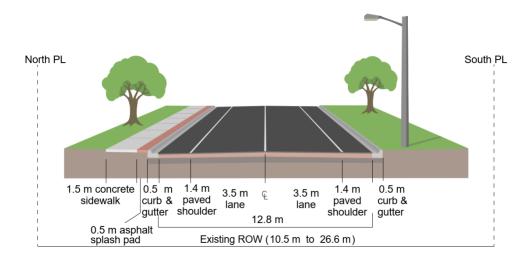
Figure 4.5 - Alternative 2: Curb and Gutter with Sidewalks

Alternative 2 – Curb and Gutter with Sidewalks: One lane of traffic in each direction (3.5 meters wide) with signage for vehicles to share the roadway; 1.4-meter-wide paved shoulders with 0.5-meter-wide curb and gutter on both sides of the road; with 1.5-meter-wide boulevards on the south side of the road and 0.5-meter-wide asphalt splashpad with 1.5-meter-wide concrete sidewalk on the north side of the road as shown in Figure 4.5Figure 5.2. The total width of this cross-section alternative is 12.8 meters wide with 9.8 meters of paved roadways and would significantly impact adjacent properties.

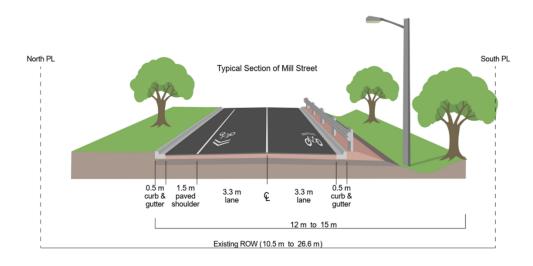
Figure 4.6 - Alternative 3: Curb and Gutter with Paved Shoulder

Alternative 3 – Curb and Gutter with Paved Shoulder: One lane of traffic in each direction (3.3 meters wide) with signage for vehicles and cyclists to share the roadway; curb and

gutter on both sides of the road; 0.5-meter depth ditch with 3:1 foreslope and maximum 2:1 backslope on the south side of the road and 1.5-meter paved shoulder on the north side of the road as shown in **Figure 4.6**. The total width of this cross-section alternative varies between 12 to 15 meters wide with 9.1 meters of paved roadway.

Alternative 3 - Curb and Gutter with Paved Shoulder was identified as the preliminary preferred solution as it provides adequate accommodation for pedestrians and cyclists, minimizes impacts to adjacent properties, and improves roadway drainage conveyance. The preliminary recommendation was presented for public input at PIC #1.

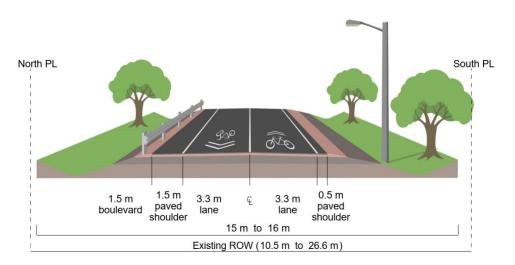
Figure 4.7 - Alternative 4 – Paved Shoulder and Re-instate Ditches

Alternative 4 – Paved Shoulder and Re-instate Ditches: One lane of traffic in each direction (3.5 meters wide) with signage for vehicles and cyclists to share the roadway; 0.5-meter depth ditch with 3:1 foreslope and maximum 2:1 backslope on both sides of the road; 1.5-meter-wide paved shoulder on the north side of the road and 0.5-meter-wide paved shoulder on the south side of the road as shown in Figure 4.7. The total width of this cross-section alternative varies between 15 to 16 meters wide with 10.1 meters of paved roadway.

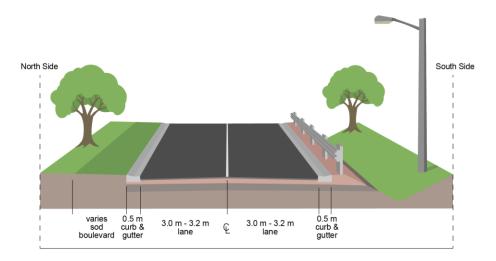
Figure 4.8 - Alternative 2: Existing Cross-Section with Mountable Curb

Alternative 2 – Existing Cross-Section with Mountable Curb: One lane of traffic in each direction (3.0 to 3.2 meters wide) with signage for vehicles to share the roadway; 0.5-meter-wide curb and gutter on both sides of the road, with sod boulevard on the north side of the road as shown in Figure 4.8.

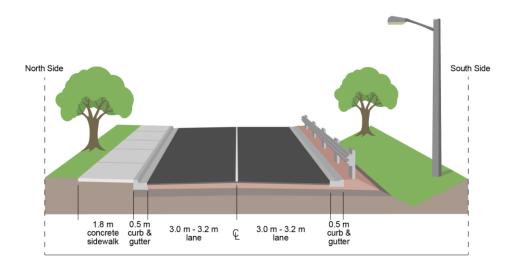
Figure 4.9 - Alternative 3: Sidewalk

Alternative 3 – Sidewalk: One lane of traffic in each direction (3.0 to 3.2 meters wide) with signage for vehicles to share the roadway; 0.5-meter-wide curb and gutter on both sides of

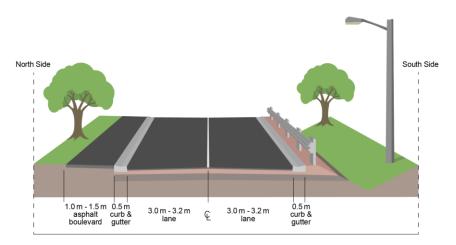
Figure 4.10 – Alternative 4: Asphalt Boulevard

Alternative 4 – Asphalt Boulevard: One lane of traffic in each direction (3.0 to 3.2 meters wide) with signage for vehicles to share the roadway; 0.5-meter-wide curb and gutter on both sides of the road, with 1 to 1.5-meter-wide asphalt boulevard on the north side of the road as shown in Figure 4.10.

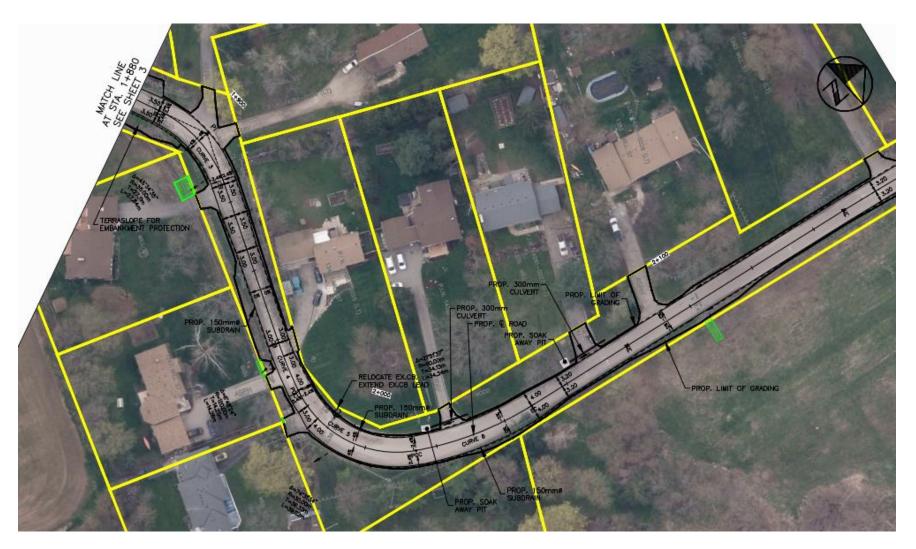
Figure 5.1 – Recommended Roadway Alignment Through Curve

The recommended operational improvements include cutting back existing vegetation to improve sightlines, traffic signs, pavement paint markings, and slightly widening the lane to 4 meters wide at the eastern most curve to provide sufficient width for large vehicle movements such as snowplows, emergency service vehicles, and garbage trucks.

By maintaining the alignment of the s-curve, impacts to adjacent properties will be minimized, the traffic calming properties of the existing curve will be maintained, and natural environmental impacts to the Credit River Valley will be largely avoided, whilst improving the safety of the s-curve for all road users. The roadway curve would remain as is, with improvements limited to resurfacing the roadway surface in the current alignment.

Further details regarding the Roadway Alignment Through Curves Recommendations, including Design Criteria and the recommended Plan and Profile sheets are provided in **Appendices 8** and 9 respectively.

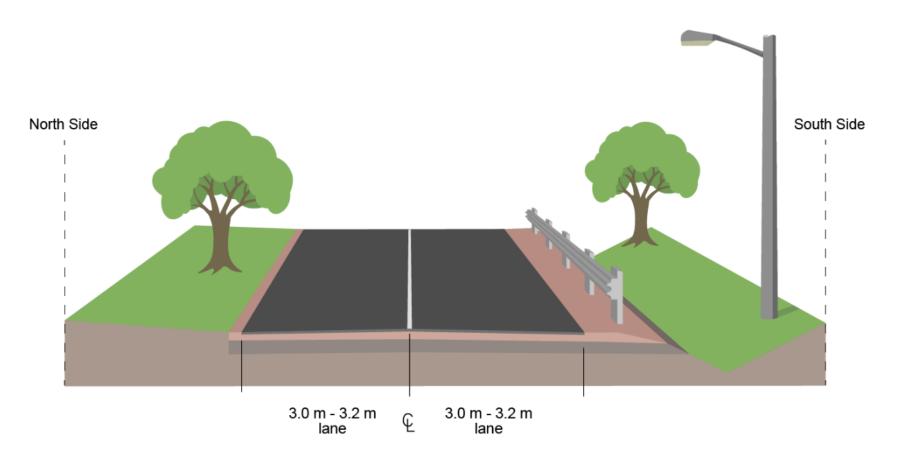
Figure 5.2 – Recommended Cross-Section (Tangent Section, 4.0m wide lanes at curves)

This cross-section minimizes property, utility, and environmental impacts as it maintains the existing paved platform width. Where required, new steelbeam guiderail will be installed to protect traffic from roadside hazards including steep embankments.

Further details regarding the Cross-Section Recommendations, including the recommended Plan and Profile sheets are provided in **Appendix 9**.
