REPORT

Phase One ESA - PIN 14272-30086, Caledon, Ontario

Proposed Caledon Pit / Quarry

June 28, 2021

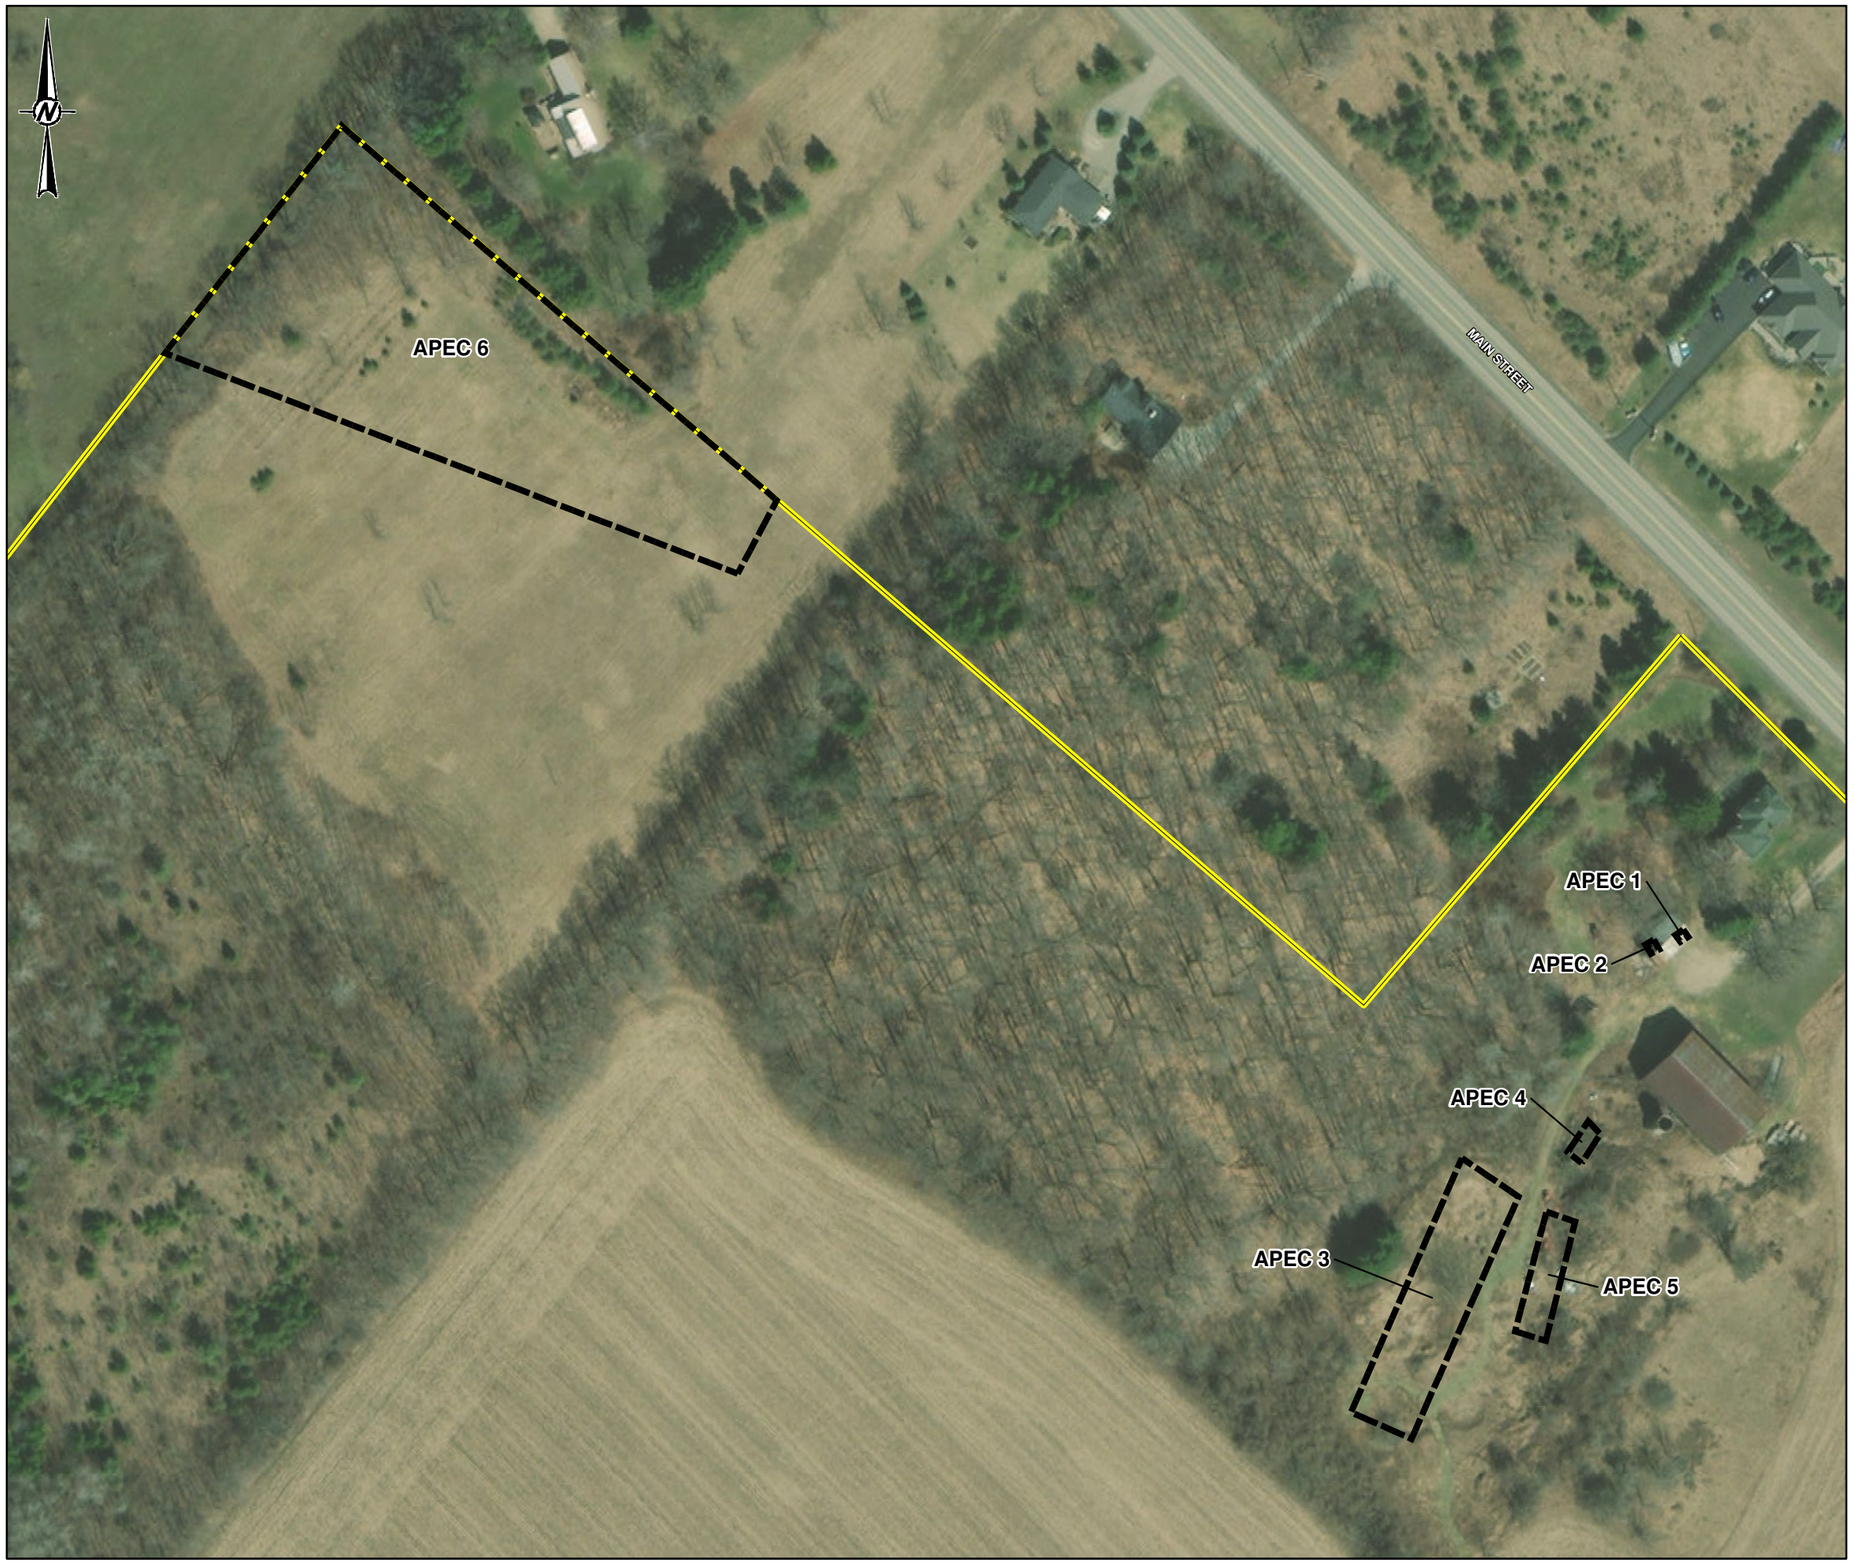
APEC	AREA OF POTENTIAL ENVIRONMENTAL CONCERN
1	#8 - CHEMICAL MANUFACTURING, PROCESSING AND BULK STORAGE - LARGE QUANTITIES OF CONTAINERS/BUCKETS CONTAINING MOTOR OIL ARE STORED IN BUILDING #2 . EXTENSIVE STAINING FROM MOTOR OIL ON SURROUNDING FLOORS.
2	#22 - FERTLIZER MANUFACTURING, PROCESSING AND BULK STORAGE - LARGE QUANTITIES OF BAGS CONTAINING FERTILIZER ARE STORED IN BUILDING #2. FERTILIZERS HAVE SPILLED OUT ONTO SURROUNDING FLOORS.
3	#30 IMPORTATION OF FILL MATERIAL OF UNKNOW QUALITY – SEVERAL LARGE MOUNDS OF DEPOSITED FILL MATERIAL.
4	#46 RAIL YARDS, TRACKS AND SPURS. PILES OF RAILWAY TIES MAY CONTAIN CREOSOTE.
5	58 WASTE DISPOSAL AND WASTE MANAGEMENT, INCLUDING THERMAL TREATMENT, LANDFILLING AND TRANSFER OF WASTE, OTHER THAN USE OF BIOSOILS AS SOIL CONDITIONERS – SCRAP/DISCARDED METAL DEBRIS INCLUDING A FUEL TANK, FARM VEHICLES, METAL TUBING, ETC.
6	#40 PESTICIDES (INCLUDING HERBICIDES, FUNGICIDES AND ANTI-FOULING AGENTS) MANUFACTURING, PROCESSING, BULK STORAGE AND LARGE-SCALE APPLICATIONS - ADJACENT GOLF COURSE.
