Memorandum

Date: December 8, 2022 Project #: 17056012

- To: Nimit Mittal, M.Eng., P.Eng.
- From: Alex Scott, M.Sc. & Robin McKillop, M.Sc., P.Geo., CAN-CISEC
 - cc: Mike Brierley, M.Sc.
 - Re: Fluvial Geomorphic Crossing Assessment for the Town of Caledon Growth Roads Program Chinguacousy Road

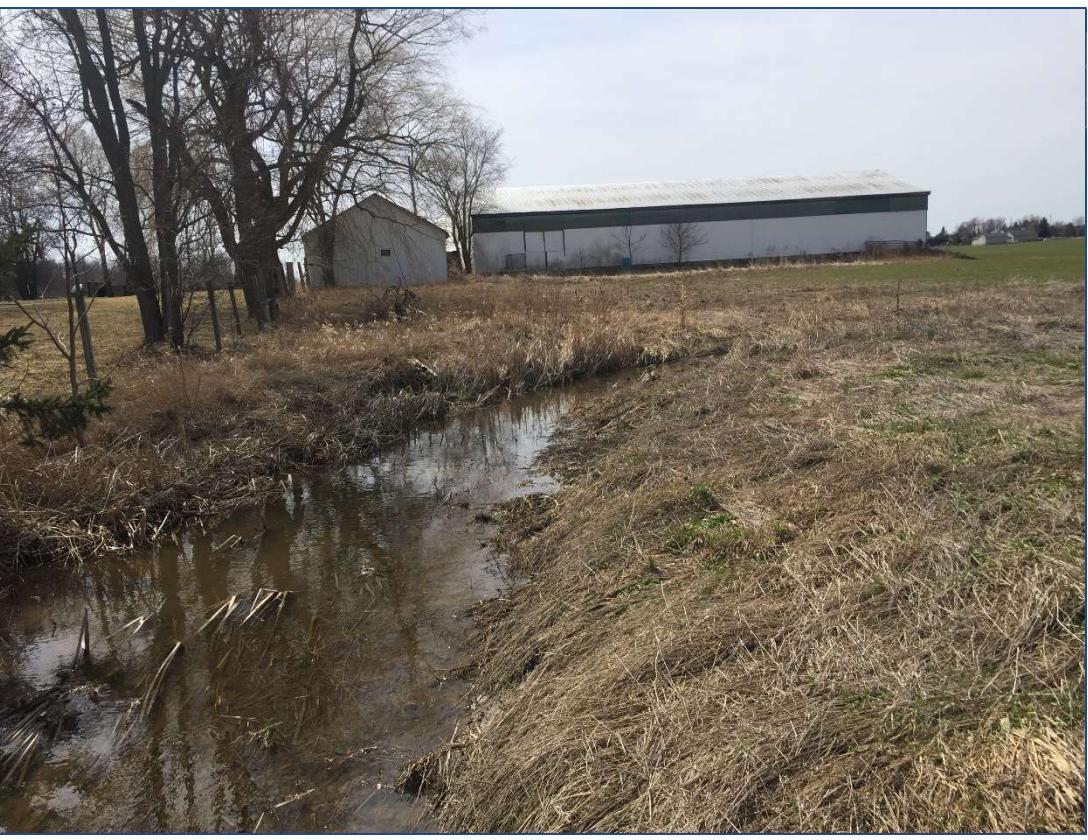
Photo #: Date. CH2 3/30/2021 Direction Photo Taken DS Description

View of the watercourse downstream of the road crossing. The channel bends 90° from east to south to flow into an excavated trench parallel to the road.
