Fluvial Geomorphological Assessment, Erosion Hazard Delineation, and Channel Realignment

12035 Dixie Road, Caledon, ON

March 16, 2021 PN20109

GEO MORPHIX Earth Science

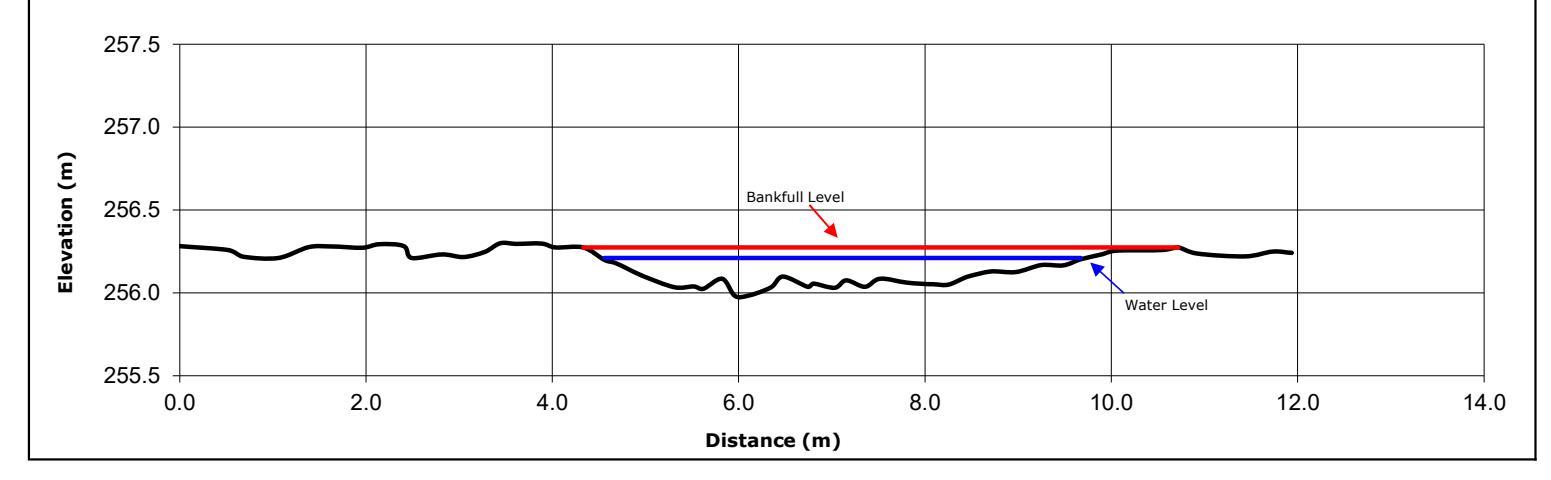
Photograph at Cross-Section 6 (looking downstream)

Reach 1 generally flows northwest to southeast across the subject property through active agricultural fields. The unconfined single channel exhibited a straight planform with a low gradient and low entrenchment. The riparian buffer zone spanned 1 to 4 channel widths and was fragmented. Riparian vegetation was comprised of immature (less than 5 years) grasses and herbaceous species. A low degree of woody debris was noted within the channel and cutbank. Aquatic vegetation consisted of rooted emergent species such as cattails and covered approximately 90% of the reach. Banks were poorly defined. Bed and bank materials consisted of entirely fine materials, ranging from clay to silt. Overall, Reach 1 was characteristic of a vegetated agricultural swale.
