CULTURAL HERITAGE IMPACT ASSESSMENT (CHIA)

for
0 & 12245 Torbram Road
'Tullamore Lands' - Part of Lot 18, 19, 20 Concession 6.
Town of Caledon, Ontario

GBCA Project No: 21012

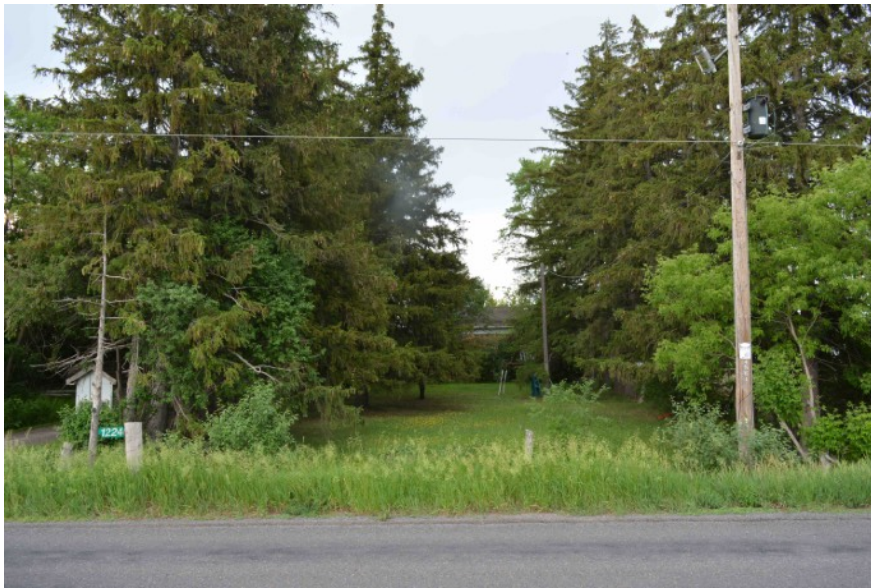
A view looking towards the front elevation of 12245 Torbram Road from the west side of the road. A portion of the west elevation is visible here, although a majority of the site is obscured from the public realm by a heavy cover of older coniferous and deciduous plantings.

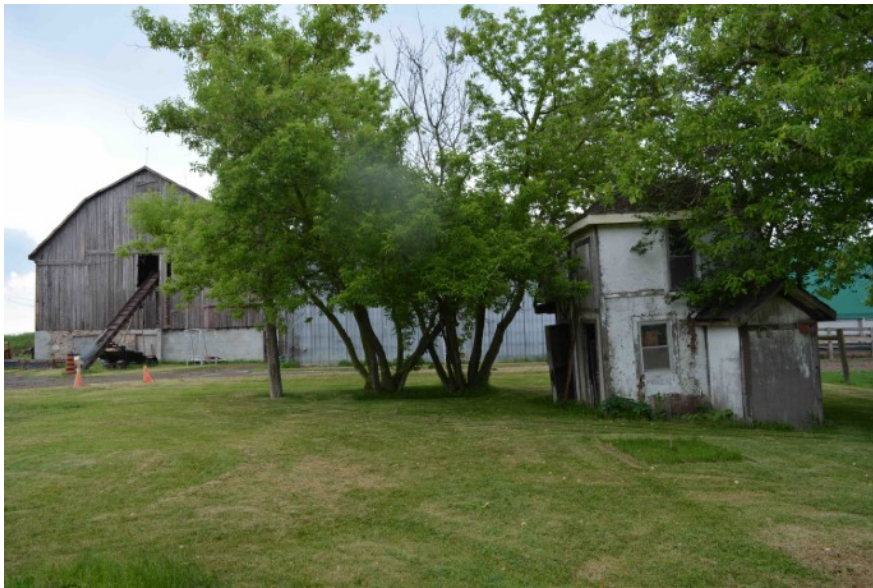
Looking east from the rear yard of the subject site towards the actively used barn on the property. The barn is proposed to be removed to accommodate Building 'F'.

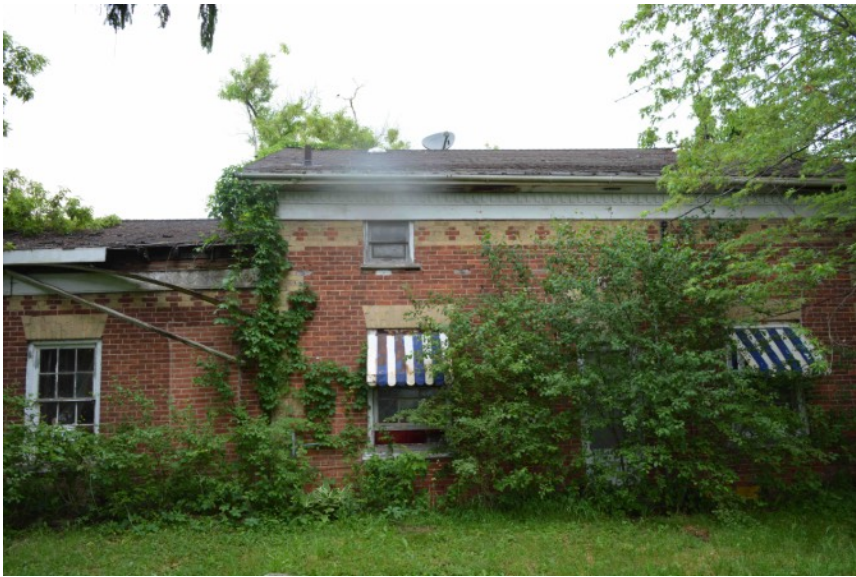
View of the principle (west) elevation of 12245 Torbram Road with the main house located to the right, with a central opening and a pair of six-over-six sash windows on either side. The frieze beneath the roof cornice is visible here, and a dentil band above.

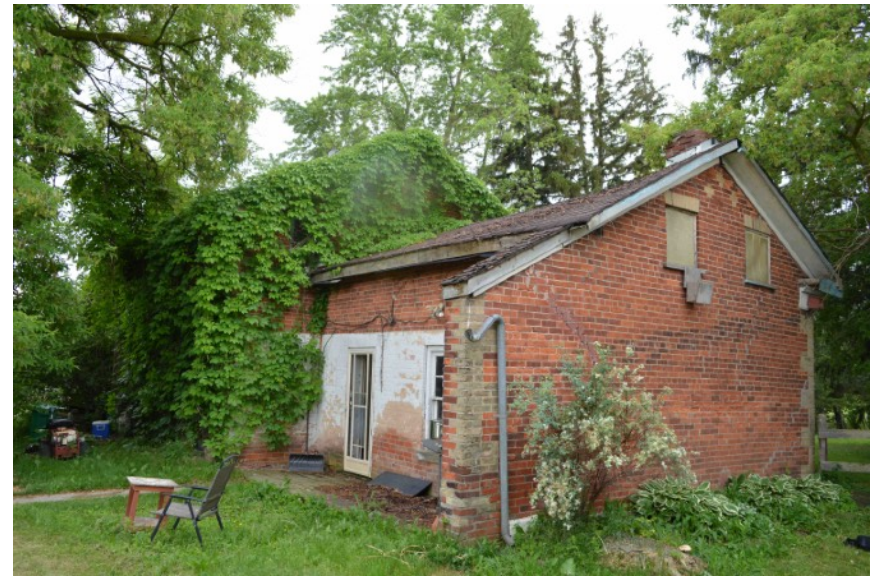
View of the east elevation, with the lower addition visible and the rear elevation of the main house obscured by vegetation. The top windows of the east elevation have been covered.

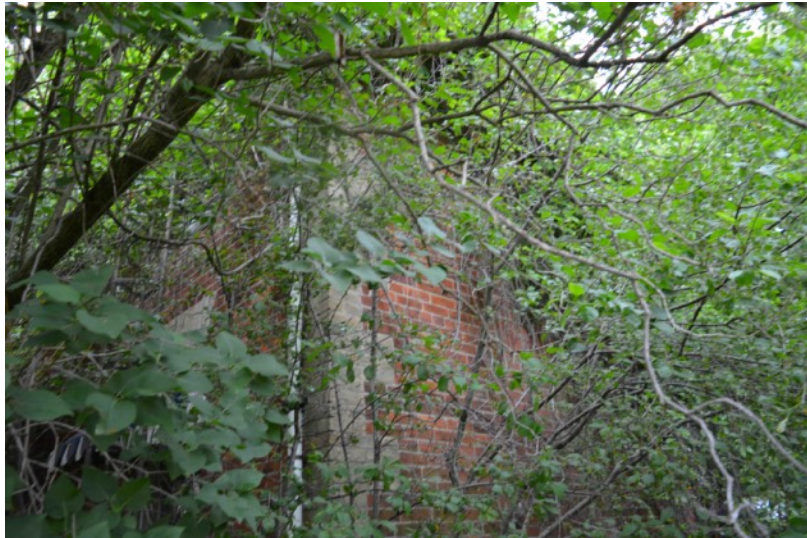
12245 Torbram Road, 2021 (GBCA). South Elevation. Inaccessible elevation due to tree and foliage overgrowth.

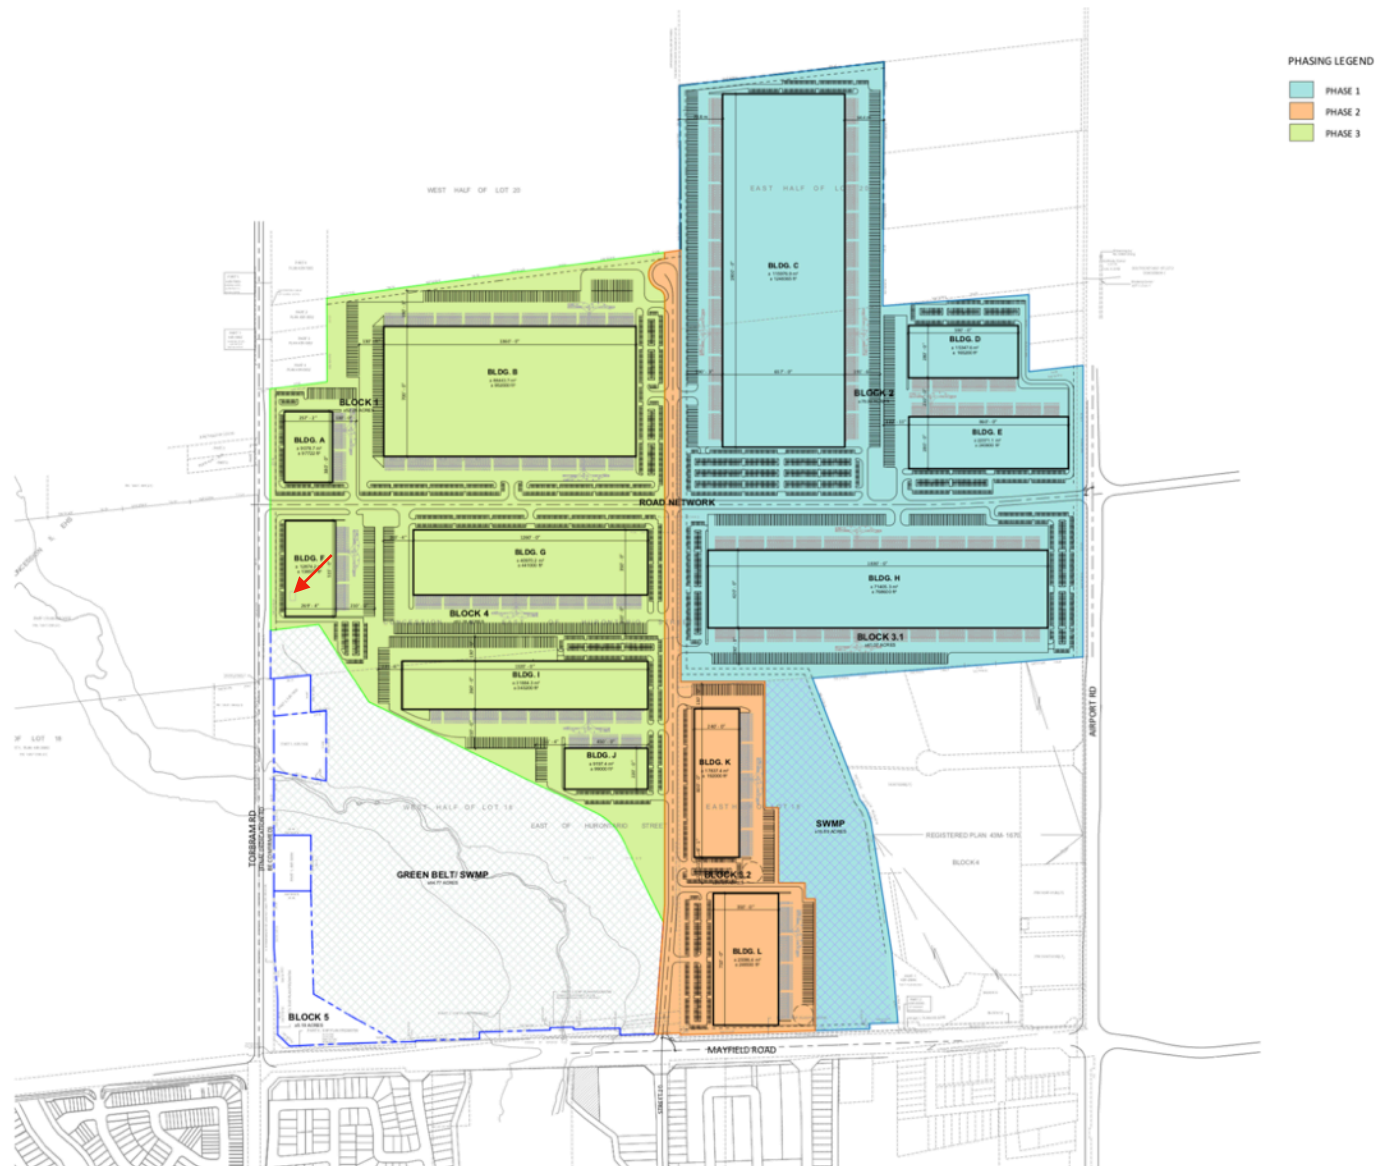
Extract of the proposed development drawings, showing the overall site plan (by Turner Fleischer Architects). Highlighted in green is the western part of the site above the Greenbelt/swamp where the subject heritage resource is located. The red arrow indicates the location of 12245 Torbram Road.

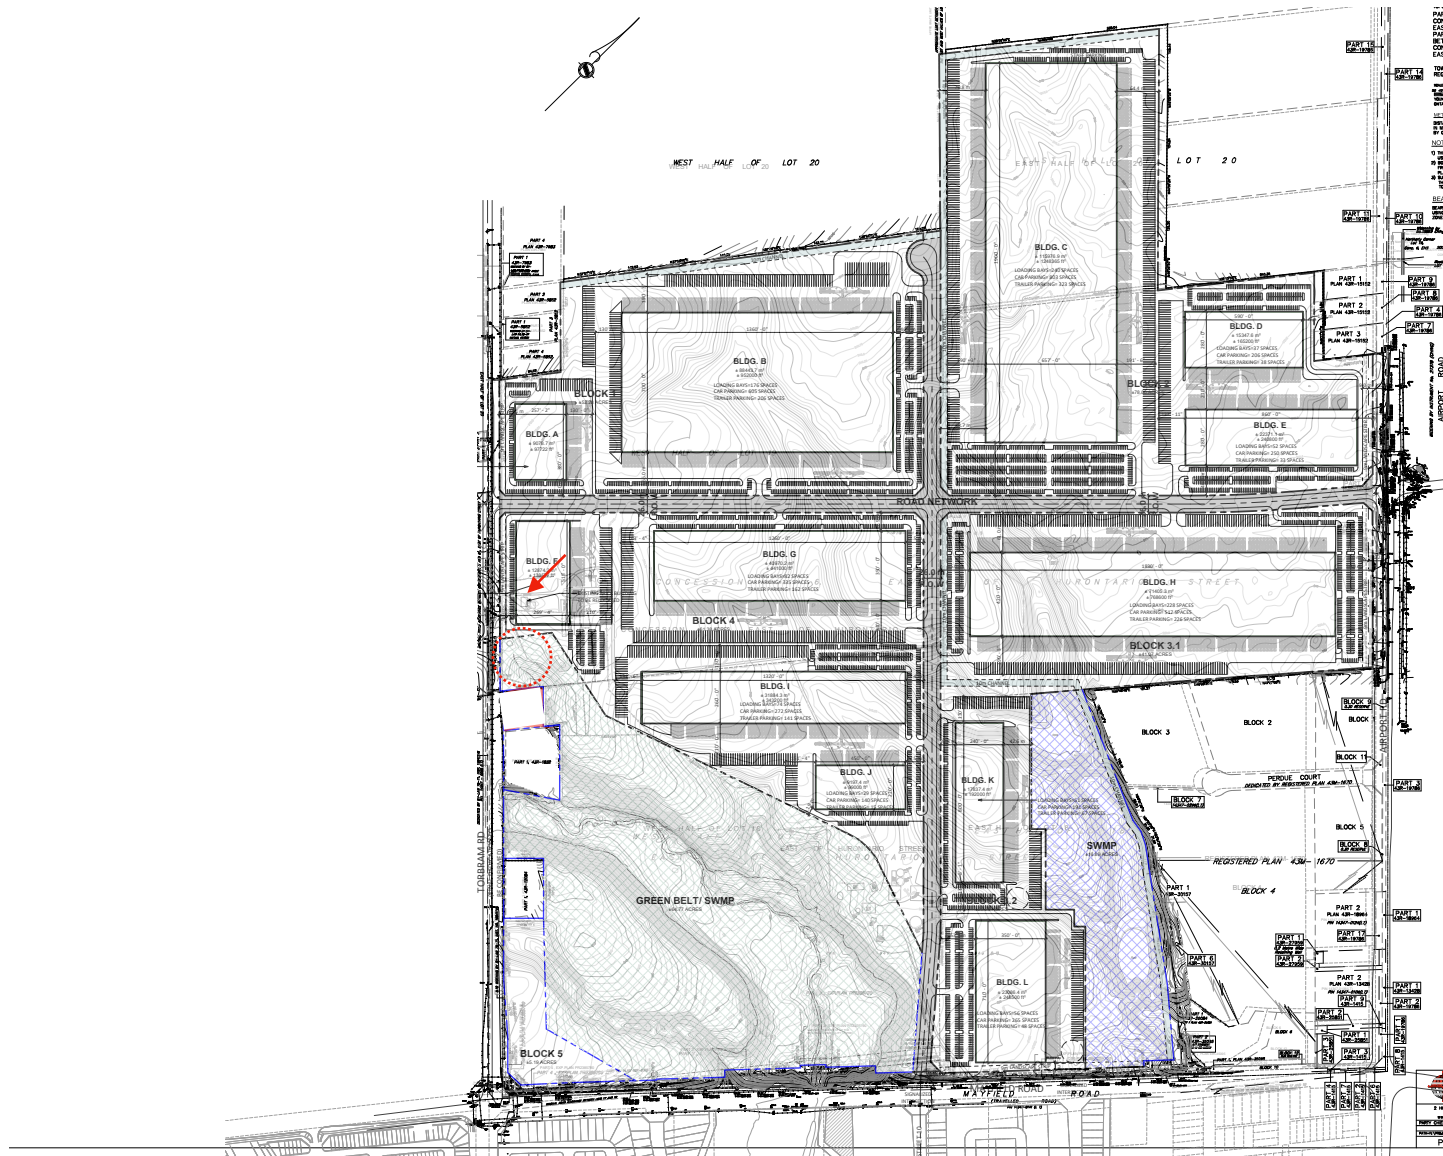
Overlay of property survey with proposed development. 12245 Torbram Road is noted with a red arrow, and an approximate location for the recipient site for the relocated building is noted with a dashed red oval.

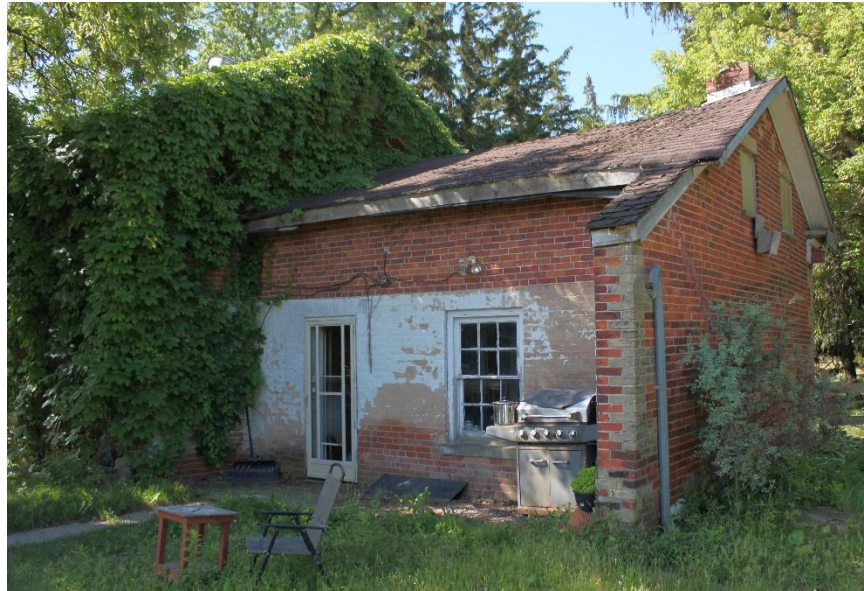
Figure 3: North Elevation

The exterior walls of the farmhouse are made of three wythes of brick. During the construction, an effort was clearly made to create a visual statement by adding yellow brick to predominantly red brick walls. Yellow brick accents can be seen around the whole house. Please see Figures 3 and 4.

Before making any definitive restoration plans for the brick walls, all vine and organic growth around the house must be removed to expose the walls completely. The following paragraphs describe some of the observed deficiencies of the brick walls.

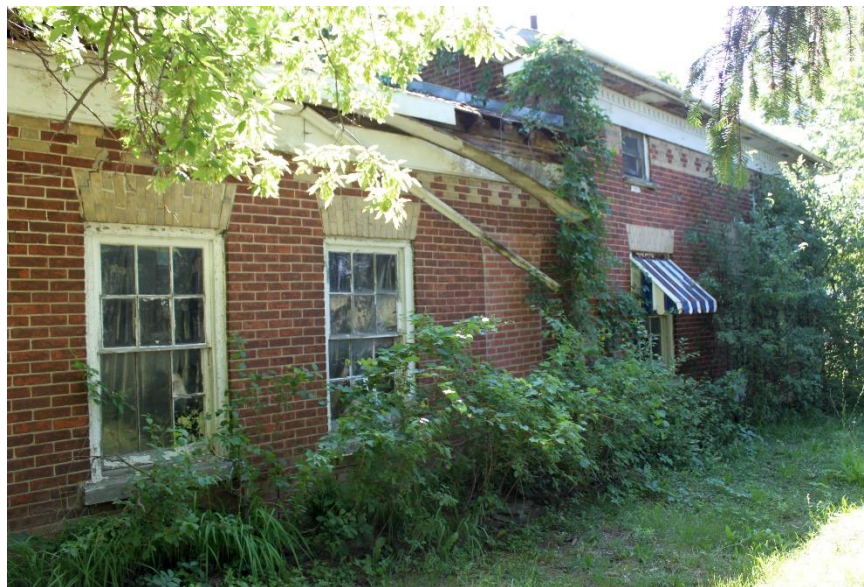
Figure 4: South Elevation

The brick wall of the main – south elevation was built using stretcher bond, probably for aesthetic reasons. It is not known if “clip” bond was used to tie the outer brick wythe with interior wythes. Stretcher bond without ties to the inner wythes results in inferior wall and there is a possibility of delamination, especially during the relocation of the house. We recommend that a test opening is performed before the move to determine whether some additional bracing of the wall is needed for the move.

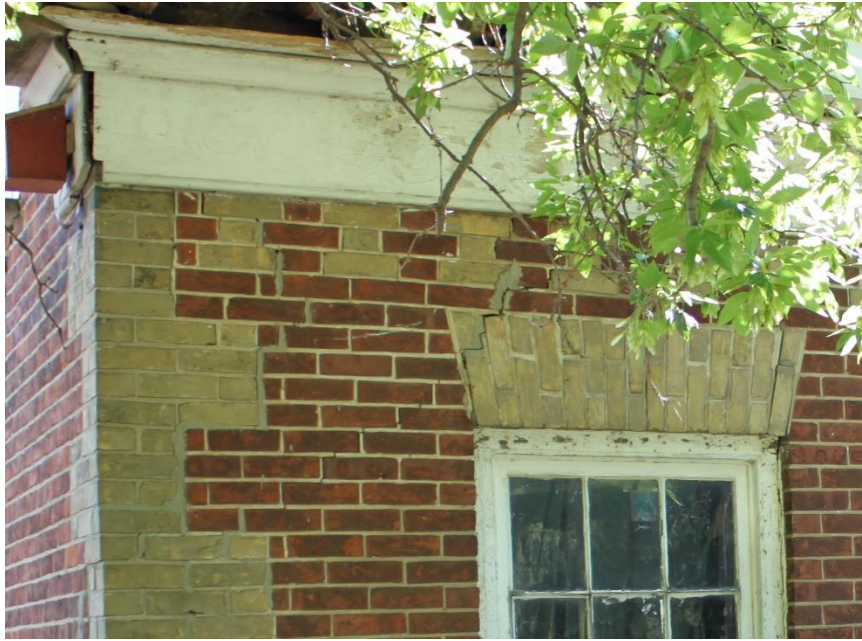
Figure 6: West End of South Wall

The west end of the south wall has a diagonal crack and apparent movement towards west of the top corner (Figure 6). Both flat arch brick lintels on this part of the wall have failed and have to be rebuilt before the move.

All damage to the masonry walls should be repaired before the move.-As long as cracks are open, the water will keep entering the walls and causing further damage. Ideally, the vine and organic growth around the base of the walls would be removed immediately, walls inspected in detail, and program of repairs specified, with repairs to follow. We do not expect any major failure if the exterior wall repairs are postponed for the year 2022, with caveat that the extent of damage will be larger, and the repairs will cost more.

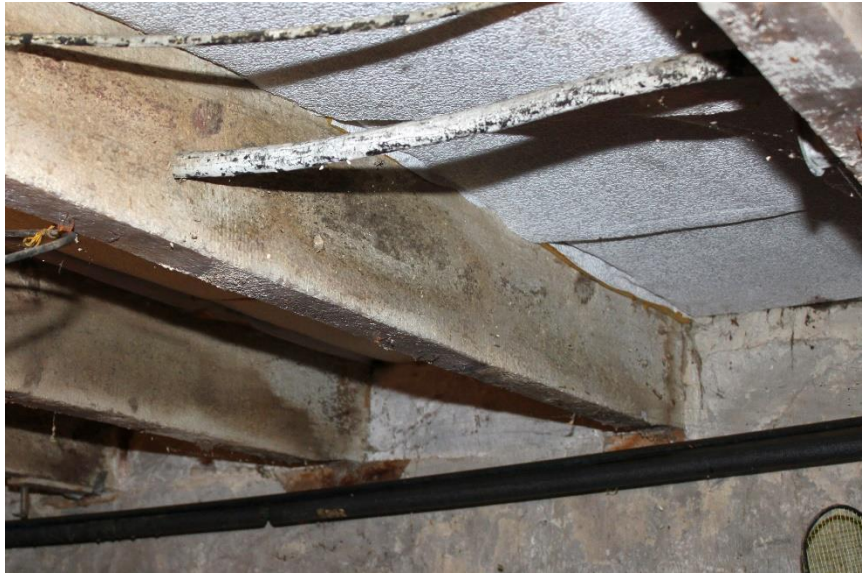
Figure 11: Ground Floor Framing

The ground floor framing of the east – taller part of the house consists of sawn wood floor joists on masonry walls. Please see Figure 11. The joists appear to be in good condition, with exception that we could not verify if the joist ends are rotting inside exterior walls.

It is assumed that the second floor framing consists of similar joists. This could not be verified because of plaster on wood lath ceiling. It was not possible to verify if the sill plates under the joists are anchored into the walls and whether the joists are nailed to the sill plates.

This review did not include load capacity analysis of the ground or second floor framing. Such analysis should be performed in case the house is meant to become a part of some heritage complex open to public, or even, if it is going to be occupied by tenants in new location.
