CULTURAL HERITAGE IMPACT ASSESSMENT (CHIA)

**0, 12245 Torbram Road and 12542 Airport
Road**

'Tullamore Lands' - Part of Lots 17 to 20, Concession 6.
Town of Caledon, Ontario

GBCA Project No: 21012

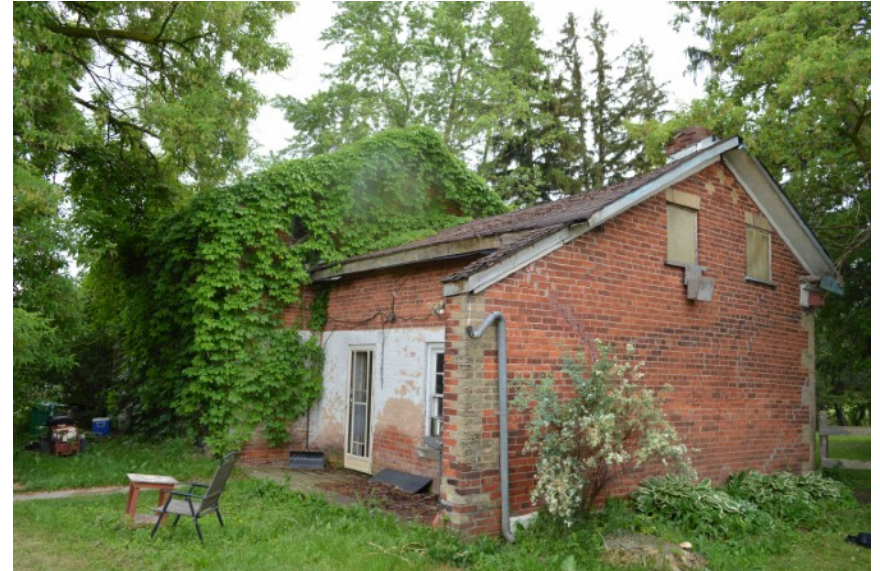
View of the east elevation, with the lower addition visible and the rear elevation of the main house obscured by vegetation. The top windows of the east elevation have been covered.

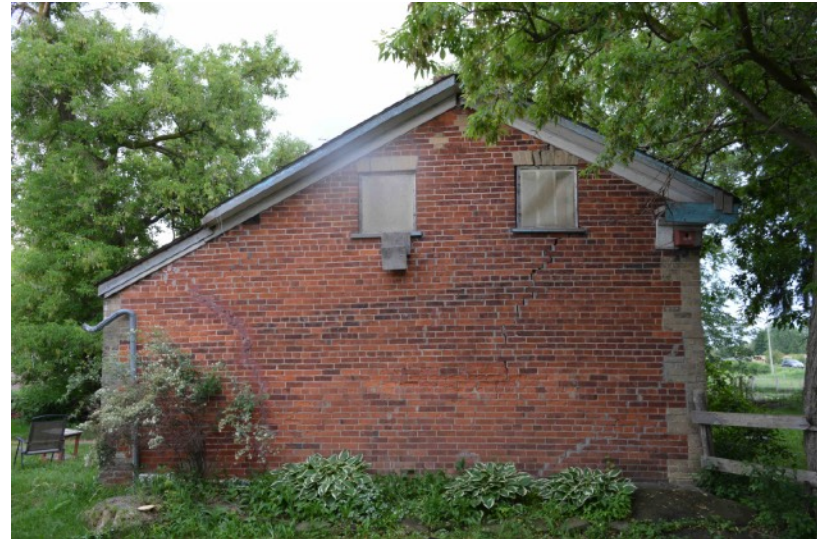
Numerous instances of pronounced step cracks ($\pm 1"$ and up to 2" or more) along the north elevation, along with other localized cracks in other portions of the east and west walls

12245 Torbram Road, 2021 (GBCA). North Elevation. Blank wall with closed window openings and buttress to the left. Open joints in the masonry are noticeable from a distance. The buff-brick quoins are clearly visible on this elevation.

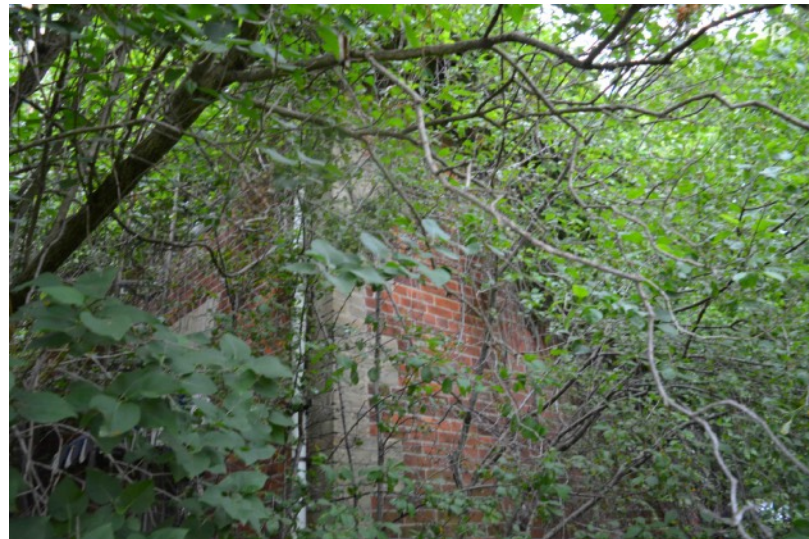
12245 Torbram Road, 2021 (GBCA). South Elevation. Inaccessible elevation due to tree and foliage overgrowth.

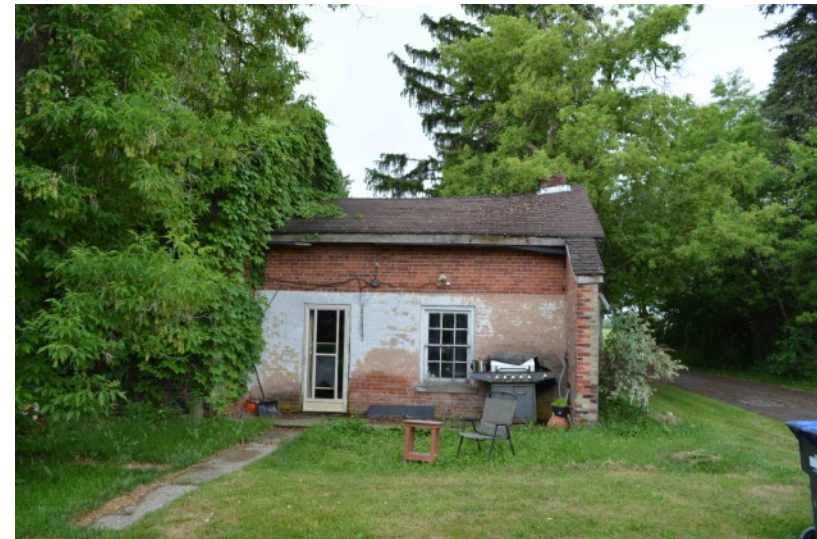
12245 Torbram Road, 2021 (GBCA). East Elevation (rear), showing current entrance to house with a brick buttress extending from the elevation, and structural deflection noticeable at gable ridge.

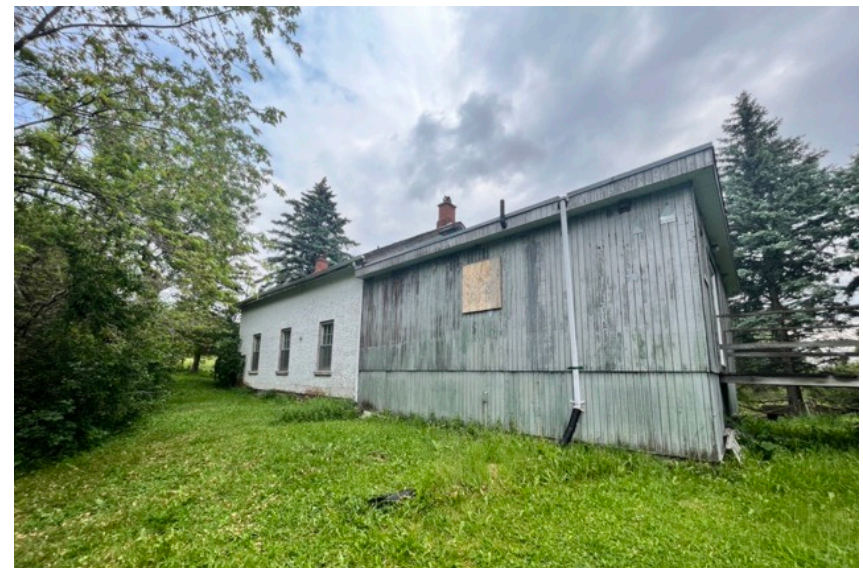
A view from the south elevation of the neoclassical style farmhouse with central plan, and a newer two-storey garage addition to the west.

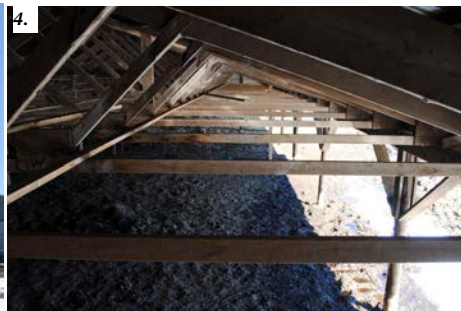
Figure 6: Interior view of newer 2x beams in the hay barn (Building #3) viewed from within the main barn.

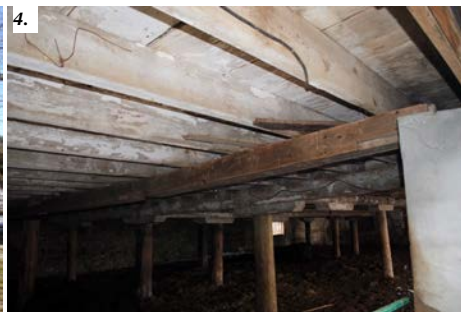
Figure 9: Interior view of the hay barn (Building #3) showing a mix of new timbers, and older hewn beams. Foundation is a combination of cinder block and wood construction.

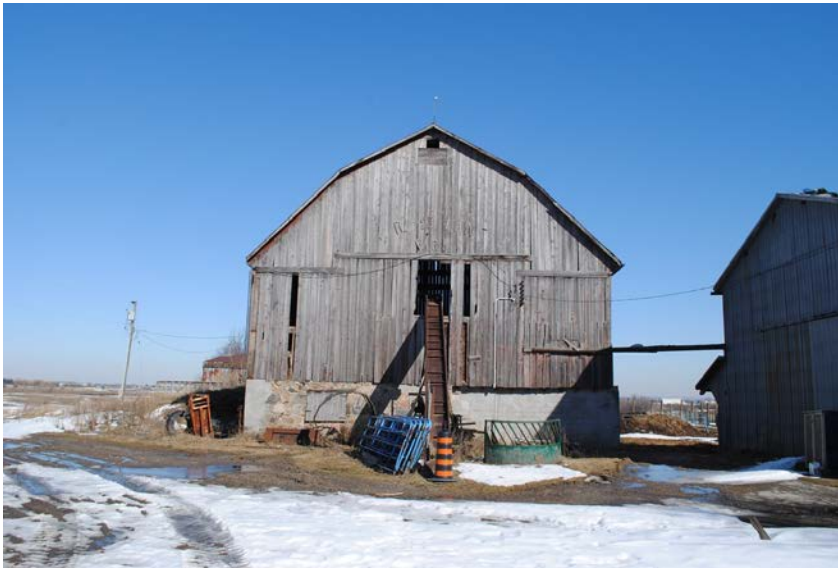
Figure 11: West end of the barn showing gambrel roof. It is likely that materials were salvaged from an earlier barn with the majority of the gambrel roof barn constructed sometime between the 1920's and 1970s.

Note the missing boards to the left and right of the conveyor. To the right of this is a hay barn clad with corrugated metal, which would have been an addition in the mid-20th century.

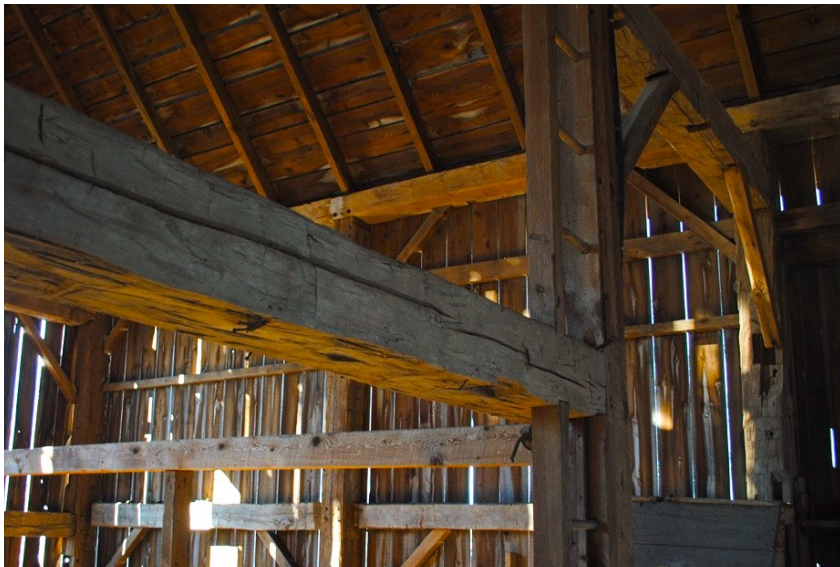
Figure 15: Detailed view of tie beam showing splitting that has not been restrained with iron strapping. Note the empty mortices indicating that this and several other elements have been re-assembled.

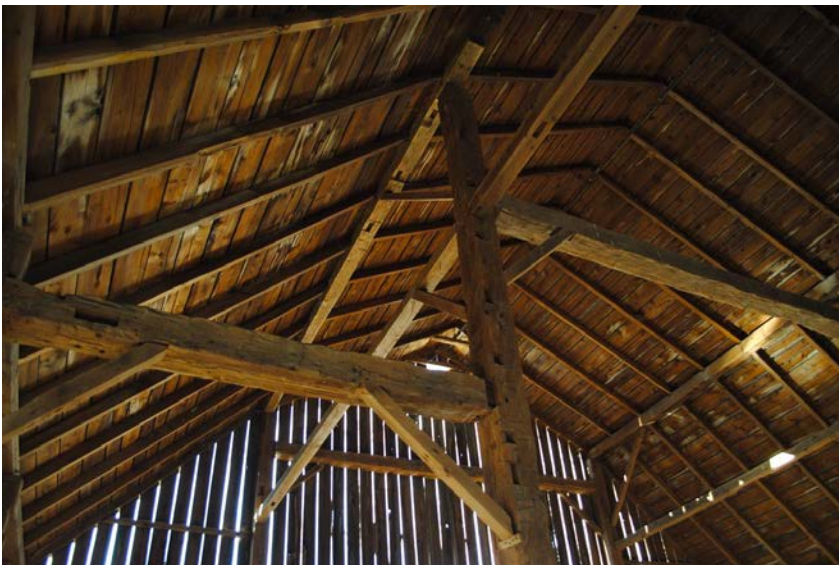
Figure 18: Detailed view of roof framing – east side showing roof planking, roof rafters, roof purlins, diagonal bracing, and horizontal members.

Note the 2x4 braces with metal brackets that have replaced smaller mortise and tenon braces.

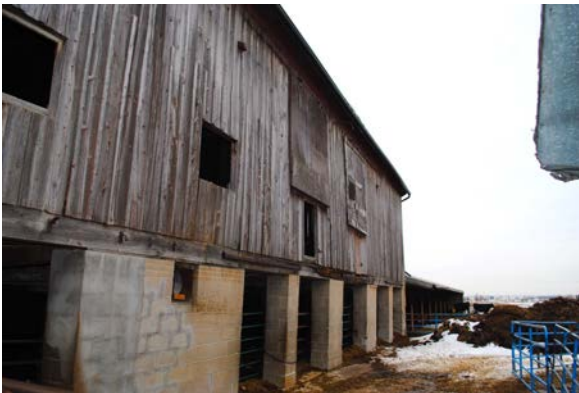
Figure 23: The forebay terminates in a plate, which is supported by cinder blocks, allowing for a much deeper space.

The 8" x 16" blocks used cinder as an aggregate prior to the mid 1960's, thus putting the alterations sometime before this.

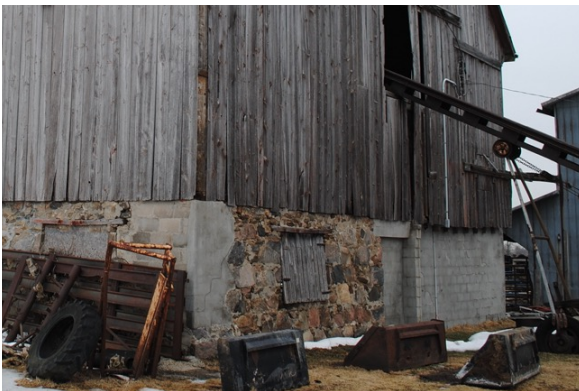
Figure 24: The forebay terminates in a plate, which is supported by cinder blocks, allowing for a much deeper space.

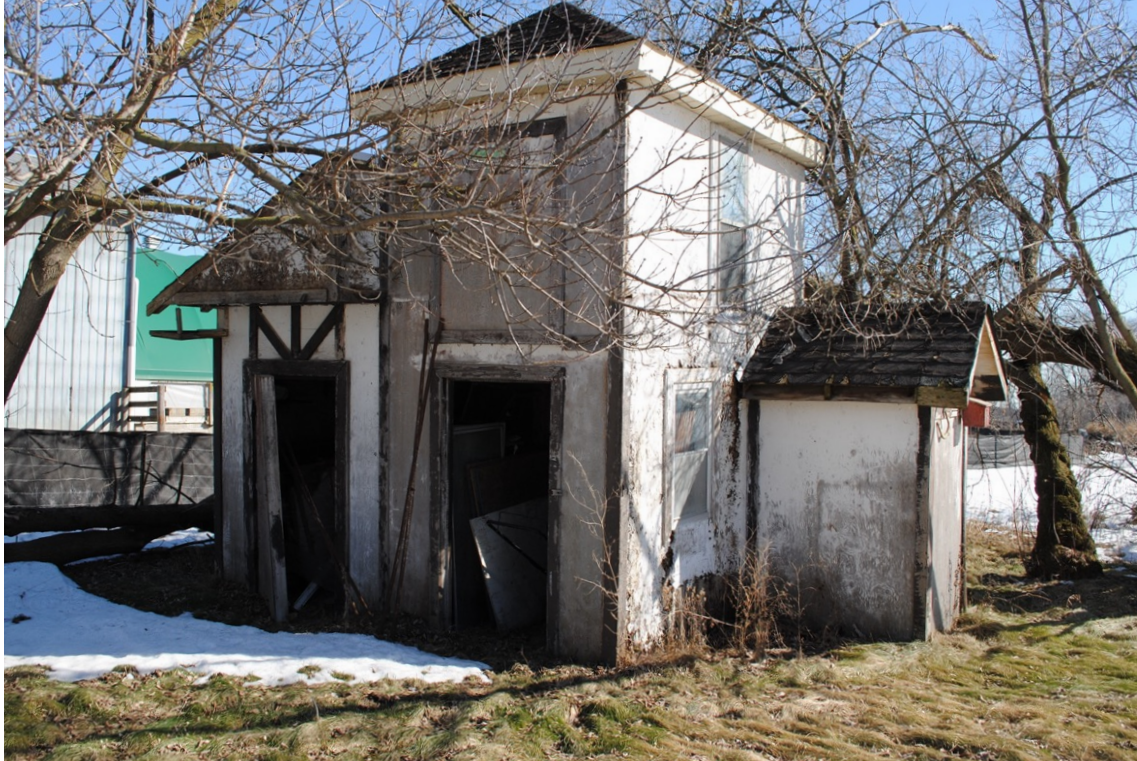
Figure L: Building #4 located on the rear lot of the farmhouse, clad with plywood and faux half-timbers.
