Slope Stability Study

Tullamore Employment Lands

Mayfield Road & Torbram Road, Caledon, Ontario

February 18, 2022
Project No. 2100975

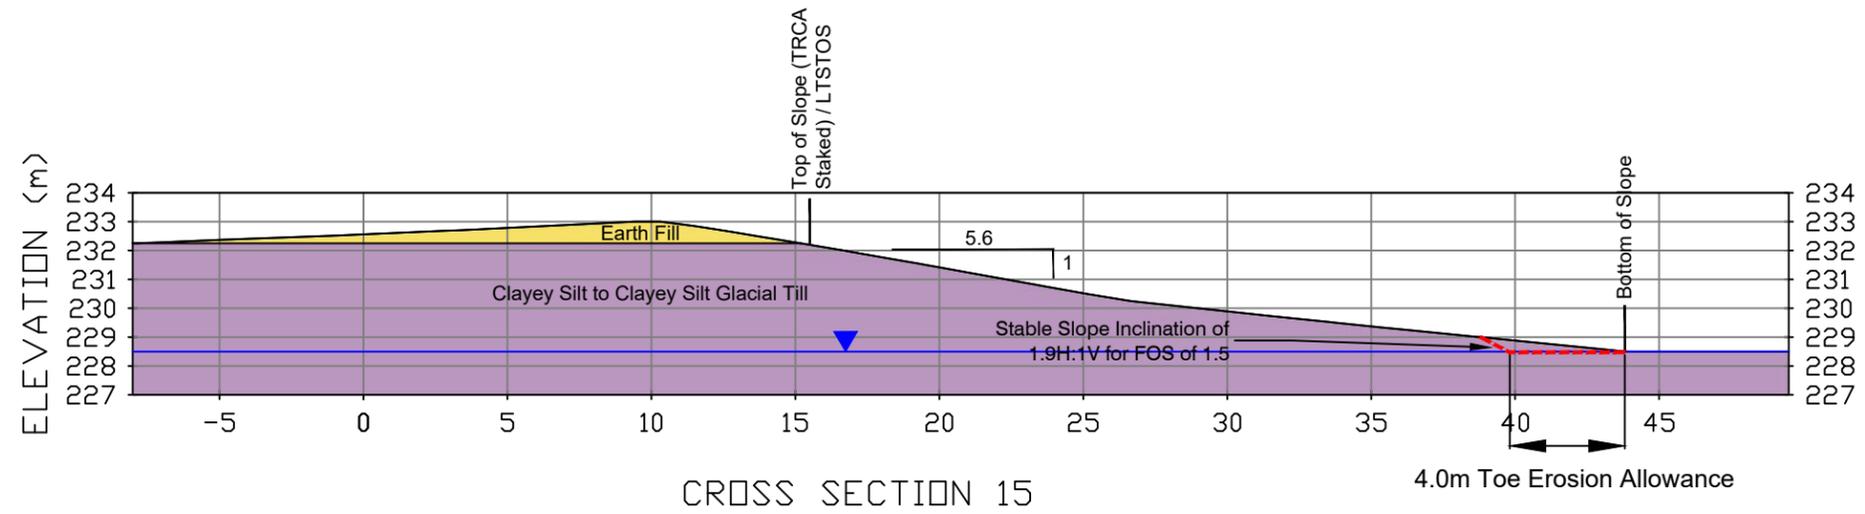
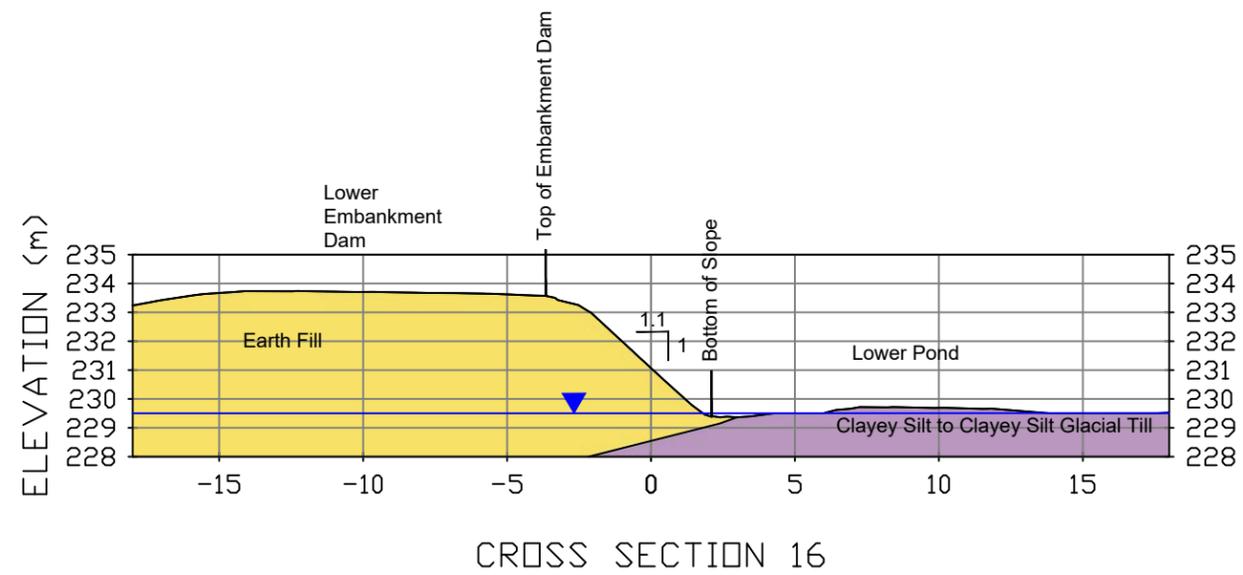
Project:			Tullamore Employment Lands
Title:			Detailed Cross-Section 15 & 16
Approved by:	A.W.	Date:	February 2022
Project No.:	2100975		
Drawn by:	R.W.	Scale:	1:250
Figure No.:	XS 15-16

- The embankments are showing signs of distress and are eroding / failing in some locations (see Cross-Section 16 at the lower dam and the photos of the culvert inlets and outlets at both locations).

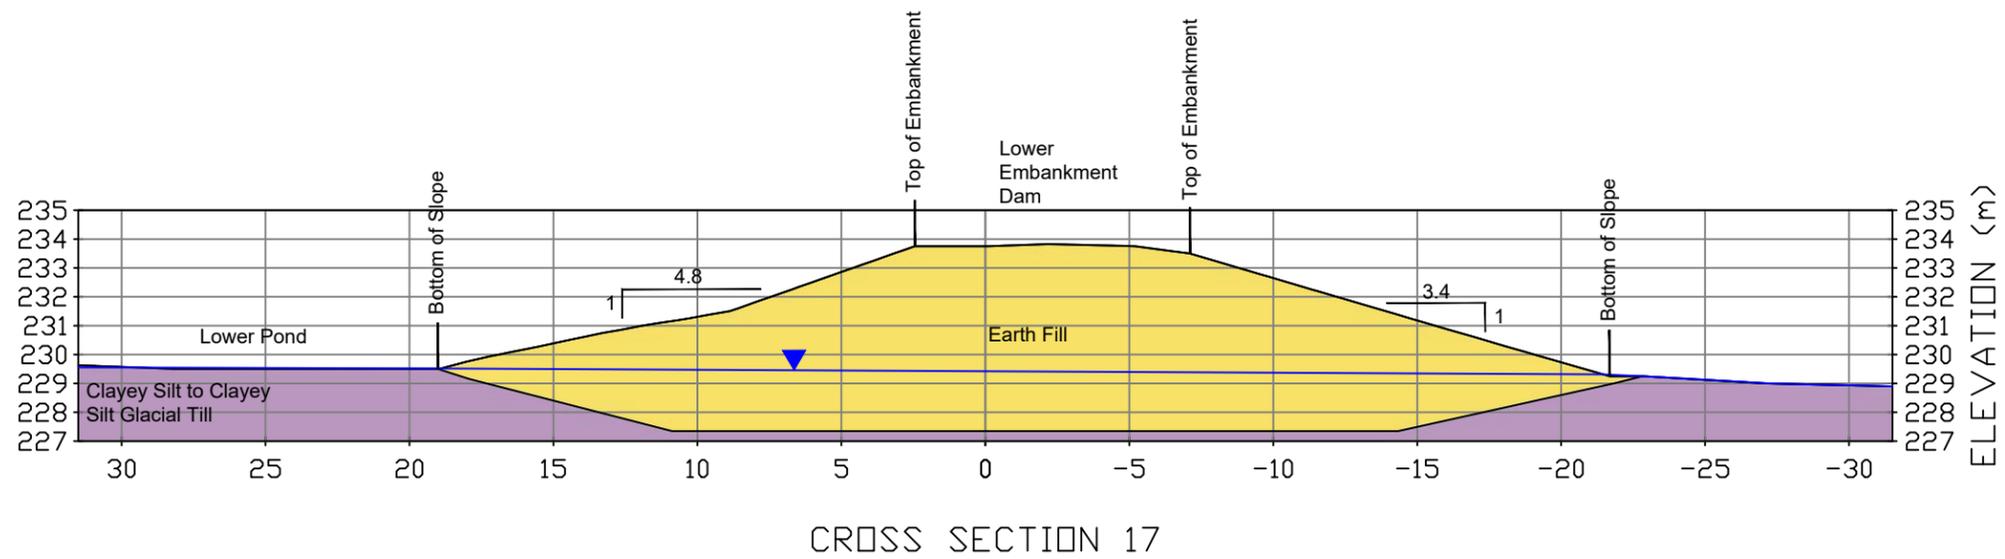
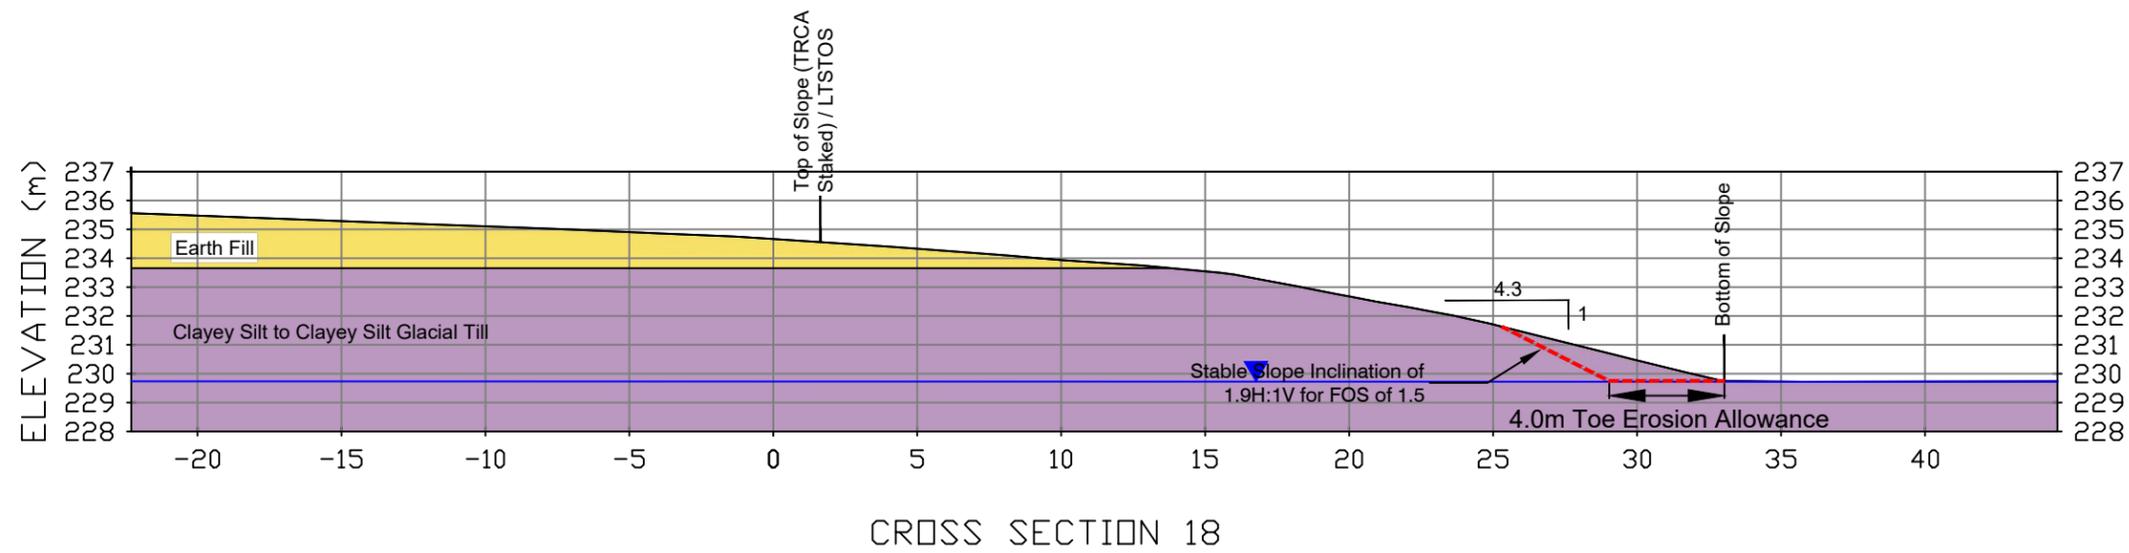
Project:			Tullamore Employment Lands
Title:			Detailed Cross-Section 17 & 18
Approved by:	A.W.	Date:	February 2022
Project No.:	2100975		
Drawn by:	R.W.	Scale:	1:250
Figure No.:	XS 17-18

The side slopes of the lower and upper embankment dams typically ranged from 2.9 to 4.0 horizontal to 2 vertical, as shown on Cross-Sections 17 and 20 that were cut through the lower and upper dams, respectively. There is a portion of the lower dam that is over-steepened at the upstream face due to erosion at the culvert inlet, with an inclination of 1.1 horizontal to 1 vertical as shown on Cross-Section 16. Active slope failures (slumping / sloughing of soil from the exposed face) were observed near the culvert inlets of both dams during the visual inspection.

Loading Condition	Minimum Factor of Safety Required per MNRF Guidelines	Cross-Section Location	Minimum Calculated Factor of Safety for Embankment		Meets Guidelines?
			Upstream	Downstream	
Long-Term (steady state seepage, normal reservoir level)	1.5	16	0.7	N/A	No
		17	1.8	1.9	Yes ¹
Pseudo-Static Loading	Greater than 1.0	17	1.6	1.7	Yes ¹

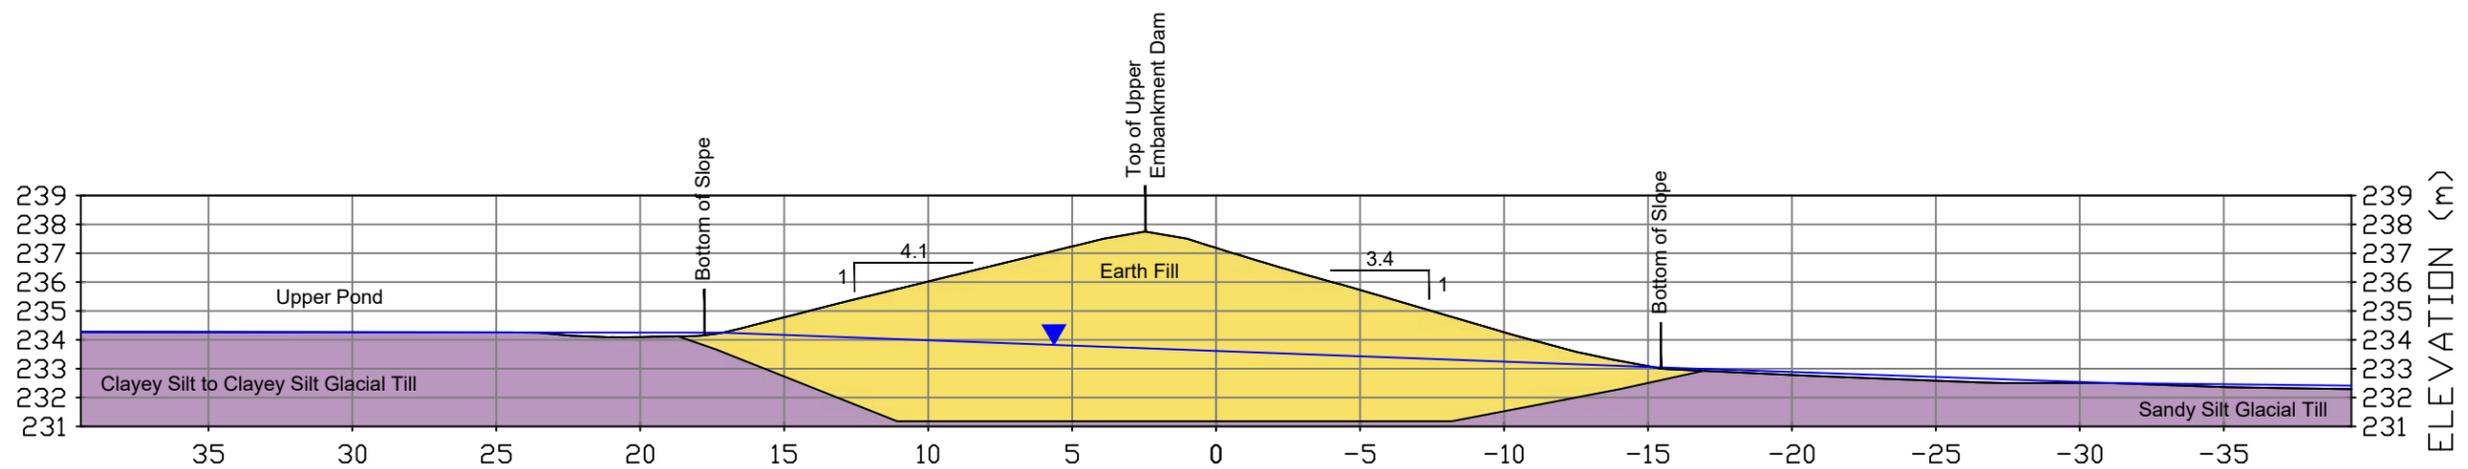
CROSS SECTION 20

Loading Condition	Minimum Factor of Safety Required per MNRF Guidelines	Cross-Section Location	Minimum Calculated Factor of Safety for Embankment		Meets Guidelines?
			Upstream	Downstream	
Long-Term (steady state seepage, normal reservoir level)	1.5	20	2.2	1.9	See notes ^{1,2}
Pseudo-Static Loading	Greater than 1.0		1.9	1.7	See notes ^{1,2}

Although the analysis shows the upper embankment dam exceeds the required FOS for the two loading cases, the dam is eroding and there are localized slope failures that are not reflected in the topographic information available for the cross-sections. Based on this, the upper embankment dam does not meet the guidelines as the factor of safety will be less than 1.0 in the localized areas.

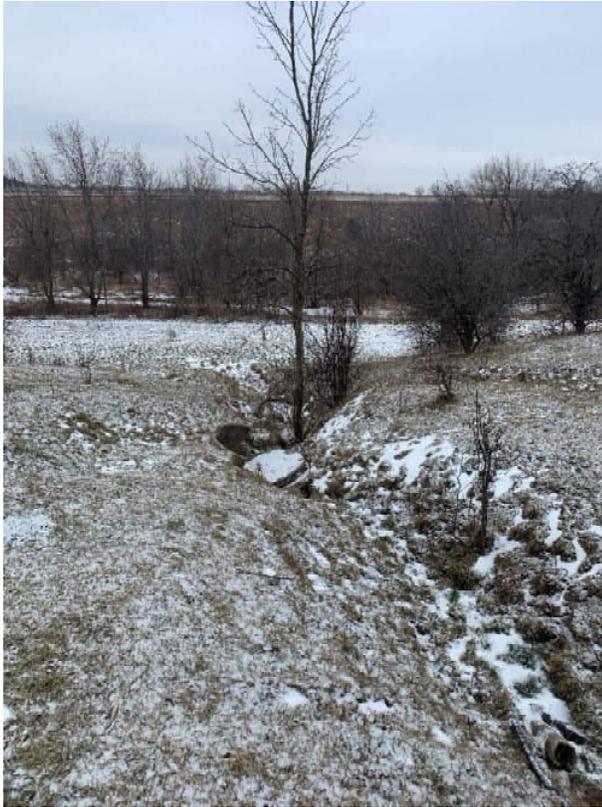
PHOTOGRAPH 5

A view of gully erosion extending down the slope face due to concentrated runoff from the barns and other structures.

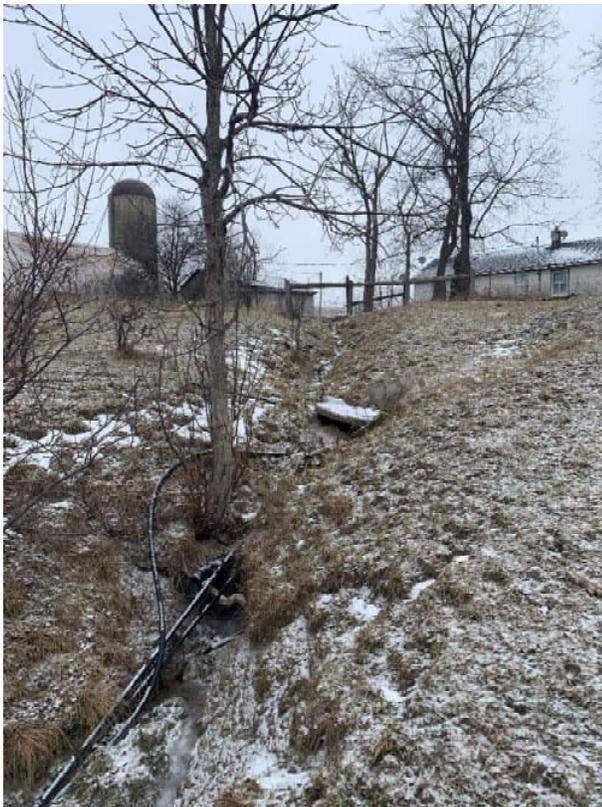
PHOTOGRAPH 6

Another view of gully erosion extending down the slope face due to concentrated runoff from the barns and other structures. Weeping pipes outlet partway down the slope.

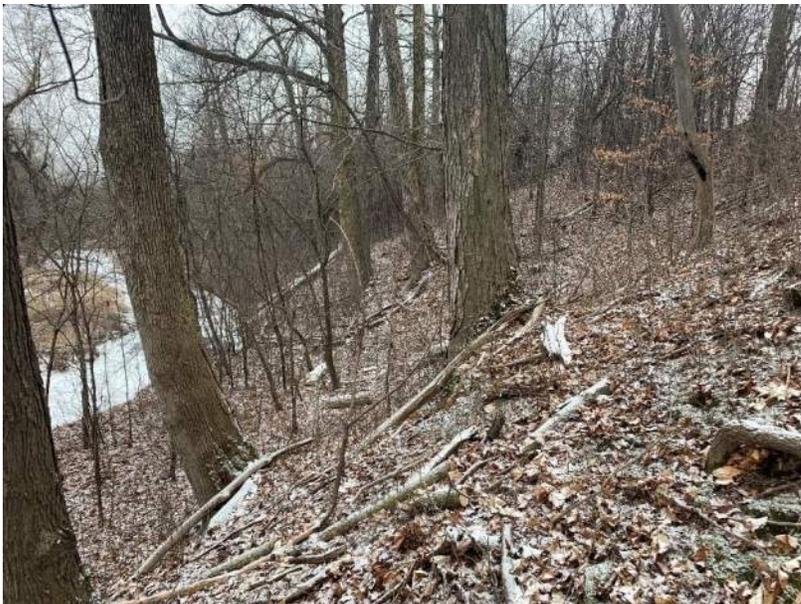
PHOTOGRAPH 12

Another view of the well vegetated northern slope profile. Some trees are partially tilting, likely due to long term slope creep.

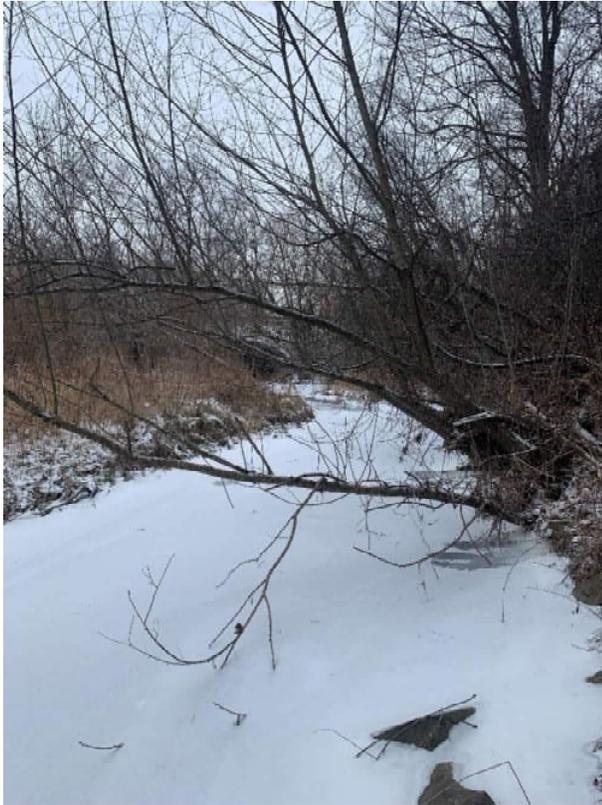
PHOTOGRAPH 13

Active erosion is occurring along the west tributary watercourse.

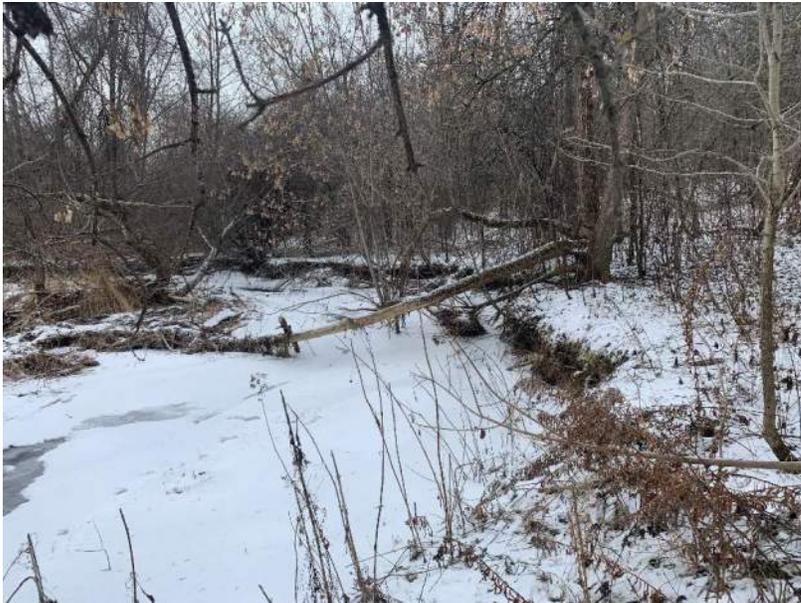
PHOTOGRAPH 14

Active erosion is occurring along the west tributary watercourse.

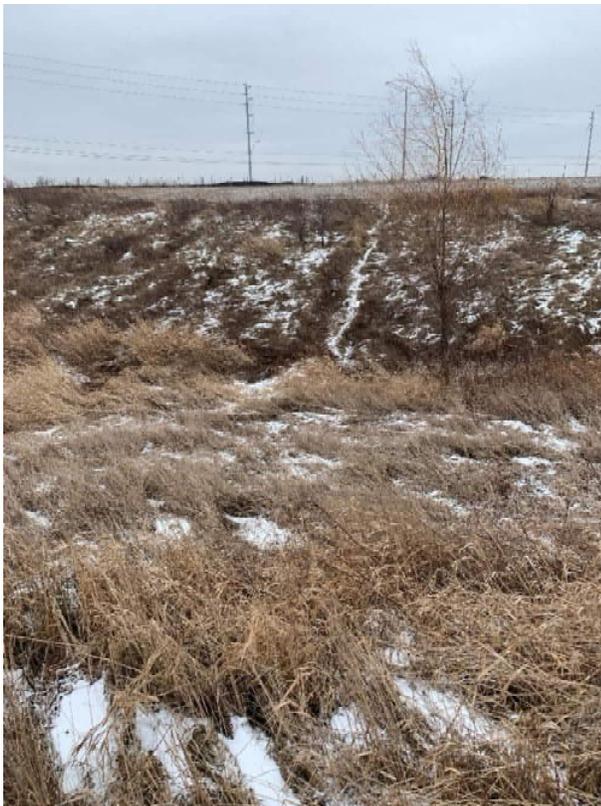
PHOTOGRAPH 16

A view of the south slope of the southern drainage feature. Some rilling was observed on the slope face, due to concentrated runoff.

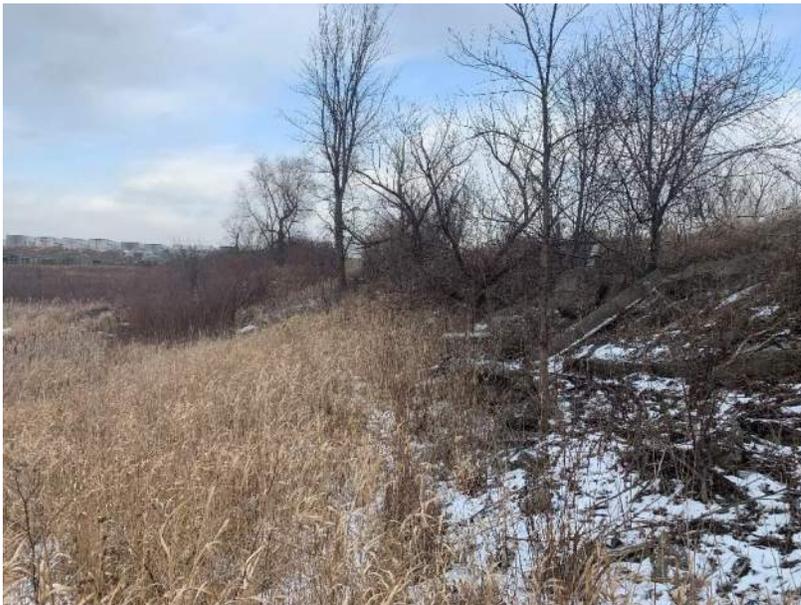
PHOTOGRAPH 22

A view of the side slope of the upper pond / embankment dam, containing some concrete and other debris.

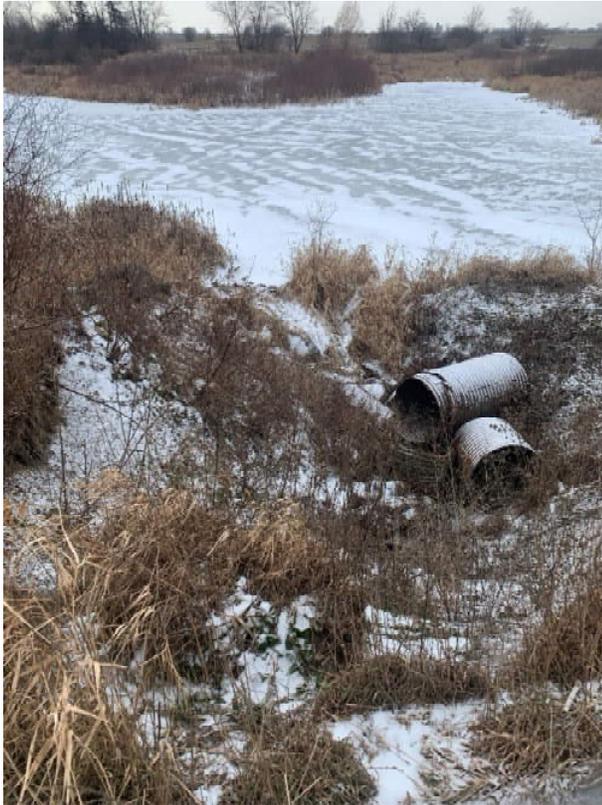
PHOTOGRAPH 23

A view of the upper pond and damaged / destroyed culvert inlet that extends below the berm (upstream side of the upper pond).

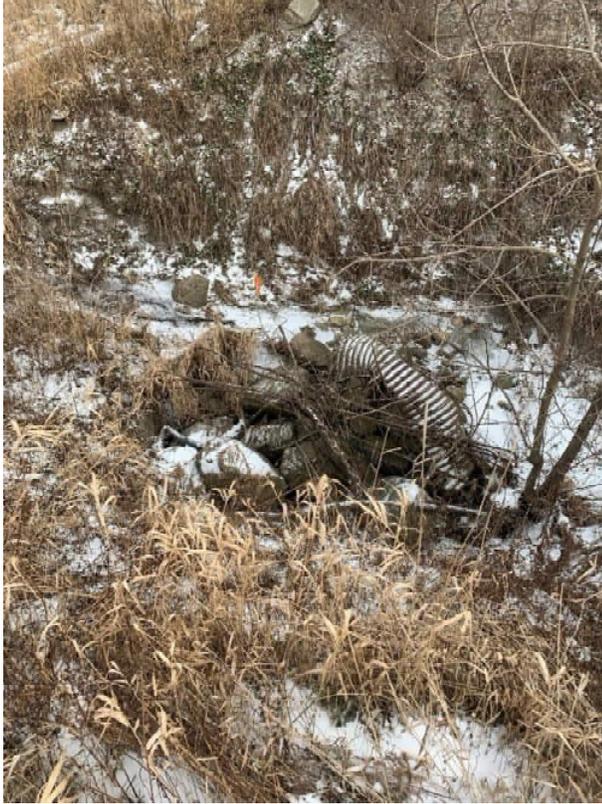
PHOTOGRAPH 29

A view of the damaged / destroyed culvert inlet at the upstream face of the lower pond embankment dam. There is erosion and slope failures around the inlet.

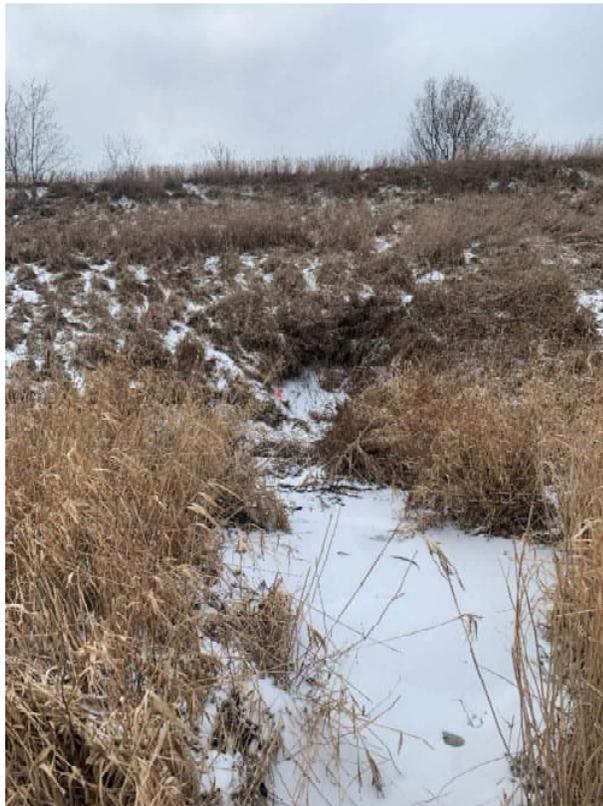
PHOTOGRAPH 32

A view of the assumed outlet (downstream side) for the culvert that passes beneath the lower pond embankment dam. There is erosion in the area.

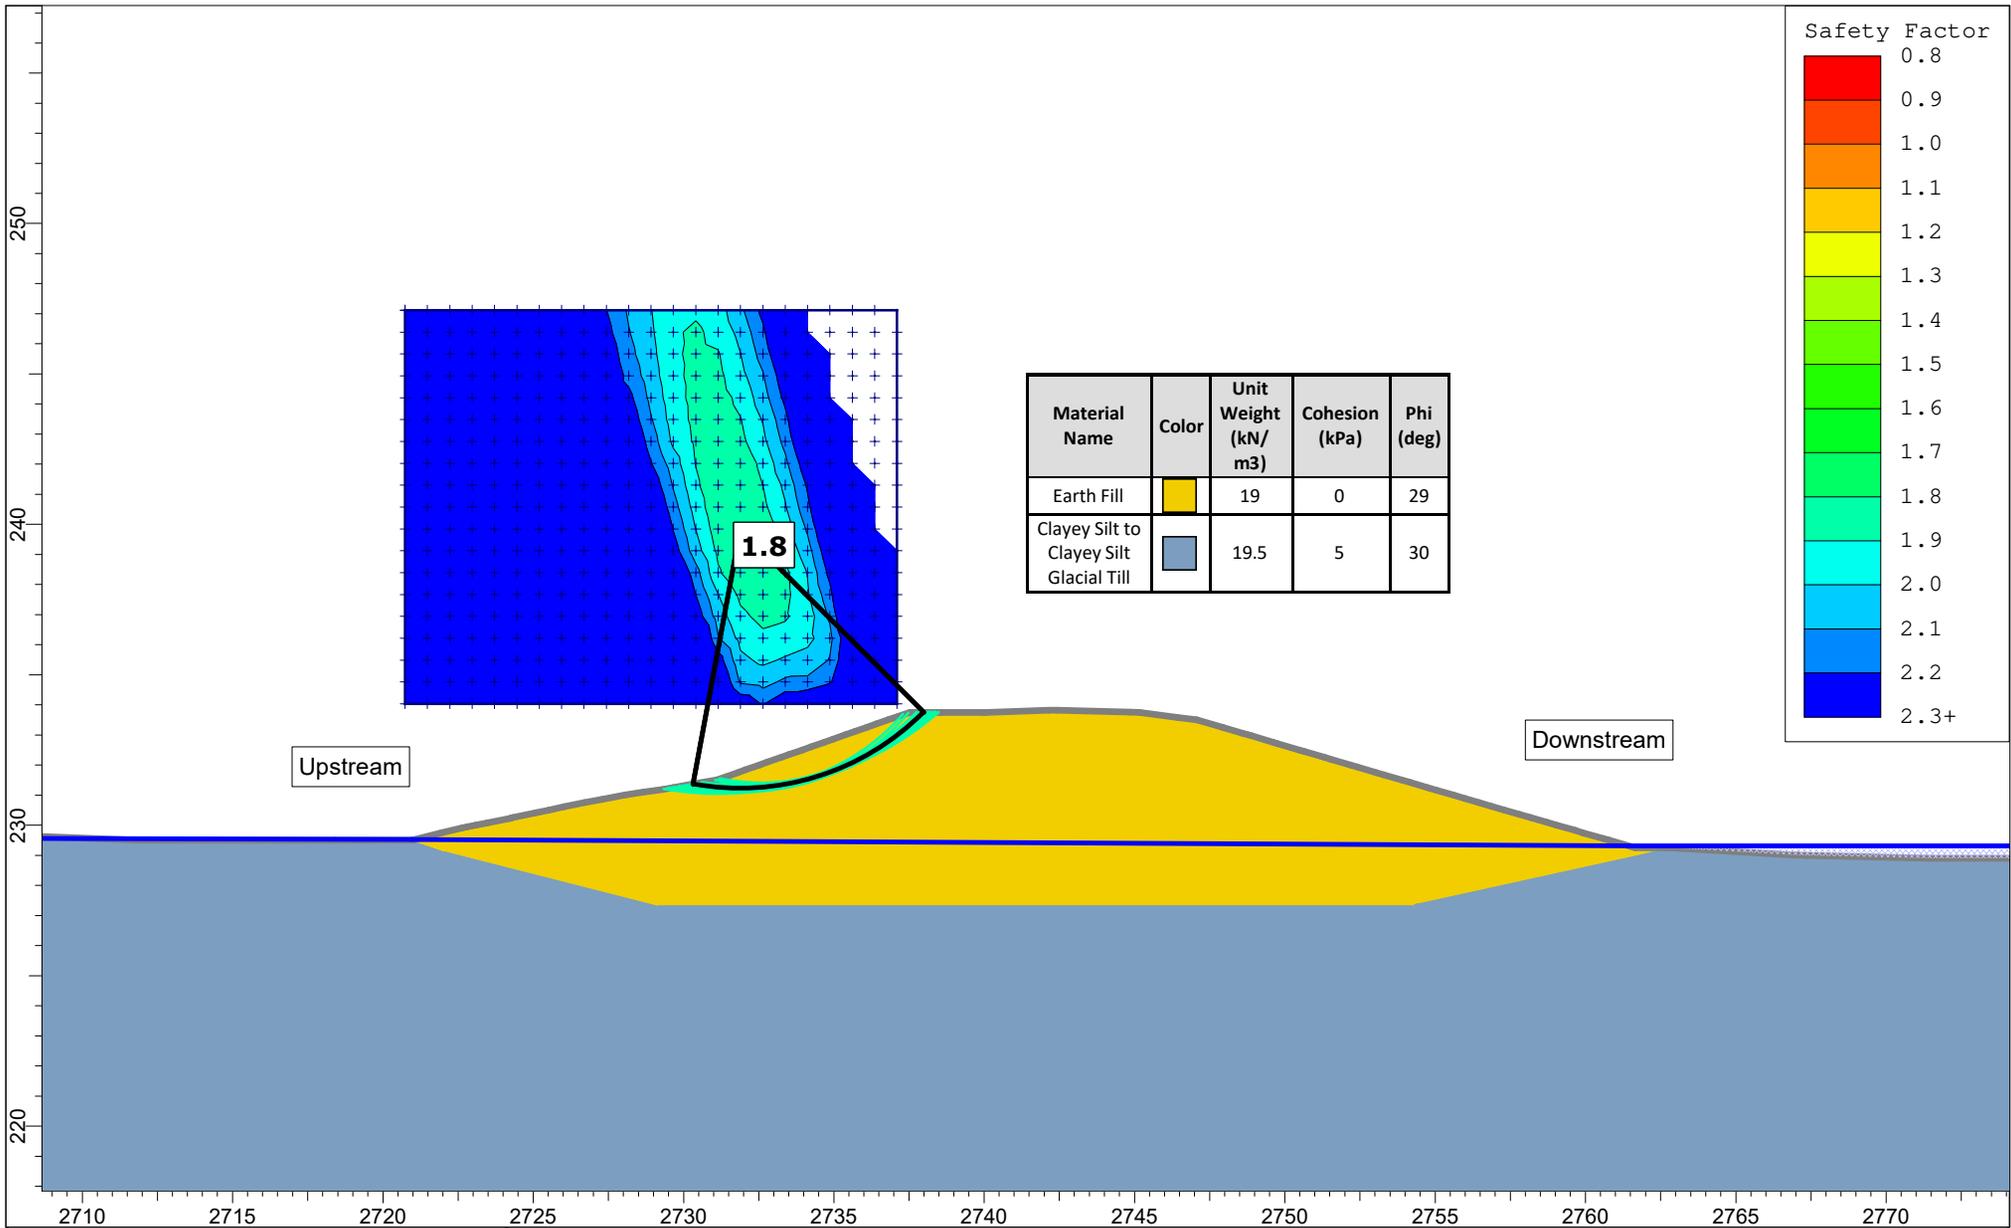
Project			
	Tullamore Employment Lands			
	Analysis Description			
	Section 17 - Lower Pond Embankment Dam, Downstream - Long-Term			
	Drawn By	RW	Scale	1:250
Date	2/17/2022		Company	GEI
			Project No.	2100975

The lower pond does not meet the MNRF design factors of safety for the two loading conditions.
