## ARBORIST REPORT

12519 & 12713 Humber Station Road, Caledon, Ontario  
21T-24014C & RZ 2024-0032  
Prologis Canada Holding 3 GP ULC

Nick Miele, Partner, MHBC

April 19, 2024 [*Revised March 27, 2026*]

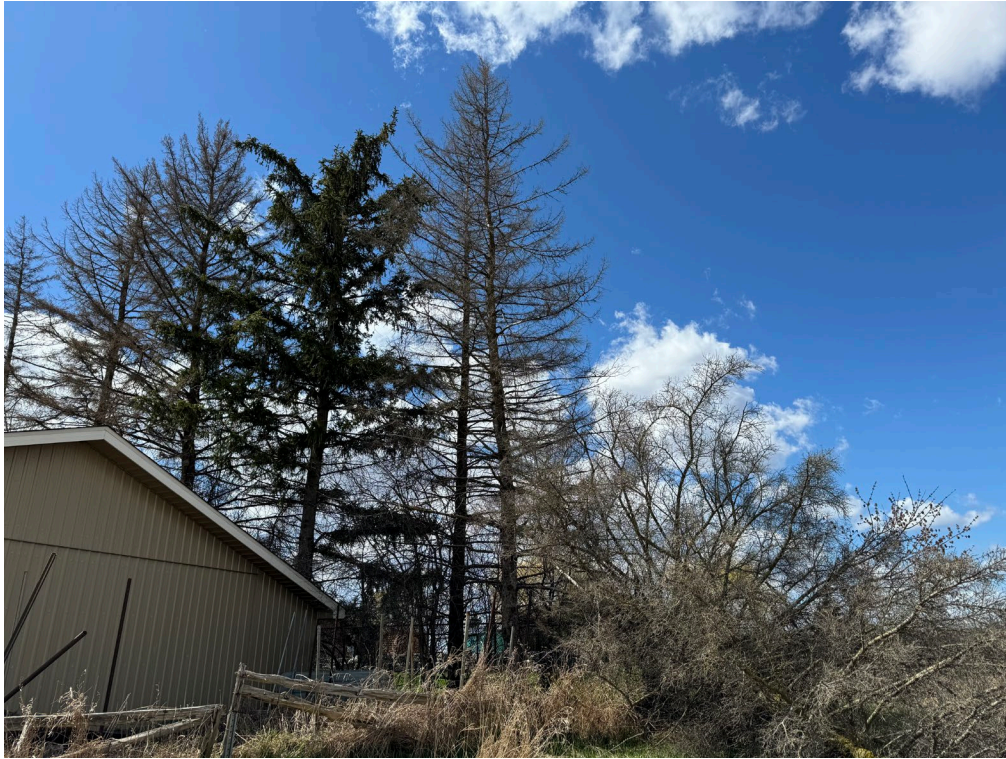
Trees 151 – 155

151	Shared (Private and Neighbour)	Flowering Crabapple Tree	Malus Sp.	6	27	2	F	2 stem at 0.5 metres	Retain
152	Neighbour	Flowering Crabapple Tree	Malus Sp.	3	17	1	F/P	Contorted limbs, previous limb failures, irregular form, suspected internal rot	Retain

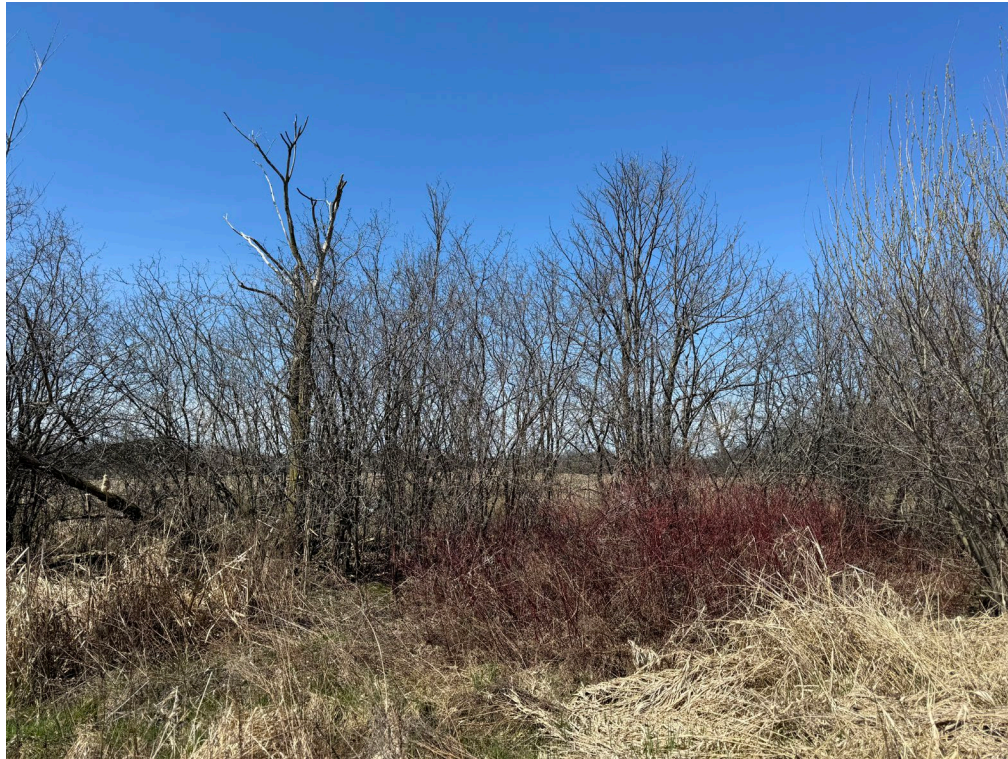
Trees 191, 196 – 199

197	Neighbour	Manitoba Maple	Acer negundo	8	18	1	P	Partial failure at base of main trunk and union, water shoots at base, minor deadwood throughout	Retain
198	Neighbour	Basswood	Tilia americana	3	13	1	F	Mild lean	Retain
199	Neighbour	Basswood	Tilia americana	7	18	1	F	Multi-stem at base	Retain

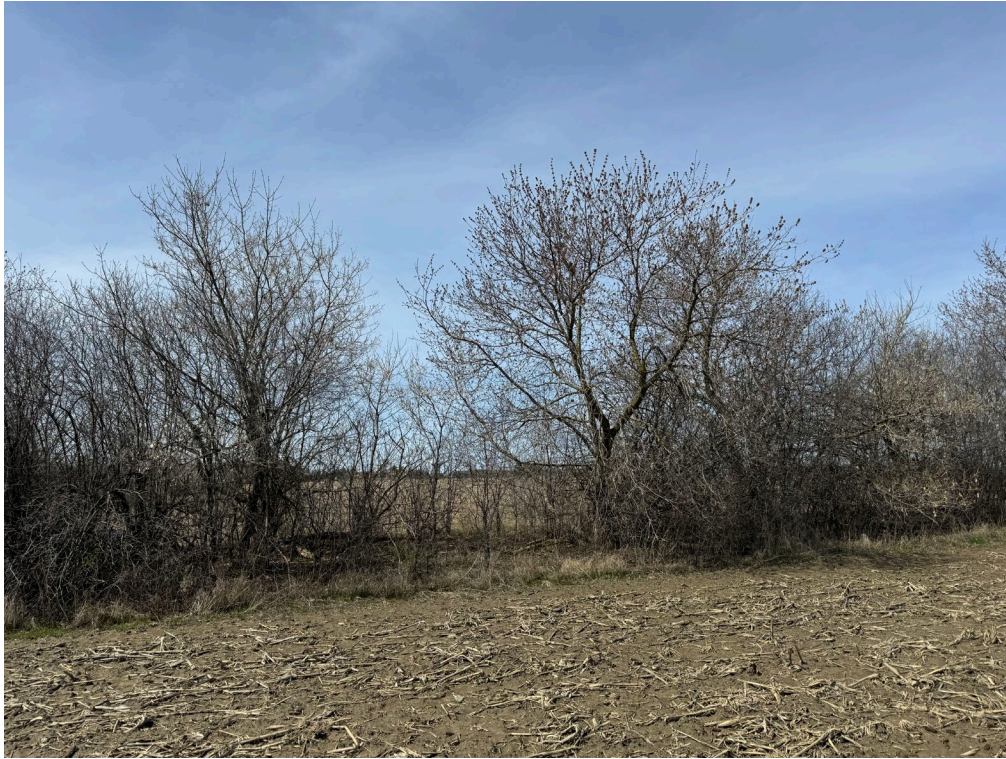
Trees 200 – 205

200	Neighbour	Manitoba Maple	Acer negundo	4	12	1	F/P	2 stem at 0.3 metres, moderate lean, minor deadwood in canopy	Retain
201	Neighbour	Manitoba Maple	Acer negundo	3	13	1	P	2 stem at base, one stem is dead with cavity at base, moderate lean	Retain
202	Neighbour	Manitoba Maple	Acer negundo	4	19	1	P	Main leader is dead and previously failed	Retain
203	Neighbour	Manitoba Maple	Acer negundo	8	26	2	F/P	2 stem at 0.6 metres, one stem is in decline, water shoots throughout	Retain
204	Neighbour	Manitoba Maple	Acer negundo	8	17	1	F/P	2 stem at 0.6 metres, minor deadwood throughout, water shoots throughout	Retain
205	Neighbour	Manitoba Maple	Acer negundo	7	23	2	F/P	2 stem at 0.2 metres, cavity at base, water shoots throughout	Retain
206	Neighbour	Manitoba Maple	Acer negundo	7	16	1	F	Multi-stem, water shoots throughout, minor deadwood throughout	Retain
207	Neighbour	Manitoba Maple	Acer negundo	4	18	1	F	Mild lean	Retain

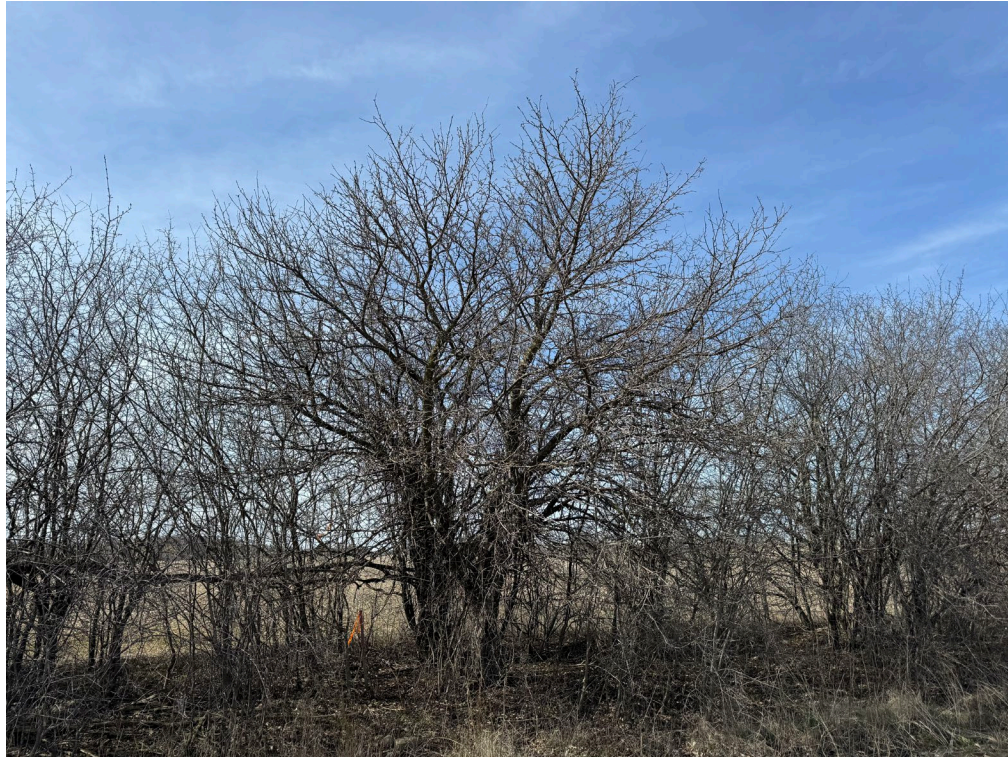
Trees 210 – 214

211	Neighbour	Manitoba Maple	Acer negundo	8	29	2	F/P	Multi-stem, multiple limbs previously failed, moderate deadwood in canopy, water shoots throughout	Retain
212	Neighbour	Manitoba Maple	Acer negundo	3	17	1	F/P	Bow in trunk, cavity at 1.0 metre	Retain
213	Neighbour	Shagbark Hickory	Carya ovata	3.5	14	1	F		Retain
214	Neighbour	Flowering Crabapple Tree	Malus Sp.	9	28	2	F/P	Multi-stem at 0.4 metres, cavity at stem union, minor to moderate deadwood in canopy	Retain
215	Private	Flowering Crabapple Tree	Malus Sp.	6	26	2	F		Retain
216	Private	Flowering Crabapple Tree	Malus Sp.	5	20	1	F	Multi-stem at 0.8 metres	Retain
217	Private	Flowering Crabapple Tree	Malus Sp.	5	15	1	F	Multi-stem at base, cavity at base between all stems, main stem previously failed	Remove due to construction
218	Private	Flowering Crabapple Tree	Malus Sp.	7	29	2	F	2 stem at 0.6 metres	Remove due to construction
219	Town	Honey Locust	Gleditsia triacanthos	2.5	15	1	P	Cavity at base, bow in trunk	Remove due to construction

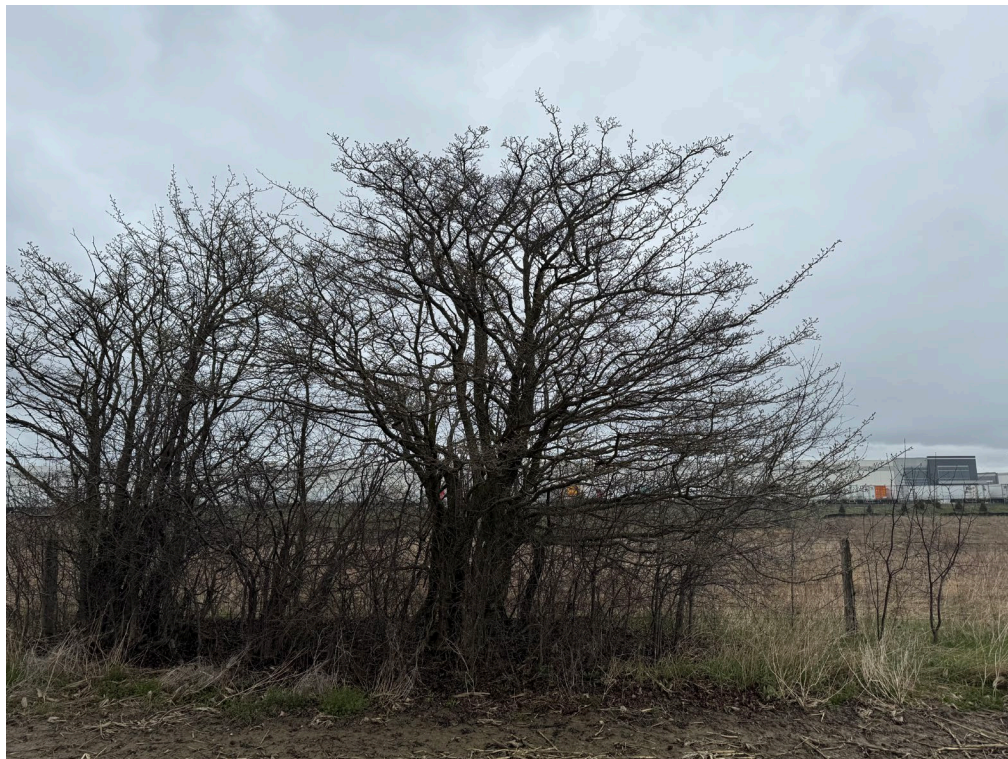
Trees 229 – 233

232	Town	Honey Locust	Gleditsia triacanthos	8	28	2	F/P	3 stem at 1.3 metres, cavity at union, previous limb failures	Remove due to construction
233	Town	Honey Locust	Gleditsia triacanthos	3	13	1	F		Remove due to construction
234	Private	Flowering Crabapple Tree	Malus Sp.	8	24	2	F	Multi-stem	Retain
235	Private	Flowering Crabapple Tree	Malus Sp.	8	17	1	F	Multi-stem	Retain
236	Private	Flowering Crabapple Tree	Malus Sp.	6	11	1	F	Multi-stem	Retain
237	Private	Willow Sp.	Salix Sp.	4	31	2	F		Retain
238	Neighbour	Colorado Blue Spruce	Picea pungens var. glauca	4.5	34	2	F/P	Minor deadwood in canopy, imbalanced canopy at one side to 4 metres above grade	Retain
239	Neighbour	Colorado Spruce	Picea pungens	6	42	3	F	Mild lean	Retain
240	Neighbour	Willow Sp.	Salix Sp.	15	97	5	F/G		Retain
369	Town	Honey Locust	Gleditsia triacanthos	3	17	1	P	Cavity in trunk, leader previously failed	Remove due to construction
370	Town	Honey Locust	Gleditsia triacanthos	5	29	2	F		Remove due to construction
