# ARBORIST REPORT

Location: 13291 Airport Road, Caledon

Project: Truck Trailer Parking

Project No: GPI037

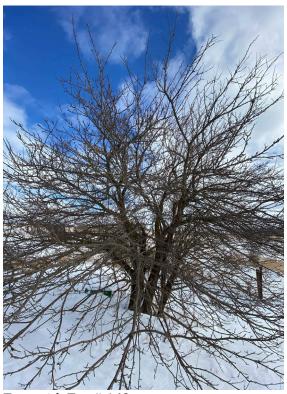
Tree with Tag # 168

166	Crataegus sp. (Hawthorn)	12/15/18/1 0	2	1.8	Good	1	Multistem. Preserve with injury.	Preserve	
167	Crataegus sp. (Hawthorn)	19	4	1.8	Fair	1		Preserve	
168	Acer negundo(Manitoba Maple)	20	4	1.8	Good	1	Preserve with injury.	Preserve	
169	Malus sp.(Apple species)	30/20/25/2 2/10	6	2.4	Good	1	Multistem.	Preserve	
170	Ulmus americana( American Elm)	12/11/10	2	1.8	Good	1	Multistem	Preserve	
171	Ulmus americana( American Elm)	20	3	1.8	Good	1		Preserve	
172	Ulmus americana( American Elm)	39	5	2.4	Good	1	Preserve with injury.	Preserve	
173	Acer platanoides(Norway Maple)	22	4	1.8	Good	1		Preserve	
						1		Total Compensation Trees	90
