## **ARBORIST REPORT**

**ARGO MAYFIELD WEST V  
PROPOSED RESIDENTIAL SUBDIVISION  
12192 CHINGUACOUSY ROAD  
TOWN OF CALEDON, ONTARIO**

**February 7, 2025**

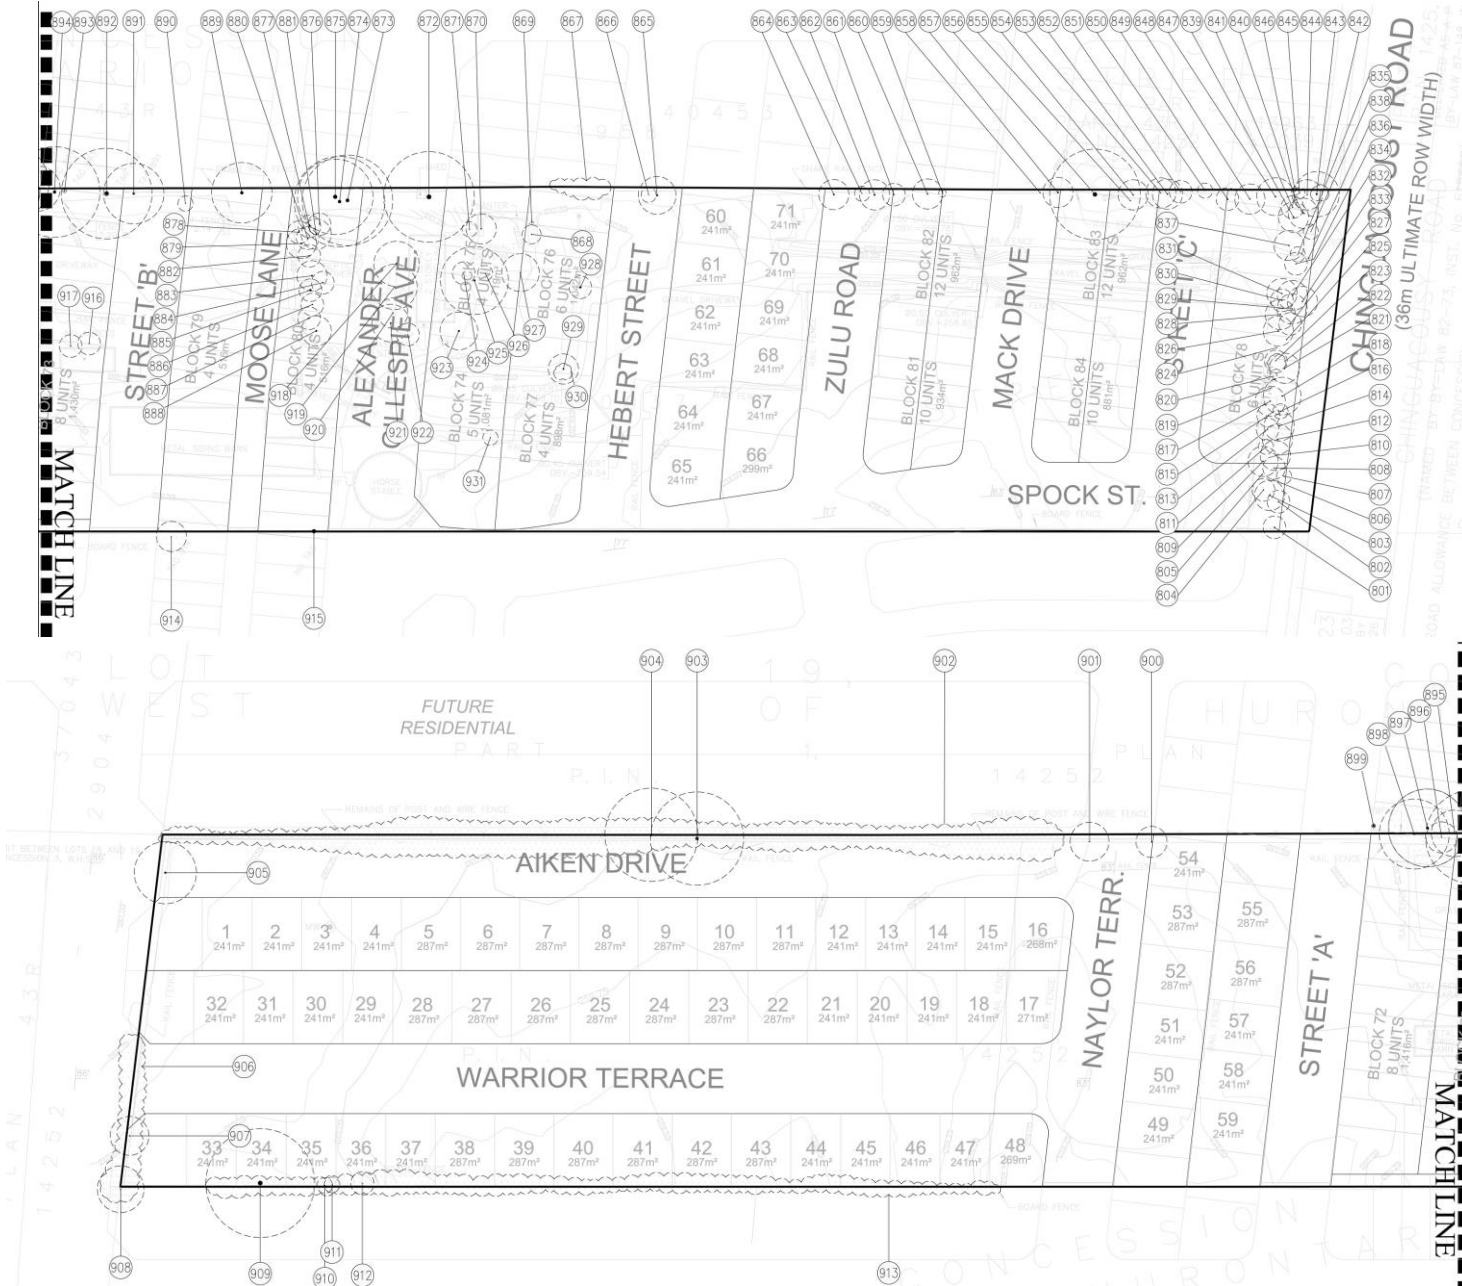
**APPENDIX B – CONTEXTUAL TREE INVENTORY AND PRESERVATION PLAN**

The associated Tree Inventory & Preservation Plan prepared by our office provides detailed tree locations and removal/preservation recommendations.
