Humber River Tributaries Fluvial Geomorphological Assessment

**Bolton North Hill Secondary Plan Area
Local Subwatershed Study - Stage 1**
Town of Caledon, Ontario

GEO Morphix Project No. PN24084

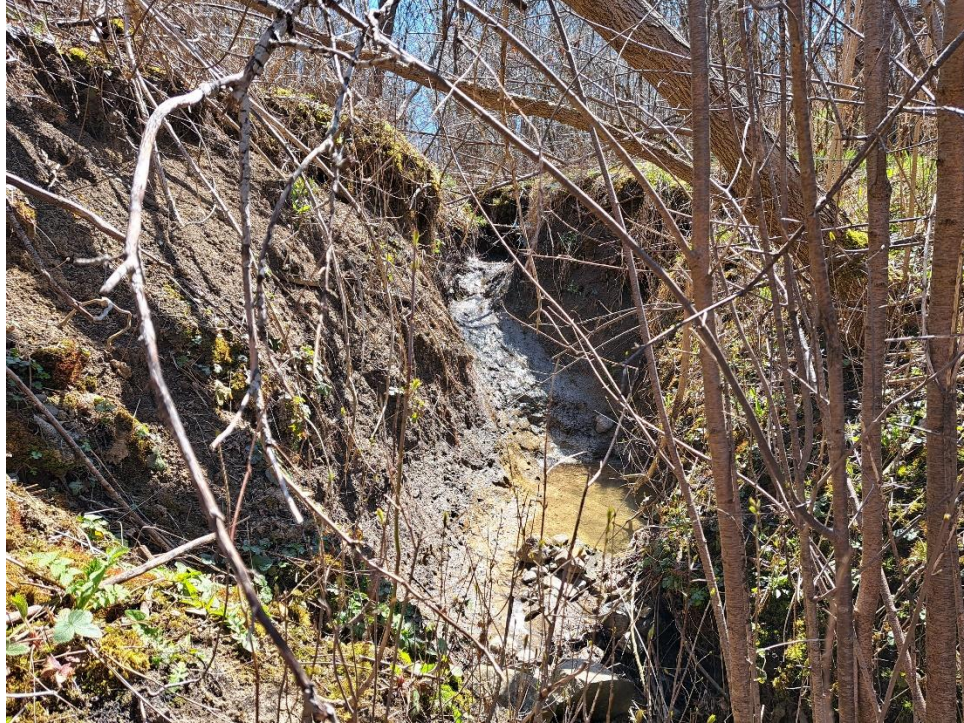
Photo 4
Tributary of the Humber River - Reach THRF-2, Caledon,
Ontario

The gradient along the reach was high and entrenchment increased at localized sections where knickpoints were present.

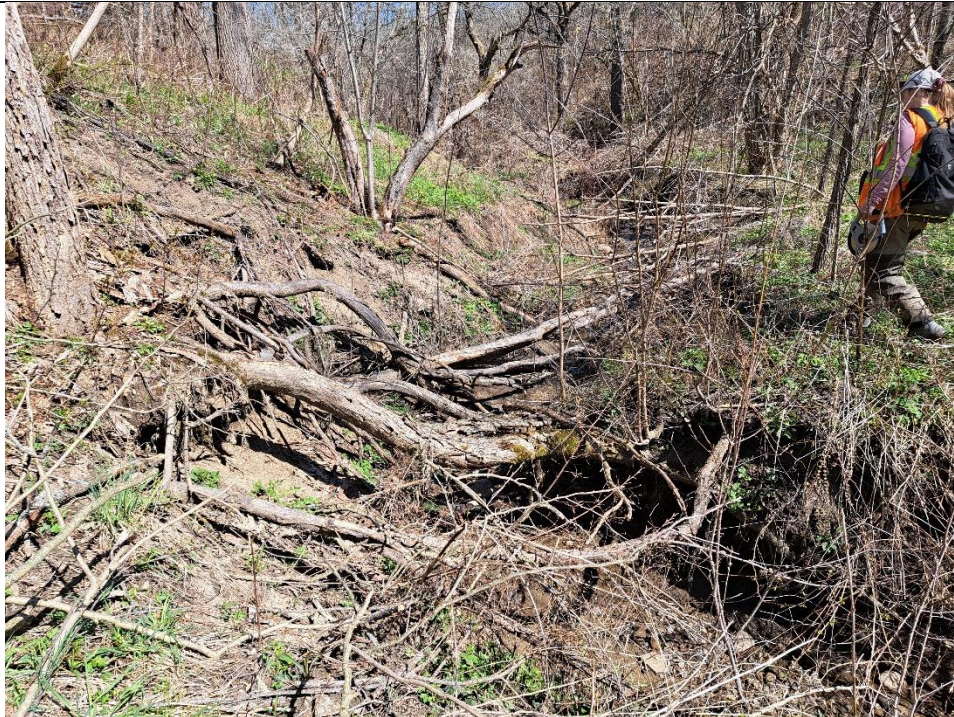
Photo 5
Tributary of the Humber River - Reach THRE-1, Caledon,
Ontario

Woody debris, leaning and fallen trees, and exposed roots were common, with the highest concentration in the upstream section of the reach.

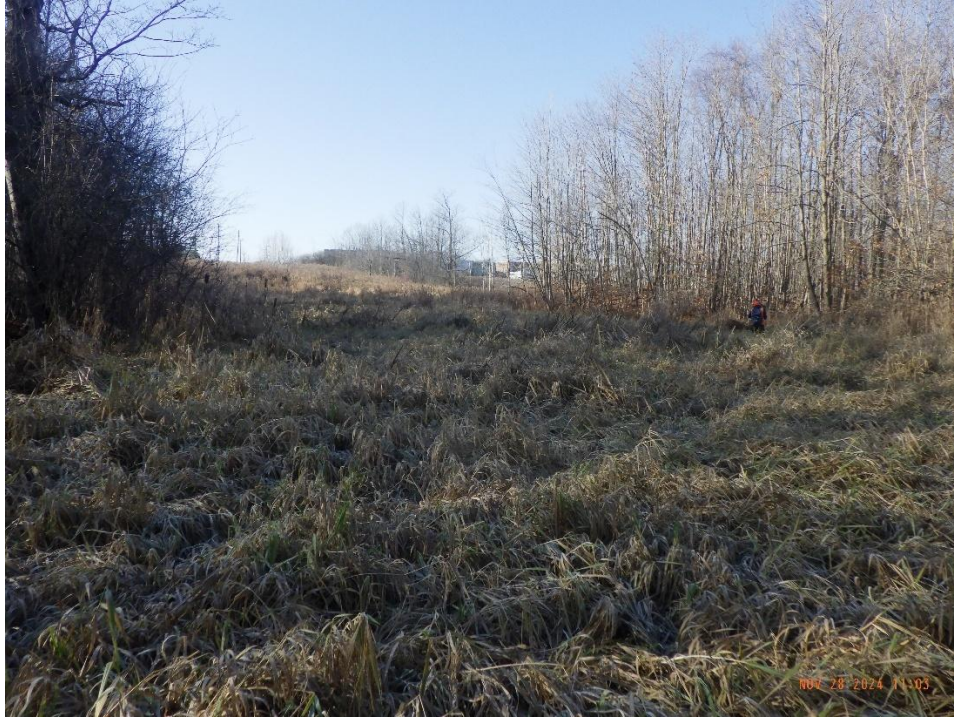
Photo 6
Tributary of the Humber River - Reach THRE-1, Caledon,
Ontario

The majority of the reach, and particularly the upstream portion, was characterized as a grassy meadow with multiple flow paths.

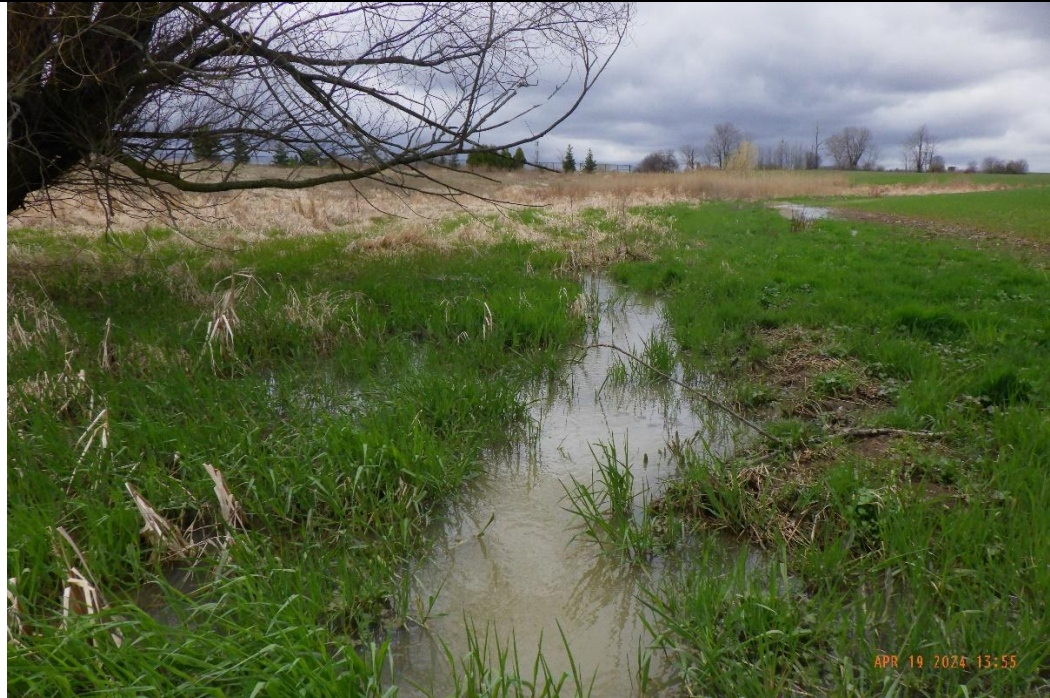
Photo 9
Tributary of the Humber River - Reach THRE-2, Caledon,
Ontario

Feature was intermittently defined and water was turbid at the time of the assessment.

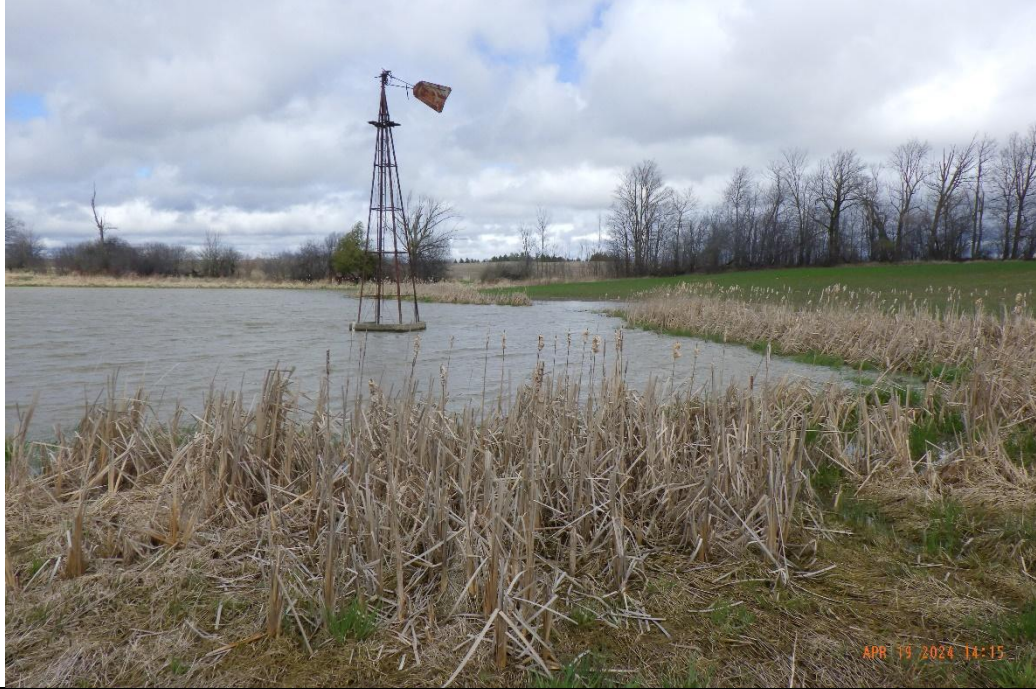
Photo 12
Tributary of the Humber River - Reach THRE-4, Caledon,
Ontario

This reach consisted of a waterbody. Cattails and wetland vegetation surrounded the margins of the pond.

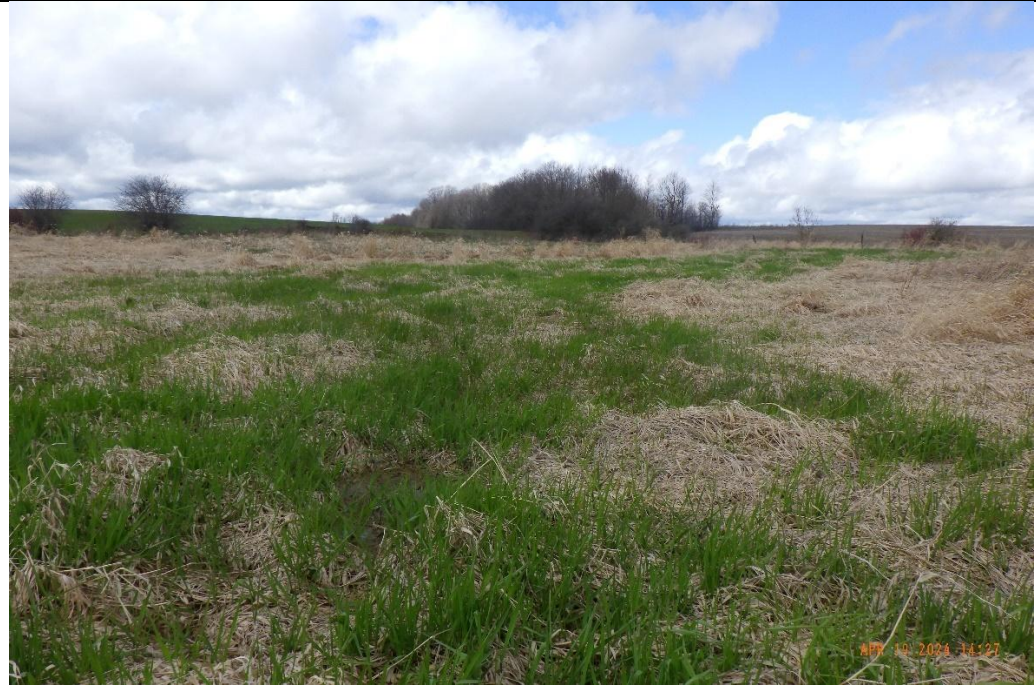
Photo 13
Tributary of the Humber River - Reach THRE-4, Caledon,
Ontario

Wetland feature with poorly defined banks and multiple flow paths. The riparian vegetation consisted of grasses that extensively encroached the channel.

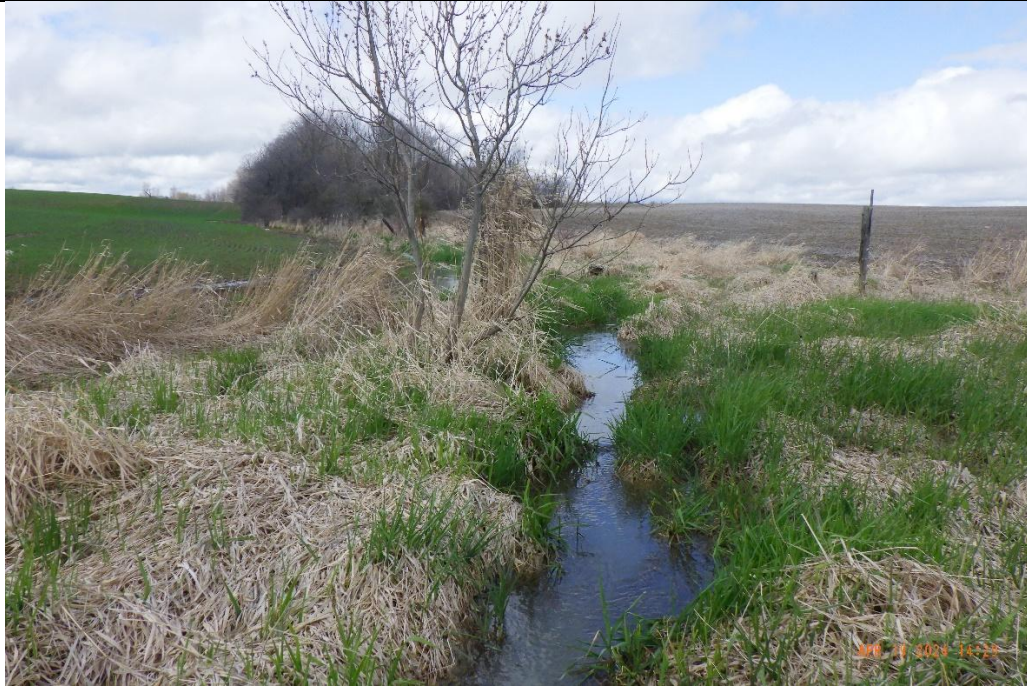
Photo 14
Tributary of the Humber River - Reach THRE-5, Caledon, Ontario

Reach was better defined in the upstream extent and at the inlet to the pond.

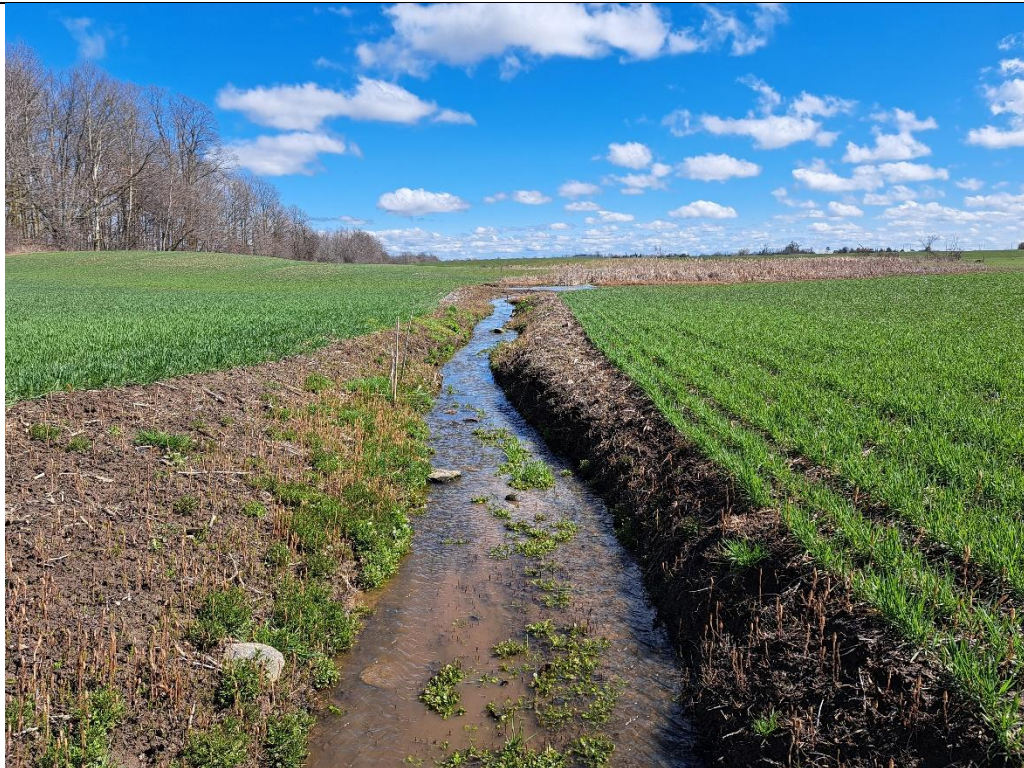
Photo 27
Tributary of the Humber River - Reach THRE-8, Caledon, Ontario

At the downstream portion of the reach the channel flowed between two agricultural fields before connecting to a pond. This portion of the reach was likely historically straightened (facing downstream).

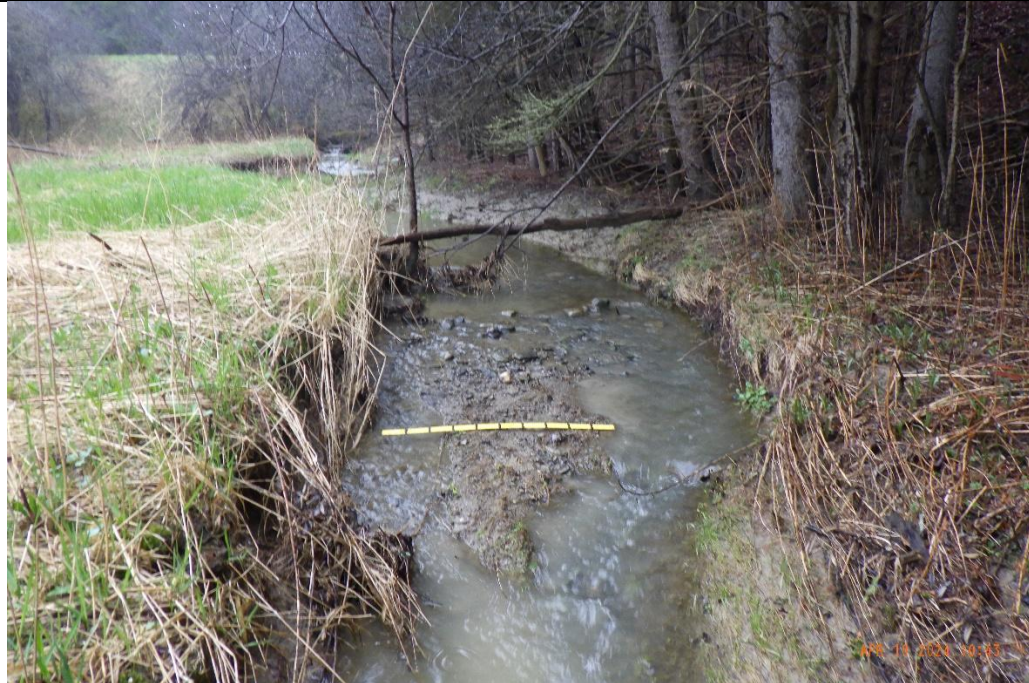
Photo 31
Tributary of the Humber River - Reach THRD-1, Caledon,
Ontario

Medial bars and point bars were identified throughout the reach and consisted of sand, gravel and cobbles.

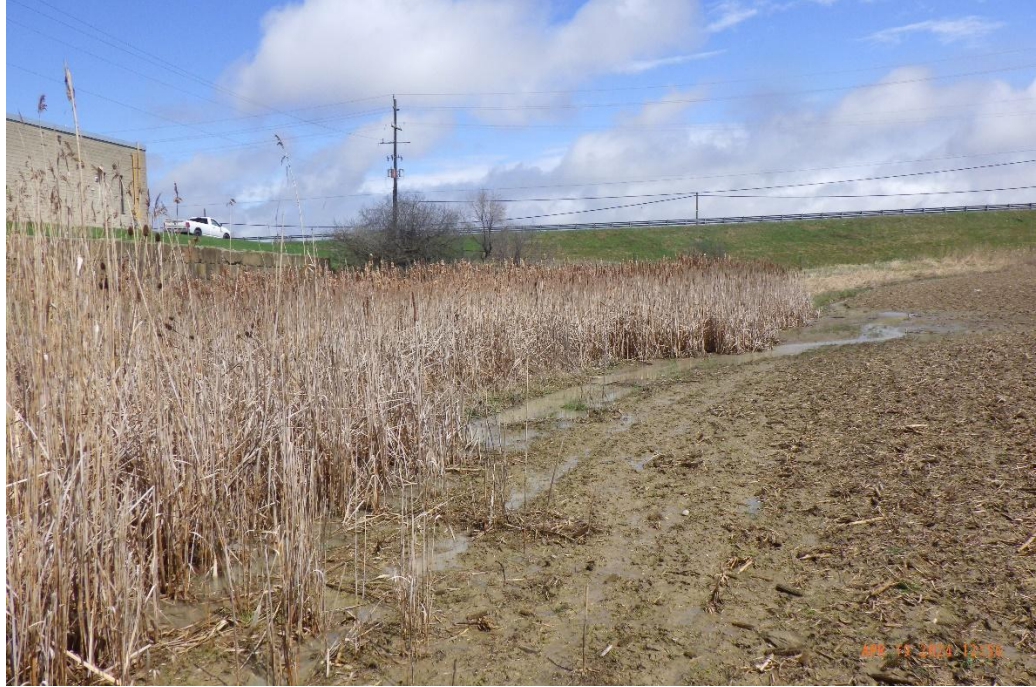
Photo 34
Tributary of the Humber River - Reach THRD-2b, Caledon,
Ontario

The majority of the reach was poorly defined and contained stands of phragmites.

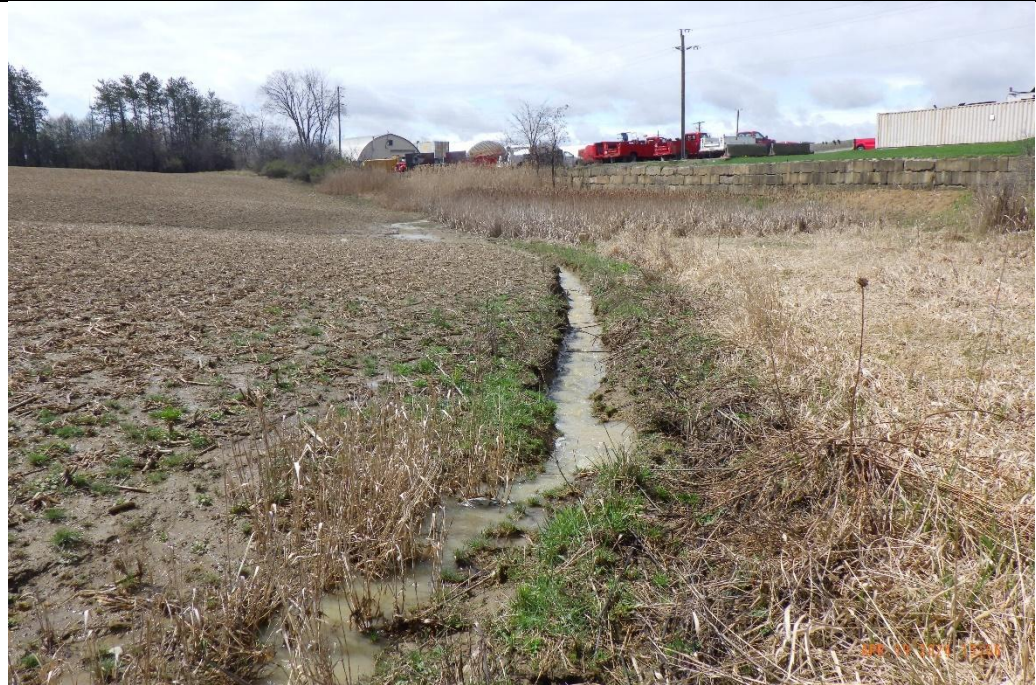
Photo 35
Tributary of the Humber River - Reach THRD-2b, Caledon,
Ontario

The upstream portion of the reach contained a defined, straightened channel along an agricultural field. The water was turbid from the recent rainfall.

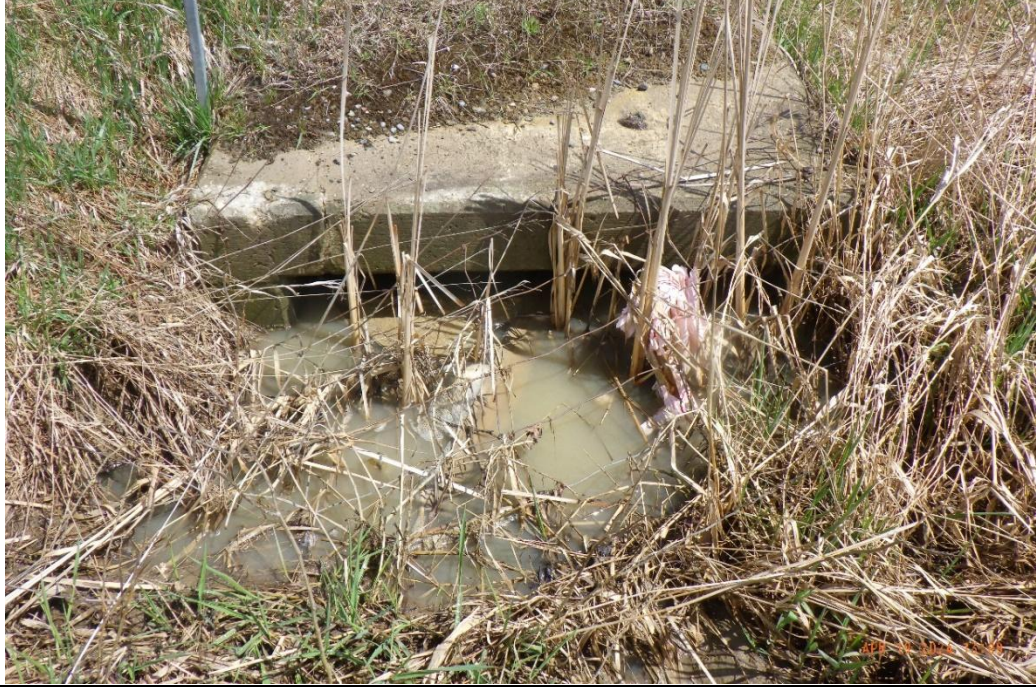
Photo 36
Tributary of the Humber River - Reach THRC-1, Caledon,
Ontario

The rectangular concrete culvert at the road was silted and at approximately 75% capacity.

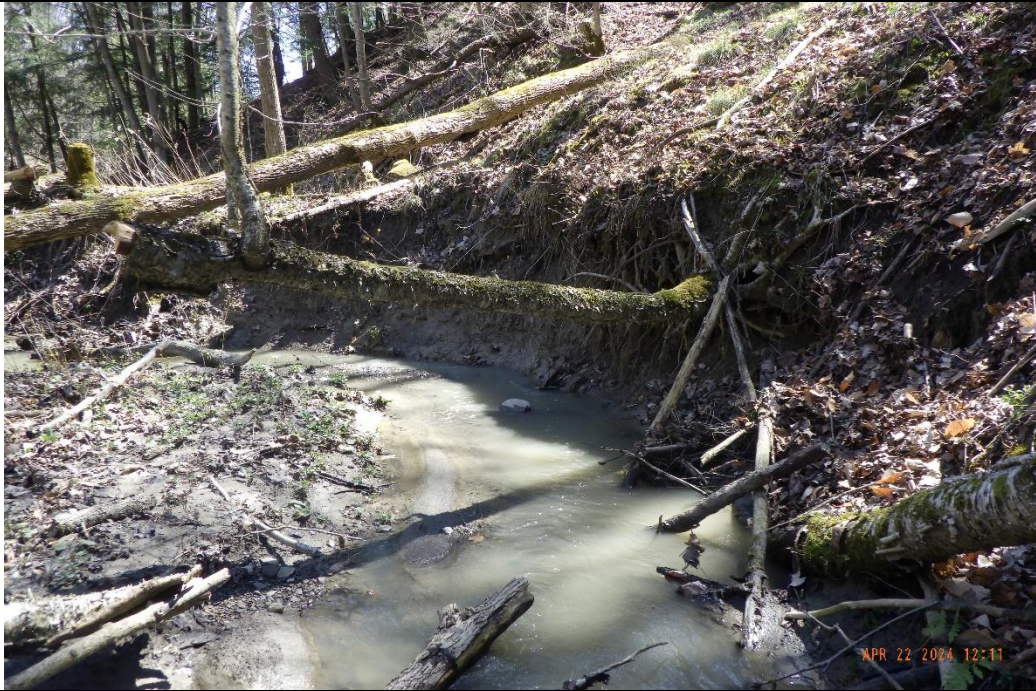
Photo 37
Tributary of the Humber River - Reach THRC-1, Caledon,
Ontario

Valley wall contact occurred in multiple locations along the reach. The reach has steep banks, erosion, and undercuts measuring up to 0.5 m.

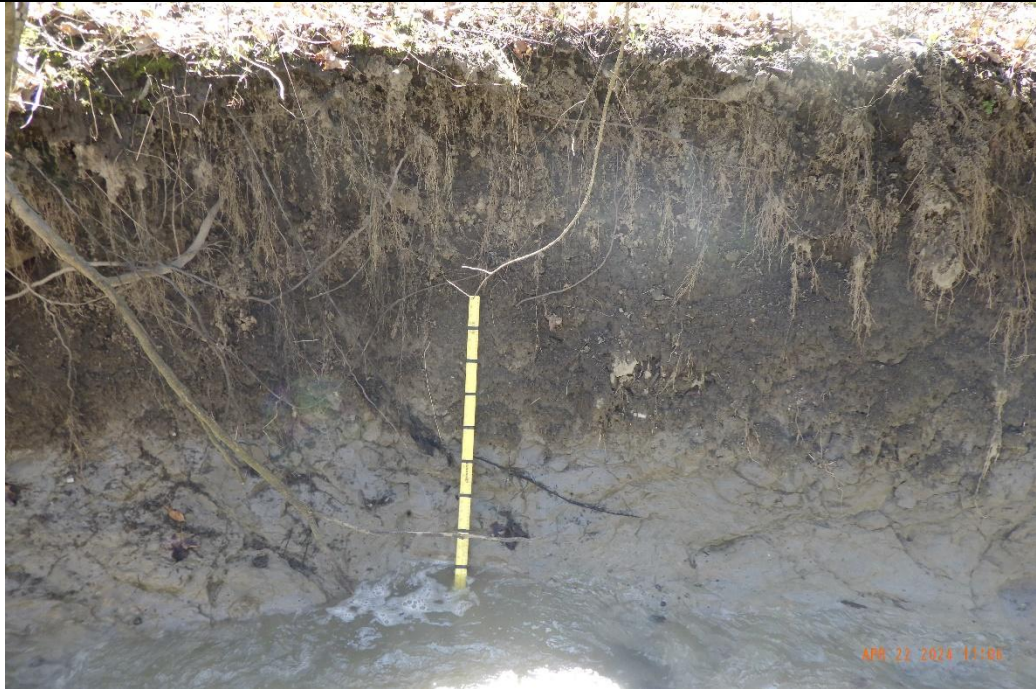
Photo 43
Tributary of the Humber River - Reach THRC-2, Caledon,
Ontario

The channel had deeply incised into the clay/till parent material. Bed substrate consisted of till/clay, silt, gravel and cobbles.

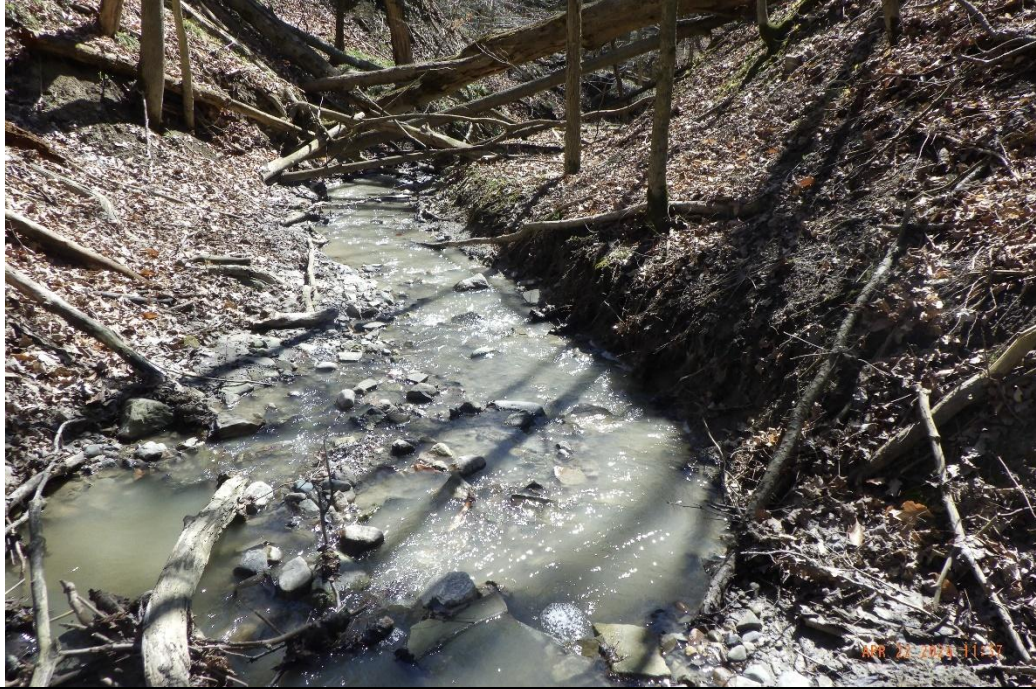
Photo 44
Tributary of the Humber River - Reach THRC-3, Caledon,
Ontario

Instream morphology consisted of well-developed riffle-pool sequences

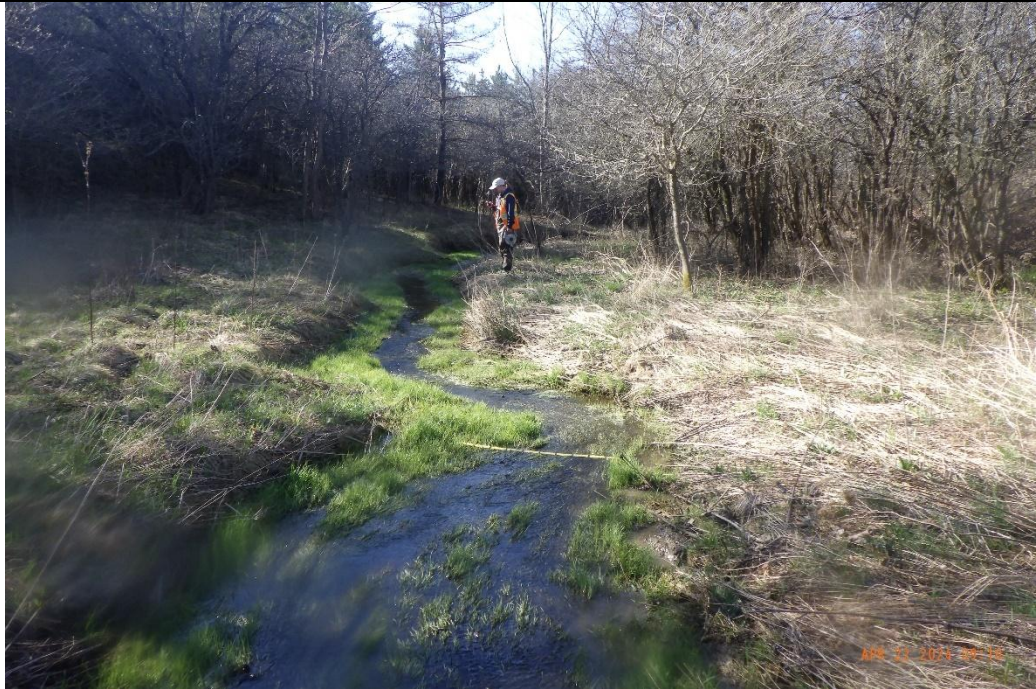
Photo 49
Tributary of the Humber River - Reach THRC-4, Caledon,
Ontario

The channel flowed through a grassy meadow within a confined valley; however the valley walls were set back from the channel.

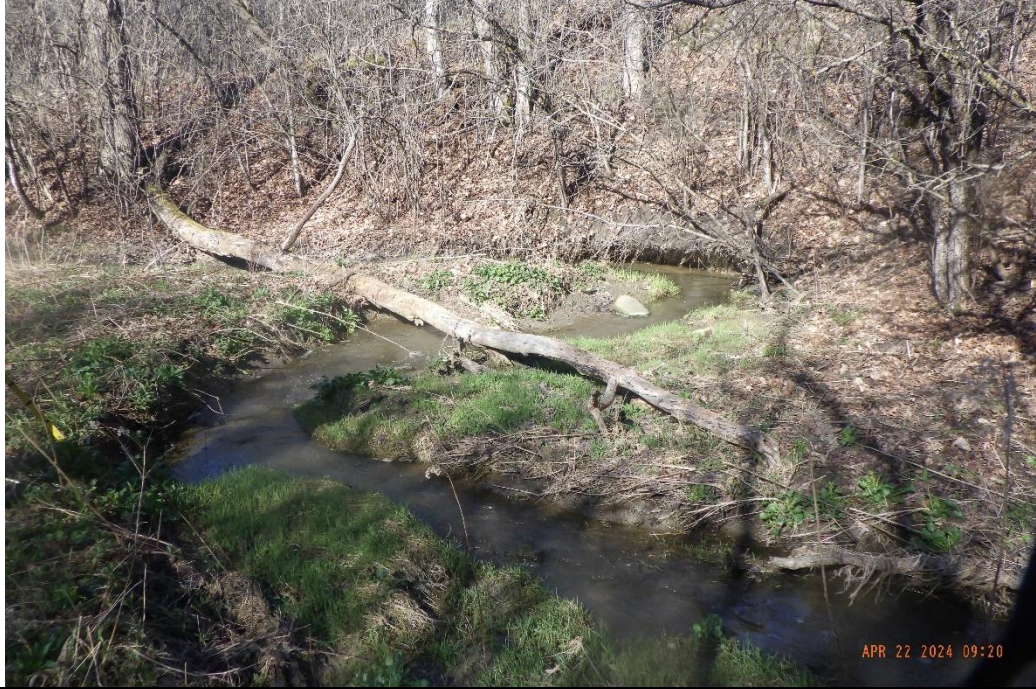
Photo 50
Tributary of the Humber River - Reach THRC-4, Caledon,
Ontario

Although woody debris was present throughout the reach, woody debris jams were uncommon.

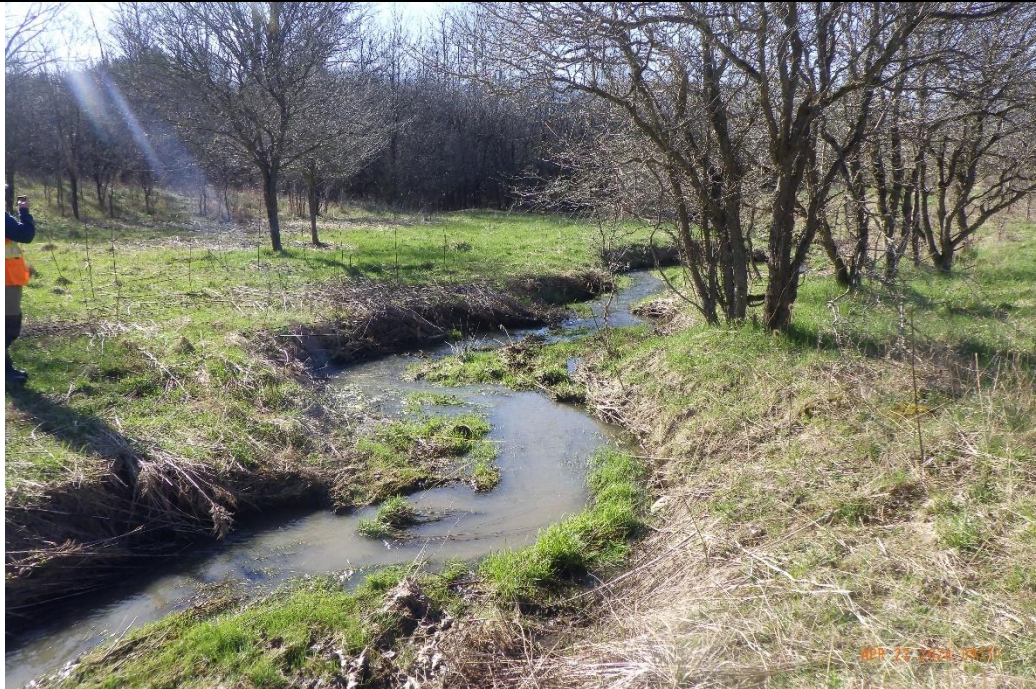
Photo 51
Tributary of the Humber River - Reach THRC-4, Caledon, Ontario

Grasses were growing in the channel along 60% of the reach.

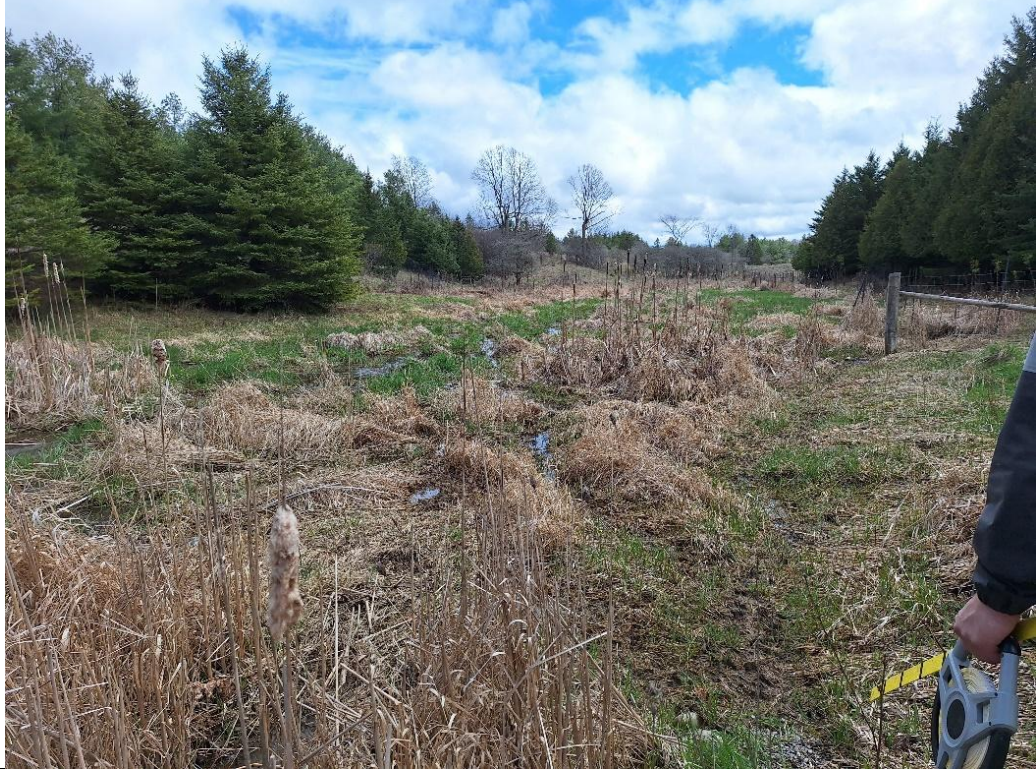
Photo 56
Tributary of the Humber River - Reach THRC-6, Caledon, Ontario

The reach was poorly defined, contained multiple flow paths and riparian vegetation consisted of predominantly cattails and other wetland species.

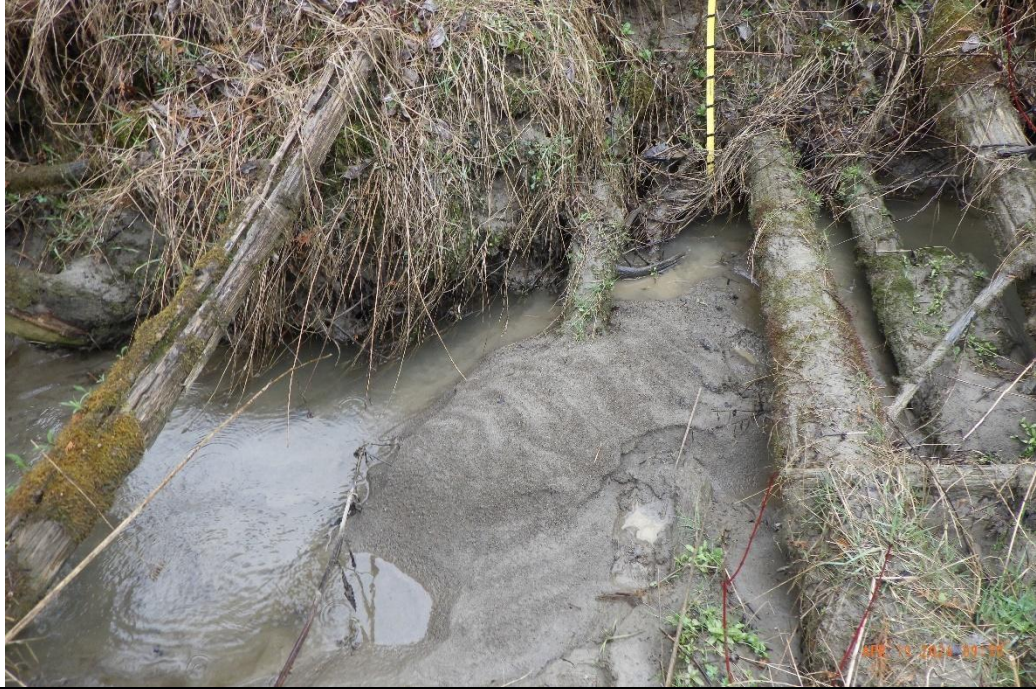
Photo 60
Tributary of the Humber River - Reach THRB-1, Caledon,
Ontario

Sand deposits were common, including in the overbank zone.

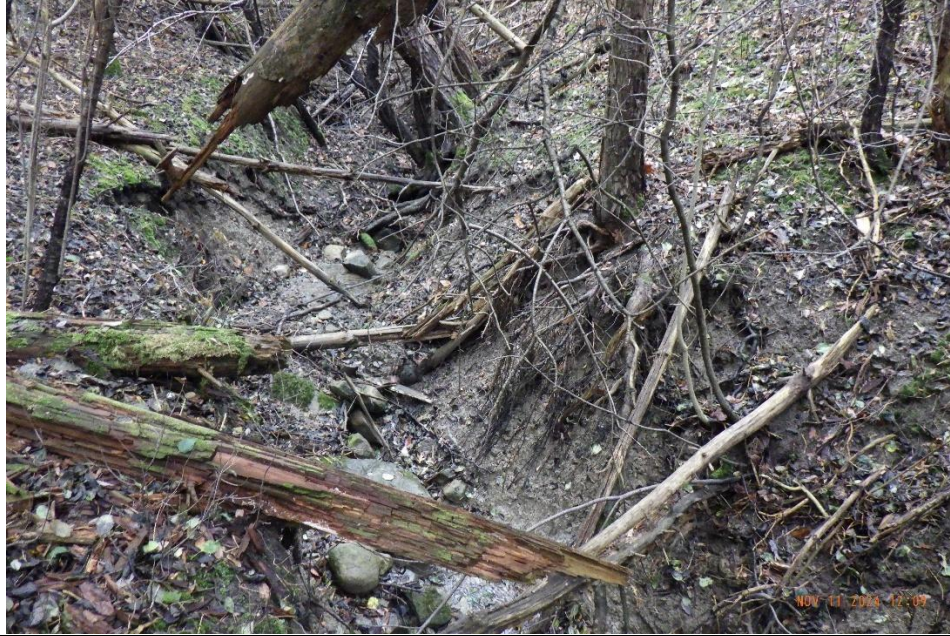
Photo 76
Tributary of the Humber River - Reach THRD-1a,
Caledon, Ontario

The feature consisted of a sinuous gully with a steep gradient and moderate entrenchment.

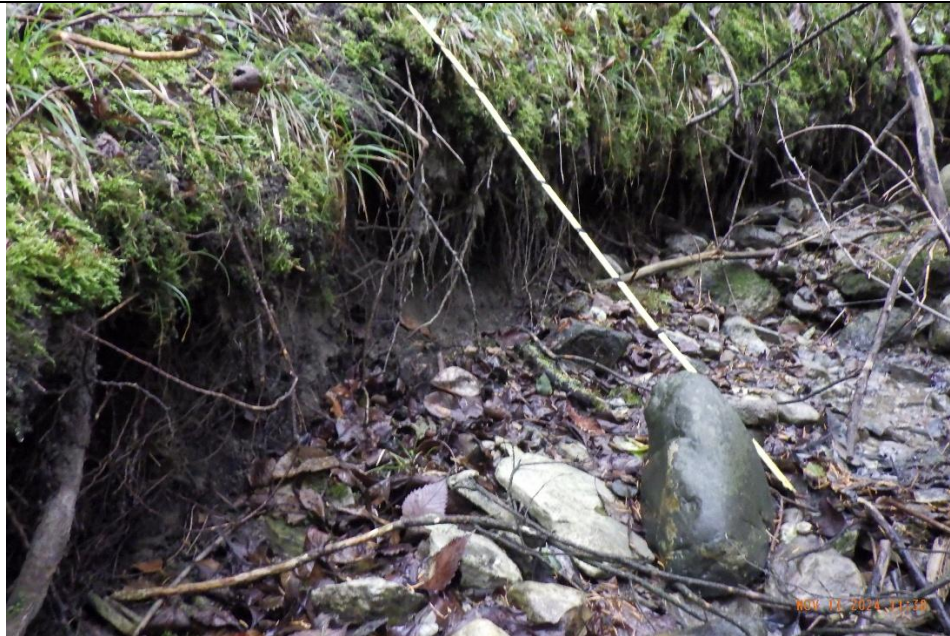
Photo 77
Tributary of the Humber River - Reach THRD-1a,
Caledon, Ontario

The channel was actively widening and contained undercuts measuring up to 0.69 m.

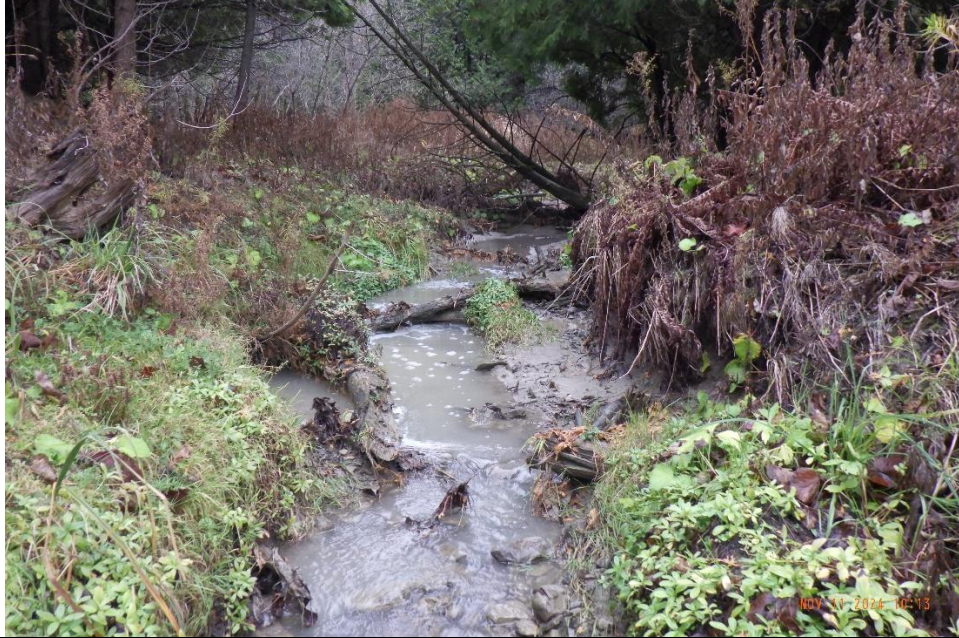
Photo 80
Tributary of the Humber River - Reach THRC, Caledon,
Ontario

The reach contained primarily riffles and runs, with only a few pools identified.

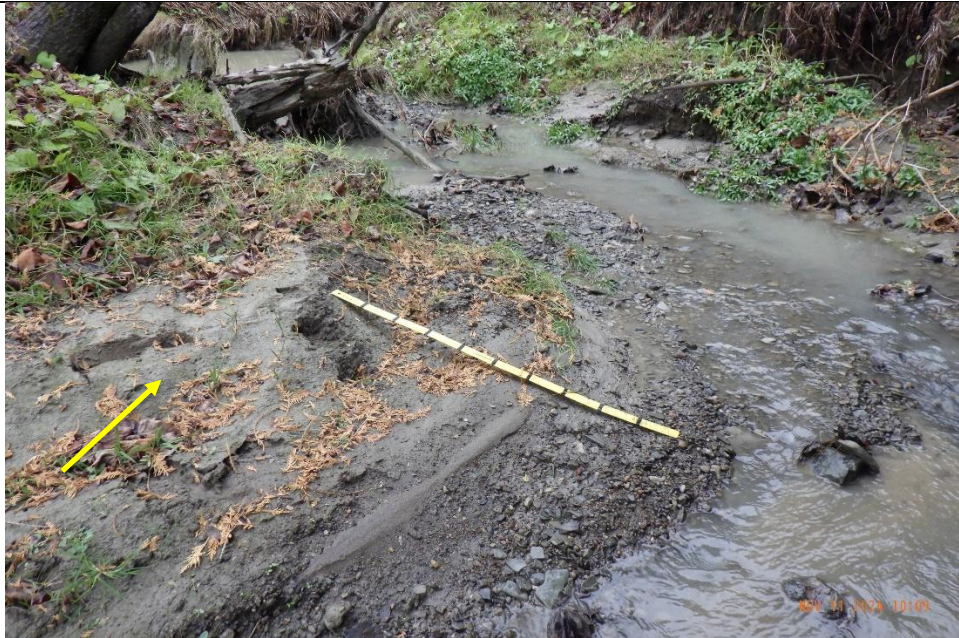
Photo 81
Tributary of the Humber River - Reach THRC, Caledon,
Ontario

Sand deposits were common in the channel and on point bars.
