# HERITAGE IMPACT ASSESSMENT

18667 MISSISSAUGA ROAD, TOWN OF CALEDON,  
REGIONAL MUNICIPALITY OF PEEL, ONTARIO

CBM AGGREGATES

PROJECT NO.: OCUL2216  
DATE: JULY 28, 2023

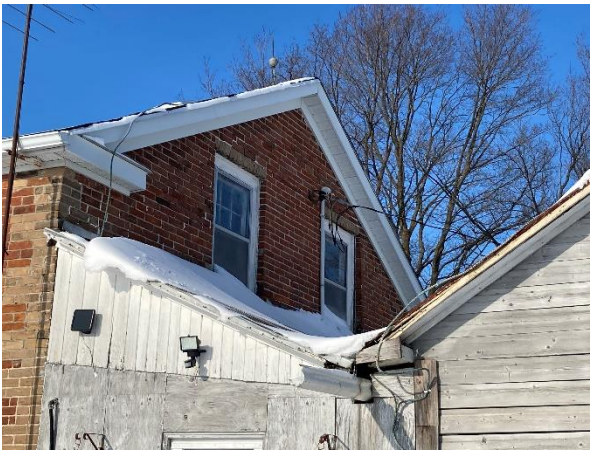
The north elevation of the main block is mostly obscured from the exterior by the rear addition but the visible second storey appears in much the same style and condition as the south elevation, the only difference being the lack of decorative brickwork beneath the gable (Plate 27). The north addition encompasses the north elevations of both the original main block and the side addition, again discernable by the change in brick bonds. Within the rear addition, the north elevation of the main block includes an entrance on the east side, with a four-panel Greek Revival style door, similar in style to the formal entrance on the east elevation except for the window panels (Plate 29). A window is located on the west side, within the side addition. The door and window are topped with the same buff brick soldier course header as the south and west elevation.

**Plate 27: Portion of north elevation of original main block visible from exterior**

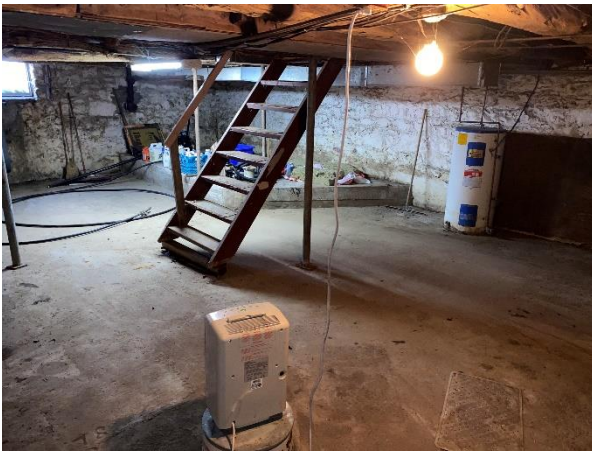
The basement is an open, rectangular room that encompasses the footprint of the original main block (Plate 30 and Plate 31). The entrance to the basement is via a stairwell located in the hallway on the west side of the main block. The floor is poured concrete and the random rubble walls of the foundation have been parged (Plate 32 and Plate 33). The floor joists are visible and consists primarily of logs which were hand-hewn on the top and bottom to provide a flat surface but otherwise left in the round, some with the bark still intact (Plate 34). There are ten hand-hewn log joists spanning the entirety of the main block, with five on each side of the staircase. A singular log joist has been squared on all sides and cut to accommodate the staircase (Plate 35). Later, metal floor joist jacks were added to support the framing. The main block's plank subflooring is visible between the log joists (Plate 36). There is a single basement window on the south elevation. The window has sawn wooden frames and is set into the parged stone foundation. Concrete has been hand applied between the window frames and stone foundation. The window has a hand-hewn timber lintel. A sawn piece of wood sits atop the lintel and plexiglass has been attached on the interior. (Plate 37).

**Plate 30: Basement of the farmhouse**

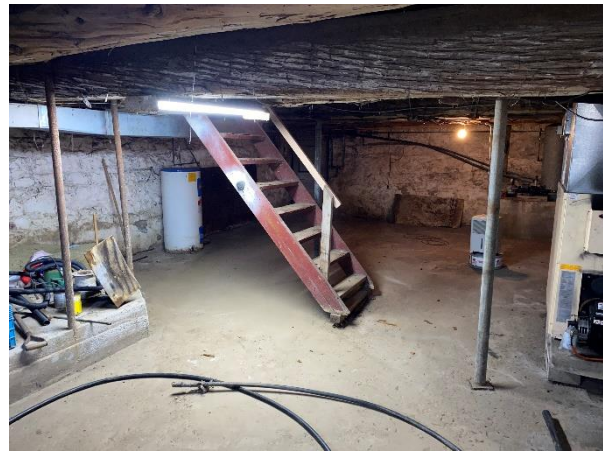
**Plate 31: Basement of the farmhouse**

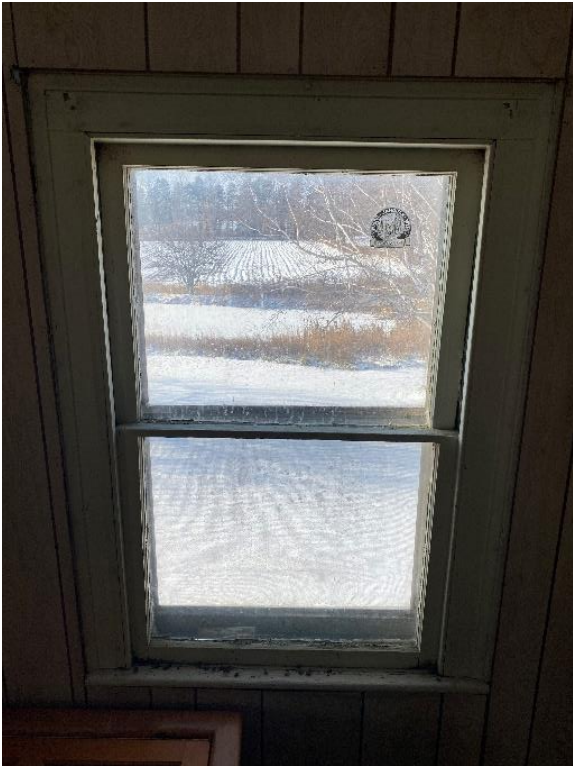
The southeast room is decorated with faux wood panelling and wallpaper on the walls and carpet over linoleum flooring (Plate 48). Both windows (of the north and west elevations) appear to be original and in good condition (Plate 49 and Plate 50). Cracks and subsequent repairs are evident in the plaster of the ceiling (Plate 53).

**Plate 49: Detail of south window of southeast second floor room**

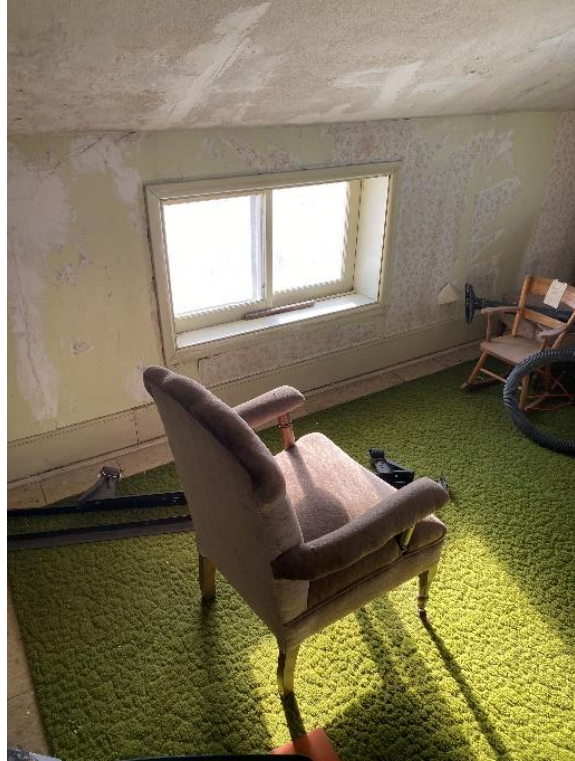
**Plate 50: East window of southeast second floor room**

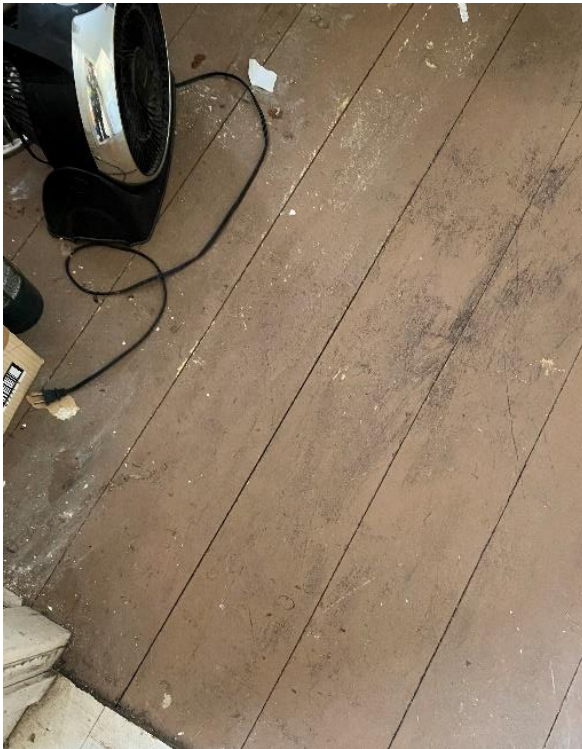
The storage room has painted wood floors, plaster walls (covered in wallpaper), and built in wood cabinets on the east wall (Plate 71 and Plate 72). One six-over-six hung and one one-over-one sash window are located on the west wall, both with wood frames (Plate 73). There is one six-over-six wood sash window on the north wall, looking into the north addition (Plate 74). There is a boarded-up window in the kitchen that acts as a nook on the west elevation of the original main block (Plate 75).

**Plate 72: Wood floors of side addition storage room**

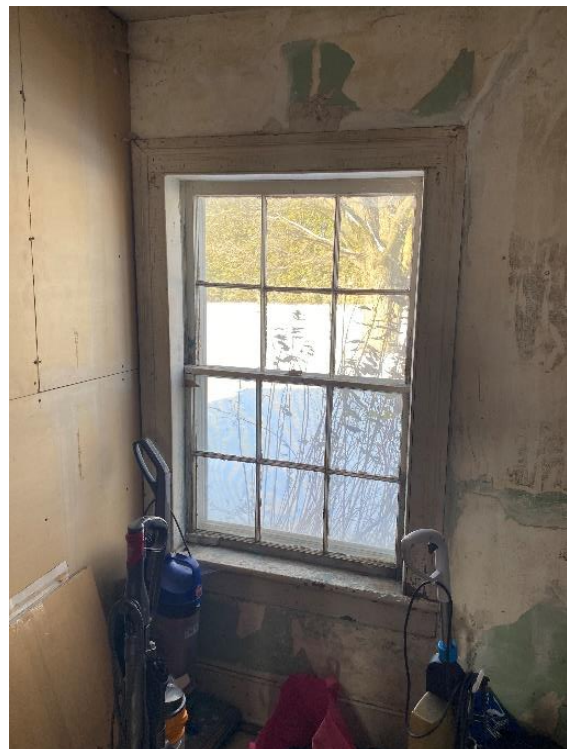
**Plate 73: Side addition storage room window on west elevation**

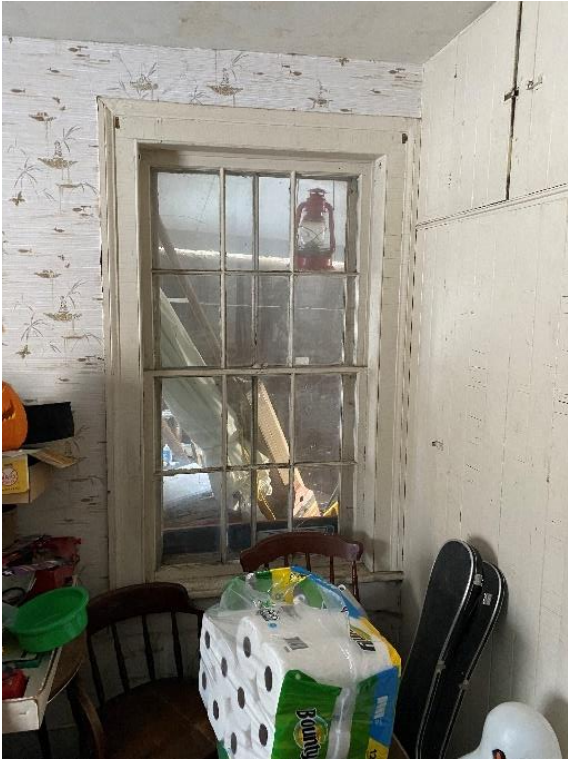
**Plate 74: North elevation window**

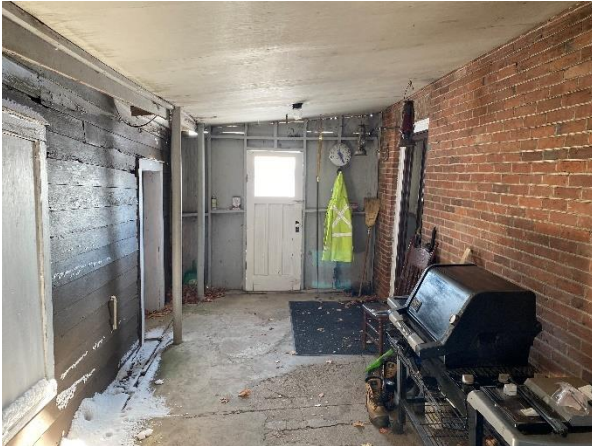
A frame and plywood side passage between the main block and summer kitchen rests on a concrete pad and extends along the north elevation of the main block (Plate 76 to Plate 81). The side passage encloses part of the footprint of a veranda that previously wrapped around the north and east elevations of the farmhouse. This veranda is depicted in a mid-20th century painting of the house (Plate 1). The original veranda support pillars are extant in the rear addition (Plate 78 and Plate 79 ). The rear addition connects the house to a large summer kitchen north of the main block. The south wall of the addition is composed of the brick wall of the north elevation of the main block. The north wall of the addition is composed of the wood wall of the south elevation of the summer kitchen. The east and west walls of the addition are composed of recently added plywood.

**Plate 76: Enclosed frame and plywood side passage on the north elevation**

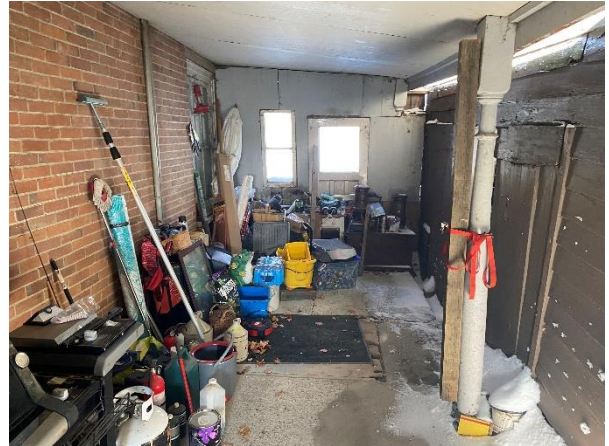
**Plate 77: Enclosed frame and plywood side passage on the north elevation**

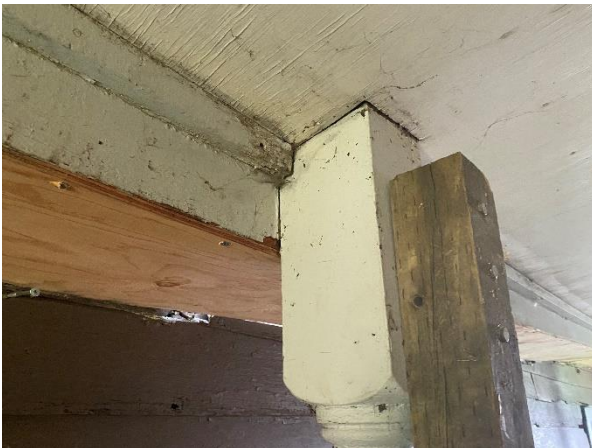
**Plate 78: Original veranda pillar**

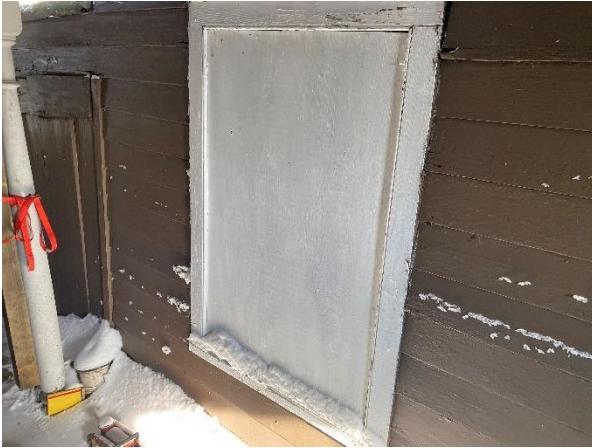
**Plate 80: Framed window opening between frame and plywood addition to storage room/summer kitchen**

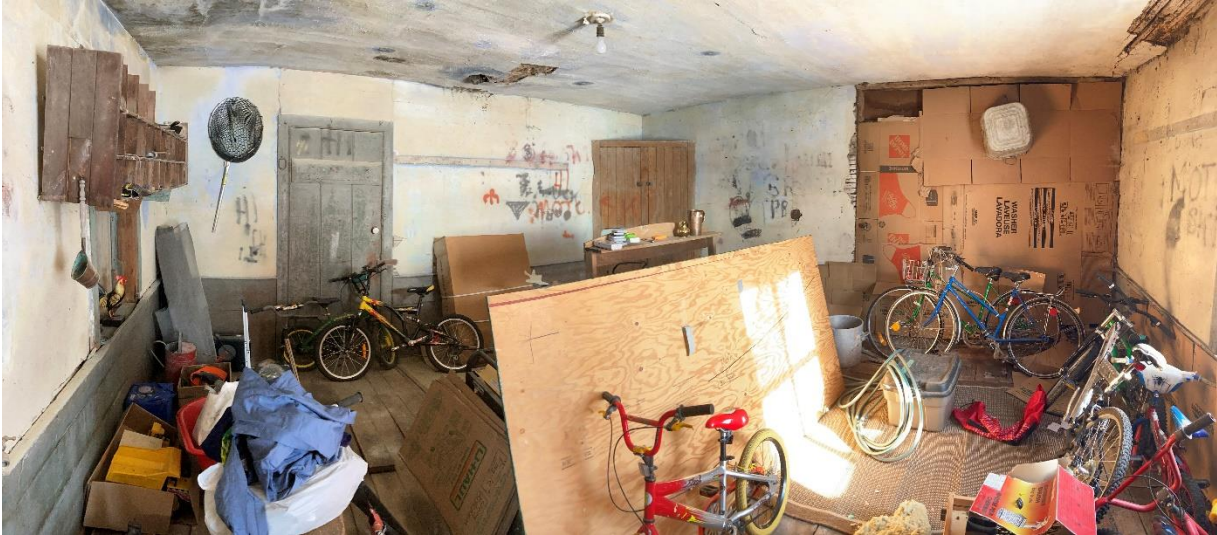
Plate 82: East storage room of north addition

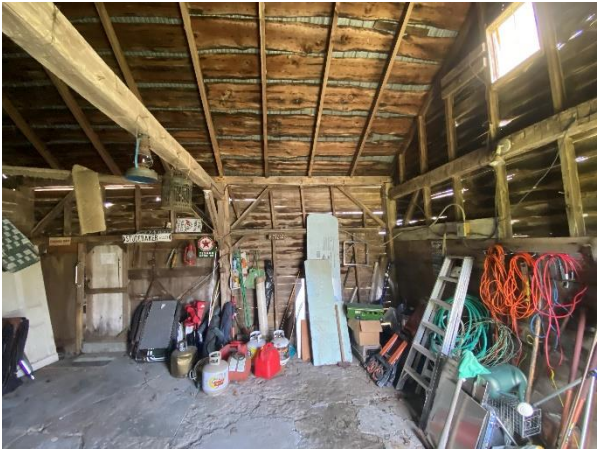
Plate 83: West storage room of north addition

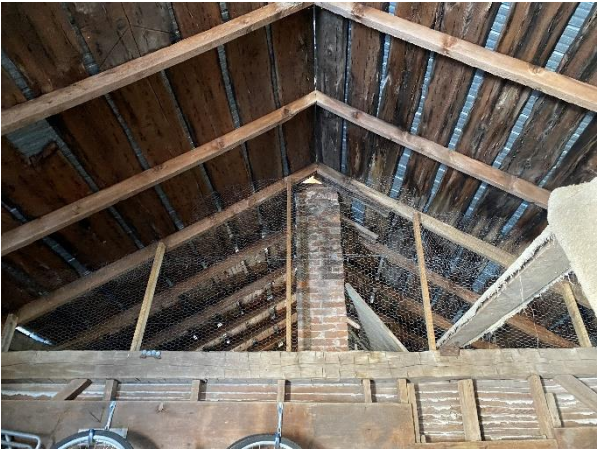
Plate 84: Central brick chimney remnant in north addition

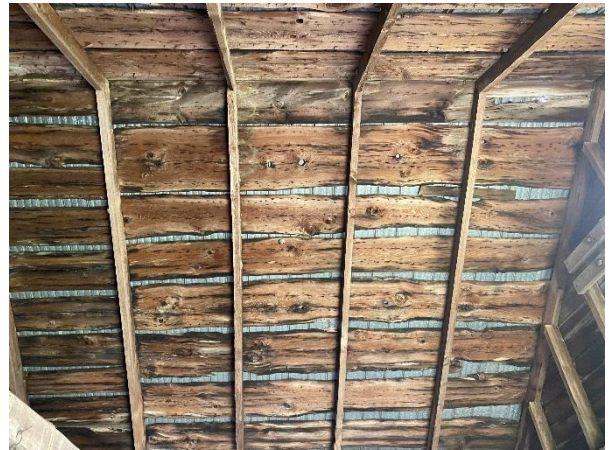
**Plate 86: Wide board roof sheathing**

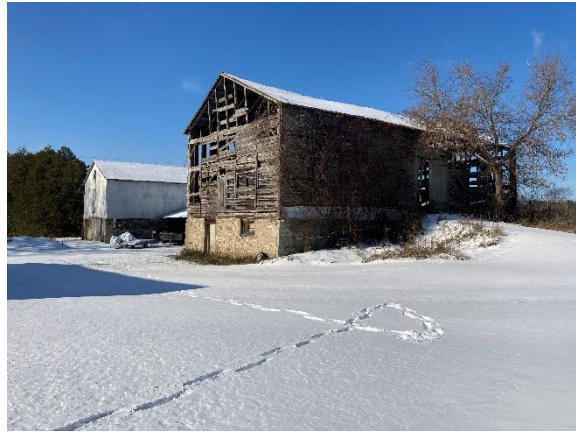
**Plate 90: North and east elevations of north barn**

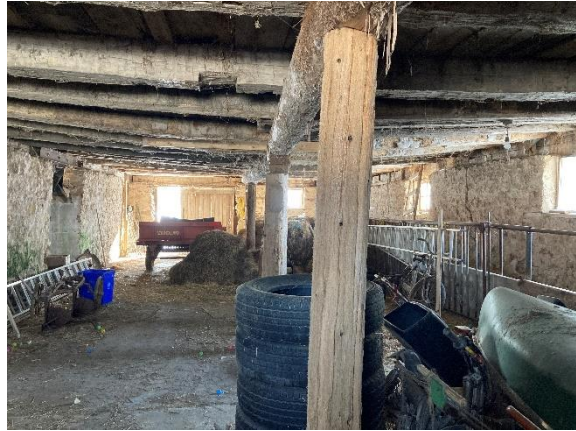
**Plate 96: South barn interior showing hand hewn beams and redundant mortices**

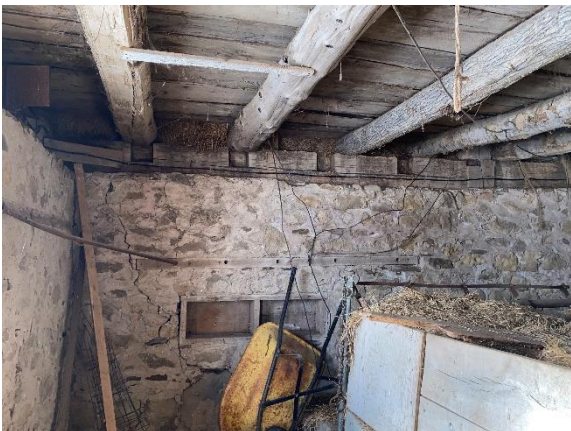
**Plate 97: South barn interior, redundant mortices visible along sill**

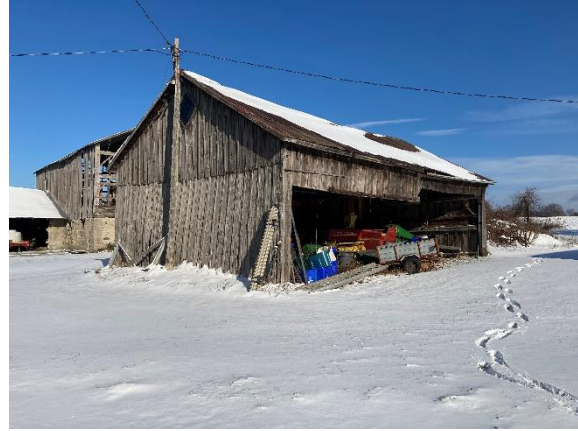
Two outbuildings are located to the north (rear) of the house. Outbuilding No. 1 is a timber-framed drive shed with a metal gable roof (Plate 100). Wide plank sheathing on the rafters have been covered in corrugated sheet metal (Plate 101 and Plate 102). The drive shed roofing has undergone similar upgrades to the rafters as the summer kitchen. While the rafters appear to have been replaced, the plank sheathing seems to have been reused. This structure features a diamond shaped gable window on the south elevation and a diamond cross owl hole within the gable of the north elevation (Plate 103 and Plate 104). The outline of the original opening to the drive shed is visible on the west elevation and was closed using the same board and batten wood siding as the rest of the structure (Plate 105). The current opening is a modification to the original structure and is located on the east elevation.

**Plate 100: Outbuilding No. 1 (timber framed drive shed)**

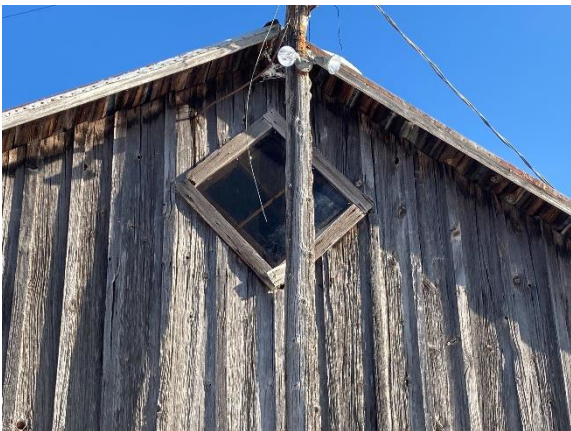
**Plate 103: Diamond gable window on south elevation of Outbuilding No. 1**

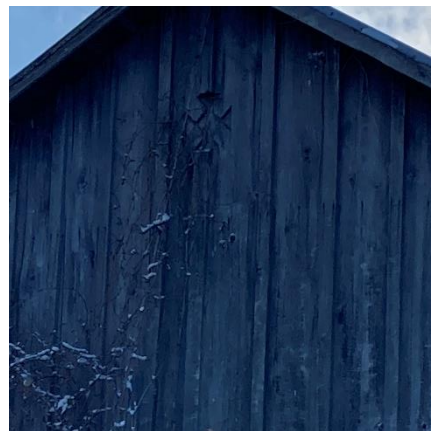
**Plate 104: Diamond cross owl hole on north elevation of Outbuilding No. 1**

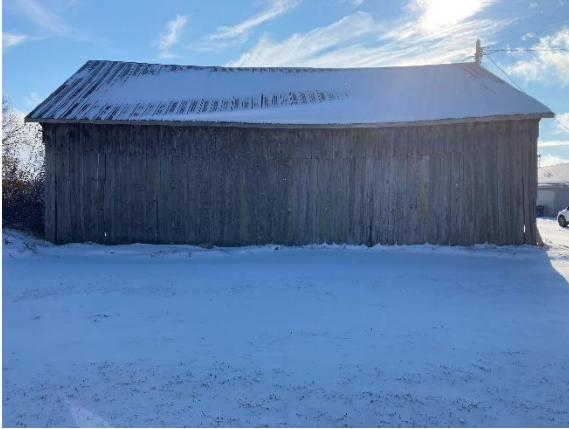
**Plate 105: West elevation of Outbuilding No. 1 showing the (now boarded) original entrance which faced the driveway**
