February 14, 2025

**Re: Fluvial Geomorphic Assessment at Credit River and Tributary System in Caledon, Ontario  
Proposed CBM Caledon Pit/Quarry Project  
GEO Morphix Ltd. Project No. PN24061 – Report Version 1.0**

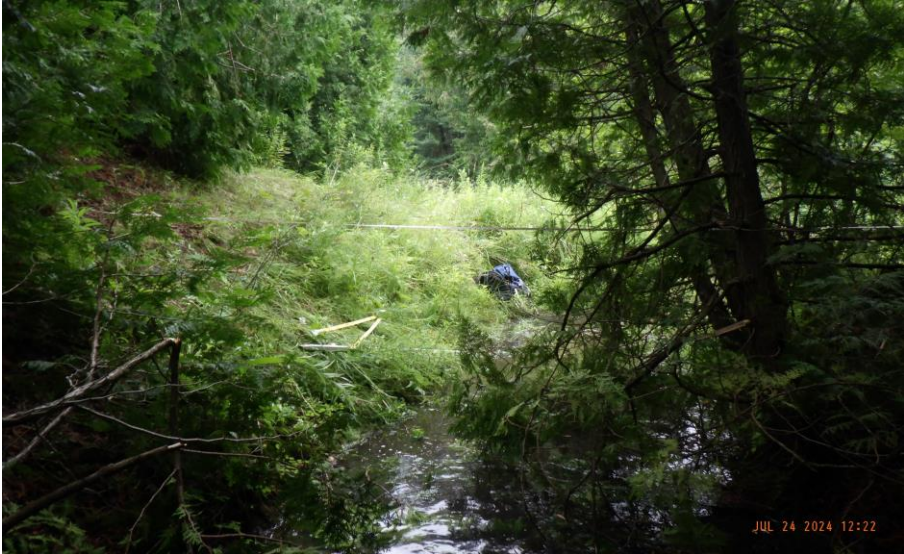
| General Field Observations |
|---|
| <p style="text-align: center;"><b>Channel Description</b></p> <p>The East Ponds Outlet Channel is a minor, ~35m tributary of the Credit River in Caledon, ON which conveys flows from the southeast side of the Osprey Valley Golf Course (OVGC) through a series of inline ponds, and into the mainstem of the Credit River. During the time of assessment, water was observed overtopping the banks of the nearest upstream inline pond, permitting flow through the subject reach, with no flow observed from the outflanked tile drain. The subject reach consisted of a straight channel within a confined, forested valley with a prominent knickpoint (~0.75m) at the upstream extent, revealing the exposed tile. Channel bed morphology was notably homogeneous downstream of the knickpoint and was planar in profile; however, channel substrates became gradually finer downstream, with materials consisting of sand and small to large cobbles (Embeddedness: 10-40%; <math>D_{50}</math>: 10.8 mm). The channel exhibited multiple indicators suggestive of aggradation, widening and degradation. Aggradation processes were supported by the observed sediment accumulation at the downstream extent, but was ultimately secondary to widening and degradational processes. These processes were evidenced by the persistent scour and exposed roots observed along the toe of the valley wall, as well as the exposed tile drainage.</p> <p style="text-align: center;"><b>Cross Section 3 - Facing Downstream</b></p> |

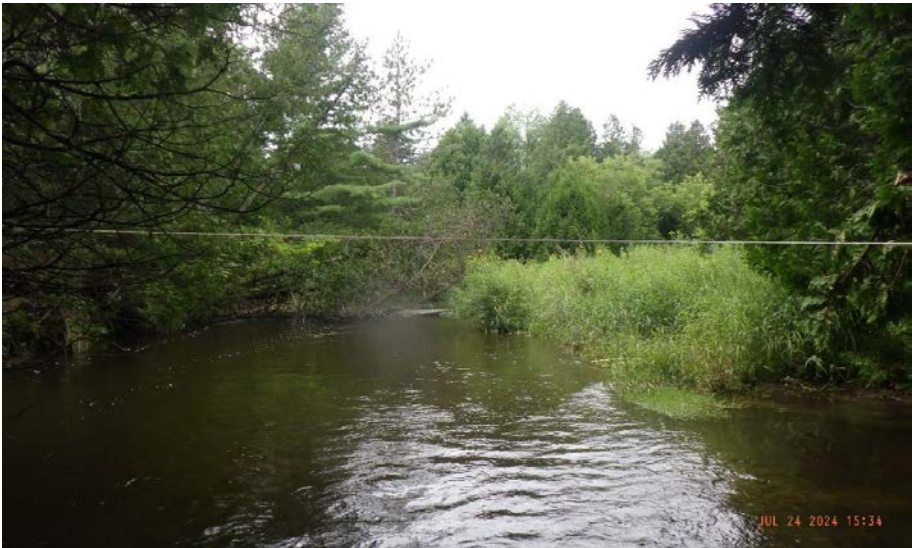
Cross Section 2 - Facing Upstream

The assessed stretch of channel consisted of ~400m of the Credit River in Caledon, ON, receiving inputs from the East Ponds Outlet Channel originating from the Osprey Valley Golf Course (OVGC). The Credit River was characterized by a meandering channel set within a forested corridor. Dominant riparian vegetation consisted of coniferous trees which provided good cover over the channel and stability to the loosely consolidated, sandy-silt banks. Channel bed morphology demonstrated notable heterogeneity and was characterized by an alternating riffle-pool sequence featuring abundant micro-habitats/refugia. Widening processes were evidenced by fallen and leaning trees, as well as bank scour, while evidence of planimetric form adjustment was observed by an occasionally misaligned thalweg in straight sections of channel. Significant valley wall contact was observed along both banks, particularly upstream from the confluence with the East Ponds Outlet Channel. Despite steady inputs of sand and silt due to the described bank scour, aggradational processes were less significant as stream conditions were sufficient in preventing the formation of in-channel bars and embedment of larger substrates that would otherwise be

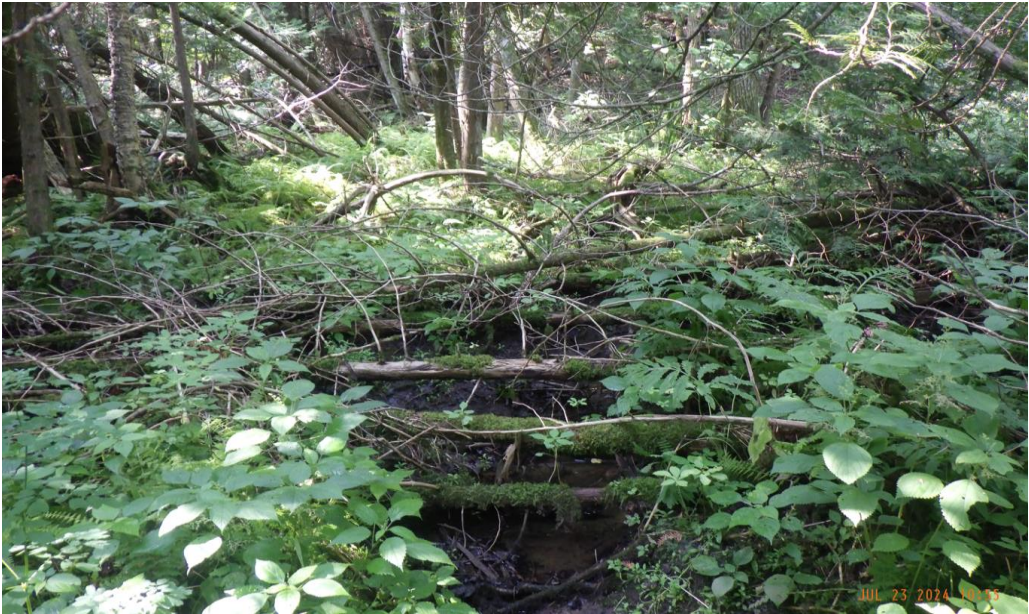
| General Field Observations | |
|---|--|
| <p style="text-align: right;"><b>Channel Description</b></p> <p>Tributary 4 flows unconfined northwest through a golf course before discharging to the Credit River upstream of the East Ponds Outlet Channel. At time of assessment, the channel was predominantly dry with some flow occurring within isolated pools. The riparian zone was continuous, spanning over 10 channel widths and consists of mature vegetation. Heavy encroachment of vegetation into the channel was observed, along with a high density of woody debris. Rooted emergent aquatic vegetation was also present at time of assessment. Bank angles range from 15-45, with no undercutting observed. The right and left bank consisted primarily of very fine to medium sand, with a small percentage of coarse sand, gravel and small stones. The bed was composed of medium to very coarse sand, with small to large cobbles observed throughout the extent of the channel.</p> <p style="text-align: center;"><b>Cross Section 3 - Facing Downstream</b></p> | |

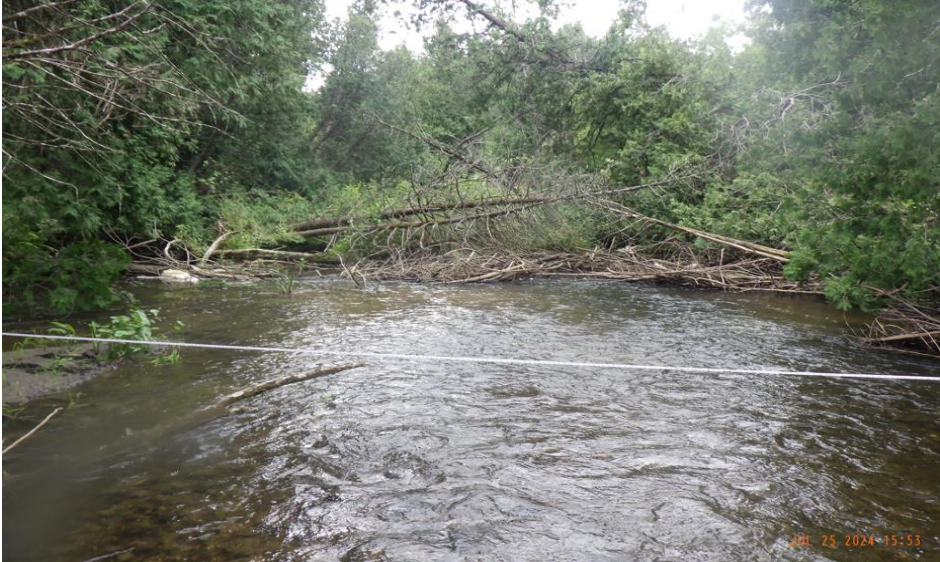
| General Field Observations |
|---|
| <div>Channel Description</div> <p>The assessed stretch of channel consisted of ~450m of the Credit River in Caledon, ON, receiving inputs from Tributary 4 from the Osprey Valley Golf Course (OVGC). The Credit River at Tributary 4 was characterized by a meandering channel set within an expansive, forested corridor, with localized pockets of meadow habitat. Dominant riparian vegetation consisted of coniferous trees which provided good cover over the channel and stability to the loosely consolidated, sandy-silt banks. Channel bed morphology demonstrated notable heterogeneity and was characterized by an alternating riffle-pool sequence featuring abundant micro-habitats/refugia. Widening processes were evidenced by fallen and leaning trees, as well as bank scour, while evidence of planimetric form adjustment was observed by an occasionally misaligned thalweg in straight sections of channel, and formation of several islands. The upstream extent of the channel was marked by a debris jam resulting in multiple flow paths and sediment accumulation. Aggradational processes within the channel were limited due to sufficient flow conditions allowing for transport of the fine sediment input from the eroded/undercut banks.</p> <div>Cross Section 6 - Facing Upstream</div> |
