# Fluvial Geomorphological Assessment and Flow Monitoring

## Tributary of Etobicoke Creek

### Snell's Hollow Secondary Plan Town of Caledon, Ontario

April 15, 2020  
PN19033

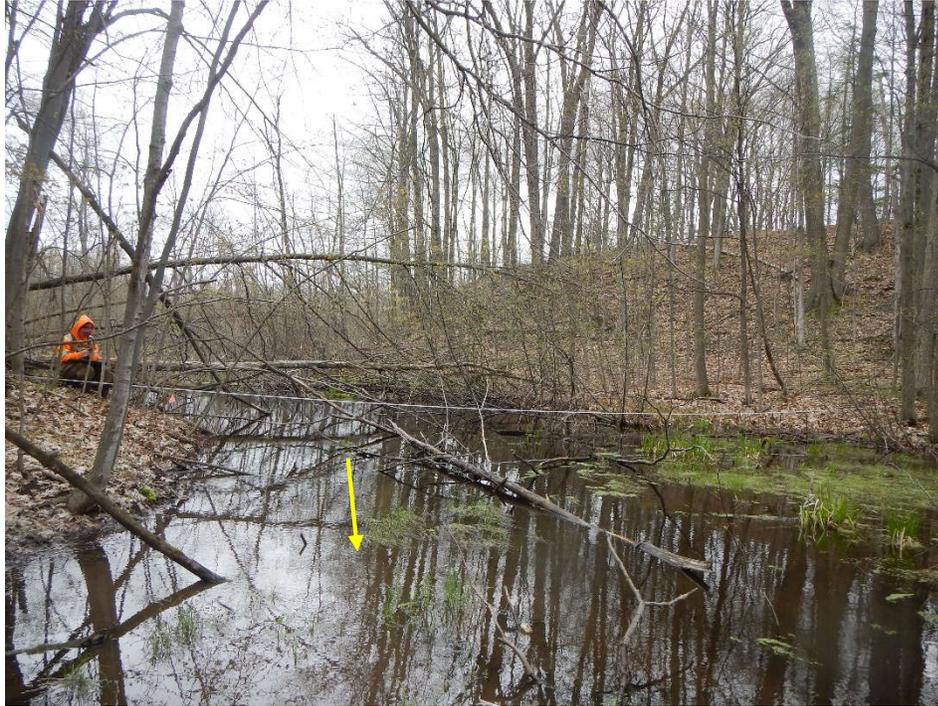
Photo 1  
Tributary of Etobicoke Creek  
Reach EC-1 Cross section 1

Channel flowed through a confined, wooded valley with a low gradient. Yellow arrow denotes flow direction.

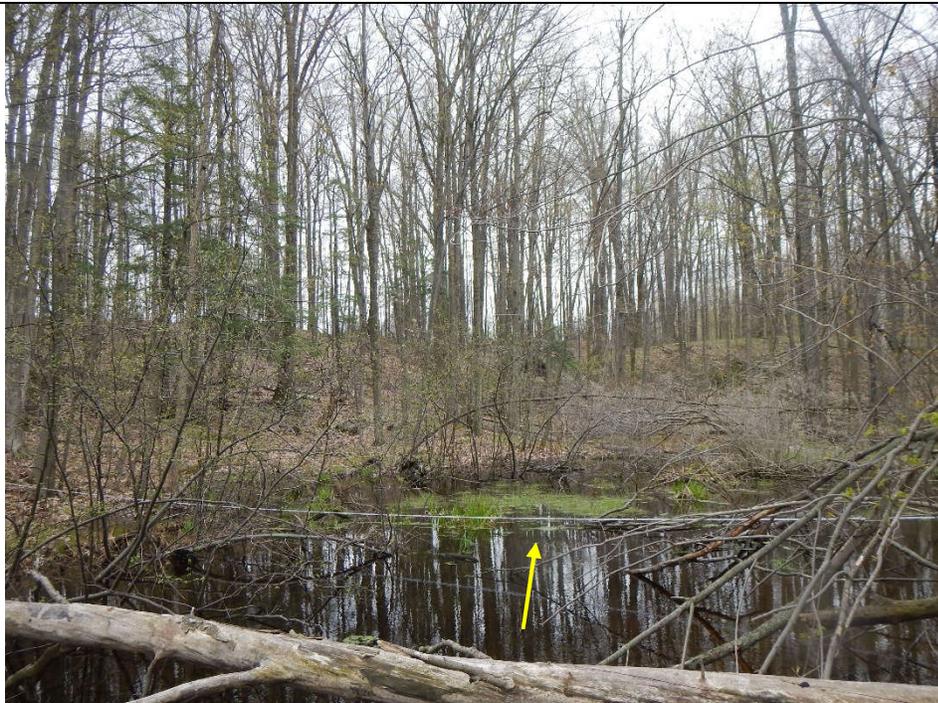
Photo 2  
Tributary of Etobicoke Creek,  
Reach EC-1 Cross section 1

Woody debris present in the channel was not attributed to channel adjustment (e.g. widening or planform adjustment) as there was limited erosion in the reach.

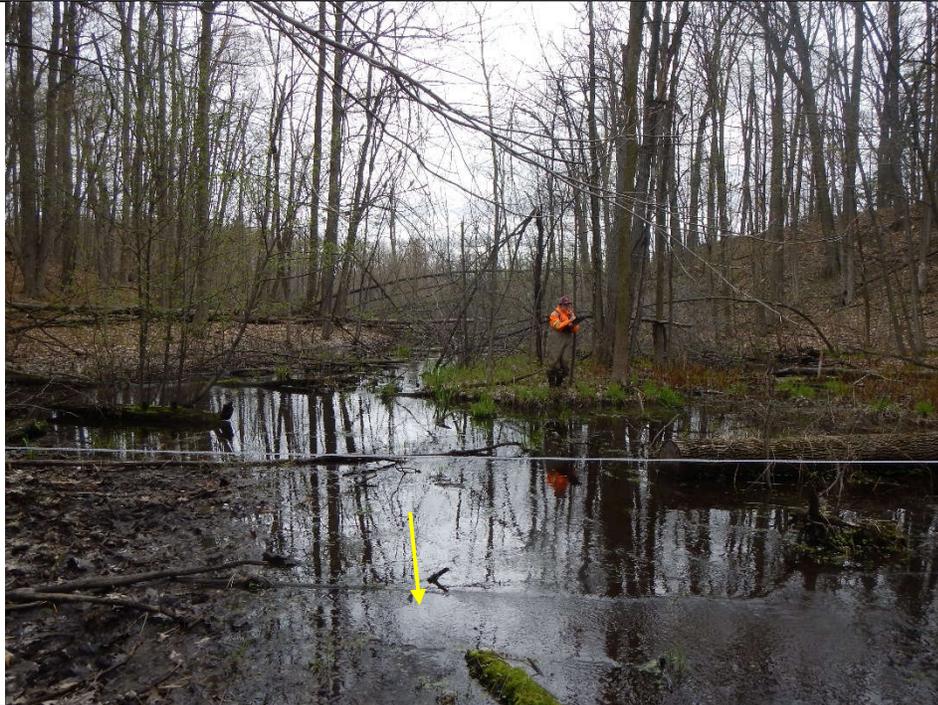
Photo 3  
Tributary of Etobicoke Creek  
Reach EC-1 Cross section 2

Channel was wide and shallow, with low bank angles on both sides.

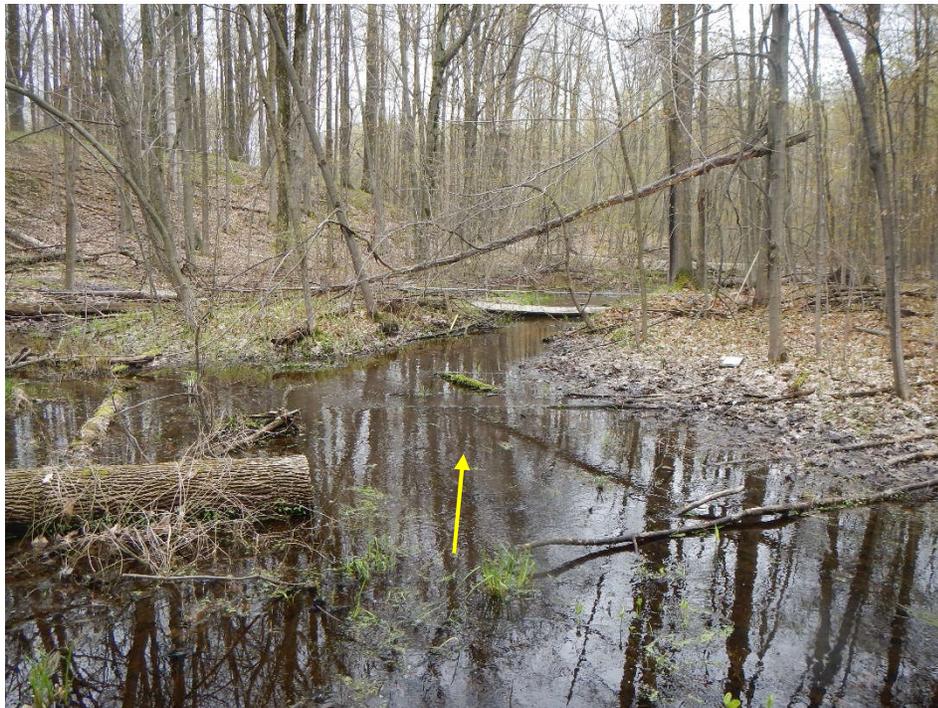
Photo 6  
Tributary of Etobicoke Creek  
Reach EC-1 Cross section 3-M

Vegetation established in the channel bed was indicative of low flow velocities

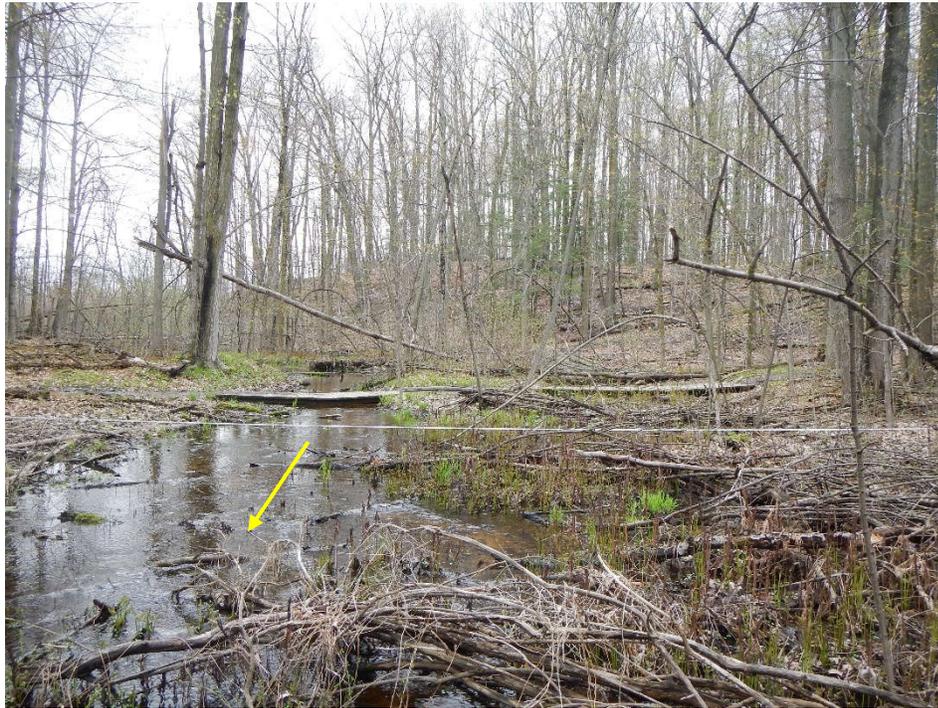
Photo 7  
Tributary of Etobicoke Creek  
Reach EC-1 Cross section 4-M

Channel showed wetland-like characteristics and contained clay, silt and sand substrates. No riffles or pools were present.

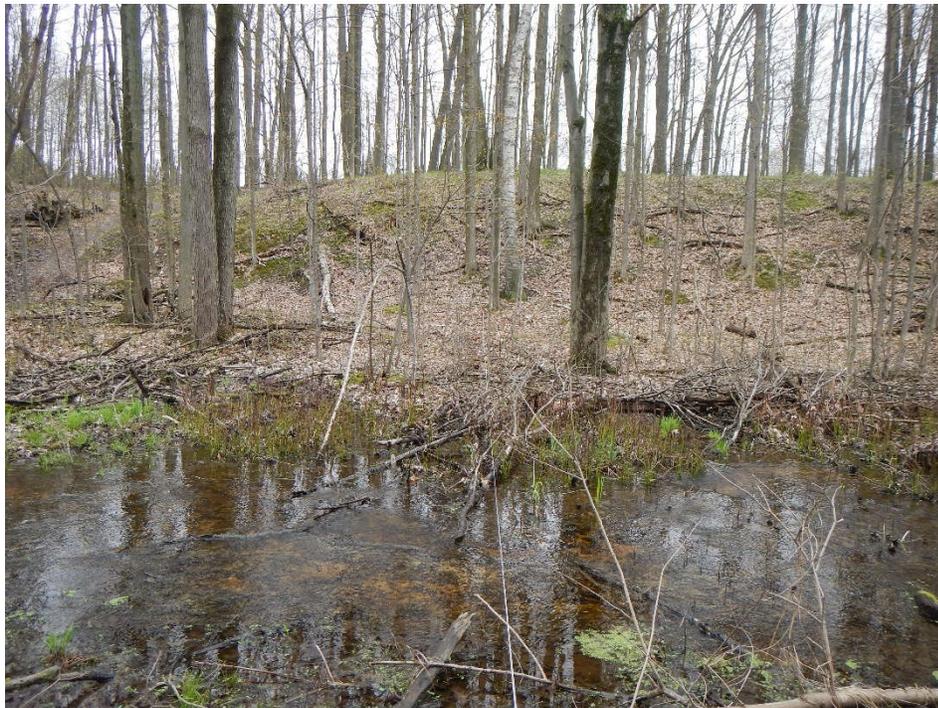
Photo 8  
Tributary of Etobicoke Creek,  
Reach EC-1 Cross section 4-M

View of the left bank and associated riparian vegetation, which provided shade to the feature.

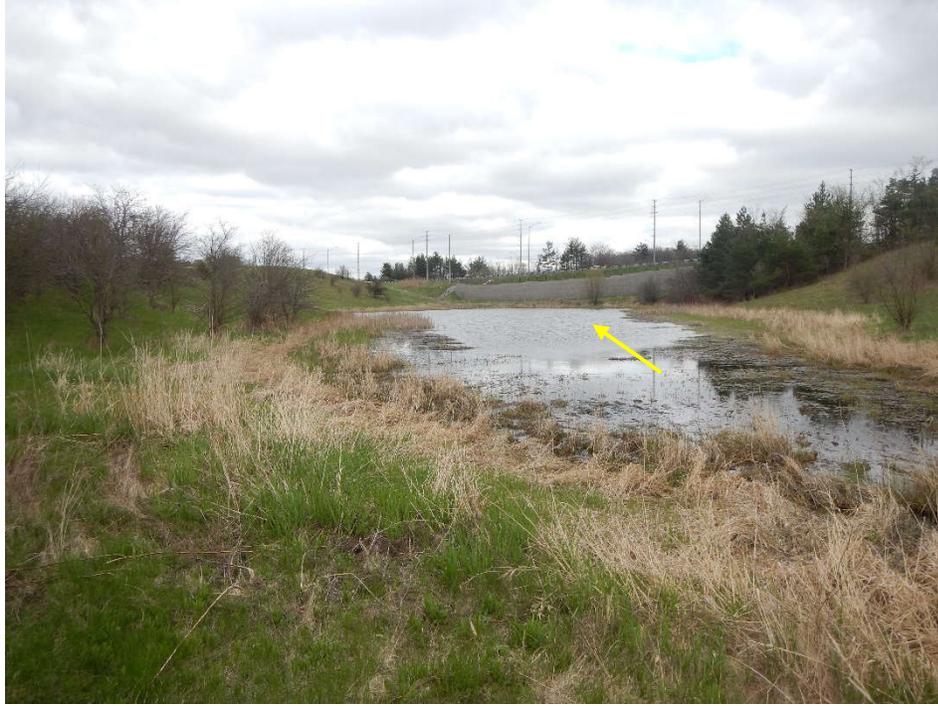
Photo 13  
Tributary of Etobicoke Creek,  
Reach EC-2

Photo taken from the upstream extent of the reach showing the open water feature.

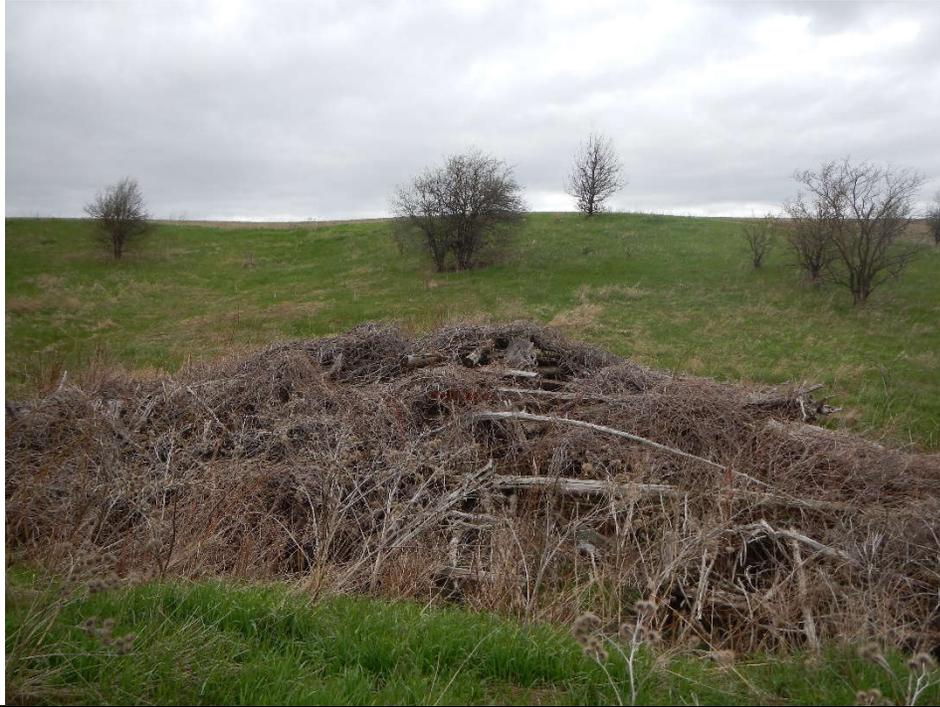
Photo 17  
Tributary of Etobicoke Creek  
Reach EC-2a

A large brush pile was present mid-reach.

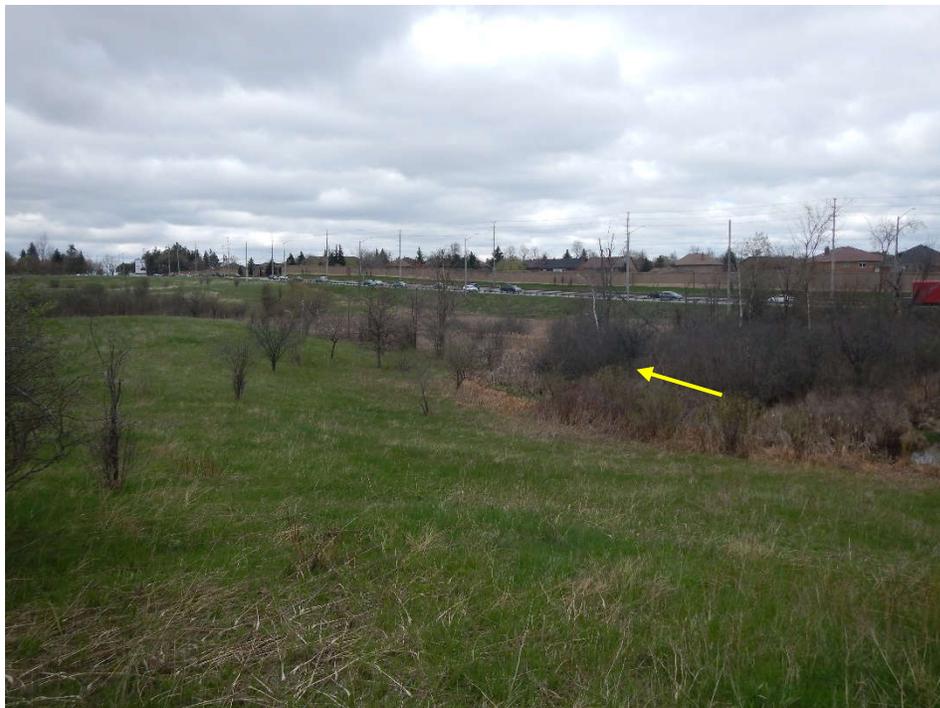
Photo 20  
Tributary of Etobicoke Creek  
Reach EC-3

Photo taken from the west side of **Reach EC-3**, facing east across the wetland feature towards Mayfield Road.

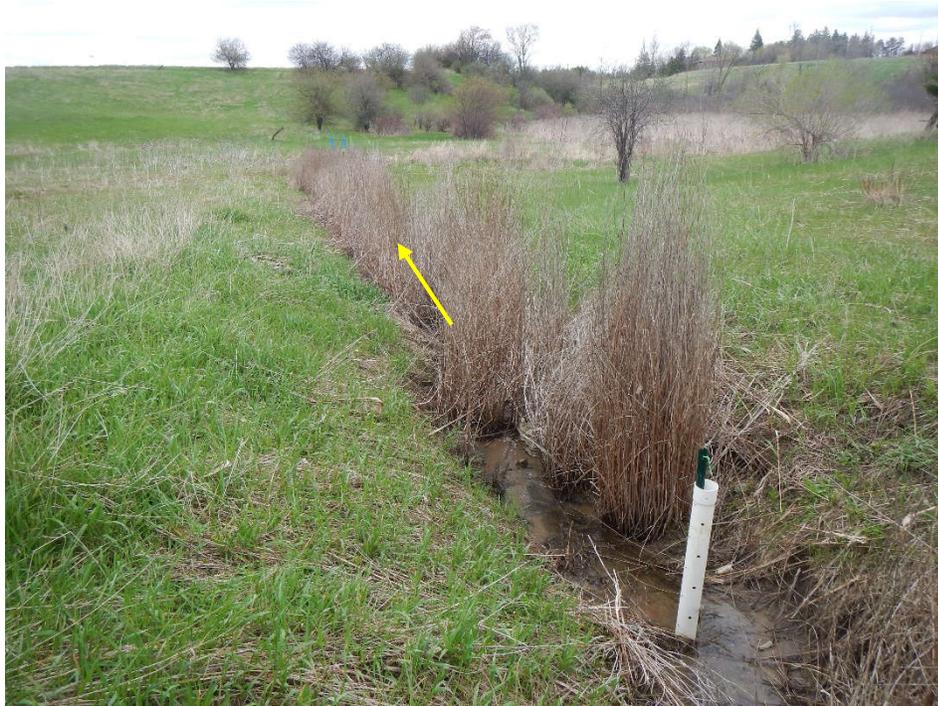
Photo 23  
Tributary of Etobicoke Creek  
Reach EC-3a

Photo taken at the **W Inlet** flow monitoring site facing downstream. Reach was a ditch feature draining a property upstream.

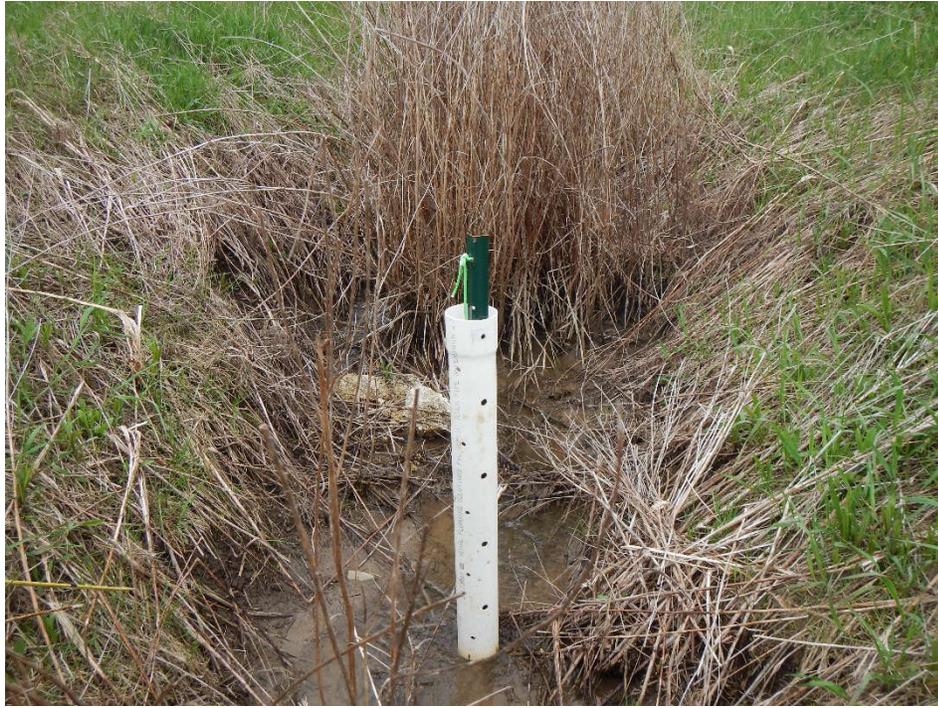
Photo 25  
Tributary of Etobicoke Creek,  
Flow Monitoring Site: W Inlet

Photo taken facing upstream after a 21.59 mm rain event.

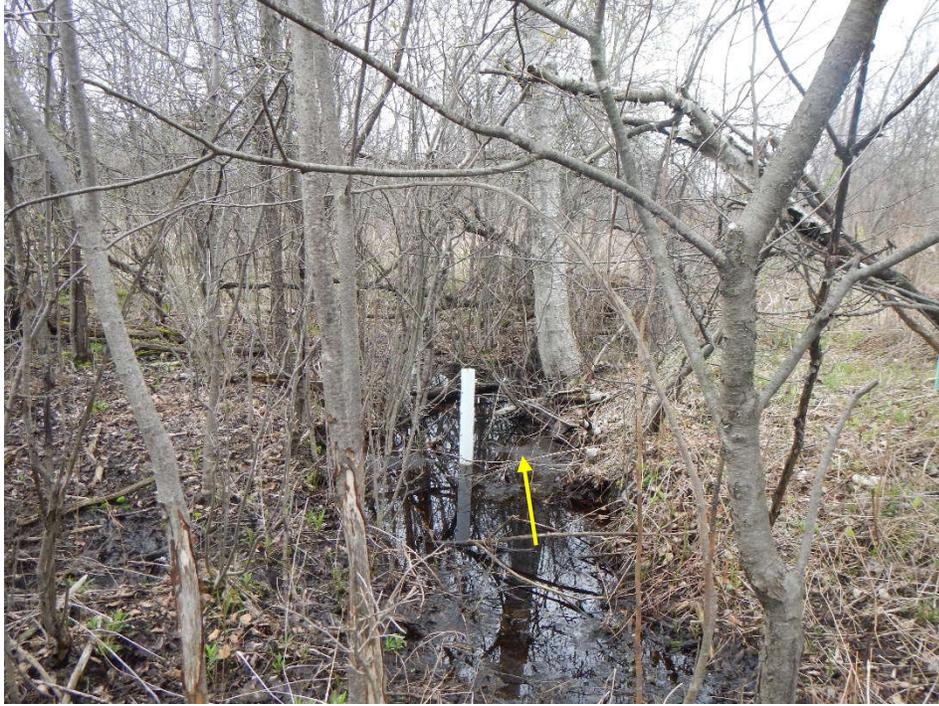
Photo 27  
Tributary of Etobicoke Creek  
Flow Monitoring Site: S Inlet

Photo taken facing downstream after a 21.59 mm rain event.

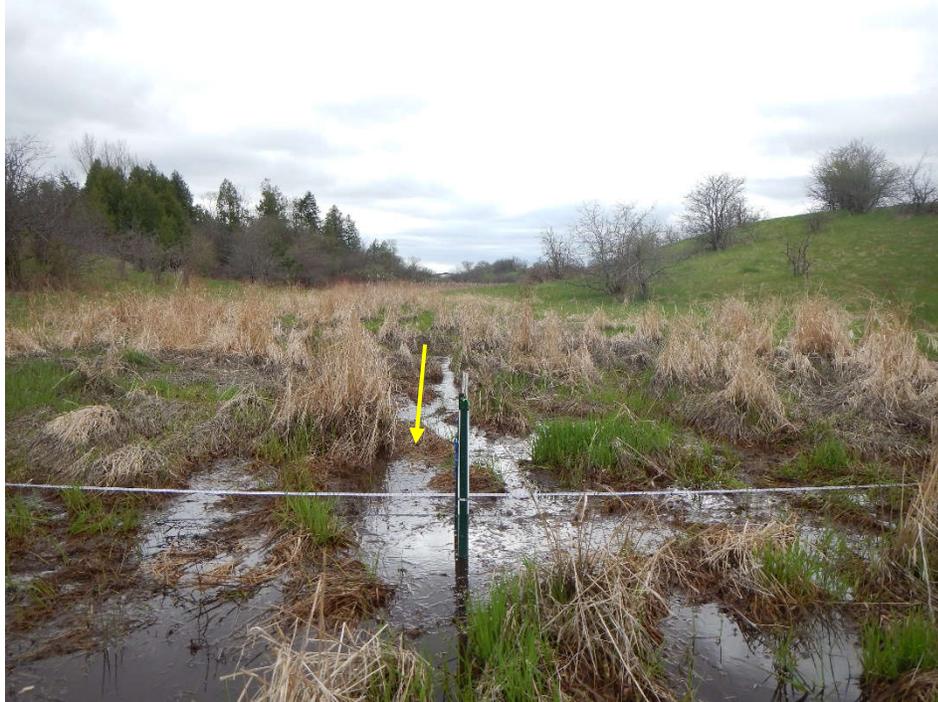
Photo 29  
Tributary of Etobicoke Creek  
Flow Monitoring Site: Bridge

Photo taken facing upstream after a 21.59 mm rain event.

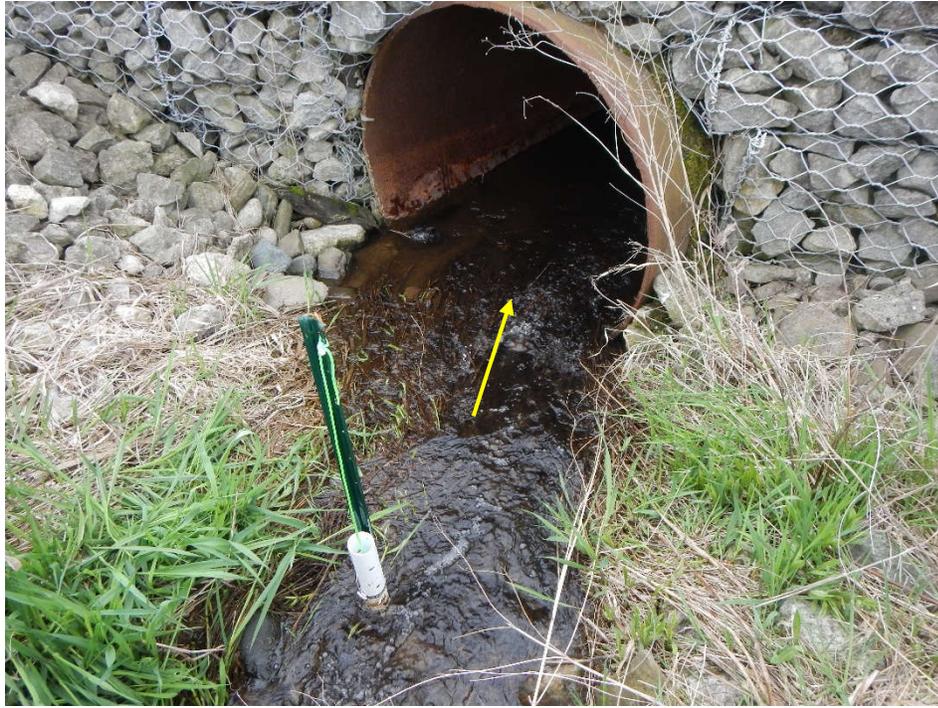
Photo 31  
Tributary of Etobicoke Creek  
Flow Monitoring Site: Outlet

Photo taken facing downstream towards the Mayfield Road culvert after a 21.59 mm rain event.

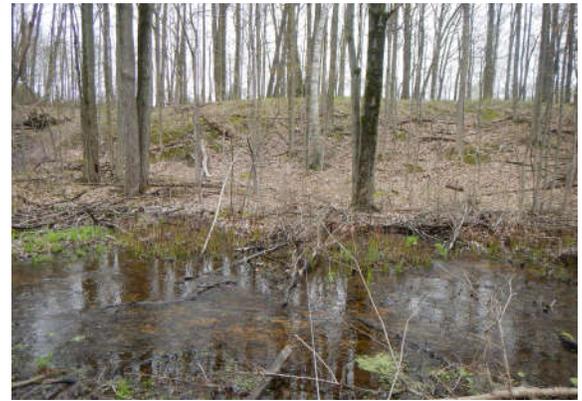
Photograph at cross section 4 (left bank)

Bank Characteristics						
	Minimum	Maximum	Average	Minimum	Maximum	Average
<b>Bank Height (m):</b>	0.2	0.70	0.45			
<b>Bank Angle (deg):</b>	10	45	24	<b>Torvane Value (kg/cm<sup>2</sup>):</b>	Not measured	
<b>Root Depth (m):</b>	0.05	0.20	0.10	<b>Penetrometer Value (kg/cm<sup>3</sup>):</b>	Not measured	
<b>Root Density (%):</b>	10	70	42	<b>Bank Material (range):</b>	Clay, silt, sand	
<b>Bank Undercut (m):</b>	No undercuts
