Fluvial Geomorphological Assessment and Baseline Monitoring

Tributary of Etobicoke Creek

Snell's Hollow Secondary Plan Town of Caledon, Ontario

April 8, 2021
PN19033

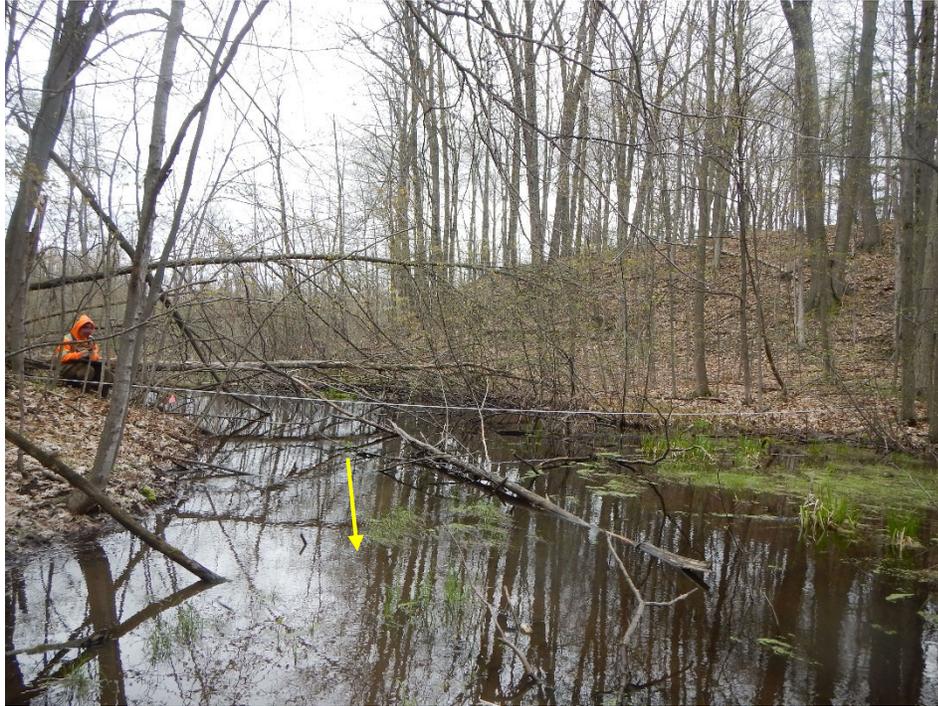
Photo 1
Tributary of Etobicoke Creek
Reach EC-1 Cross section 1

Channel flowed through a confined, wooded valley with a low gradient. Yellow arrow denotes flow direction.

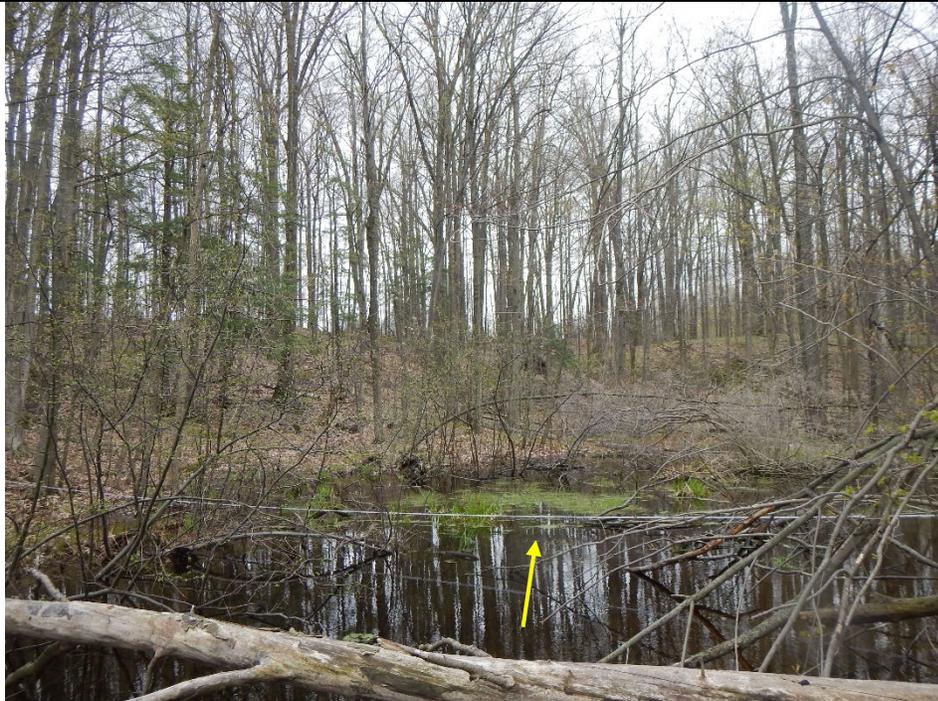
Photo 2
Tributary of Etobicoke Creek,
Reach EC-1 Cross section 1

Woody debris present in the channel was not attributed to channel adjustment (e.g. widening or planform adjustment) as there was limited erosion in the reach.

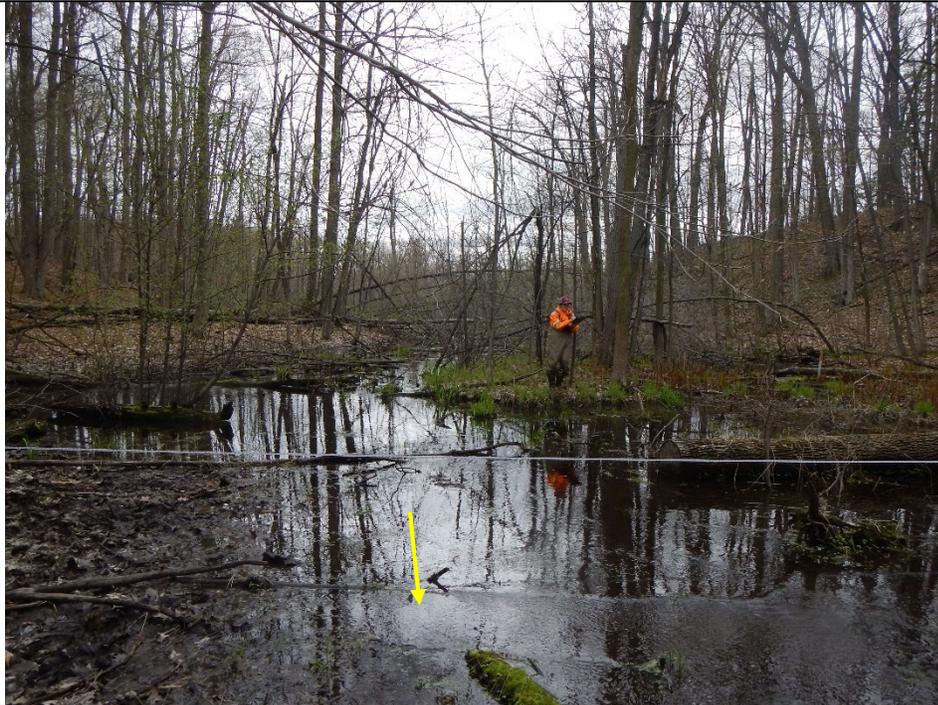
Photo 3
Tributary of Etobicoke Creek
Reach EC-1 Cross section 2

Channel was wide and shallow, with low bank angles on both sides.

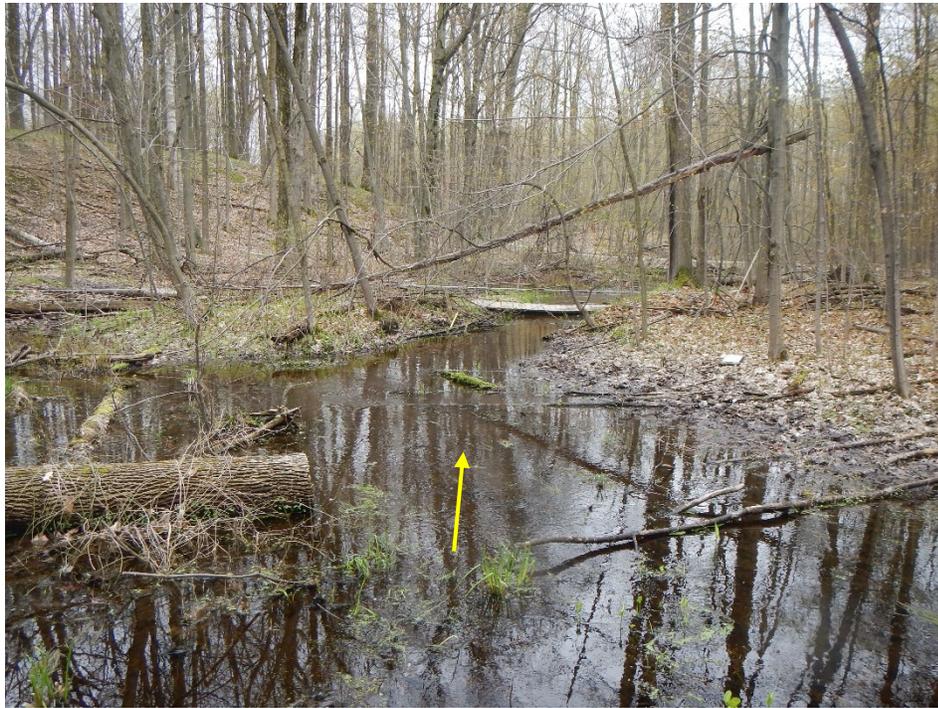
Photo 6
Tributary of Etobicoke Creek
Reach EC-1 Cross section 3-M

Vegetation established in the channel bed was indicative of low flow velocities

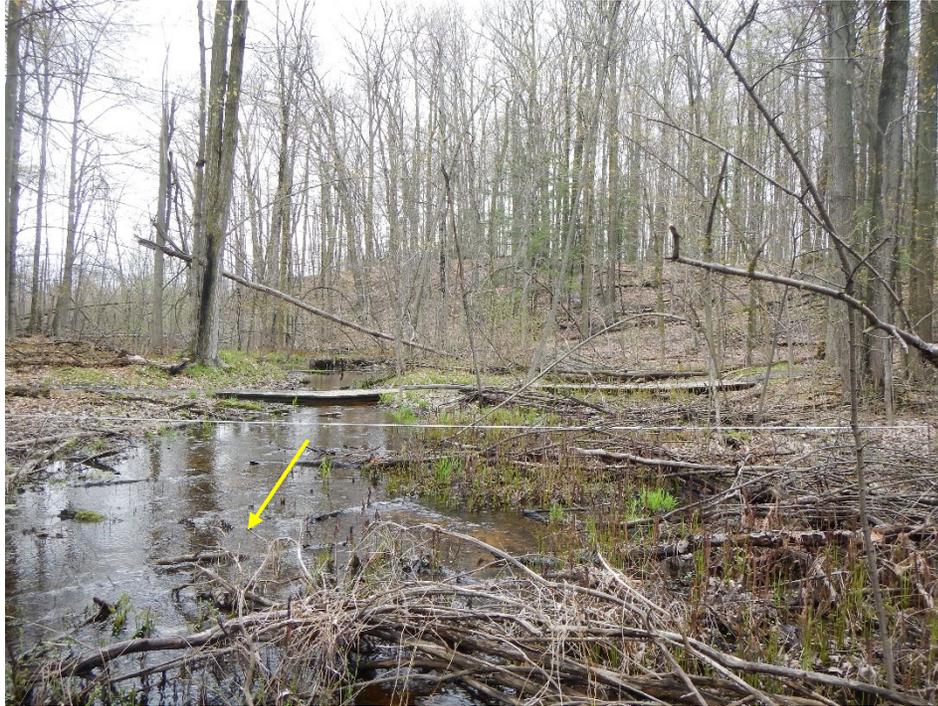
Photo 7
Tributary of Etobicoke Creek
Reach EC-1 Cross section 4-M

Channel showed wetland-like characteristics and contained clay, silt and sand substrates. No riffles or pools were present.

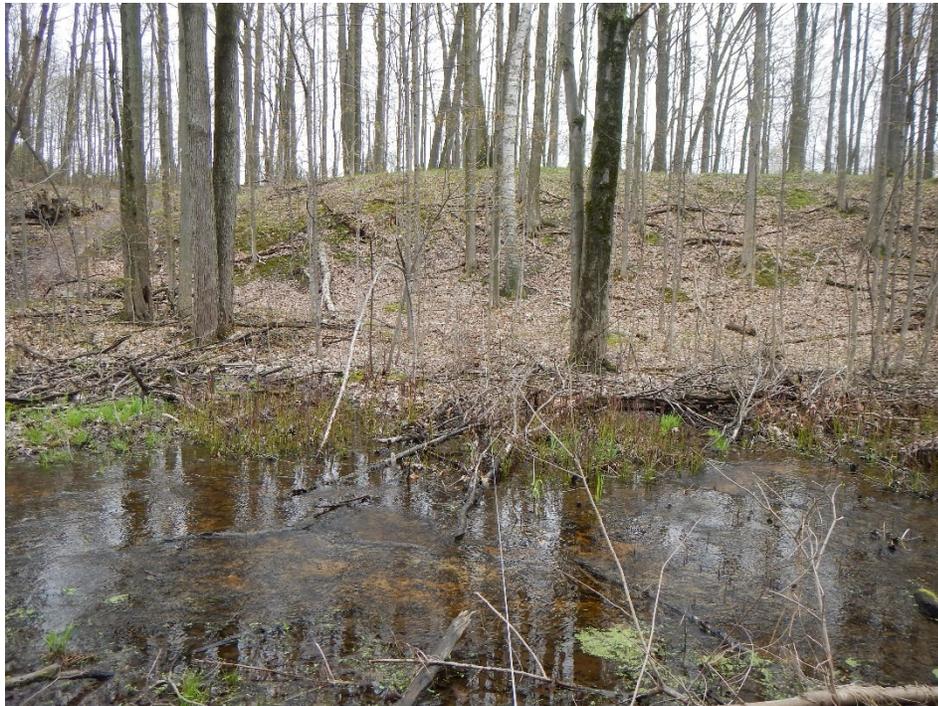
Photo 8
Tributary of Etobicoke Creek,
Reach EC-1 Cross section 4-M

View of the left bank and associated riparian vegetation, which provided shade to the feature.

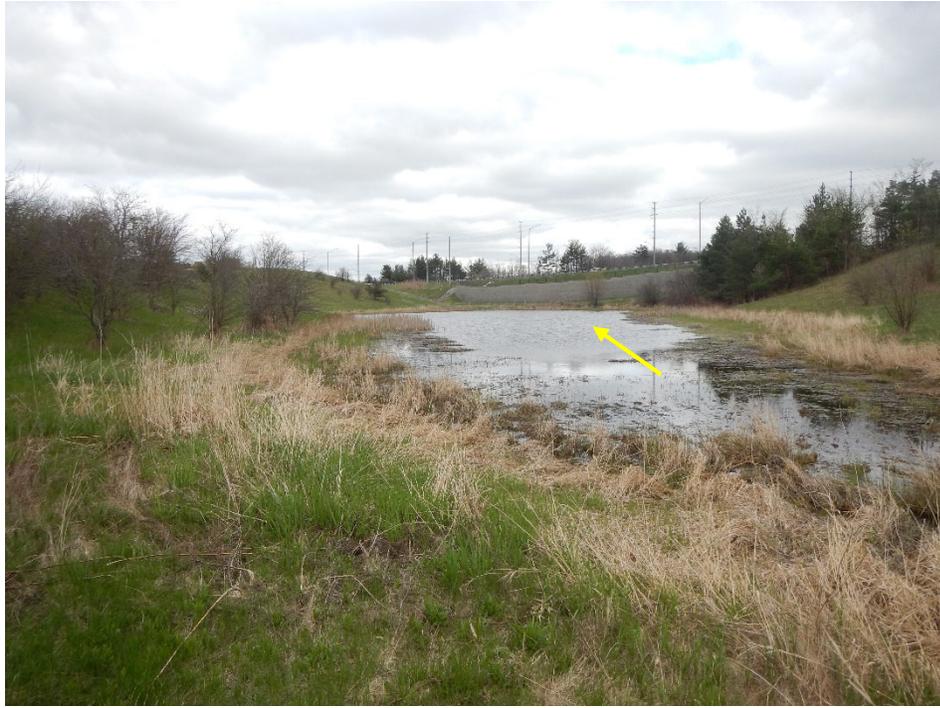
Photo 13
Tributary of Etobicoke Creek,
Reach EC-2

Photo taken from the upstream extent of the reach showing the open water feature.

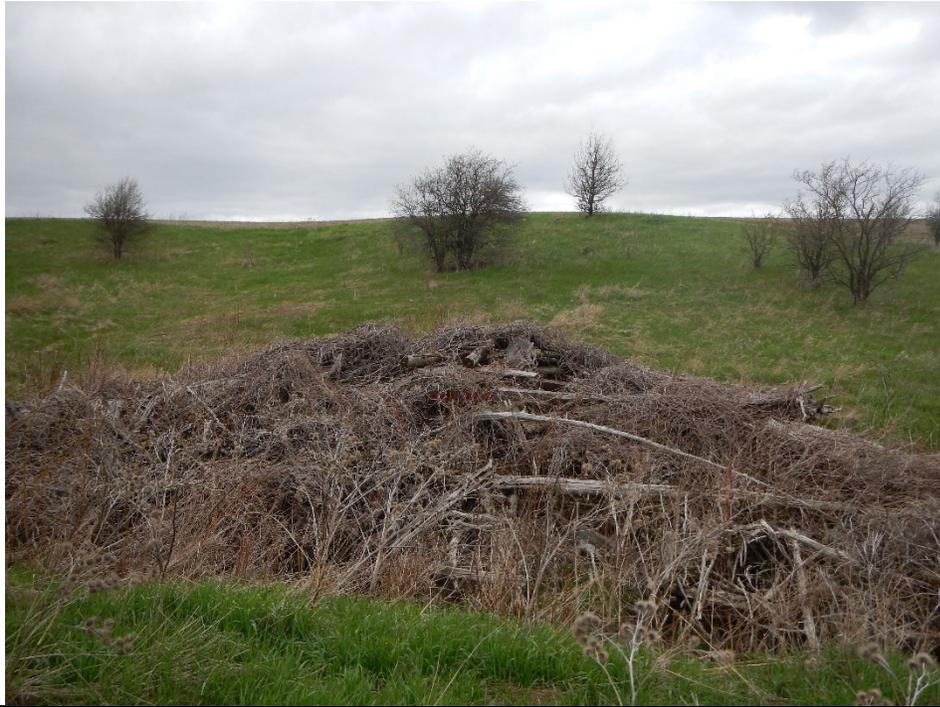
Photo 17
Tributary of Etobicoke Creek
Reach EC-2a

A large brush pile was present mid-reach.

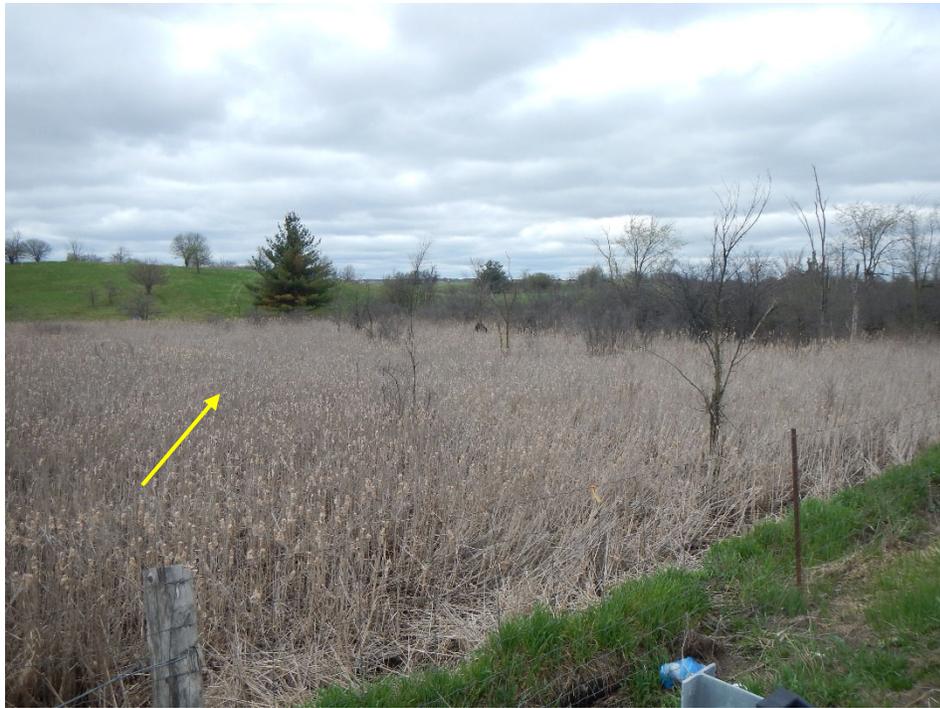
Photo 18
Tributary of Etobicoke Creek,
Reach EC-3

View from the southwest corner of the subject lands. The wetland receives input from an adjacent stormwater management pond.

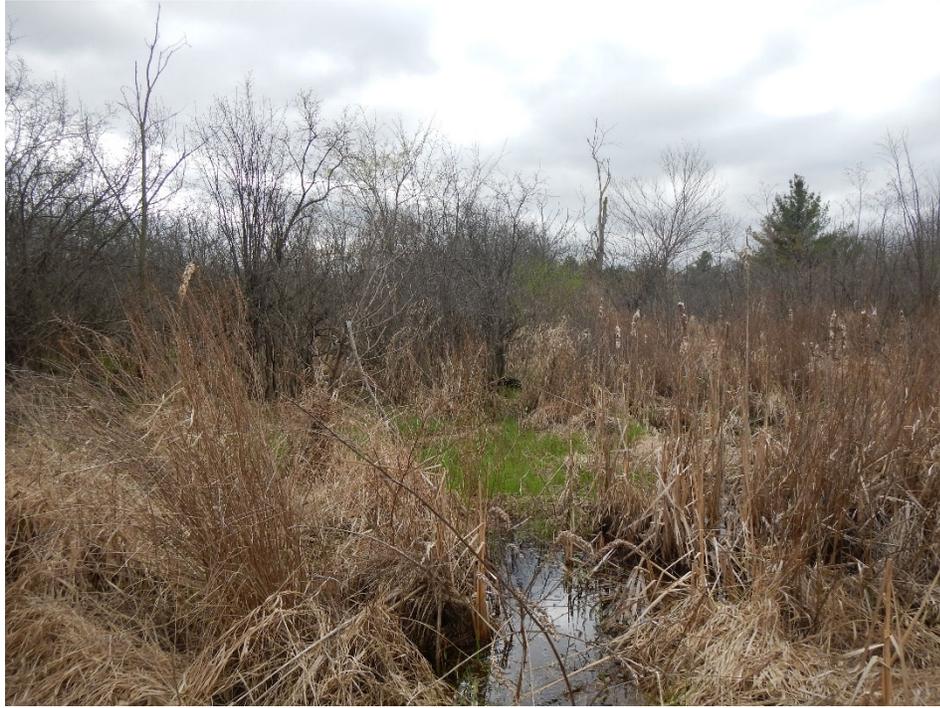
Photo 19
Tributary of Etobicoke Creek
Reach EC-3

Middle of the wetland feature, where standing water was present.

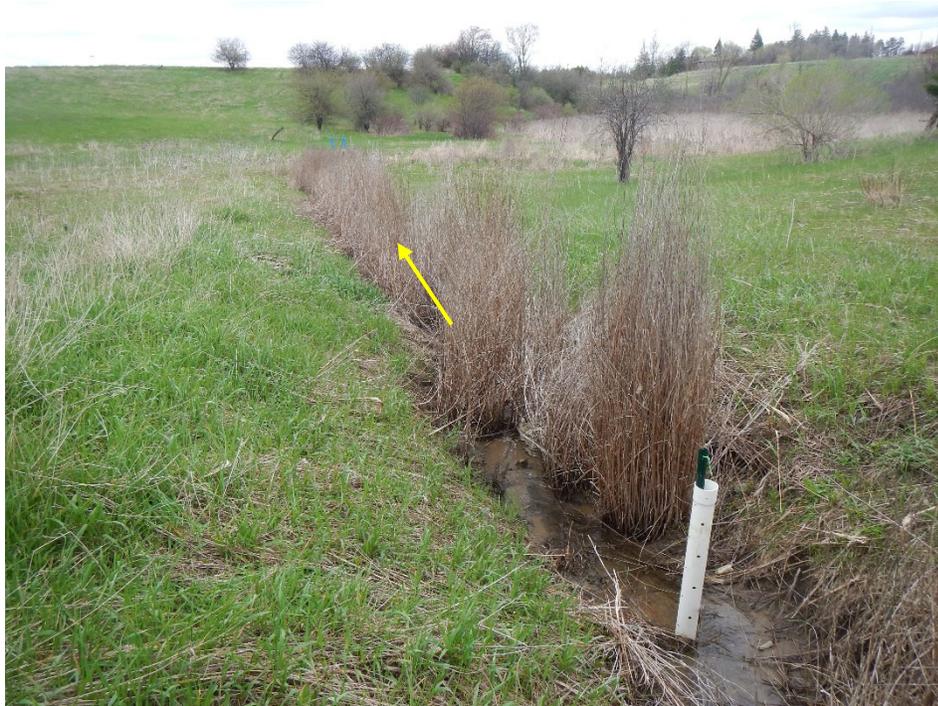
Photo 23
Tributary of Etobicoke Creek
Reach EC-3a

Photo taken at the **W Inlet** flow monitoring site facing downstream. Reach was a ditch feature draining a property upstream.

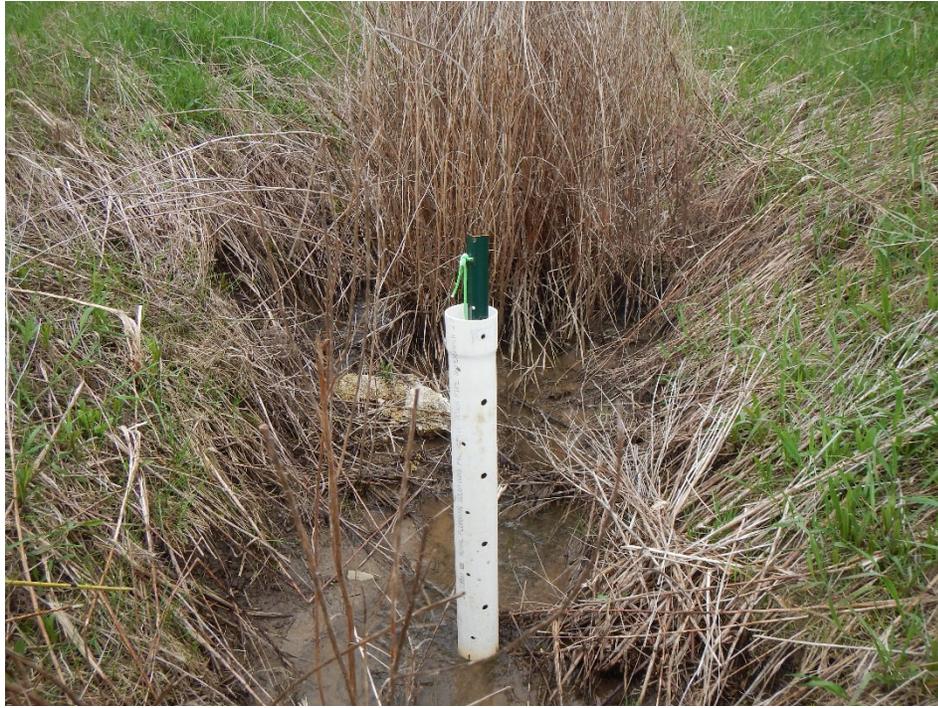
Photo 25
Tributary of Etobicoke Creek,
Flow Monitoring Site: W Inlet

Photo taken facing upstream after a 21.59 mm rain event.

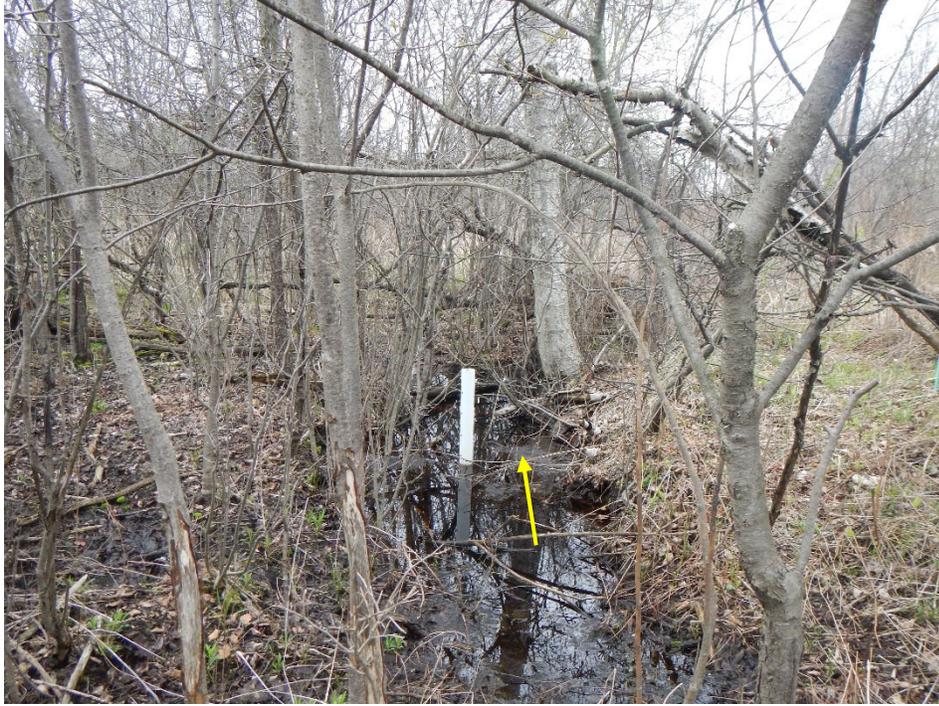
Photo 27
Tributary of Etobicoke Creek
Flow Monitoring Site: S Inlet

Photo taken facing downstream after a 21.59 mm rain event.

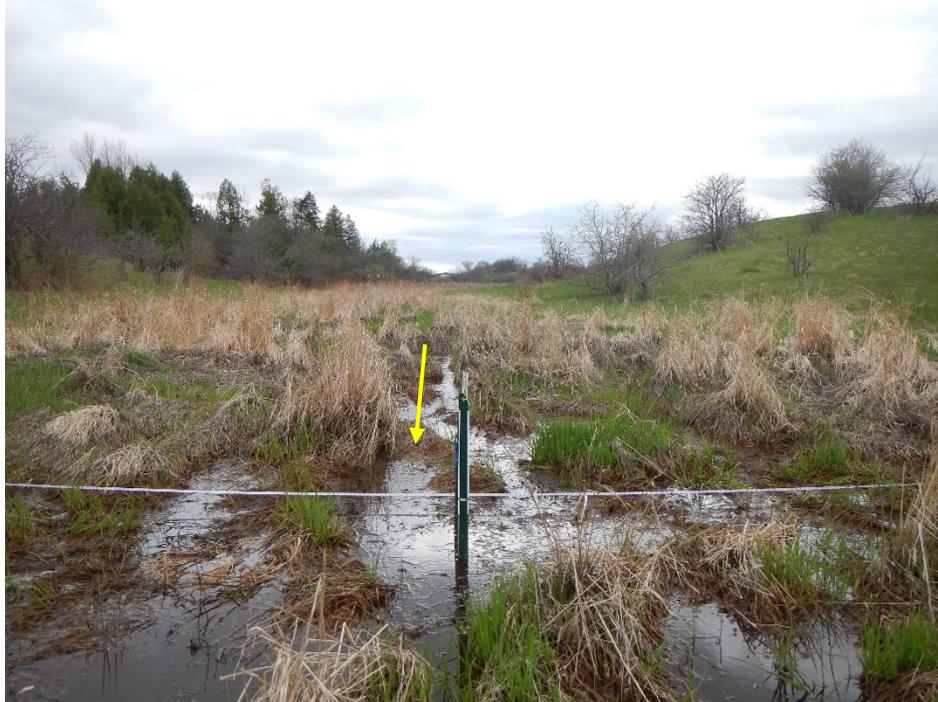
Photo 29
Tributary of Etobicoke Creek
Flow Monitoring Site: Bridge

Photo taken facing upstream after a 21.59 mm rain event.

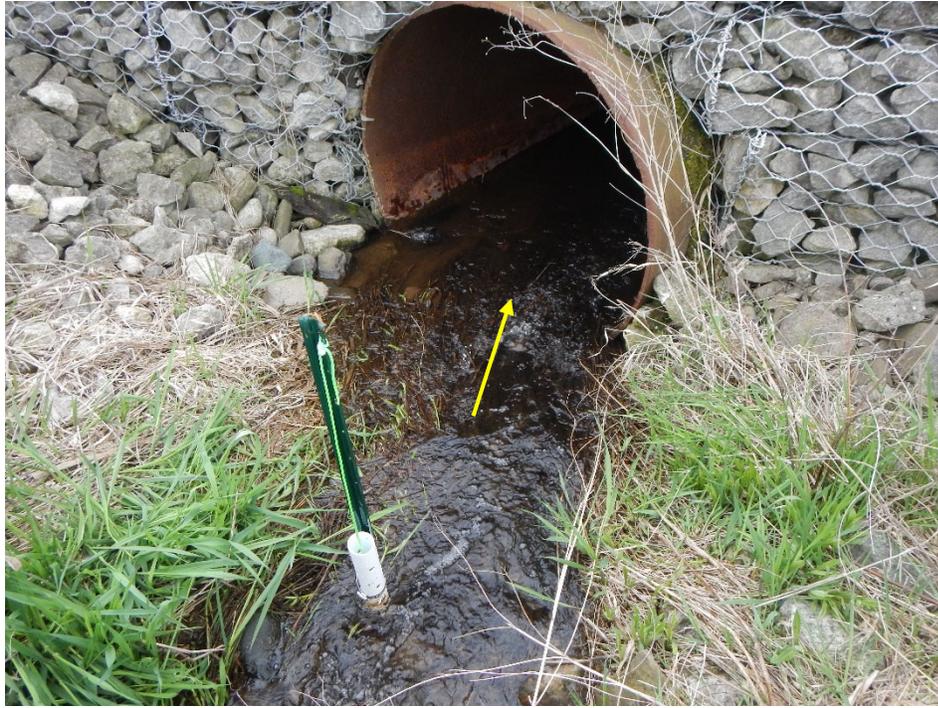
Photo 31
Tributary of Etobicoke Creek
Flow Monitoring Site: Outlet

Photo taken facing downstream towards the Mayfield Road culvert after a 21.59 mm rain event.
