Fluvial Geomorphology Assessment and Conceptual Natural Corridor Designs

Alloa Secondary Plan Area – Phase 1 Lands
Caledon, Ontario

Submitted:
March 17, 2026

GEO Morphix Project No. 24018

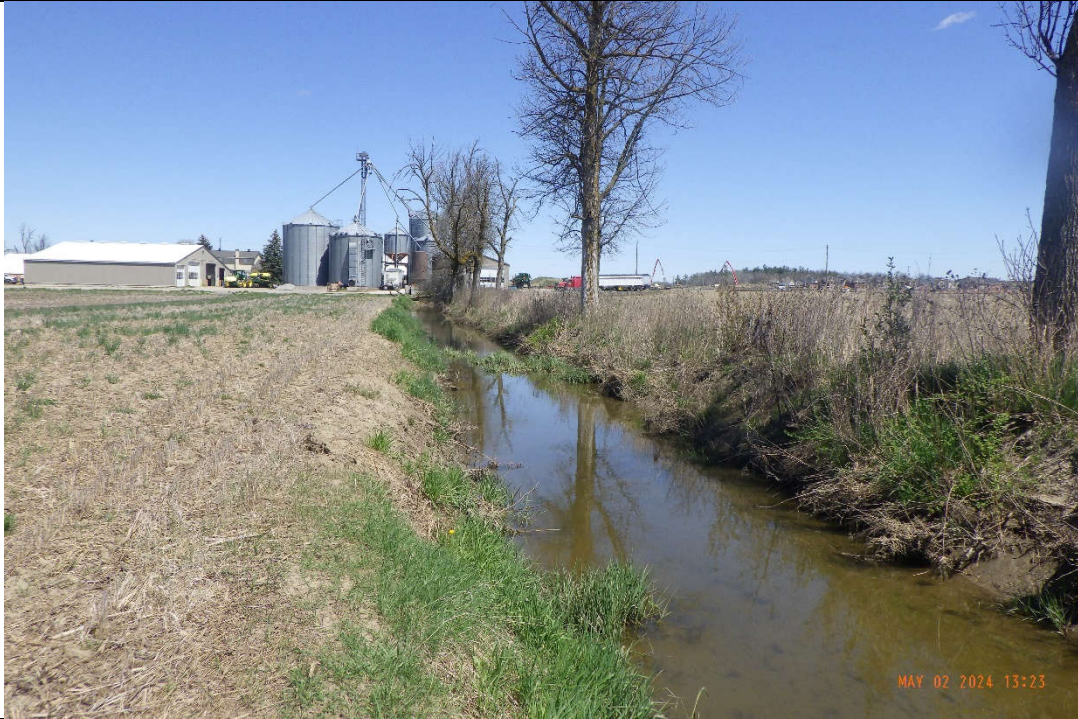
Photo 1
Alloa Drain - Reach AD2, Caledon, Ontario

The bed and bank substrate consisted of clay/silt and sand. The reach was dominated by runs with very few riffles and pools.

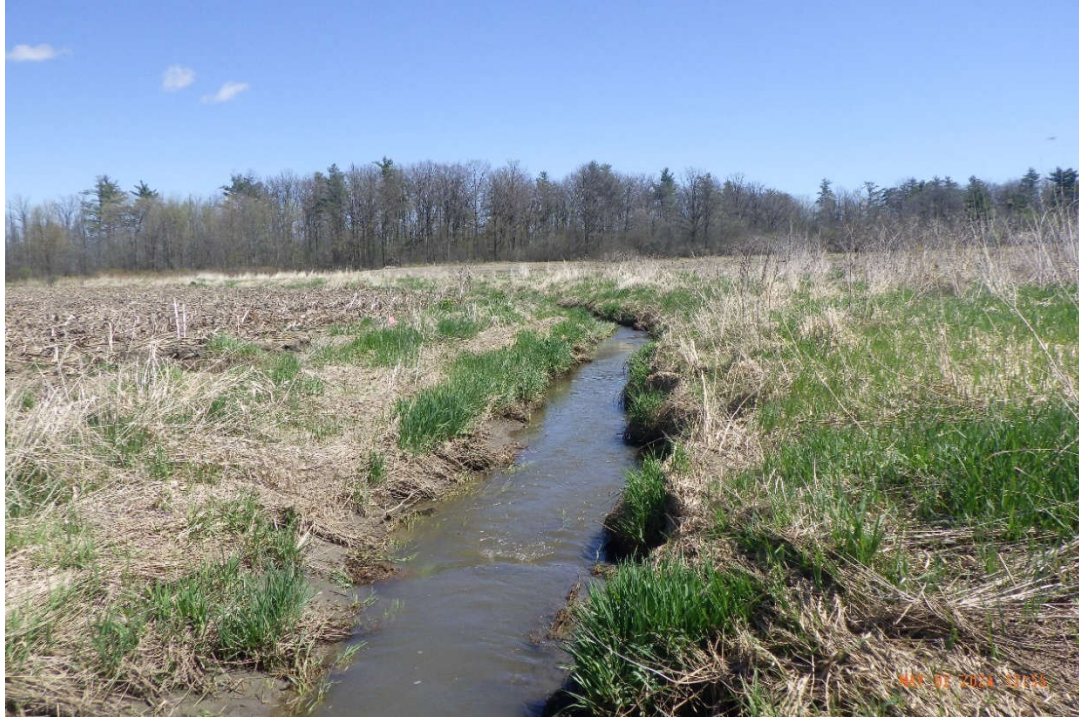
Photo 5
Alloa Drain - Reach AD3, Caledon, Ontario

Generally, the reach was run dominant; however, approximately 25% of the reach contained riffles.

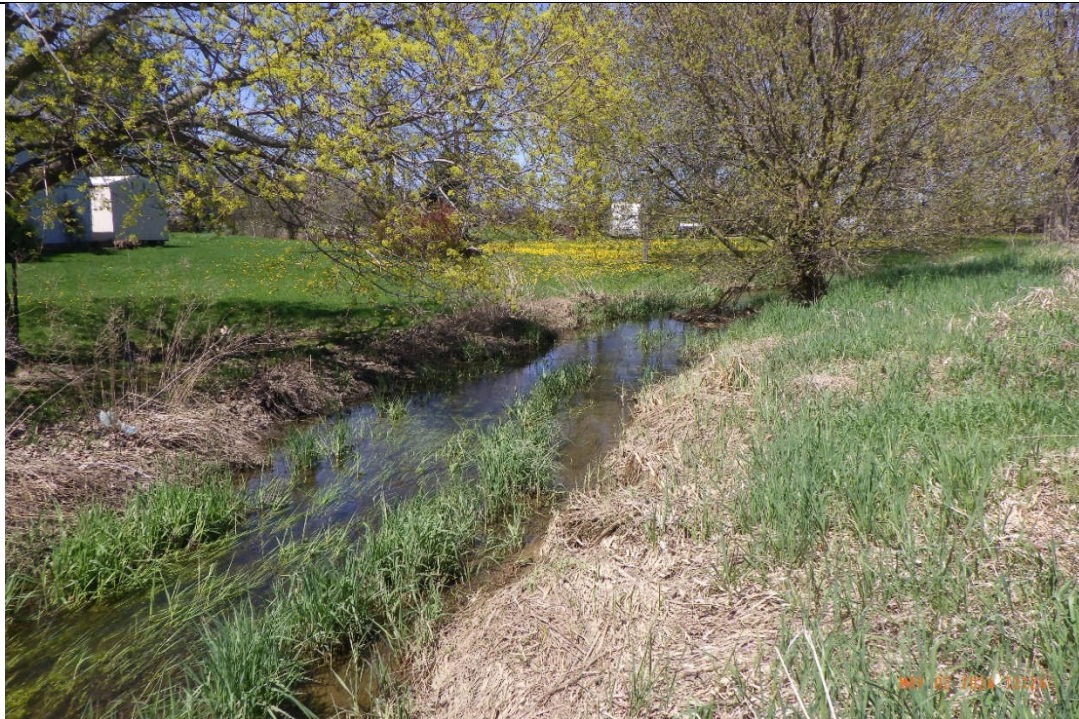
Photo 8
Alloa Drain - Reach AD3, Caledon, Ontario

The riparian vegetation consisted of primarily grasses and shrubs. The grasses encroached into the channel in various locations throughout the reach. A few trees were also present, located primarily in the upstream portion of the reach.

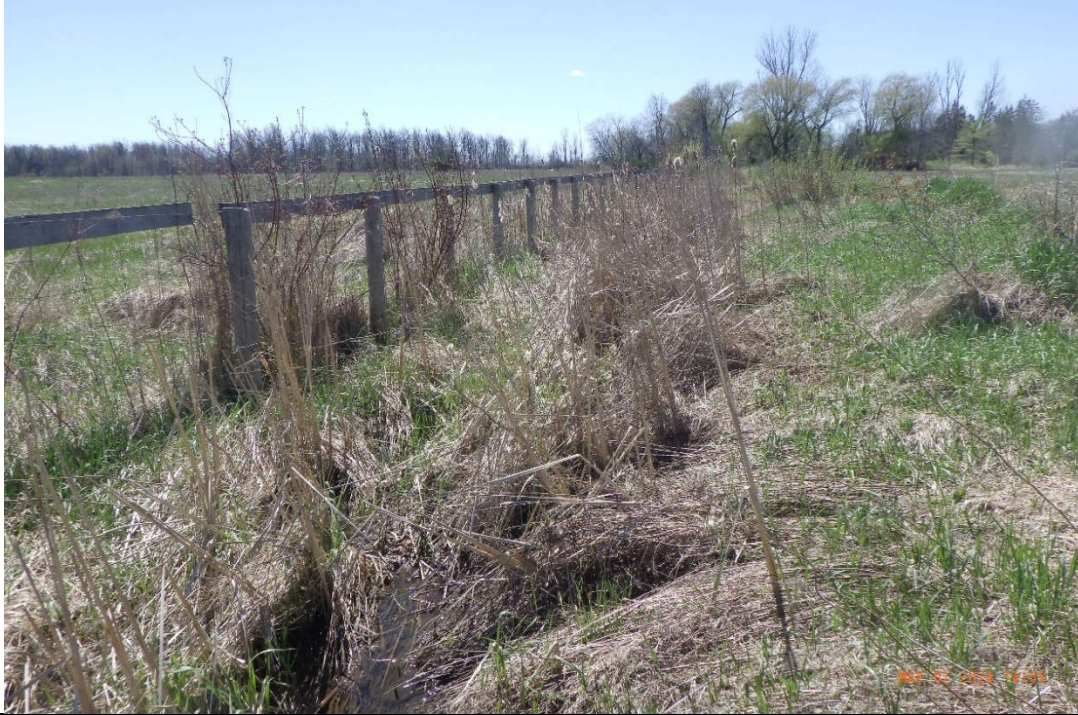
Photo 9
Tributary of the Alloa Drain - Reach AD1-2, Caledon, Ontario

The downstream portion of the reach had rooted emergent instream vegetation throughout the channel. This vegetation was present from the forest edge to the downstream reach break.

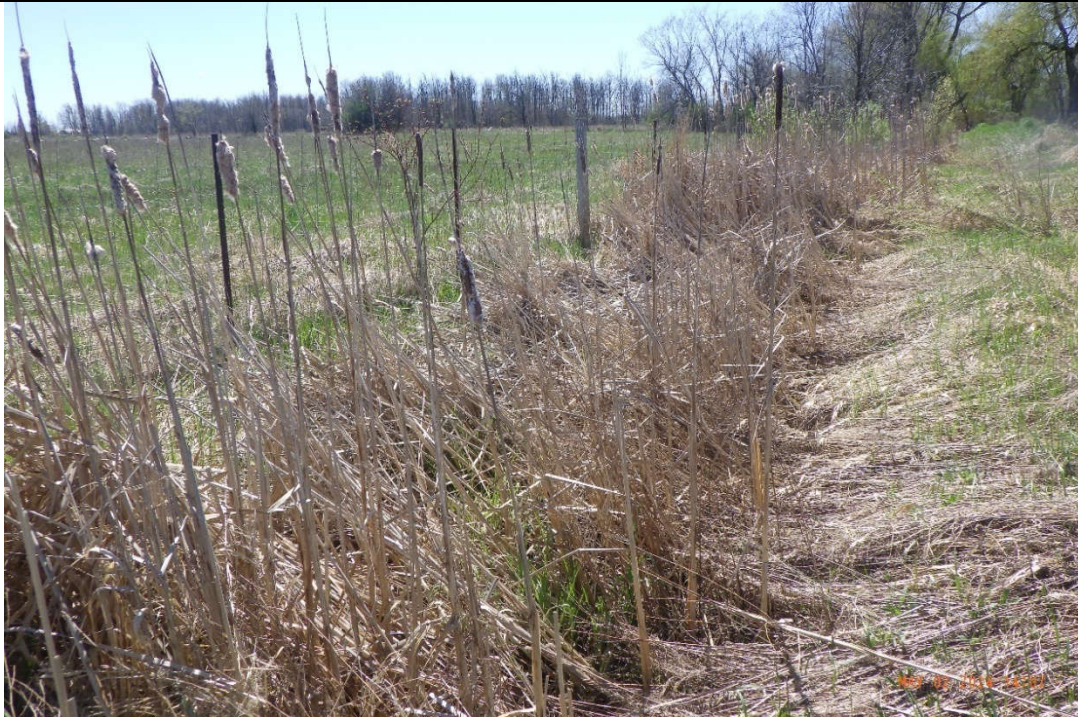
Photo 10
Tributary of the Alloa Drain - Reach AD1-2, Caledon, Ontario

Channel banks were defined and bank angles were relatively low (i.e., up to 30 degrees).

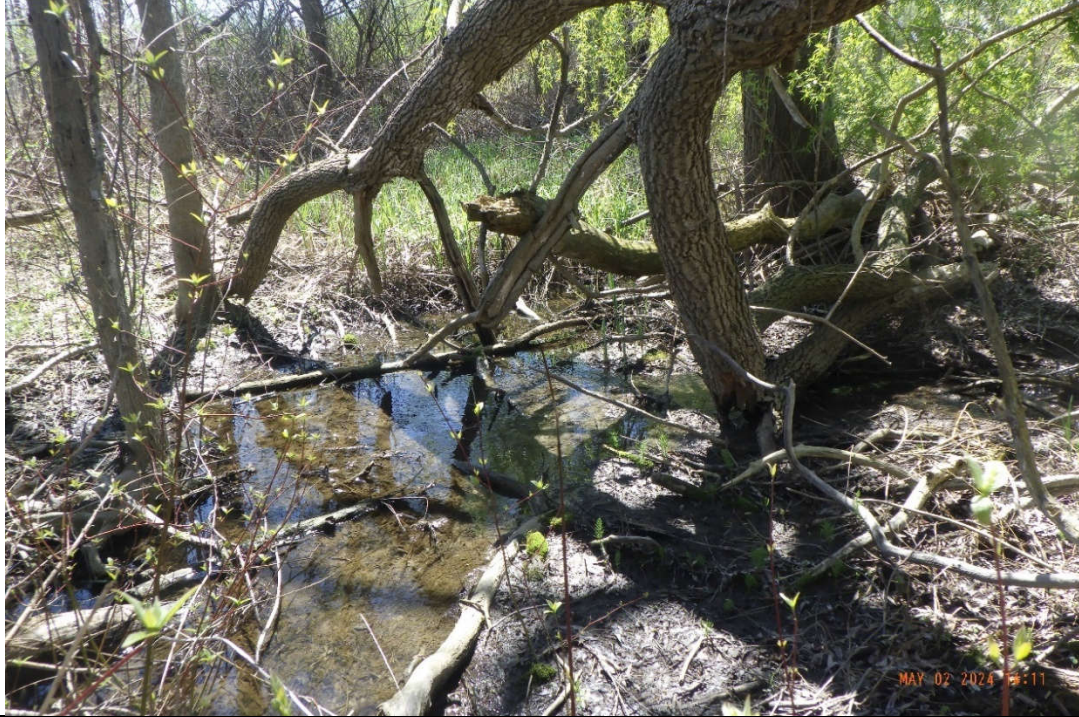
Photo 11
Tributary of the Alloo Drain - Reach AD1-2, Caledon, Ontario

The upstream portion of the reach had multiple leaning and fallen trees, which contributed woody debris to the channel.

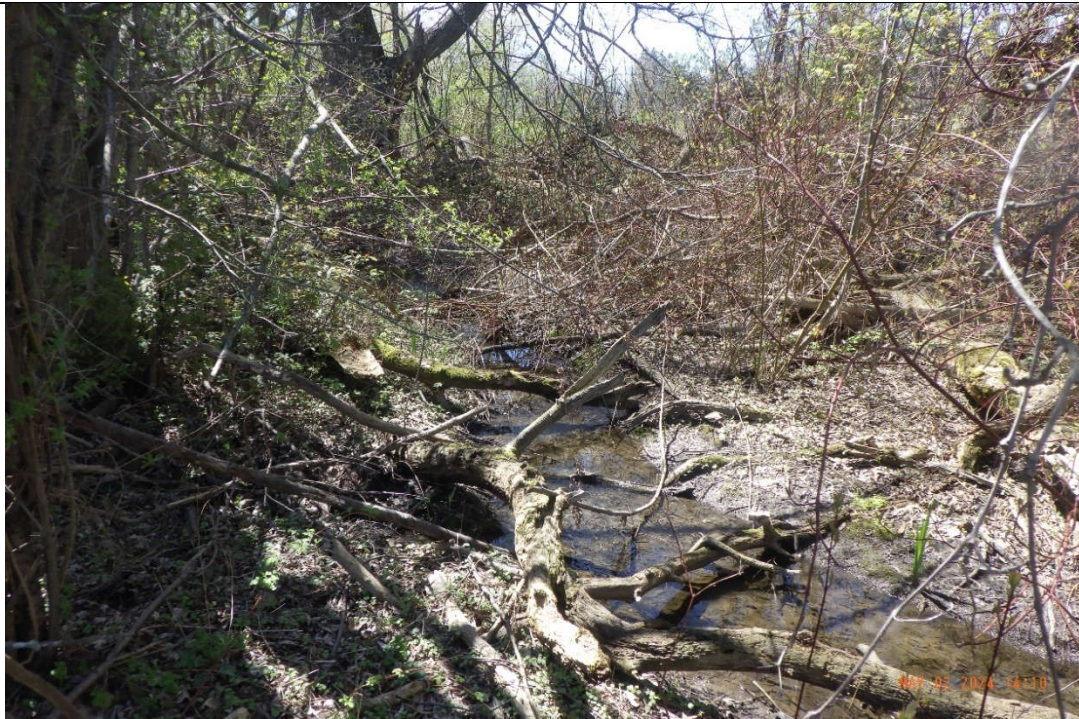
Photo 12
Tributary of the Alloo Drain - Reach AD1-2, Caledon, Ontario

The bed and bank substrates consisted of clay/silt and sand with organic debris on the channel bed.

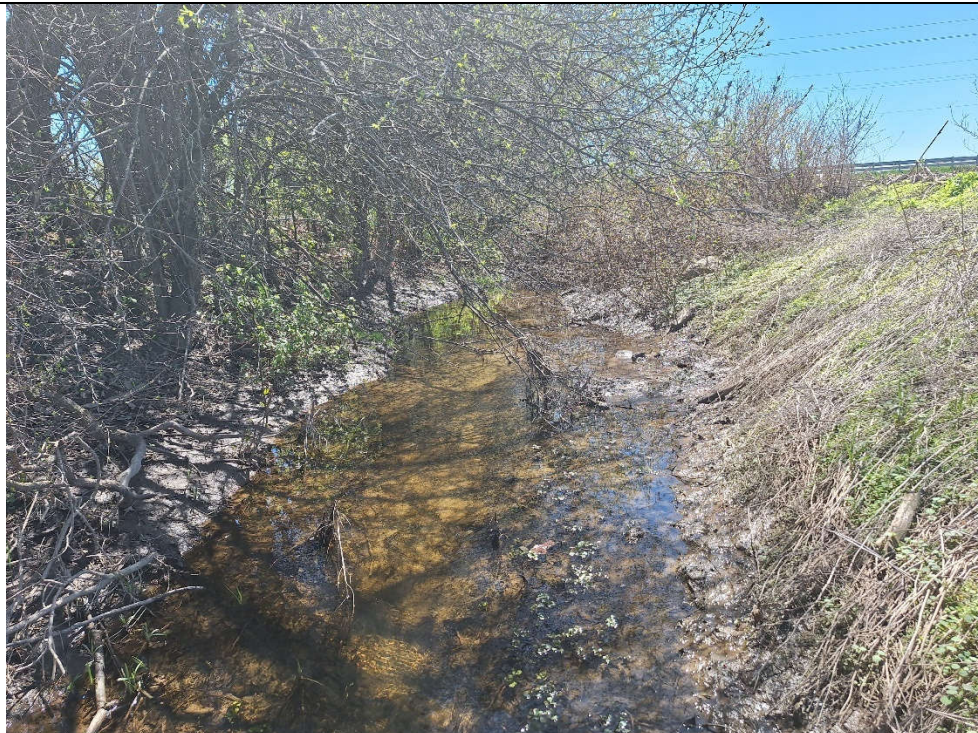
Photo 16
Lyons Drain - Reach LD1, Caledon, Ontario

The reach was a short and contained a straight channel that had minimal erosion and was moderately entrenched.

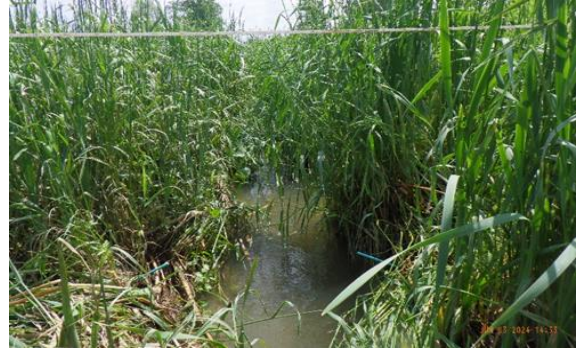
Photograph at cross section 8-M (looking upstream)

Reach AD1 consisted of a relatively straight channel flowing through agricultural pastures. The reach was run dominant with a lack of riffles and pools identified. The assessment was completed during a rain event which produced saturated banks, suspended sediment transport throughout the channel, and chutes in six of eight cross sections. The riparian zone was dominated by tall grasses, which encroached minimally. Aquatic vegetation was present throughout 100% of reach encroaching heavily on chutes, but had minimal impact on the main channel. Bed and bank materials were homogenous throughout the channel; primarily comprised of silt and clay. Minor undercutting was measured at three cross sections.

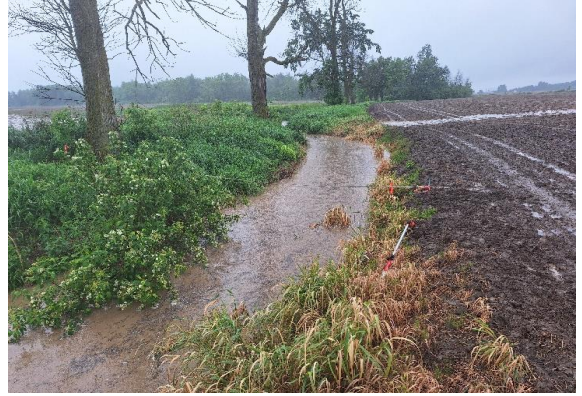
Photograph at cross section 1M (looking upstream)

The reach is located west of Mississauga Road in Caledon. It is important to note that the channel was surveyed during high flow conditions after a large rain event. Water levels were over bankfull conditions, nearly overtopping the surrounding agricultural area. The channel is unconfined and widens towards the downstream extent of the surveyed portion. The channel is part of the Alloa drain and the portion surveyed was straight. There was poor riffle-pool morphology and the dominate feature was runs. The right bank had greater riparian vegetation than the left bank. The right bank had more dense grasses and mature trees, whereas the left bank was solely grasses. Instream vegetation consisted primarily of sparse grasses. The channel is U-shaped and moderately entrenched. Bed material was composed primarily of silts with some cobble. Sediment transport in the form of siltation was observed due to high flows and intense precipitation.

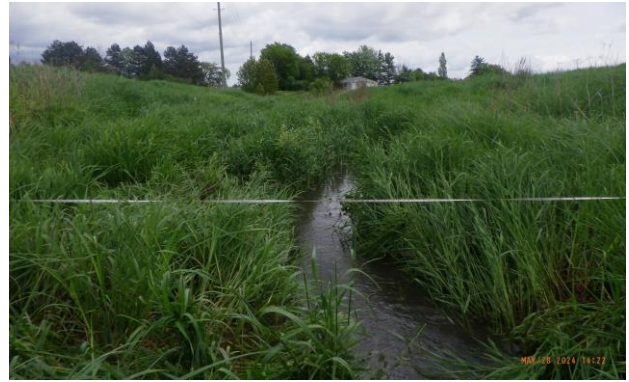
Photograph at cross section 7 (looking downstream)

Reach LD2 is a tributary of Etobicoke Creek in Alloo, ON which conveys flows within the agricultural lands north of Mayfield Rd between Creditview Rd and Mississauga Rd. Nearing the downstream extent of Lyon's Drain, the subject reach consists of a straightened roadside ditch that runs parallel to Creditview Rd with culverts at the upstream and downstream extent. Channel bed morphology was notably homogenous, characterized by run and pool features, with a distinct scour pool at the upstream extent. Channel substrates predominantly consisted of fine materials including clay, silt and sand (D₅₀: < 0.2 mm). The channel demonstrated indicators of systematic aggradation as fine sediment deposits were observed along the entirety of the channel bed, likely as a consequence of the heavily encroaching aquatic vegetation which slows incoming flows and promotes sediment settling.
