Fluvial Geomorphology Assessment and Conceptual Natural Corridor Design

**Mount Hope West Secondary Plan Area
Local Subwatershed Study**
Town of Caledon, Ontario

Submitted:
February 25, 2026

GEO Morphix Project No. 25026

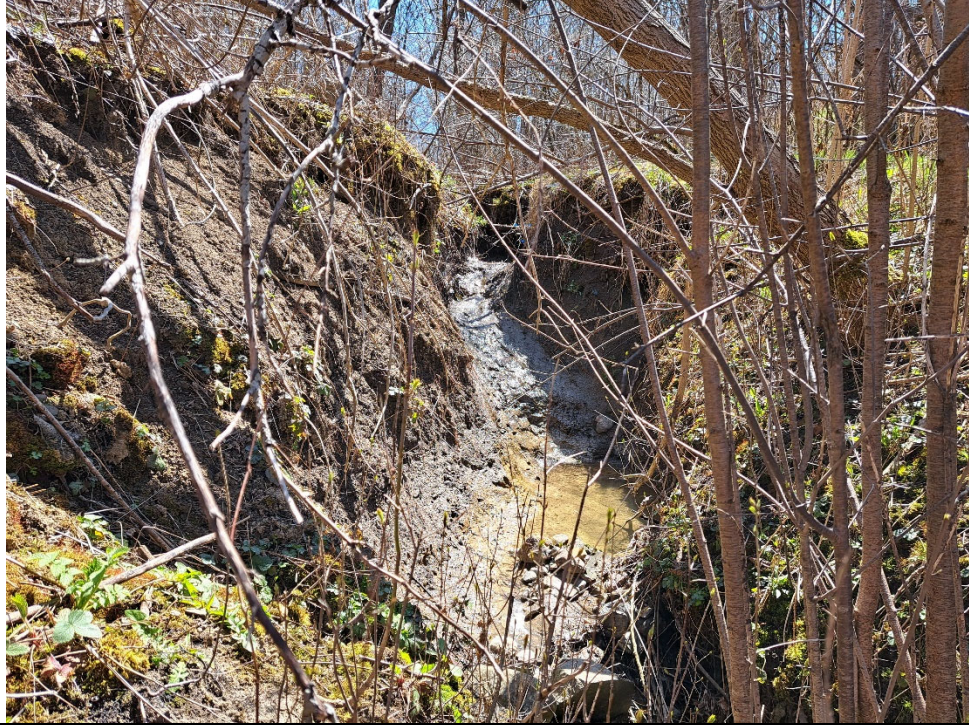
Photo 22
Tributary of Humber River, Reach- THRF-2
Caledon, Ontario

Photograph taken facing upstream. The gradient along the reach was high and entrenchment increased at localized sections where knickpoints were present.

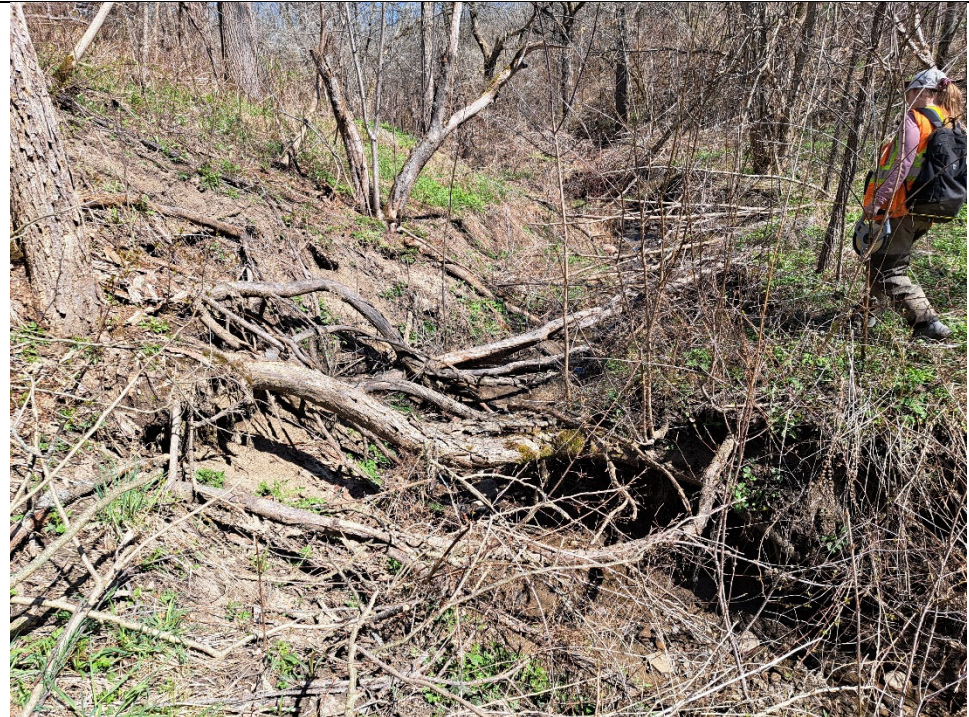
Photograph taken facing downstream. Woody debris, leaning and fallen trees, and exposed roots were common, with the highest concentration in the upstream section of the reach.

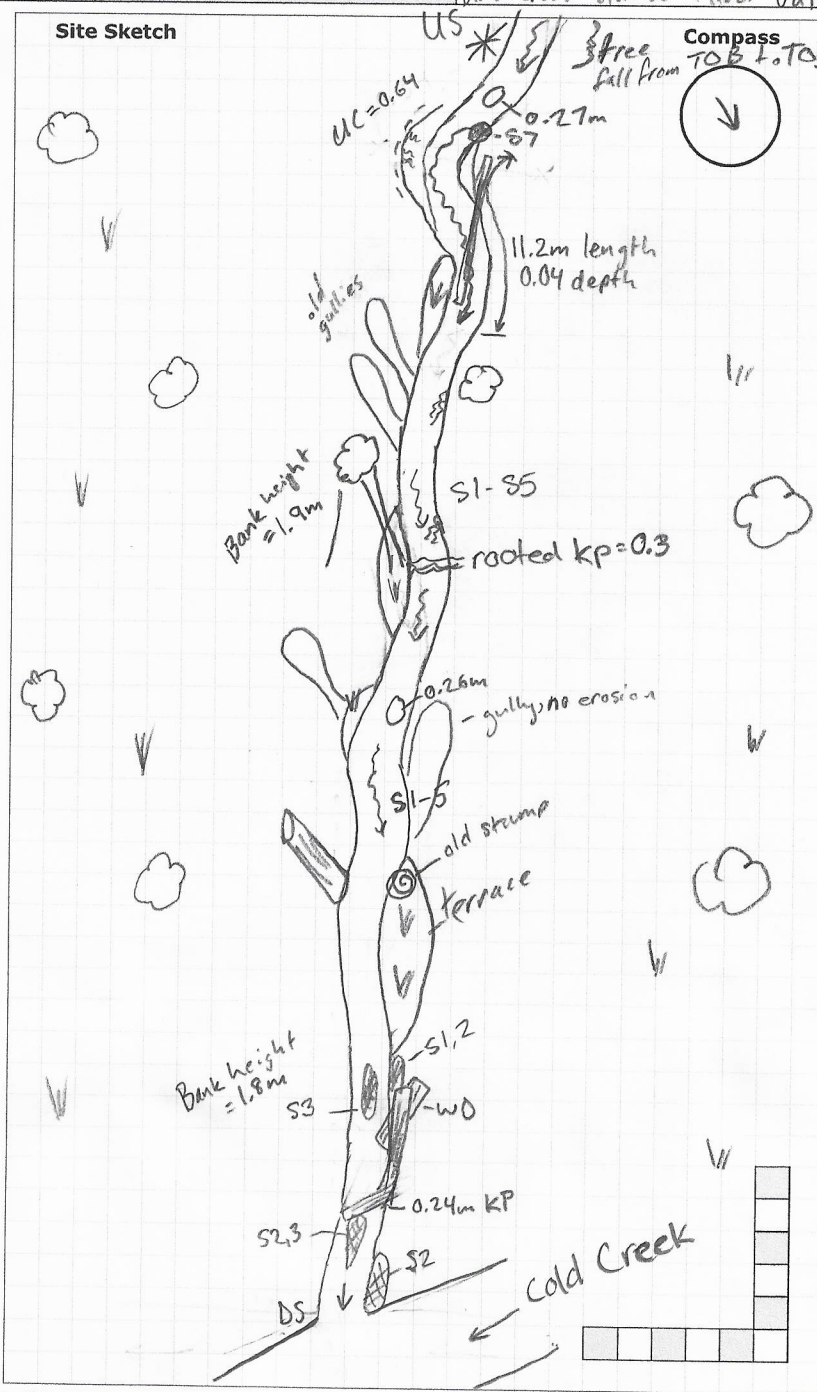
Notes: Exposed soil, highly entrenched, erosion on most banks for all of the reach. Grain size ranged silt to large boulders. US portion of reach became very exposed hard clay bed with less unconsolidated material.

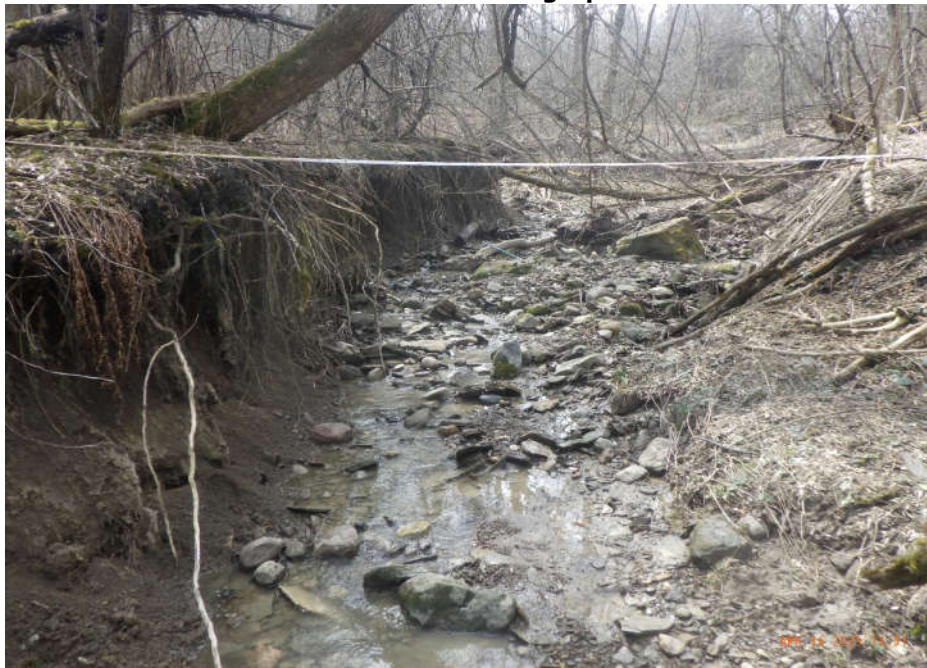
Cross Section 3 - Facing Upstream

The subject reach was characterized by a channel with a low sinuosity set within a confined, wooded valley. Agricultural fields bordered the forest on either side of the channel. Instream vegetation was predominantly absent for the full extent of the reach. Channel bed morphology was characterized by occasional riffle-pool sequences and had a moderate gradient. The channel exhibited evidence of systematic widening. Bank soil was additionally loose and exposed to flow, with bank erosion being visible throughout the reach. Flow in the channel was minimal, and was largely only observed in riffles. Bank substrate was primarily consisted of sand, silt, and clay materials, while bed substrate was defined by sand, gravel, cobble, and boulders. Notably, a rooted knickpoint was observed at the downstream extent of the reach.

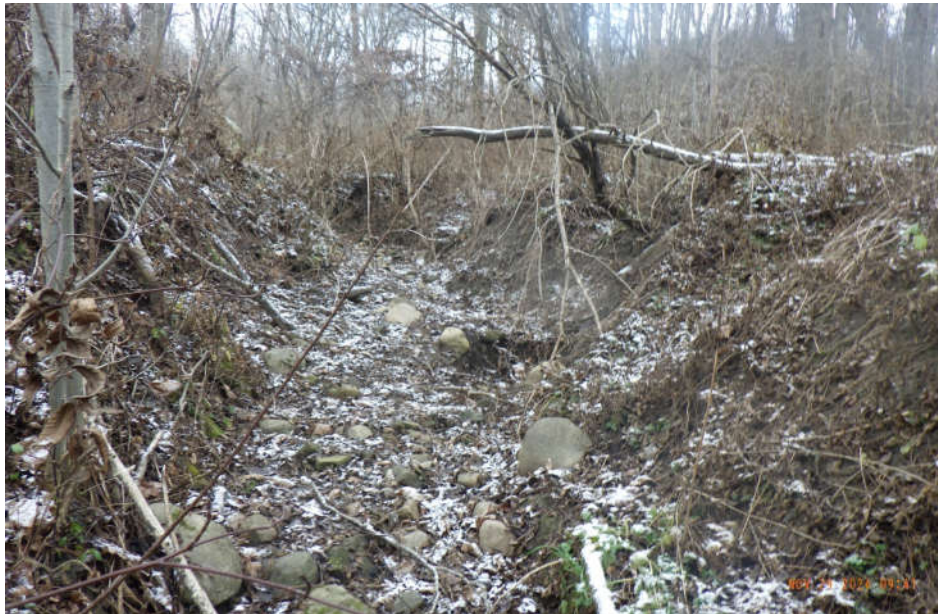
Representative channel conditions at the time of the survey

The subject reach was characterized by a sinuous channel set within an confined, forested valley. Dominant riparian vegetation consisted of deciduous trees and shrubs, which provided good cover over the channel. Channel bed morphology was characterized by runs near the upstream survey extent, and became dominated by riffles following a knickpoint, then pools at the furthest downstream extent. The channel exhibited evidence of systematic degradation with signs of recent knickpoint migration, and planform adjustment into the valley wall. Gullies on the banks were frequent. Channel banks were generally vegetated with young herbaceous plants and exposed to flow, with both young and old tree root exposure. The channel displayed multiple indicators associated with fair channel health. For example, instream woody debris would provide refuge and differences in bed morphology were observed, however the channel was dry at the time of the survey and channel degradation/erosion would result in poor water quality.
