**REPORT ON**  
Slope Stability Assessment  
Proposed Innis Lake Secondary Plan Area  
Caledon, Ontario

**PREPARED FOR:**  
Innis Lake Secondary Plan Area Landowners  
c/o Mattamy (Innis Lake) Limited

**Project No.** 22-030-100/101 (Slope)  
**Date:** February 27, 2026

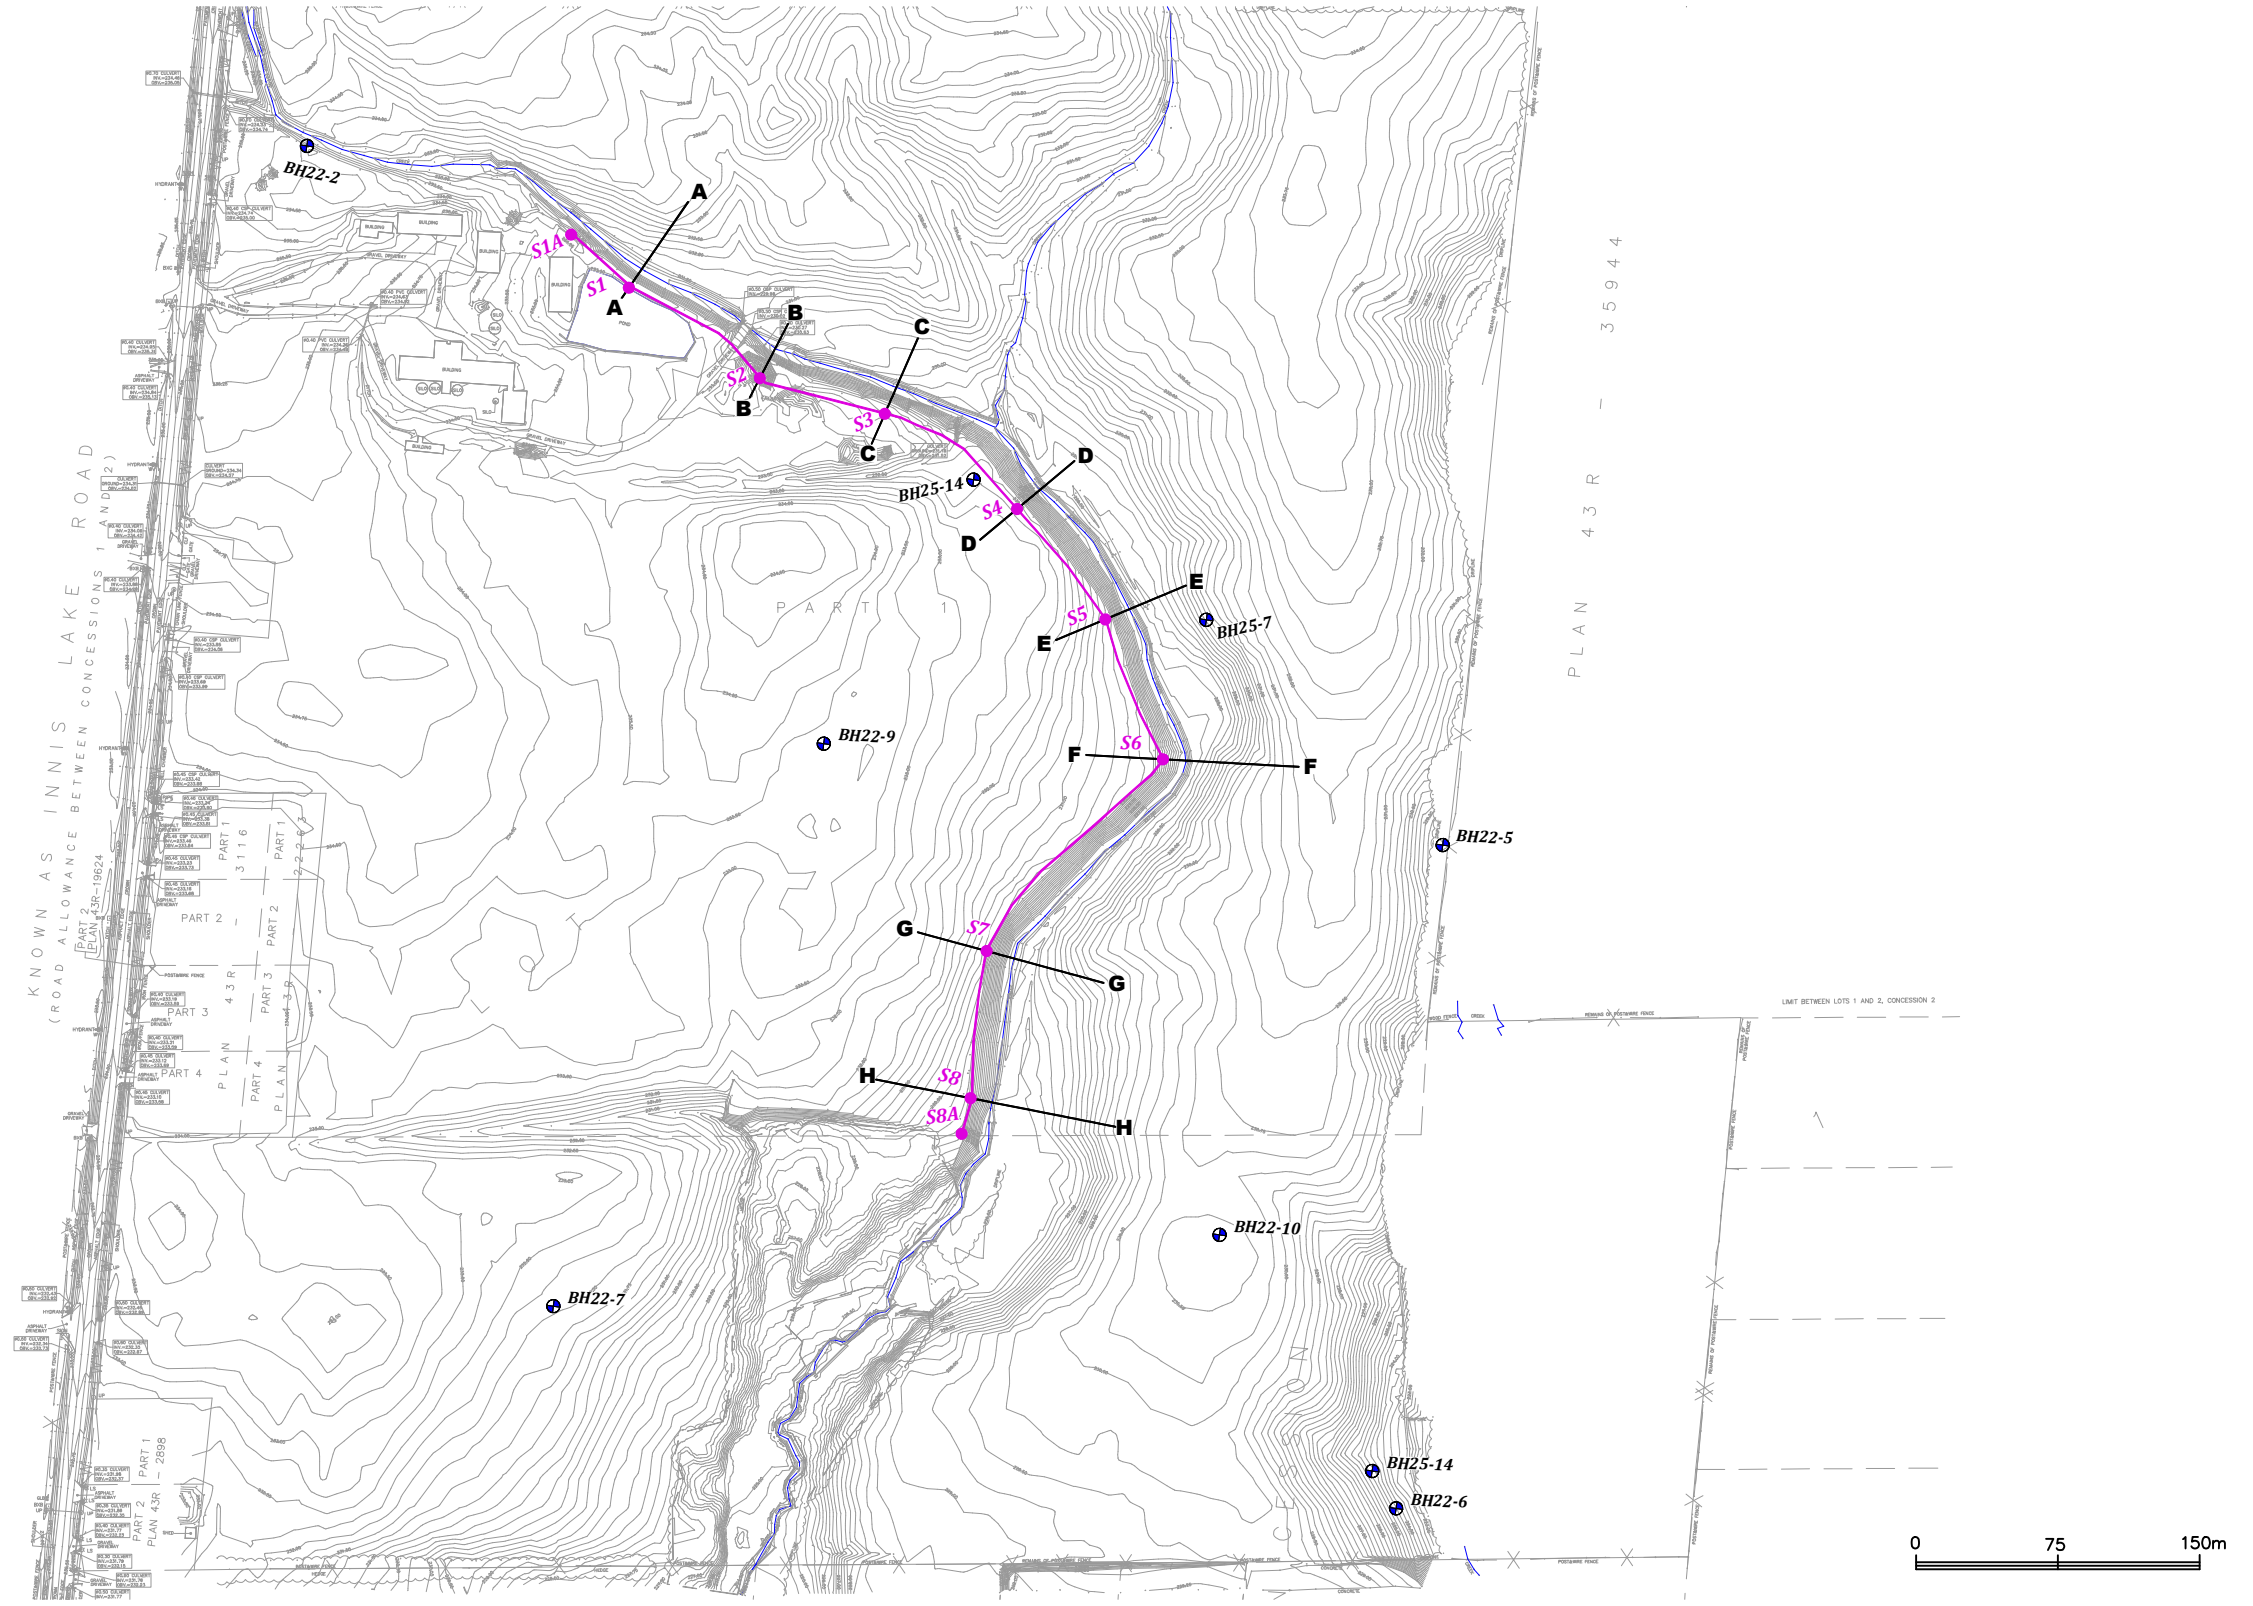
<p><b>DS CONSULTANTS LTD.</b> 6221 Highway 7, UNIT 16 Vaughan, Ontario L4H 0K8 Telephone: (905) 264-9393 www.dsconsultants.ca</p>	Project: SLOPE STABILITY ASSESSMENT Innis Lake Secondary Plan Area Landowners			
	Title: <b>SLOPE AND BOREHOLE LOCATION PLAN</b>			
Client: <b>INNIS LAKE SECONDARY PLAN AREA LANDOWNERS</b>	Size: 11 X 17	Approved By: D.W	Drawn By: S.Y	Date: February 2026
	Rev.	Scale: As Shown	Project No: 22-030-100/101	Drawing No. <b>1A</b>

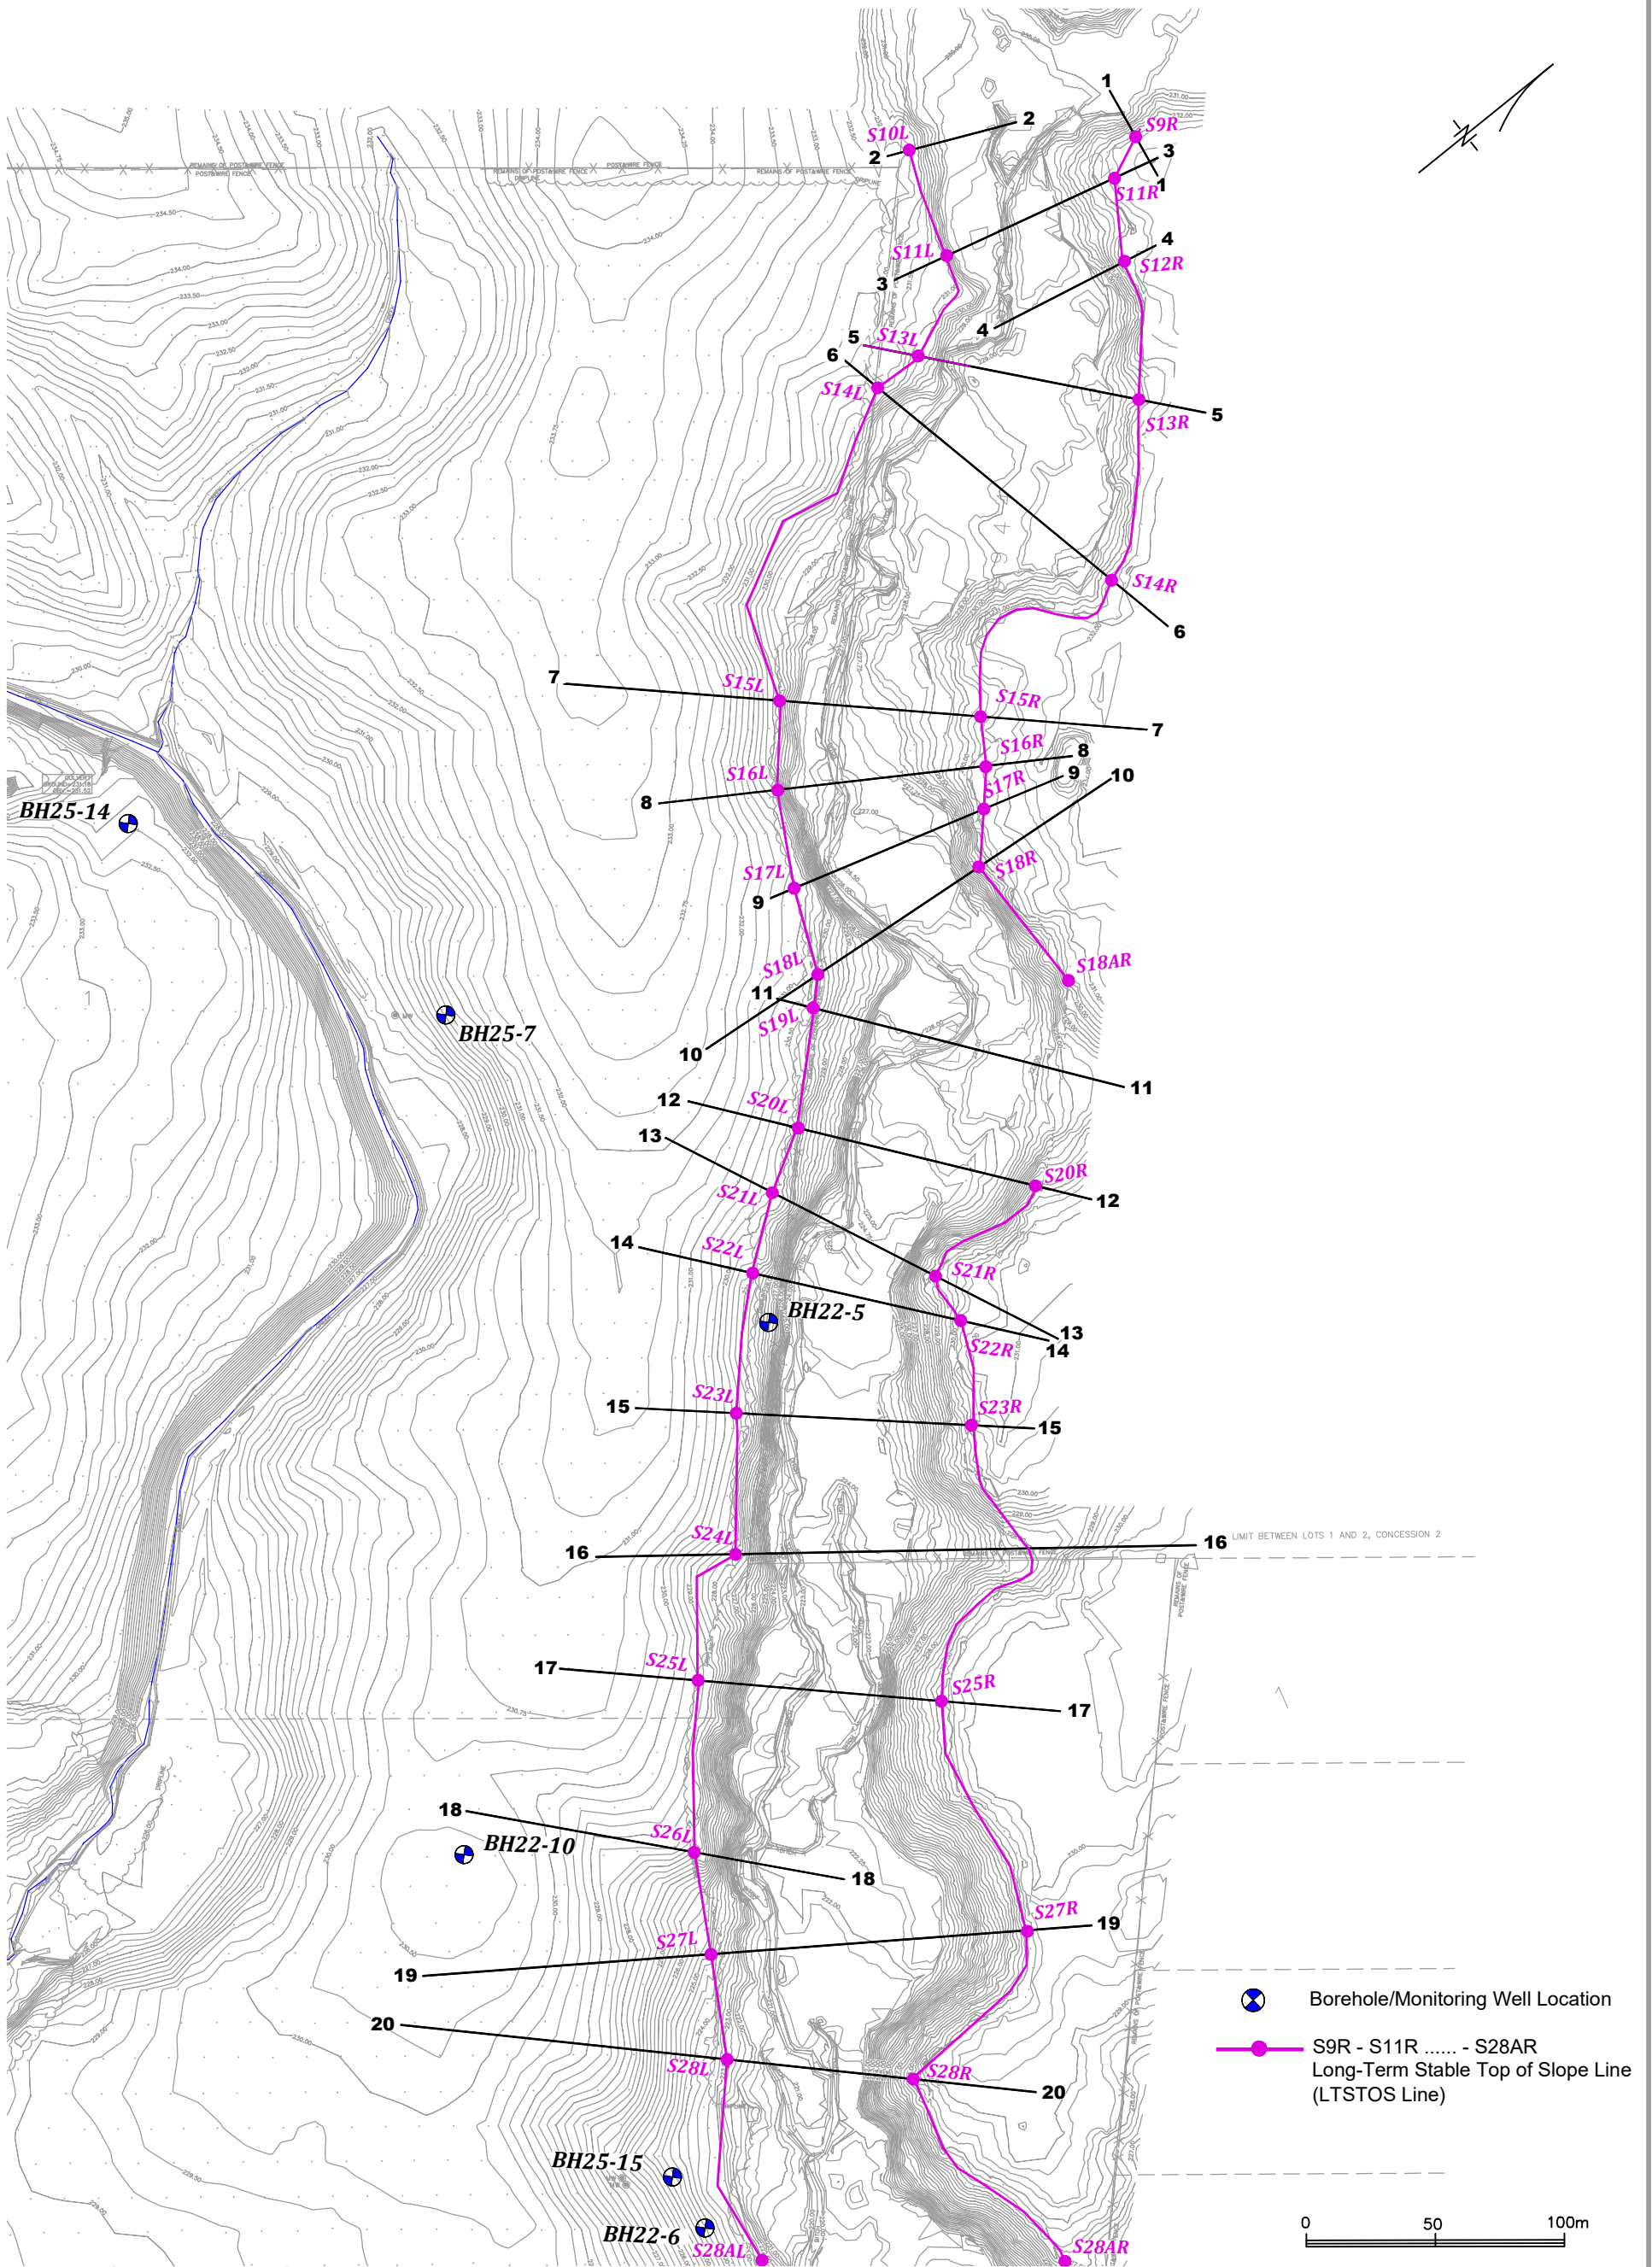
<p><b>DS CONSULTANTS LTD.</b> 6221 Highway 7, UNIT 16 Vaughan, Ontario L4H 0K8 Telephone: (905) 264-9393 www.dsconsultants.ca</p>	Project: SLOPE STABILITY ASSESSMENT Proposed Innis Lake Secondary Plan Area			
	Title: <b>SLOPE AND BOREHOLE LOCATION PLAN</b>			
Client: INNIS LAKE SECONDARY PLAN AREA LANDOWNERS	Size: 11 X 17 Rev.	Approved By: D.W. Scale: As Shown	Drawn By: S.Y. Project No: 22-030-100/101	Date: February 2026 Drawing No. <b>1B</b>
