DETAILED CONDITION SURVEY REPORT

Site No. B26030042, Main Street, Alton
Caledon, ON

Prepared for: GHD Limited

BCC Project No.: BCC19012
Report Date: May 31, 2019

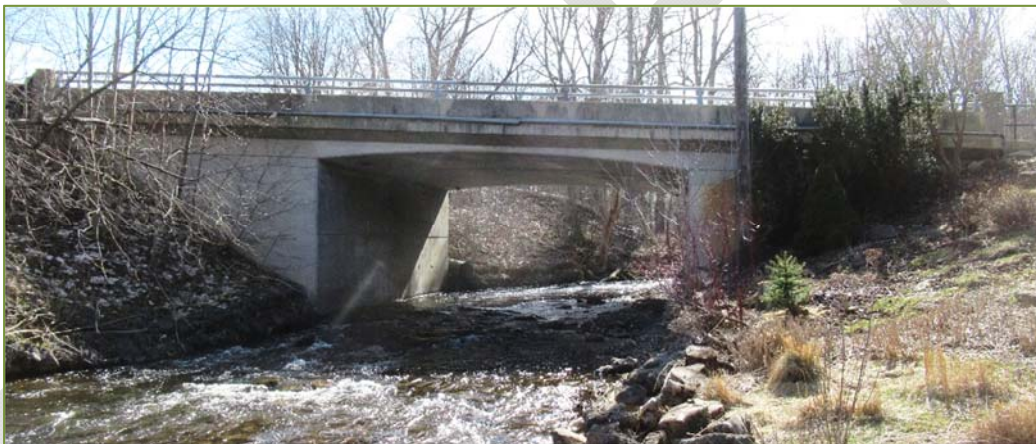
East Elevation of Site B26030042, Main Street, Alton

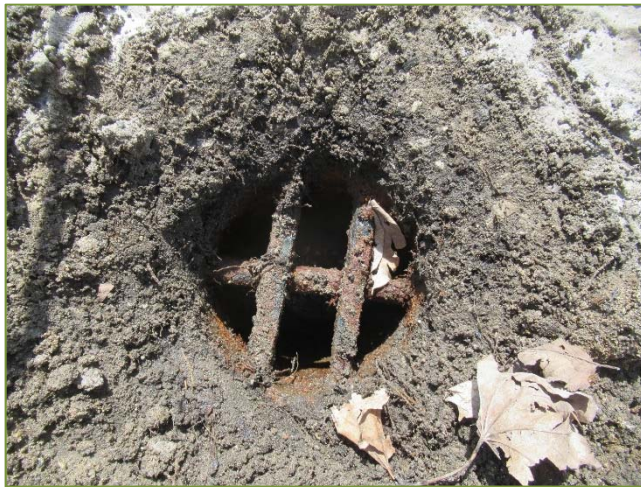
Typical Condition of Deck Drain @ Northwest

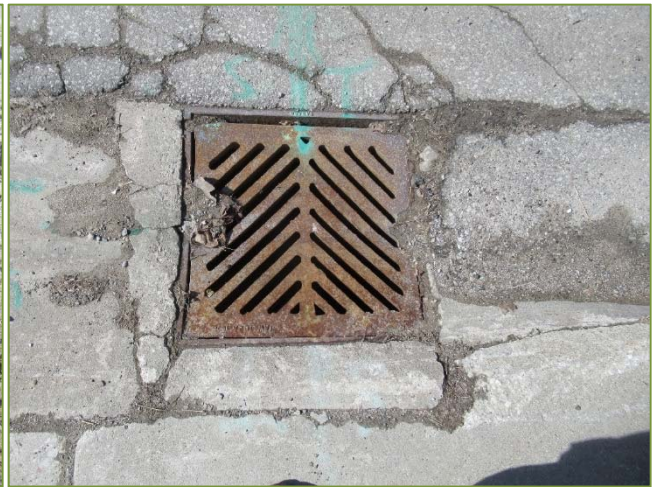
Typical Condition of Catch Basin @ Southeast

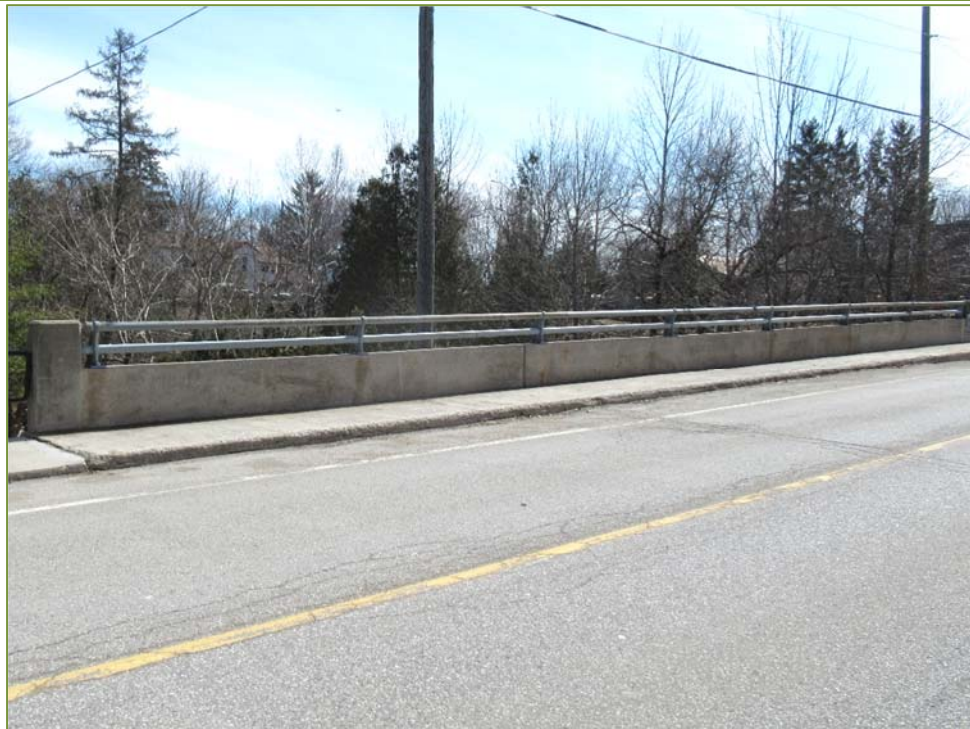
Photo P24 – East Sidewalk (fair condition – wide crack, spall, delamination and light/medium scaling) and Parapet Wall (fair to good condition – cracks, delamination and light scaling)

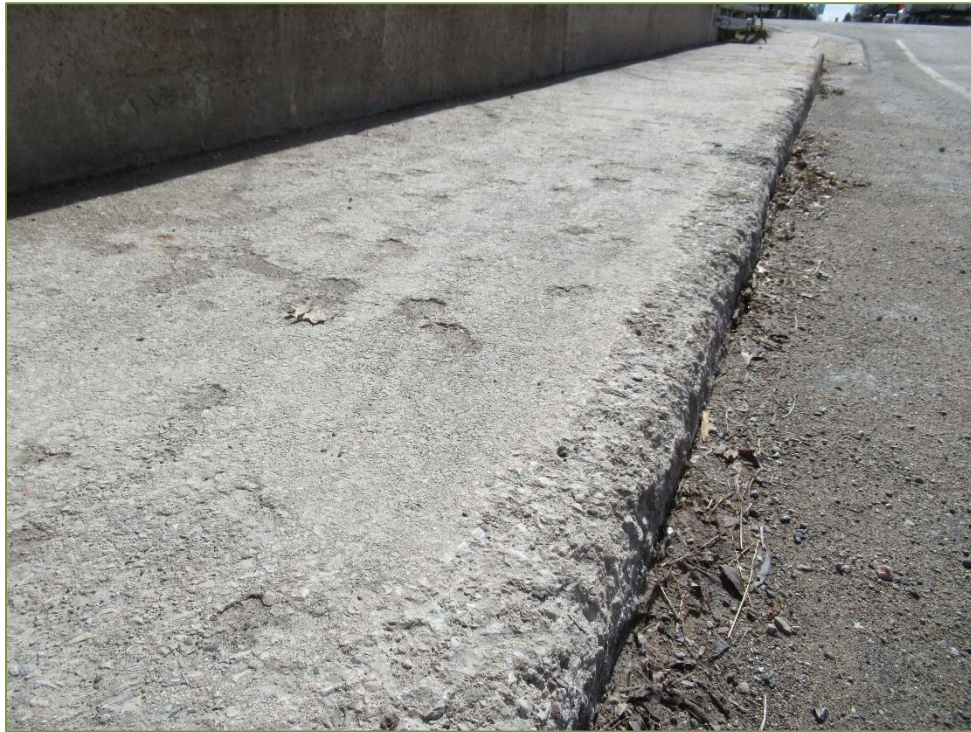
Photo P27 – East Sidewalk (light/medium scaling)

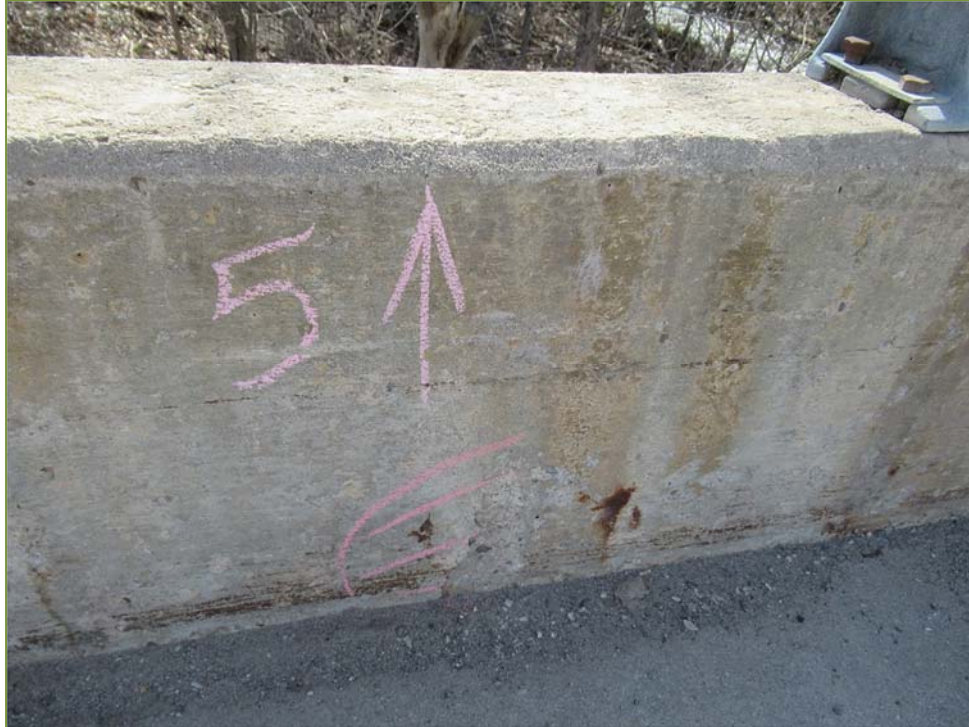
Photo P32 – West Parapet Wall (spall and delamination)

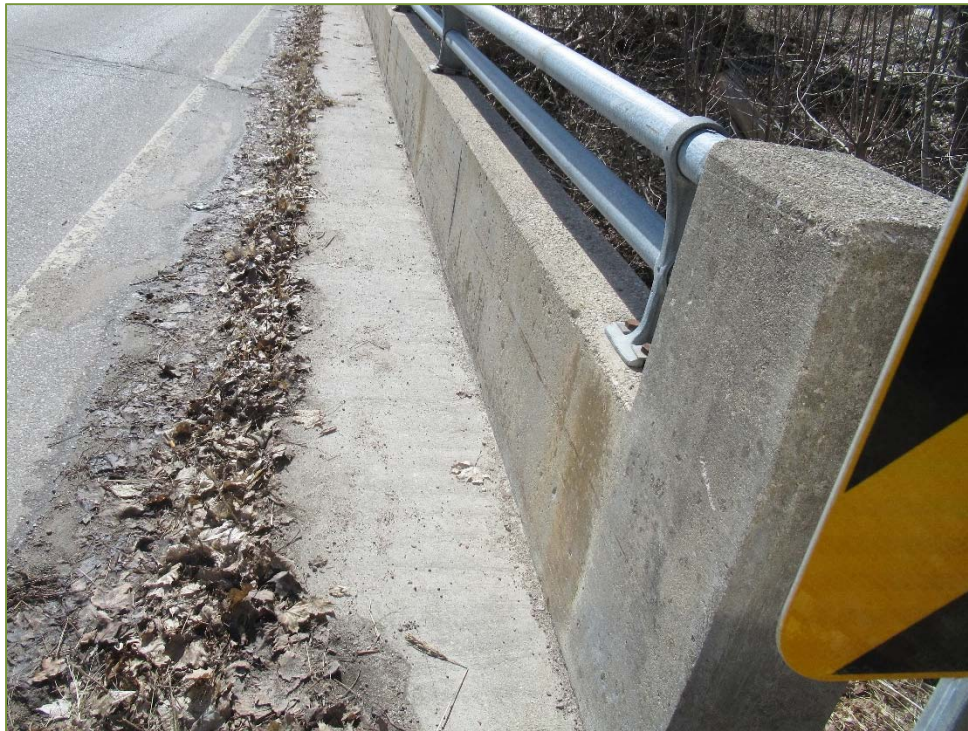
Photo P38 – Northwest End Post (good condition)

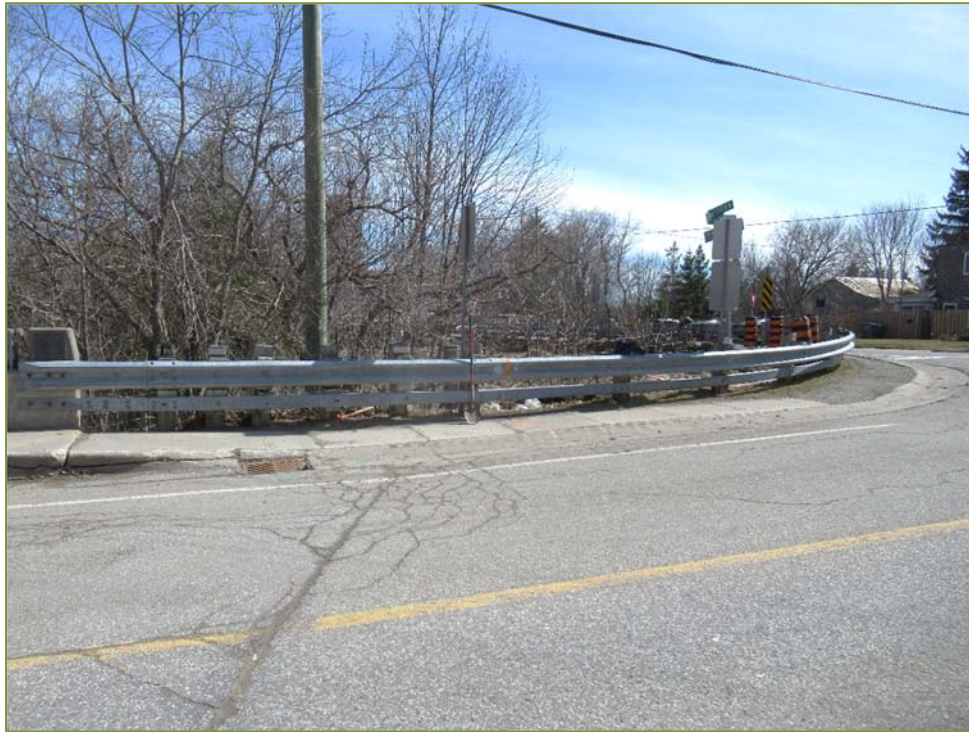
Photo P41 – Southeast Guiderail (good condition)

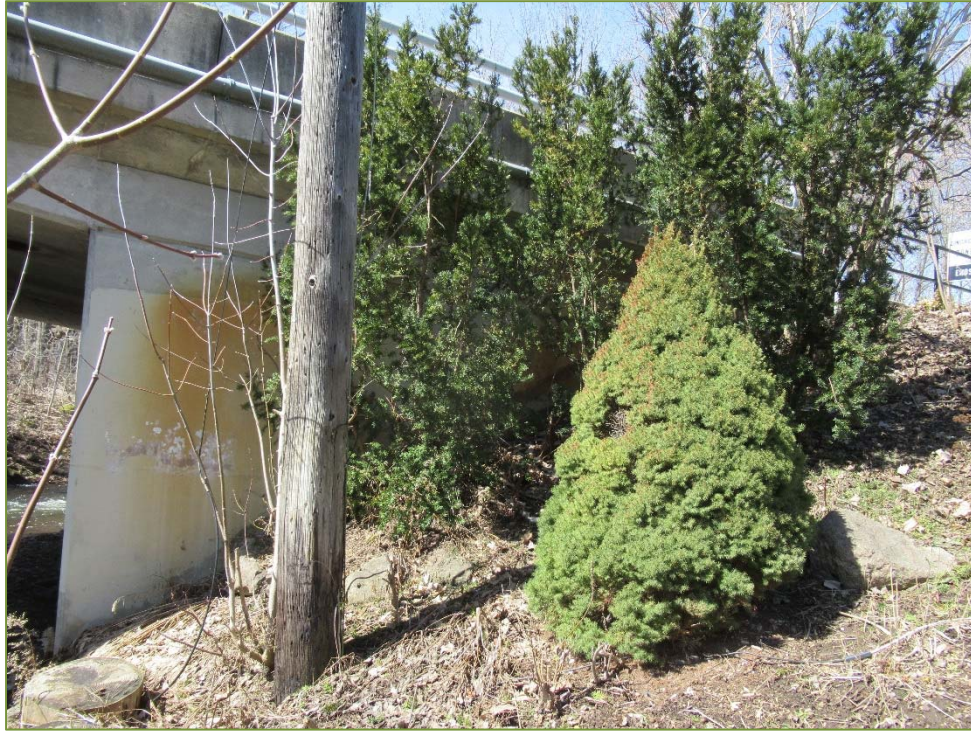
Photo P47 – Northeast Wingwall (good condition)

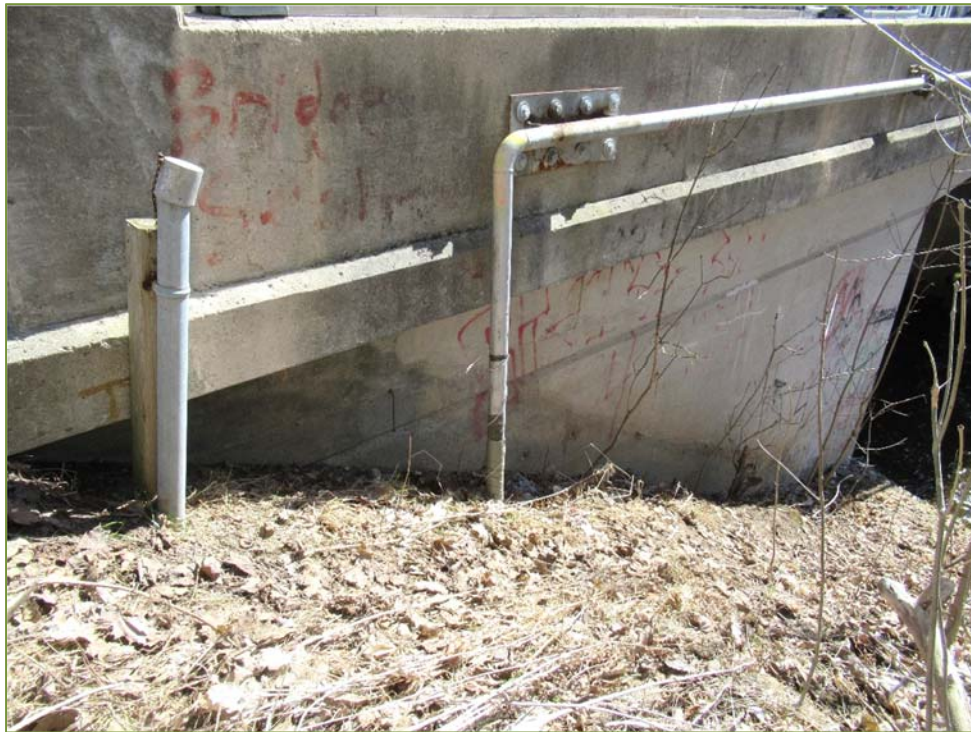
Photo P48 – Northwest Wingwall (good condition)

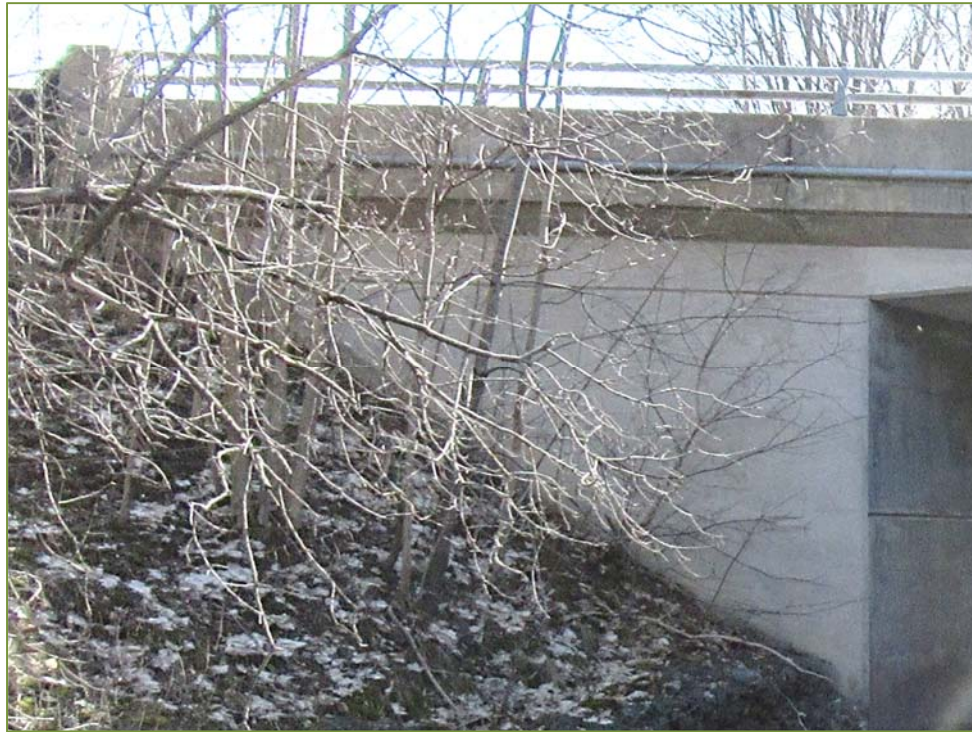
Photo P49 – Southeast Wingwall (good condition)

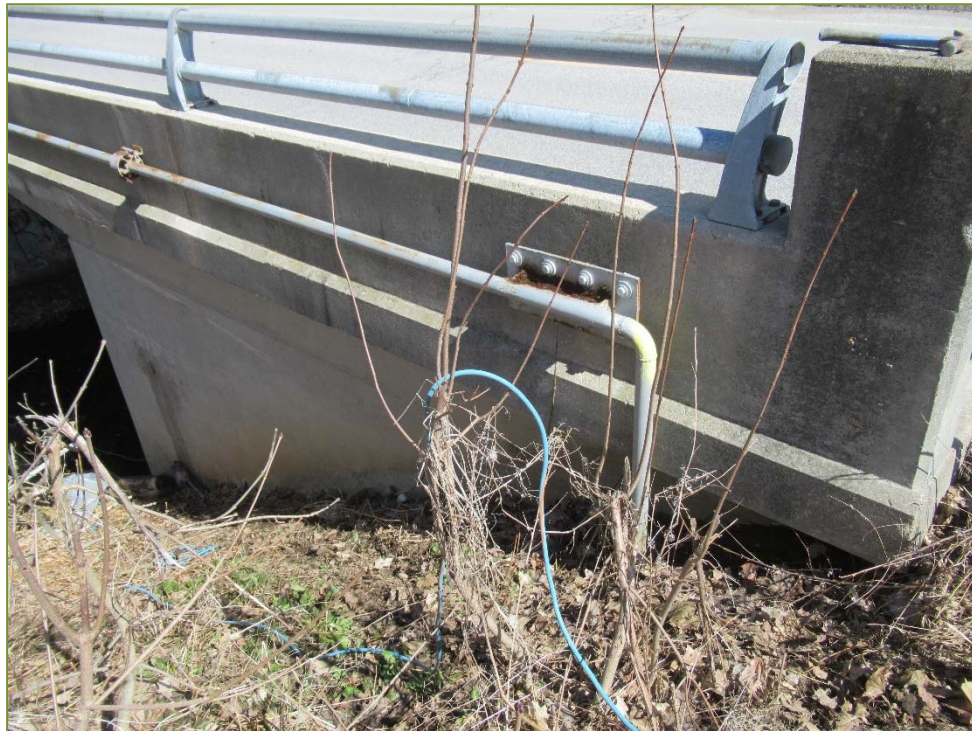
Photo P50 – Southwest Wingwall (good condition)

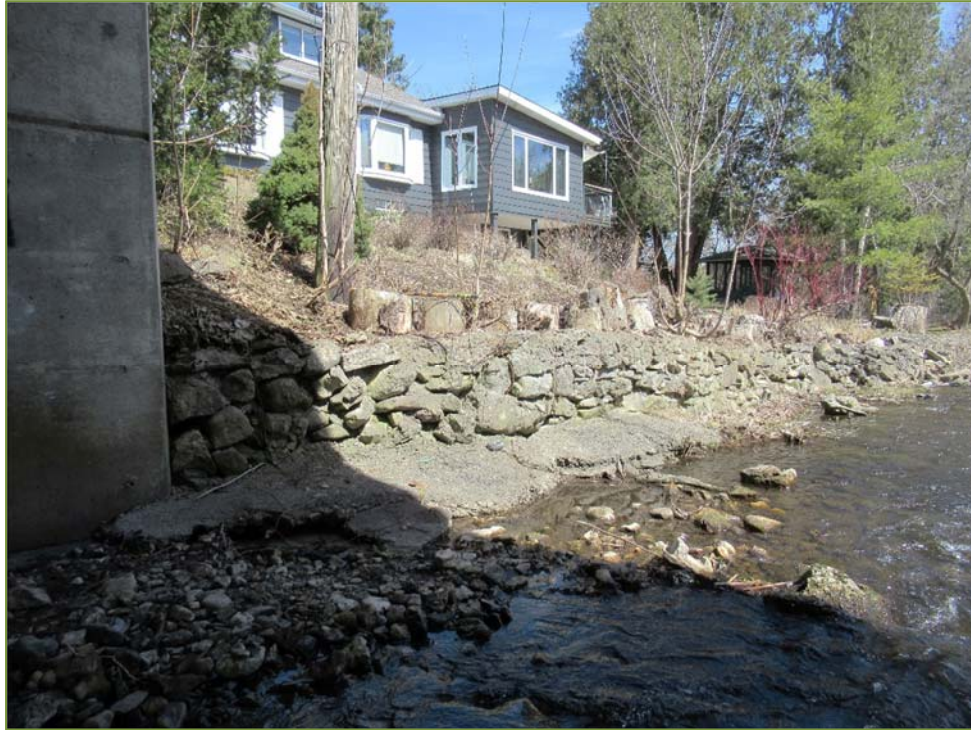
Photo P51 – Northeast Gabion Wall (good condition)

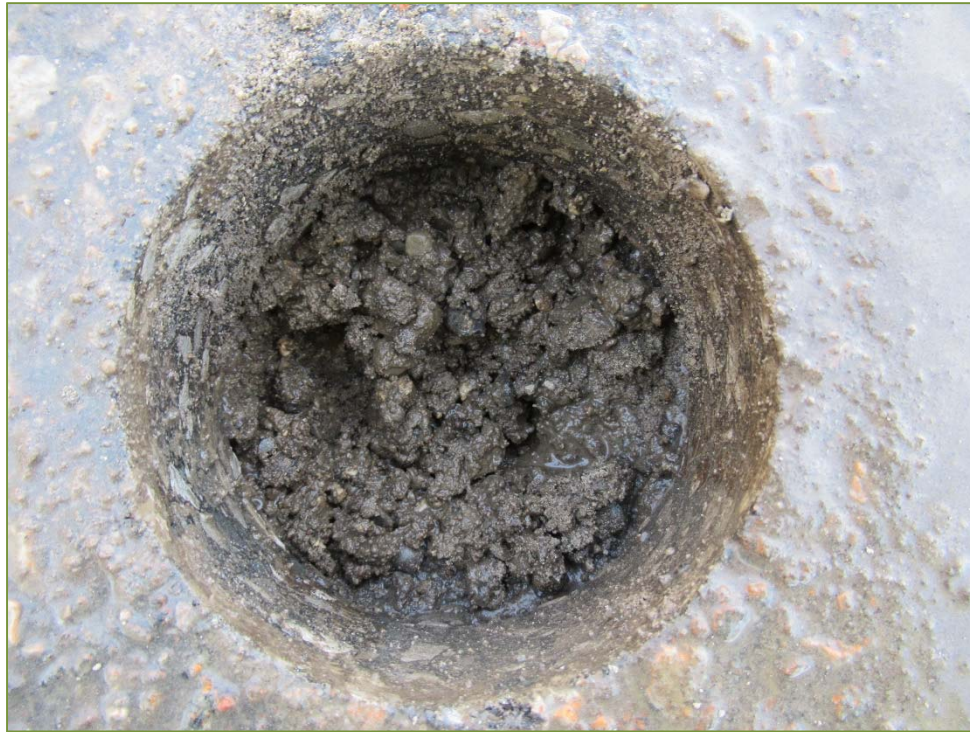
Photo P61 – Typical Condition of Inside Core – C1 (north approach; granular)
