# INTERIM STORMWATER FACILITY OPERATIONS & MAINTENANCE MANUAL

#### **HUMBER STATION DISTRIBUTION CENTRE**

## TOWN OF CALEDON REGION OF PEEL

**AUGUST 2025**

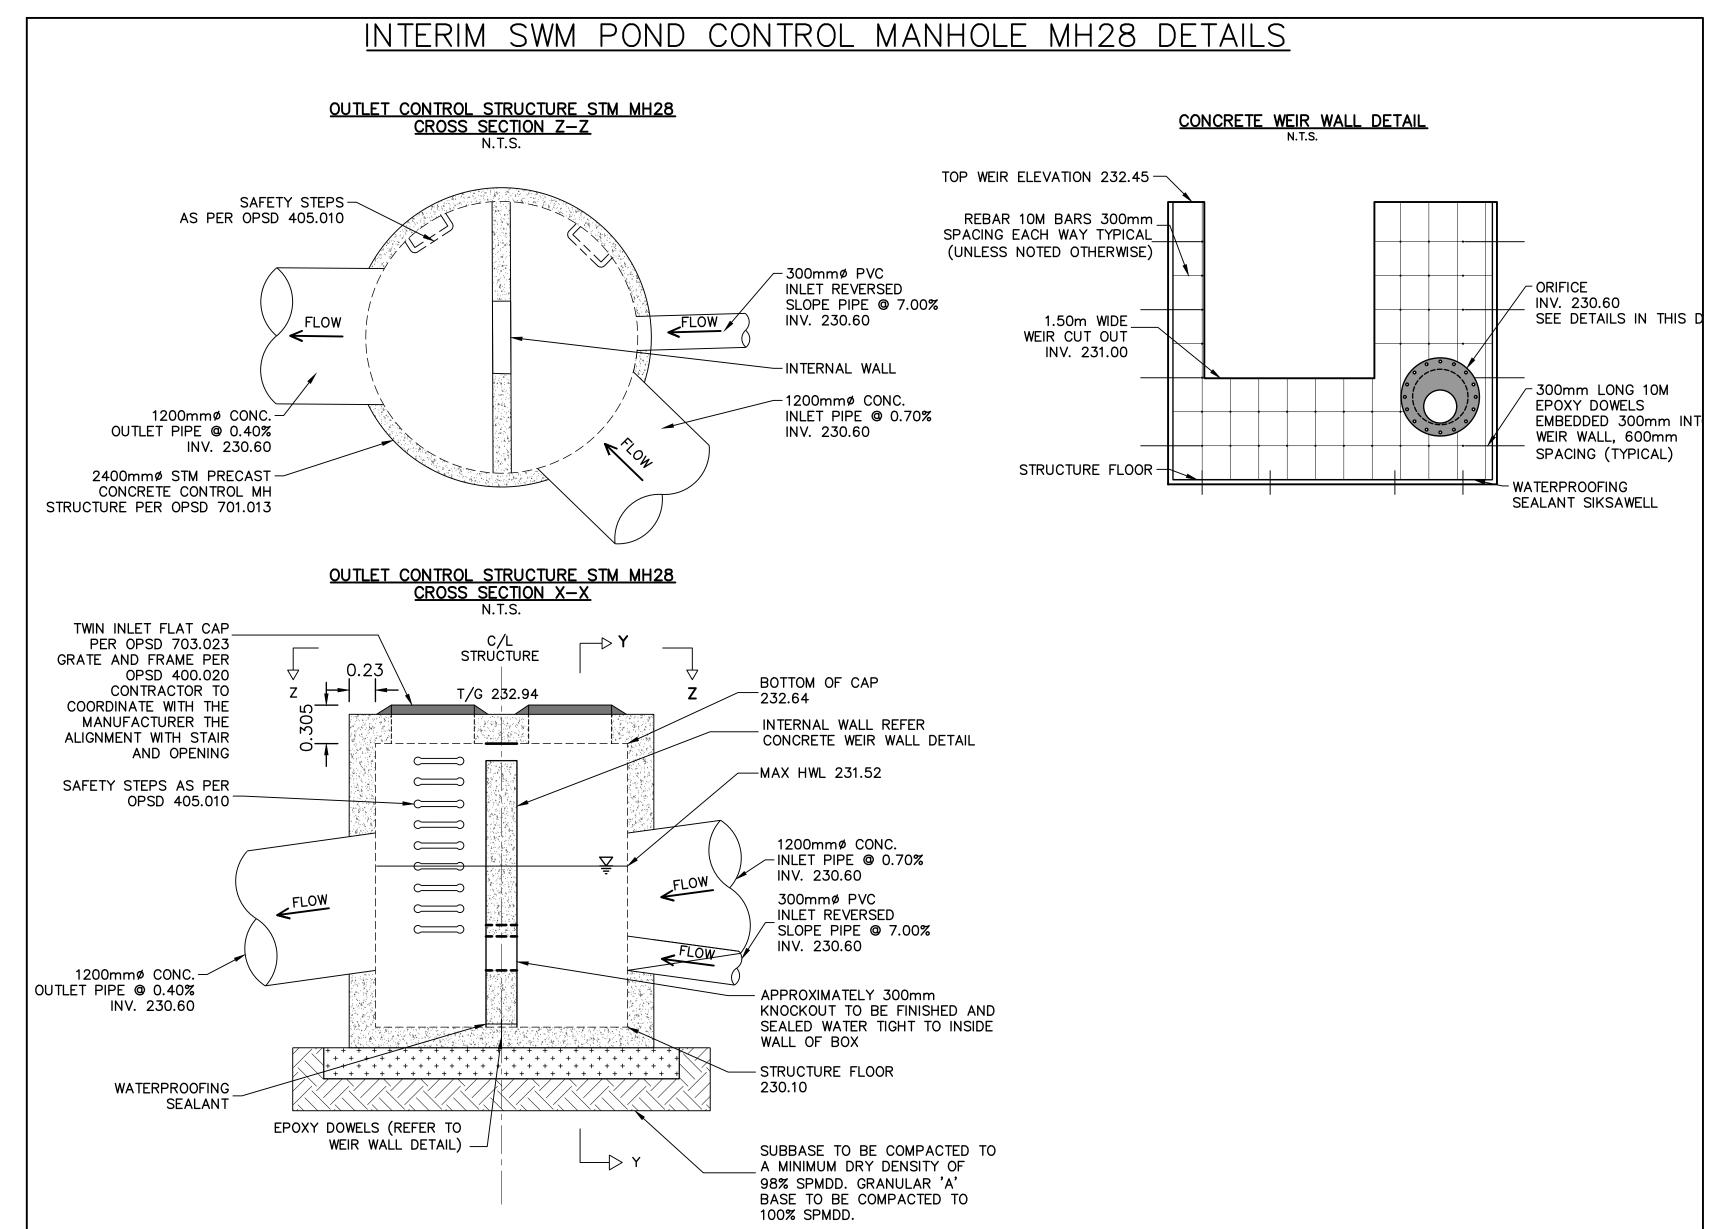
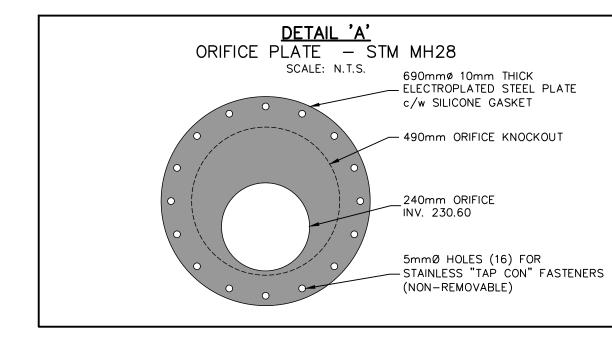
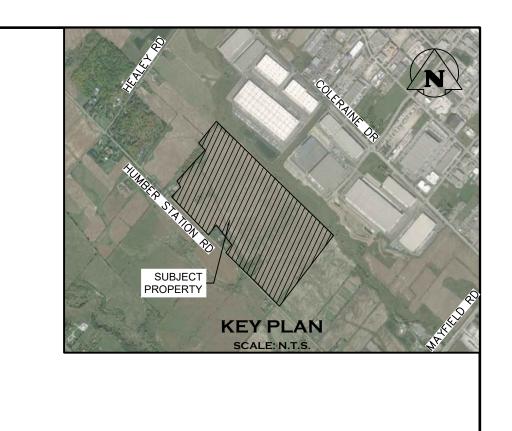
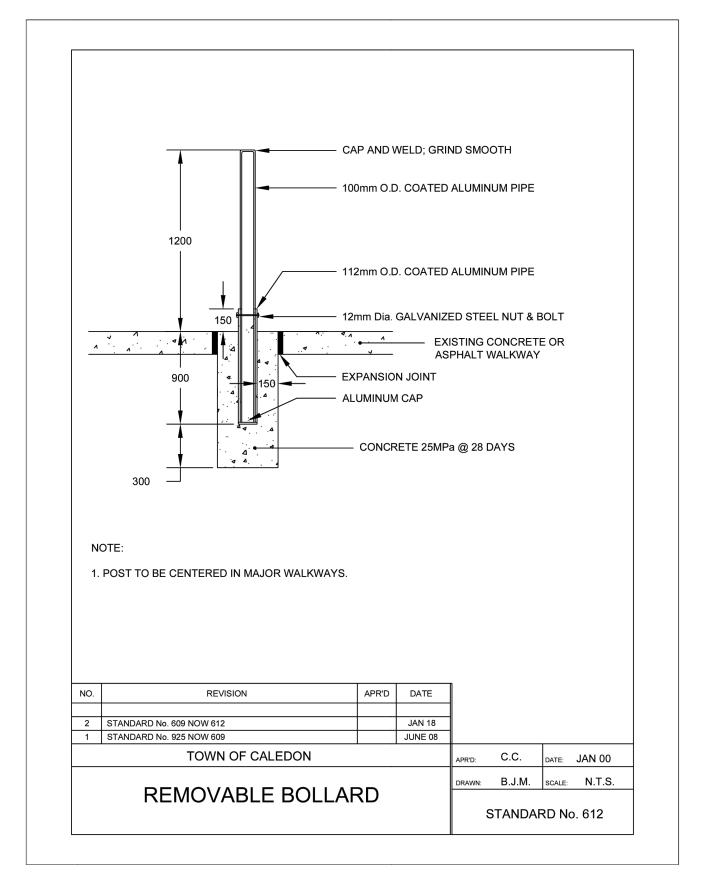
INTERIM STORMWATER MANAGEMENT POND SECTIONS

HUMBER STATION DISTRIBUTION CENTRE TOWN OF CALEDON

**Drawing C607:** Interim Stormwater Management Pond
