# Visual Impact Assessment Report

## McCormick Property

Category 1 – Class “A” License, Pit Below Water  
For Blueland Farms Limited

January 2018

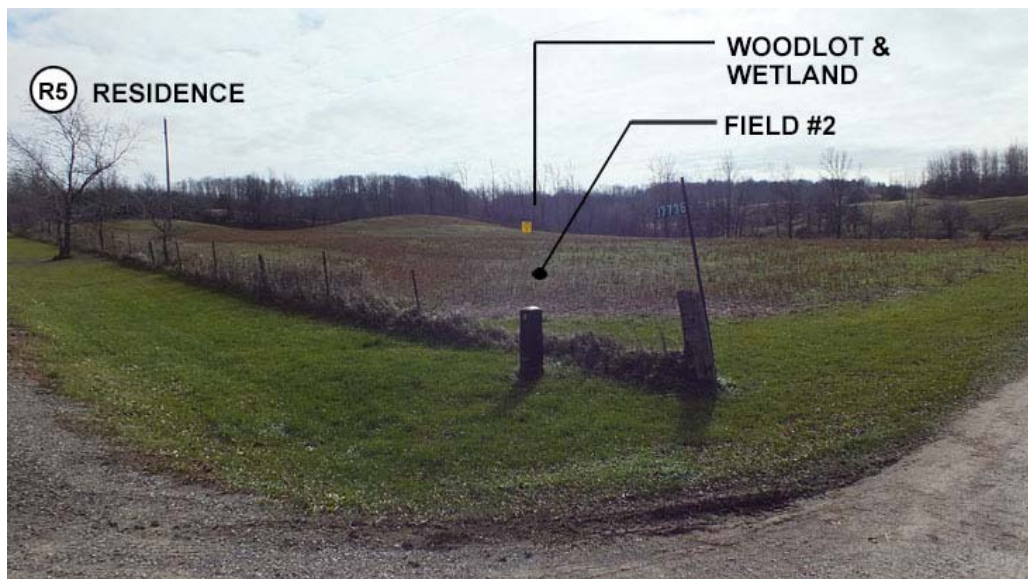
Figure 8. View #2  
Field #2 (November 2012)

Southeast of the McCormick house and sheds is a field composed of rolling hills. This area is surrounded by Woodlot to the southwest, Residence R5 to the southeast and a post and wire fence and Heart Lake Road to the northeast. Traveling southeast on Heart Lake Road Woodlot and a post and wire fence outline the open space of rolling hills. In this view the fence and tall grasses lie within the Foreground, but are not dominating or intimidating because they are Viewer Level. In the Middleground the elevation of Field #2 fluctuates, but is relatively Viewer Level. The woodlot in the Background is at a lower elevation than the rolling hills in the Middleground, yet still screens the view further into the subject property and the escarpment environment.

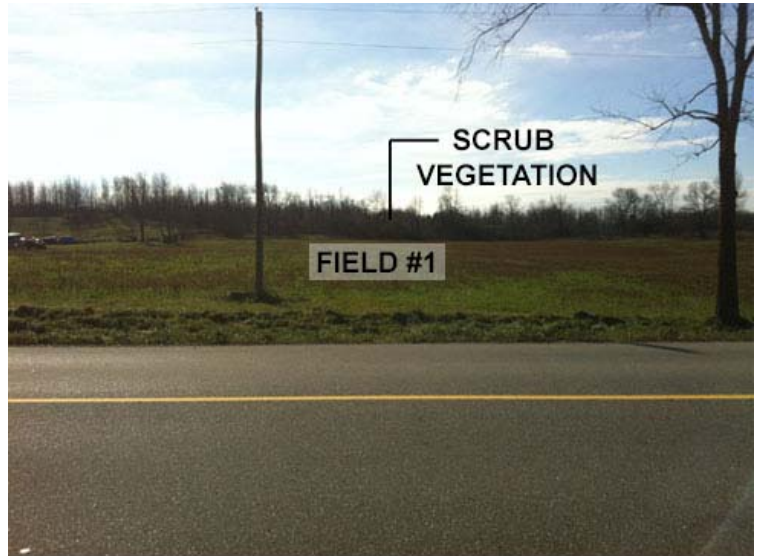
Figure 9. View #3  
Field #1 (November 2012)

At the north end of the subject property is a flat existing field. The vegetation surrounding the open space screen the view further into the subject property and also focuses one's attention towards the field. The entrance to Residence R3 is located directly across Heart Lake Road from Field #1. Therefore, someone exiting Residence R3 will have a direct line of sight to this field. Located in the Foreground is Heart Lake Road. In the Middleground at Viewer Level lies Field #1 and the Deciduous Woodlot and scrub vegetation sits in the Background. Although the woodlot is Viewer Inferior, it is at too far a distance from the viewer to impose a sense of grandeur.

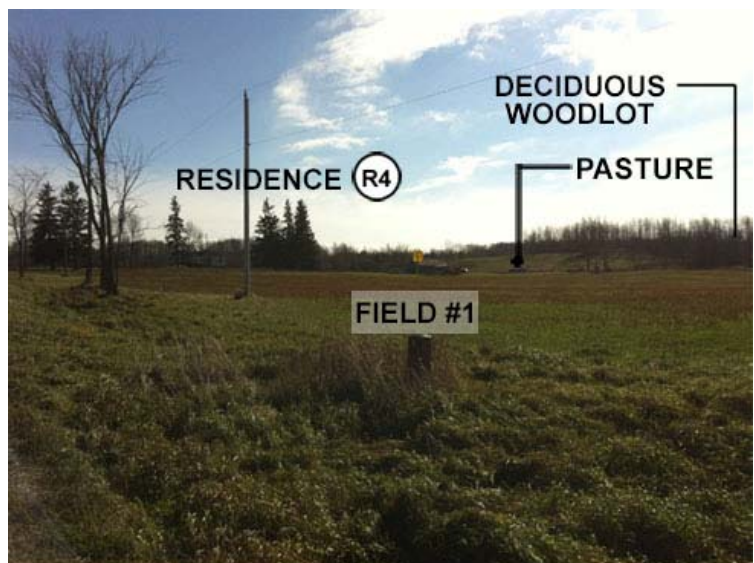
Figure 10. View #4  
View South (November 2012)

A good portion of the landscape is captured in a view from the northern corner of the subject property on Heart Lake Road. Our attention is immediately focused towards Field #1 in the Foreground at Viewer Level. The Pasture sits Viewer Inferior in the Middleground. Although objects located at a higher elevation usually inflict a sense of warmth and encouraging dominance upon the viewer, the Pasture's location in the picture and distance from the viewer leaves it inferior to the vastness of the dominating field. Finally, in the Background, the Deciduous Woodlot stretches along the skyline. Similar to the Pasture, the woodlot is Viewer Inferior, however, the distance between the control points and its angle in relation to the view leave it submissive in the landscape.

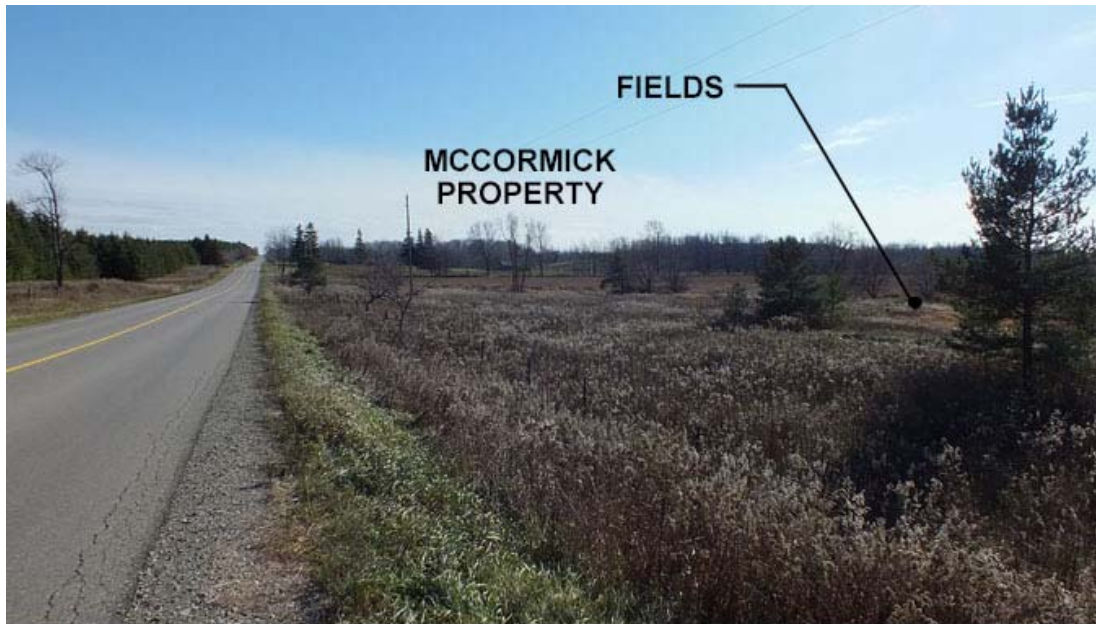
Figure 11. View #5  
View Southeast (November 2012)

Residence R1 is approximately 320m northwest of the subject property. This residence is located at a higher elevation than Field #1 on the subject property. One travelling southeast on Heart Lake Road towards the McCormick Property would view Field #1 on the subject property through the existing sparse vegetated screen at the property boundary, as well as the woodlot and escarpment environment in the Far Background. As a result, the subject property is Viewer Superior in the Background of this view.

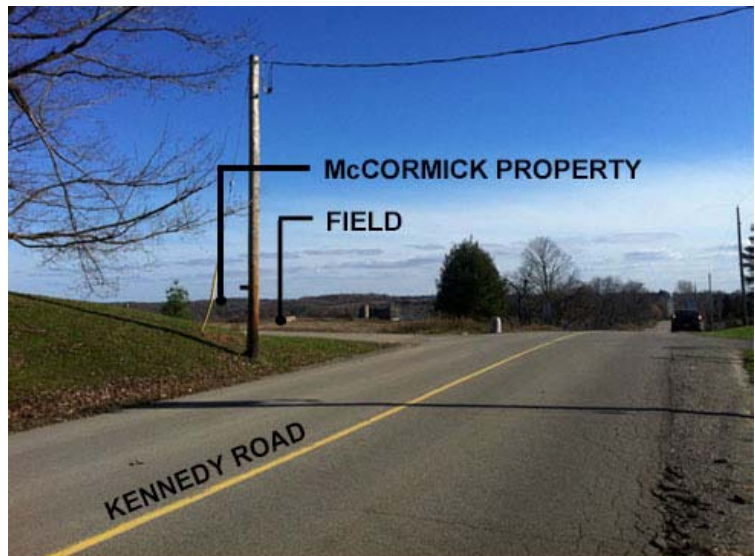
Figure 12. View #6  
View East (November 2012)

There is a section of Kennedy Road that is at a higher elevation. From this point there is a view east towards the subject property. There is no form of a visual barrier restricting the view to only Kennedy Road. As a result, Kennedy Road sits in the Foreground of this picture. A field lies within the Middleground and there is a skyline view of a woodlot in the Background. This woodlot is located just outside of the subject lands. Although Field #3 is located at the western corner of the subject property it will be hidden from view by the woodlot.

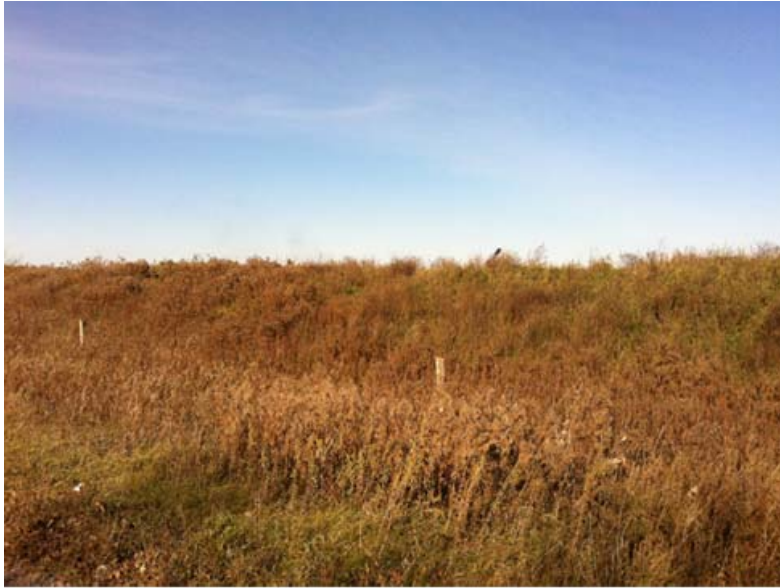
Figure 13. View #7  
View Northeast (November 2012)

The existing license operated by Caledon Sand and Gravel Inc. neighbours the subject property to the southwest. The proposed operation plan for the McCormick pit would involve transporting material, either by conveyor or by truck, from the McCormick site, to the neighbouring licensed site for processing and shipping. Mitigation measures have already been implemented to reduce the visual impacts of this extraction site. As a result, the subject property cannot currently be viewed from this location.

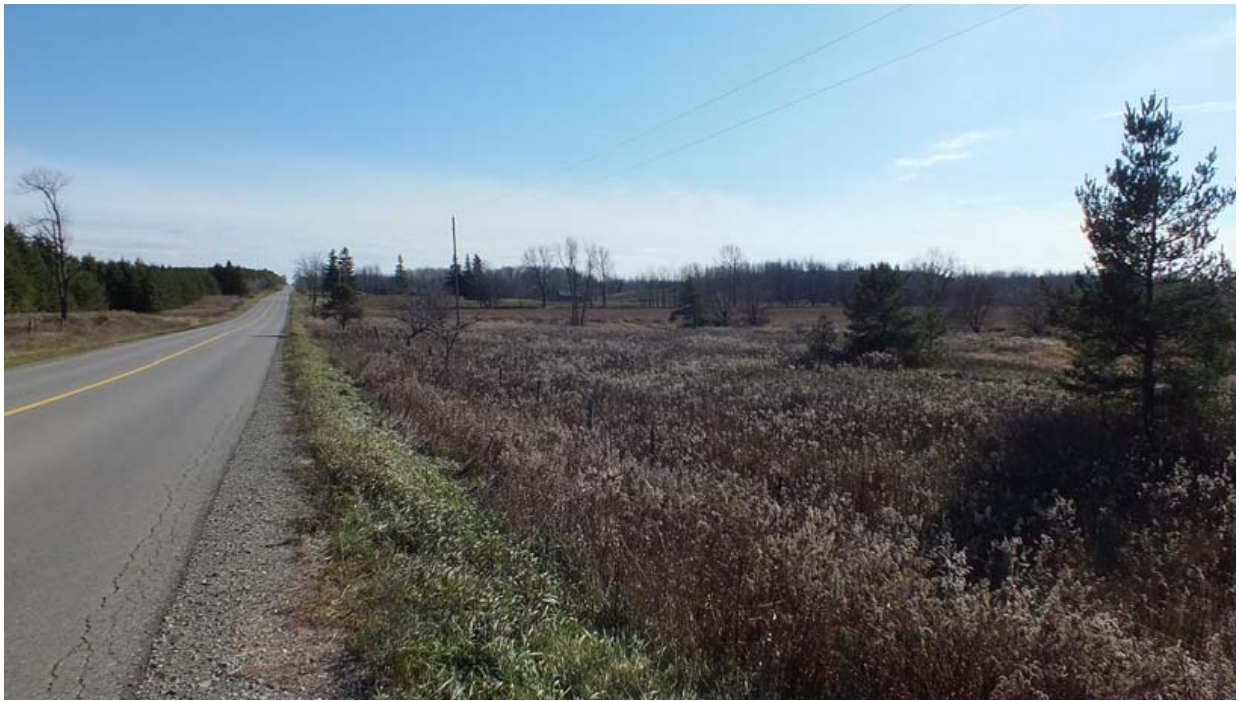
**Figure 27. Existing View Southeast (View #5)**

In this view the subject property sits Viewer Superior in the background of this view. As a result the proposed temporary seeded berm is not a dominant feature in the picture plane (see Figure 27 and 28).

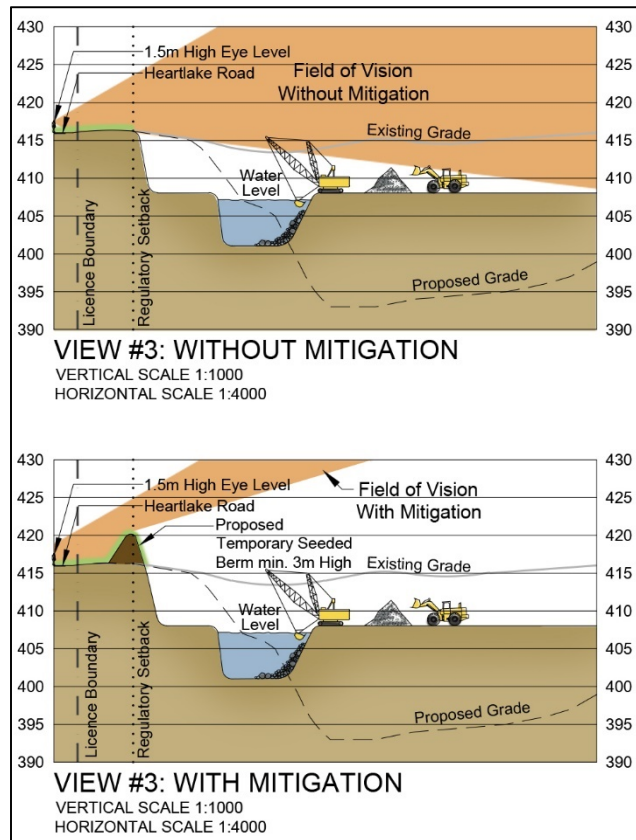
**Figure 29. View #3: Line of Sight Cross Section**

View #3 (Field #1) is from the entrance to Residence R3 across Heart Lake Road towards Hay Field #1. As shown in the line of sight cross section of View#3 (see Figure 29), the recommended temporary seeded berm will be more than sufficient to serve as a visual barrier to screen the view of the proposed pit floor, equipment, and operations (See Figure 30 and 31).
